Expertise

Protocol number: 46542409  
Order No. / Reference: 26674075  
Inspection date: 15 Jul 2026

| Manufacturer: Opel | Model: Grandland Plug-in-Hybrid 1.6 DI Automatik Business Edition |

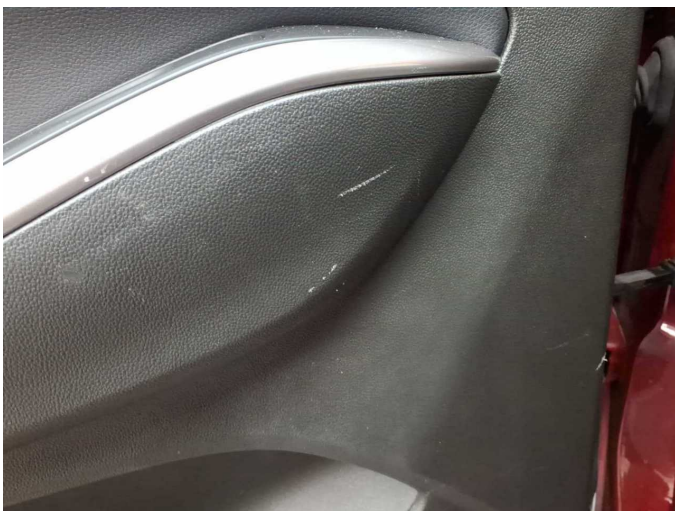
| No. | Component group | Description |
|---|---|---|
| 2 | Trim / covers | Door trim - rear left side - Scratch(es) - Loss in value |

**Damage 2:** Trim / covers: Door trim - rear left side - Scratch(es) - Loss in value

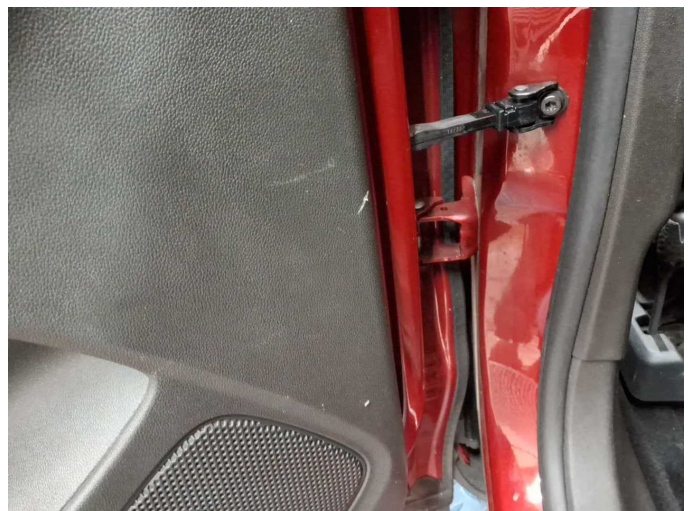
**Damage 2:** Trim / covers: Door trim - rear left side - Scratch(es) - Loss in value

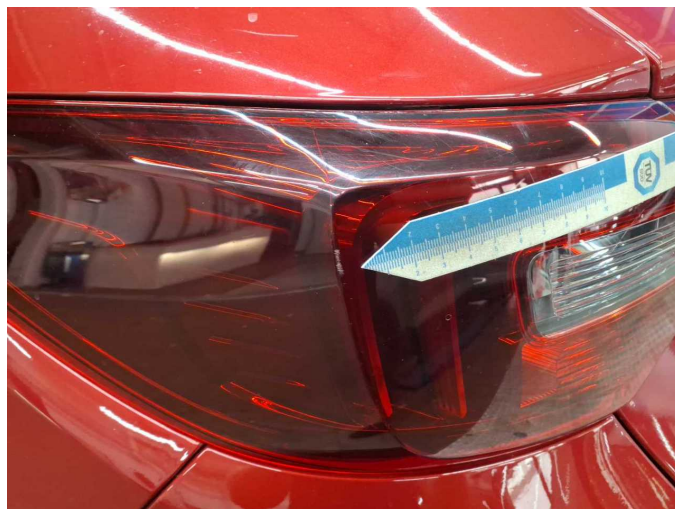
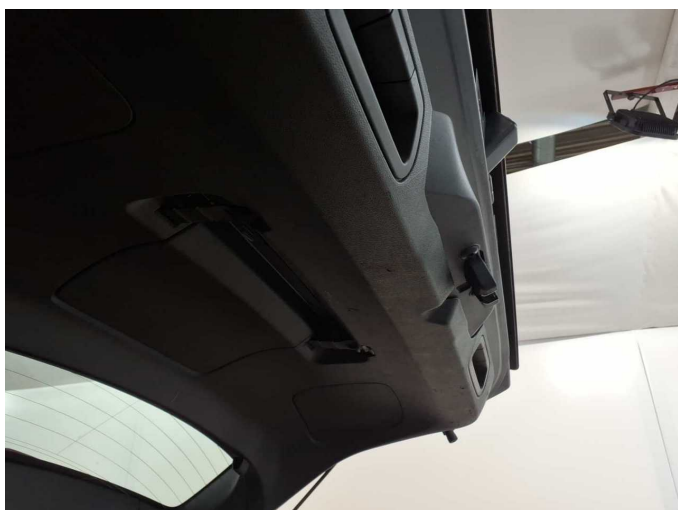
| No. | Component group | Description |
|---|---|---|
| 3 | Tail light | Tail lamp - left side - Scratch(es) - Loss in value |

**Damage 3:** Tail light: Tail lamp - left side - Scratch(es) - Loss in value

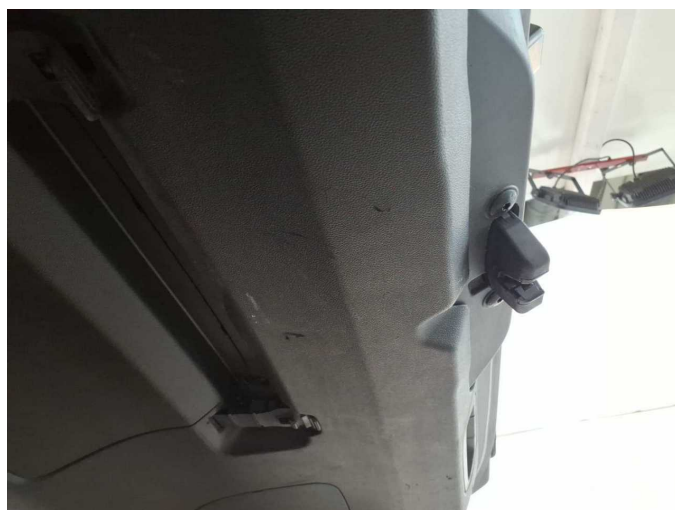
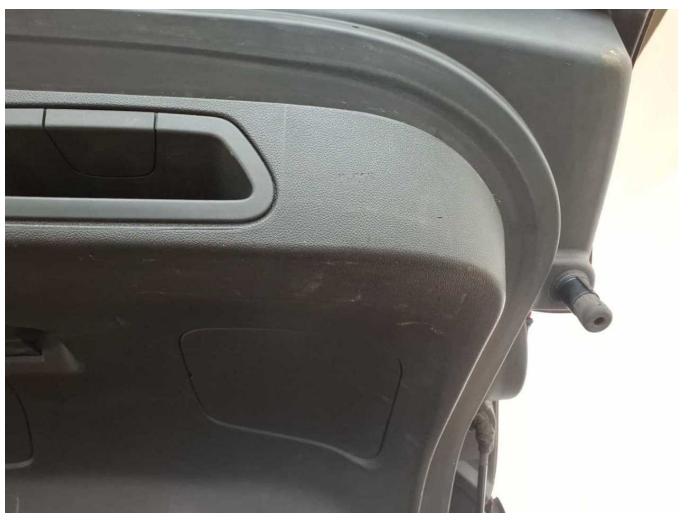
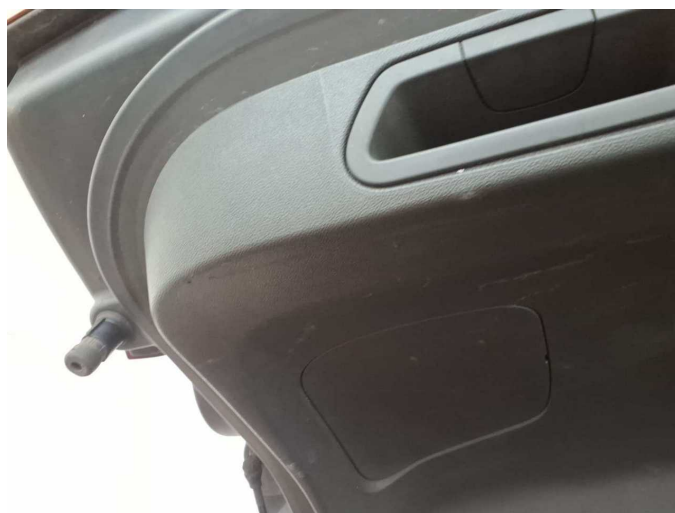
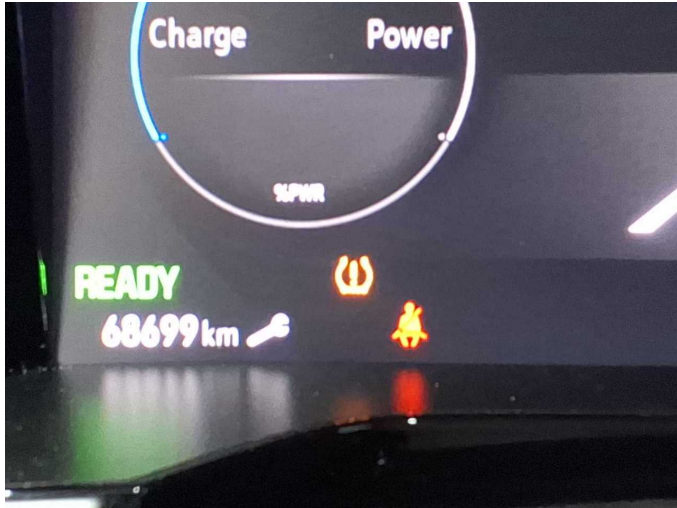
| No. | Component group | Description |
|---|---|---|
| 4 | Trim / covers | Boot lid - interior trim - Scratch(es) - Loss in value |

**Damage 4:** Trim / covers: Boot lid - interior trim - Scratch(es) - Loss in value

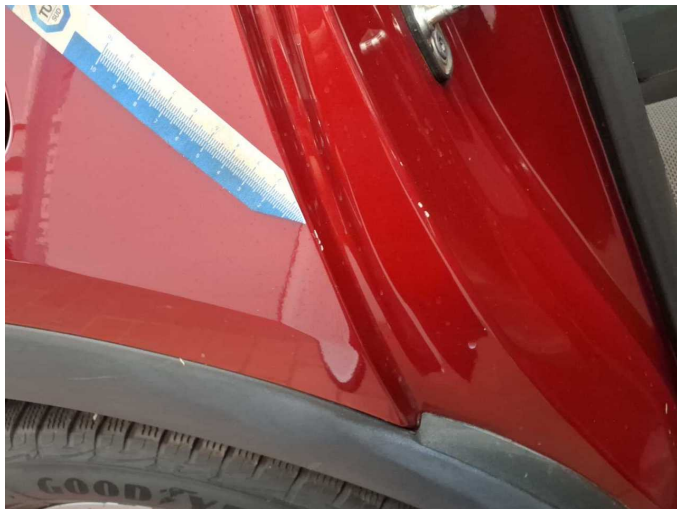
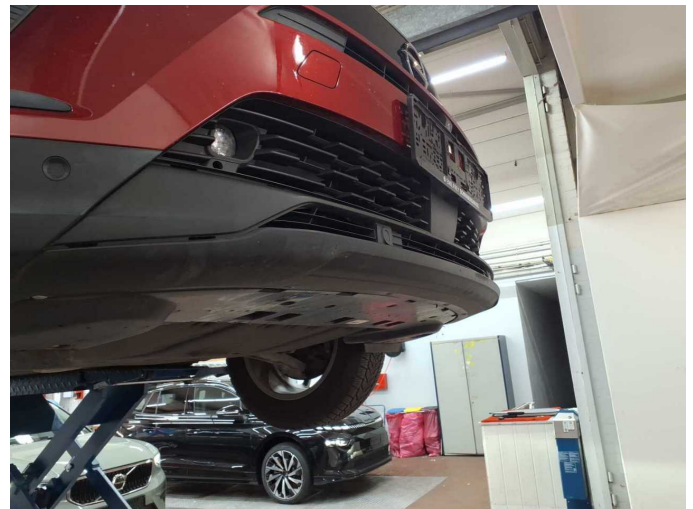
| No. | Component group | Description |
|---|---|---|
| 6 | Side panel - rear right side | Side panel - Scratch(es) - Smart repair |

**Damage 6:** Side panel - rear right side: Side panel - Scratch(es) - Smart repair

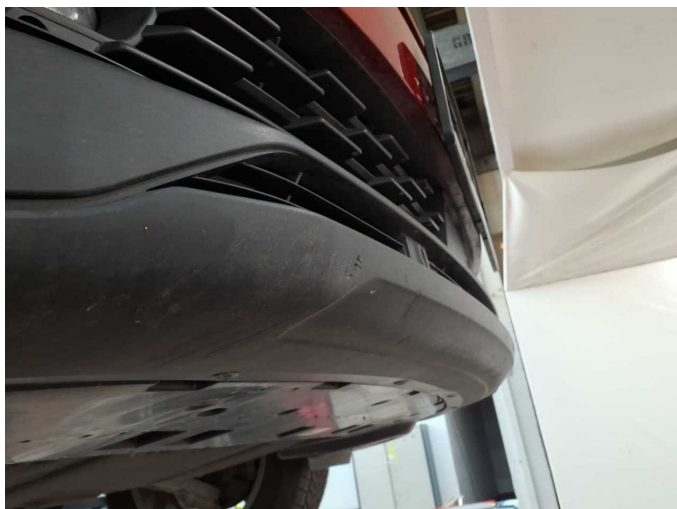
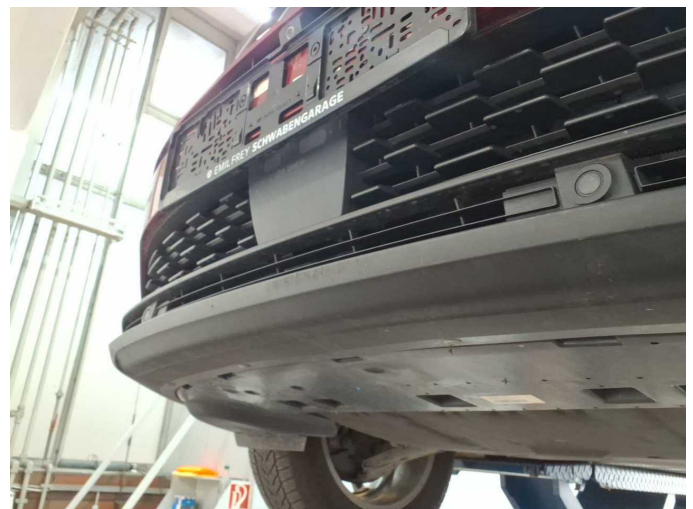
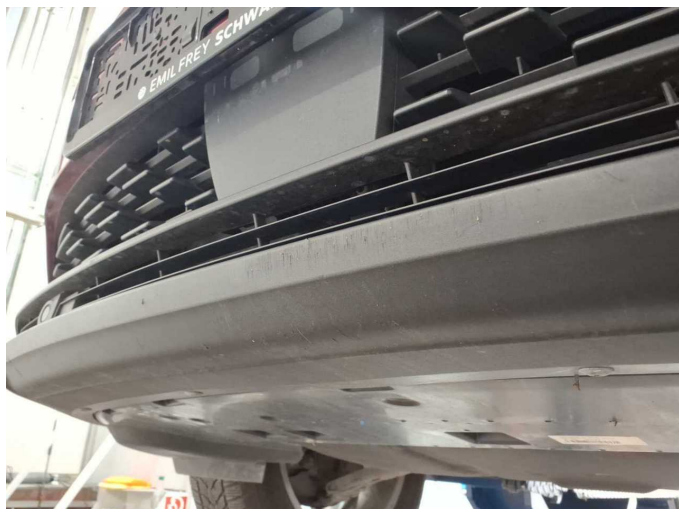
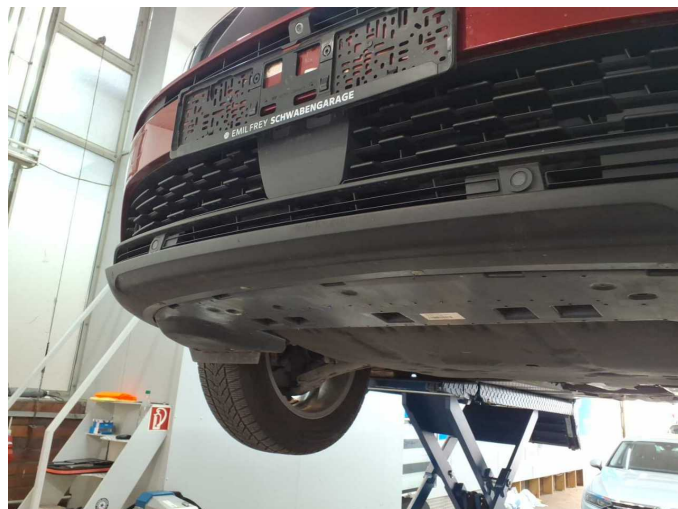
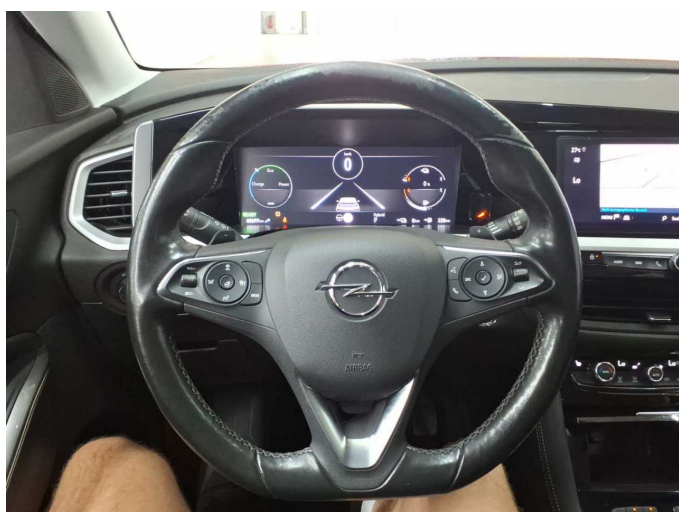
| No. | Component group | Description |
|---|---|---|
| 7 | Front bumper | Front bumper - Scratch(es) - Loss in value |

**Damage 7:** Front bumper: Front bumper - Scratch(es) - Loss in value

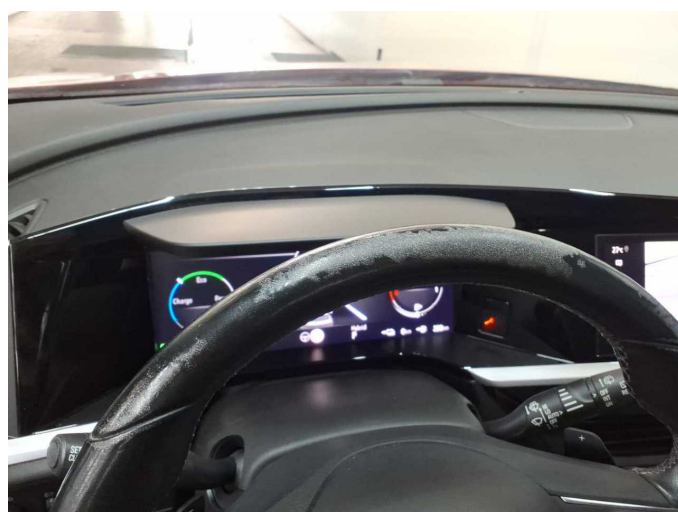
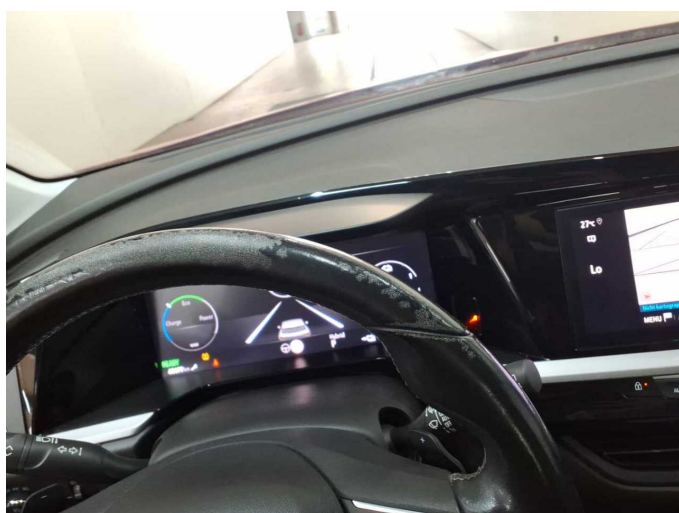
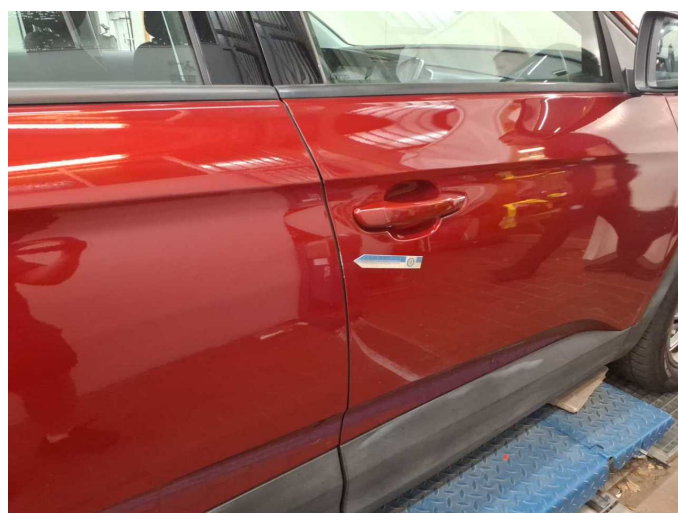
| No. | Component group | Description |
|---|---|---|
| 8 | Steering system | Steering wheel - Abrasion - Loss in value |

**Damage 8:** Steering system: Steering wheel - Abrasion - Loss in value

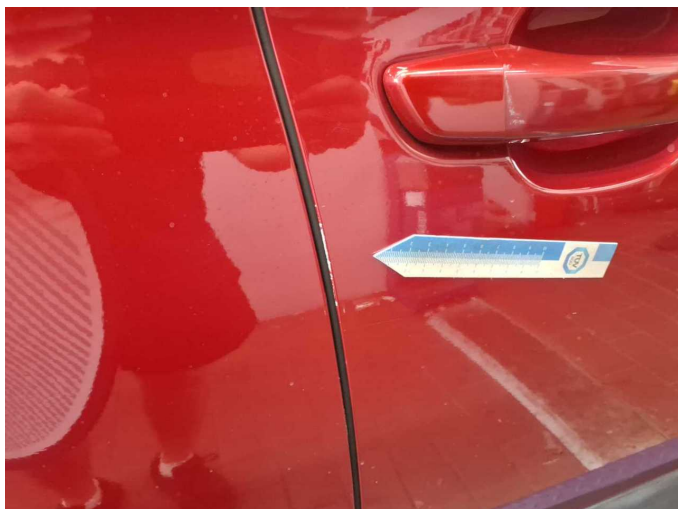
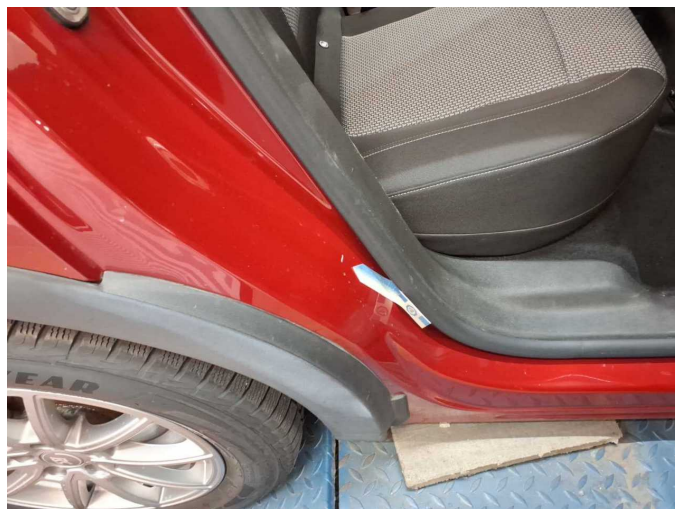
| No. | Component group | Description |
|---|---|---|
| 9 | Door - front right side | Door edge - Scratch(es) - Smart repair |

**Damage 9:** Door - front right side: Door edge - Scratch(es) - Smart repair

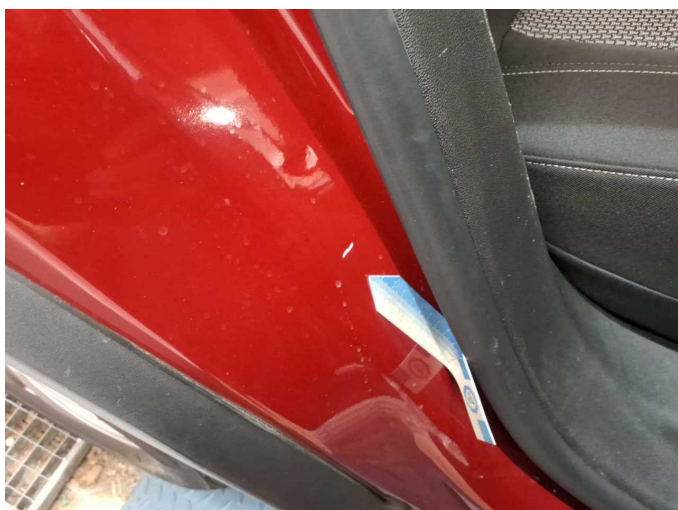
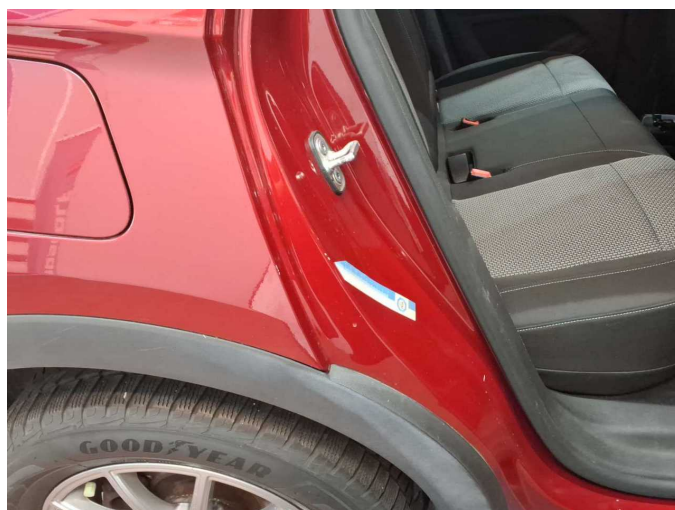
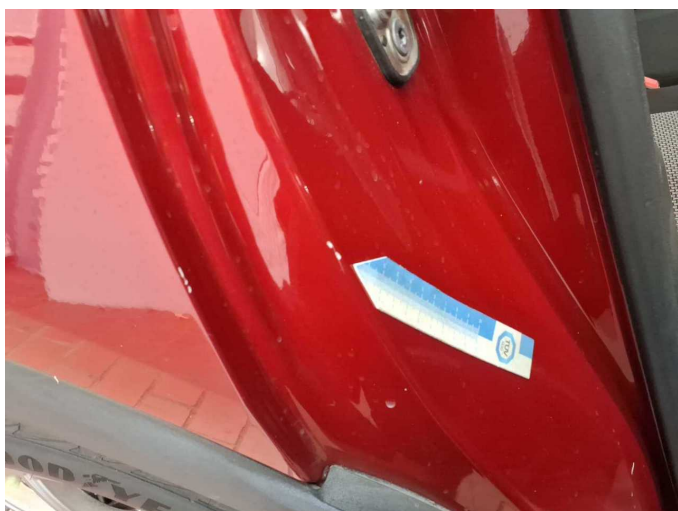
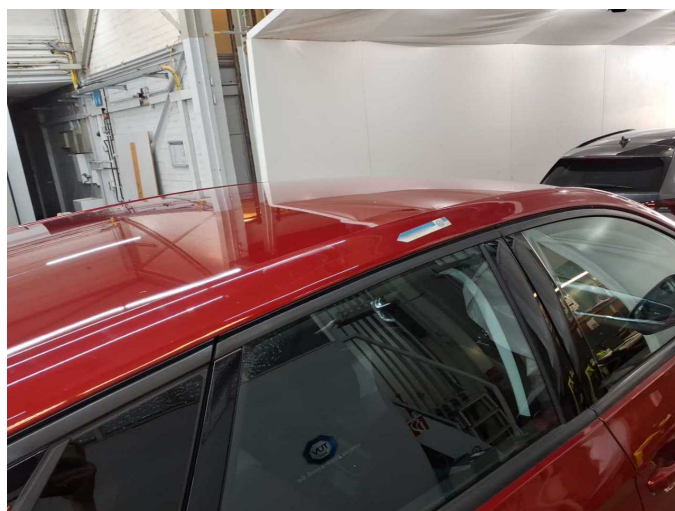
| No. | Component group | Description |
|---|---|---|
| 10 | Side panel - rear right side | Sill - Scratch(es) - Smart repair |

**Damage 10:** Side panel - rear right side: Sill - Scratch(es) - Smart repair

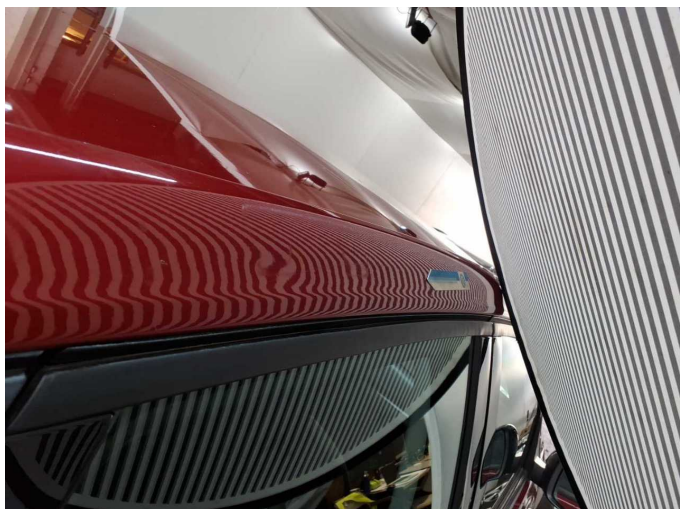
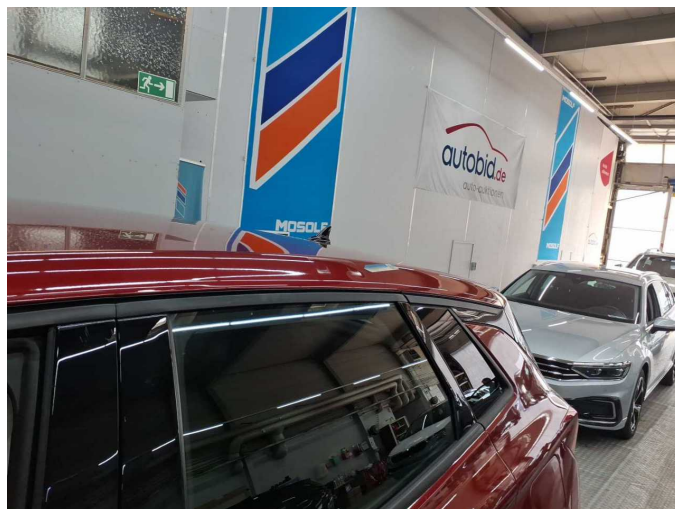
| No. | Component group | Description |
|---|---|---|
| 11 | Roof | Roof rail - right side - dent(s) - Smart repair |

**Damage 11:** Roof: Roof rail - right side - dent(s) - Smart repair

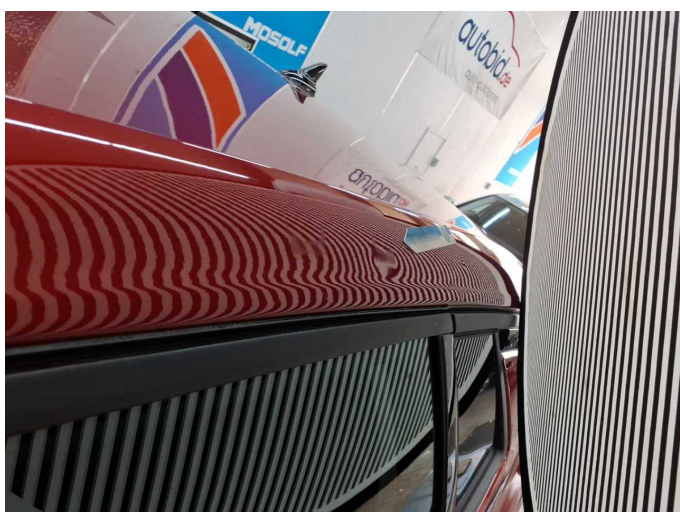
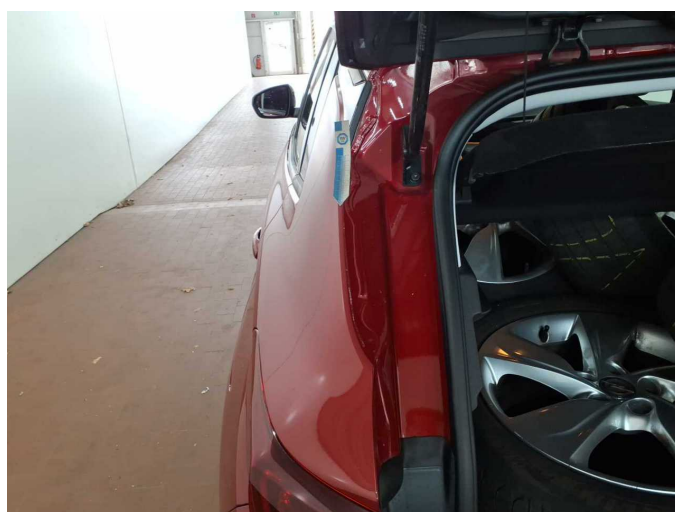
| No. | Component group | Description |
|---|---|---|
| 12 | Roof | Roof rail - left side - dent(s) - Smart repair |

**Damage 12:** Roof: Roof rail - left side - dent(s) - Smart repair

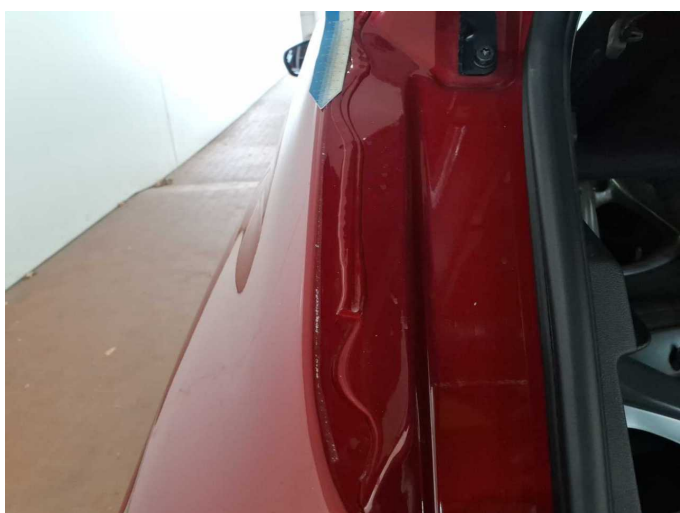
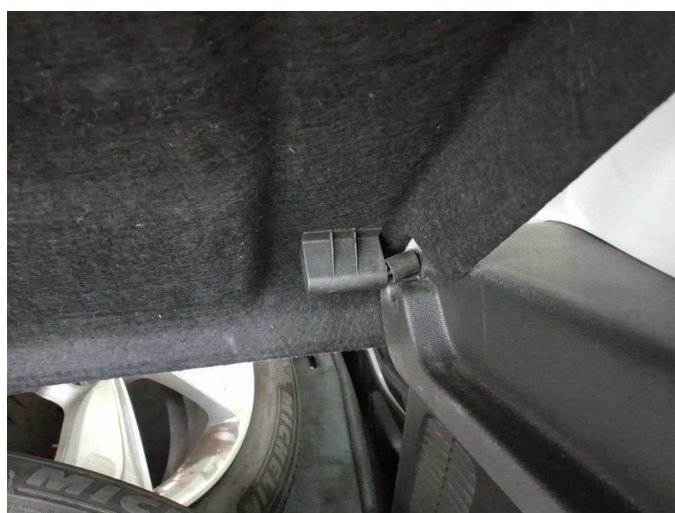
| No. | Component group | Description |
|---|---|---|
| 13 | Side panel - rear left side | Side panel - Scratch(es) - Smart repair |

**Damage 13:** Side panel - rear left side: Side panel - Scratch(es) - Smart repair

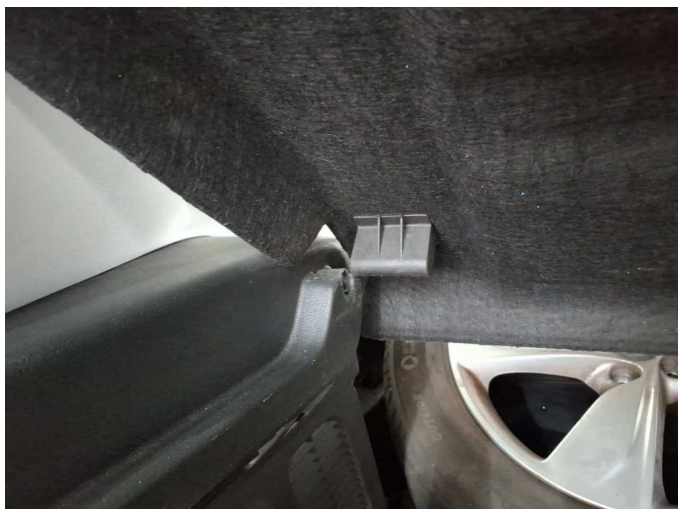
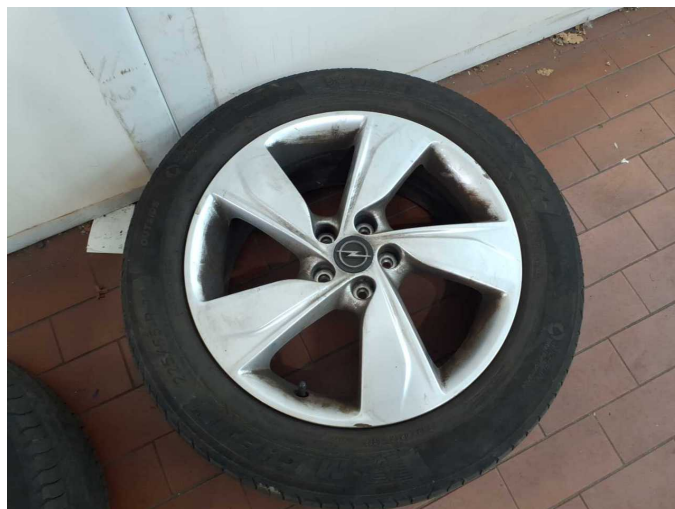
| No. | Component group | Description |
|---|---|---|
| 14 | Interior | Rear shelf (Halter gerissen) - Damaged - Replace |

**Damage 14:** Interior: Rear shelf (Halter gerissen) - Damaged - Replace

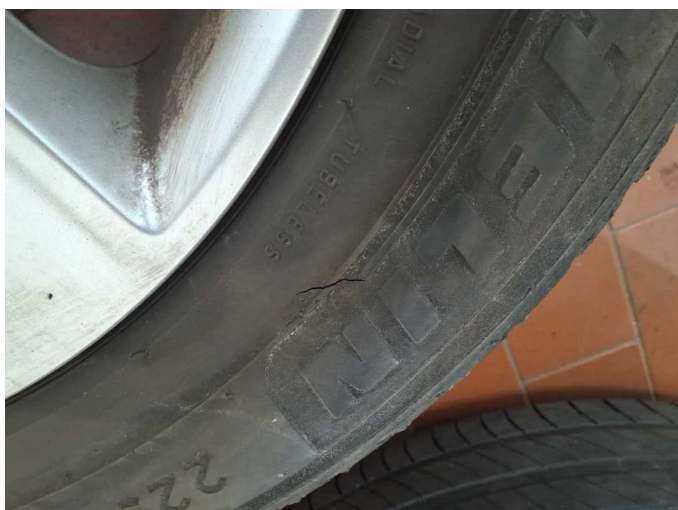
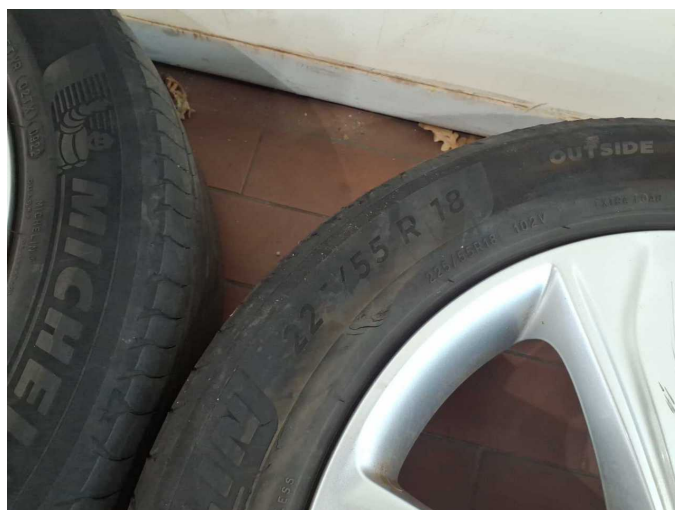
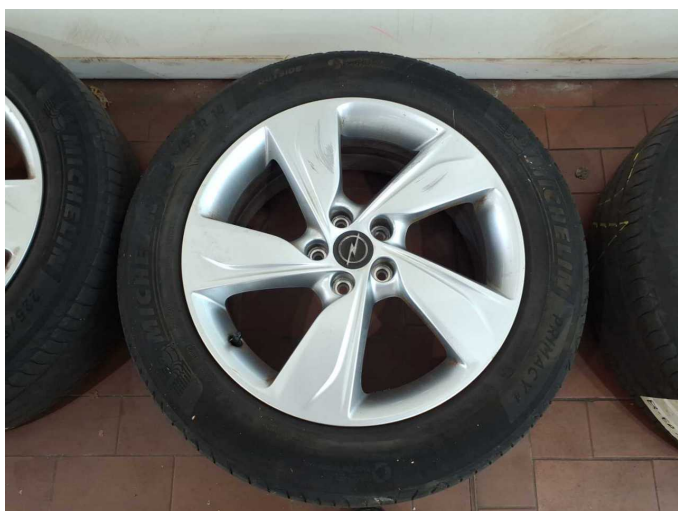
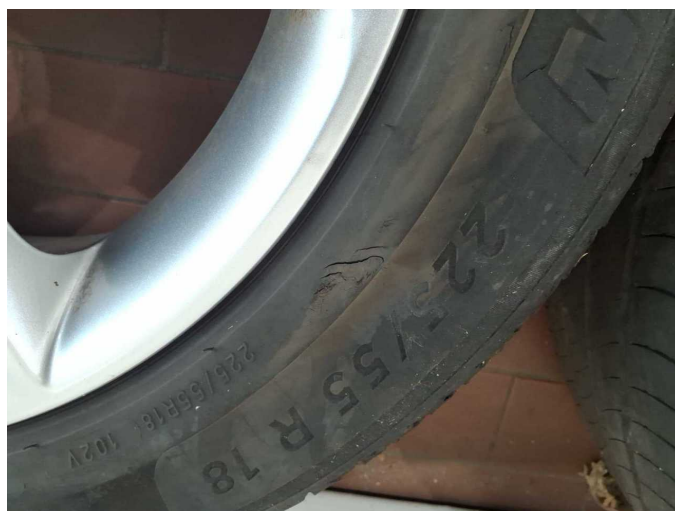
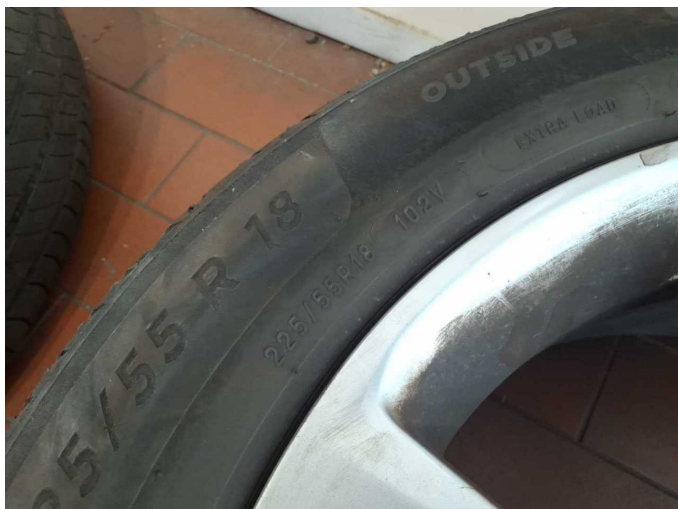
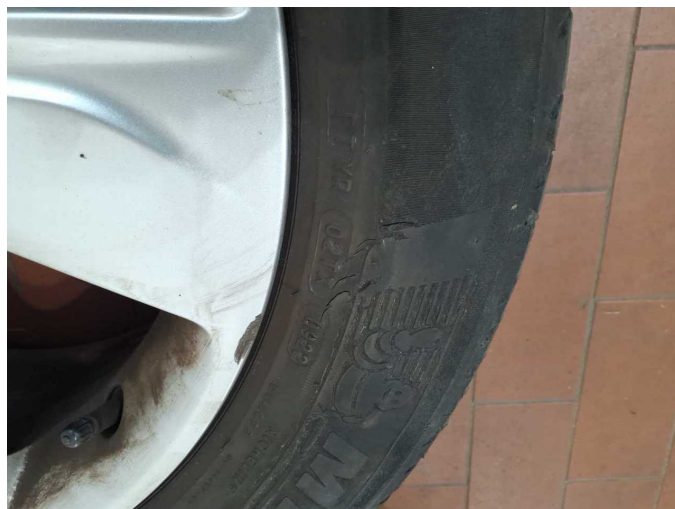
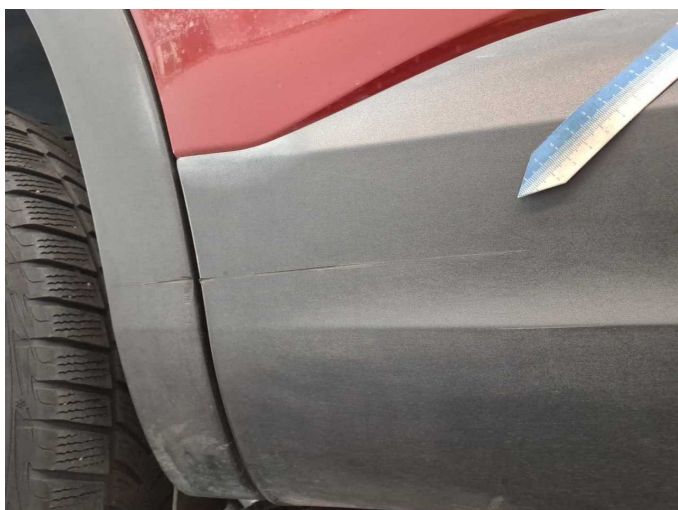
| No. | Component group | Description |
|---|---|---|
| 15 | 2nd wheel set | 2 tyres - Damaged - Replace |

**Damage 15:** 2nd wheel set: 2 tyres - Damaged - Replace

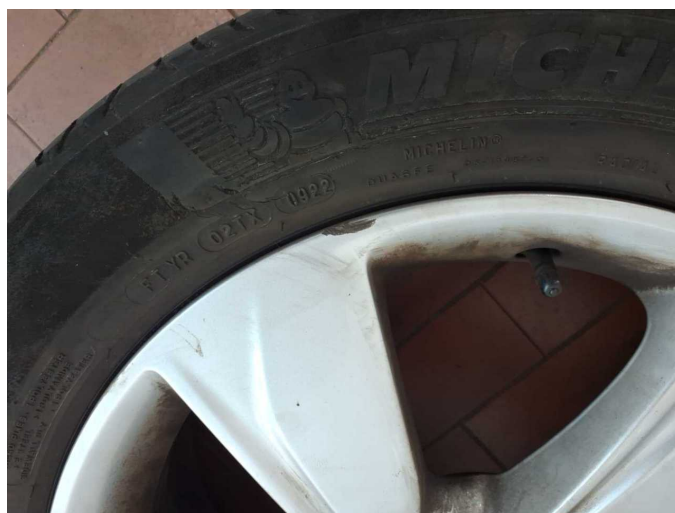
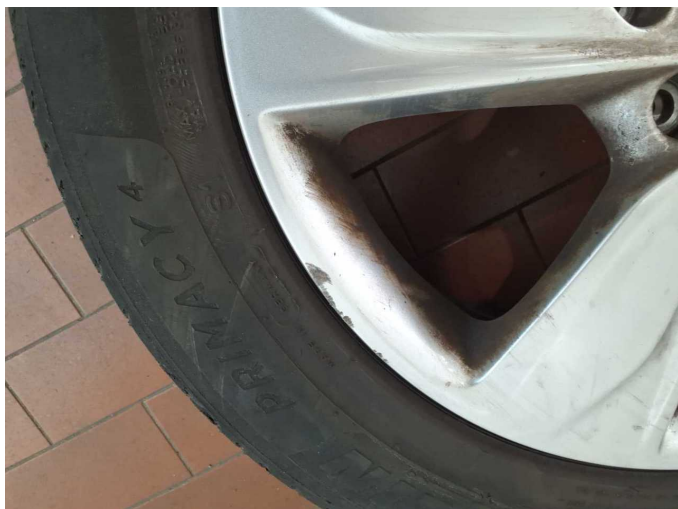
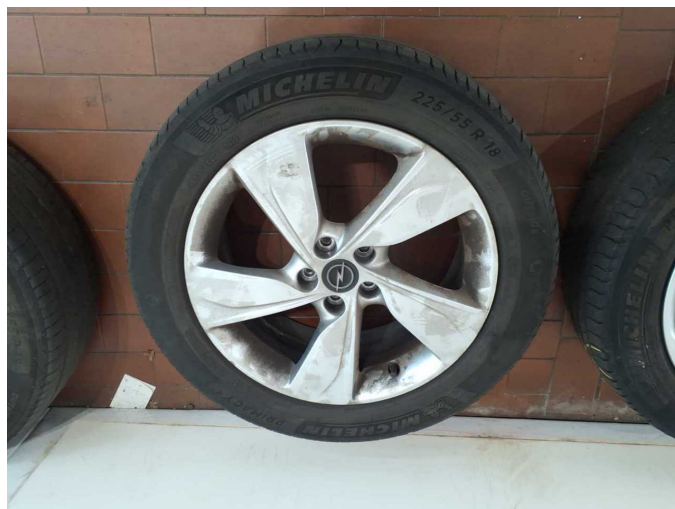
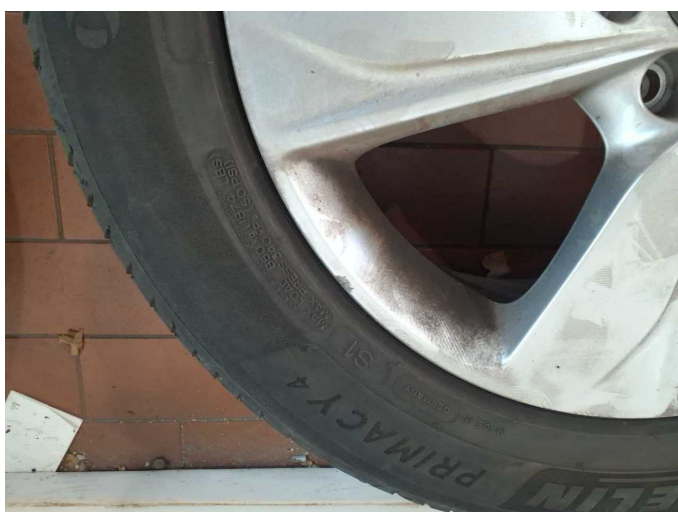
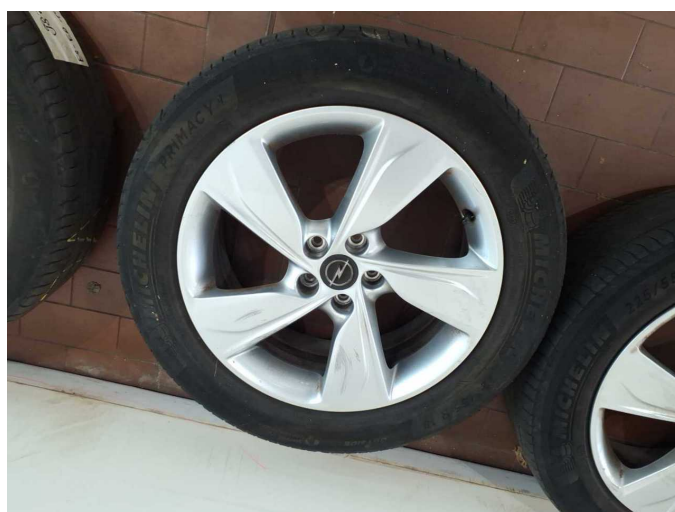
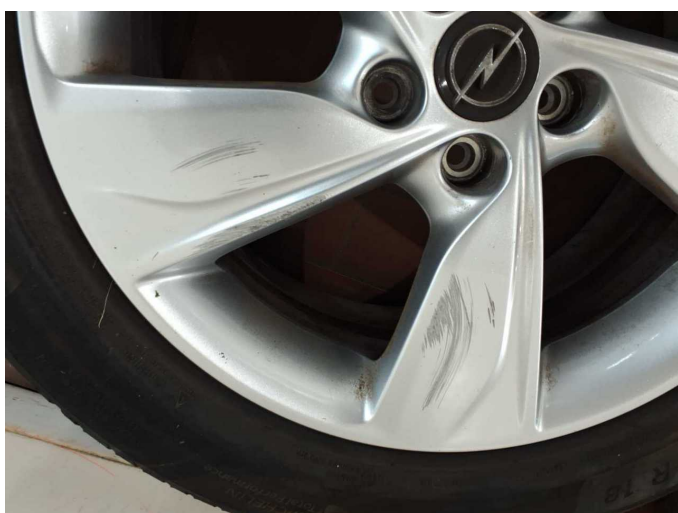
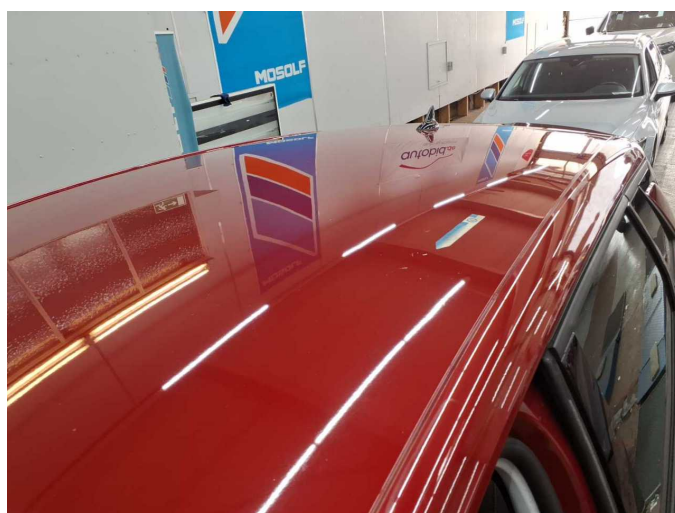
| No. | Component group | Description |
|---|---|---|
| 18 | 2nd wheel set | 3 alloy rims - Scratch(es) - Loss in value |

**Damage 18:** 2nd wheel set: 3 alloy rims - Scratch(es) - Loss in value

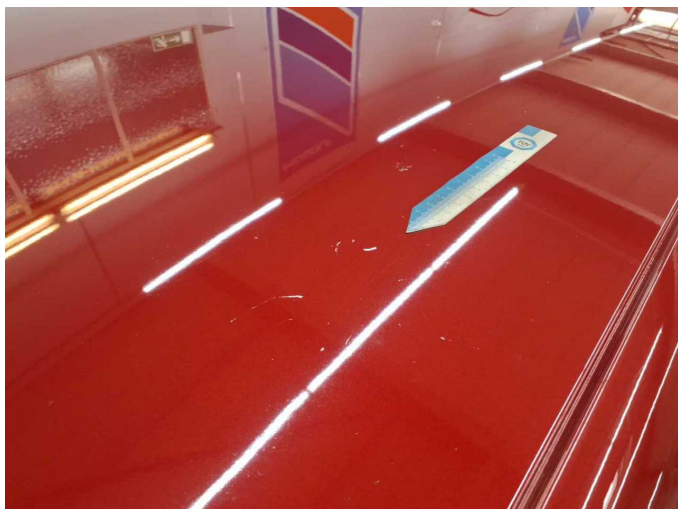
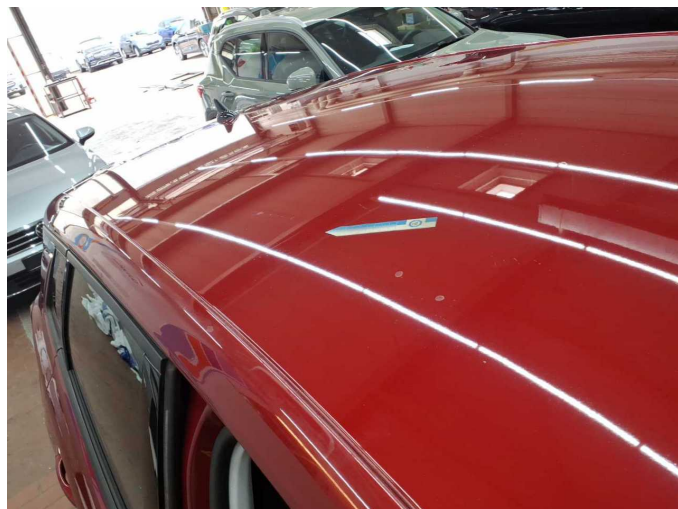
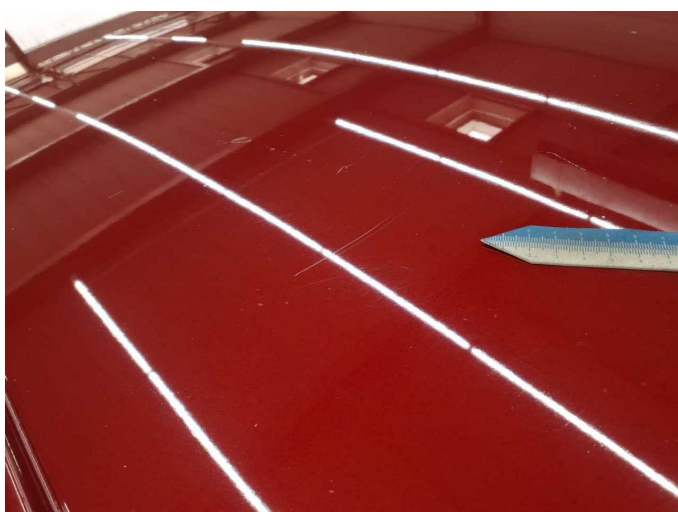
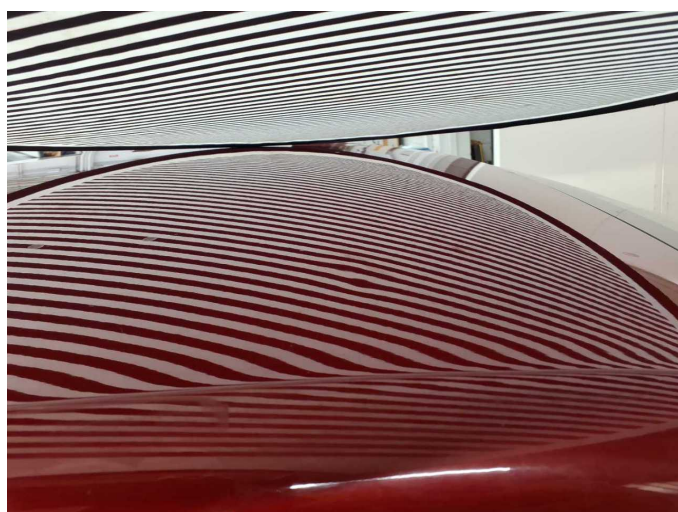
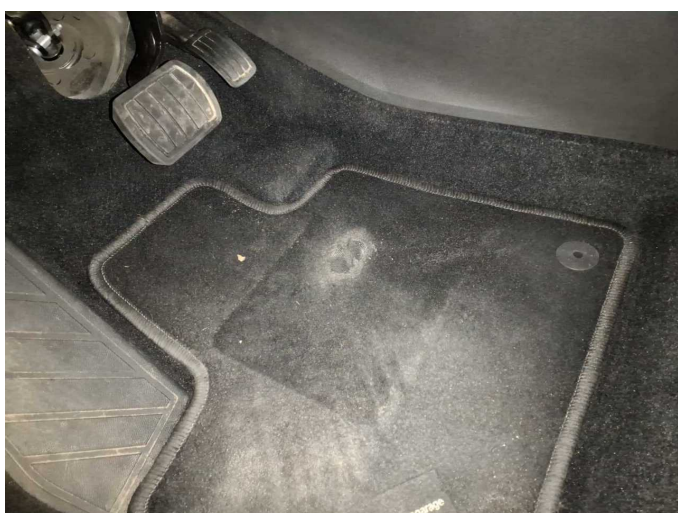
| No. | Component group | Description |
|---|---|---|
| 19 | Roof | Roof (Mit Dellen) - Scratch(es) - Paint |

**Damage 19:** Roof: Roof (Mit Dellen) - Scratch(es) - Paint
