Expertise

Protocol number: 46333639
Order No. / Reference: 25934909
Inspection date: 16 Jun 2026

Model: Vito 116 CDI Tourer Lang Aut. PRO

VIN: W1VVLFEZ9T4550469

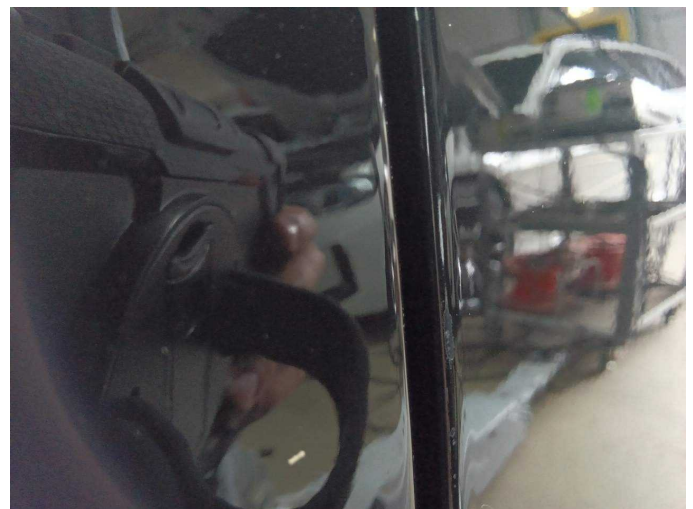
| No. | Component group | Description |
|---|---|---|
| 1 | Door - front right side | Door edge - Scratched - Smart repair |

Damage 1: Door - front right side: Door edge - Scratched - Smart repair

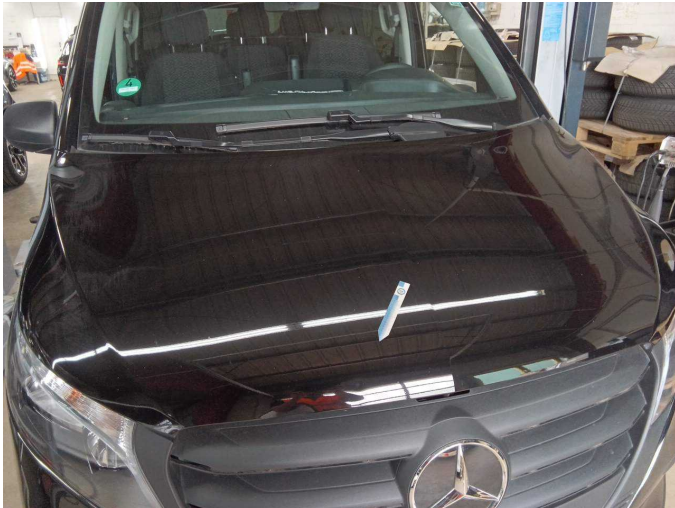
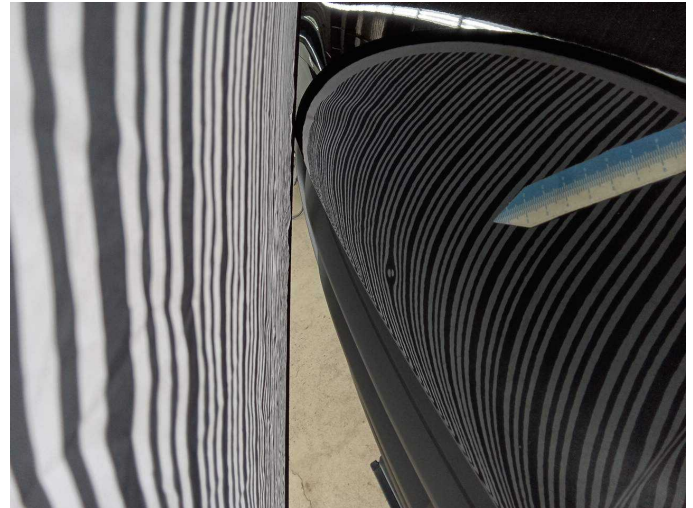
| No. | Component group | Description |
|---|---|---|
| 2 | Bonnet | Bonnet - dent(s) - Smooth repair work |

Damage 2: Bonnet: Bonnet - dent(s) - Smooth repair work

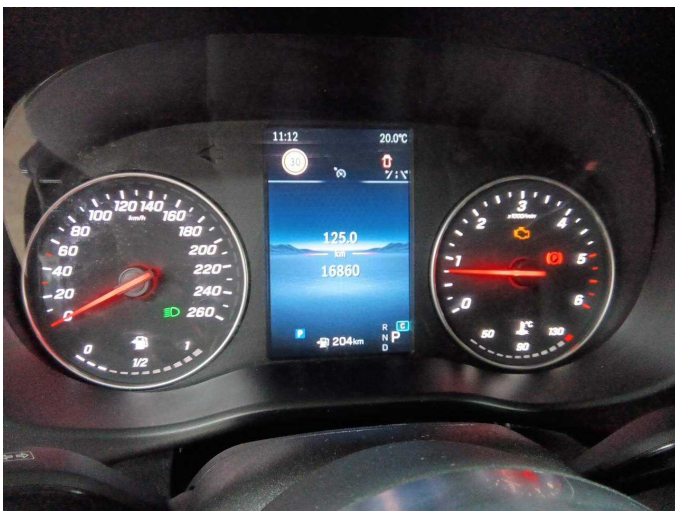
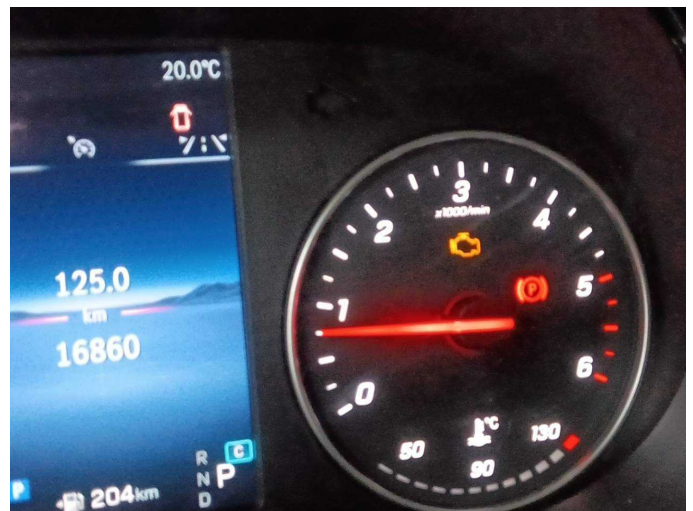
| Engine function test | An engine test run was performed, problem has been detected This is due to the following reason.: Motorkontrollleuchte leuchtet |

| No. | Component group | Description |
|---|---|---|
| 3 | Instrument panel | Indicator light (Motorkontolleuchte) - on - Perform diagnosis |

Damage 3: Instrument panel: Indicator light (Motorkontolleuchte) - on - Perform diagnosis

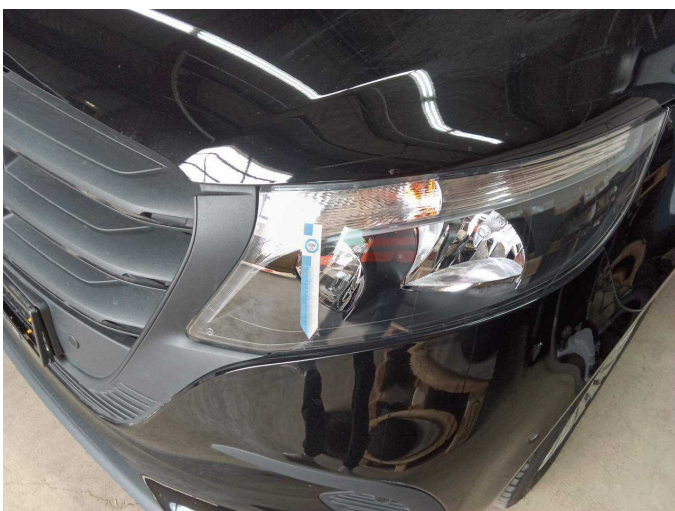
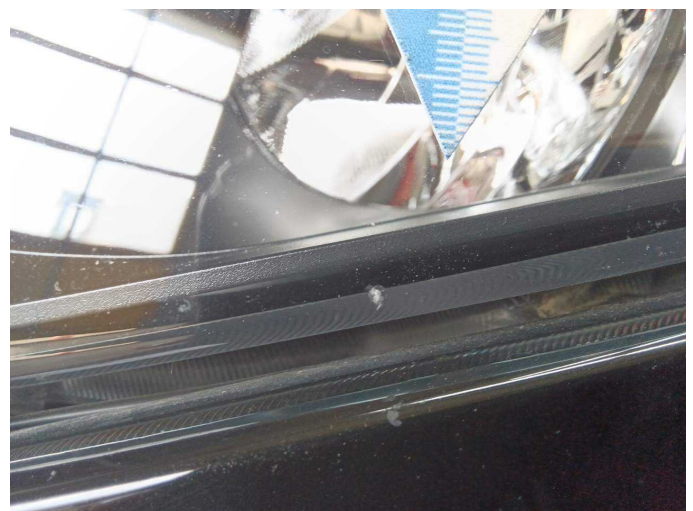
| No. | Component group | Description |
|---|---|---|
| 4 | Headlight | Headlight - left side - Stone chips - Replace |

Damage 4: Headlight: Headlight - left side - Stone chips - Replace

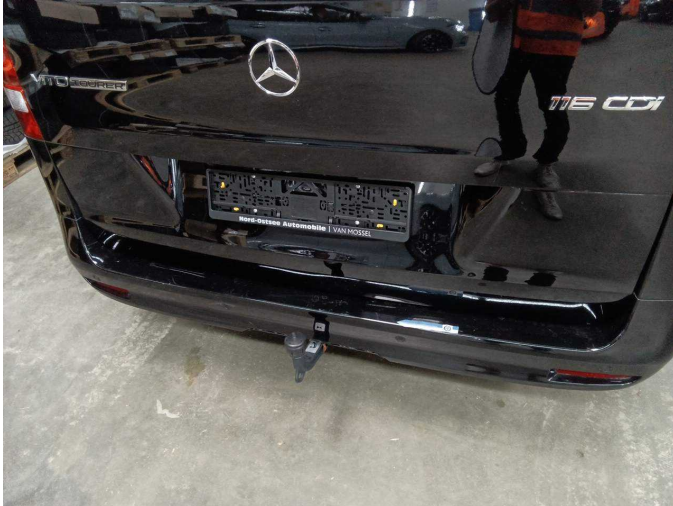
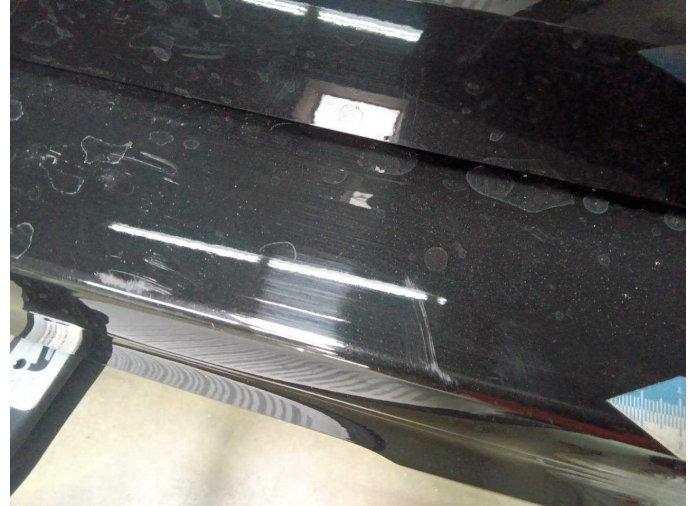
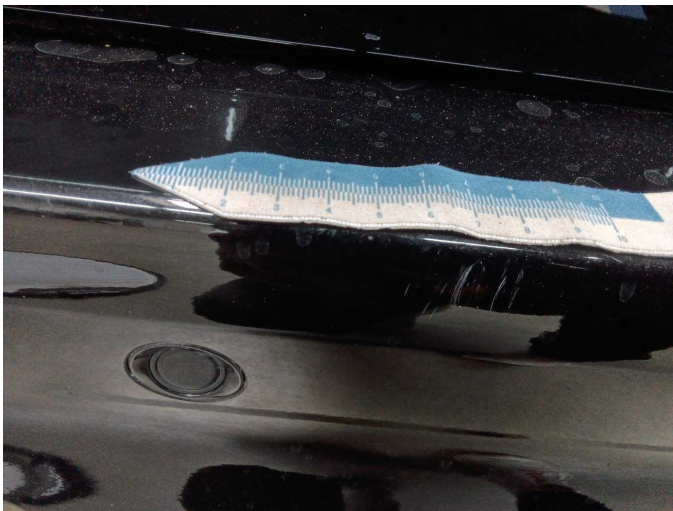
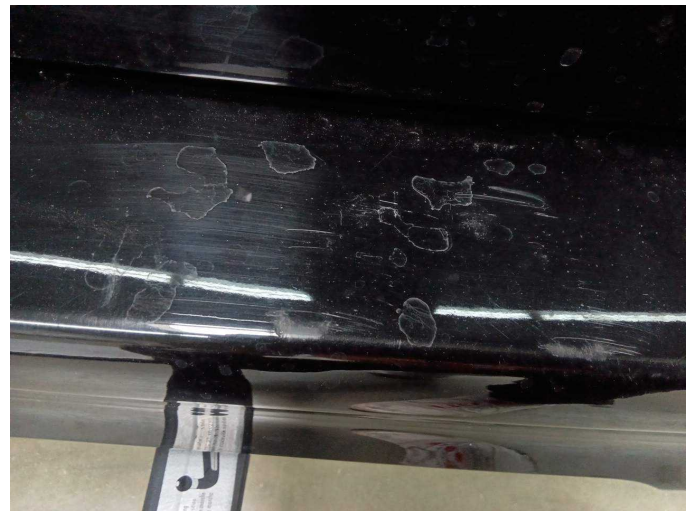
| No. | Component group | Description |
|---|---|---|
| 5 | Rear bumper | Rear bumper - Scratch(es) - Paint |

Damage 5: Rear bumper: Rear bumper - Scratch(es) - Paint

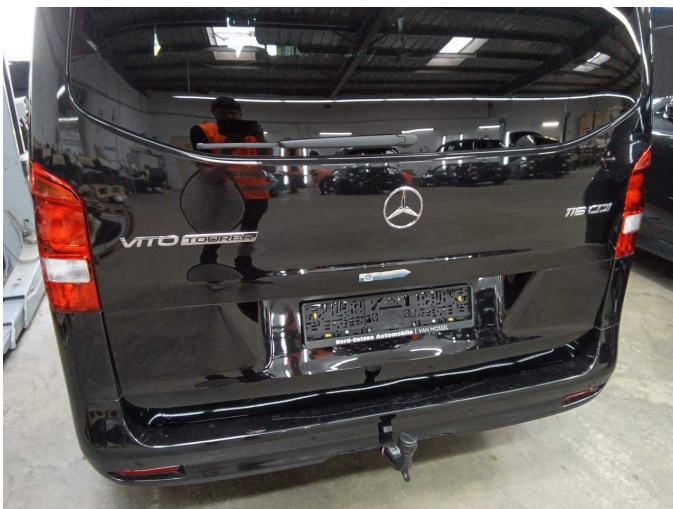
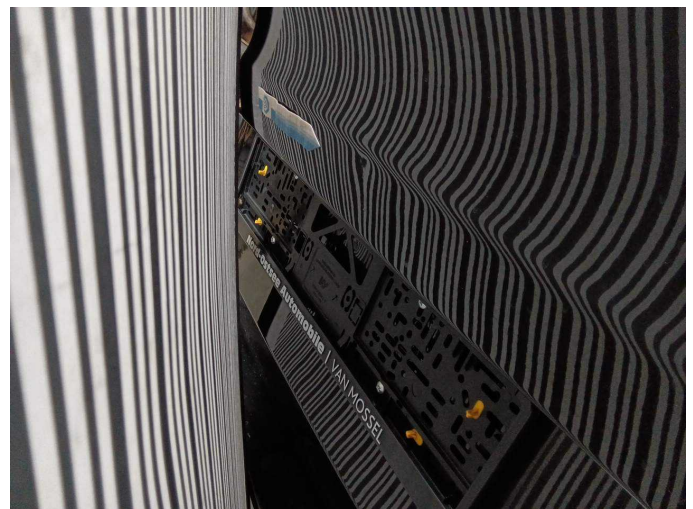
| No. | Component group | Description |
|---|---|---|
| 6 | Boot lid / rear door | Boot lid - Dent / paintcoat damage - Repair and paint |

Damage 6: Boot lid / rear door: Boot lid - Dent / paintcoat damage - Repair and paint

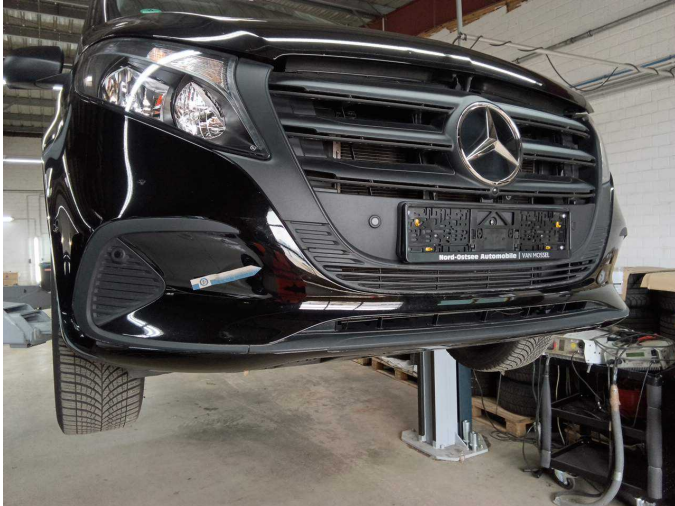
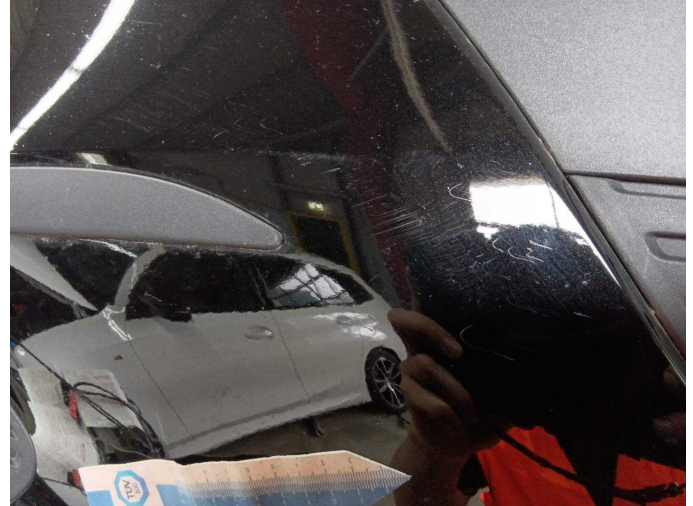
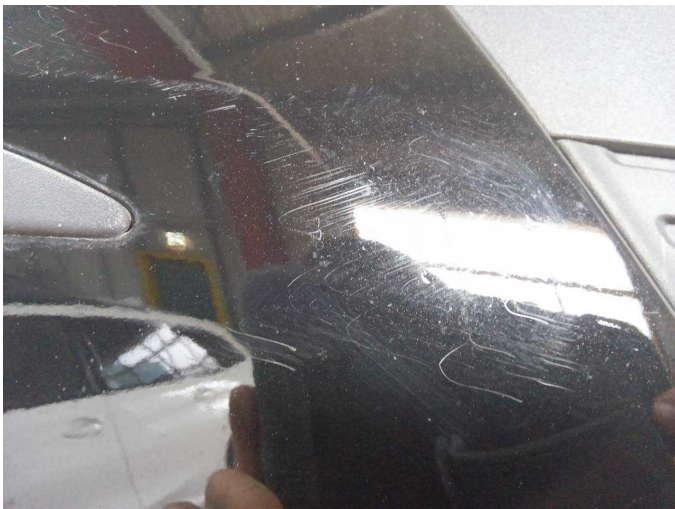
| No. | Component group | Description |
|---|---|---|
| 7 | Front bumper | Front bumper - Scratch(es) - Paint |

Damage 7: Front bumper: Front bumper - Scratch(es) - Paint

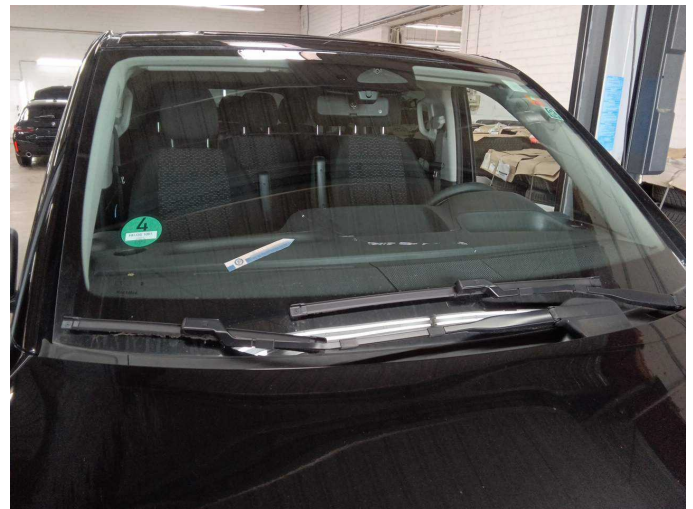
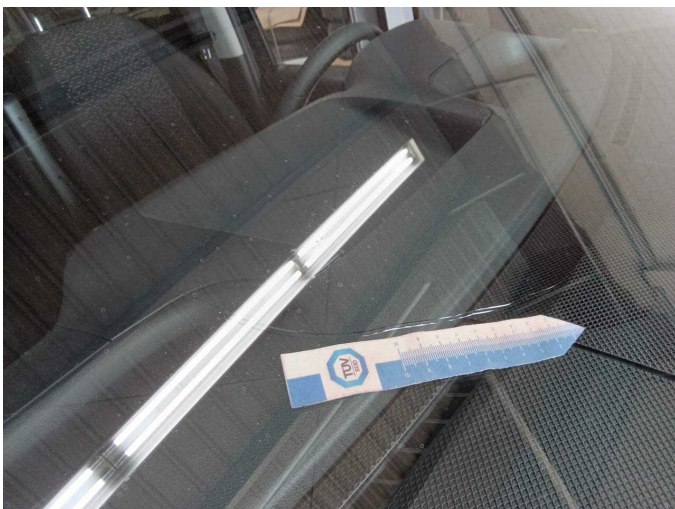
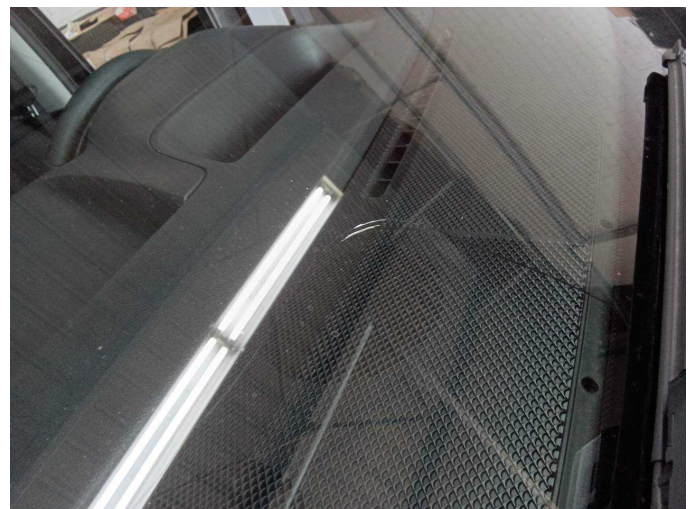
| No. | Component group | Description |
|---|---|---|
| 8 | Vehicle glazing | Windscreen - Broken / torn - repair according to calculation |

Damage 8: Vehicle glazing: Windscreen - Broken / torn - repair according to calculation

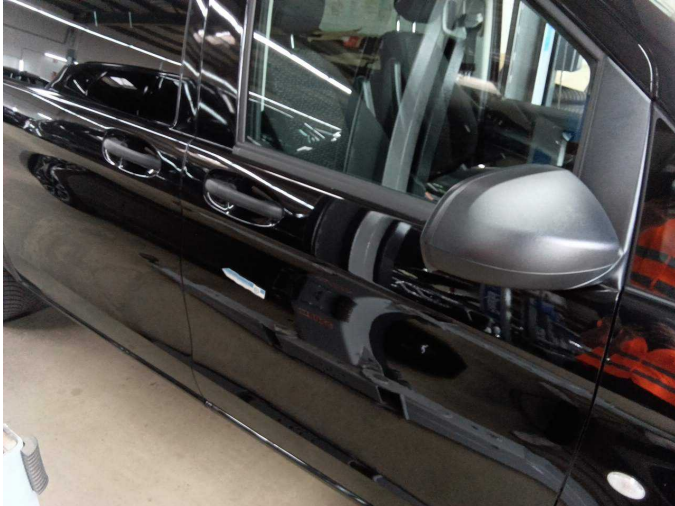
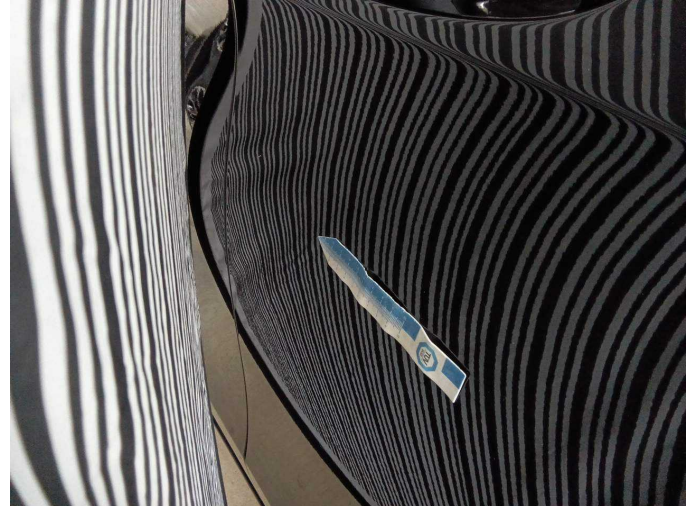
| No. | Component group | Description |
|---|---|---|
| 1 | Door - front right side | Door - dent(s) - No deduction |

Wear and tear 1: Door - front right side: Door - dent(s) - No deduction

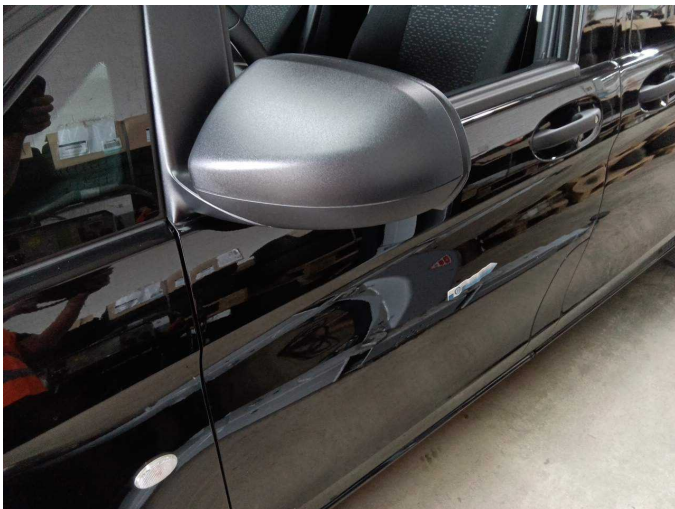
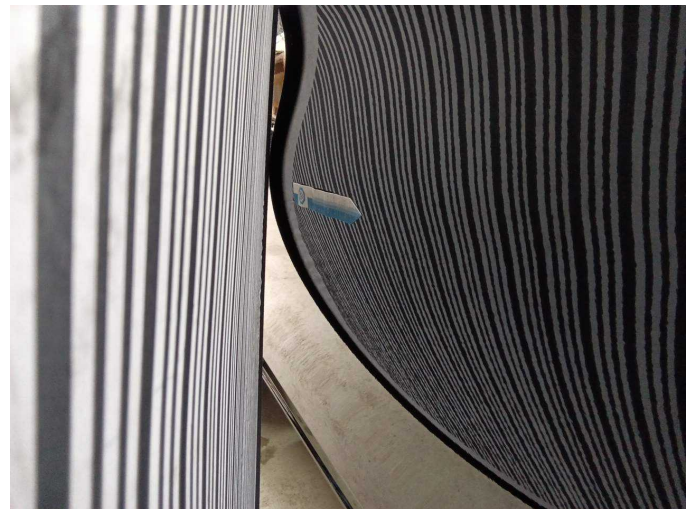
| No. | Component group | Description |
|---|---|---|
| 2 | Door - front left side | Door - dent(s) - No deduction |

Wear and tear 2: Door - front left side: Door - dent(s) - No deduction

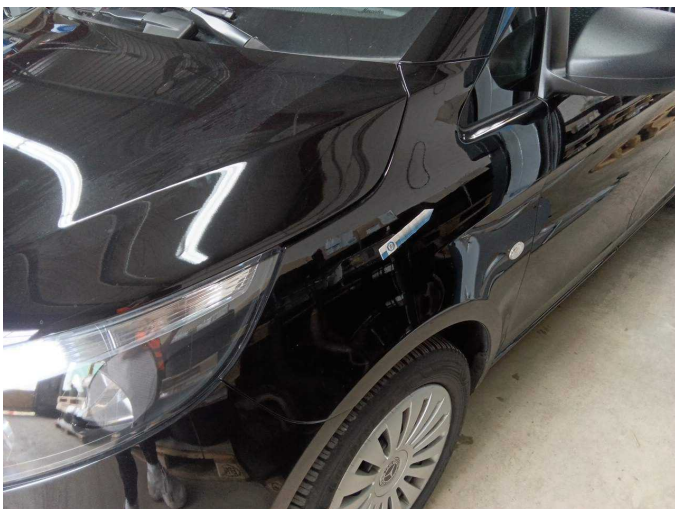
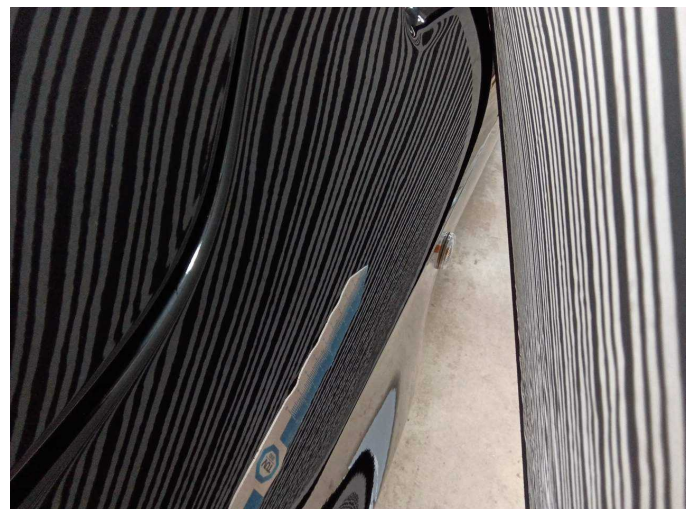
| No. | Component group | Description |
|---|---|---|
| 3 | Mudguard - left side | Mudguard - left side - dent(s) - No deduction |

Wear and tear 3: Mudguard - left side: Mudguard - left side - dent(s) - No deduction

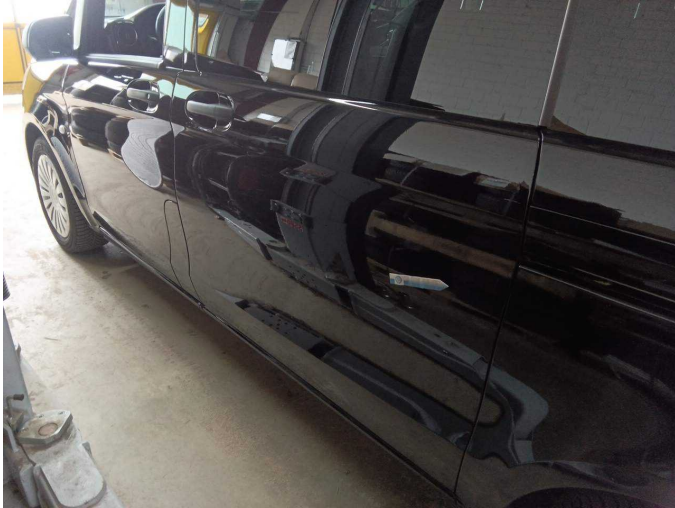
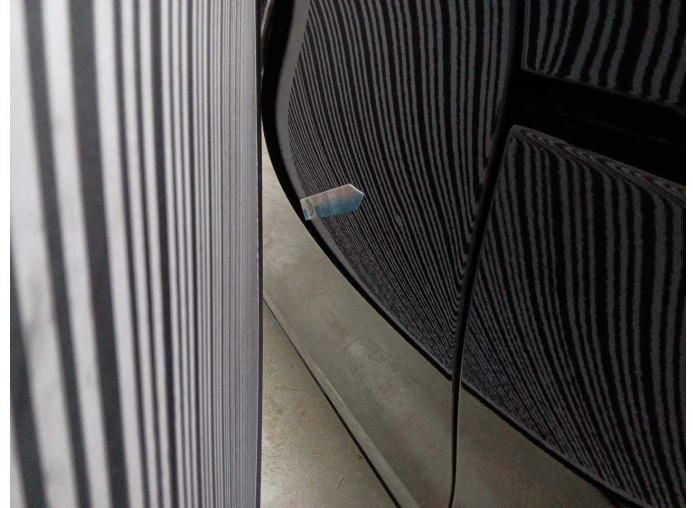
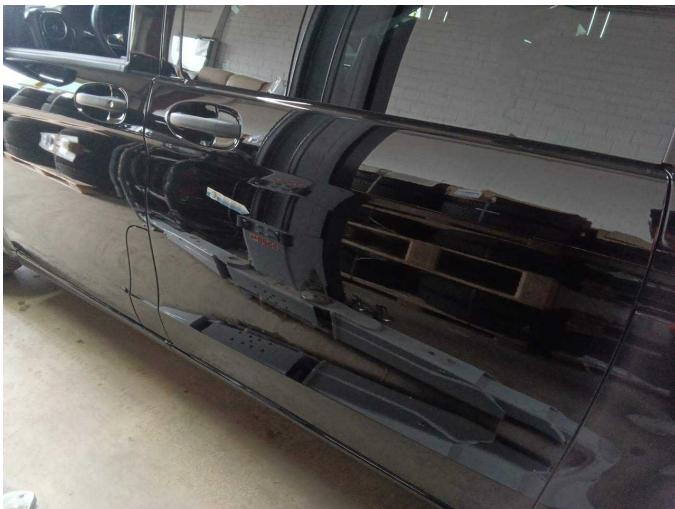
| No. | Component group | Description |
|---|---|---|
| 4 | Sliding door - left side | Sliding door - dent(s) - No deduction |

Wear and tear 4: Sliding door - left side: Sliding door - dent(s) - No deduction
