Expertise

Protocol number: 46193465
Order No. / Reference: 26512429
Inspection date: 18 Jun 2026

Model: Passat Variant 2.0 TDI SCR DSG Business

VIN: WVVZZZ3CZPE018641

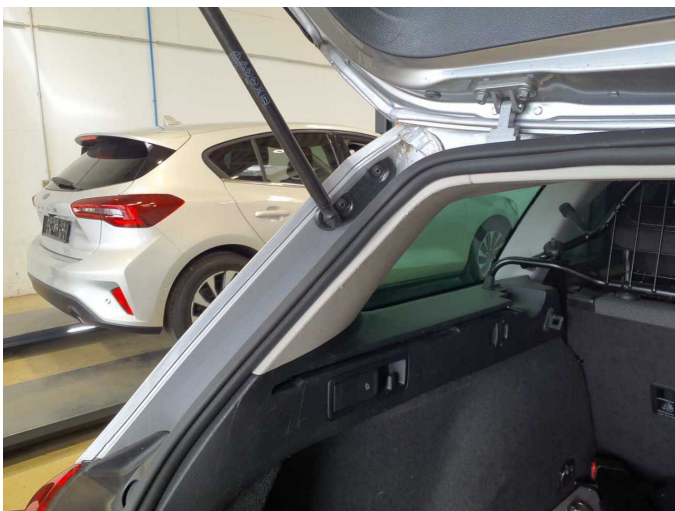
Damage 1: Interior: Cargo space partition - Scratched - No deduction

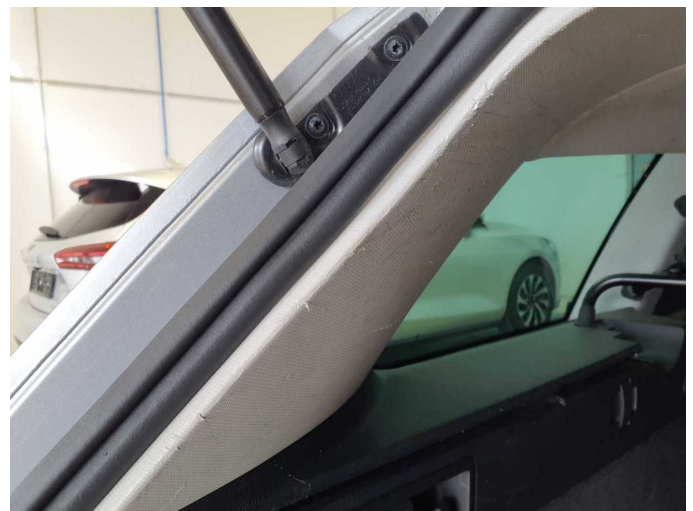
Damage 1: Interior: Cargo space partition - Scratched - No deduction

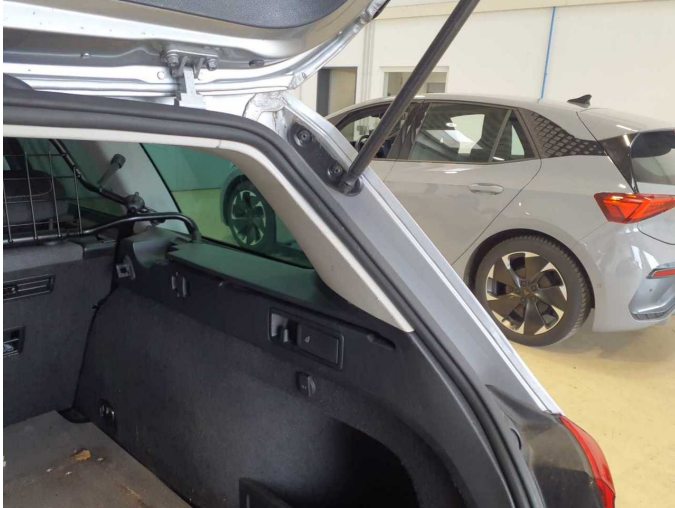
Damage 1: Interior: Cargo space partition - Scratched - No deduction

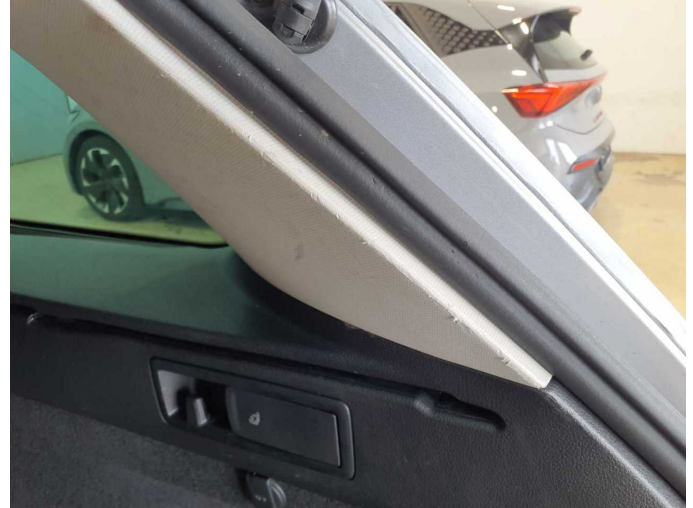
Damage 1: Interior: Cargo space partition - Scratched - No deduction

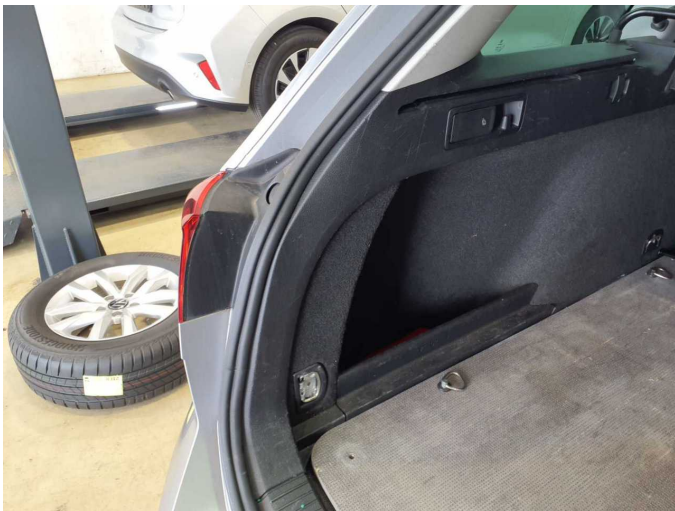
Damage 1: Interior: Cargo space partition - Scratched - No deduction

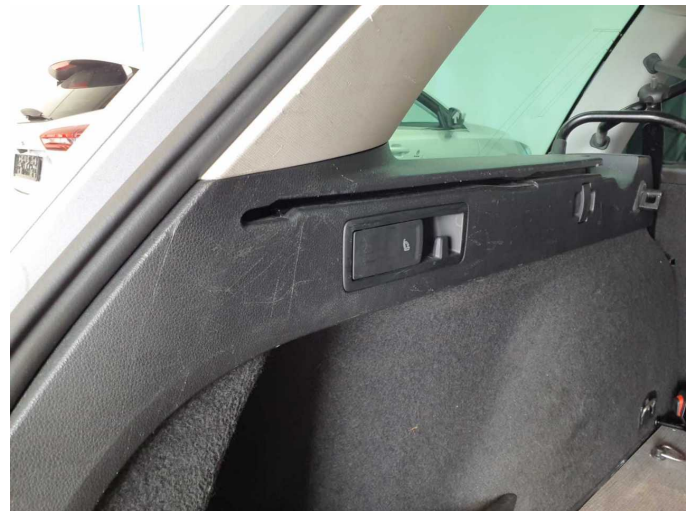
Damage 1: Interior: Cargo space partition - Scratched - No deduction

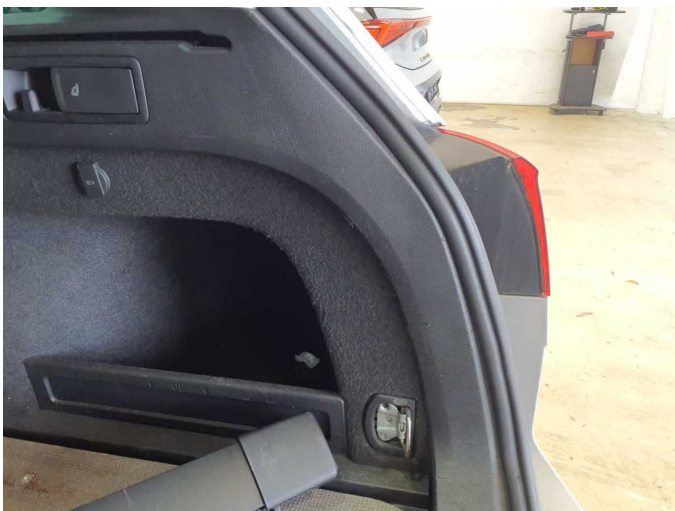
Damage 1: Interior: Cargo space partition - Scratched - No deduction

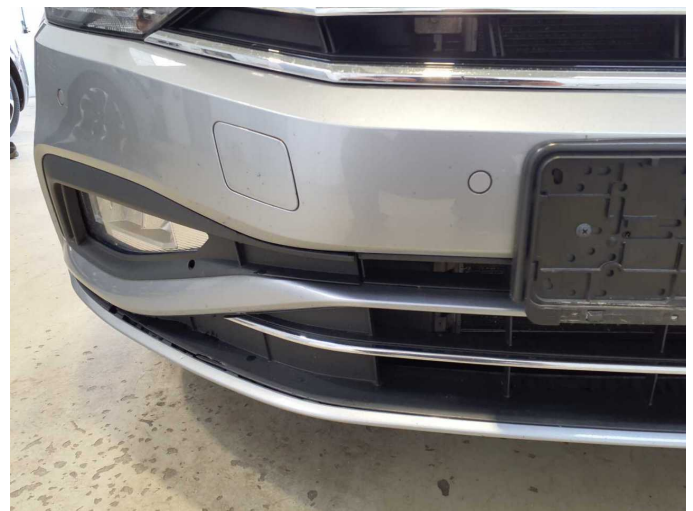
Damage 3: Front bumper: Cover bumper - front - Malposition - Perform diagnosis

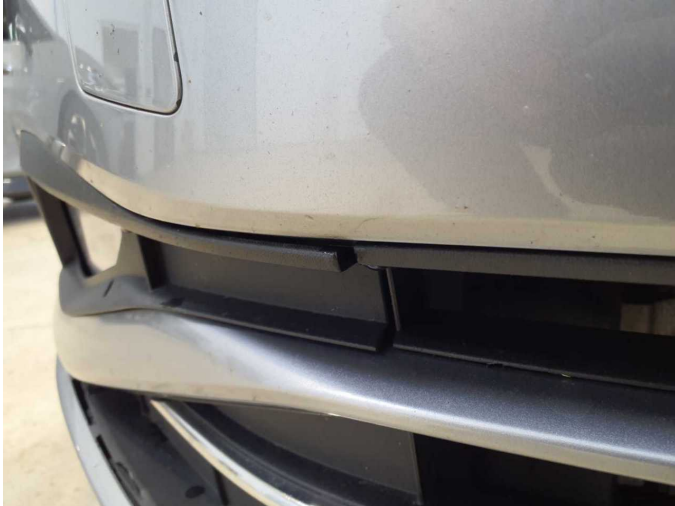
Damage 3: Front bumper: Cover bumper - front - Malposition - Perform diagnosis

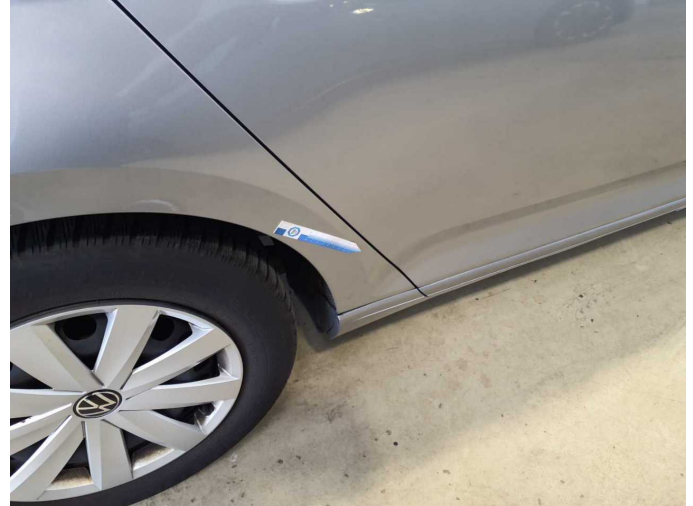
Damage 4: Side panel - rear right side: Side panel - dent(s) - Smooth repair work

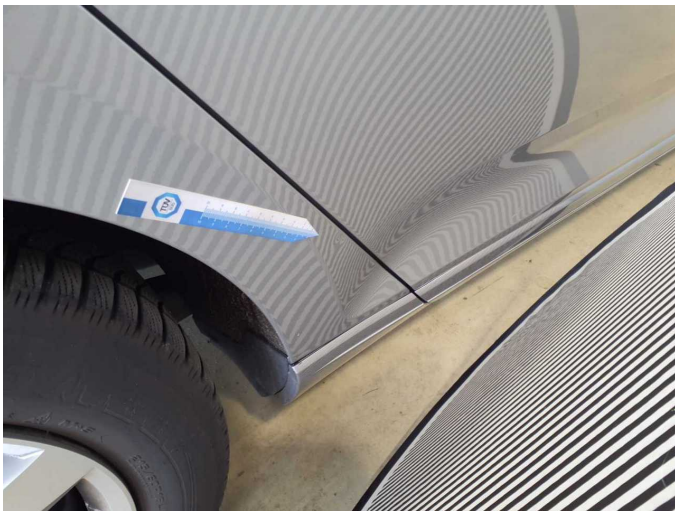
Damage 4: Side panel - rear right side: Side panel - dent(s) - Smooth repair work

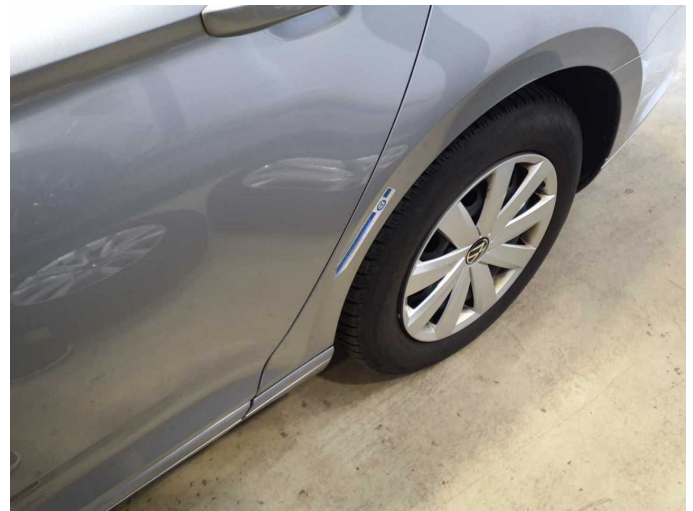
Damage 5: Side panel - rear left side: Elbow - Scratched - Smart repair

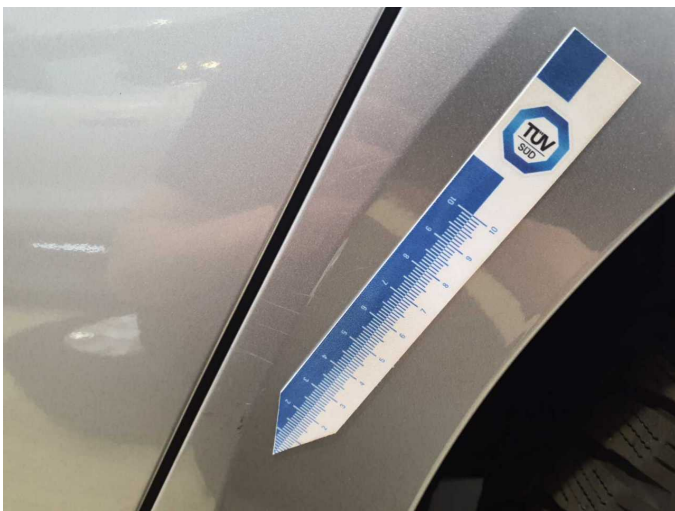
Damage 5: Side panel - rear left side: Elbow - Scratched - Smart repair

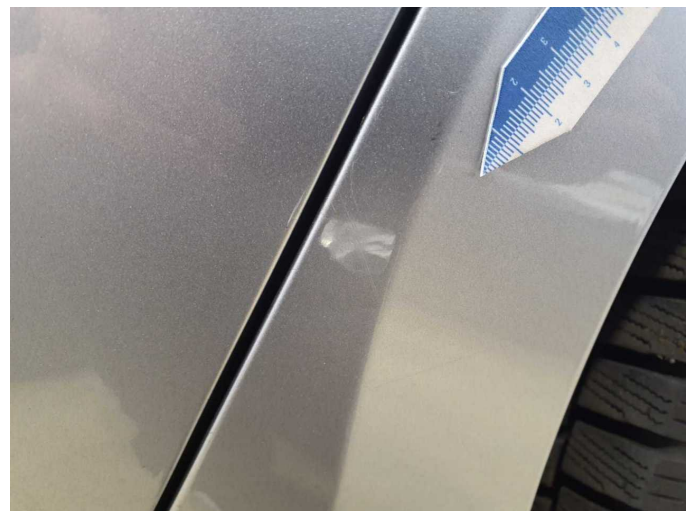
Damage 5: Side panel - rear left side: Elbow - Scratched - Smart repair

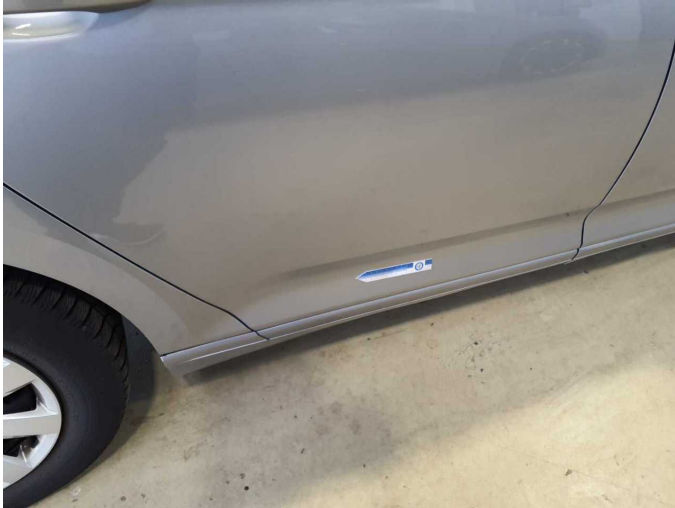
Damage 6: Door - rear right side: Door - Scratch(es) - Smart repair

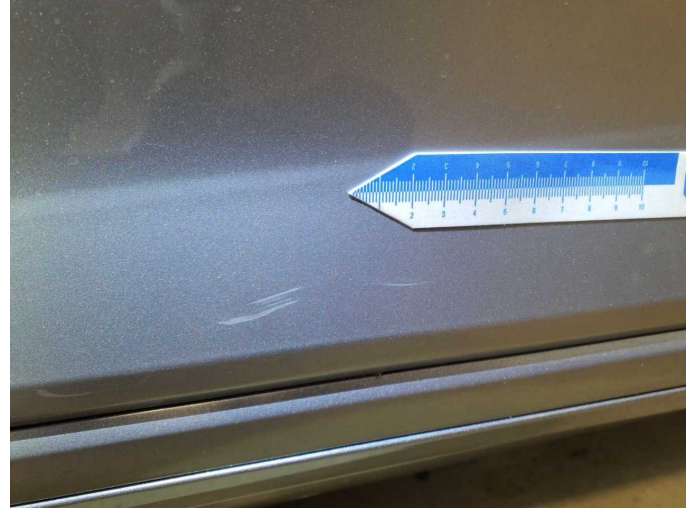
Damage 6: Door - rear right side: Door - Scratch(es) - Smart repair

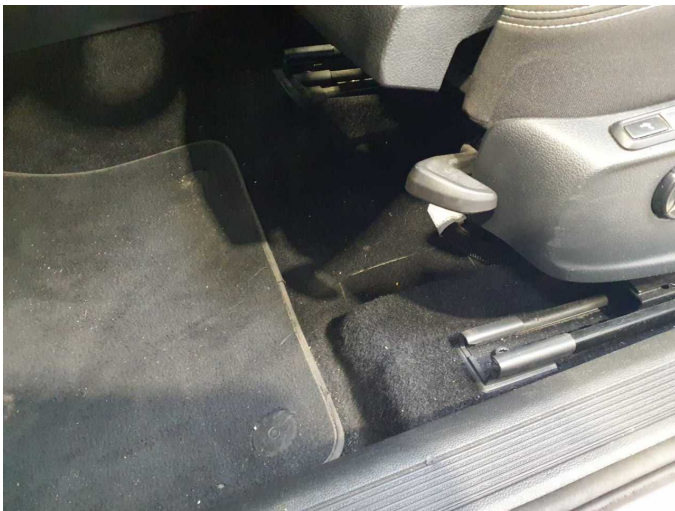
Damage 7: Trim / covers: Carpet - front left side - Damaged - Loss in value

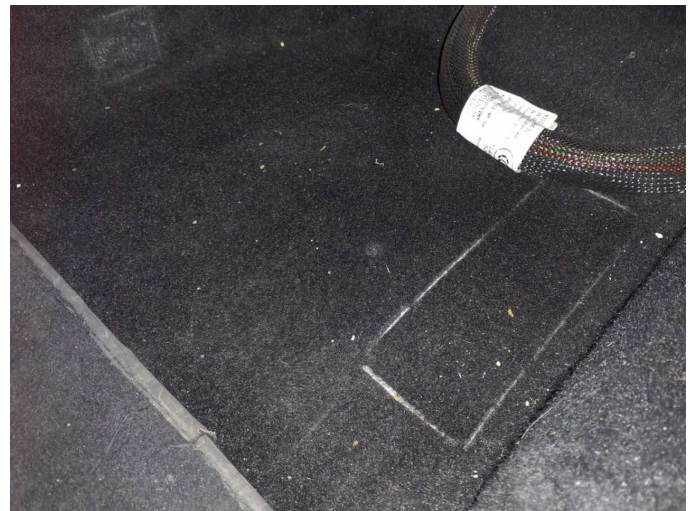
Damage 7: Trim / covers: Carpet - front left side - Damaged - Loss in value

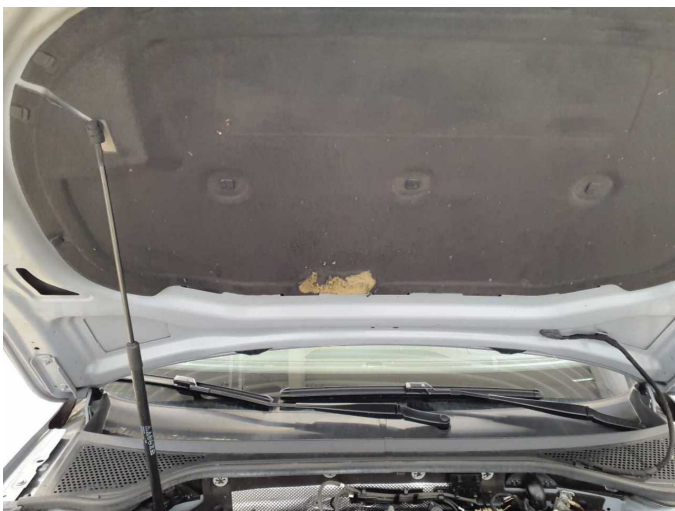
Damage 8: Bonnet: Insulation lining - Damage caused by marten / rodent - Replace

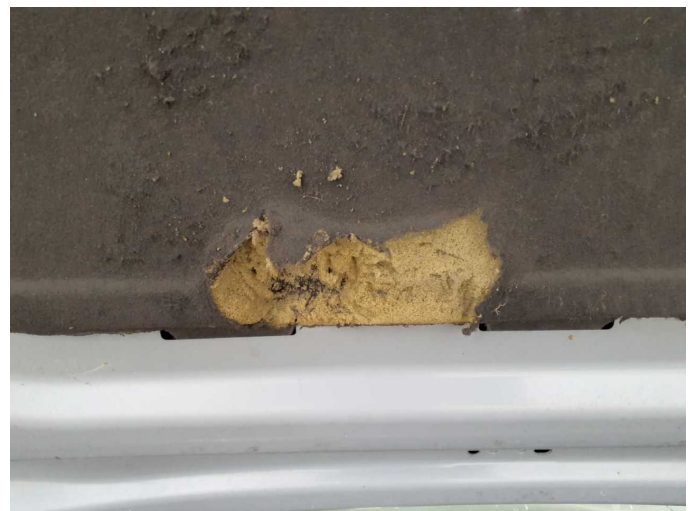
Damage 8: Bonnet: Insulation lining - Damage caused by marten / rodent - Replace

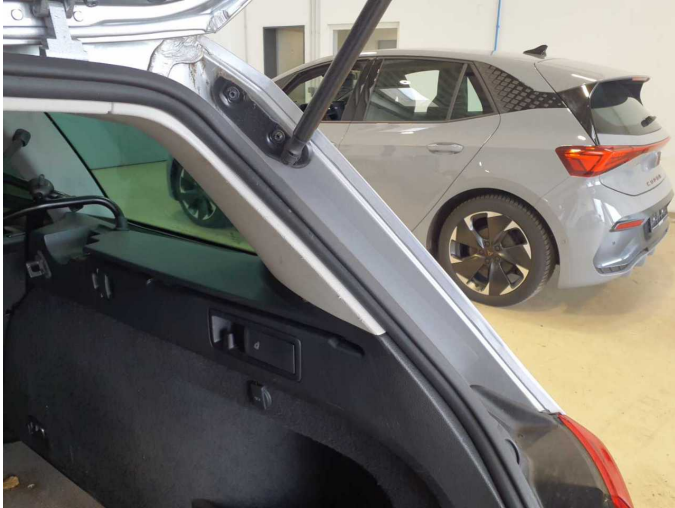
Damage 9: Boot lid / rear door: Seal - Damaged - Replace

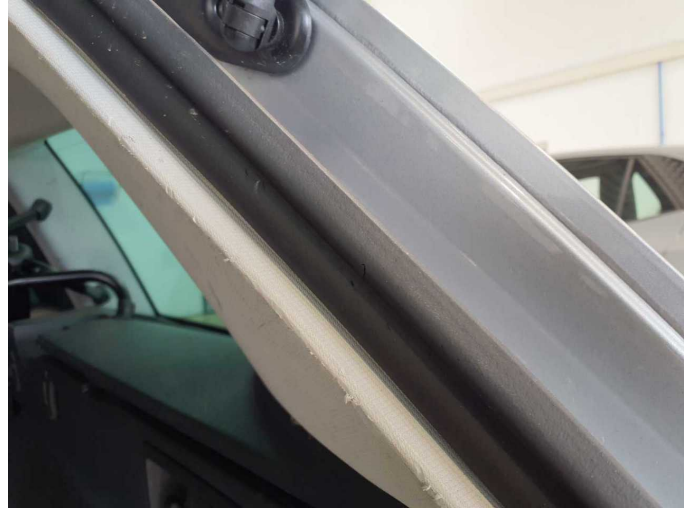
Damage 9: Boot lid / rear door: Seal - Damaged - Replace

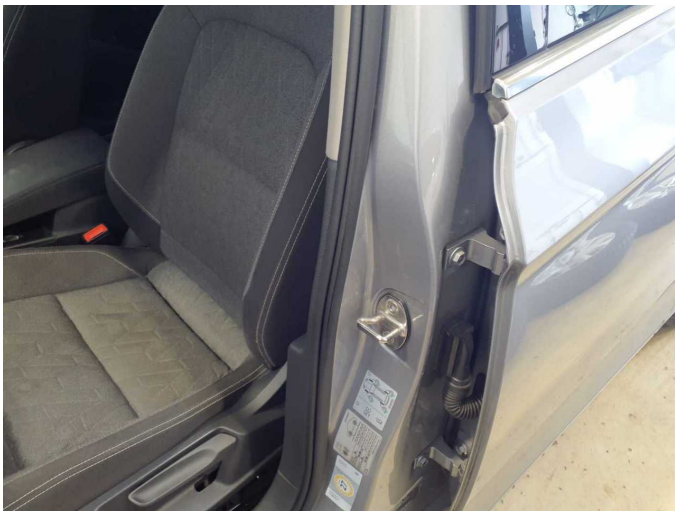
Damage 10: Door - front left side: Door seal - Damaged - Replace

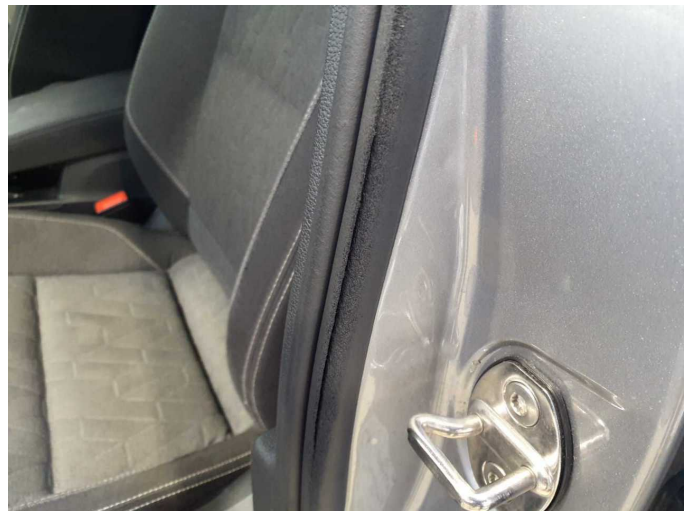
Damage 10: Door - front left side: Door seal - Damaged - Replace

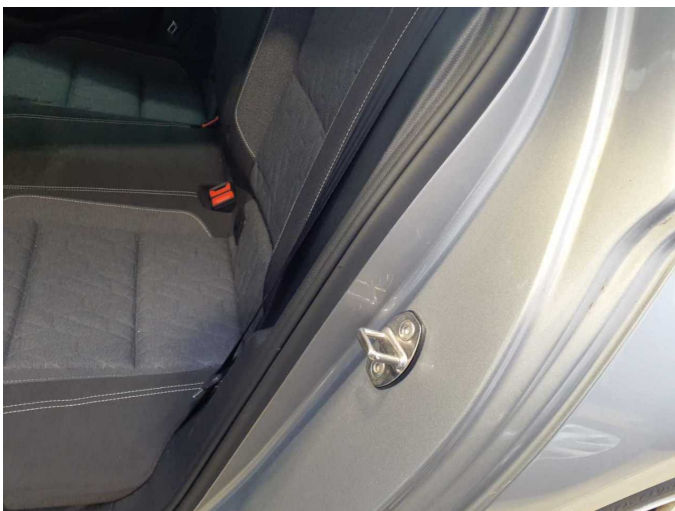
Damage 11: Door - rear left side: Door seal - Damaged - Replace

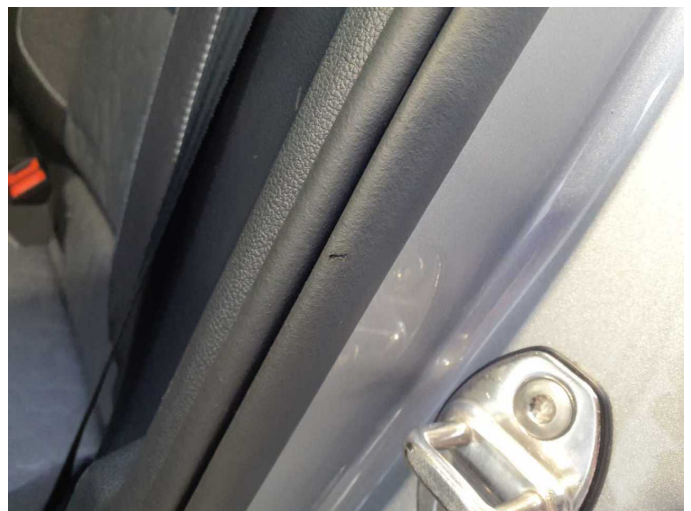
Damage 11: Door - rear left side: Door seal - Damaged - Replace

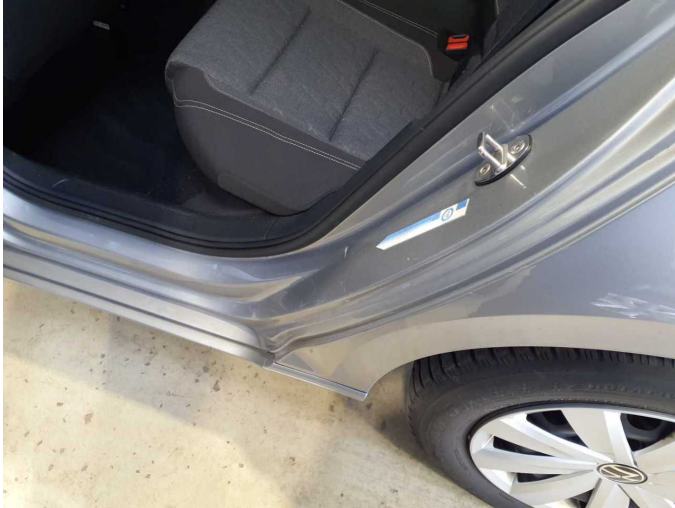
Damage 12: Side panel - rear left side: Sill - Dent / paintcoat damage - Smart repair

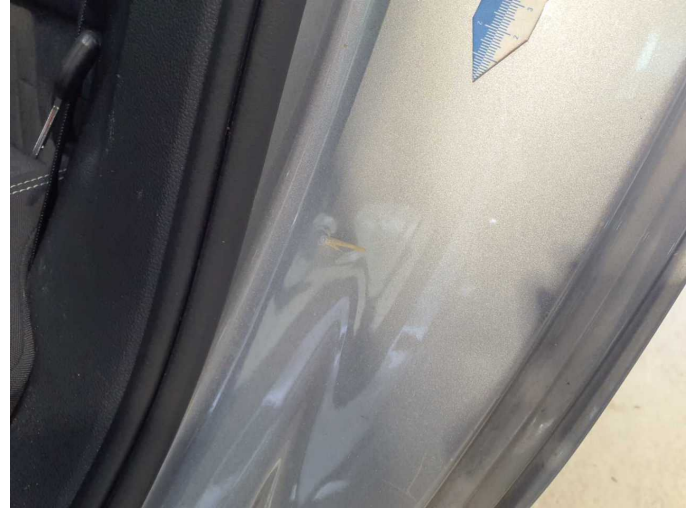
Damage 12: Side panel - rear left side: Sill - Dent / paintcoat damage - Smart repair

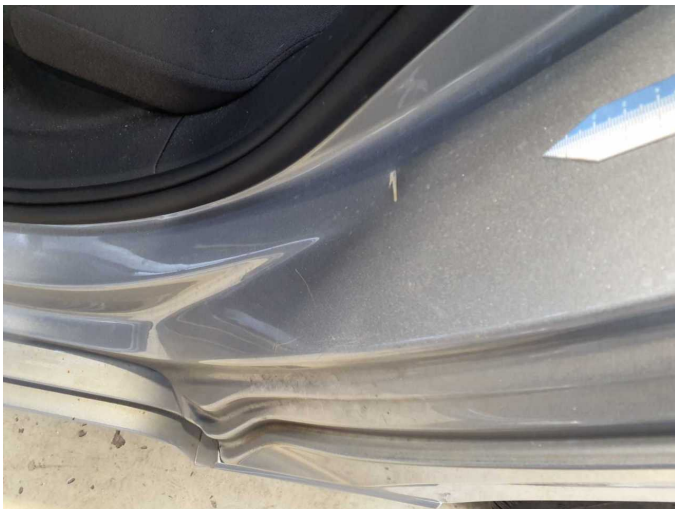
Damage 12: Side panel - rear left side: Sill - Dent / paintcoat damage - Smart repair

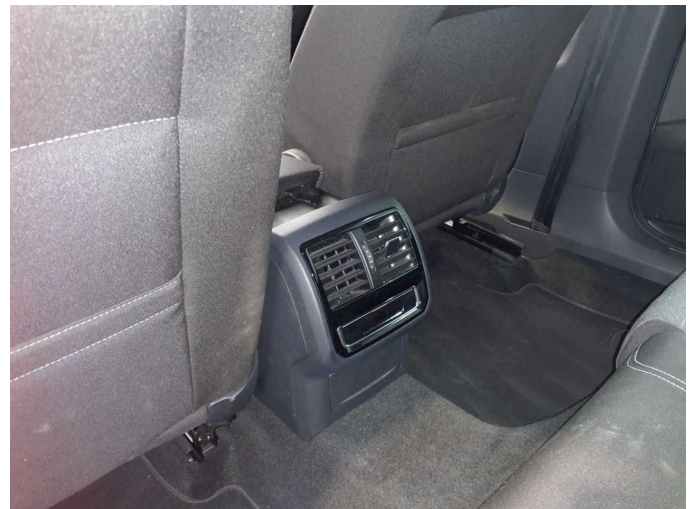
Damage 13: Instrument panel: Air nozzle - centre - Damaged - Replace

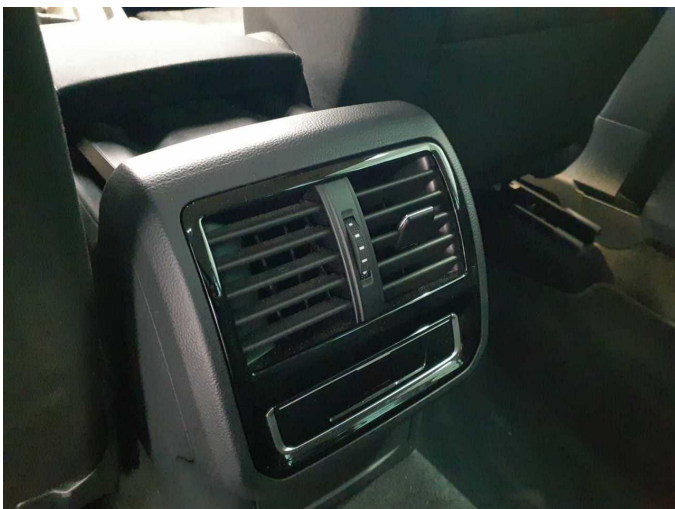
Damage 13: Instrument panel: Air nozzle - centre - Damaged - Replace

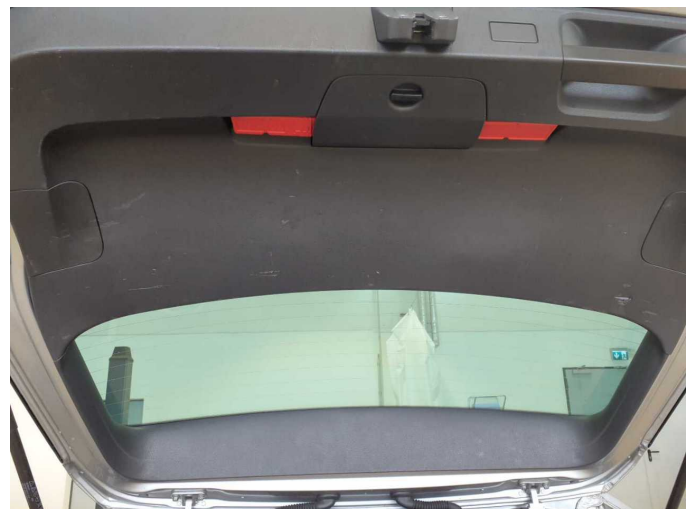
Damage 14: Boot lid / rear door: Trim - standard - lower - Scratched - Replace

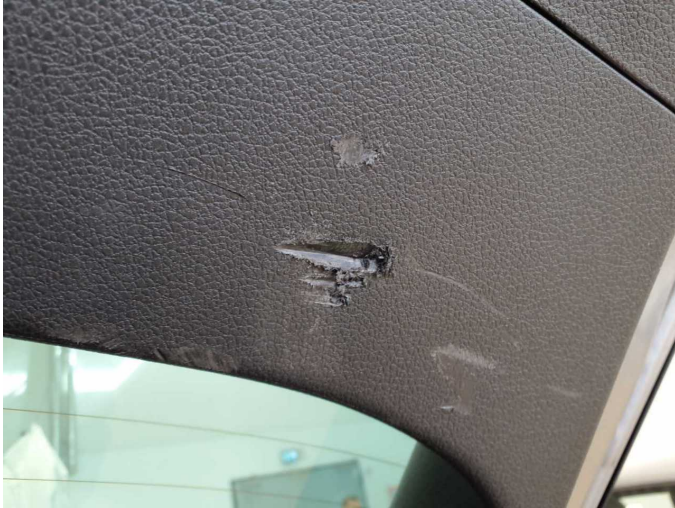
Damage 14: Boot lid / rear door: Trim - standard - lower - Scratched - Replace

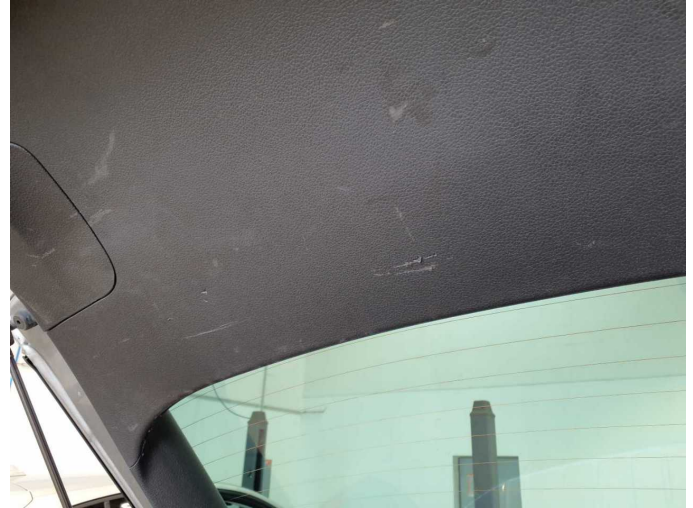
Damage 14: Boot lid / rear door: Trim - standard - lower - Scratched - Replace

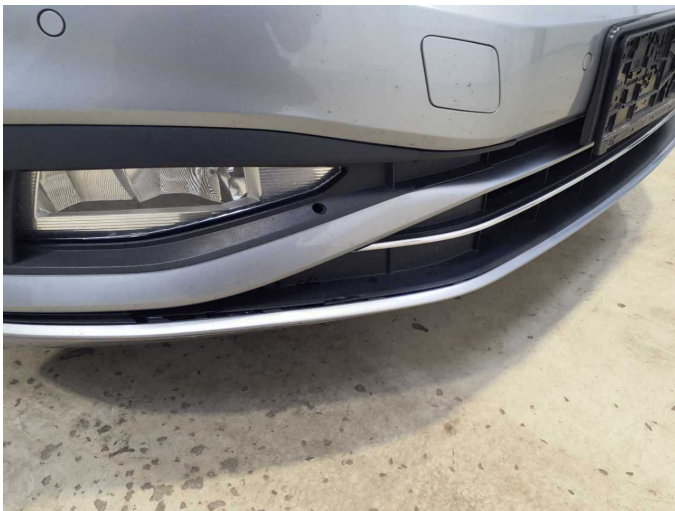
Damage 15: Front bumper: Air-inlet grille - Broken / torn - Replace

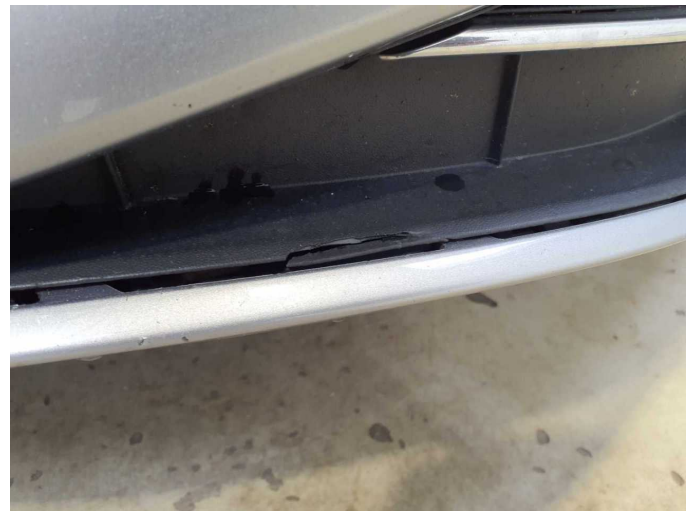
Damage 15: Front bumper: Air-inlet grille - Broken / torn - Replace

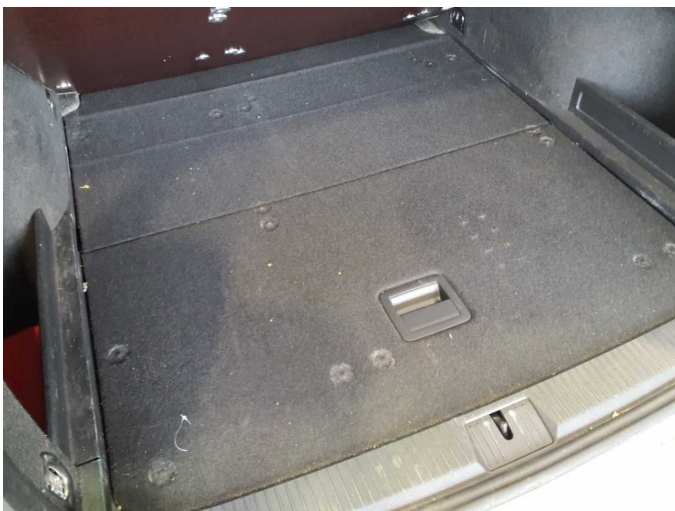
Damage 16: Interior: Cargo area floor - Deformed - Replace

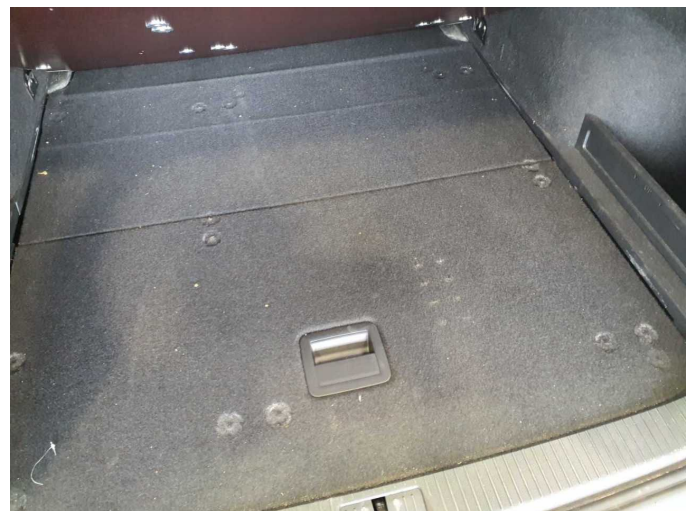
Damage 16: Interior: Cargo area floor - Deformed - Replace

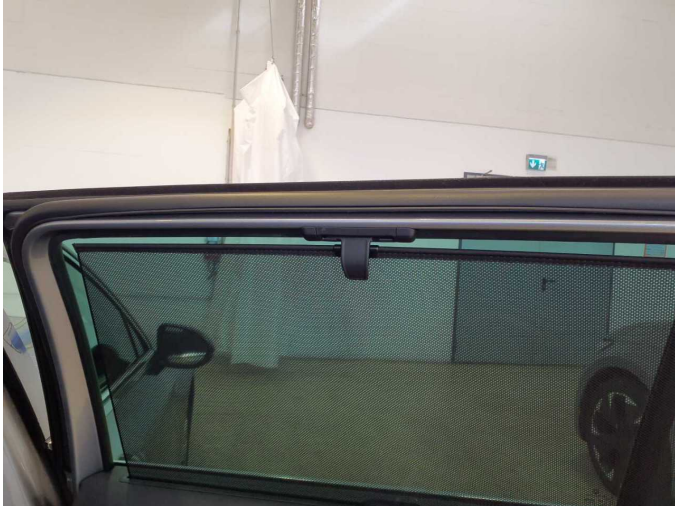
Damage 17: Interior: Roller blind rear window (Tür HR) - Damaged - Replace

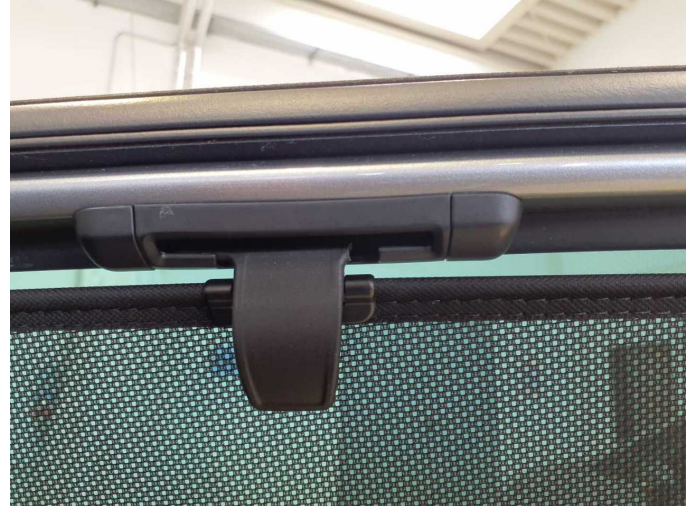
Damage 17: Interior: Roller blind rear window (Tür HR) - Damaged - Replace

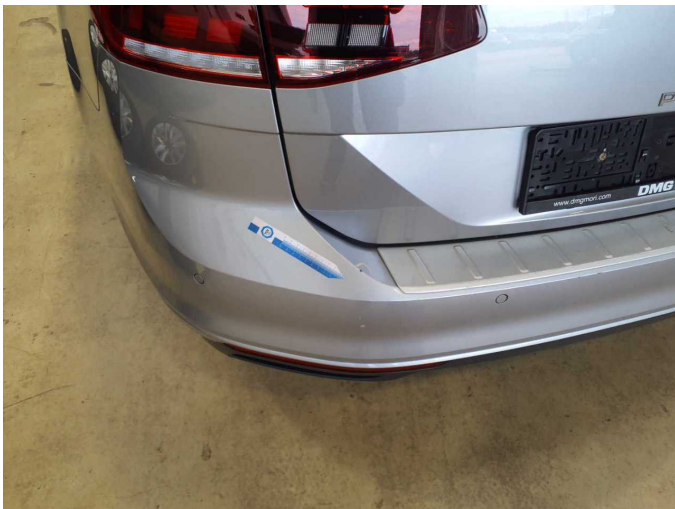
Damage 18: Rear bumper: Rear bumper - Scratched - Paint

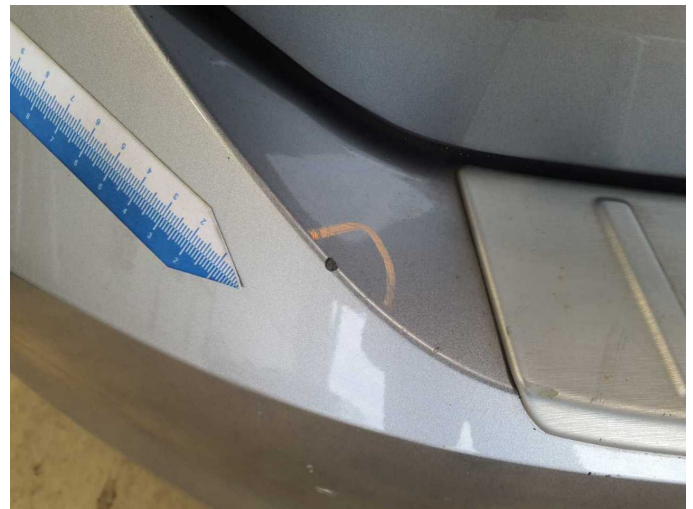
Damage 18: Rear bumper: Rear bumper - Scratched - Paint

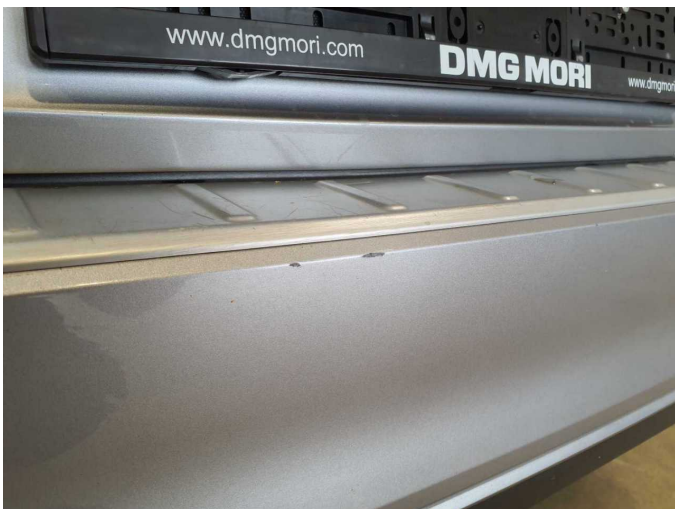
Damage 18: Rear bumper: Rear bumper - Scratched - Paint

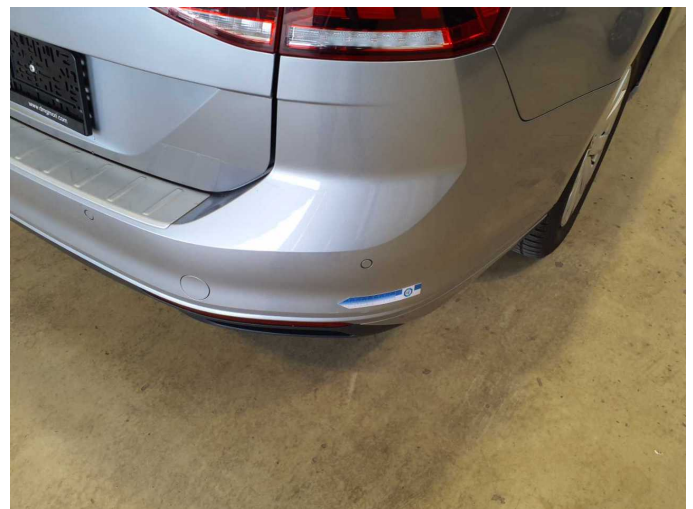
Damage 18: Rear bumper: Rear bumper - Scratched - Paint

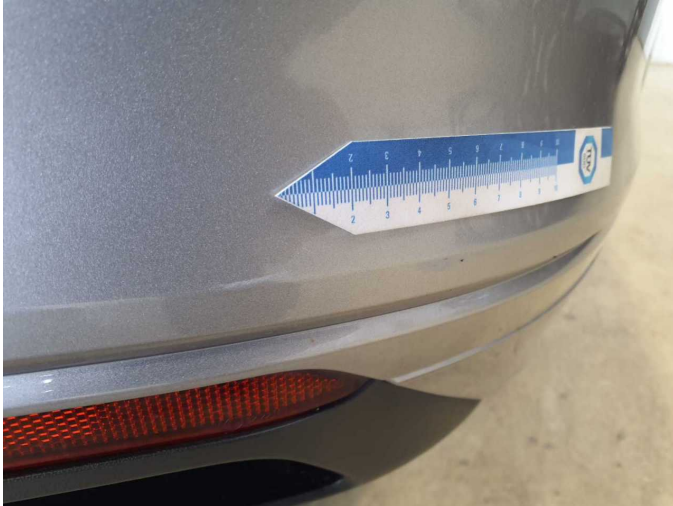
Damage 18: Rear bumper: Rear bumper - Scratched - Paint

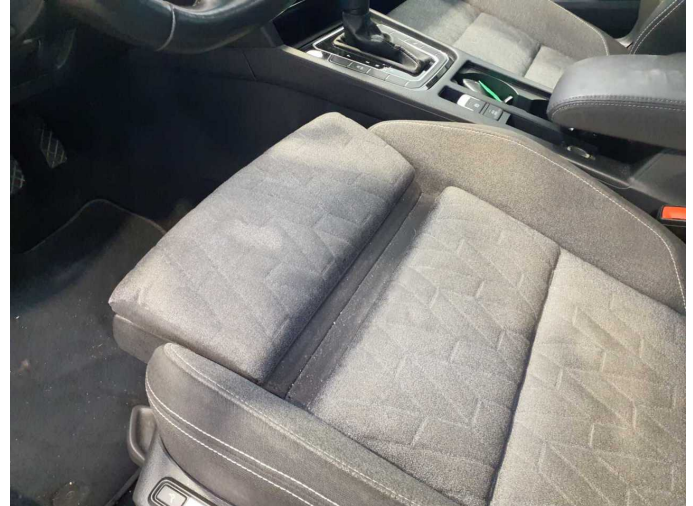
Damage 19: Seat - front: Seat cover - left side - Damaged - Replace

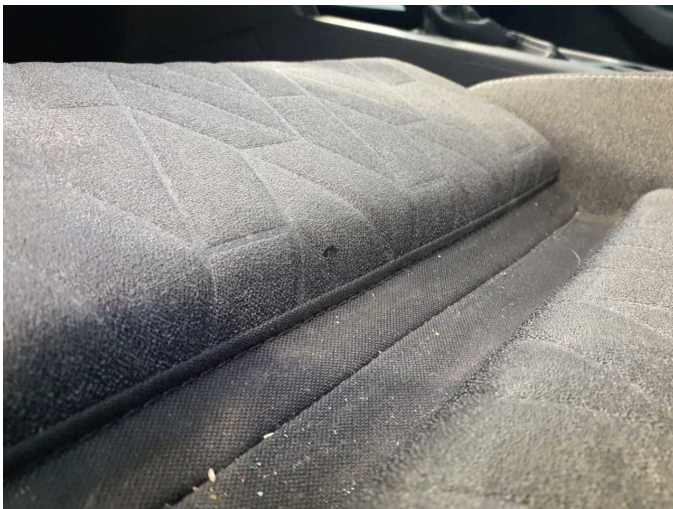
Damage 19: Seat - front: Seat cover - left side - Damaged - Replace

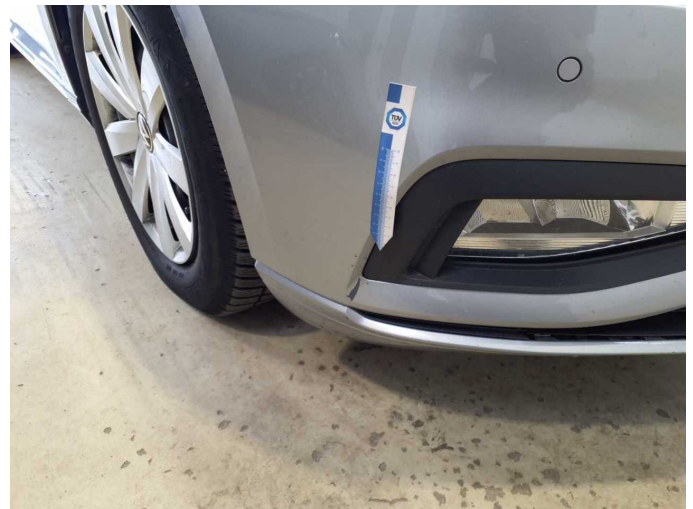
Damage 20: Front bumper: Front bumper - Scratched - Paint

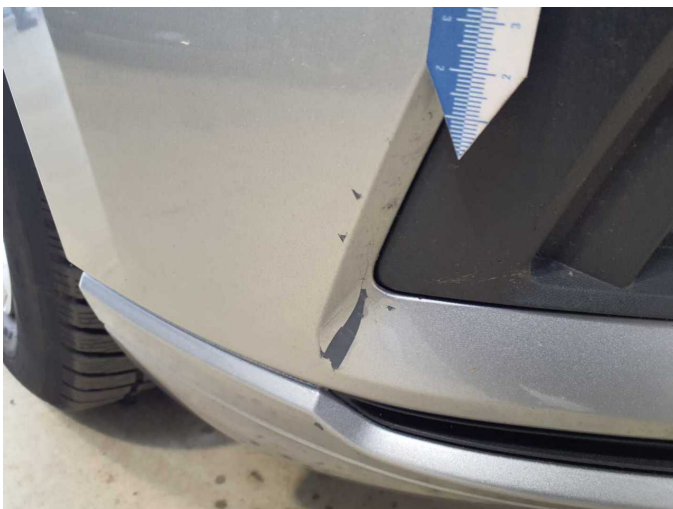
Damage 20: Front bumper: Front bumper - Scratched - Paint

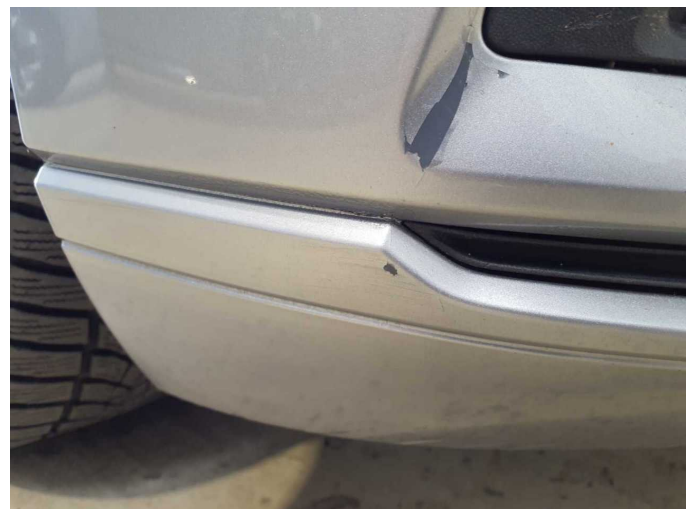
Damage 20: Front bumper: Front bumper - Scratched - Paint

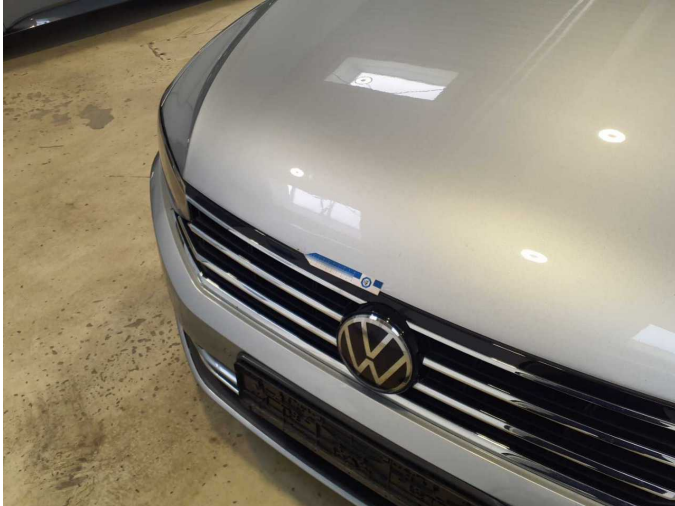
Damage 21: Bonnet: Bonnet (Wellig) - Unprofessionally repaired - Repair and paint

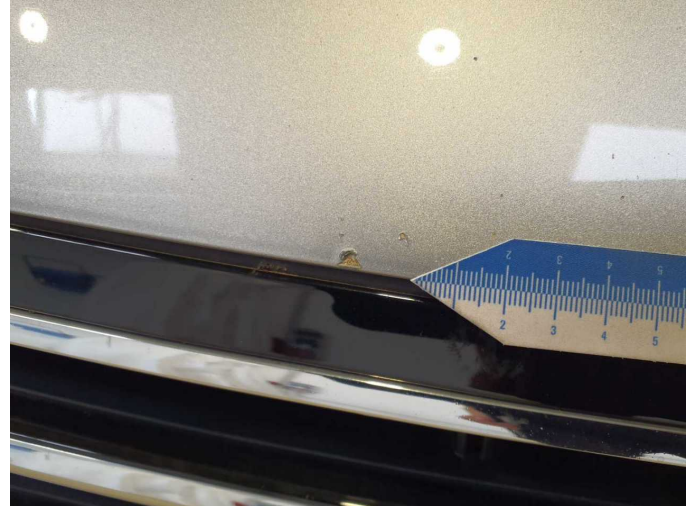
Damage 21: Bonnet: Bonnet (Wellig) - Unprofessionally repaired - Repair and paint

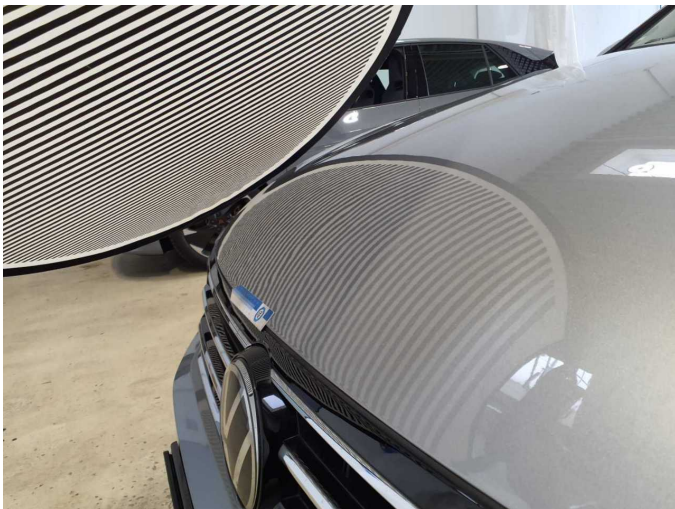
Damage 21: Bonnet: Bonnet (Wellig) - Unprofessionally repaired - Repair and paint

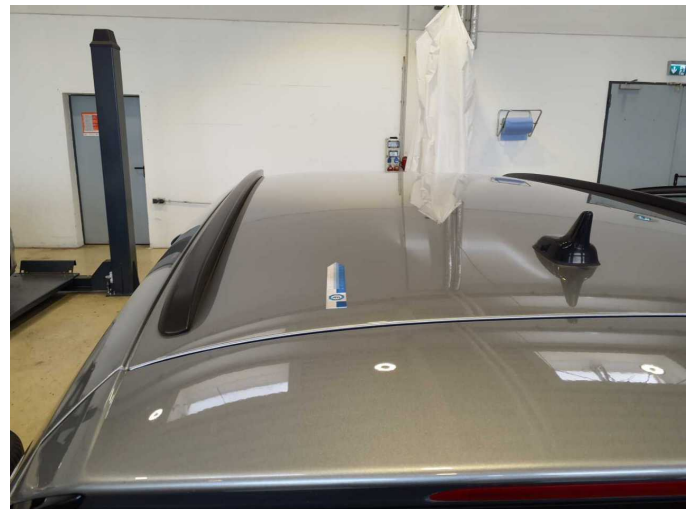
Damage 22: Roof: Roof (Korrosion) - Dent / paintcoat damage - Repair and paint

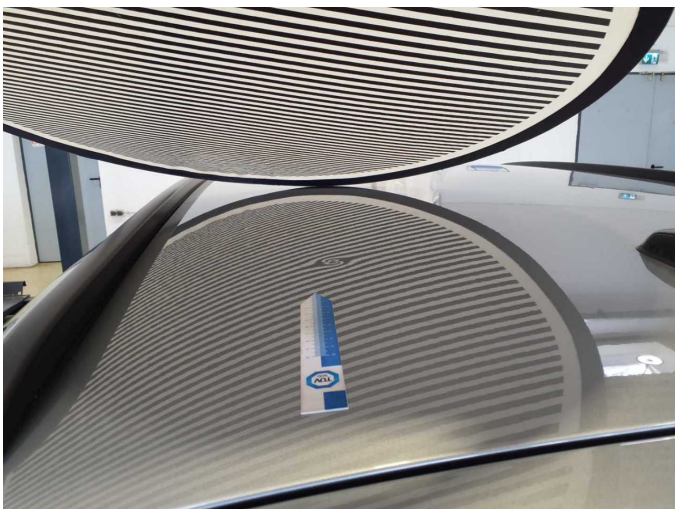
Damage 22: Roof: Roof (Korrosion) - Dent / paintcoat damage - Repair and paint

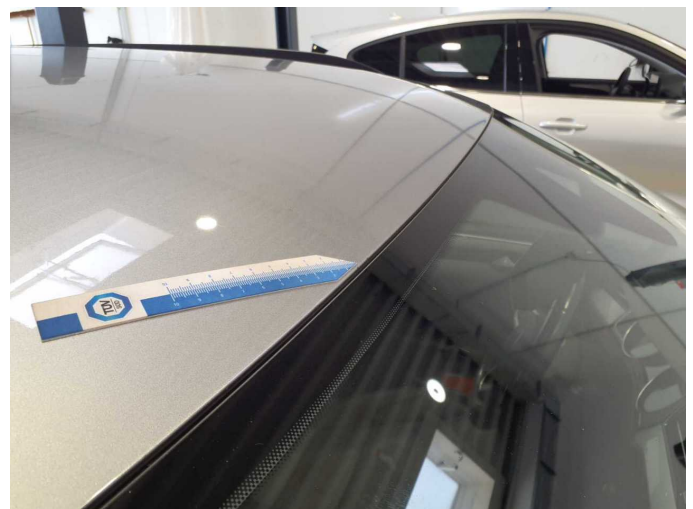
Damage 22: Roof: Roof (Korrosion) - Dent / paintcoat damage - Repair and paint

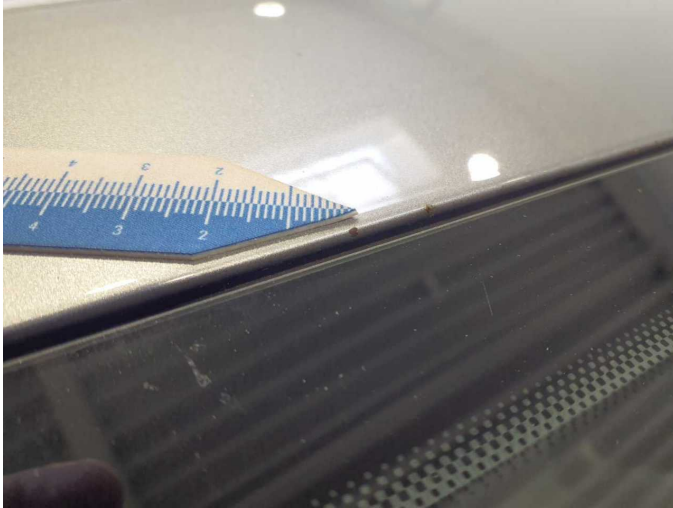
Damage 22: Roof: Roof (Korrosion) - Dent / paintcoat damage - Repair and paint

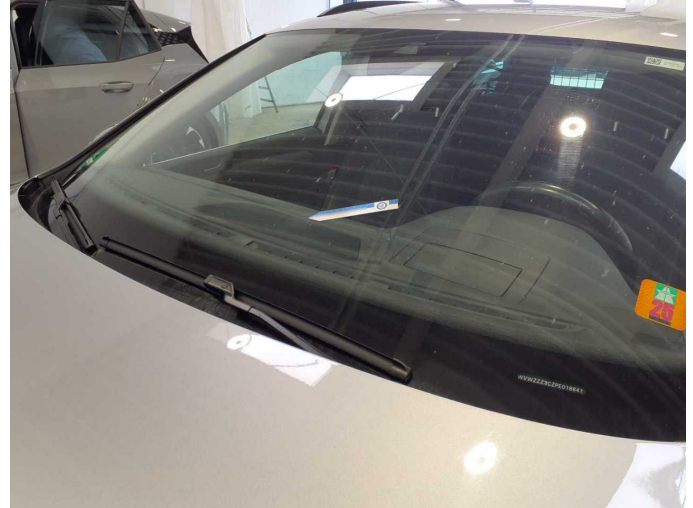
Damage 23: Vehicle glazing: Windscreen with lane departure assistant (Rissbildung) - Stone chips - Replace

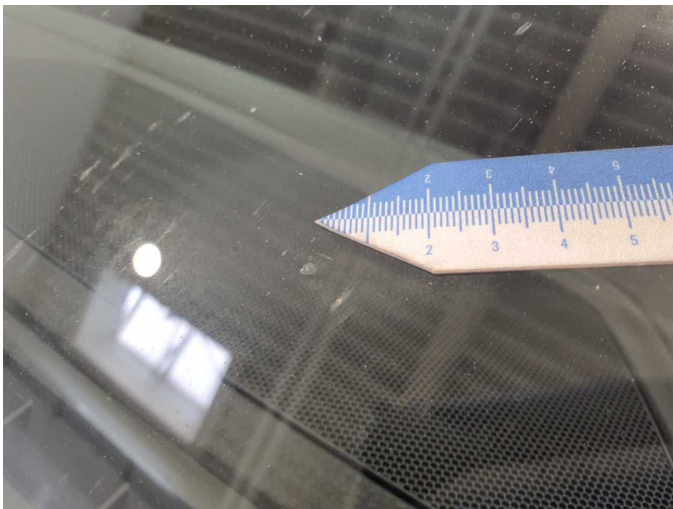
Damage 23: Vehicle glazing: Windscreen with lane departure assistant (Rissbildung) - Stone chips - Replace

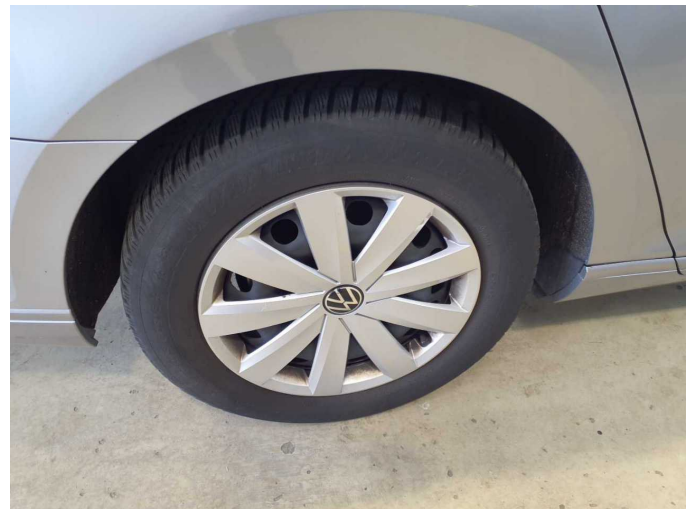
Wear and tear 1: Wheel / tyres: Tyre - rear right side (Über 4mm) - No deduction

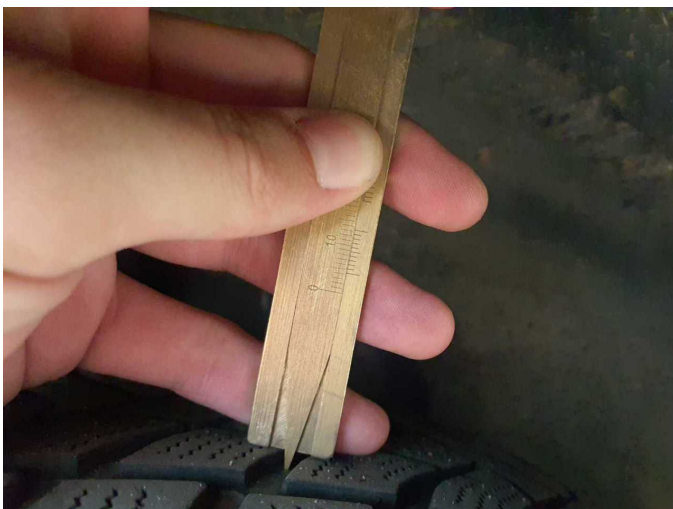
Wear and tear 1: Wheel / tyres: Tyre - rear right side (Über 4mm) - No deduction

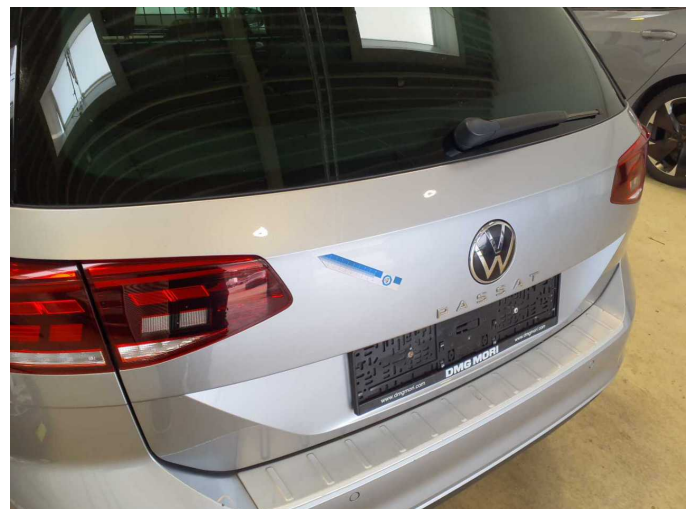
Wear and tear 2: Boot lid / rear door: Boot lid - dent(s) - No deduction

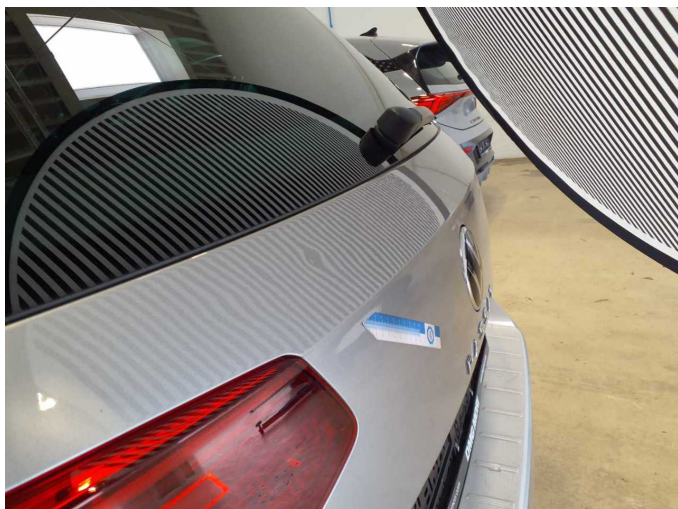
Wear and tear 2: Boot lid / rear door: Boot lid - dent(s) - No deduction
