Expertise

Protocol number: 46193465
Order No. / Reference: 26512429
Inspection date: 18 Jun 2026

Model: Passat Variant 2.0 TDI SCR DSG Business

VIN: WVVZZZ3CZPE018641

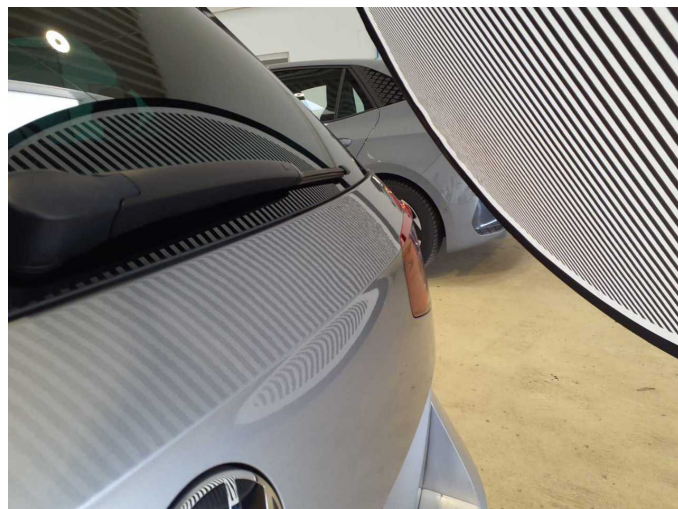
Wear and tear 2: Boot lid / rear door: Boot lid - dent(s) - No deduction

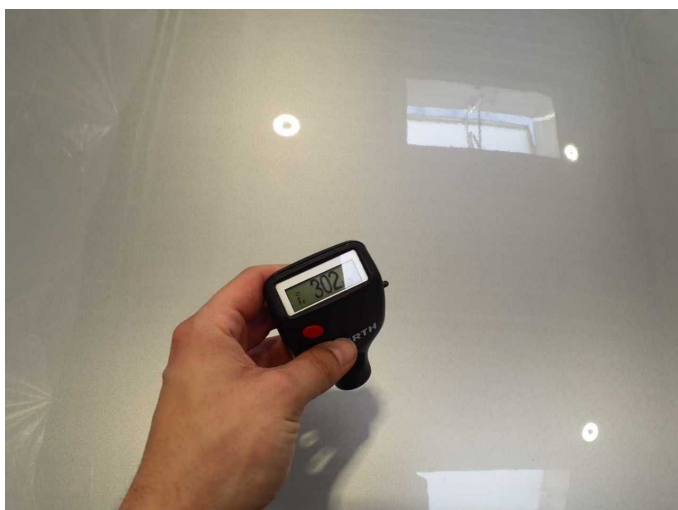
Bonnet: 302 μm
