Expertise

Protocol number: 46179385
Order No. / Reference: 26584771
Inspection date: 26 Jun 2026

Manufacturer: Ford

Model: Mustang Mach-E

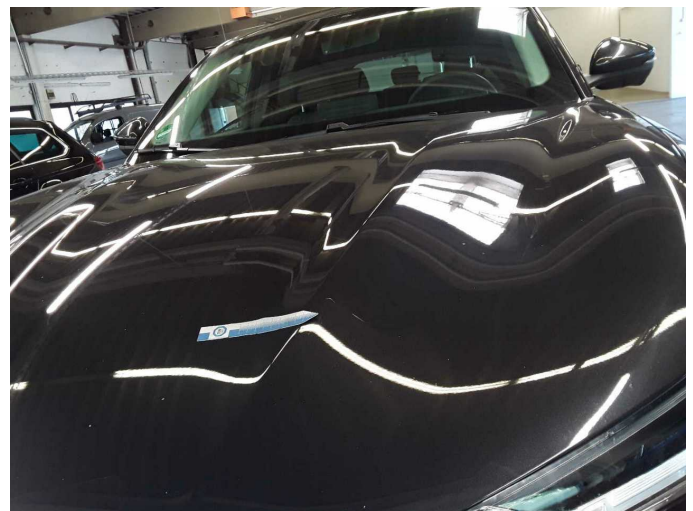
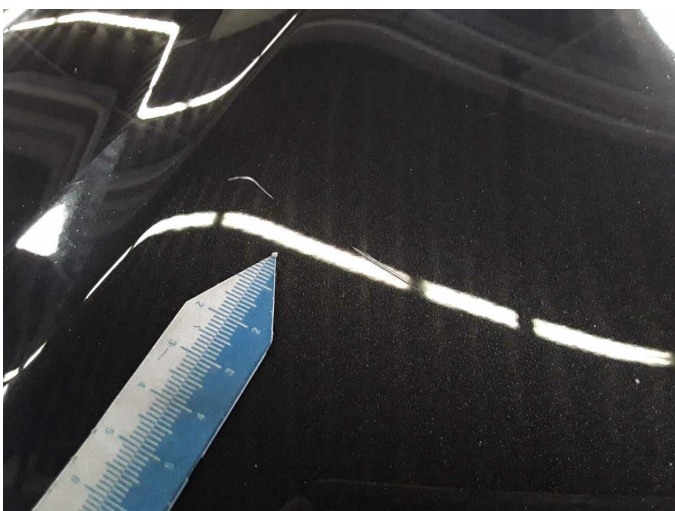
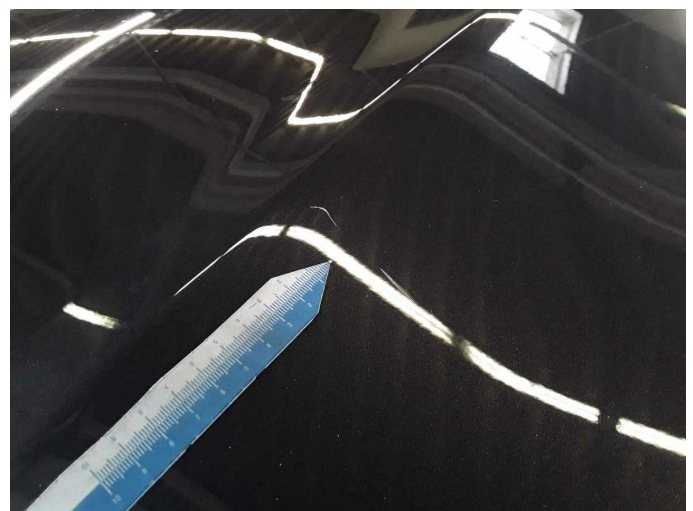
| No. | Component group | Description |
|---|---|---|
| 1 | Bonnet | Bonnet - Scratch(es) - Paint |

Damage 1: Bonnet: Bonnet - Scratch(es) - Paint

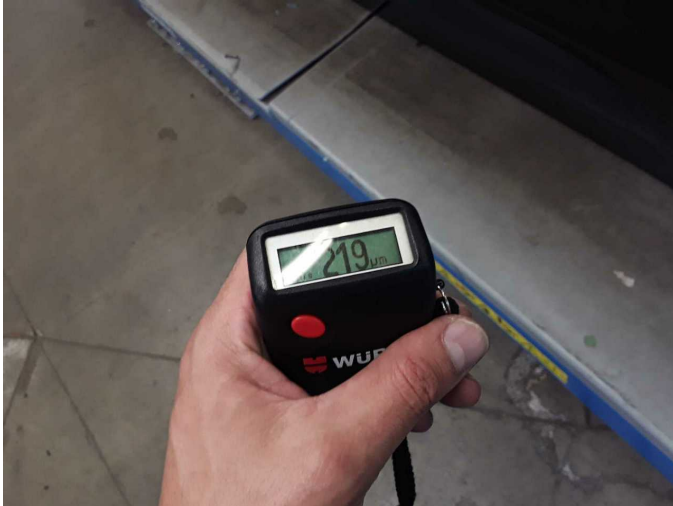
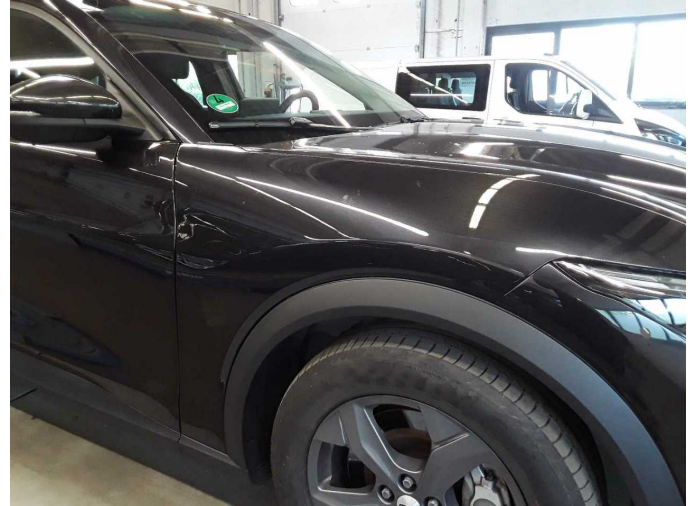
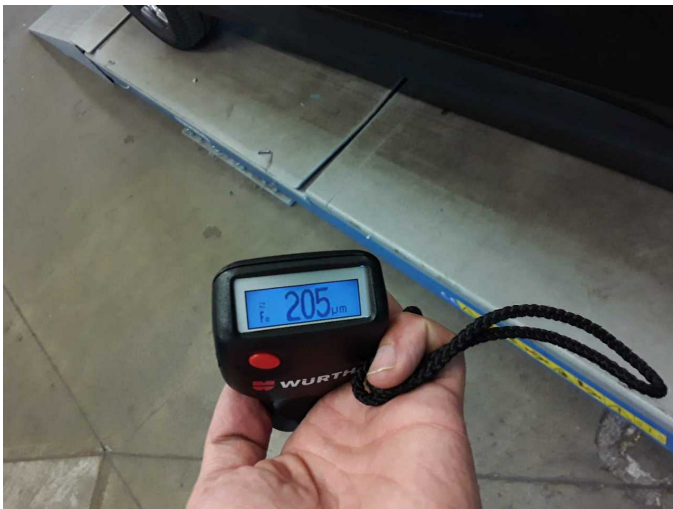
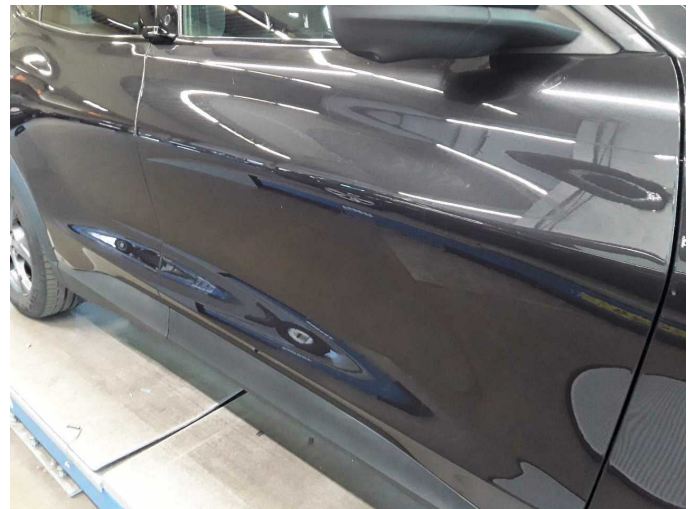
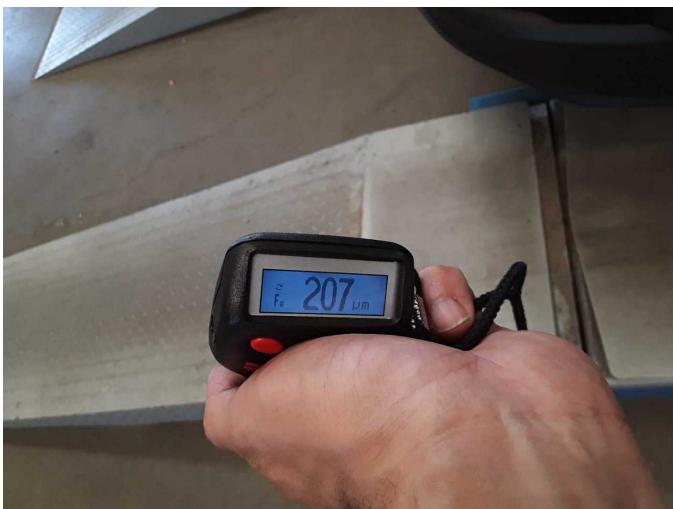
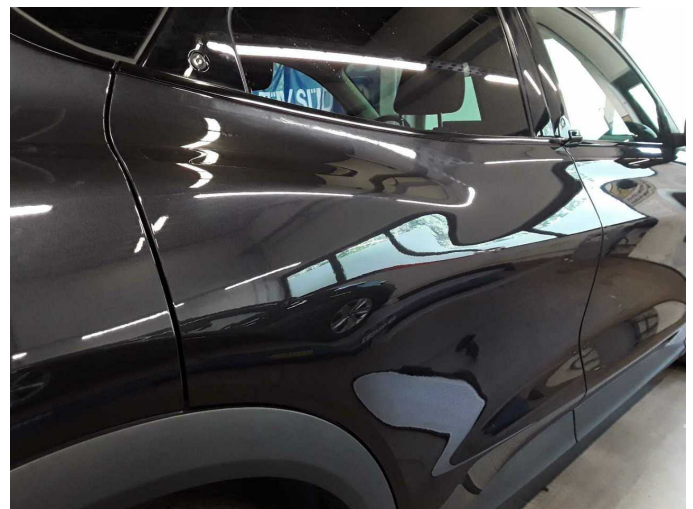
| No. | Repainting |
|---|---|
| 1 | Mudguard - right side, Door - rear right side, Door - front right side, Professionally carried out, Invoice of repair done Non-existent |

Repainting 1: Mudguard - right side, Door - rear right side, Door - front right side
