Expertise

Protocol number: 46259325
Order No. / Reference: 26151980
Inspection date: 29 Jun 2026

Model: Vito 116 CDI Extralang HA Aut. PRO

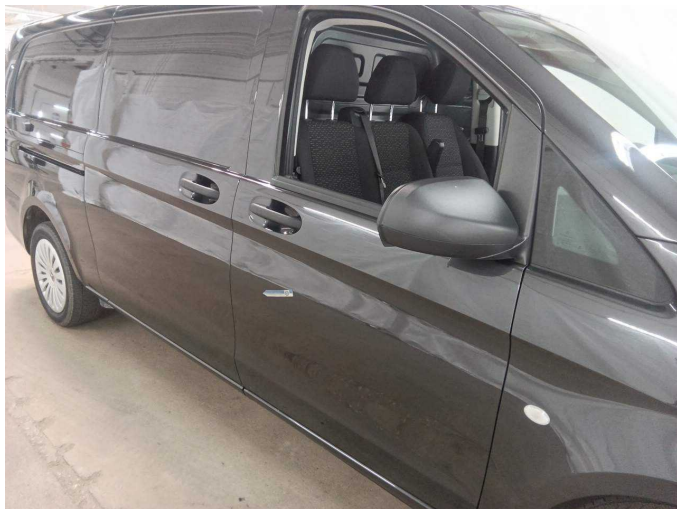
Damage 2: Door - front right side: Door - dent(s) - Smooth repair work

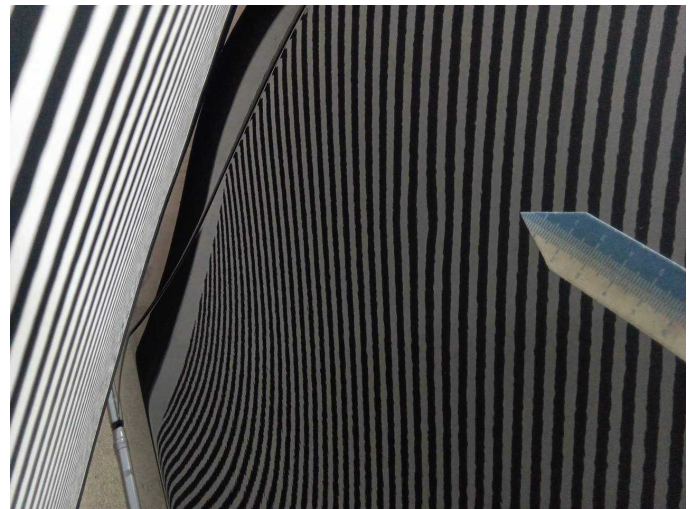
Damage 2: Door - front right side: Door - dent(s) - Smooth repair work

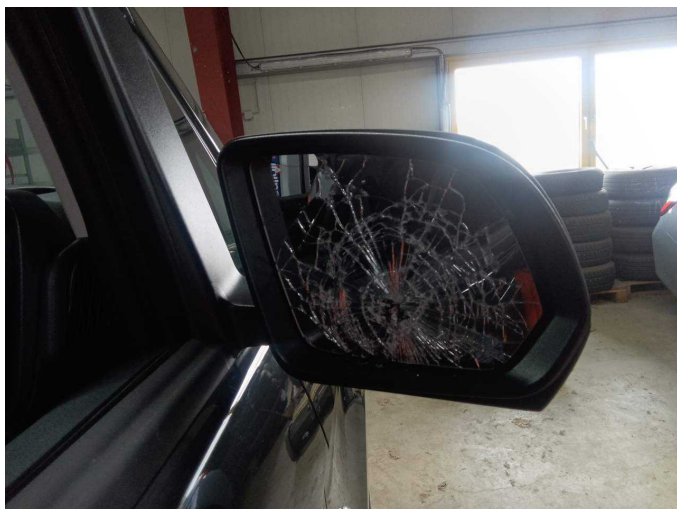
Damage 3: Wing mirror - right side: Mirror glass - Broken / torn - Replace

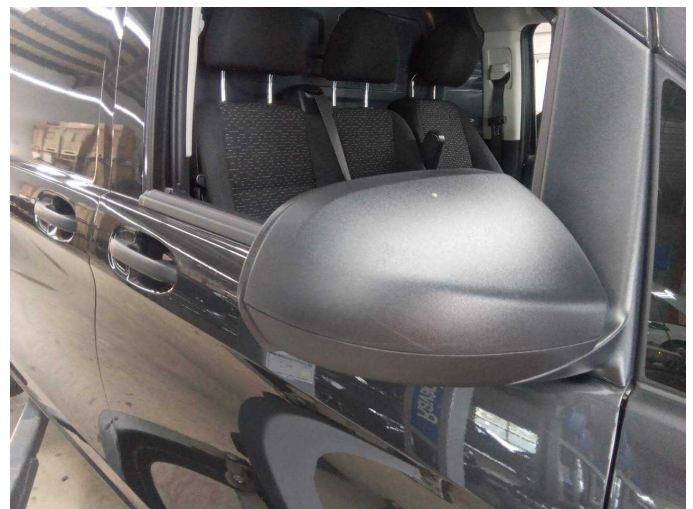
Damage 3: Wing mirror - right side: Mirror glass - Broken / torn - Replace

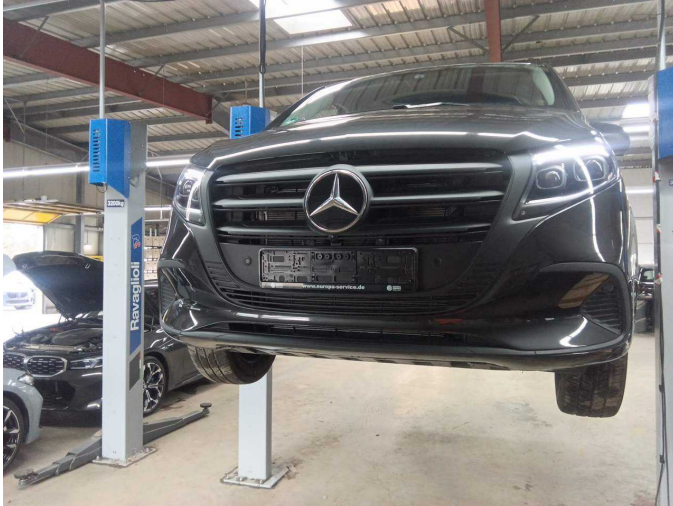
Damage 4: Front bumper: Front bumper - Scratched - Smart repair

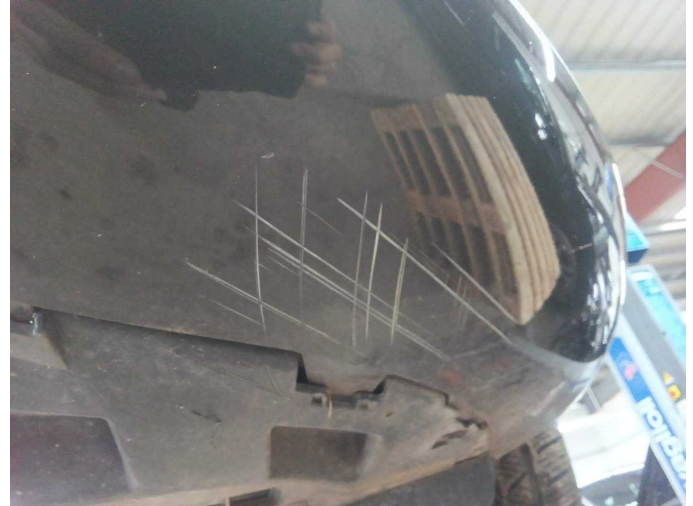
Damage 4: Front bumper: Front bumper - Scratched - Smart repair

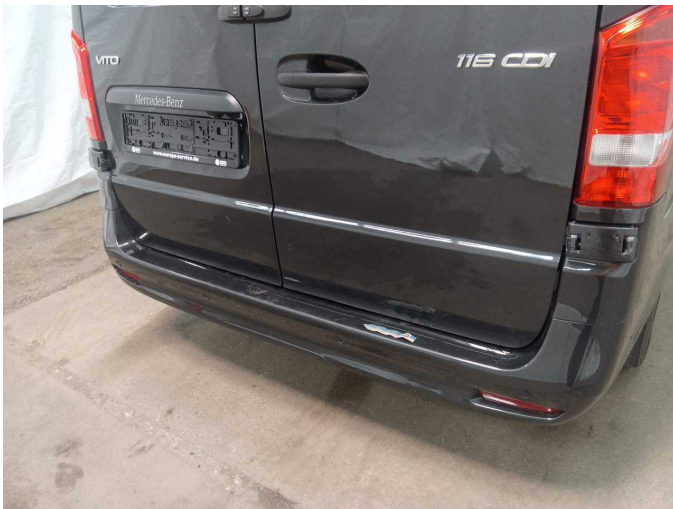
Damage 5: Rear bumper: Rear bumper - Scratched - Paint

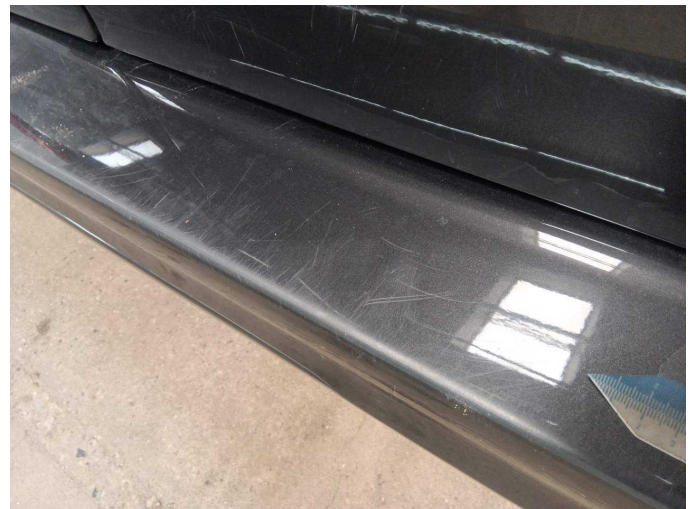
Damage 5: Rear bumper: Rear bumper - Scratched - Paint

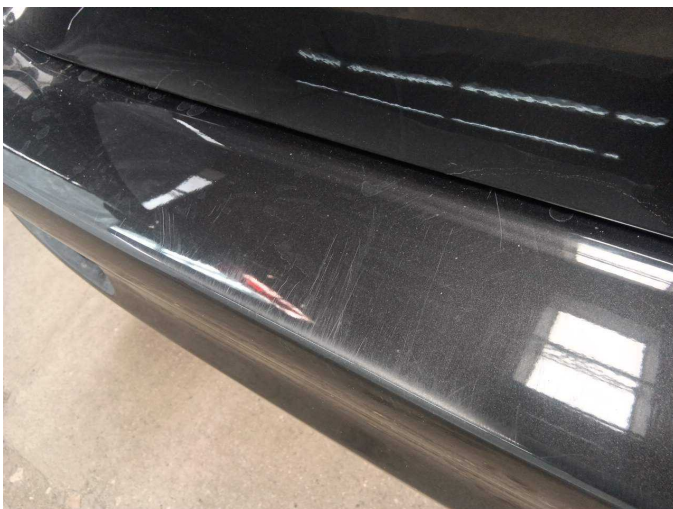
Damage 5: Rear bumper: Rear bumper - Scratched - Paint

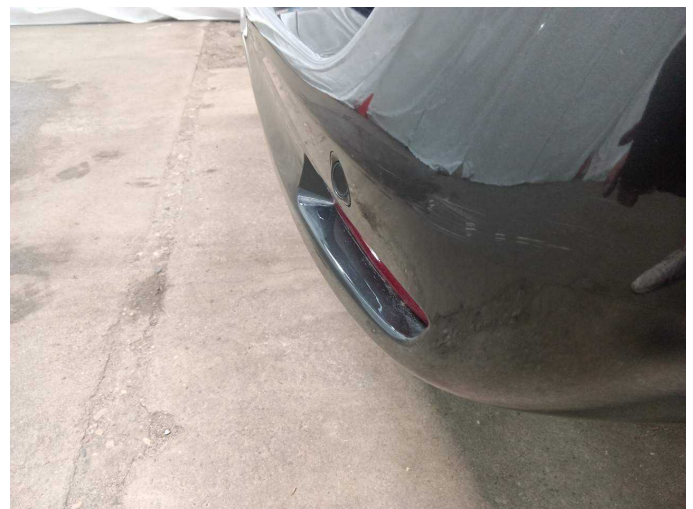
Damage 5: Rear bumper: Rear bumper - Scratched - Paint

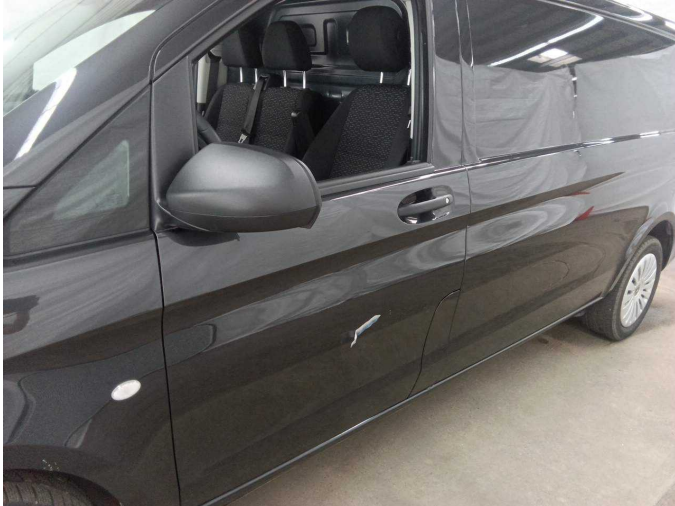
Damage 6: Door - front left side: Door - Dent / paintcoat damage - Repair and paint

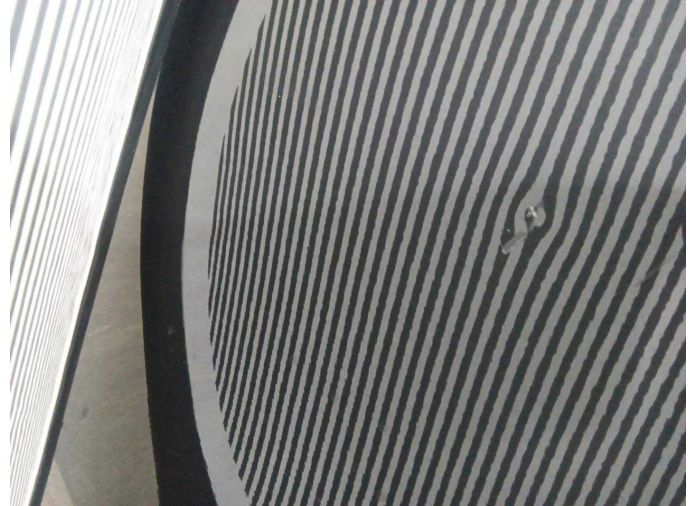
Damage 6: Door - front left side: Door - Dent / paintcoat damage - Repair and paint

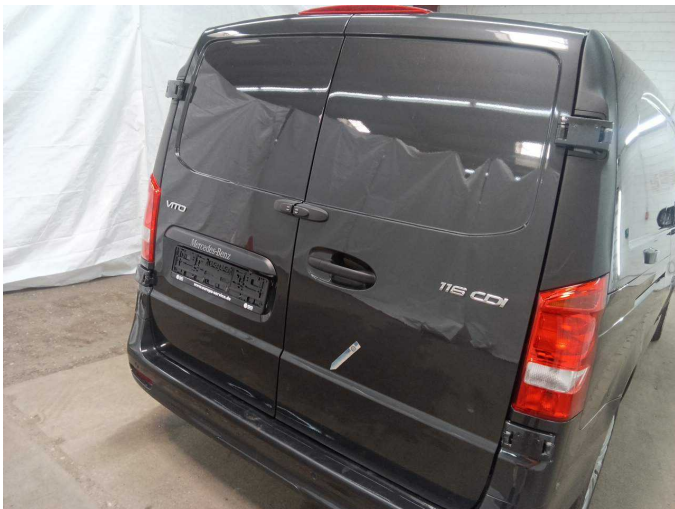
Damage 7: Boot lid / rear door: Rear door - right side - Scratched - Paint

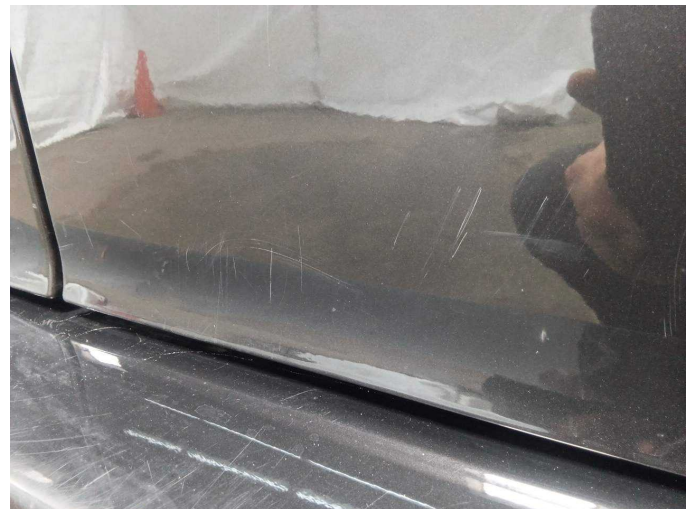
Damage 7: Boot lid / rear door: Rear door - right side - Scratched - Paint

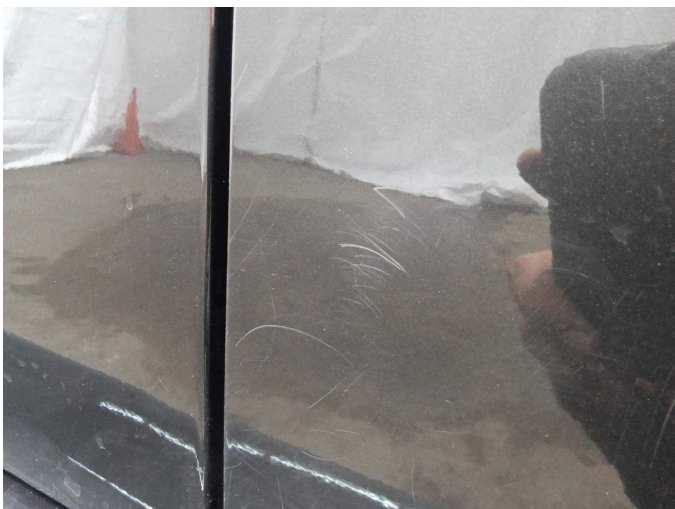
Damage 7: Boot lid / rear door: Rear door - right side - Scratched - Paint

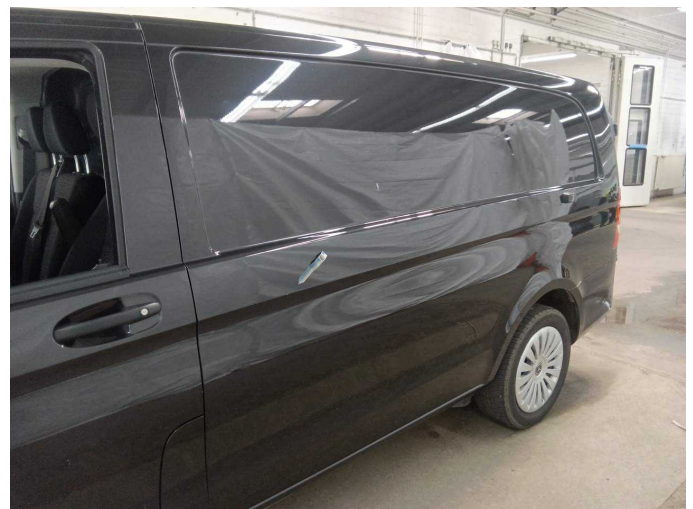
Damage 8: Side panel - rear left side: Side panel - Dent / paintcoat damage - Repair and paint

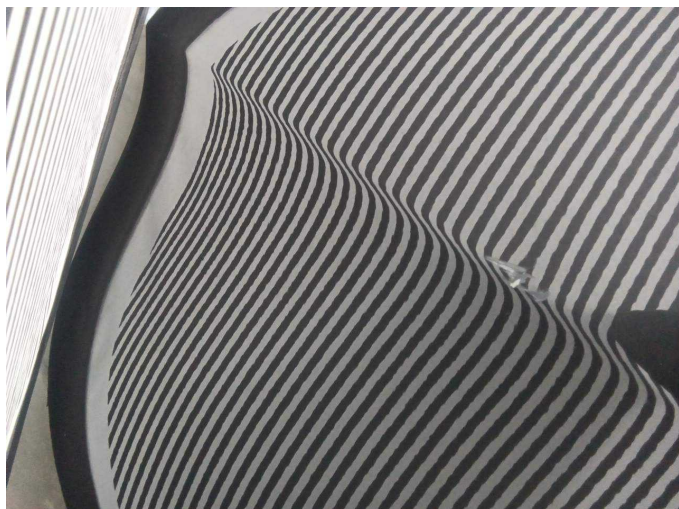
Damage 8: Side panel - rear left side: Side panel - Dent / paintcoat damage - Repair and paint
