Expertise

Protocol number: 46392935  
Order No. / Reference: 26616932  
Inspection date: 7 Jul 2026

Manufacturer: Ford

Model: Focus Turnier 1.5 EcoBlue Start-Stopp-System Aut. TITANIUM

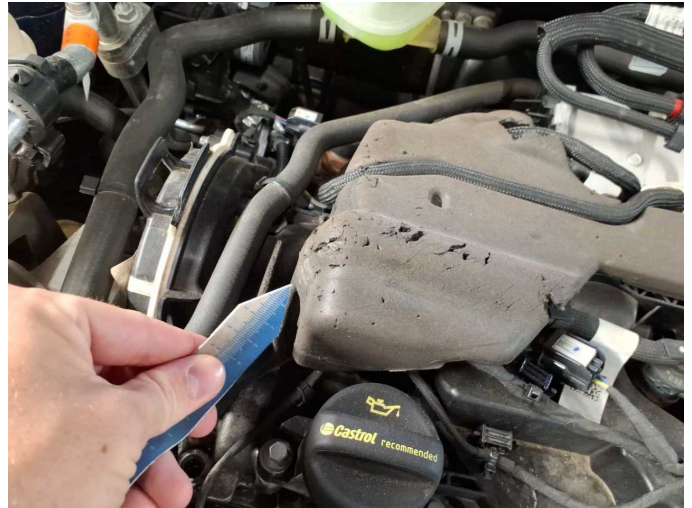
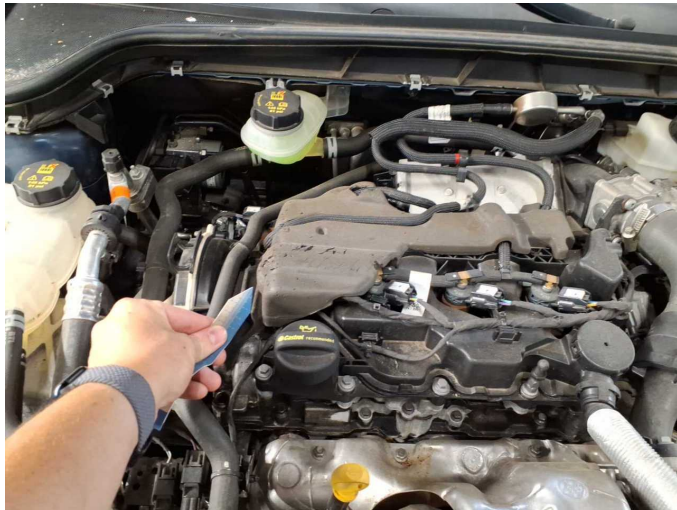
| No. | Component group | Description |
|---|---|---|
| 2 | Engine | Engine cover - Damage caused by marten / rodent - Replace |

**Damage 2:** Engine: Engine cover - Damage caused by marten / rodent - Replace

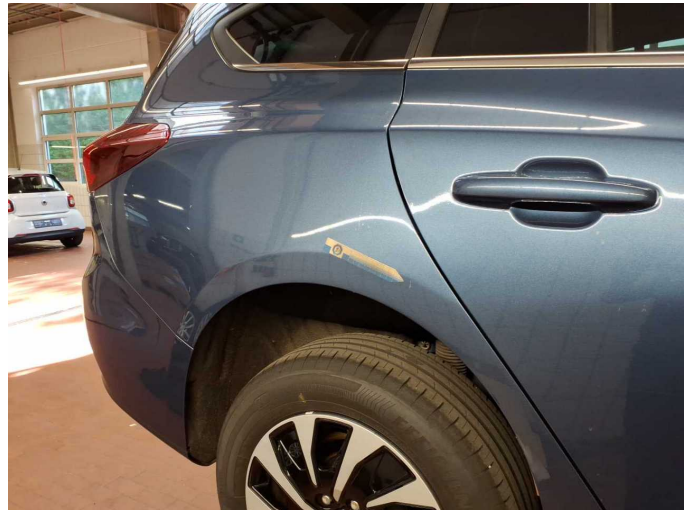
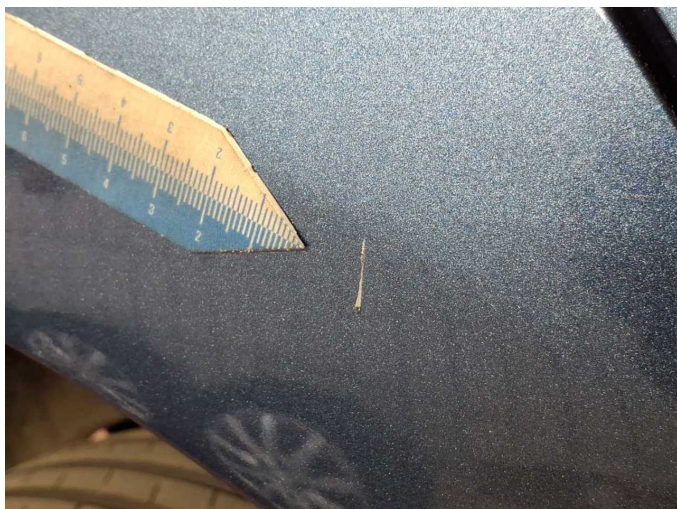
| No. | Component group | Description |
|---|---|---|
| 3 | Side panel - rear right side | Side panel - Scratch(es) - Smart repair |

| No. | Repainting |
|---|---|
| 2 | Side panel - rear right side, Professionally carried out, Invoice of repair done Non-existent |

| Roof rail - right side | 215 µm | Side panel - rear right side | 1,007 µm |

**Damage 3:** Side panel - rear right side: Side panel - Scratch(es) - Smart repair

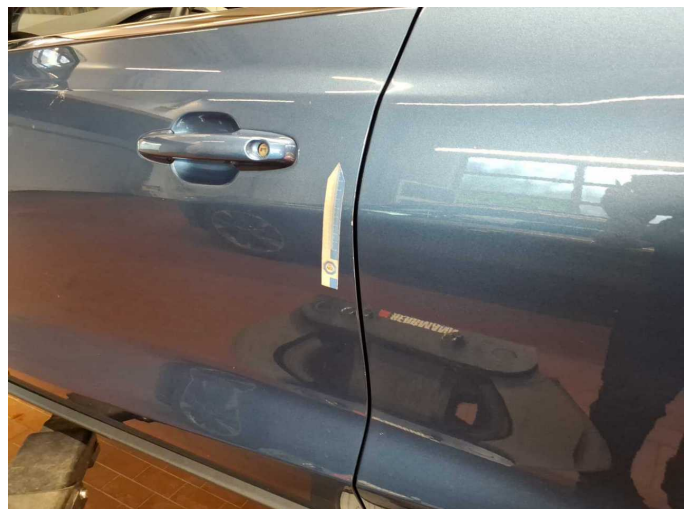
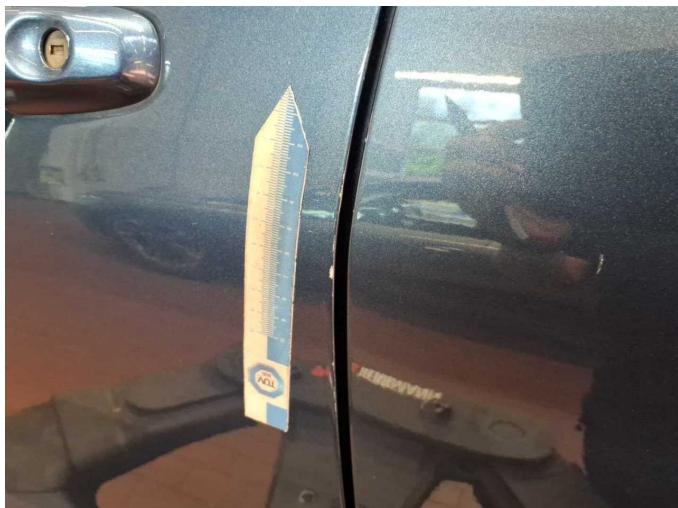
| No. | Component group | Description |
|---|---|---|
| 4 | Door - front left side | Door edge - Scratch(es) - Smart repair |

**Damage 4:** Door - front left side: Door edge - Scratch(es) - Smart repair

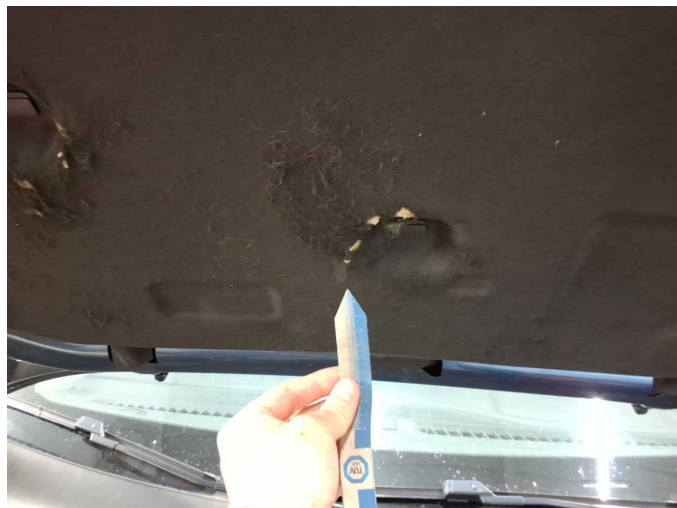
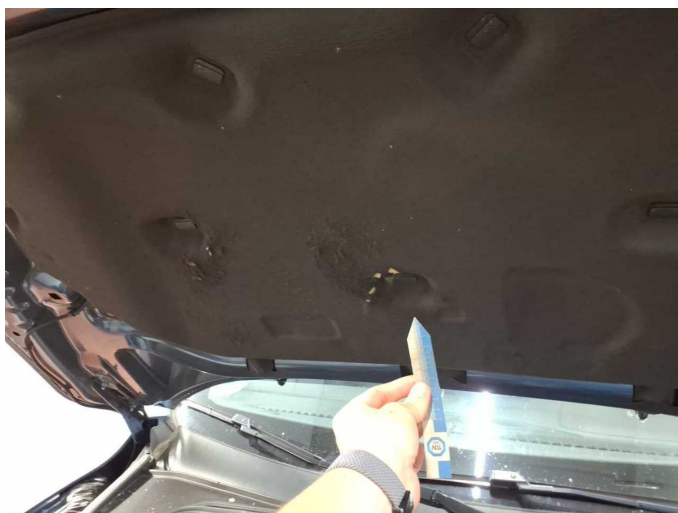
| No. | Component group | Description |
|---|---|---|
| 5 | Bonnet | Insulation lining - Damage caused by marten / rodent - Replace |

**Damage 5:** Bonnet: Insulation lining - Damage caused by marten / rodent  
- Replace

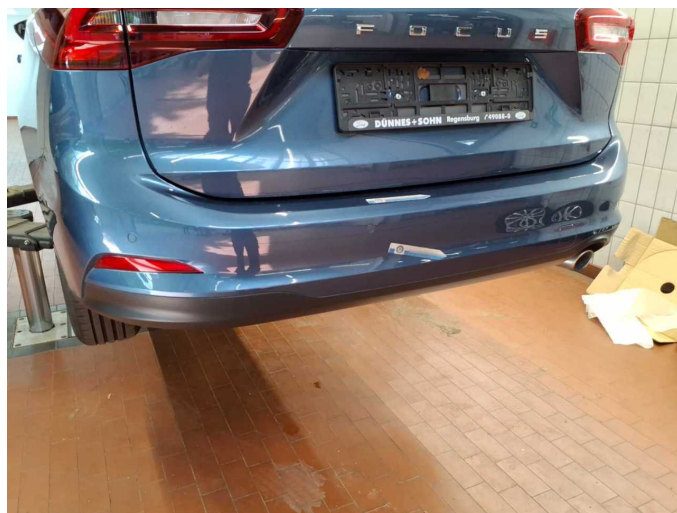
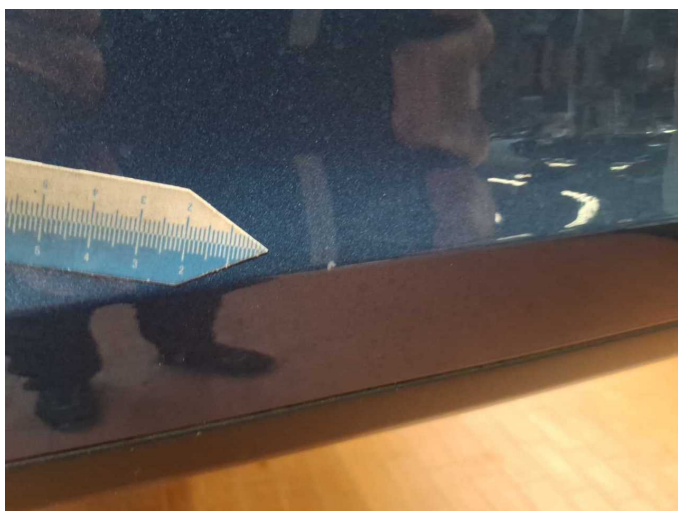
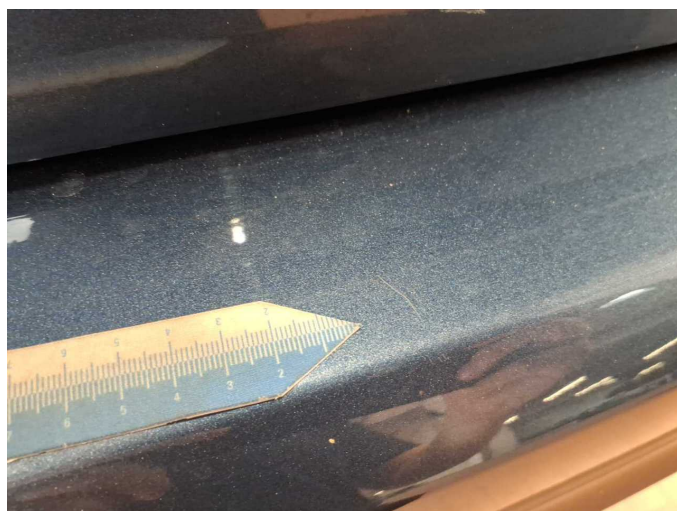
| No. | Component group | Description |
|---|---|---|
| 6 | Rear bumper | Rear bumper - Scratch(es) - Paint |

**Damage 6:** Rear bumper: Rear bumper - Scratch(es) - Paint

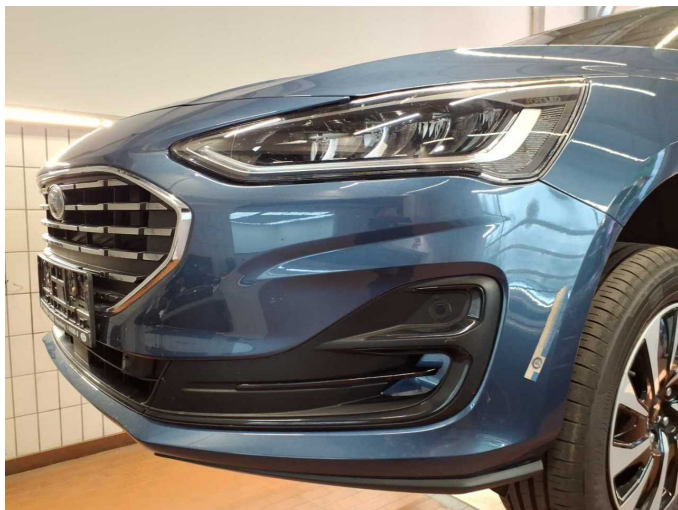
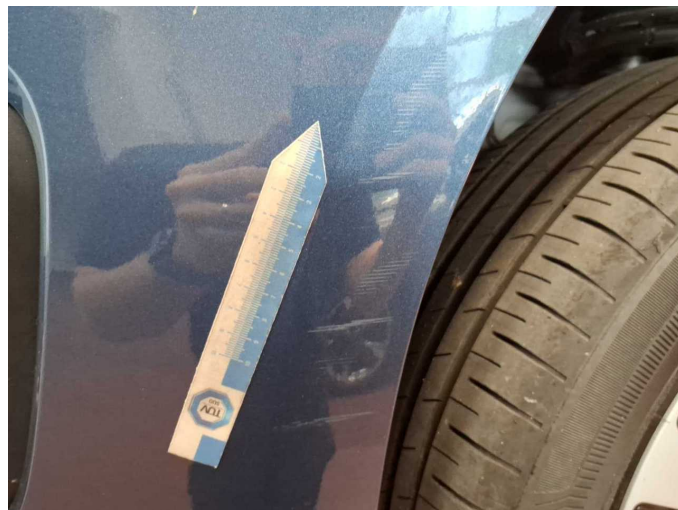
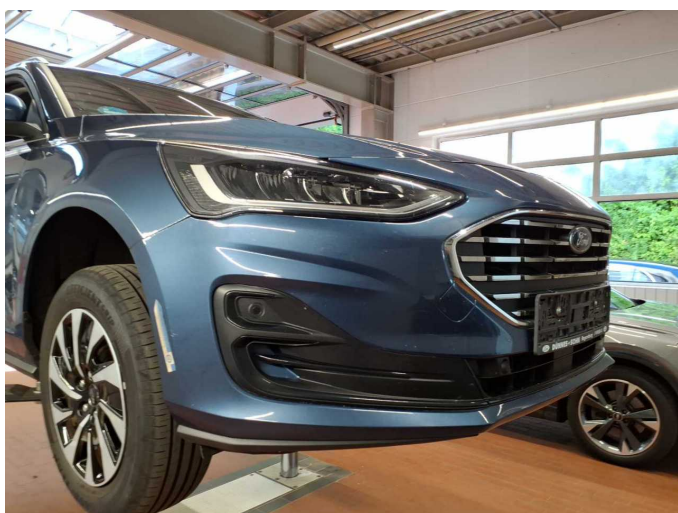
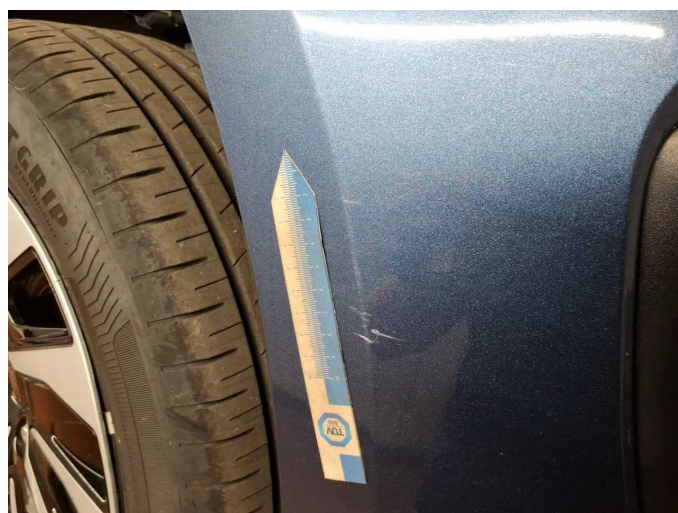
| No. | Component group | Description |
|---|---|---|
| 7 | Front bumper | Front bumper - Scratch(es) - Paint |

**Damage 7:** Front bumper: Front bumper - Scratch(es) - Paint

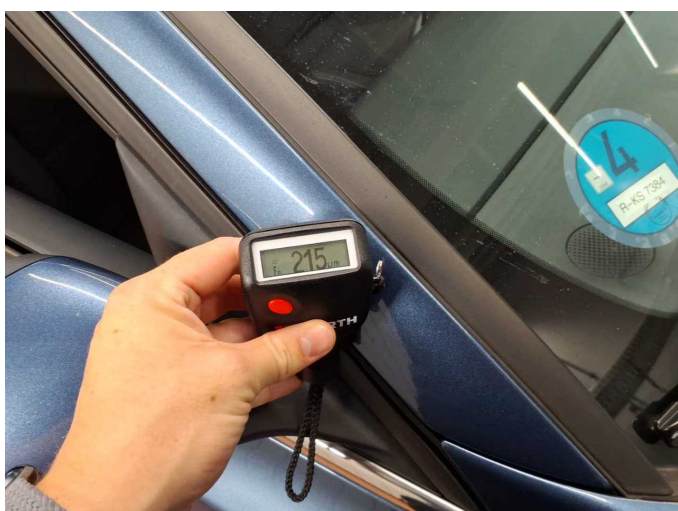
| No. | Repainting |
|---|---|
| 1 | Roof rail - right side, Professionally carried out, Invoice of repair done Non-existent |

**Repainting 1:** Roof rail - right side

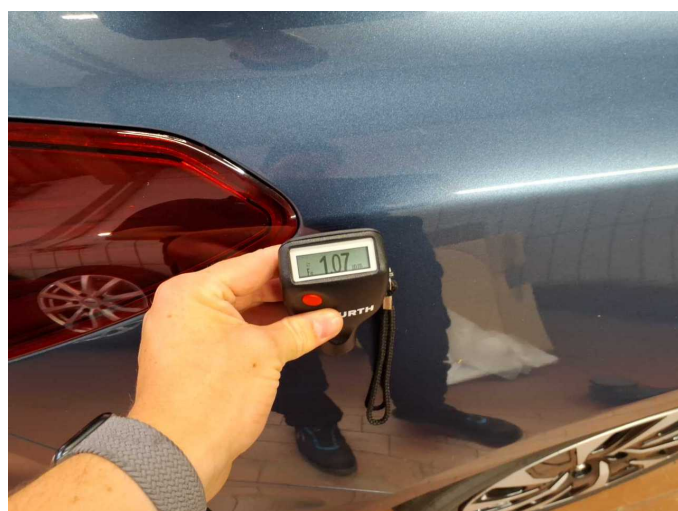
**Repainting 2:** Side panel - rear right side
