Expertise

Protocol number: 46042154
Order No. / Reference: 26154198
Inspection date: 16 Jun 2026

Manufacturer: Mercedes-Benz

Model: 317 CDI Sprinter Standard HA 9G-TRONIC PRO

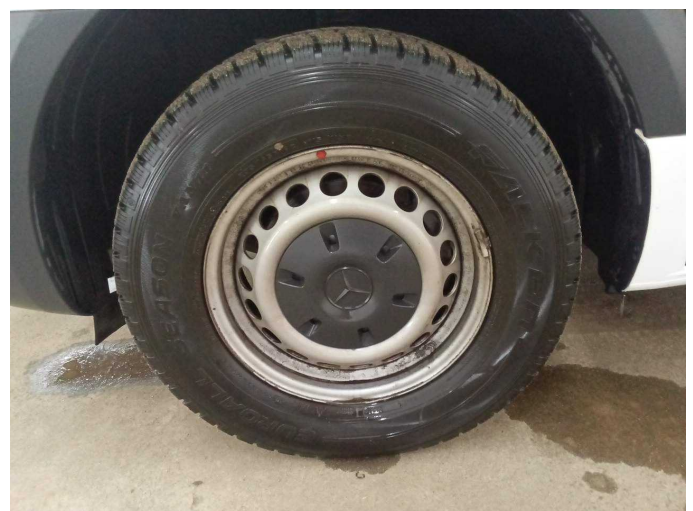
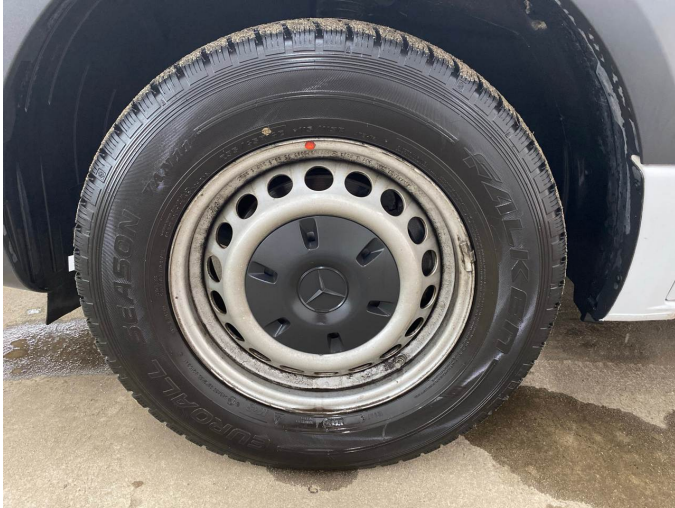
Figure 12: Mounted tyres

#	Tyre size	Type of tyre	Manufacturer	Tread depth
1)	235/65 R16 115R	All-season tyres on Steel rim with wheel cover	Falken	7mm / 7mm
2)	235/65 R16 115R	All-season tyres on Steel rim with wheel cover	Falken	7mm / 7mm

No.	Component group	Description
1	Wheel / tyres	Tyres - complete set (Allwetter- statt Sommerreifen) - Differs from the original configuration - No deduction
2	Rear bumper	Parking sensors - right side - Broken / torn - Replace
3	Front bumper	Front bumper - Scratched - Replace

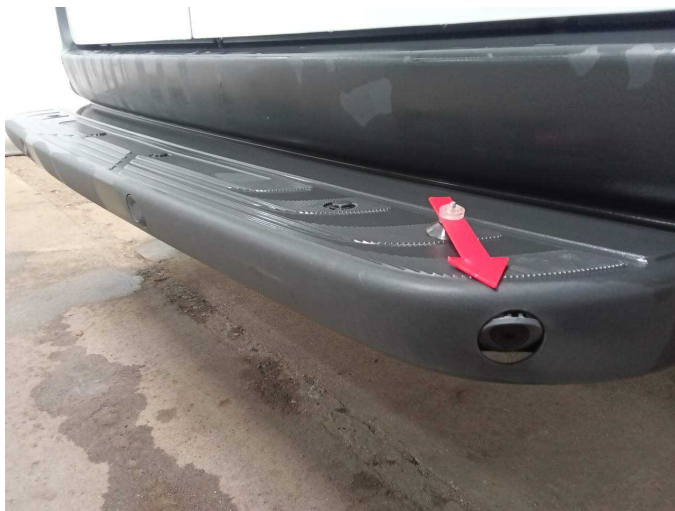
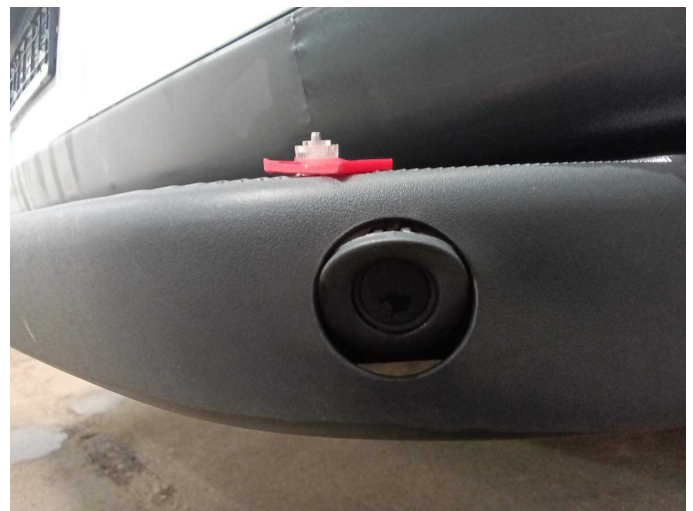
Damage 2: Rear bumper: Parking sensors - right side - Broken / torn - Replace

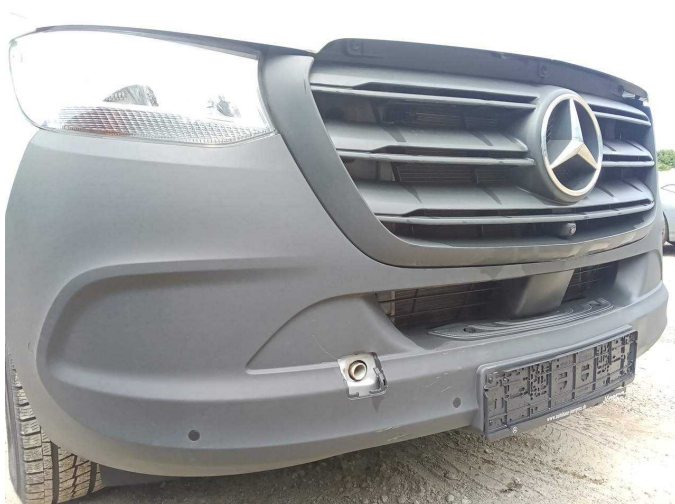
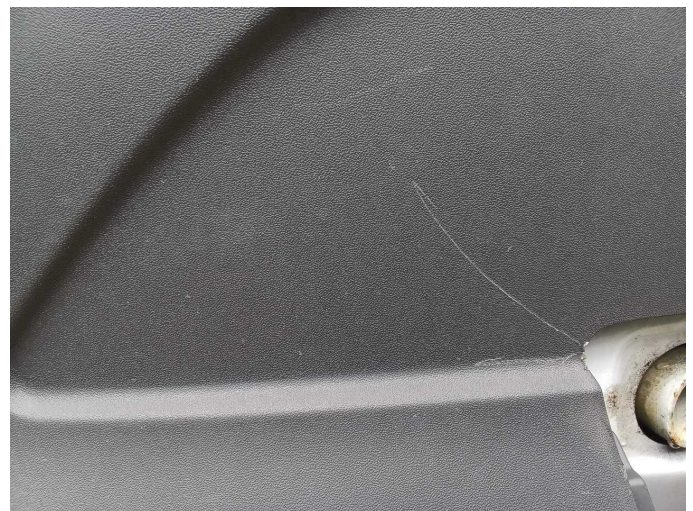
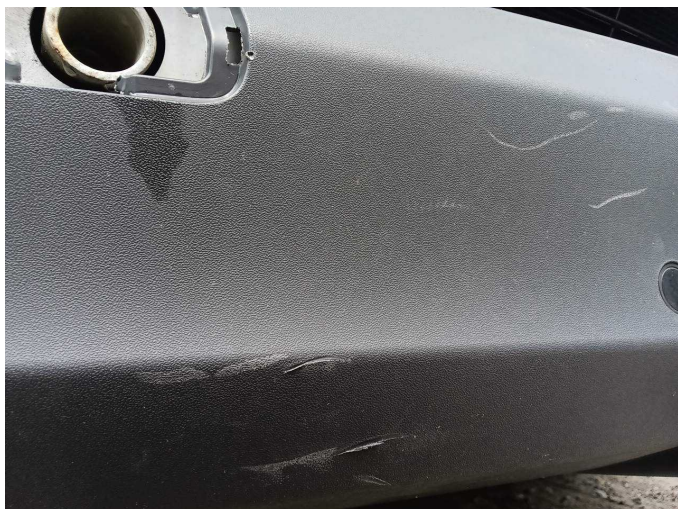
Damage 3: Front bumper: Front bumper - Scratched - Replace
