Expertise

Protocol number: 46405434  
Order No. / Reference: 26623096  
Inspection date: 8 Jul 2026

Manufacturer: Opel

Model: Corsa-e Ultimate

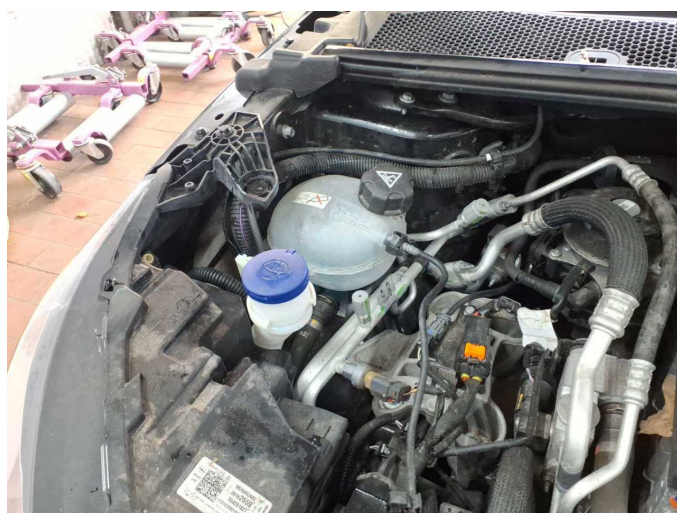
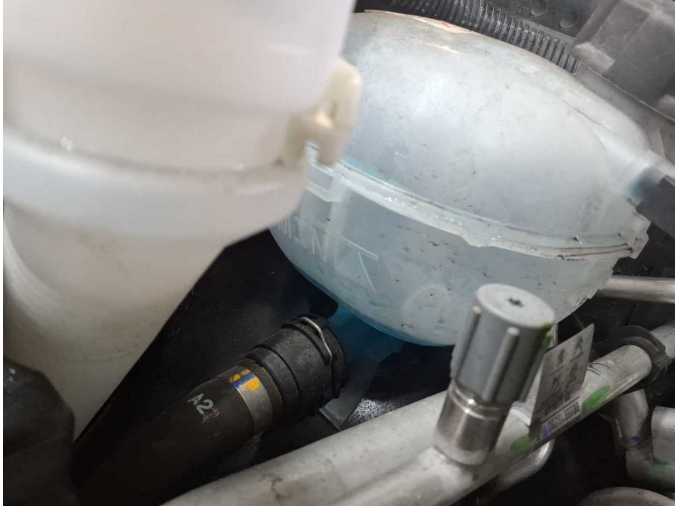
| No. | Component group | Description |
|---|---|---|
| 2 | Engine cooling | Coolant (Unter Minimum. Werkstattprüfung erf.) - Specify findings - Diagnosed and repair if necessary |

**Damage 2:** Engine cooling: Coolant (Unter Minimum. Werkstattprüfung erf.) - Specify findings - Diagnosed and repair if necessary

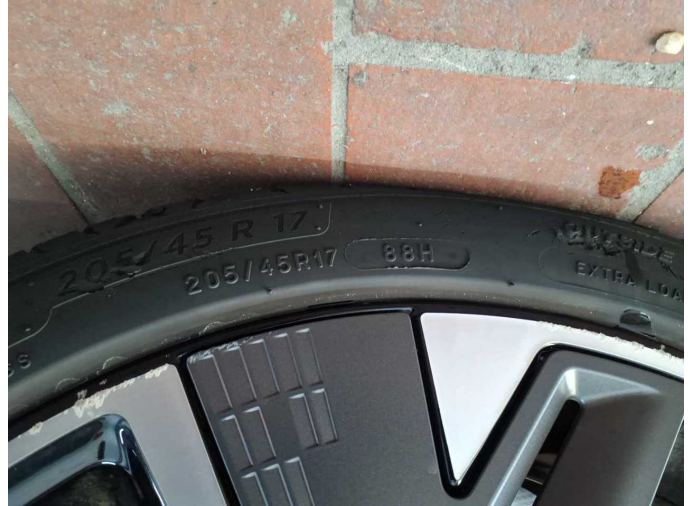
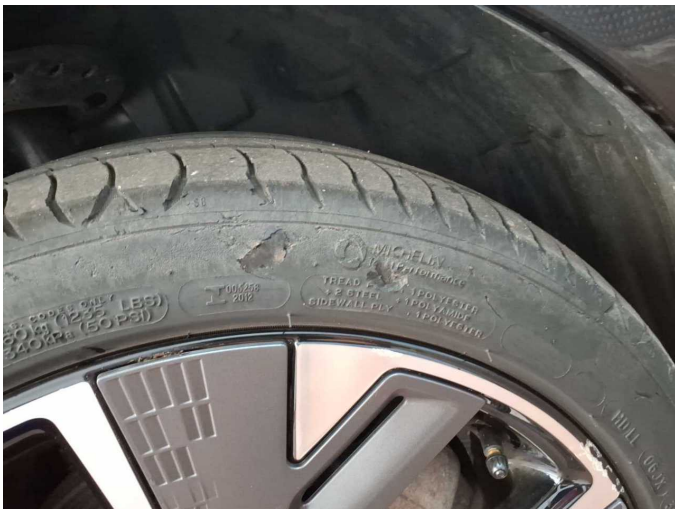
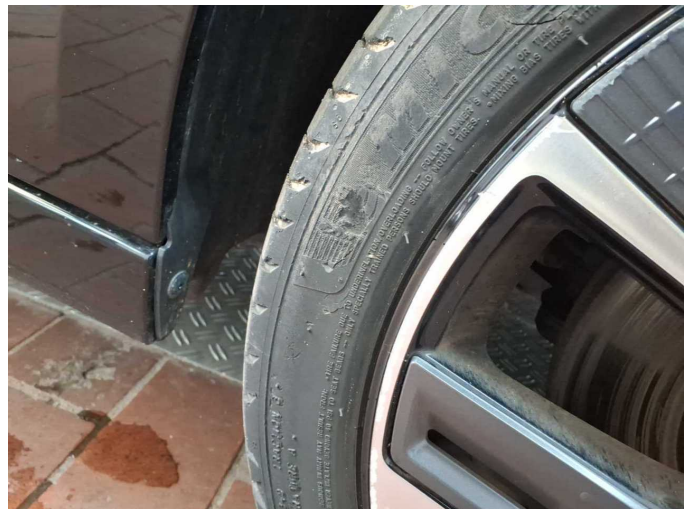
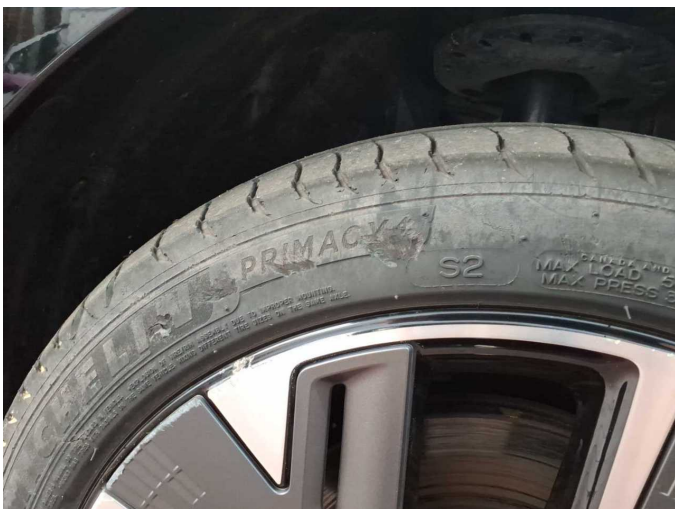
| No. | Component group | Description |
|---|---|---|
| 3 | Wheel / tyres | Tyre - front right side - Damaged - Replace |

**Damage 3:** Wheel / tyres: Tyre - front right side - Damaged - Replace

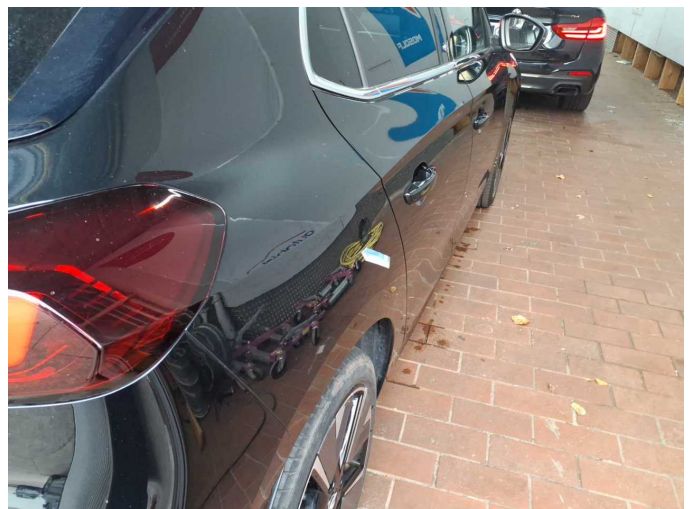
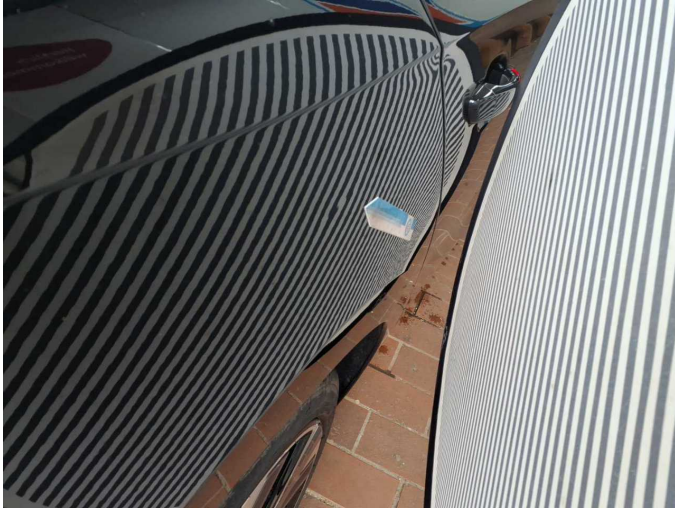
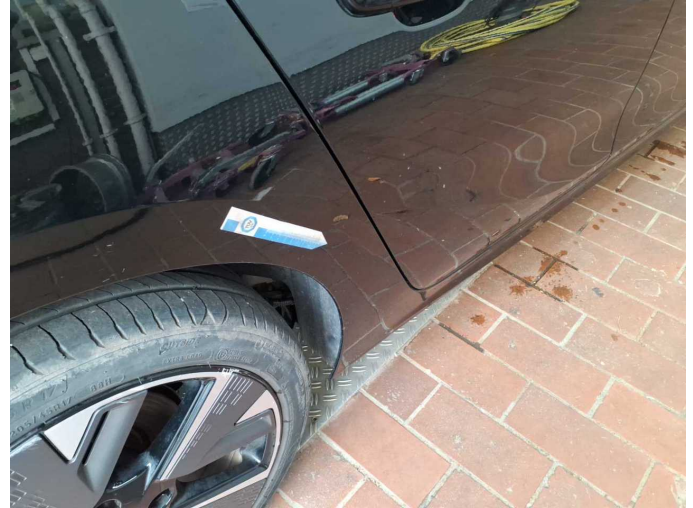
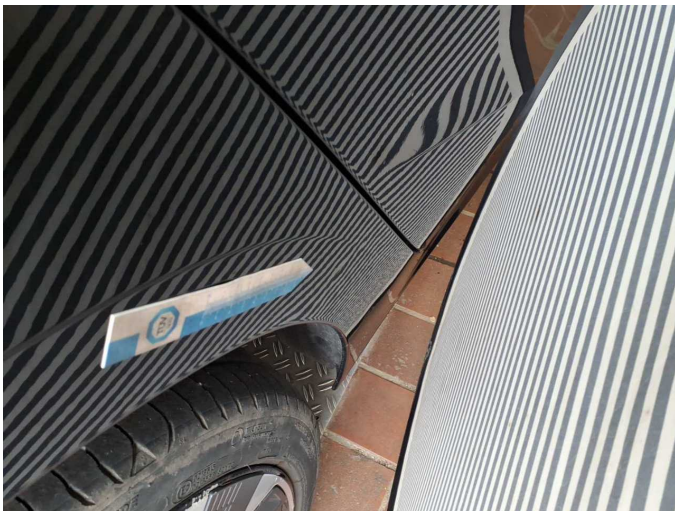
| No. | Component group | Description |
|---|---|---|
| 4 | Side panel - rear right side | Side panel - dent(s) - Smooth repair work |

**Damage 4:** Side panel - rear right side: Side panel - dent(s) - Smooth repair work

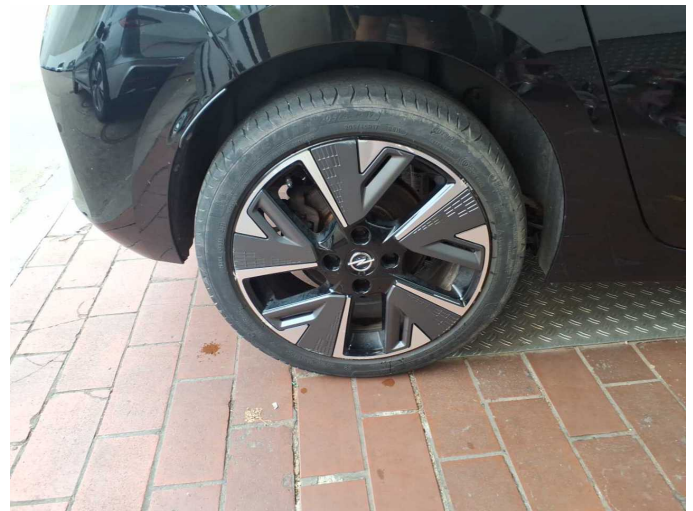
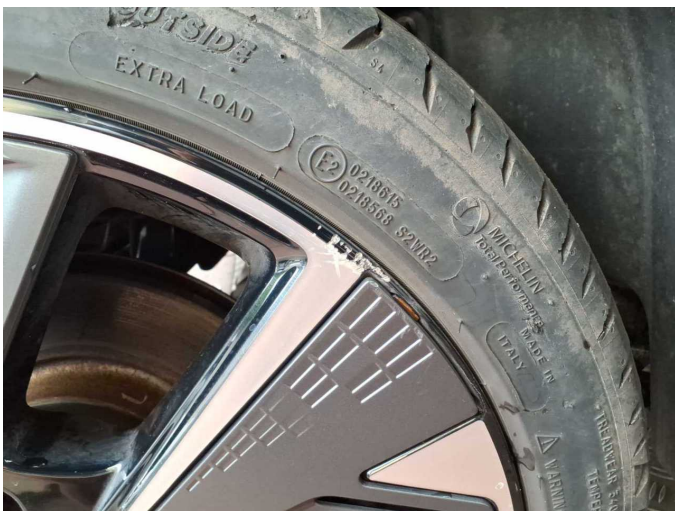
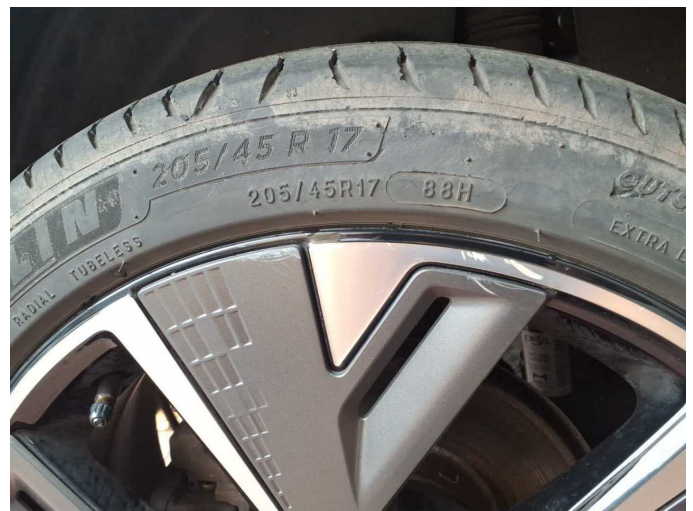
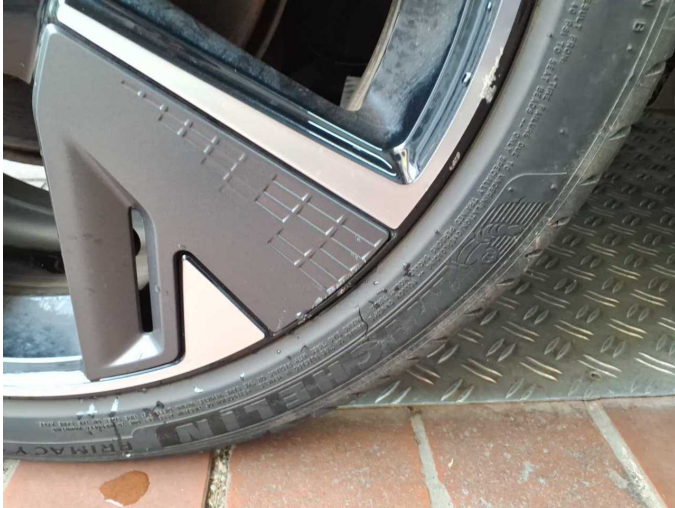
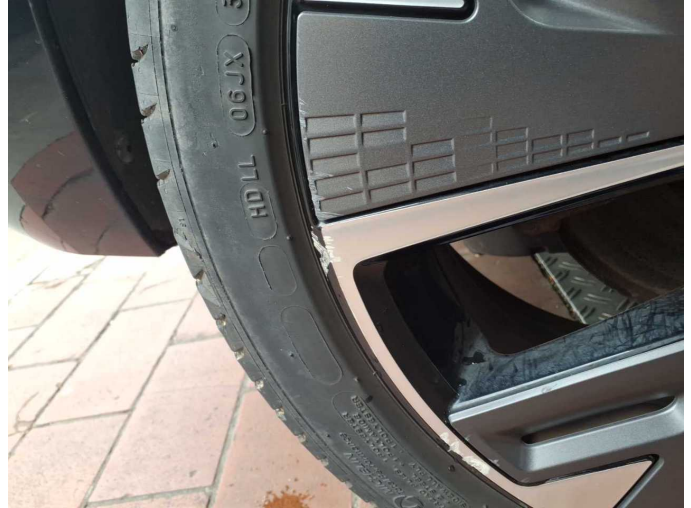
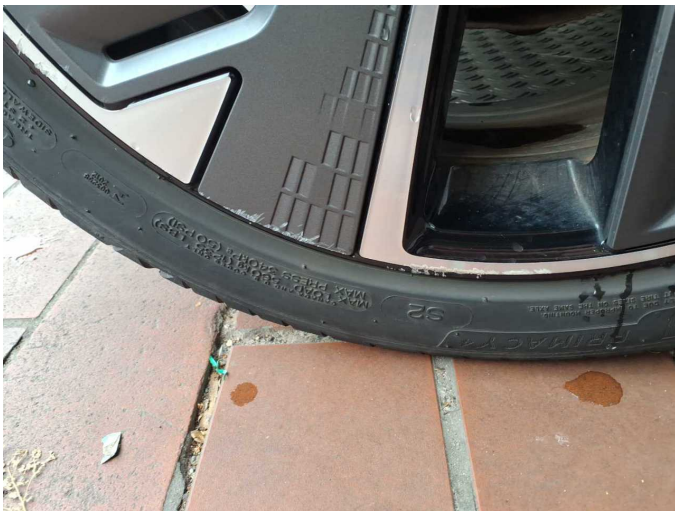
| No. | Component group | Description |
|---|---|---|
| 5 | Wheel / tyres | Alloy rim - rear right side - Scratched - Replace |

**Damage 5:** Wheel / tyres: Alloy rim - rear right side - Scratched - Replace

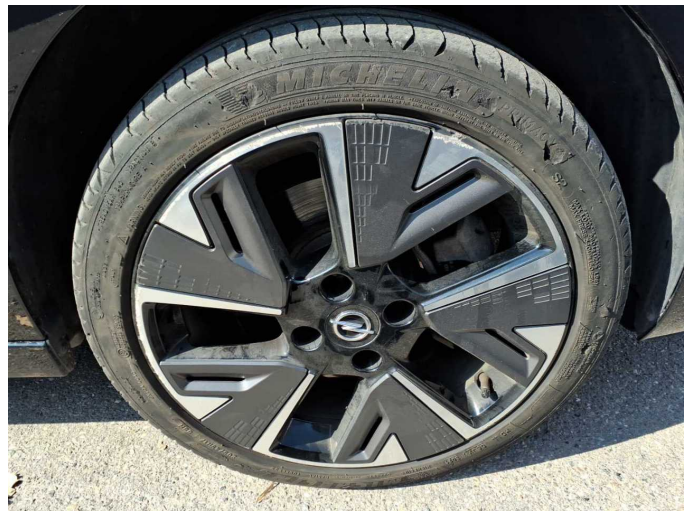
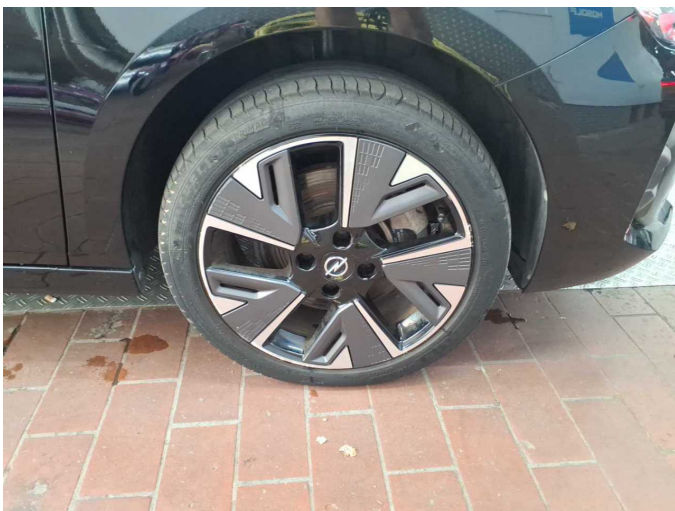
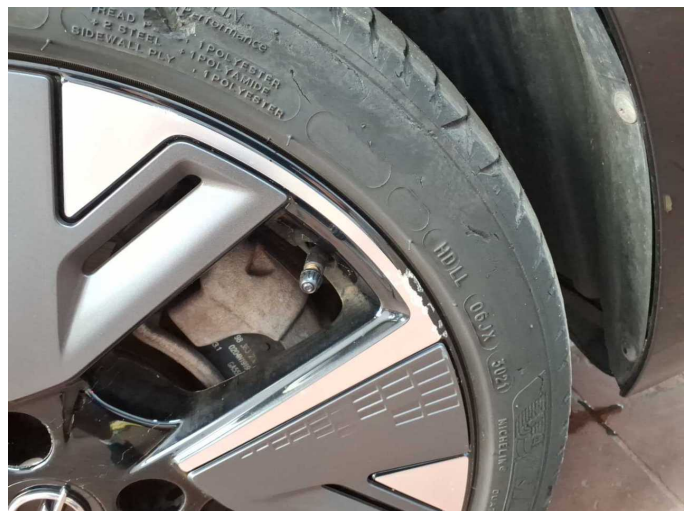
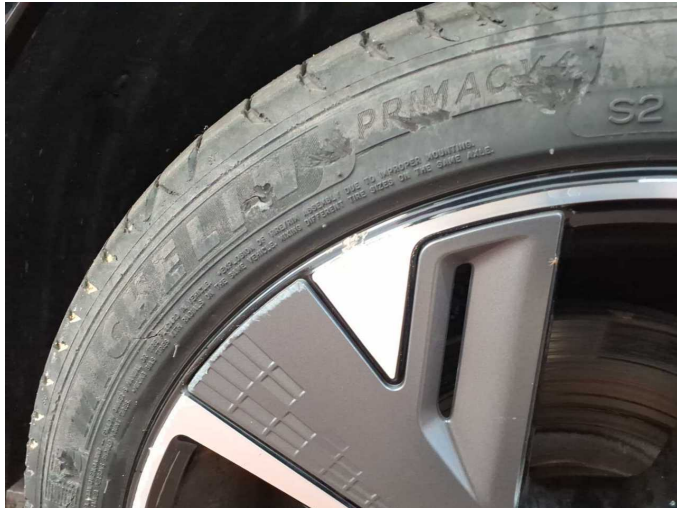
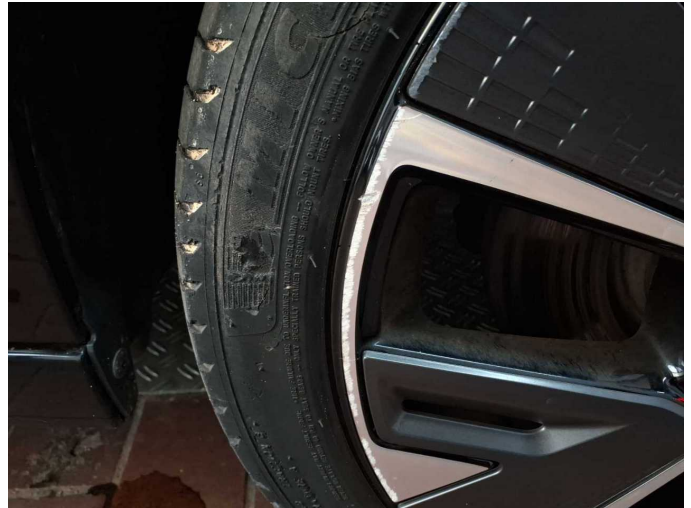
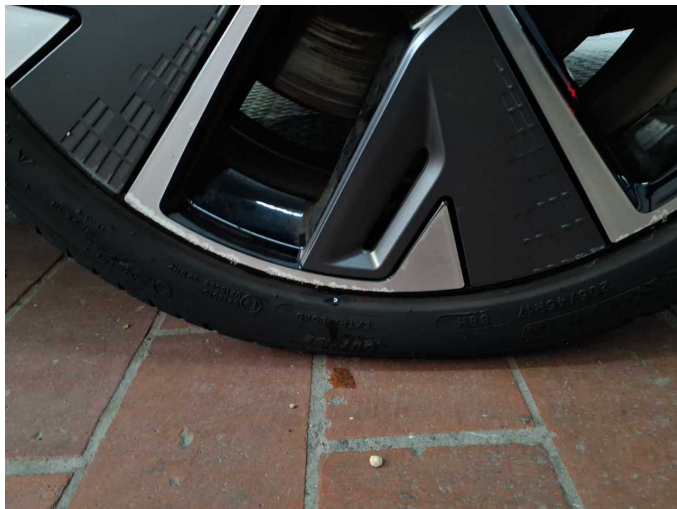
| No. | Component group | Description |
|---|---|---|
| 6 | Wheel / tyres | Alloy rim - front right side - Scratched - Replace |

**Damage 6:** Wheel / tyres: Alloy rim - front right side - Scratched - Replace

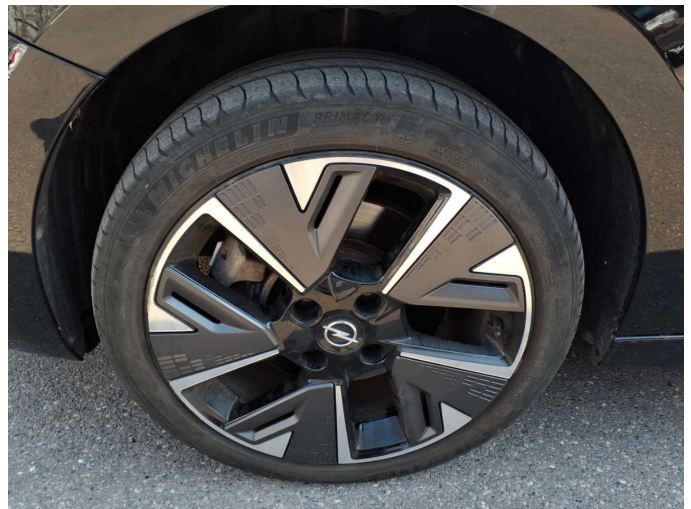
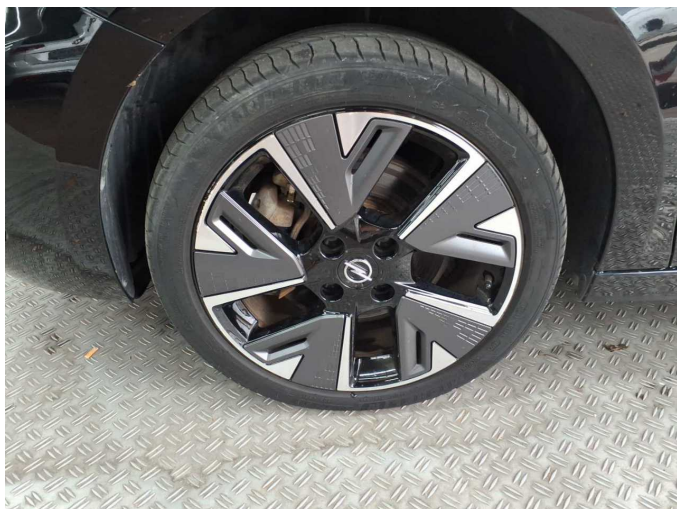
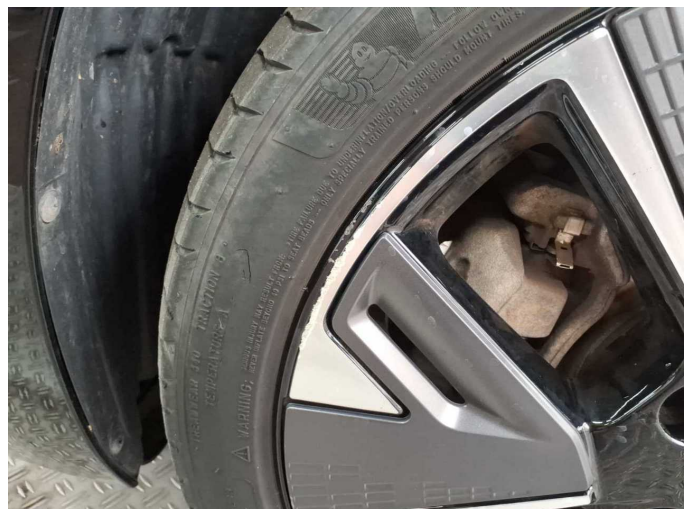
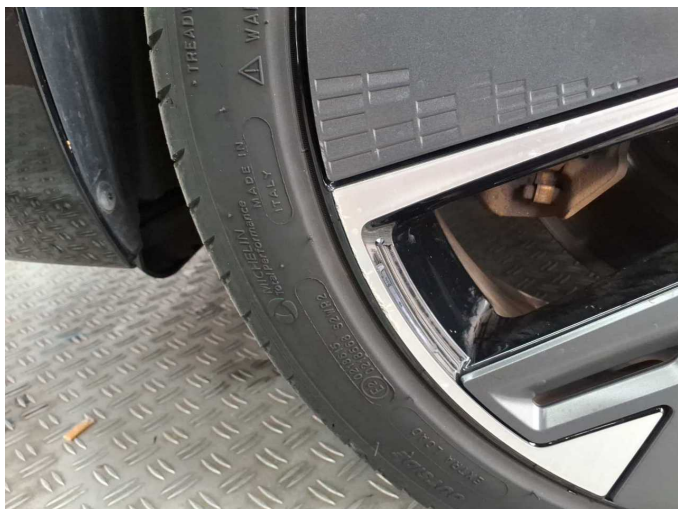
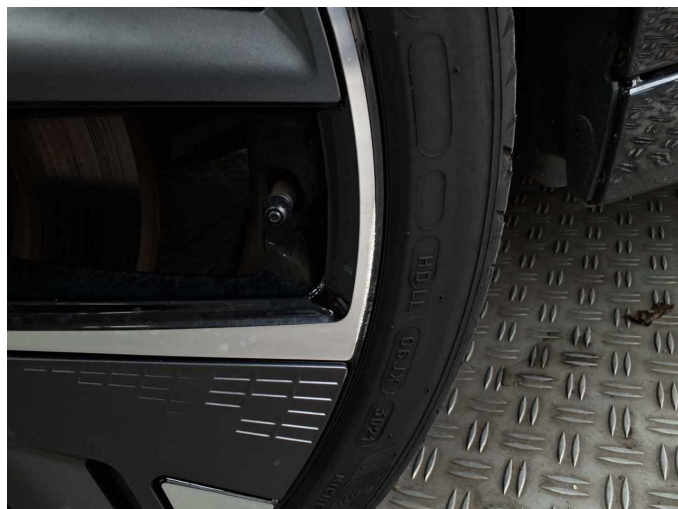
| No. | Component group | Description |
|---|---|---|
| 7 | Wheel / tyres | Alloy rim - front left side - Scratched - Replace |

**Damage 7:** Wheel / tyres: Alloy rim - front left side - Scratched - Replace

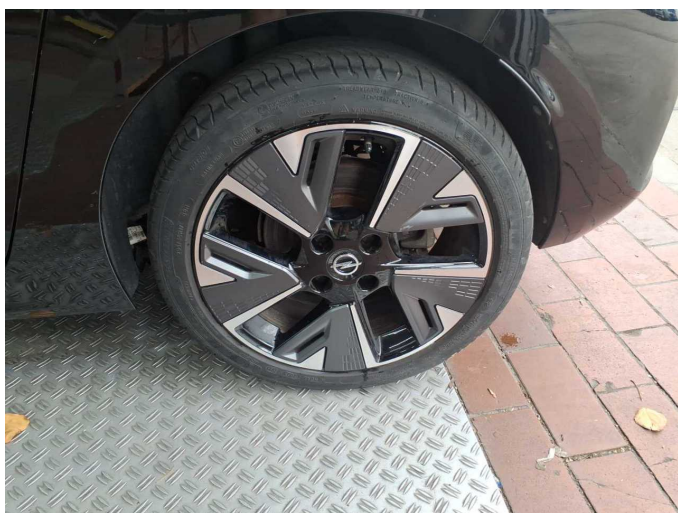
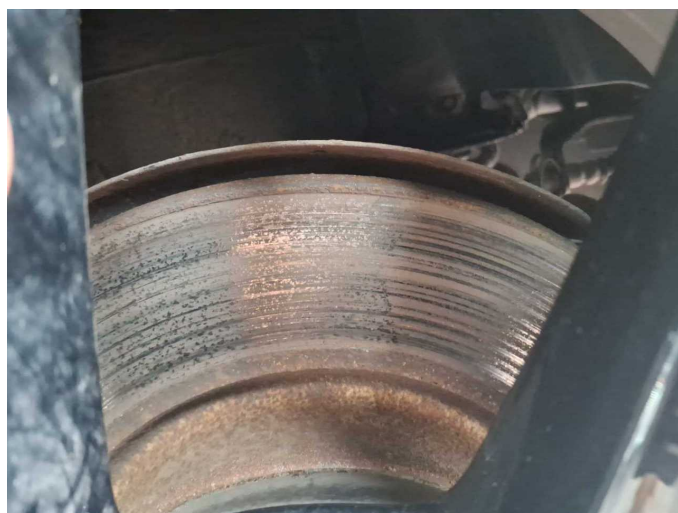
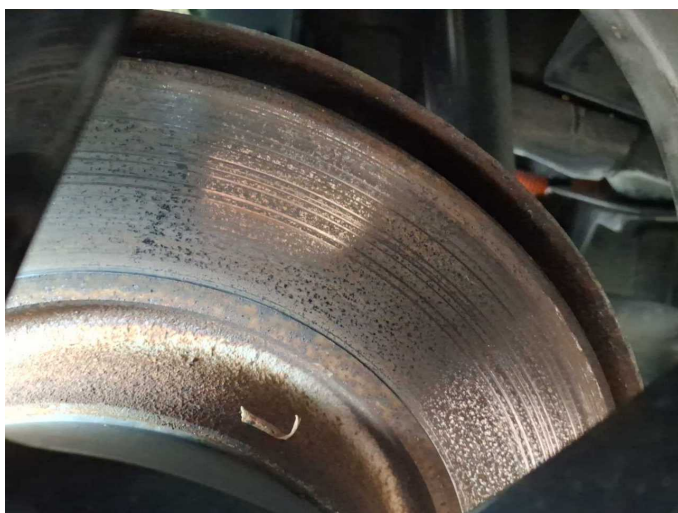
| No. | Component group | Description |
|---|---|---|
| 8 | Braking system | Brake discs and pads - rear (Tragbild mangelhaft. Riefen.) - Corrosion - Replace |

**Damage 8:** Braking system: Brake discs and pads - rear (Tragbild mangelhaft. Riefen.) - Corrosion - Replace

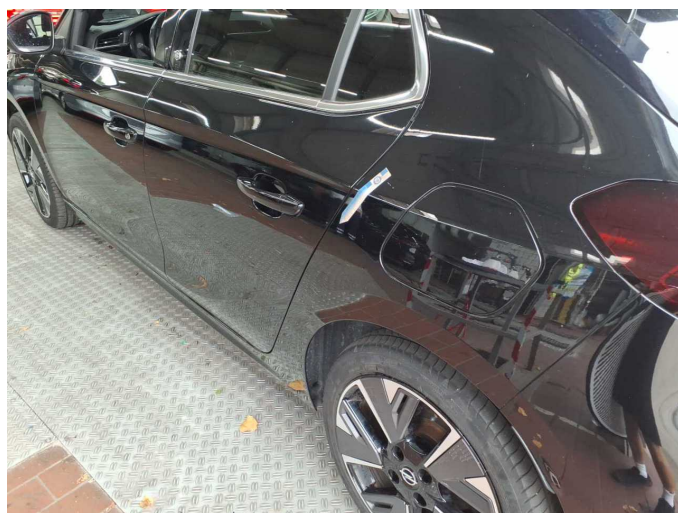
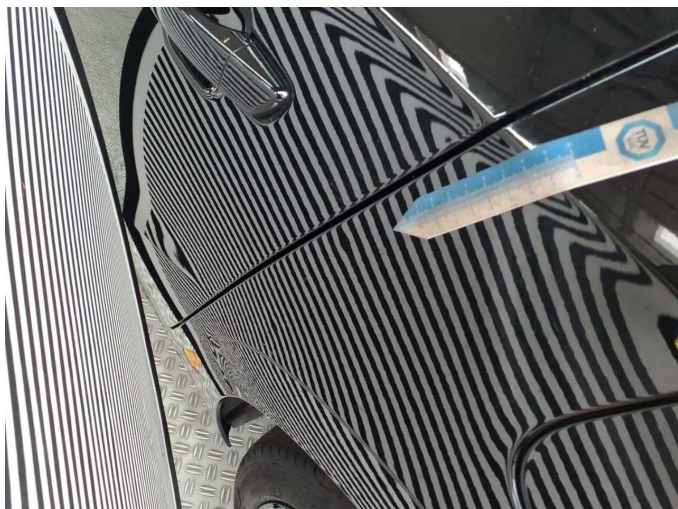
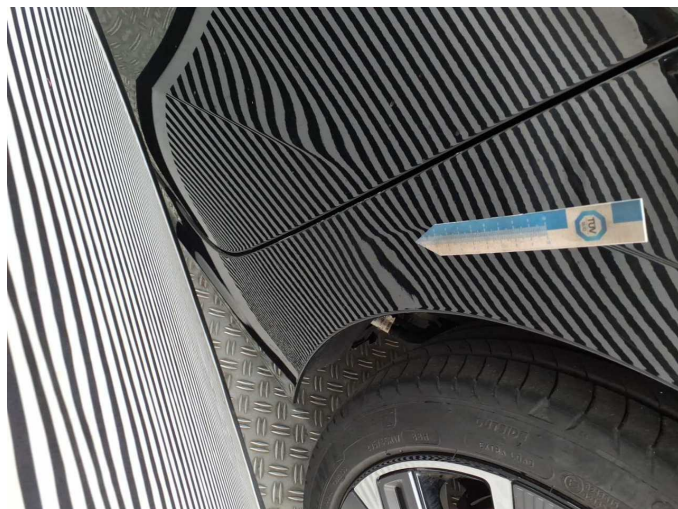
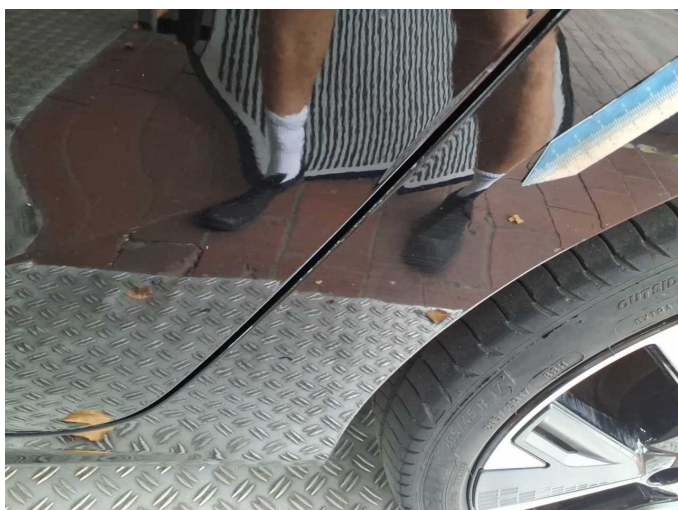
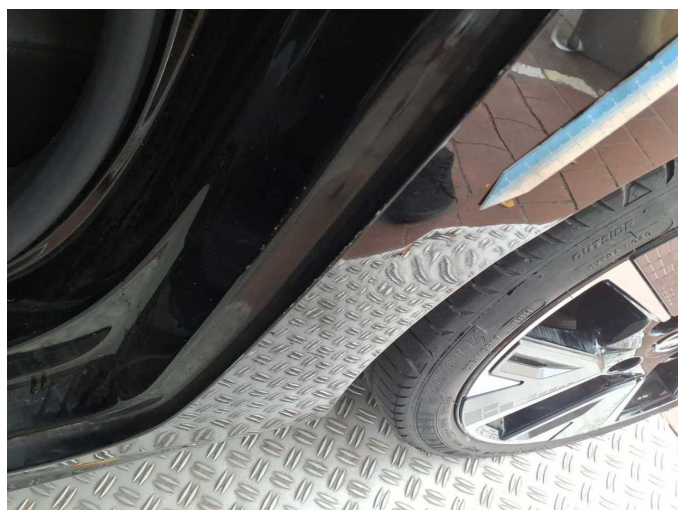
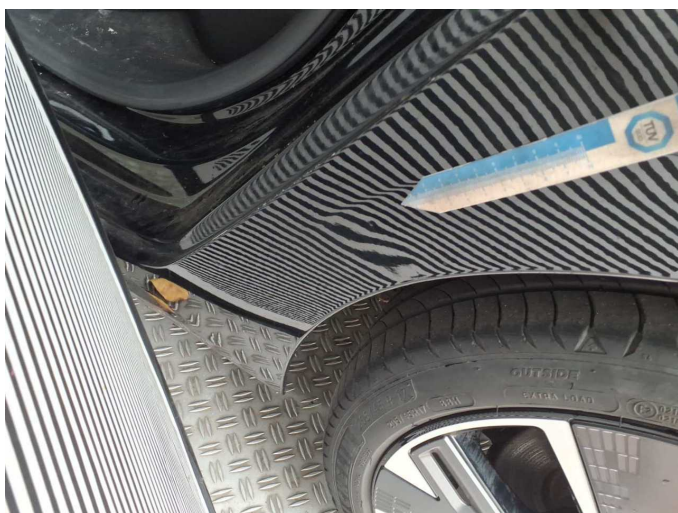
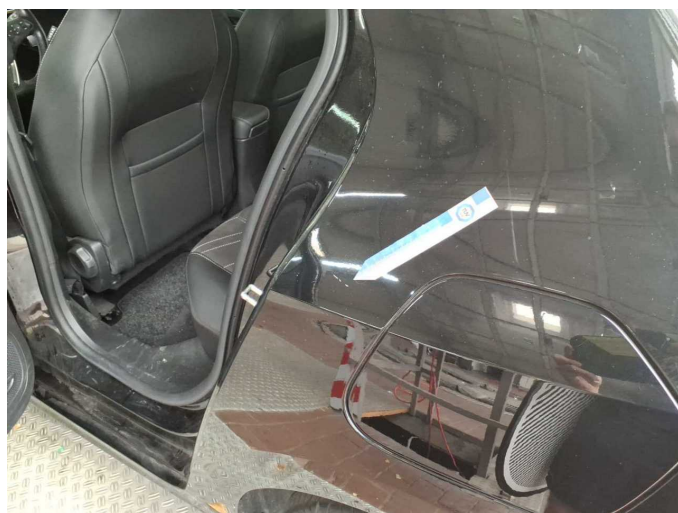
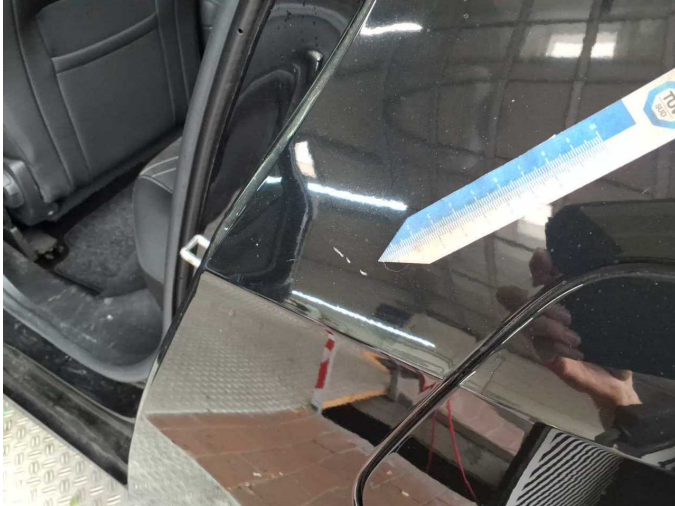
| No. | Component group | Description |
|---|---|---|
| 9 | Side panel - rear left side | Side panel (Unterhalb Kante.) - Dent / paintcoat damage - Repair and paint |

**Damage 9:** Side panel - rear left side: Side panel (Unterhalb Kante.) - Dent / paintcoat damage - Repair and paint

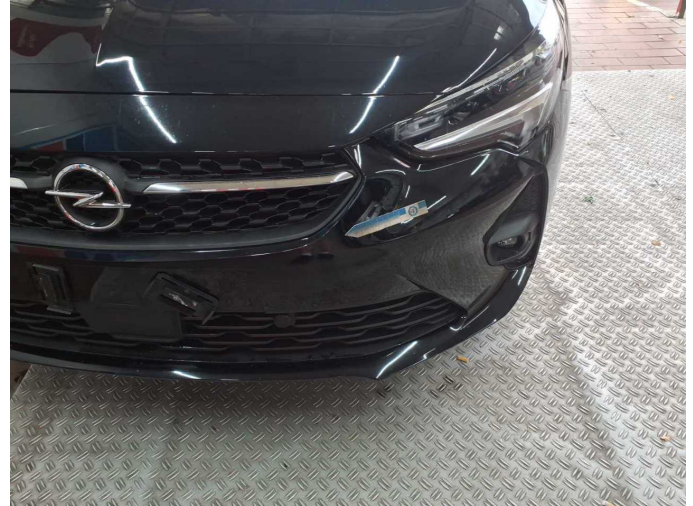
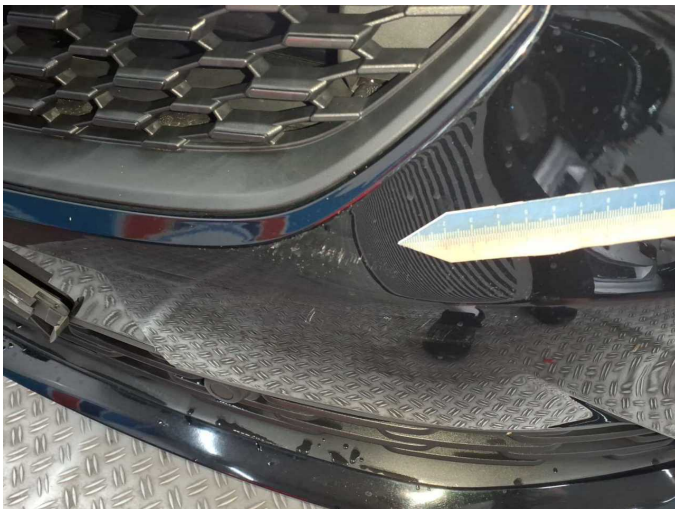
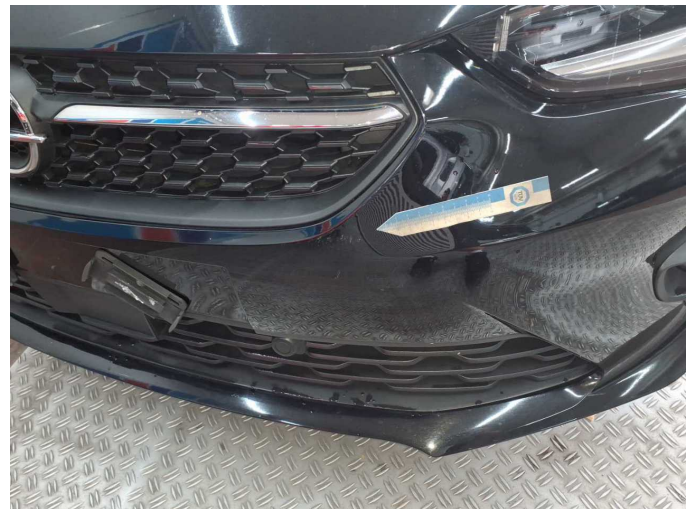
| No. | Component group | Description |
|---|---|---|
| 10 | Front bumper | Front bumper - Scratch(es) - Repair and paint |

**Damage 10:** Front bumper: Front bumper - Scratch(es) - Repair and paint
