Protocol number: 45576144
Order No. / Reference: 26116466
Inspection date: 11 May 2026

Manufacturer: Ford

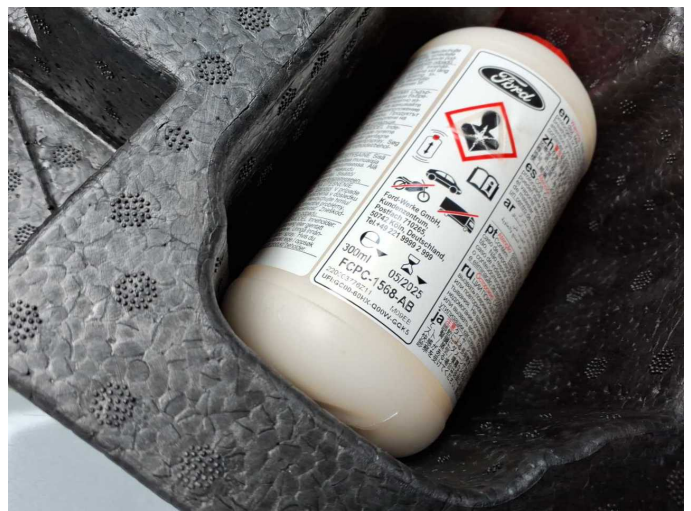
Damage 1: Equipment: Tirefit filler - Expired - Replace

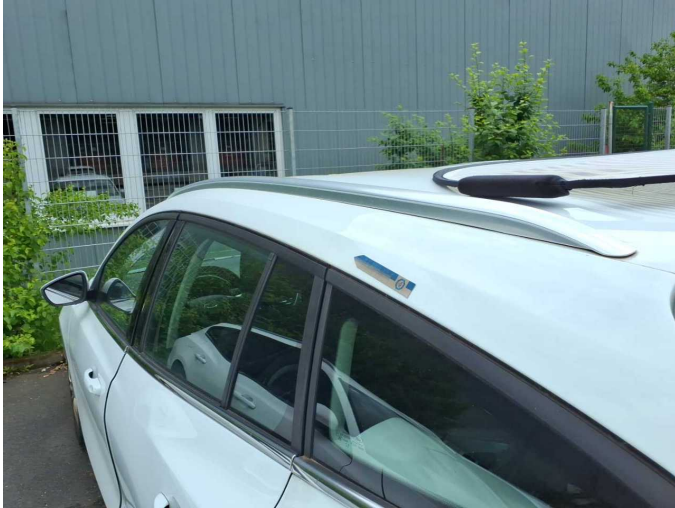
Damage 2: Roof: Roof rail - left side - dent(s) - Smooth repair work

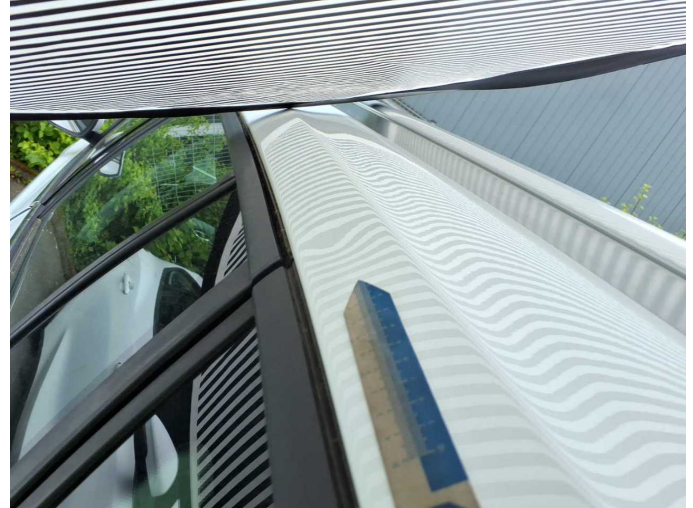
Damage 2: Roof: Roof rail - left side - dent(s) - Smooth repair work

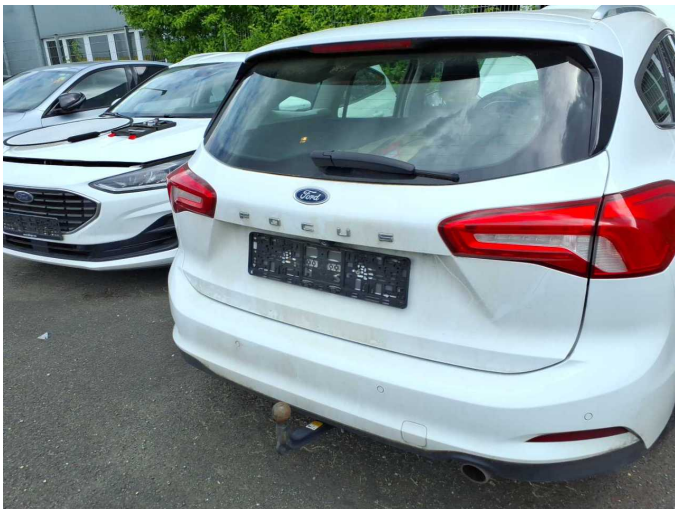
Damage 3: Boot lid / rear door: Boot lid (Lässt sich nichtöffnen) - Functional / admissibility - Perform diagnosis

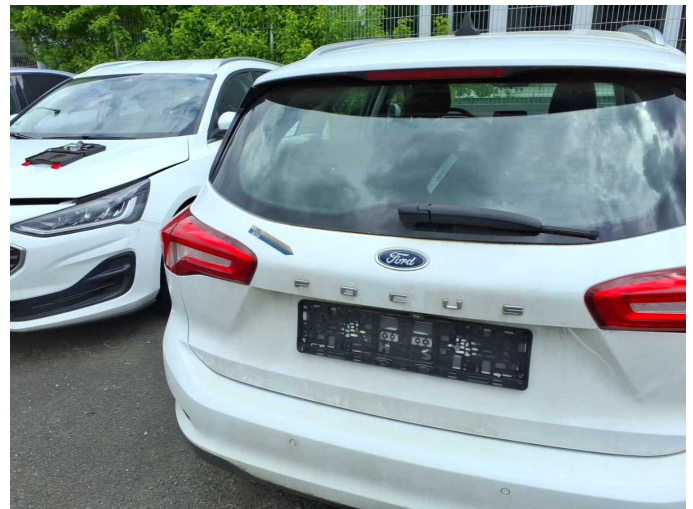
Damage 4: Boot lid / rear door: Boot lid - dent(s) - Smooth repair work

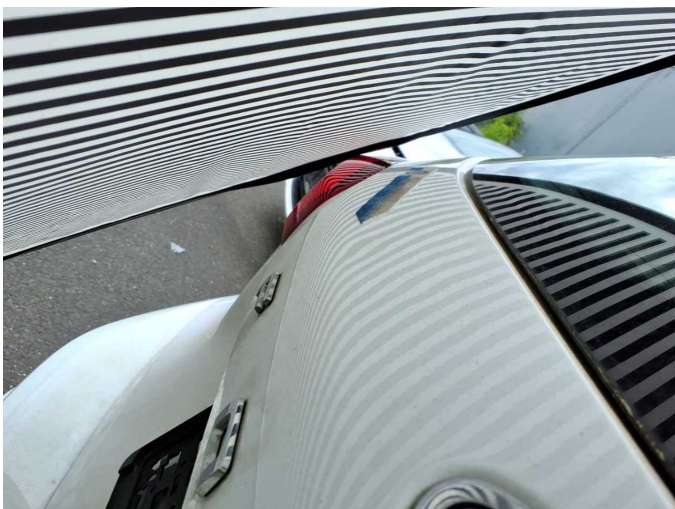
Damage 4: Boot lid / rear door: Boot lid - dent(s) - Smooth repair work

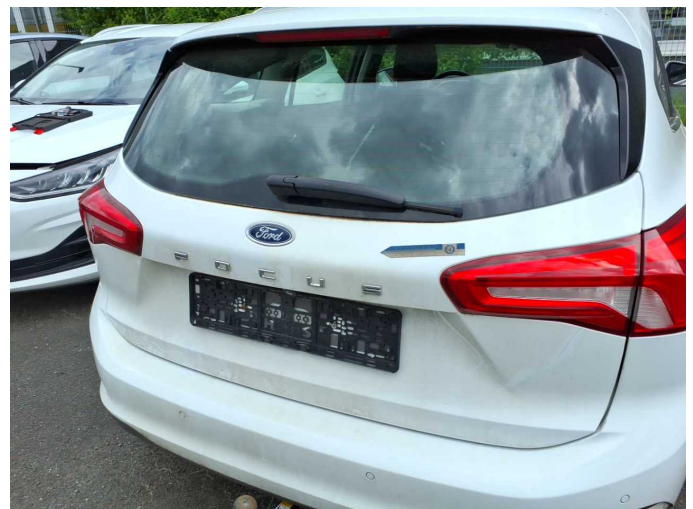
Damage 4: Boot lid / rear door: Boot lid - dent(s) - Smooth repair work

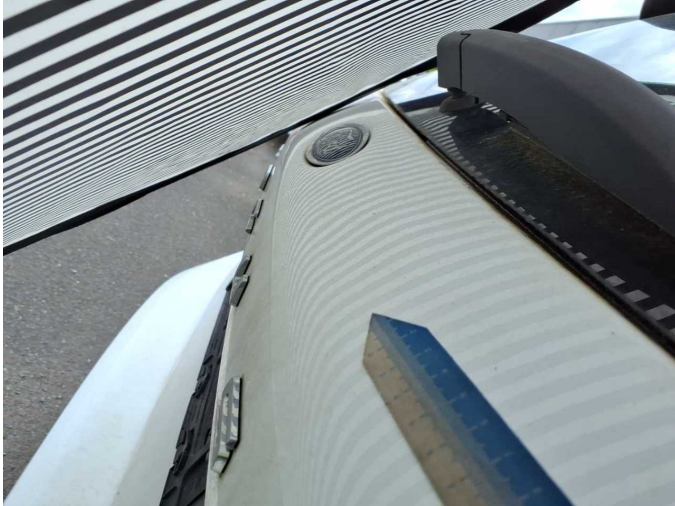
Damage 4: Boot lid / rear door: Boot lid - dent(s) - Smooth repair work

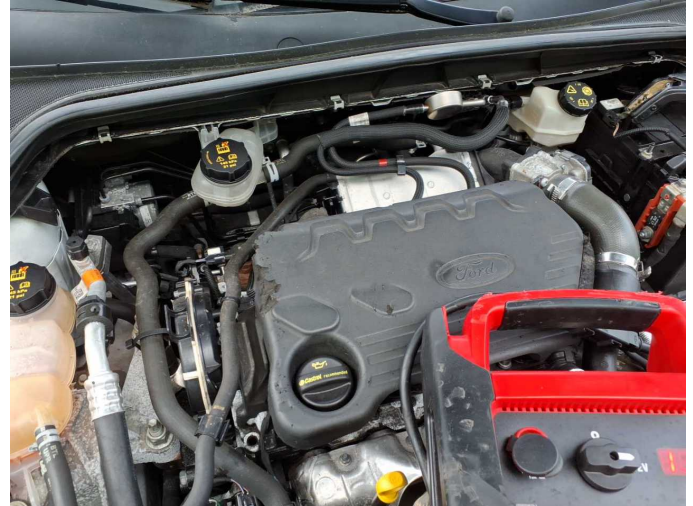
Damage 5: Engine: Engine cover - Damage caused by marten / rodent - Replace

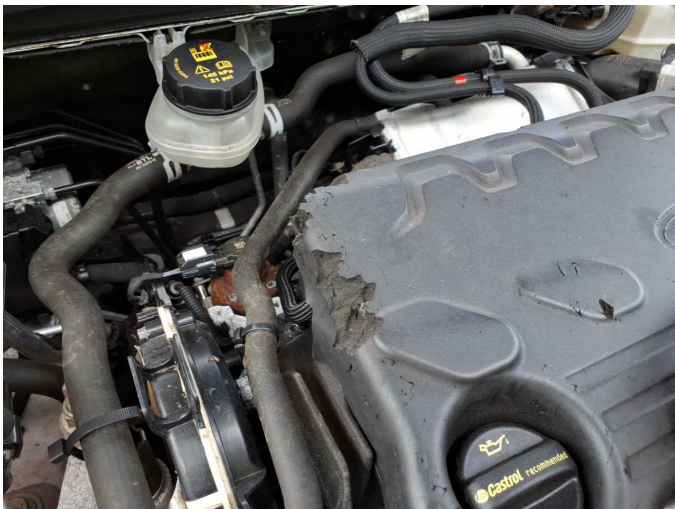
Damage 5: Engine: Engine cover - Damage caused by marten / rodent - Replace

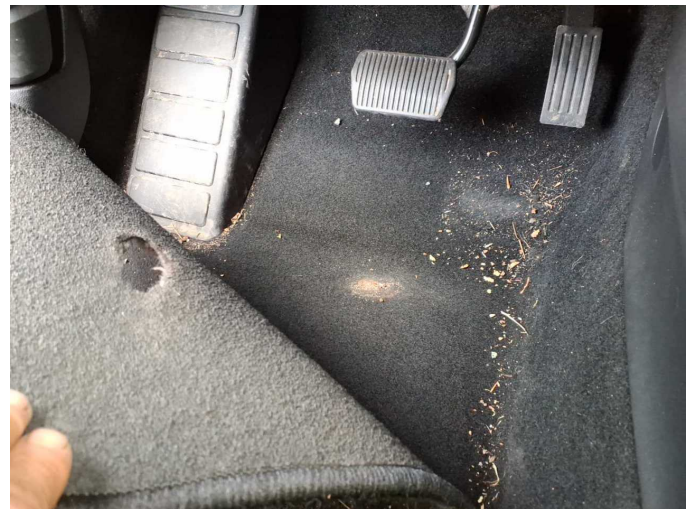
Damage 6: Trim / covers: Floor covering - front left side - Broken / torn - Smart repair

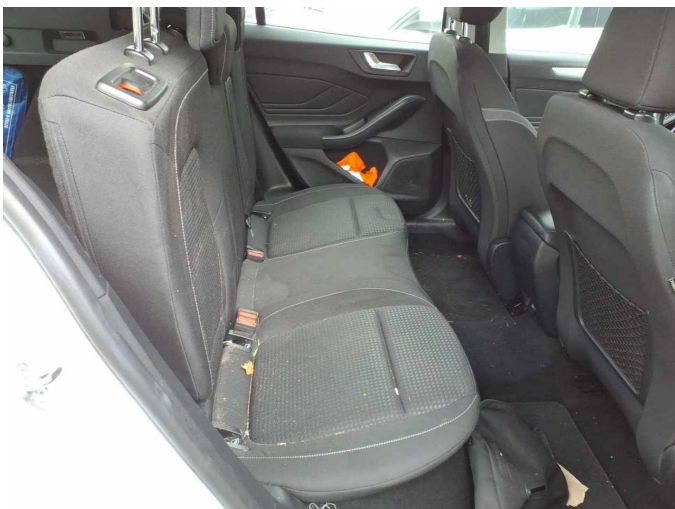
Damage 7: Interior: Interior - Soiled - Clean

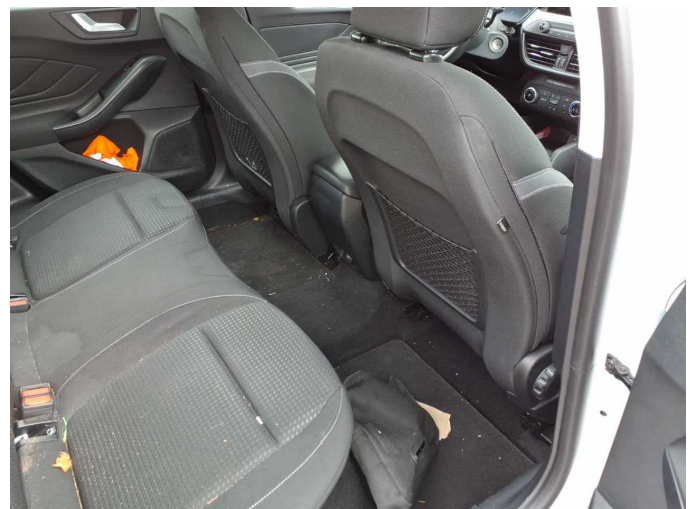
Damage 7: Interior: Interior - Soiled - Clean

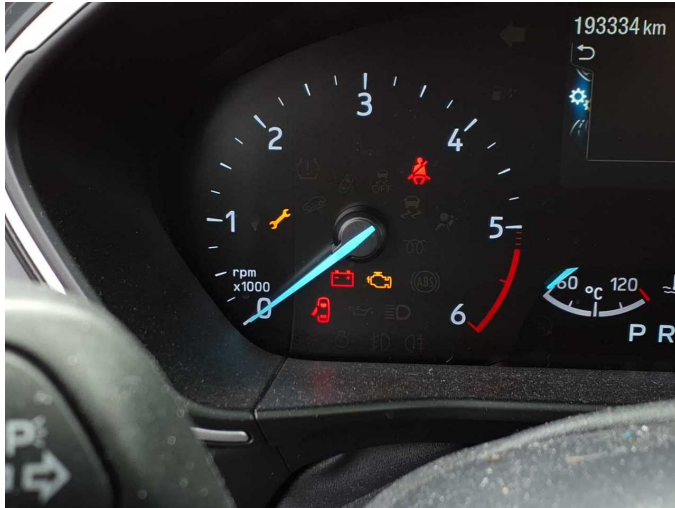
Damage 8: Engine: Engine (Startet auch mit Booster nicht) - Functional / admissibility - Perform diagnosis

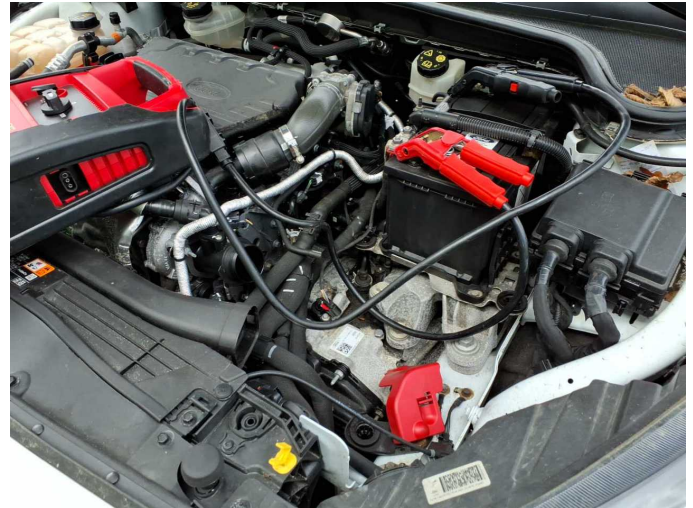
Damage 8: Engine: Engine (Startet auch mit Booster nicht) - Functional / admissibility - Perform diagnosis

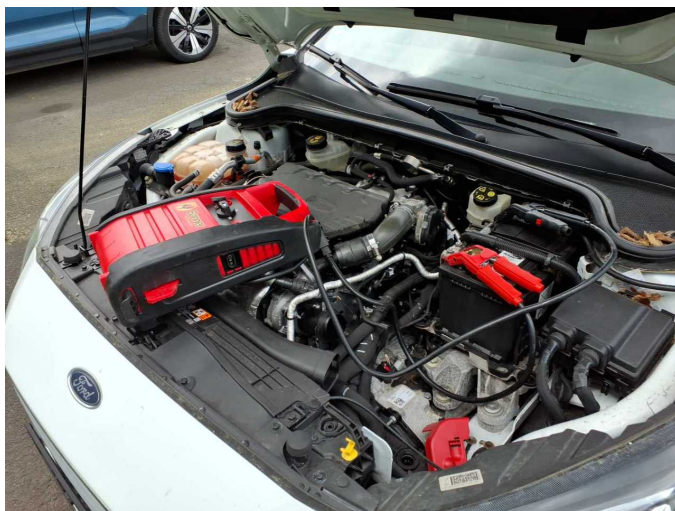
Damage 8: Engine: Engine (Startet auch mit Booster nicht) - Functional / admissibility - Perform diagnosis

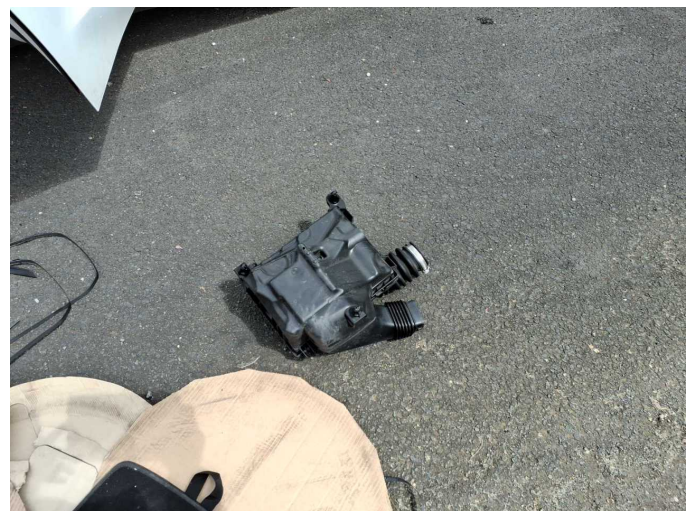
Damage 8: Engine: Engine (Startet auch mit Booster nicht) - Functional / admissibility - Perform diagnosis

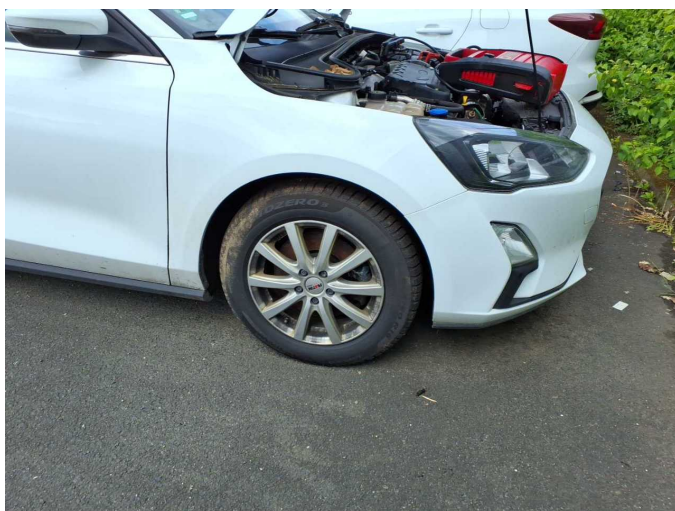
Damage 9: Braking system: Brake discs and brake pads - front - Corrosion - Replace

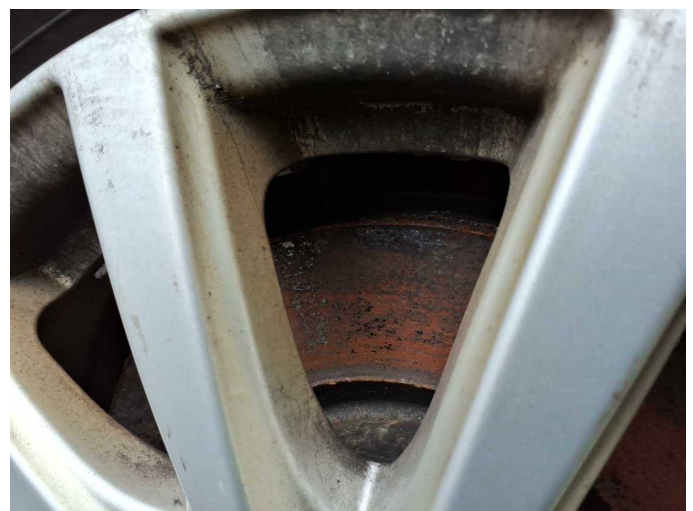
Damage 9: Braking system: Brake discs and brake pads - front - Corrosion - Replace

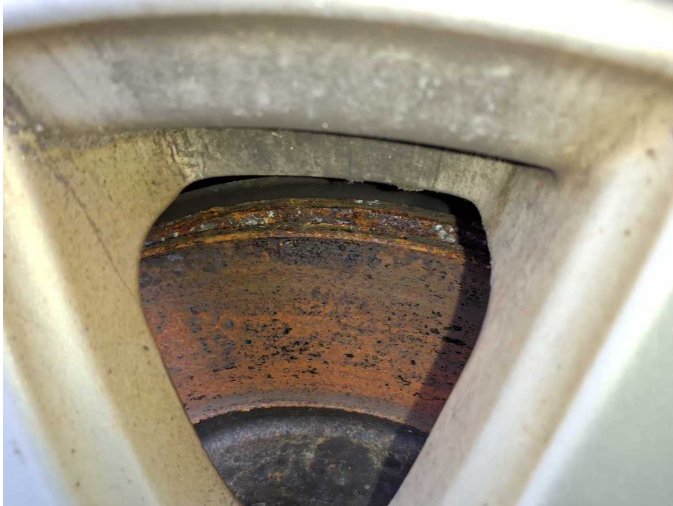
Damage 9: Braking system: Brake discs and brake pads - front - Corrosion - Replace

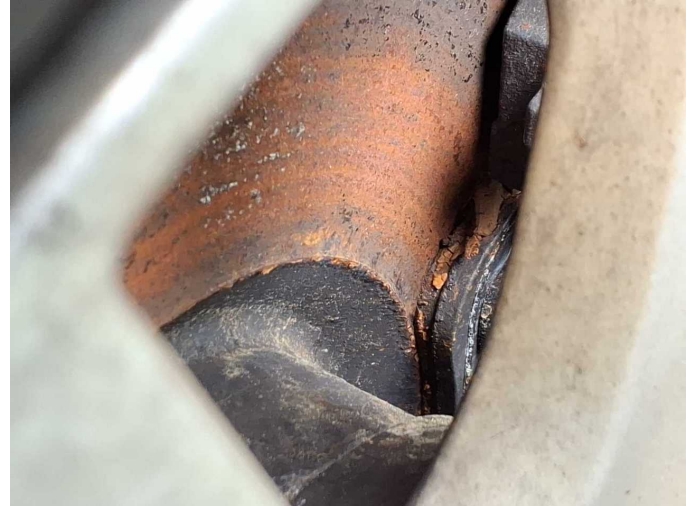
Damage 9: Braking system: Brake discs and brake pads - front - Corrosion - Replace

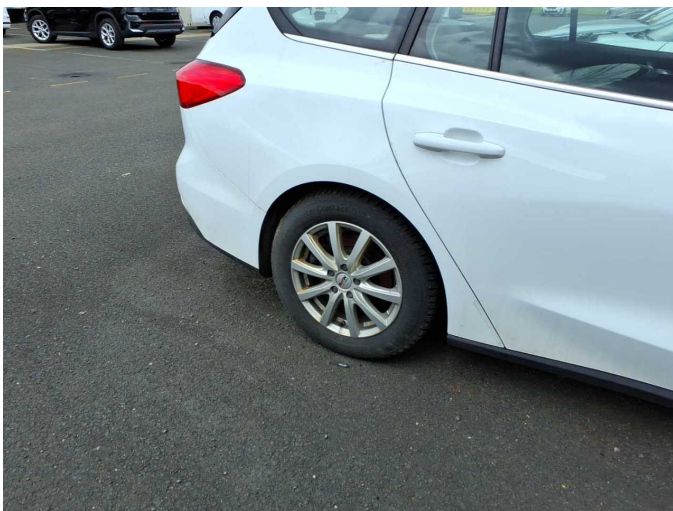
Damage 10: Braking system: Brake discs and pads - rear - Corrosion - Replace

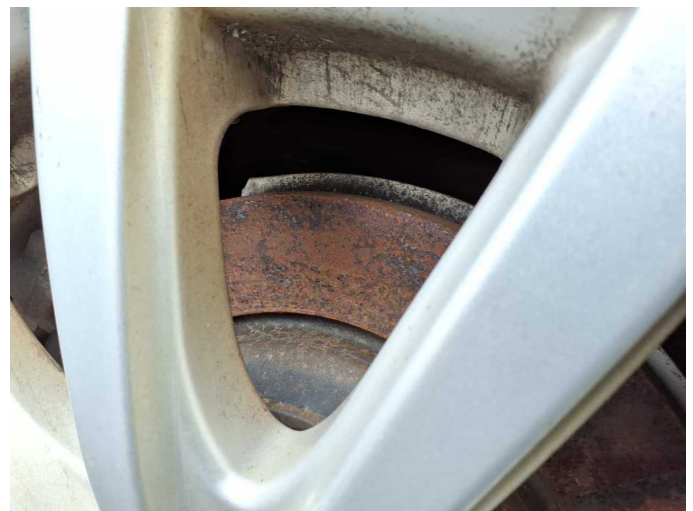
Damage 10: Braking system: Brake discs and pads - rear - Corrosion - Replace

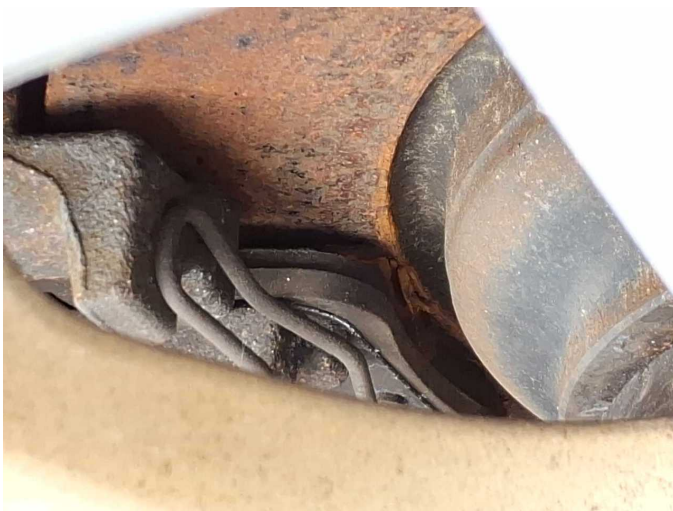
Damage 10: Braking system: Brake discs and pads - rear - Corrosion - Replace

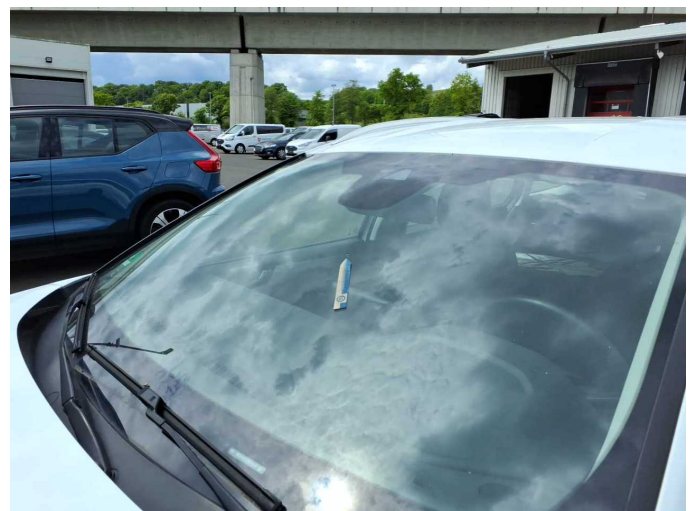
Damage 11: Vehicle glazing: Windscreen (Rissbildung, kein Staubschutz) - Stone chips - repair according to calculation

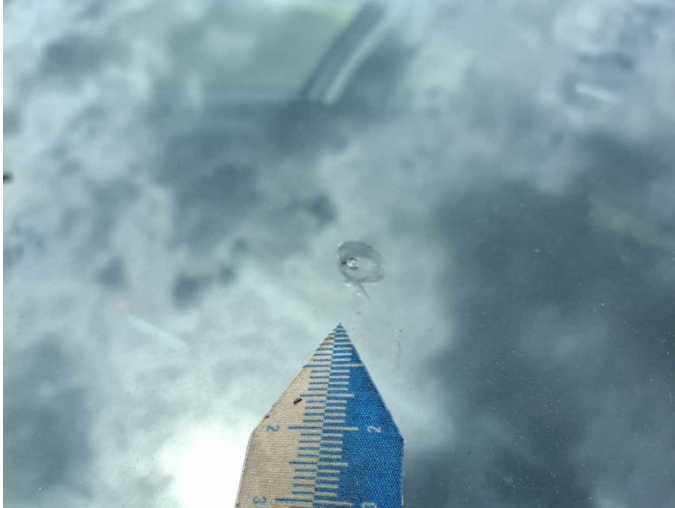
Damage 11: Vehicle glazing: Windscreen (Rissbildung, keinStaubschutz)
- Stone chips - repair according to calculation

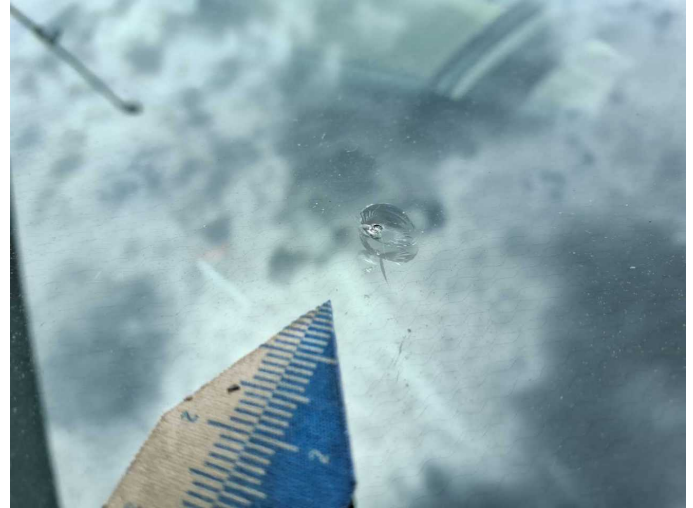
Damage 11: Vehicle glazing: Windscreen (Rissbildung, keinStaubschutz)
- Stone chips - repair according to calculation

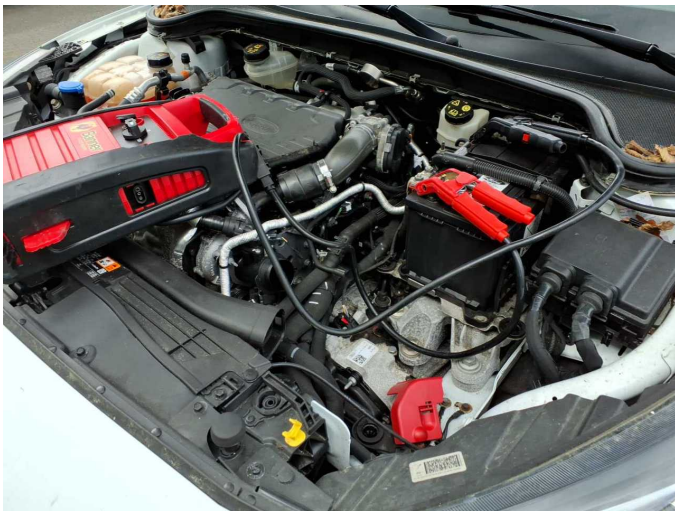
Damage 12: Gearbox: Gearbox - Non-operational - repair according to calculation

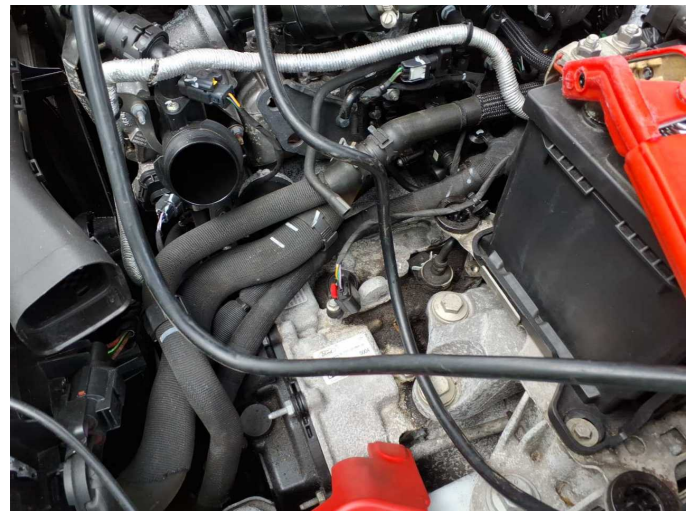
Damage 12: Gearbox: Gearbox - Non-operational - repair according to calculation

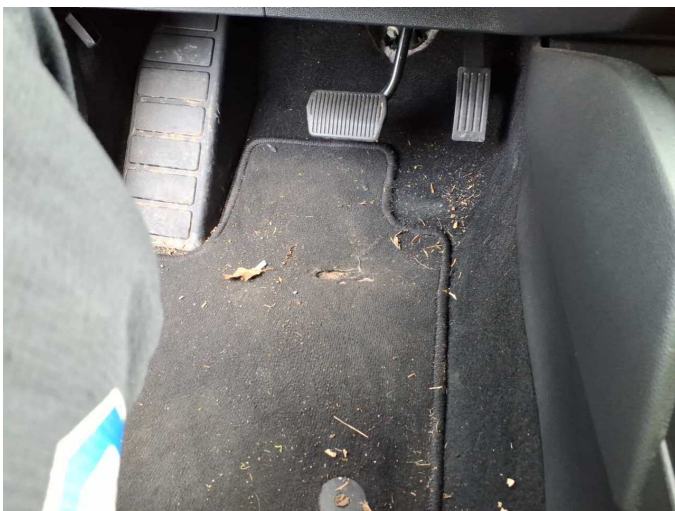
Wear and tear 2: Trim / covers: Floor mats - Broken / torn - No deduction

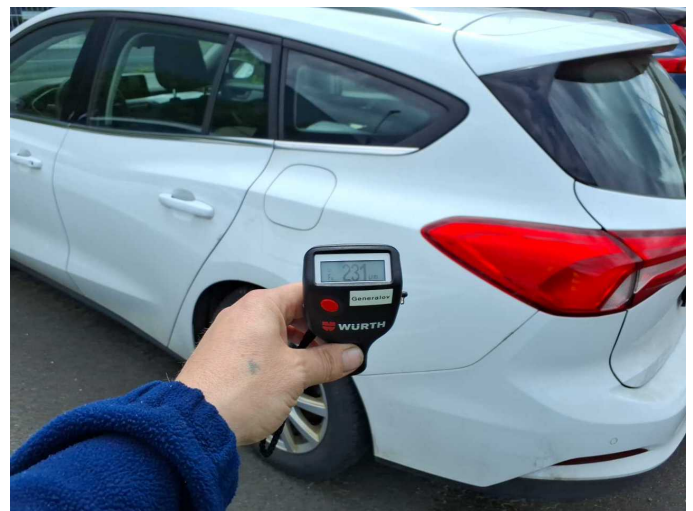
Repainting 1: Side panel - rear left side
