Expertise

Protocol number: 45803345
Order No. / Reference: 26310580
Inspection date: 8 Jun 2026

Manufacturer: Opel

Model: Astra Sports Tourer 1.2 Turbo Automatik GS Aut.

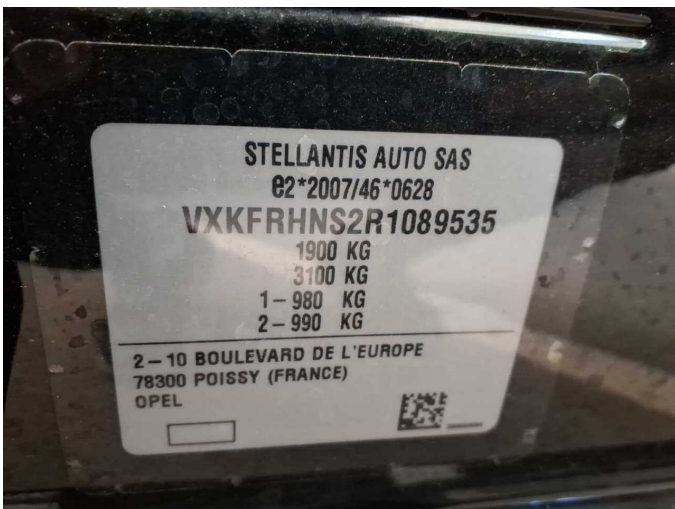
Figure 11: VIN

Documents submitted	At the time of the inspection, the vehicle registration certificate Part 2 (title) was available, but the vehicle registration certificate Part 1 (document) was not. (Copy)
VIN comparison	The vehicle identification number (VIN) was read from the vehicle and its conformity with the submitted documents was confirmed by the undersigned during the inspection.
Inspection	The inspection conditions were sufficient for the assessment of the vehicle. No lifting equipment or pit was available for inspecting the vehicle. Therefore, inspection of the vehicle's underside was only possible to a limited extent.
Test drive	No test drive/shunting maneuver was carried out during the inspection of the vehicle.
Engine function test	An engine test run was performed.
readiness to drive	The vehicle was roadworthy at the time of inspection.

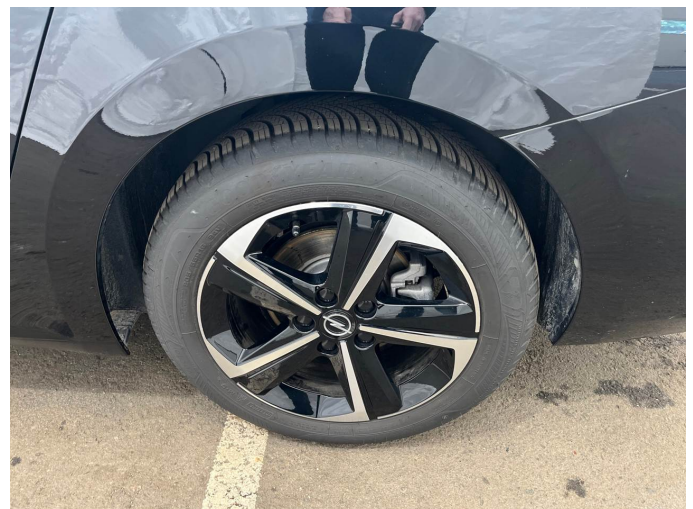
Figure 12: Mounted tyres

#	Tyre size	Type of tyre	Manufacturer	Tread depth
1)	205/55 R16 94V	All-season tyres on Light alloy	Goodyear	6mm / 6mm
2)	205/55 R16 94V	All-season tyres on Light alloy	Goodyear	6mm / 6mm

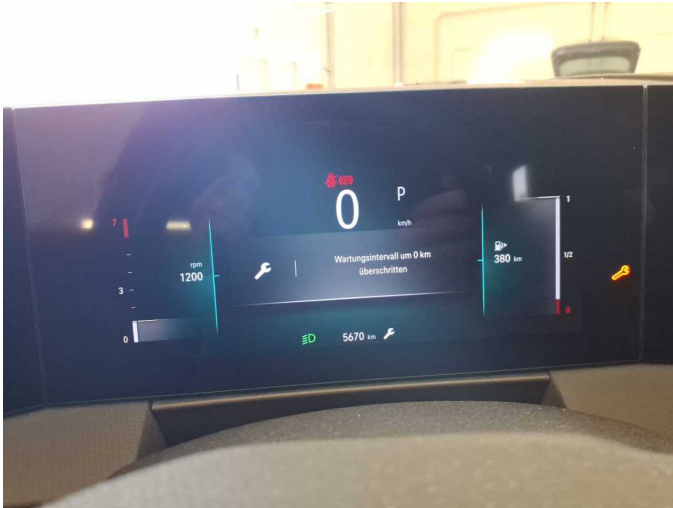
Figure 13: Documents

Maintenance booklet / proof	digital evidence / incomplete	Next maintenance in	0 km
Key is / should be	2 / 2	FZG documents	ZB#2 (B) was available (copy), ZB#1 (S) was not available.
		Letter No.	HG563648
Previous damage / Accident	None detectable	Repainting	None detectable
Inspection conditions	sufficient	Lifting equipment / pit	No
Test drive	Not performed	Engine function test	Performed
readiness to drive	Roadworthy		
Manufacturer key number/ type code number	2525 / ACA 00068		
Emission standard	EURO6;WLTP;EA;PI/CI;M, N1, N2	fine dust sticker	
Permitted total weight	1,900 kg	Empty weight

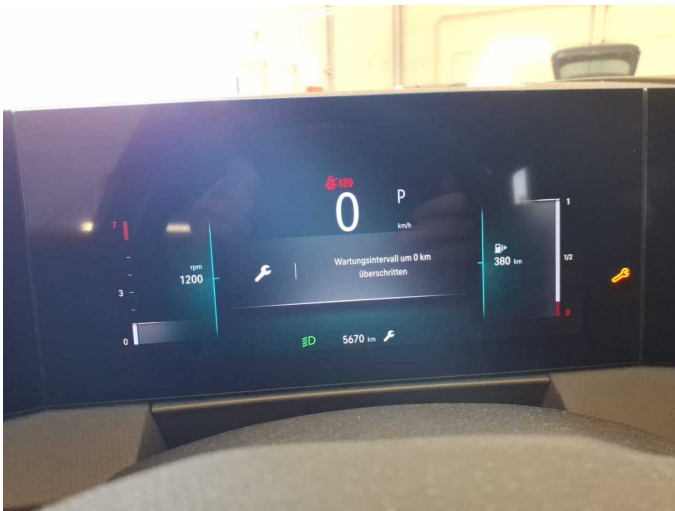
Damage 1: Misc.: Inspection / maintenance - Due - Perform
