Expertise

Protocol number: 46310181
Order No. / Reference: 26501539
Inspection date: 29 Jun 2026

Manufacturer: Ford

Model: Transit Connect 250 L2 Trend

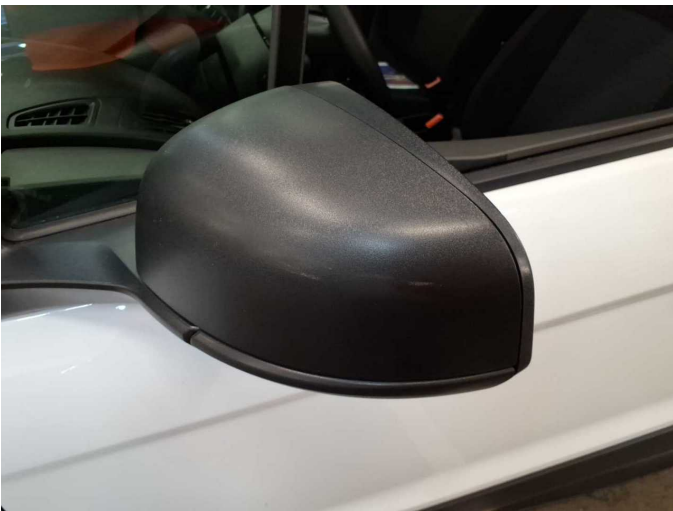
Damage 2: Wing mirror - left side: Cap - Scratch(es) - Loss in value

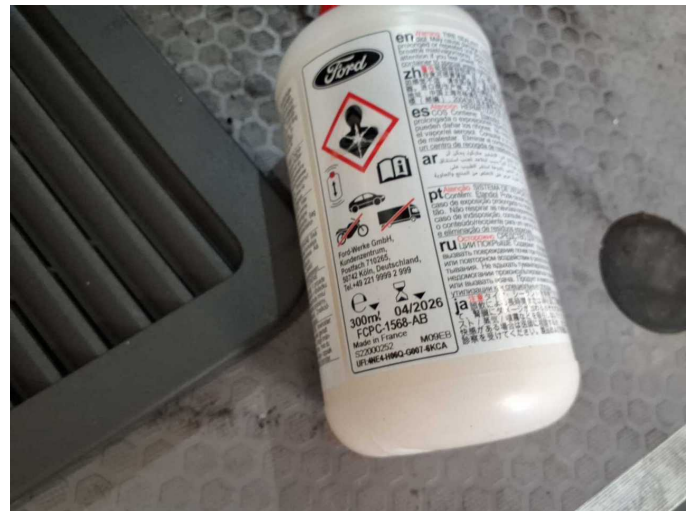
Damage 3: Equipment: Tirefit filler - Expired - Replace

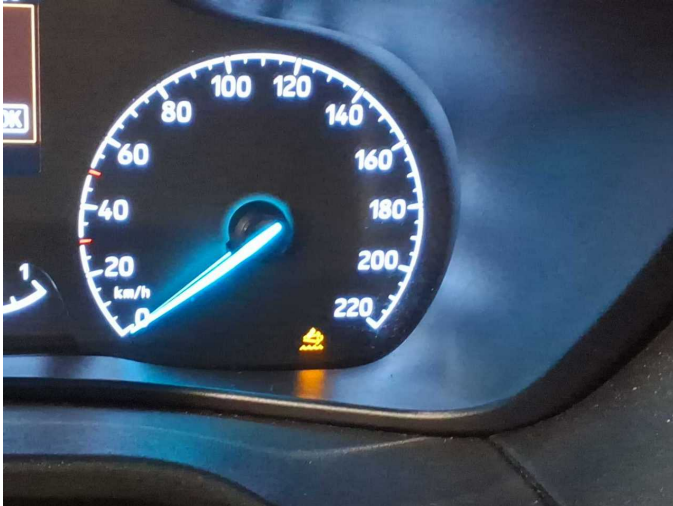
Damage 5: Instrument panel: Indicator light (Ad Blue prüfen) - on - Perform diagnosis

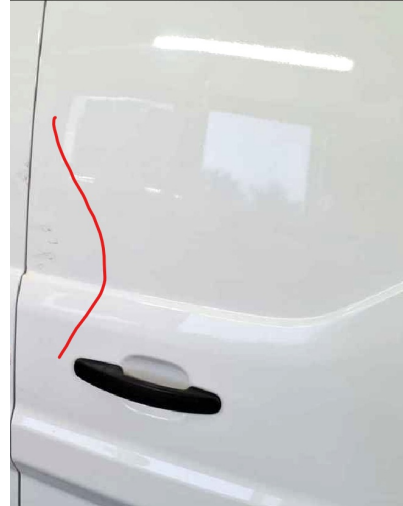
Damage 6: Boot lid / rear door: Rear door - right side - Scratch(es) - Paint

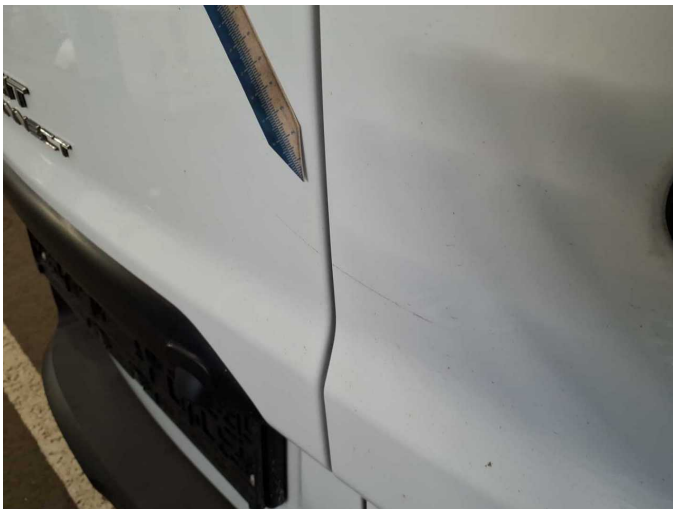
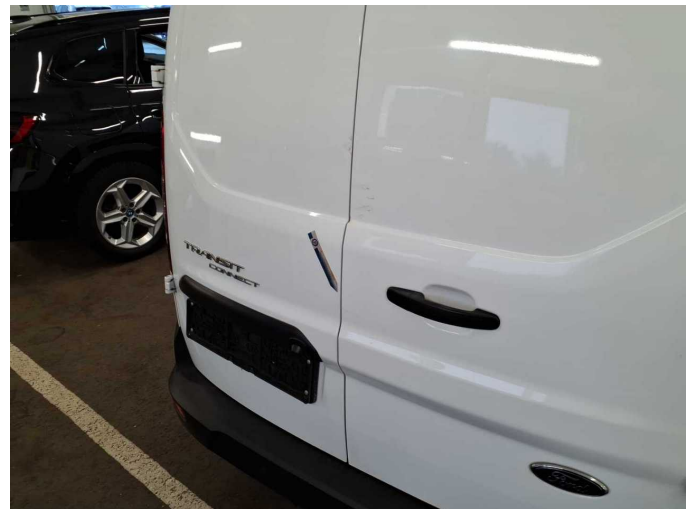
Damage 7: Boot lid / rear door: Rear door - left side - Scratch(es) - Paint

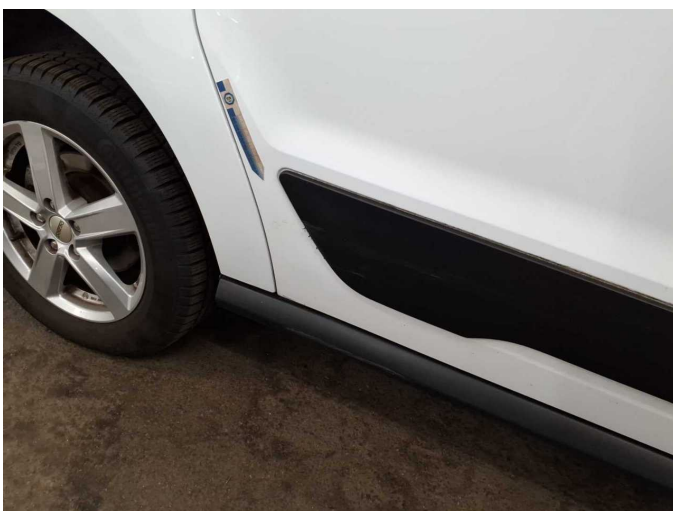
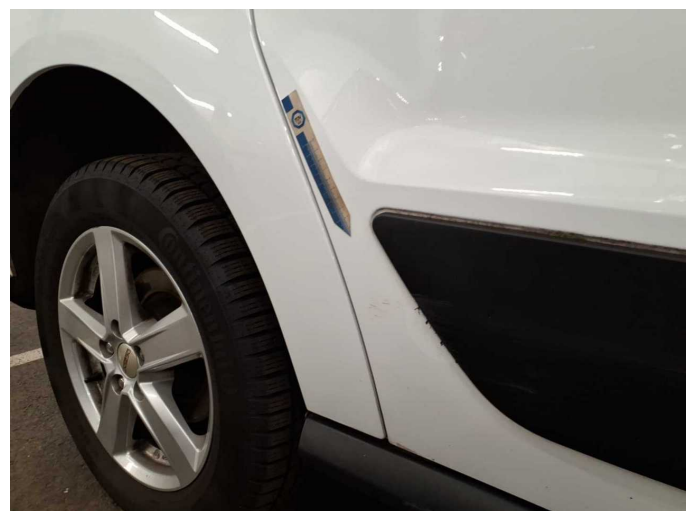
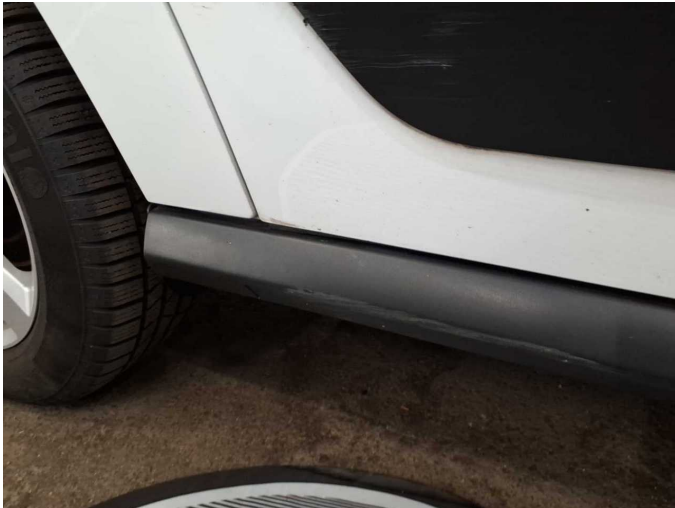
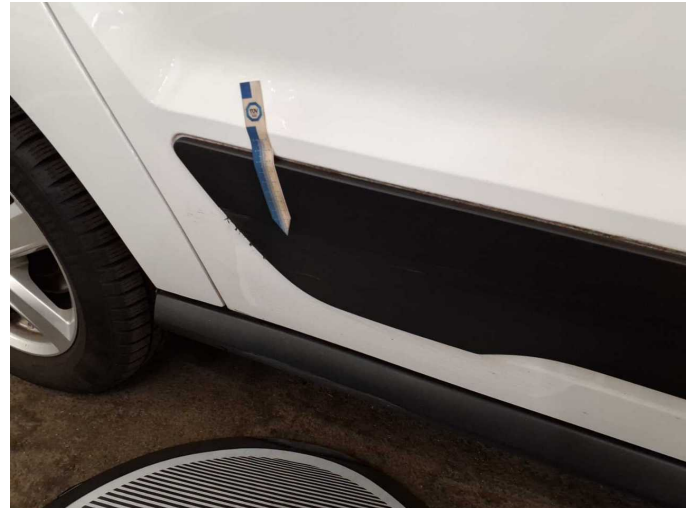
Damage 8: Sliding door, right: Sliding door (+Leiste erneuern) - Dent / paintcoat damage - Repair and paint

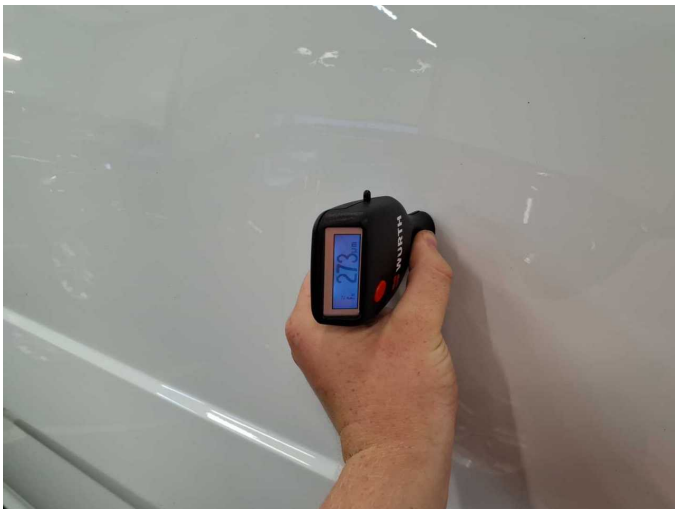
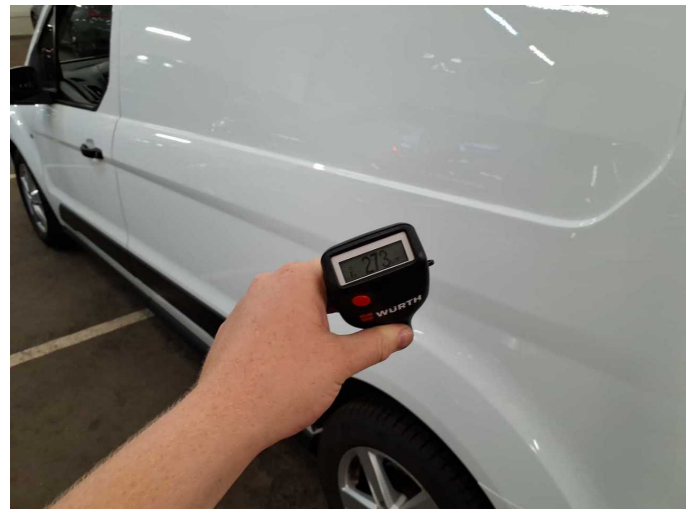
Side panel - rear left side	273 µm	Side panel - rear right side	210 µm
-----------------------------	--------	------------------------------	--------

Repainting 1: Side panel - rear left side

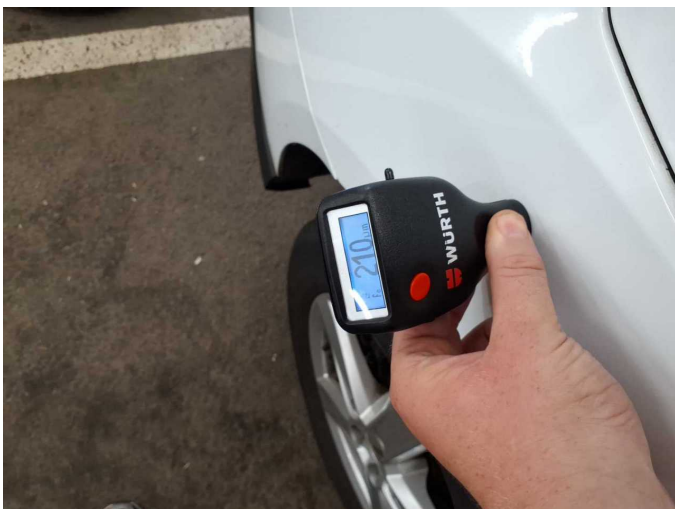
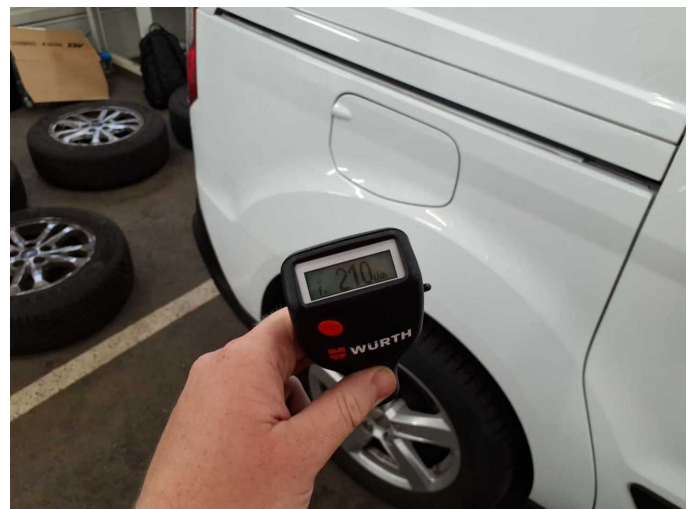
Repainting 2: Side panel - rear right side
