Expertise

Protocol number: 46237851  
Order No. / Reference: 26479218  
Inspection date: 30 Jun 2026

Manufacturer: Ford

Model: Transit Connect 220 L1 Autm. Trend

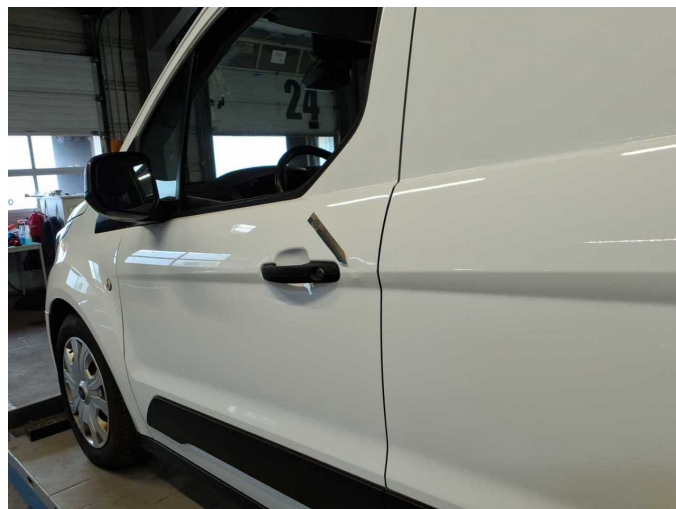
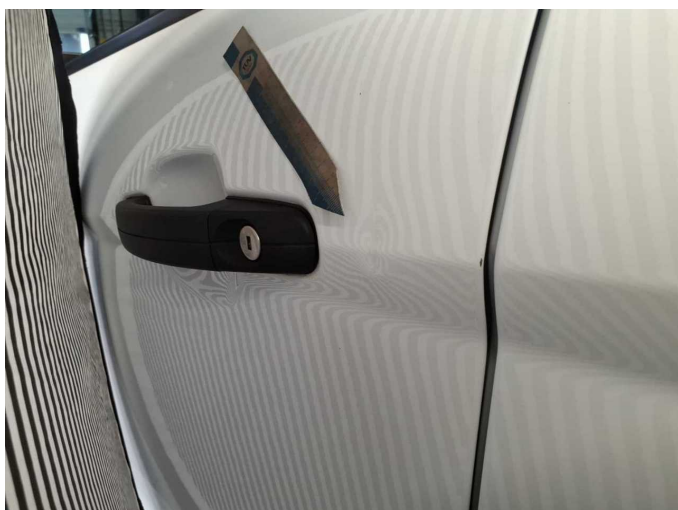
| No. | Component group | Description |
|---|---|---|
| 1 | Door - front left side | Door - dent(s) - Smooth repair work |

**Damage 1:** Door - front left side: Door - dent(s) - Smooth repair work

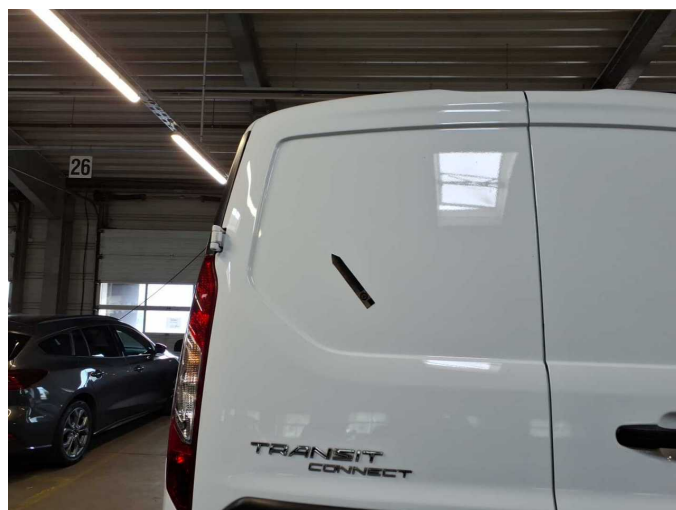
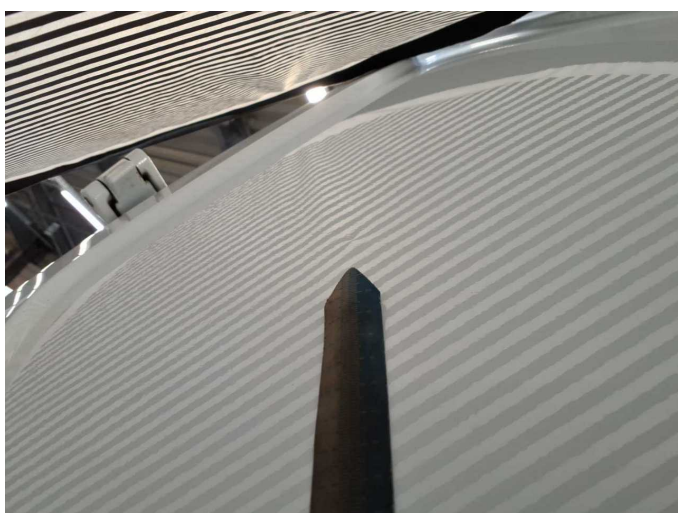
| No. | Component group | Description |
|---|---|---|
| 2 | Boot lid / rear door | Rear door - left side - dent(s) - Smooth repair work |

**Damage 2:** Boot lid / rear door: Rear door - left side - dent(s) - Smooth repair work

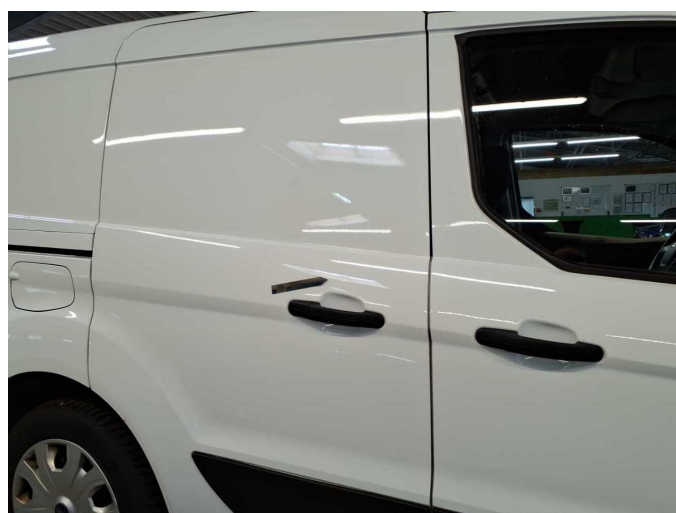
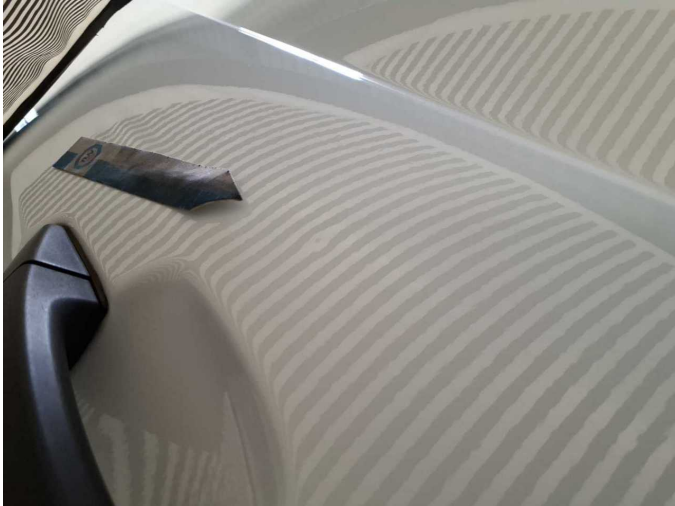
| No. | Component group | Description |
|---|---|---|
| 3 | Sliding door, right | Sliding door - dent(s) - Smooth repair work |

**Damage 3:** Sliding door, right: Sliding door - dent(s) - Smooth repair work

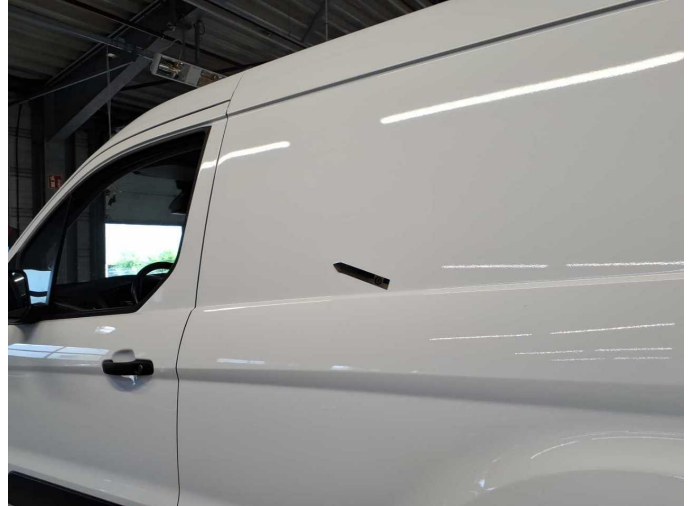
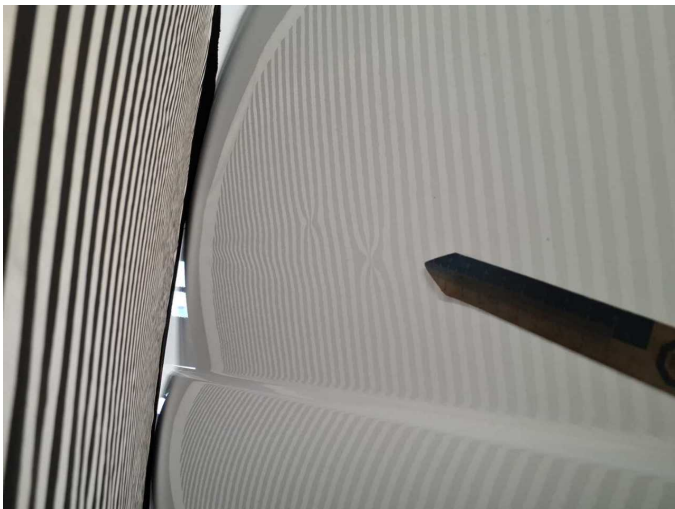
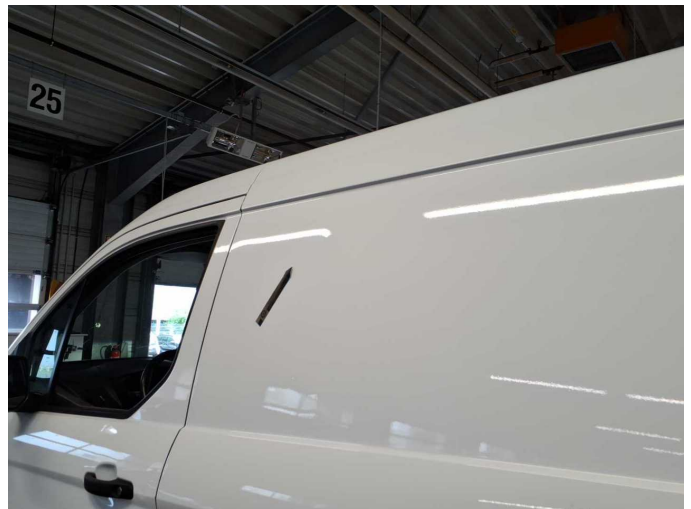
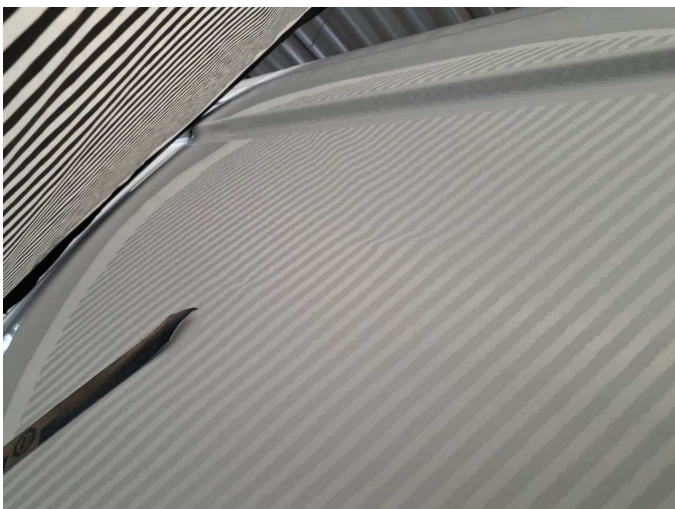
| No. | Component group | Description |
|---|---|---|
| 5 | Side panel - rear left side | Side panel - dent(s) - Smooth repair work |

**Damage 5:** Side panel - rear left side: Side panel - dent(s) - Smooth repair work

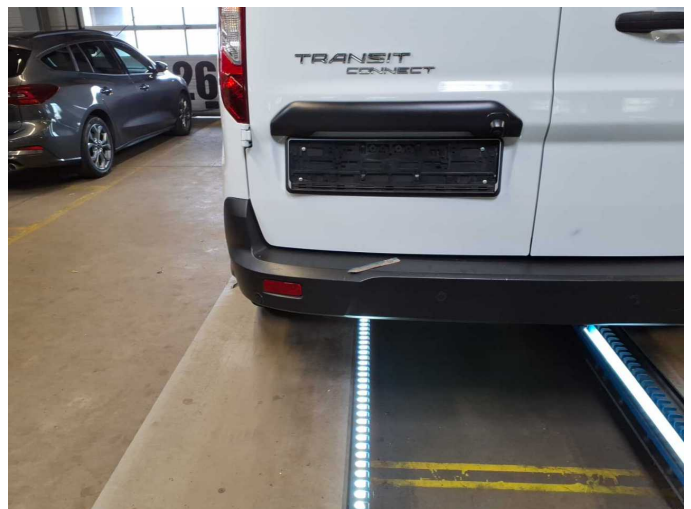
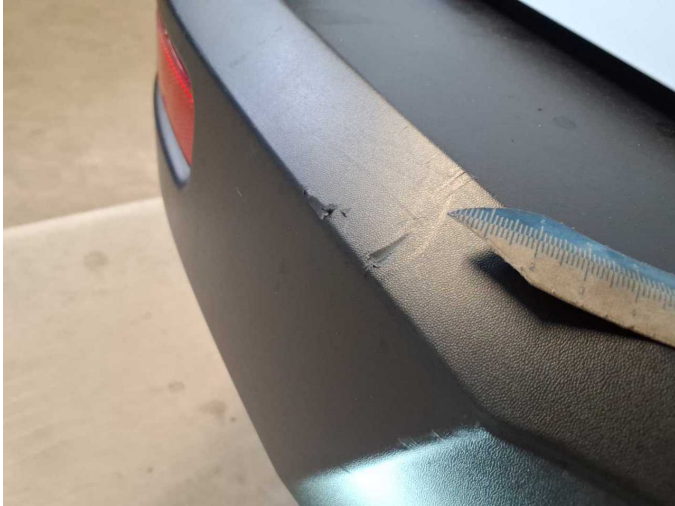
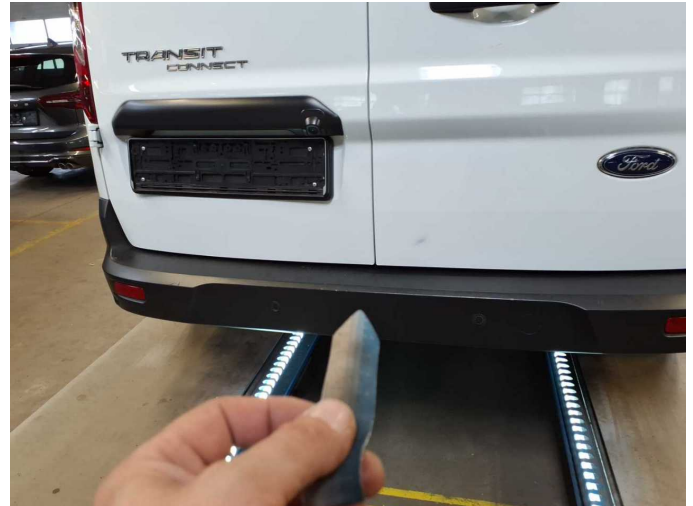
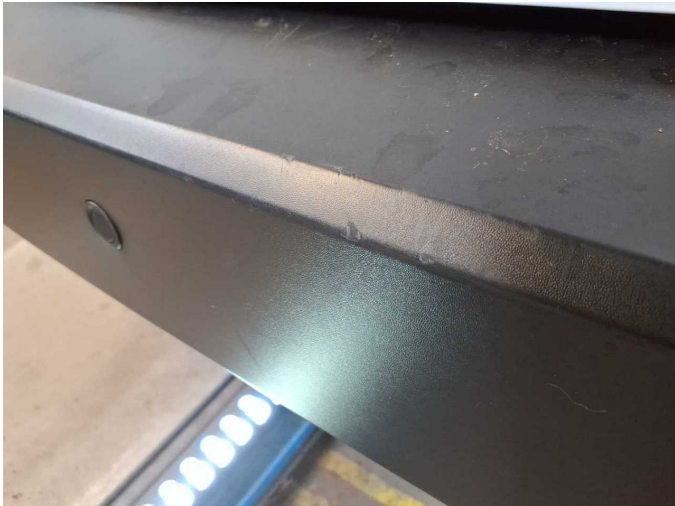
| No. | Component group | Description |
|---|---|---|
| 6 | Rear bumper | Rear bumper (unpainted) (Materialabtrag) - Scratch(es) - Replace |

**Damage 6:** Rear bumper: Rear bumper (unpainted) (Materialabtrag) - Scratch(es) - Replace
