## Expertise

Protocol number: 46349289  
Order No. / Reference: 26185535  
Inspection date: 30 Jun 2026

Model: 319 CDI Sprinter Standard HA 9G-TRONIC PRO

VIN: W1V3MBTZXP849547

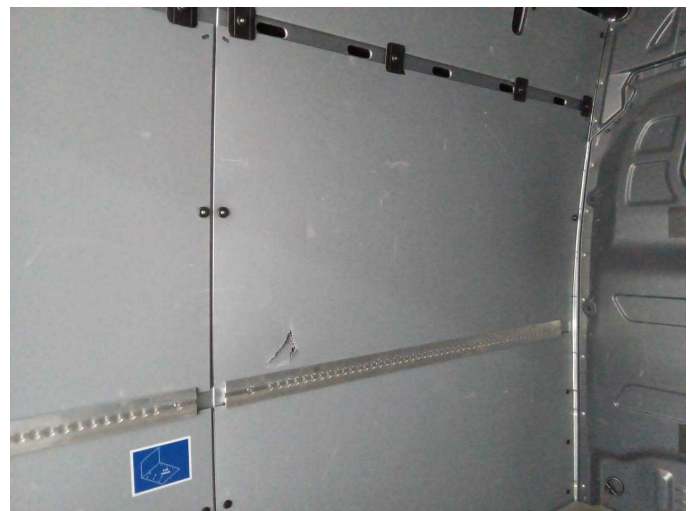
Damage 2: Trim / covers: Cargo area - lining -left side - Holes - Replace

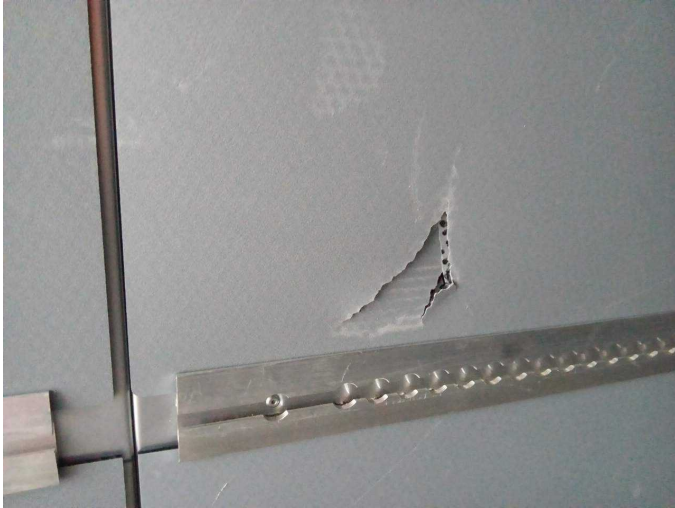
**Damage 2:** Trim / covers: Cargo area - lining -left side - Holes - Replace

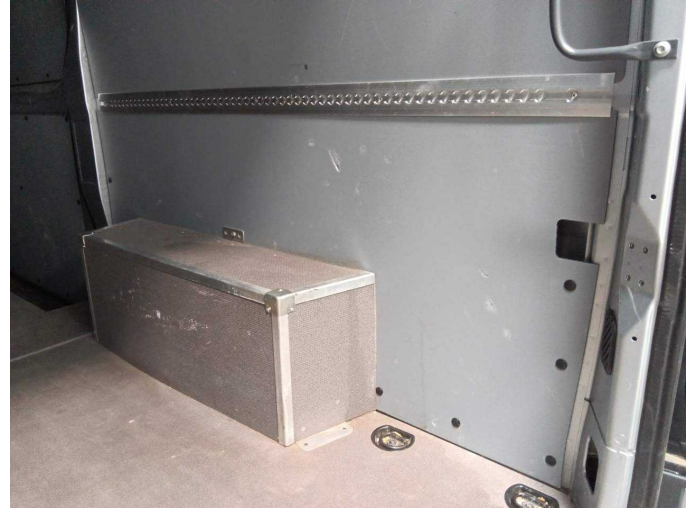
**Damage 3:** Trim / covers: Cargo area - lining - right side - Holes - Replace

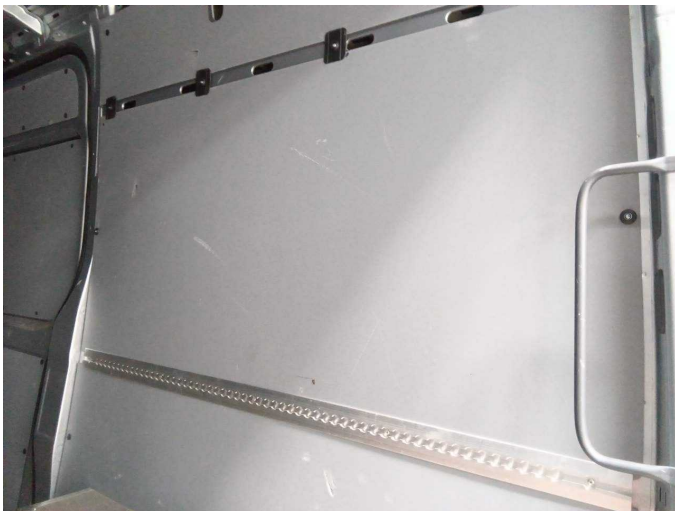
**Damage 3:** Trim / covers: Cargo area - lining - right side - Holes - Replace

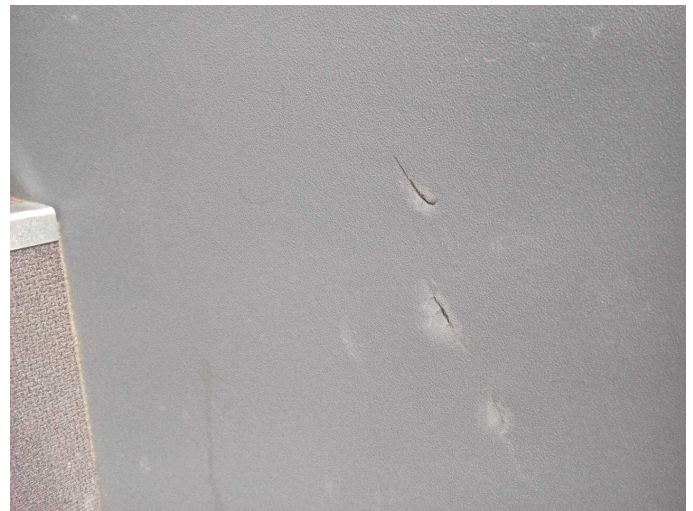
**Damage 3:** Trim / covers: Cargo area - lining - right side - Holes - Replace

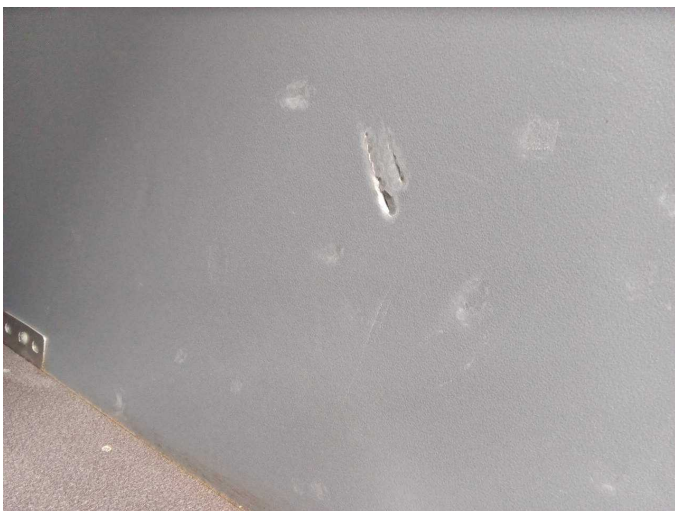
**Damage 3:** Trim / covers: Cargo area - lining - right side - Holes - Replace

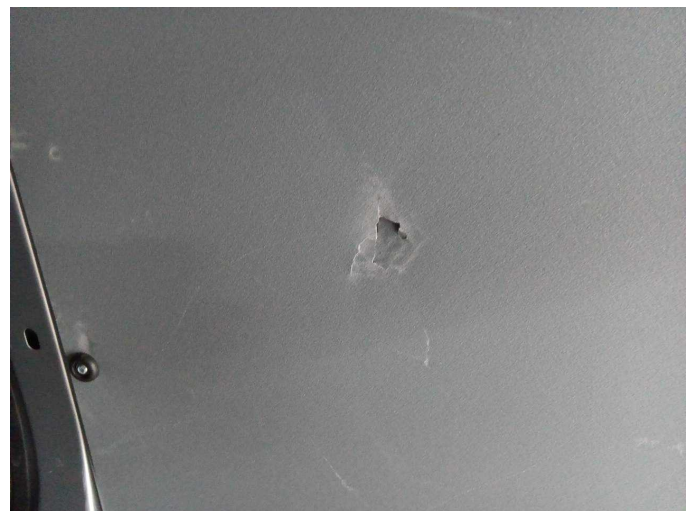
**Damage 3:** Trim / covers: Cargo area - lining - right side - Holes - Replace

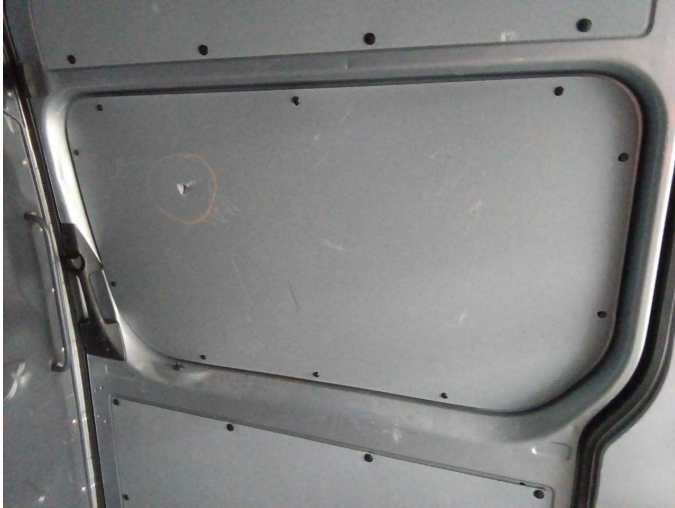
**Damage 4:** Sliding door, right: Trim - Holes - Replace

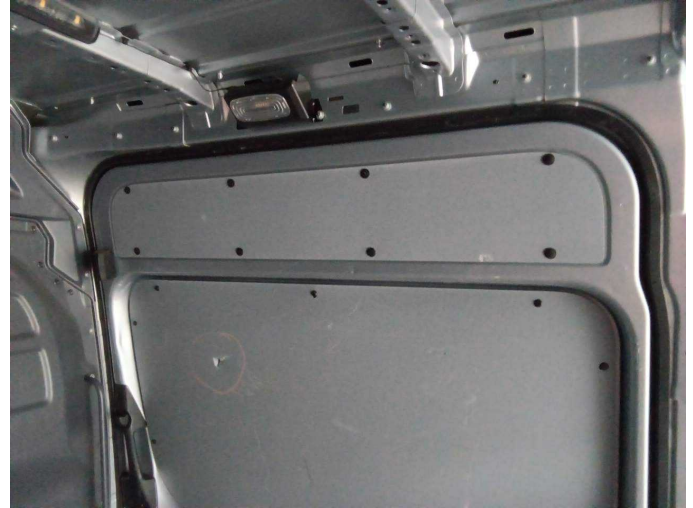
**Damage 4:** Sliding door, right: Trim - Holes - Replace

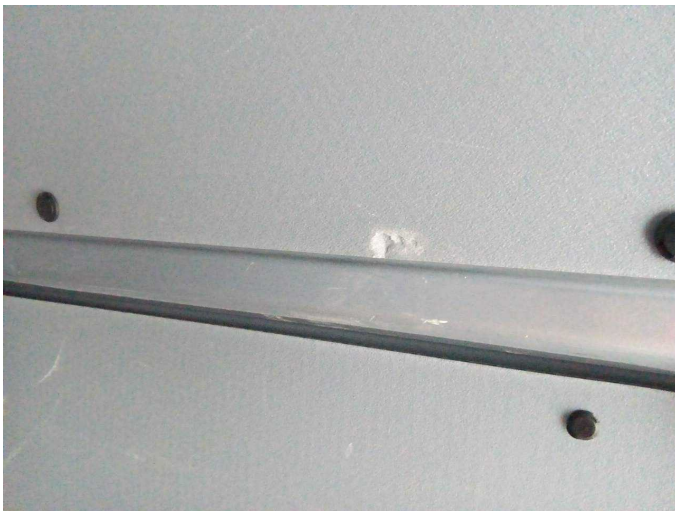
**Damage 4:** Sliding door, right: Trim - Holes - Replace

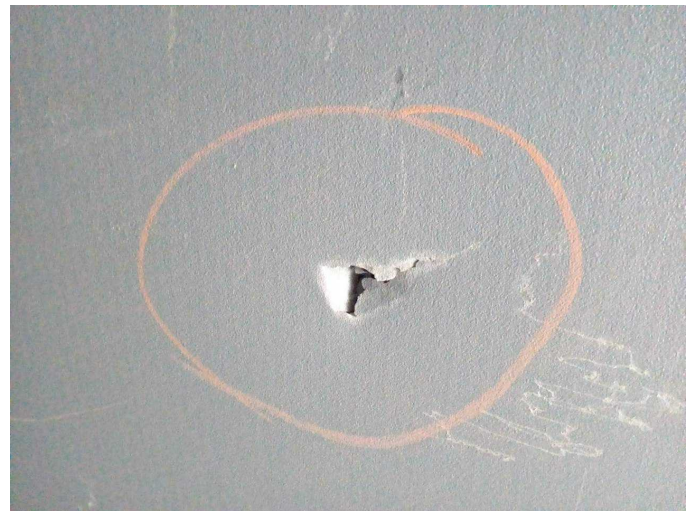
**Damage 4:** Sliding door, right: Trim - Holes - Replace

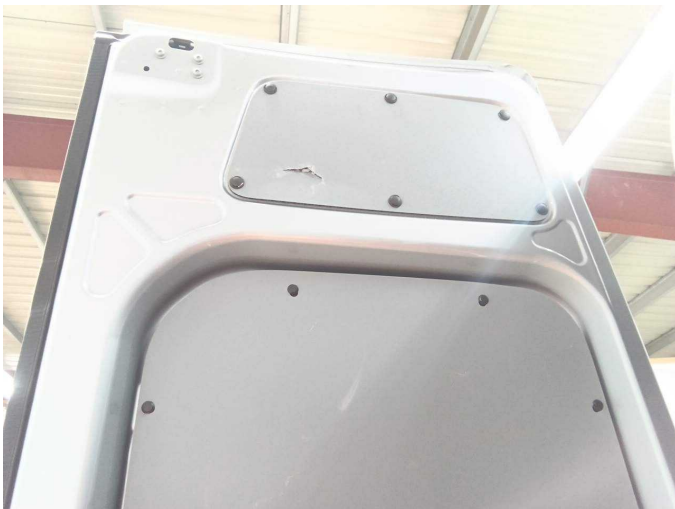
**Damage 5:** Boot lid / rear door: Trim standard - upper - Holes - Replace

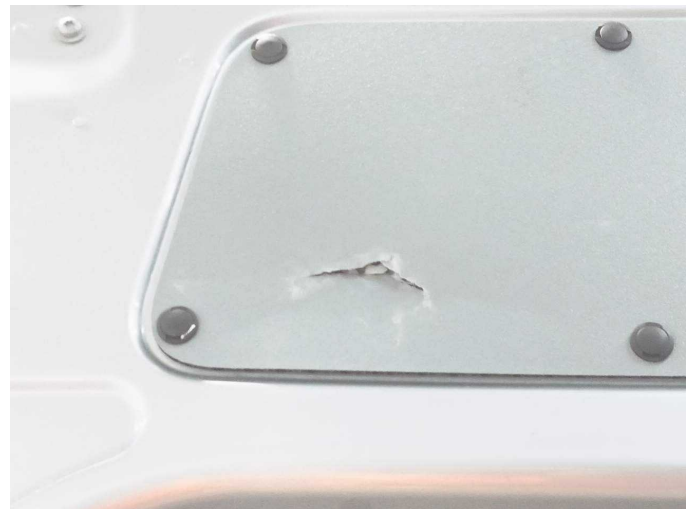
**Damage 5:** Boot lid / rear door: Trim standard - upper - Holes - Replace

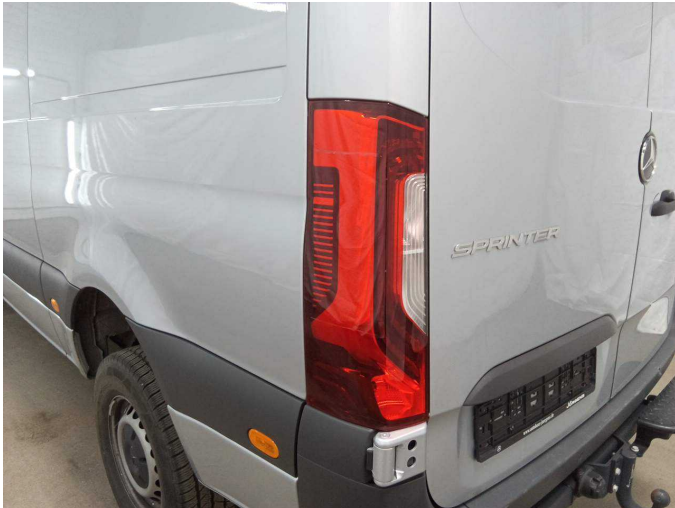
**Damage 6:** Tail light: Tail lamp - left side - Scratch(es) - Replace

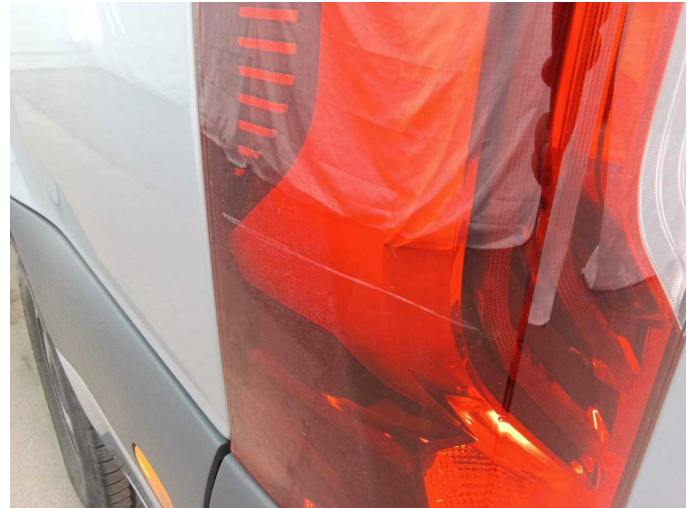
**Damage 6:** Tail light: Tail lamp - left side - Scratch(es) - Replace

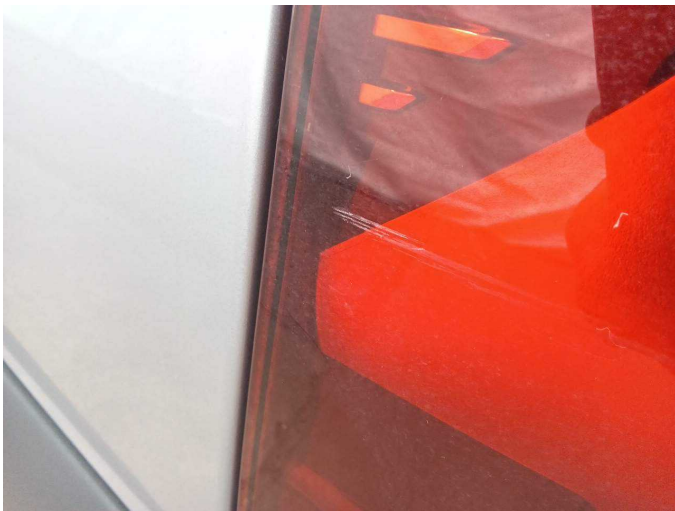
**Damage 6:** Tail light: Tail lamp - left side - Scratch(es) - Replace

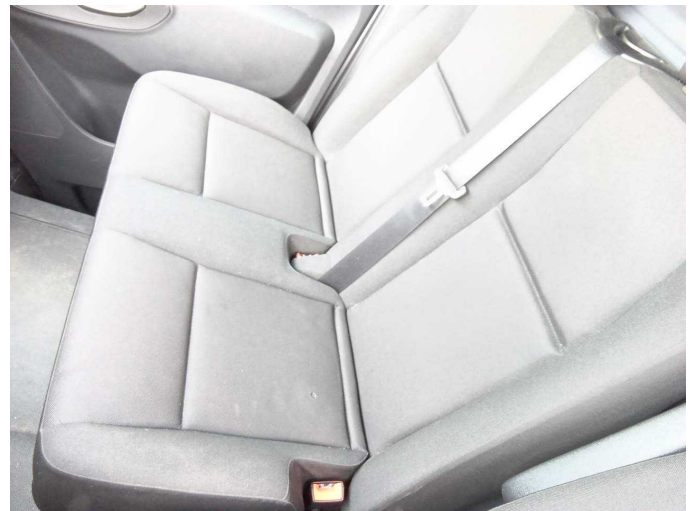
**Damage 7:** Seat - front: Seat cover - right side - Holes - Replace

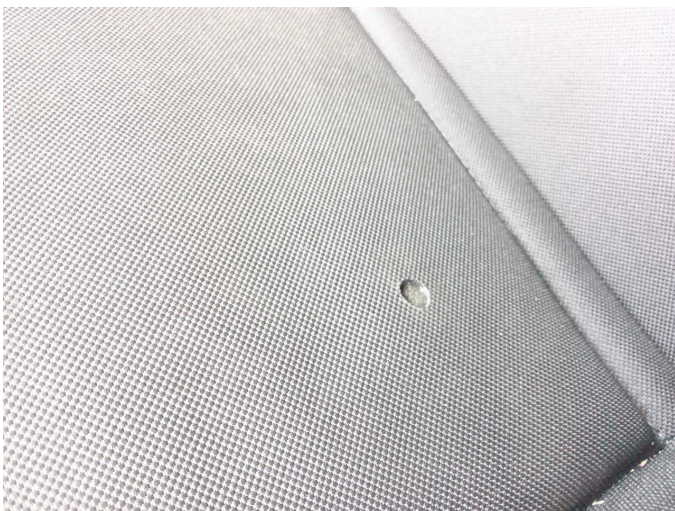
**Damage 7:** Seat - front: Seat cover - right side - Holes - Replace

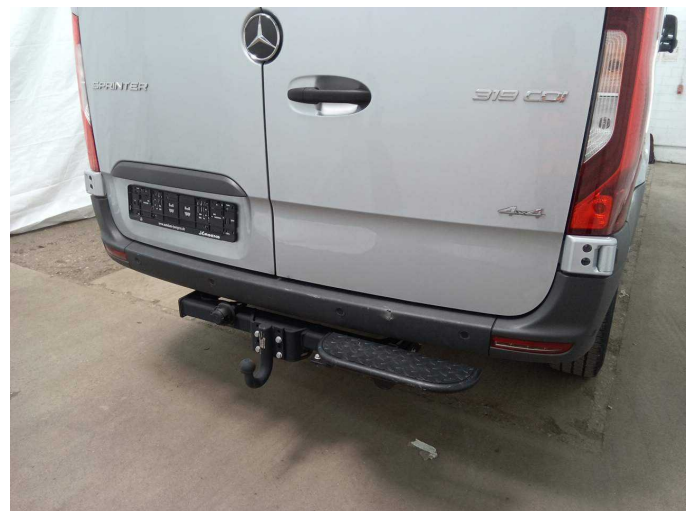
**Damage 8:** Rear bumper: Rear bumper - Broken / torn - Replace

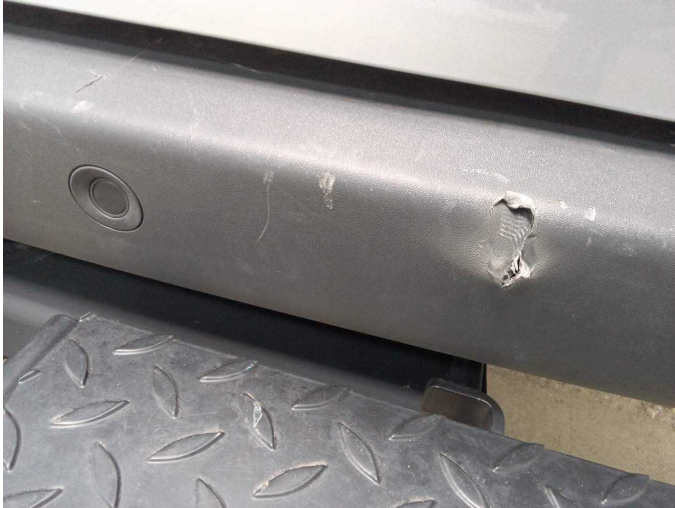
**Damage 8:** Rear bumper: Rear bumper - Broken / torn - Replace

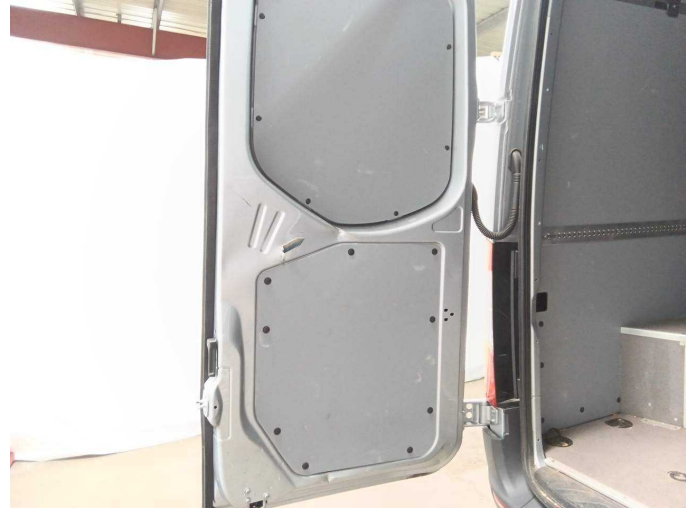
**Damage 9:** Boot lid / rear door: Rear door - left side - Dent / paintcoat damage - Repair and paint

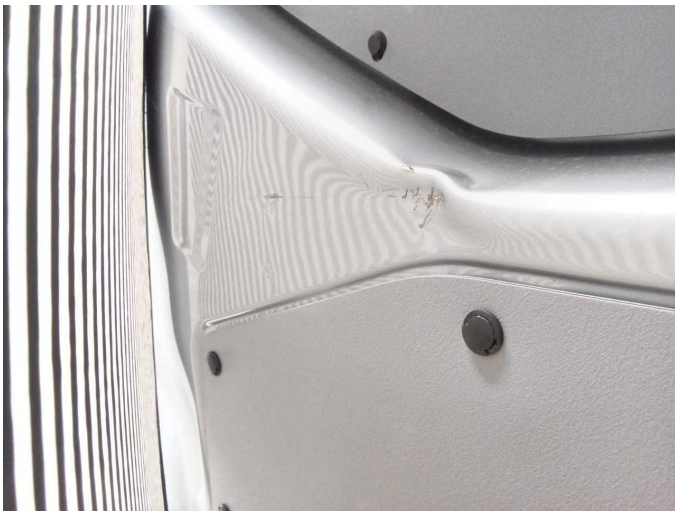
**Damage 9:** Boot lid / rear door: Rear door - left side - Dent / paintcoat damage - Repair and paint

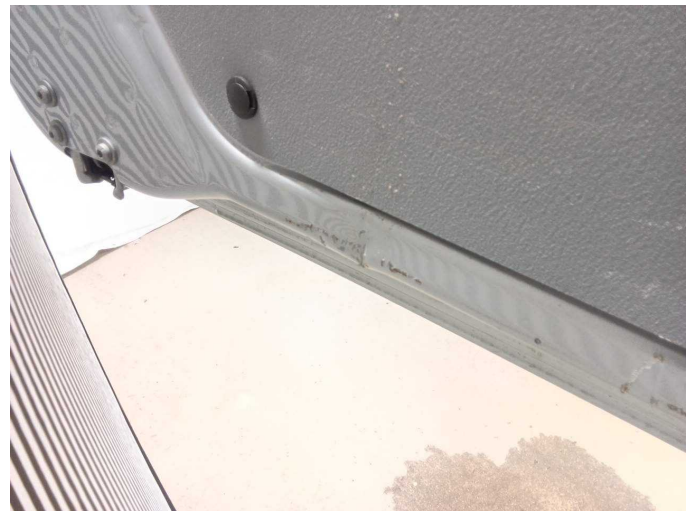
**Damage 9:** Boot lid / rear door: Rear door - left side - Dent / paintcoat damage - Repair and paint

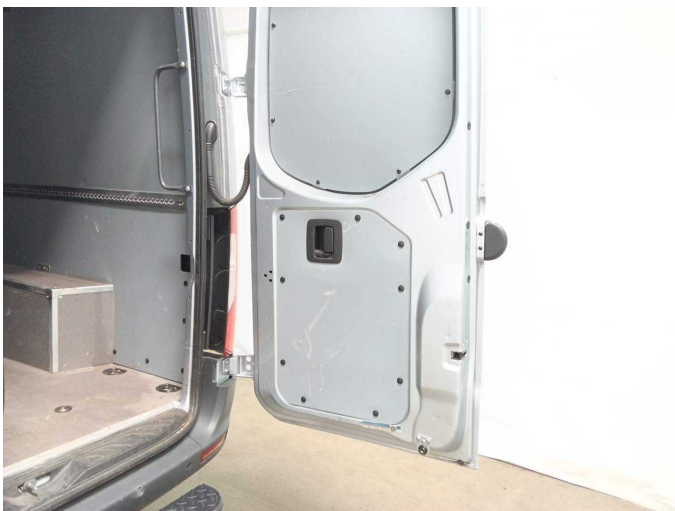
**Damage 10:** Boot lid / rear door: Rear door - right side - Dent / paintcoat damage - Repair and paint

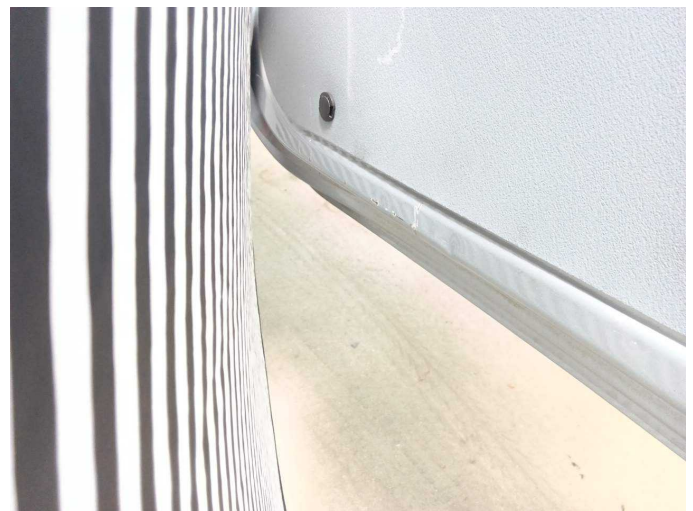
**Damage 10:** Boot lid / rear door: Rear door - right side - Dent / paintcoat damage - Repair and paint

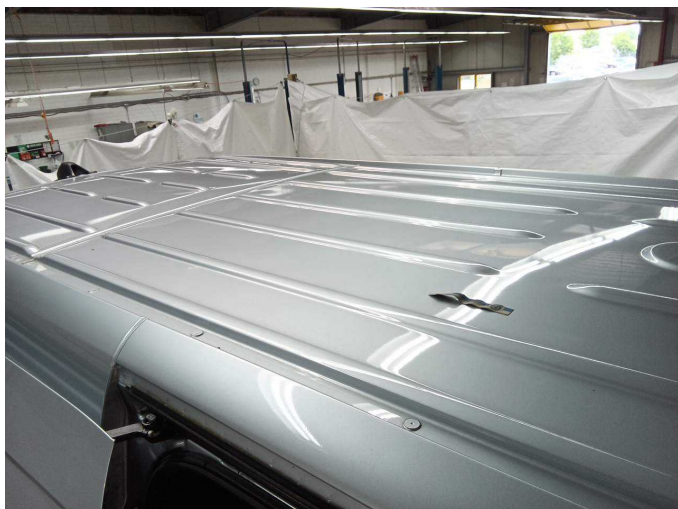
**Wear and tear 4:** Roof: Roof - dent(s) - No deduction

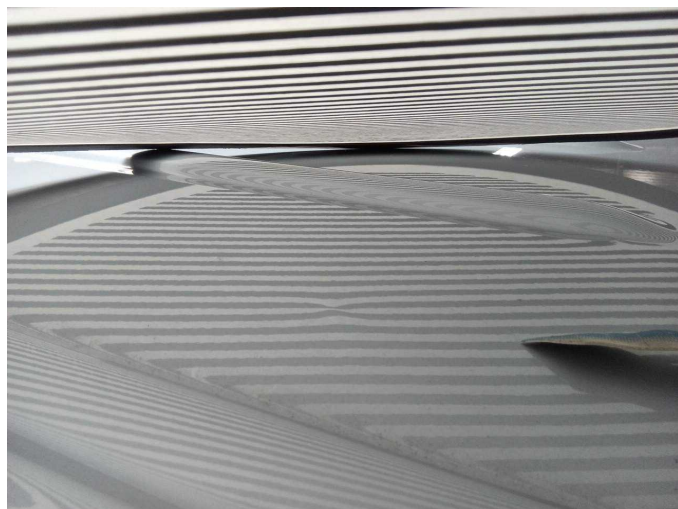
**Wear and tear 4:** Roof: Roof - dent(s) - No deduction

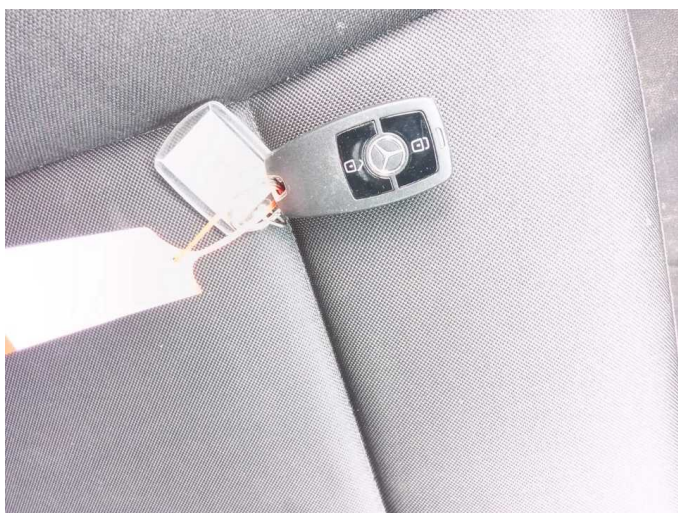
**Missing part 1:** Equipment: Vehicle key - Missing - Replace
