Expertise

Protocol number: 46322217
Order No. / Reference: 26512570
Inspection date: 3 Jul 2026

Model: Octavia Combi 2.0 TDI DSG Style

VIN: TMBJG0NX6NY056961

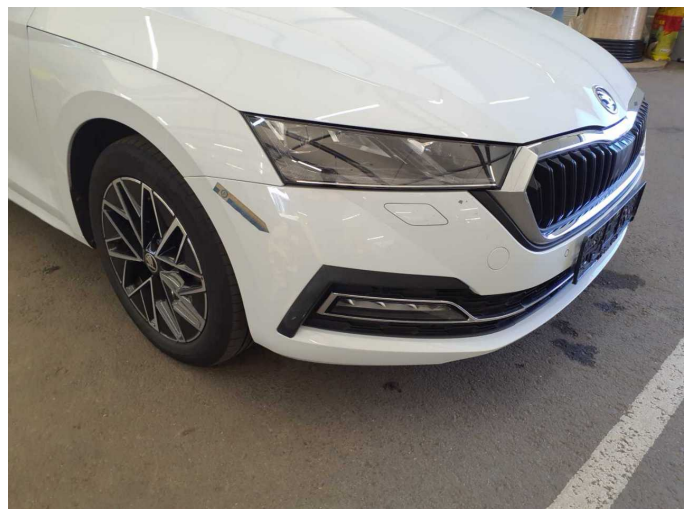
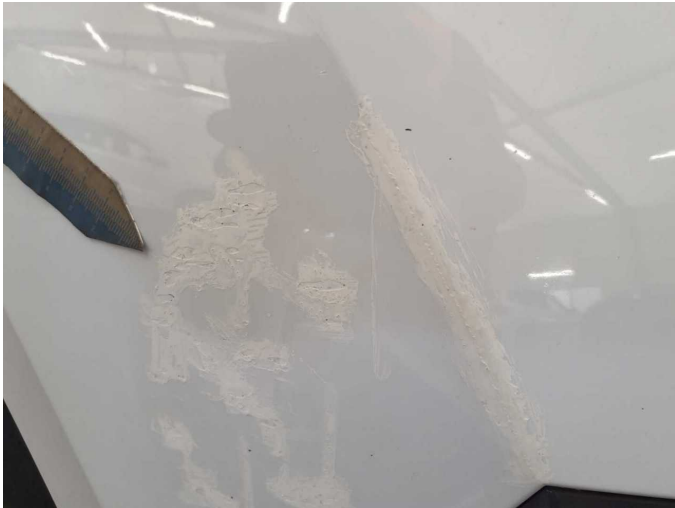
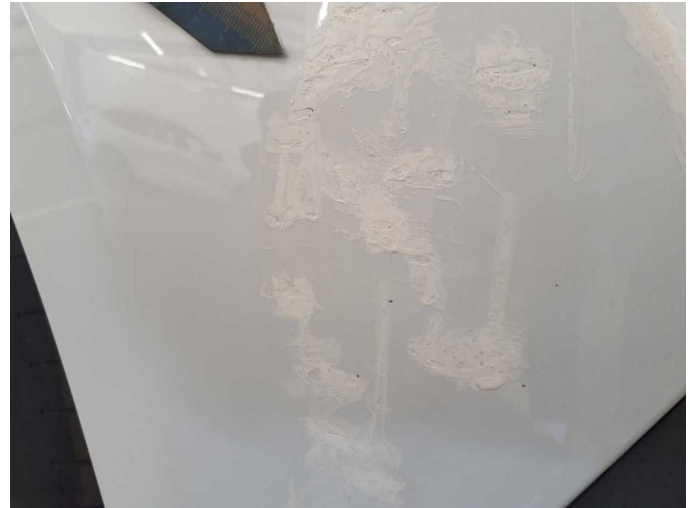
No.	Component group	Description
1	Front bumper	Front bumper (im Unfall Kalk. erhalten) - Scratch(es) - Paint
2	Rear bumper	Rear bumper (im Unfall Kalk. erhalten) - Scratch(es) - Paint
3	Equipment	Tirefit filler - Expired - Replace
4	Wheel / tyres	Alloy rim - rear right side - Scratch(es) - Loss in value
5	Side panel - rear right side	Side panel - Dent / paintcoat damage - Smart repair
6	Sill - right side	Sill - Deformed - Repair and paint
7	Headlight	Headlight - right side - Broken / torn - Replace

Damage 1: Front bumper: Front bumper (im Unfall Kalk. erhalten) - Scratch(es) - Paint

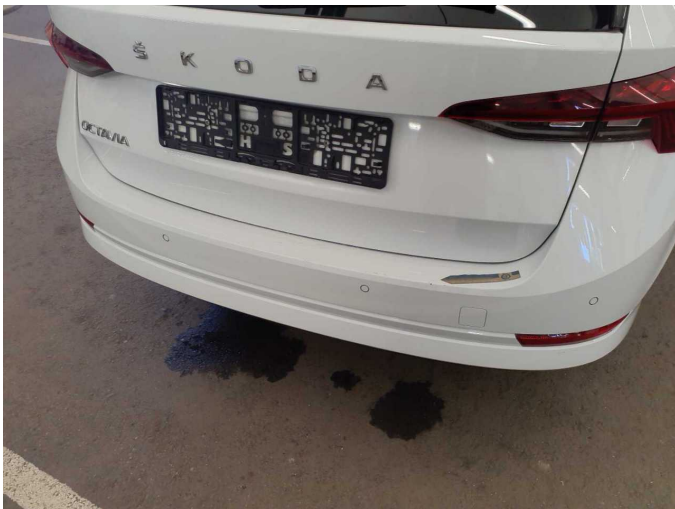
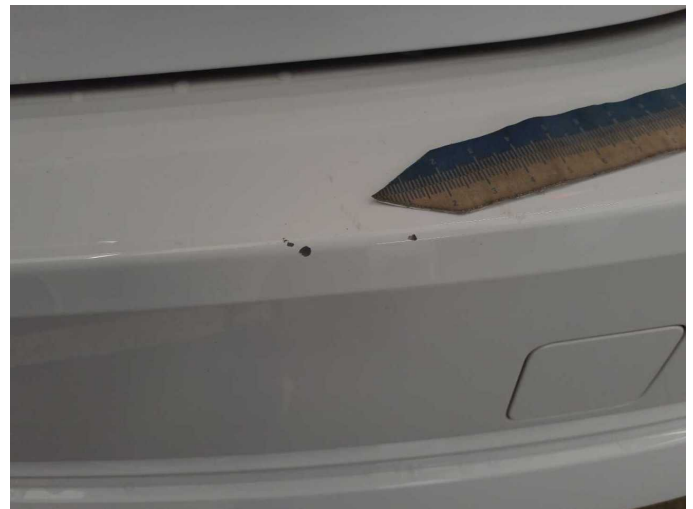
Damage 2: Rear bumper: Rear bumper (im Unfall Kalk. erhalten) - Scratch(es) - Paint

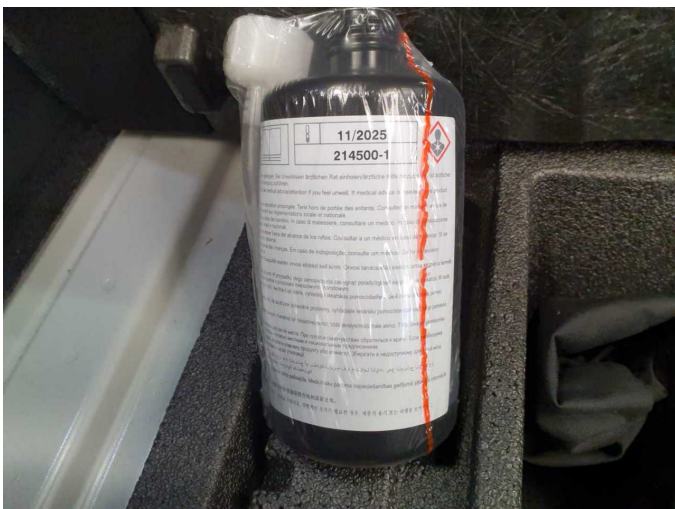
Damage 3: Equipment: Tirefit filler - Expired - Replace

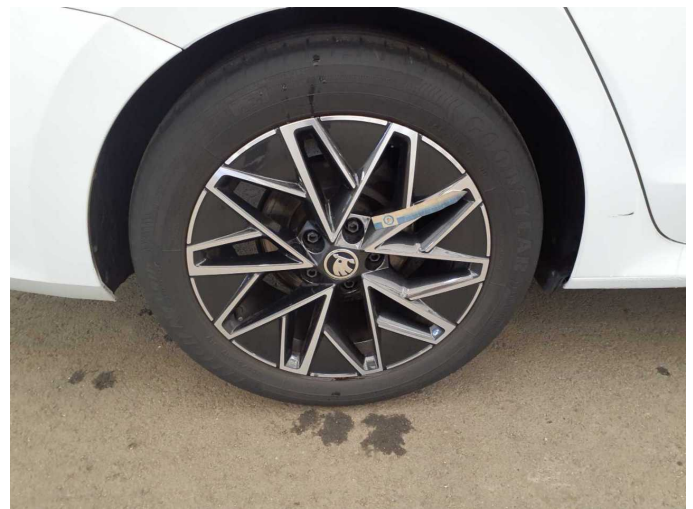
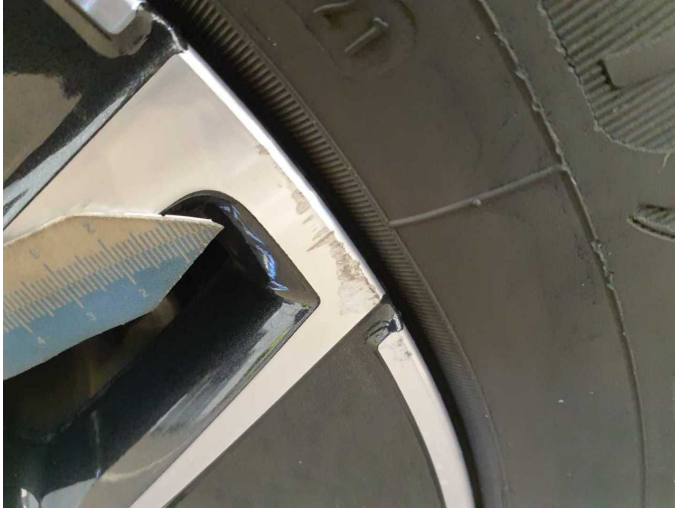
Damage 4: Wheel / tyres: Alloy rim - rear right side - Scratch(es) - Loss in value

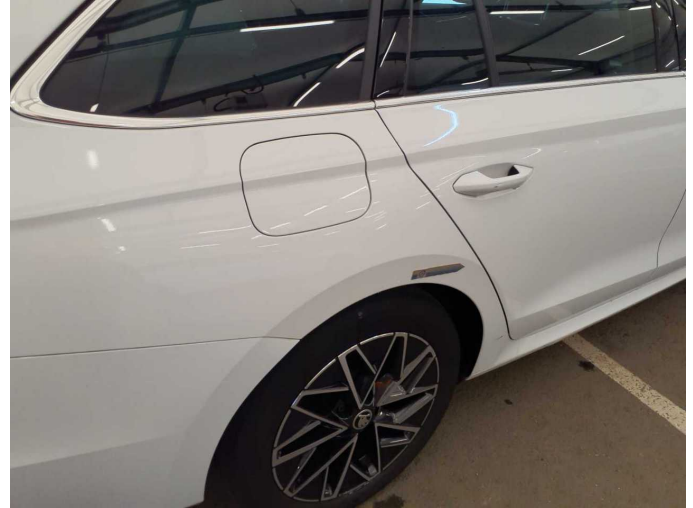
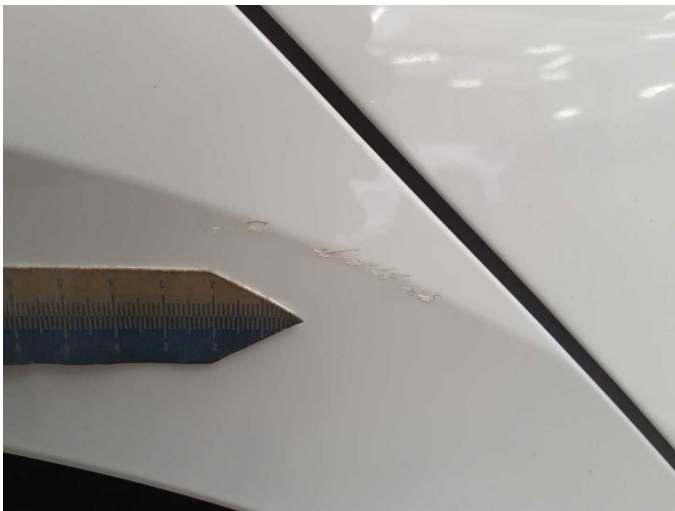
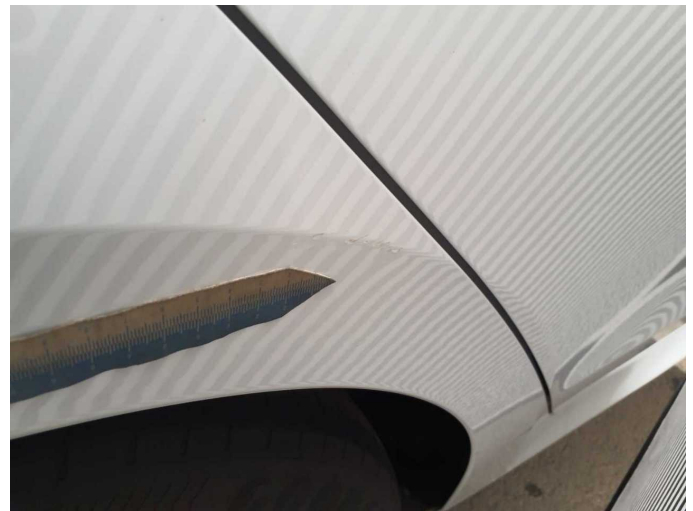
Damage 5: Side panel - rear right side: Side panel - Dent / paintcoat damage - Smart repair

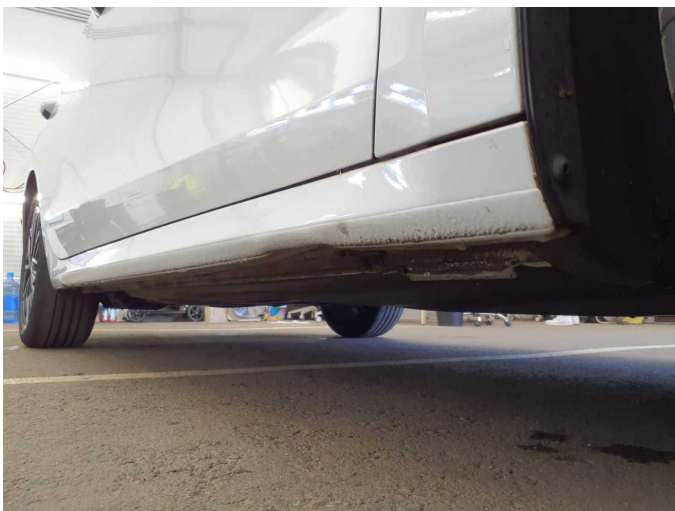
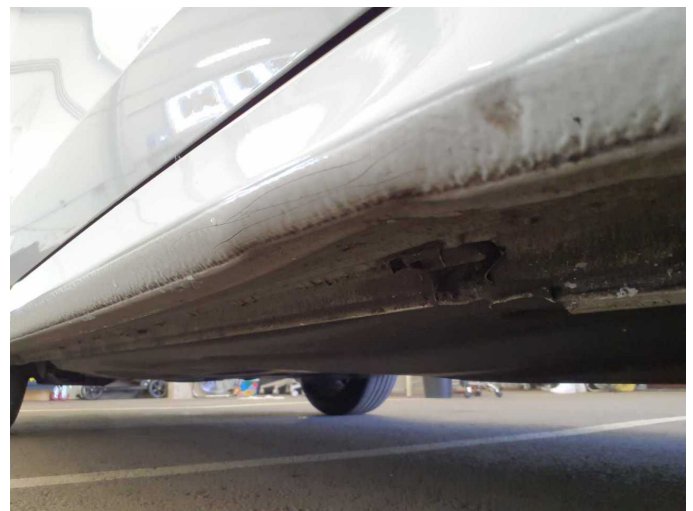
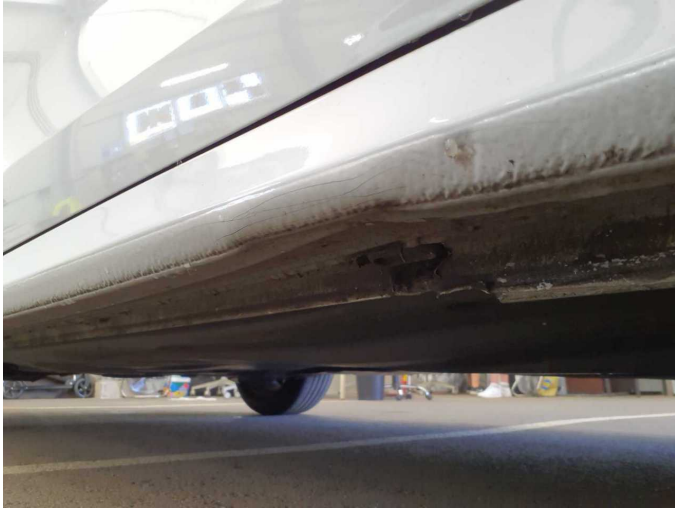
Damage 6: Sill - right side: Sill - Deformed - Repair and paint

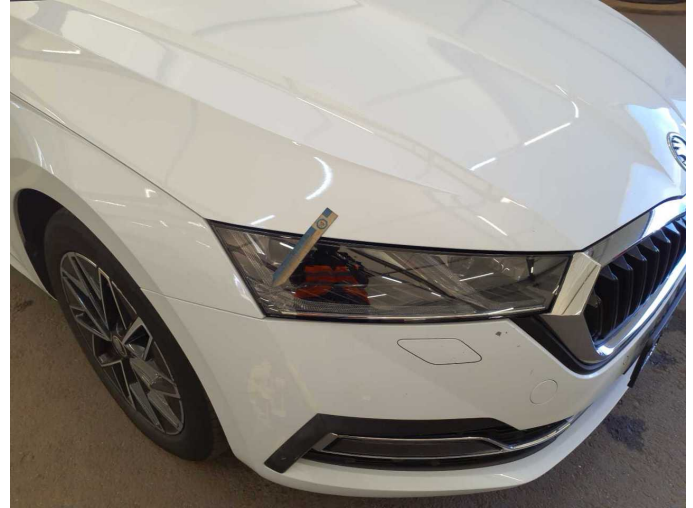
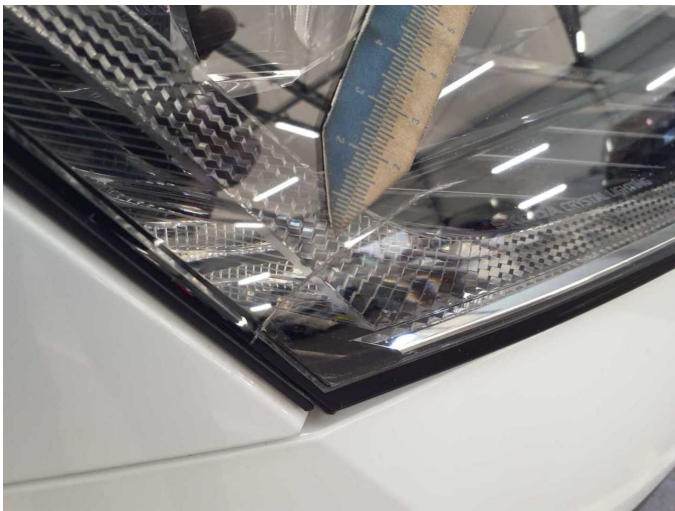
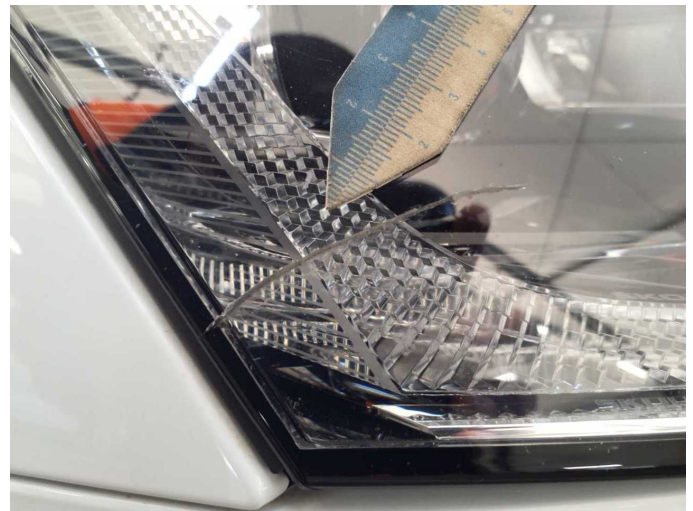
Damage 7: Headlight: Headlight - right side - Broken / torn - Replace

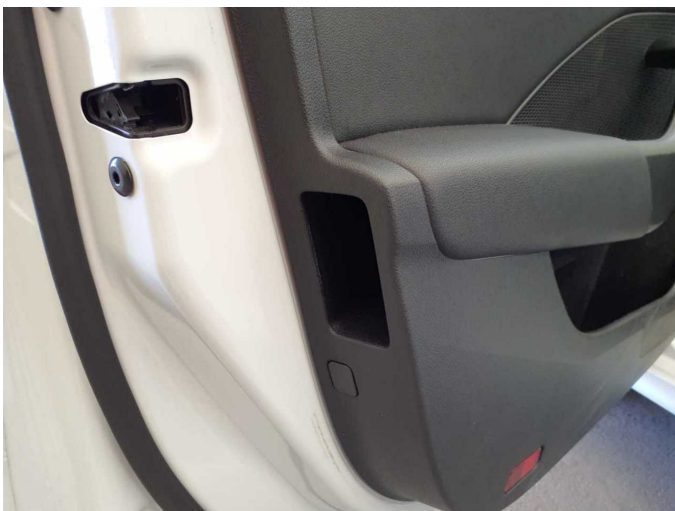
Equipment - Umbrella

Missing part 1: Equipment: Umbrella - Missing - No deduction

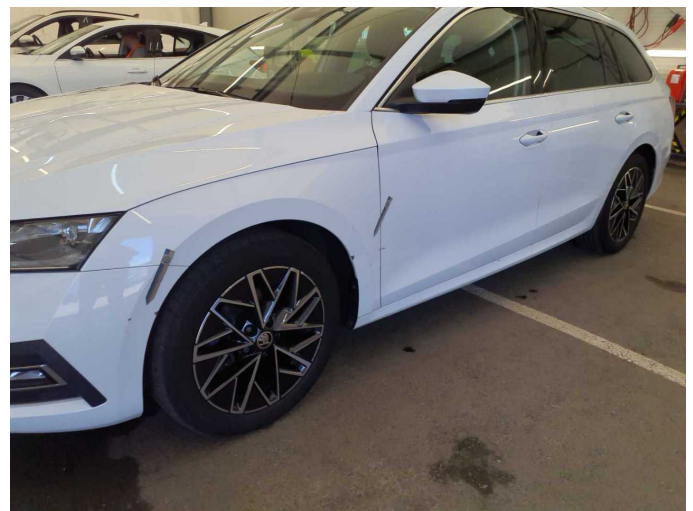
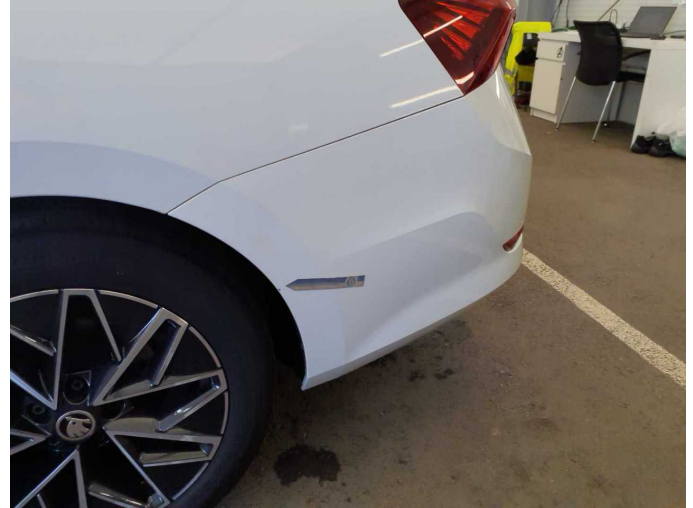
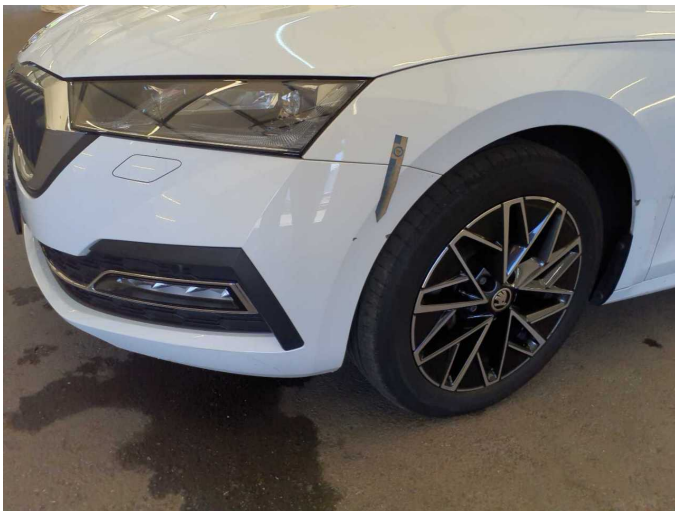
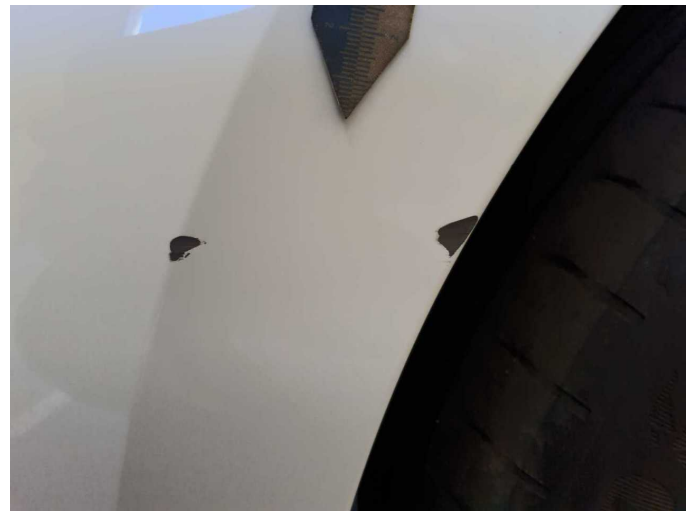
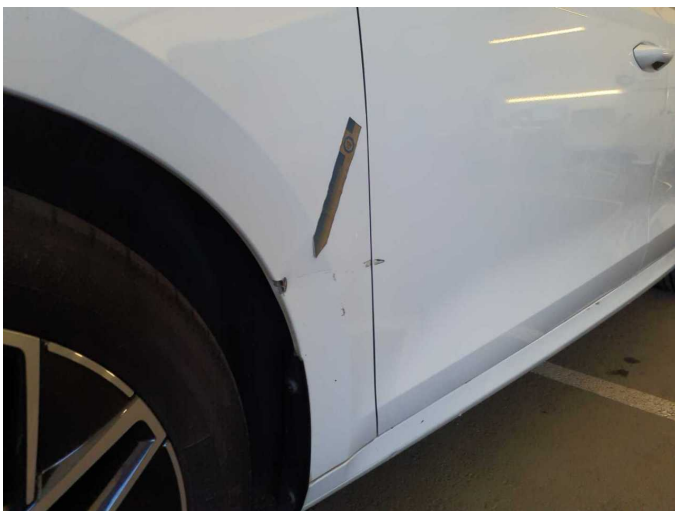
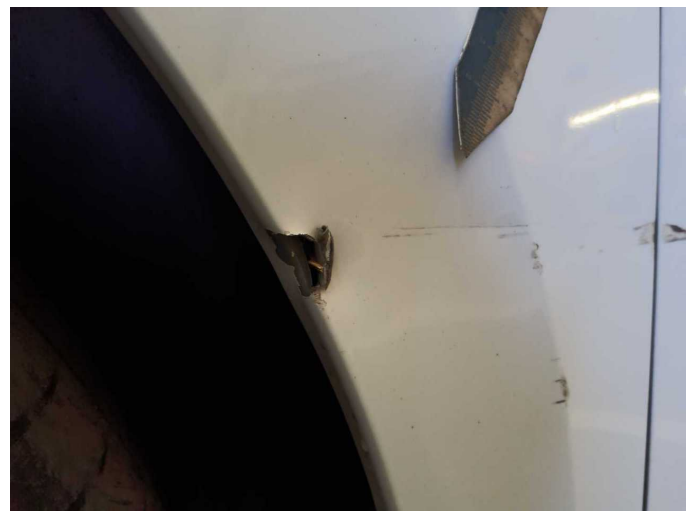
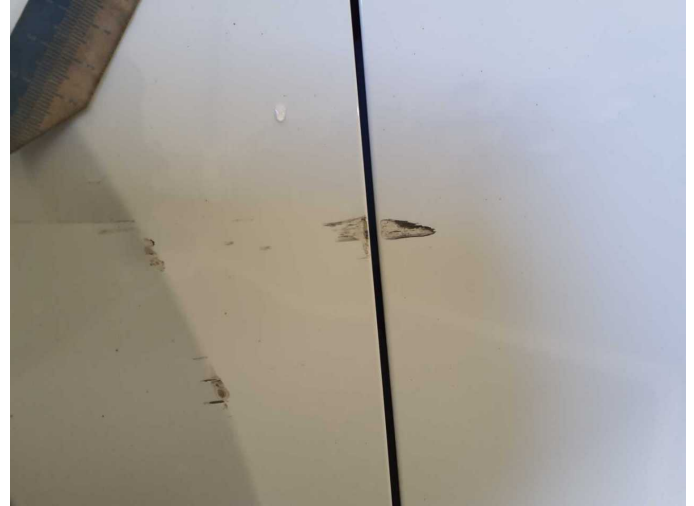
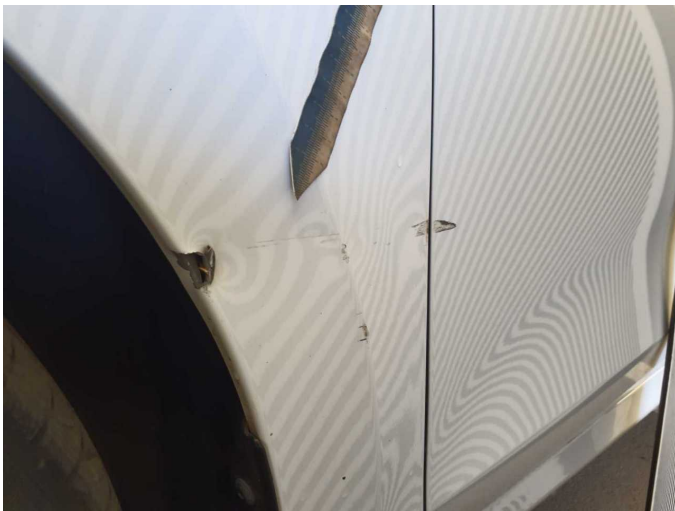
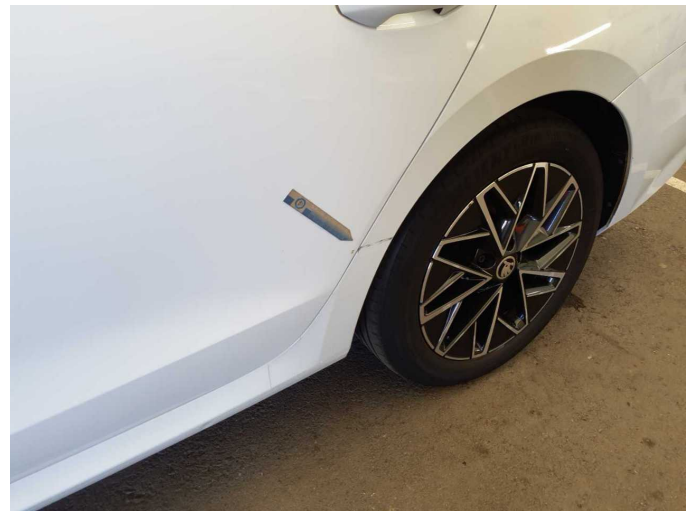
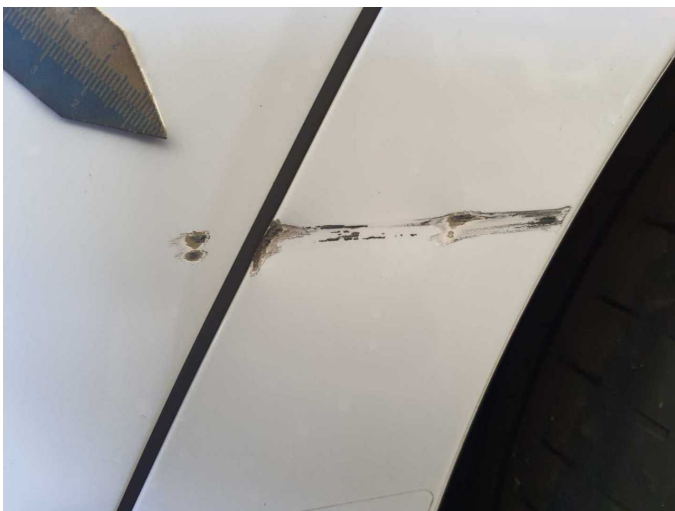
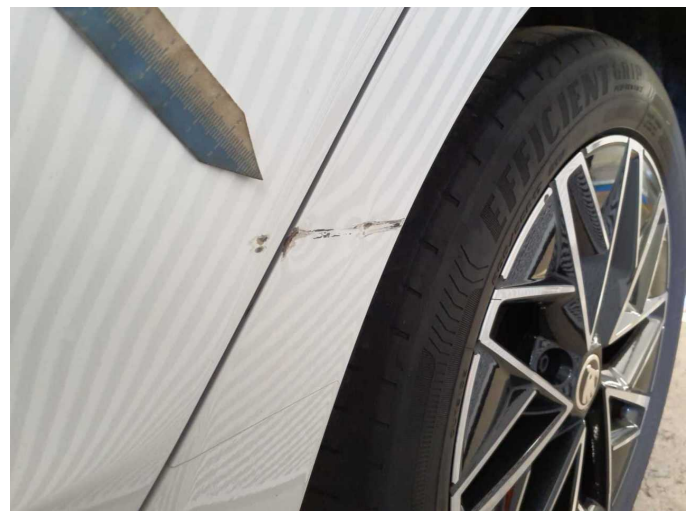
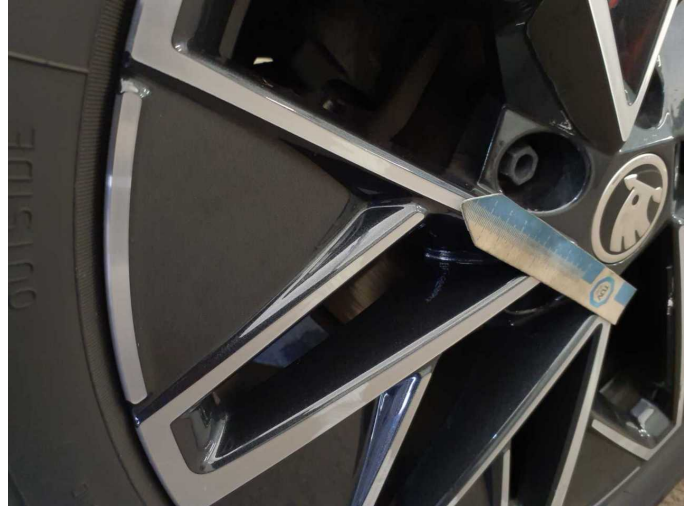
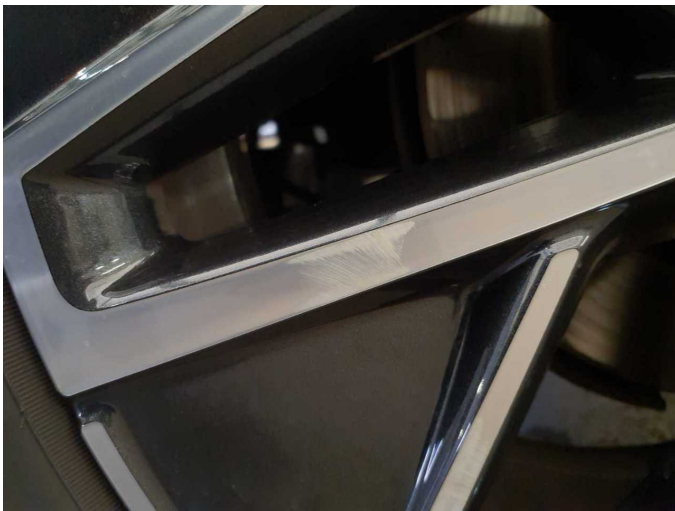
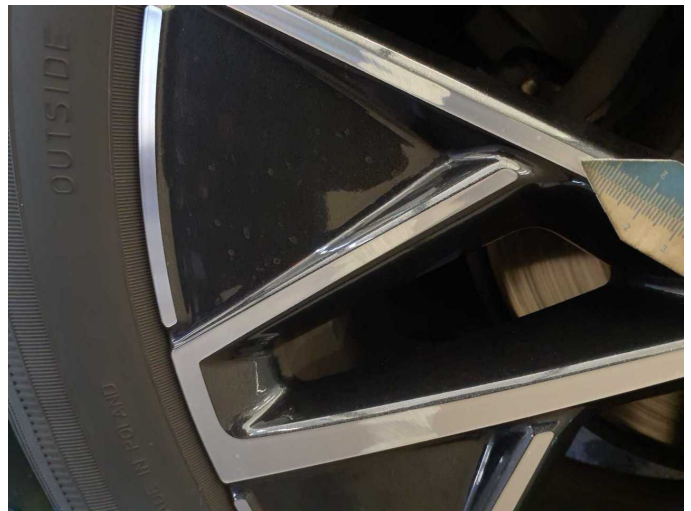
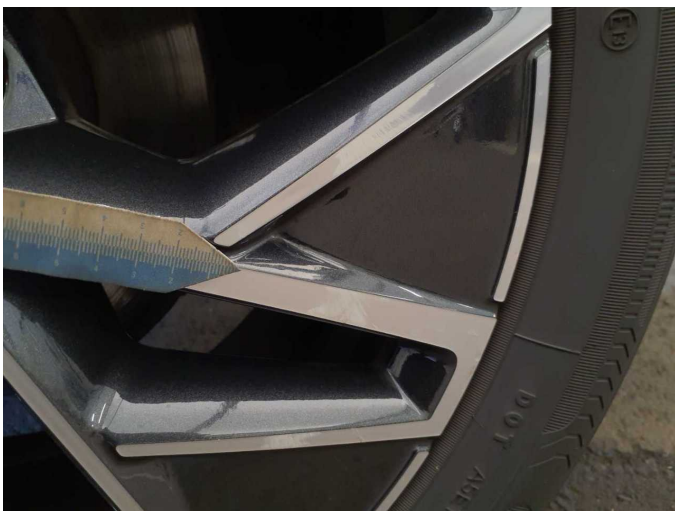
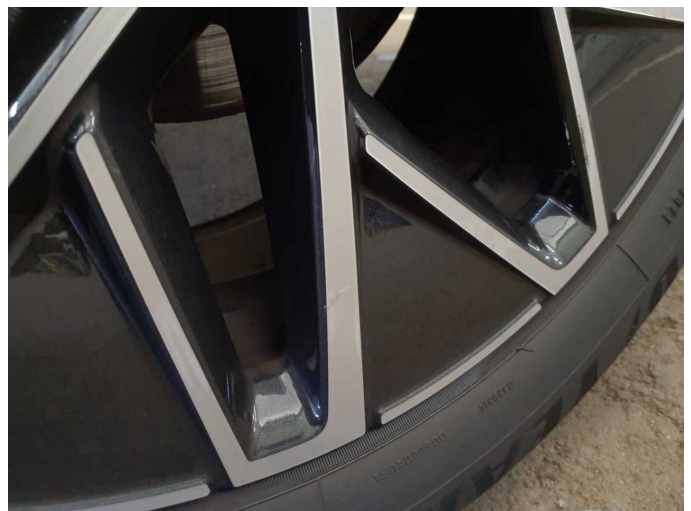
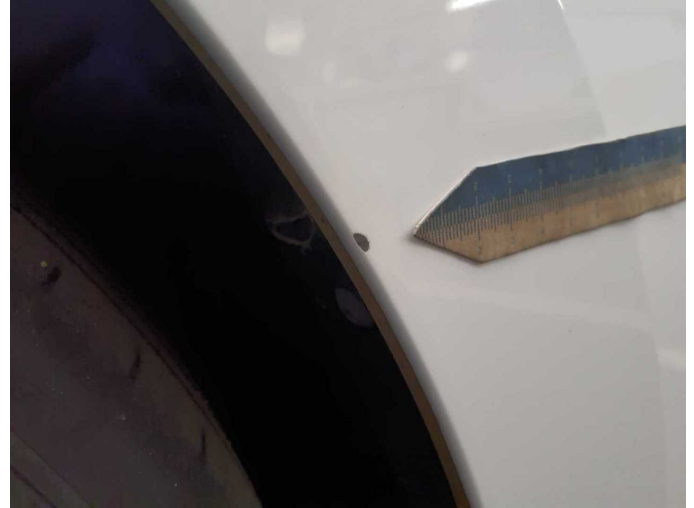
Accident 1: Side - left

1 Side - left
