## Expertise

Protocol number: 45992123  
Order No. / Reference: 26359112-1  
Inspection date: 1 Jun 2026

Manufacturer: Renault

Model: Kangoo Rapid Blue dCi 75 Extra

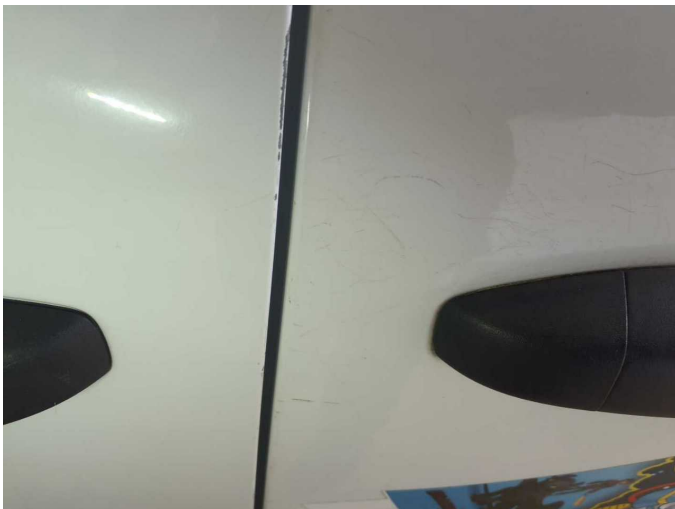
Damage 1: Door - rear left side: Door - Scratch(es) - Smart repair

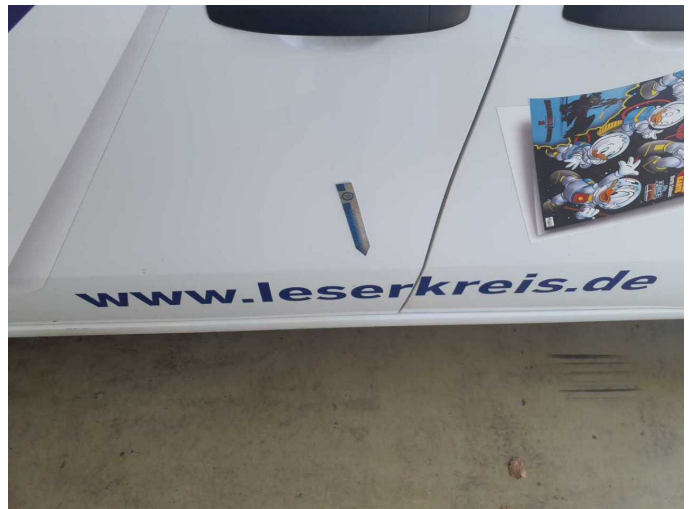
Damage 1: Door - rear left side: Door - Scratch(es) - Smart repair

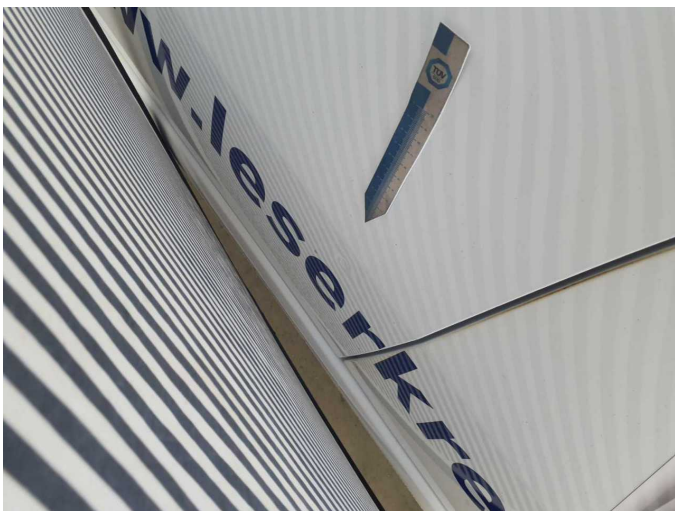
Damage 2: Door - front left side: Door - Dent / paintcoat damage - Smart repair

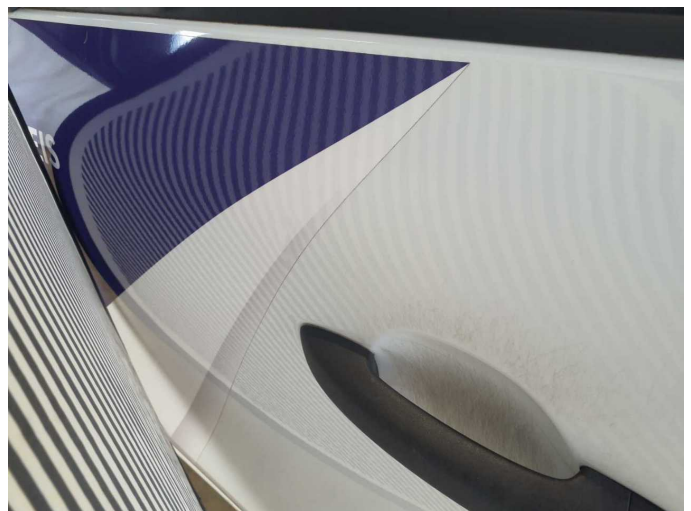
Damage 2: Door - front left side: Door - Dent / paintcoat damage - Smart repair

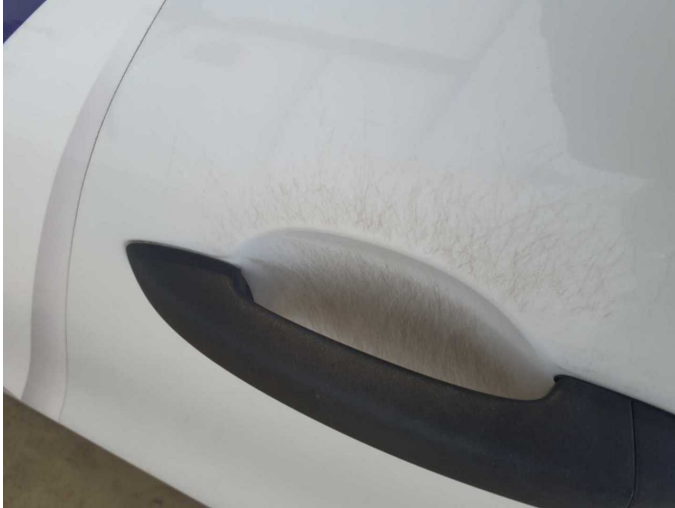
Damage 2: Door - front left side: Door - Dent / paintcoat damage - Smart repair

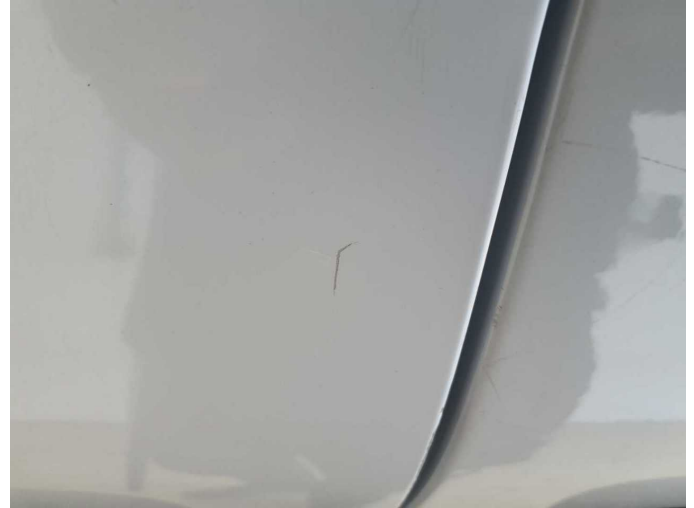
**Damage 2:** Door - front left side: Door - Dent / paintcoat damage - Smart repair

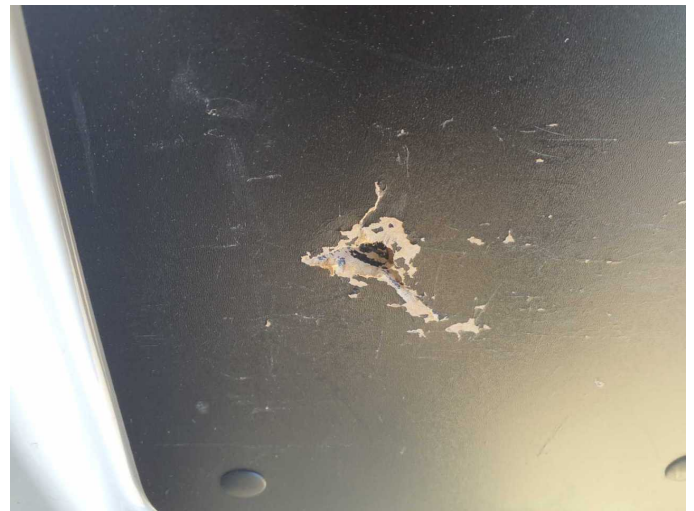
**Damage 3:** Boot lid / rear door: Trim rear door - hard fibre - lower - Broken / torn - Replace

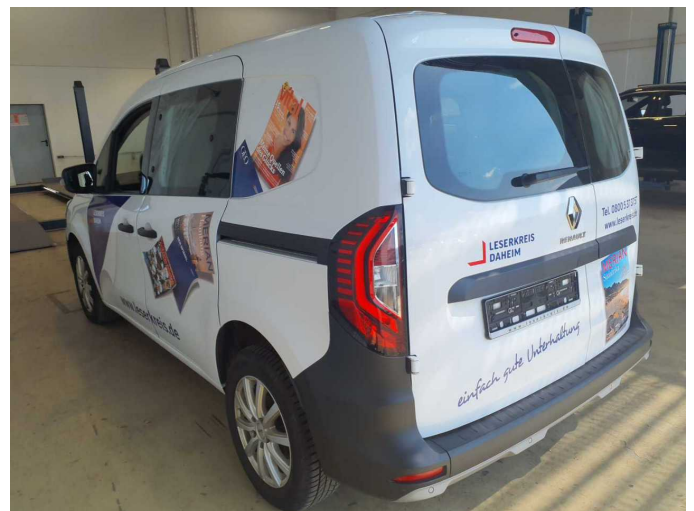
**Damage 4:** Body: Body - Glued / labelled - De-glue / neutralise

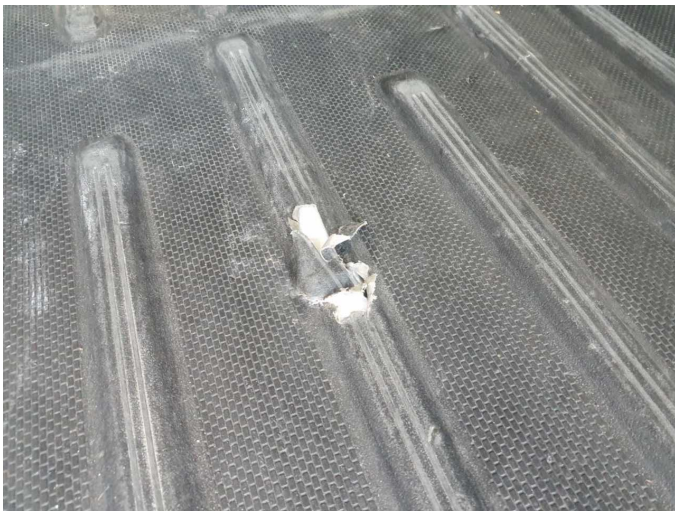
**Damage 6:** Interior: Cargo area floor - Broken / torn - Replace

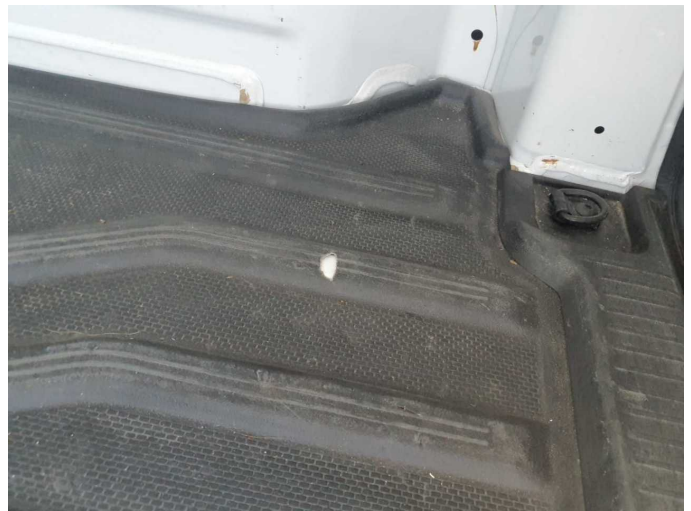
**Damage 6:** Interior: Cargo area floor - Broken / torn - Replace

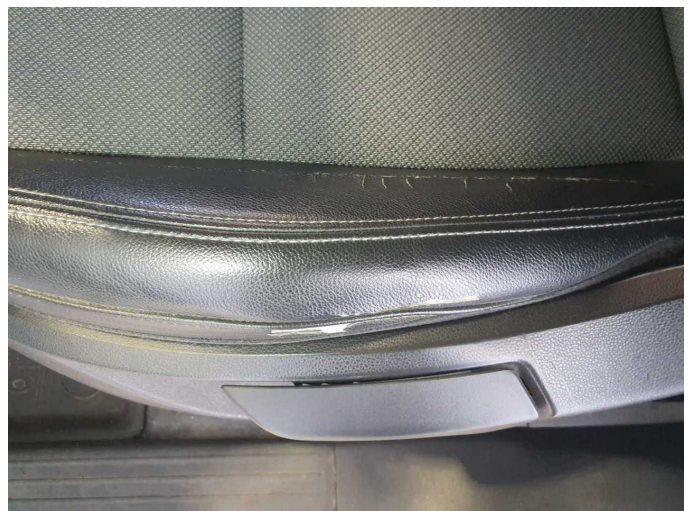
**Damage 7:** Seat - front: Seat cover - left side - Broken / torn - Replace

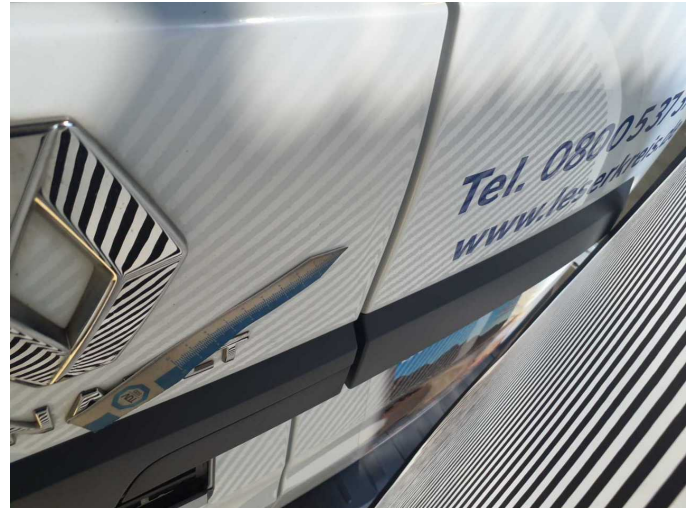
**Damage 8:** Boot lid / rear door: Rear door - left side - Dent / paintcoat damage - Paint

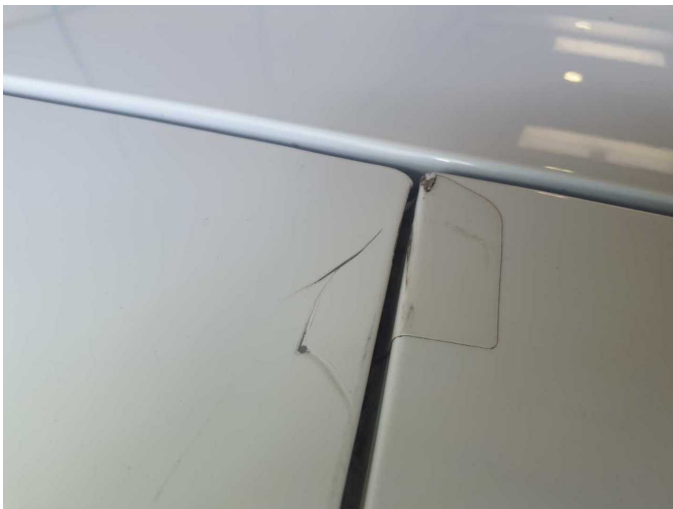
**Damage 8:** Boot lid / rear door: Rear door - left side - Dent / paintcoat damage - Paint

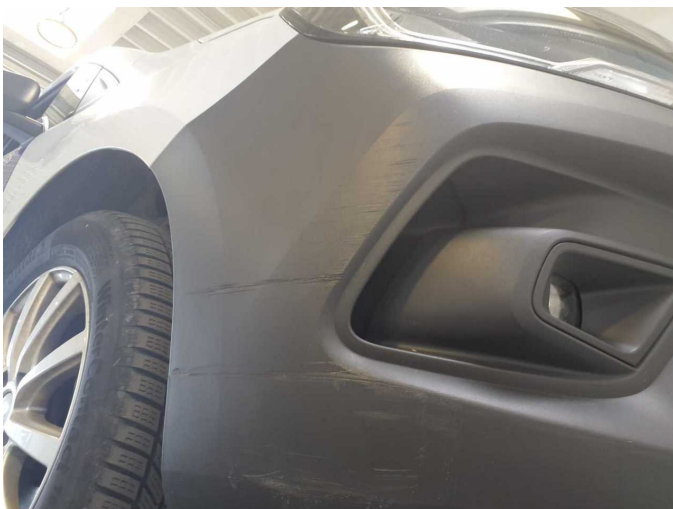
**Damage 9:** Front bumper: Front bumper (unpainted) (inkl. Schutzleiste) - Scratch(es) - Replace

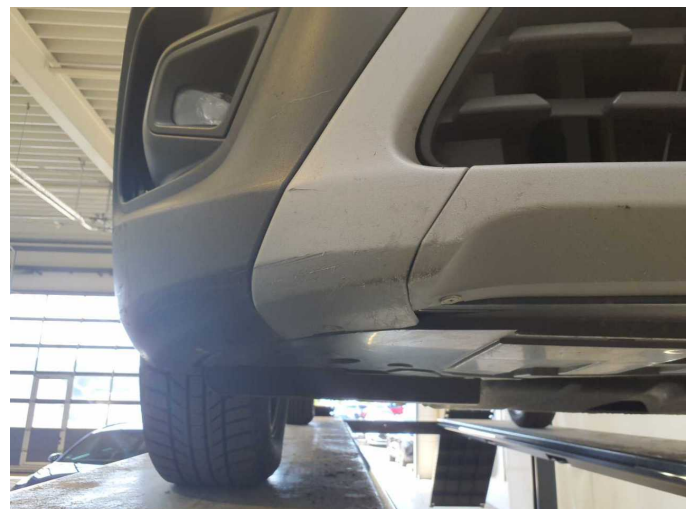
**Damage 9:** Front bumper: Front bumper (unpainted) (inkl. Schutzleiste) - Scratch(es) - Replace

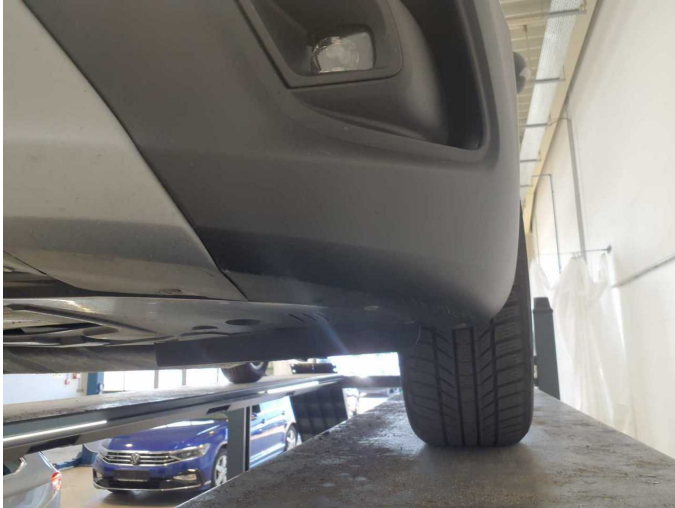
**Damage 9:** Front bumper: Front bumper (unpainted) (inkl. Schutzleiste) - Scratch(es) - Replace

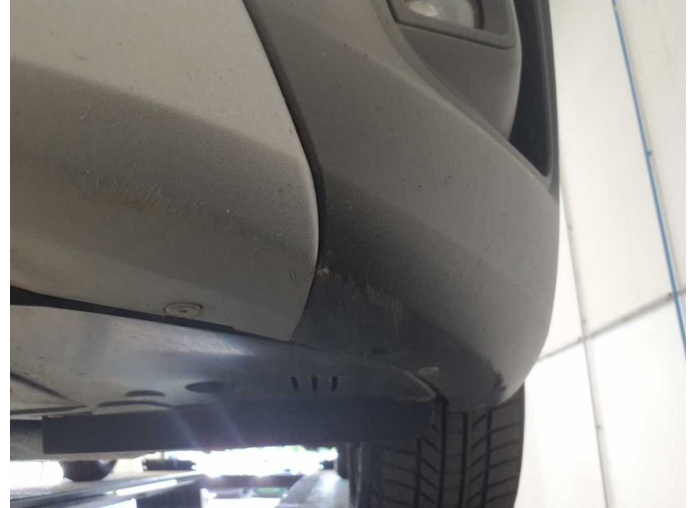
**Damage 9:** Front bumper: Front bumper (unpainted) (inkl. Schutzleiste) - Scratch(es) - Replace

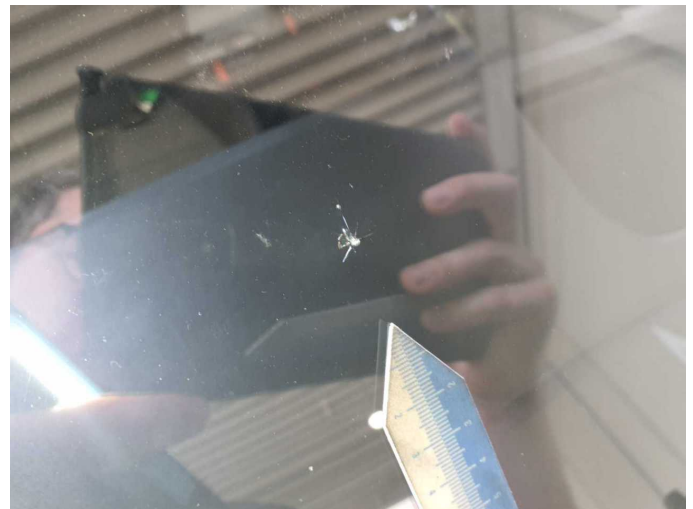
**Damage 10:** Vehicle glazing: Windscreen - Stone chips - Replace

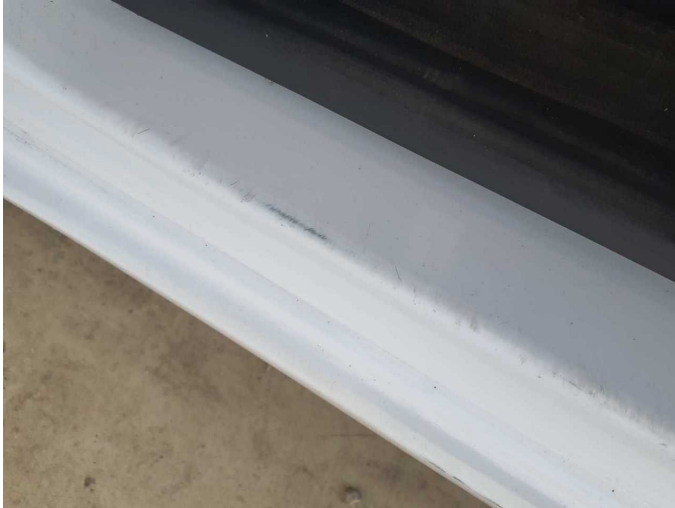
**Wear and tear 3:** Sill - left side: Sill - Scratch(es) - No deduction

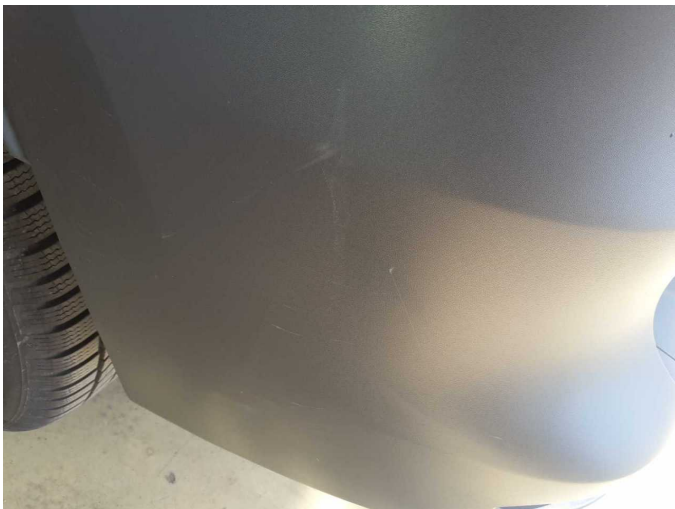
**Wear and tear 4:** Rear bumper: Rear bumper - Scratch(es) - No deduction

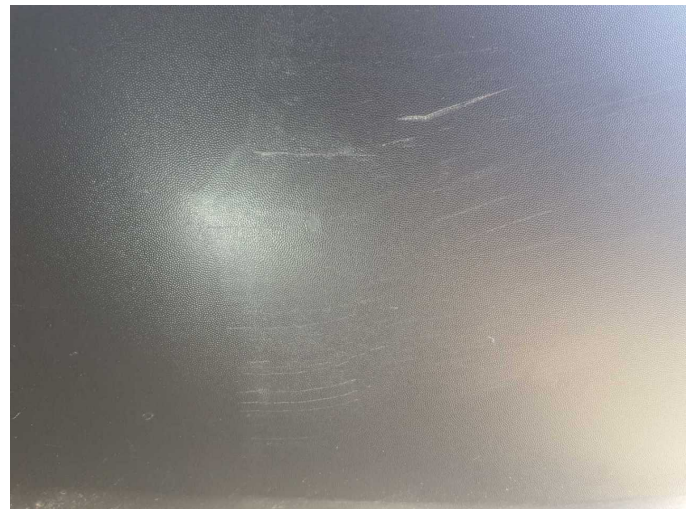
**Wear and tear 4:** Rear bumper: Rear bumper - Scratch(es) - No deduction

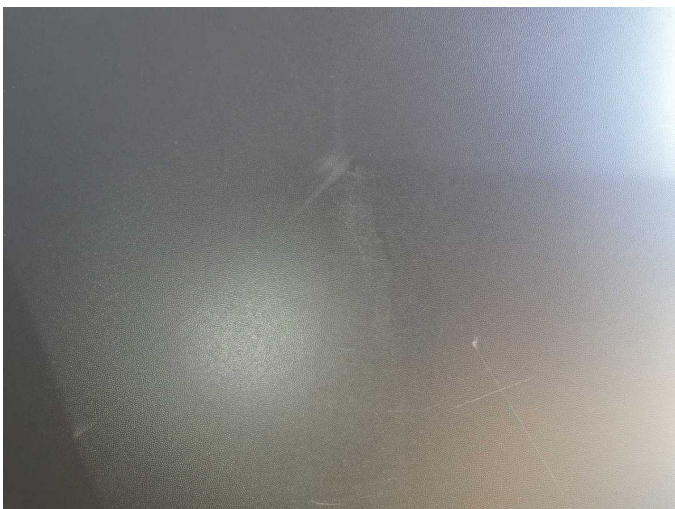
**Wear and tear 4:** Rear bumper: Rear bumper - Scratch(es) - No deduction

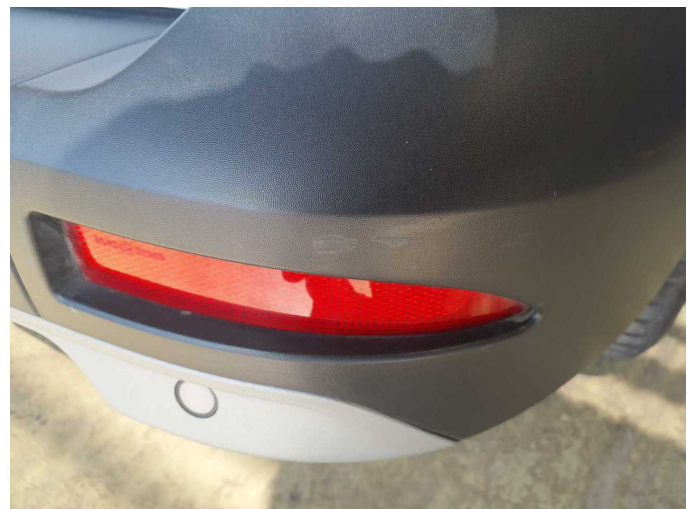
**Wear and tear 4:** Rear bumper: Rear bumper - Scratch(es) - No deduction
