## Expertise

Protocol number: 46070413  
Order No. / Reference: 26553193  
Inspection date: 22 Jun 2026

Manufacturer: Ford

Model: Focus Turnier 1.5 EcoBlue Start-Stopp-System Aut. TITANIUM  
STYLE

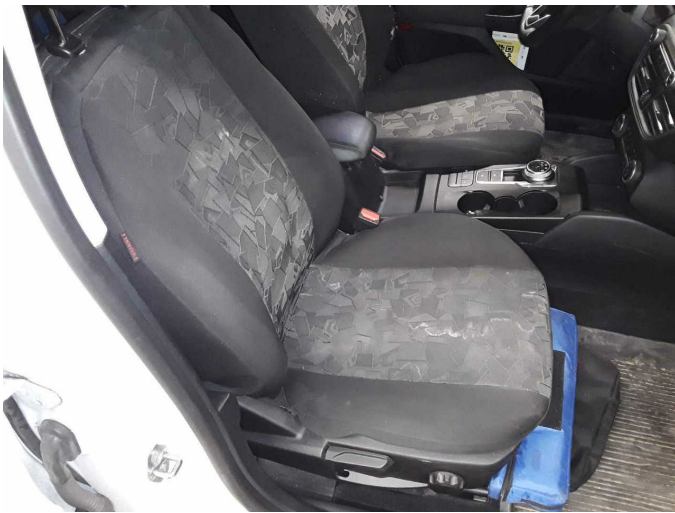
Damage 1: Seat - front: Protective cover - right side - Soiled - Replace

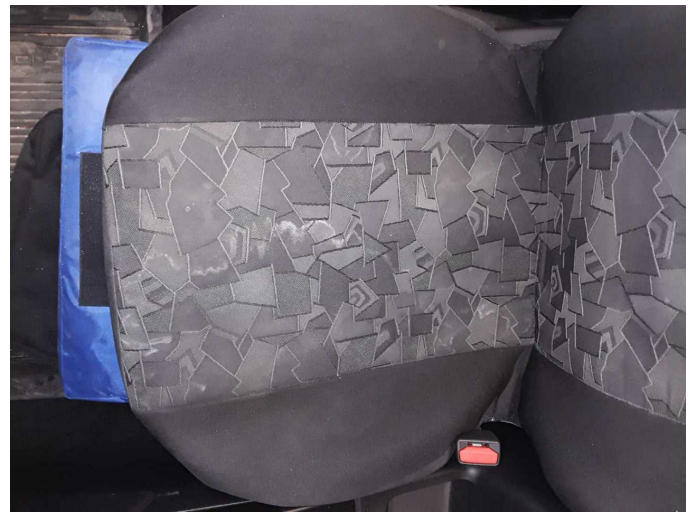
Damage 1: Seat - front: Protective cover - right side - Soiled - Replace

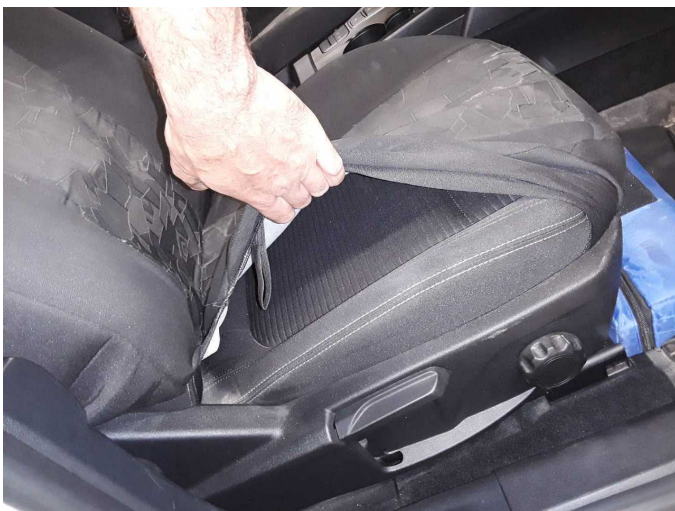
Damage 1: Seat - front: Protective cover - right side - Soiled - Replace

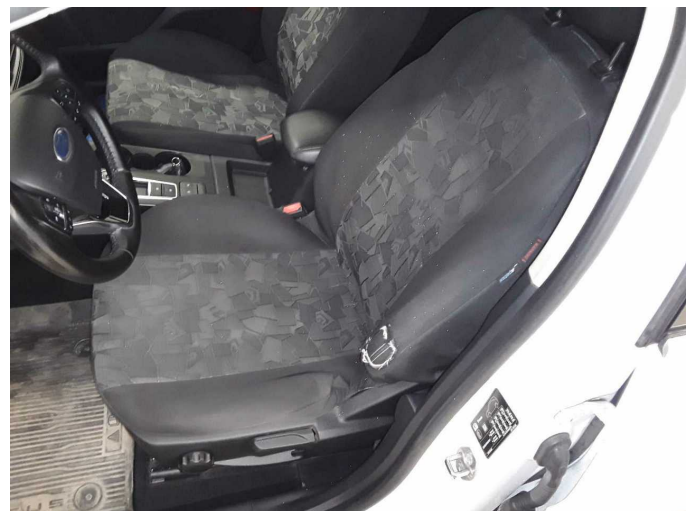
Damage 2: Seat - front: Protective Cover - left side - Broken / torn - Replace

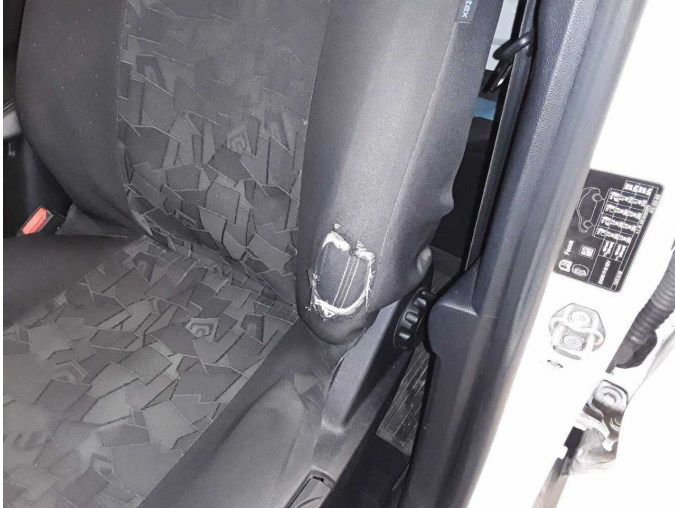
**Damage 2:** Seat - front: Protective Cover - left side - Broken / torn - Replace

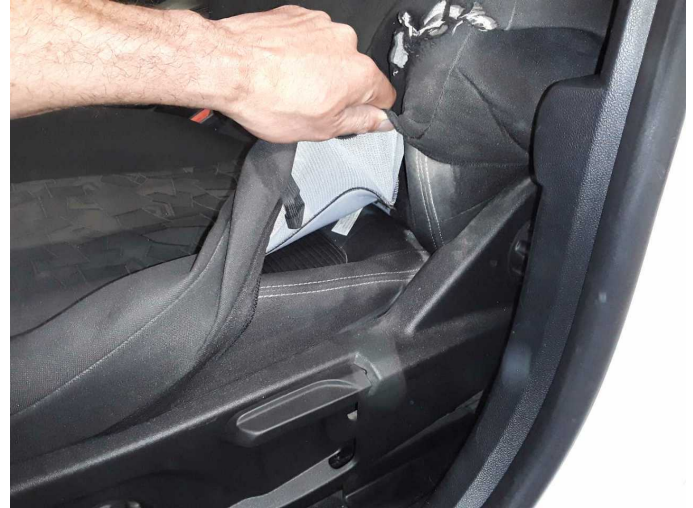
**Damage 2:** Seat - front: Protective Cover - left side - Broken / torn - Replace

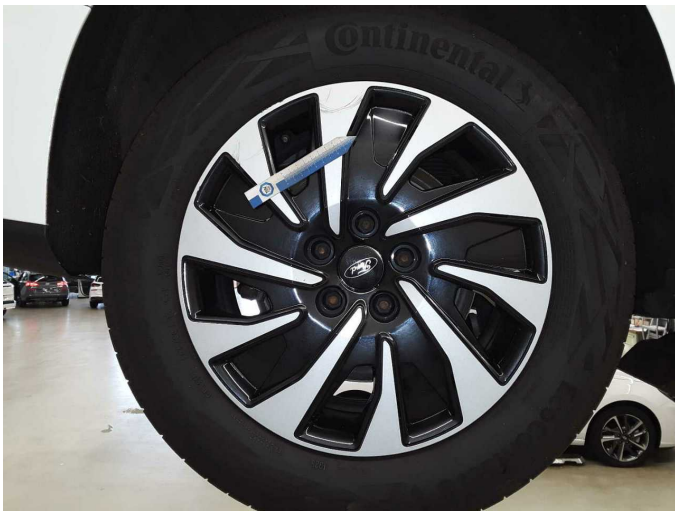
**Damage 3:** Wheel / tyres: Wheel cover - rear right side - Scratched - Replace

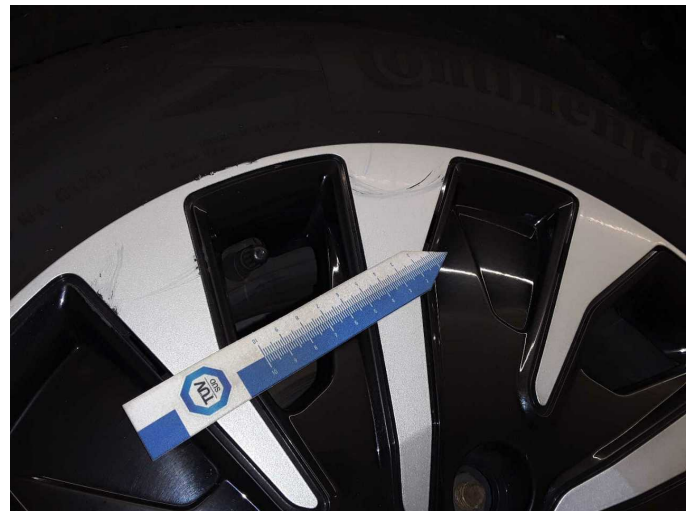
**Damage 3:** Wheel / tyres: Wheel cover - rear right side - Scratched - Replace

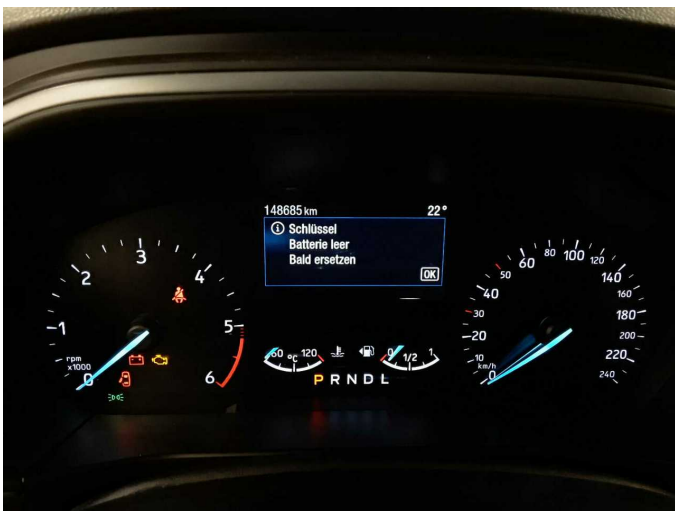
**Damage 4:** Equipment: Vehicle key - Empty - Replace

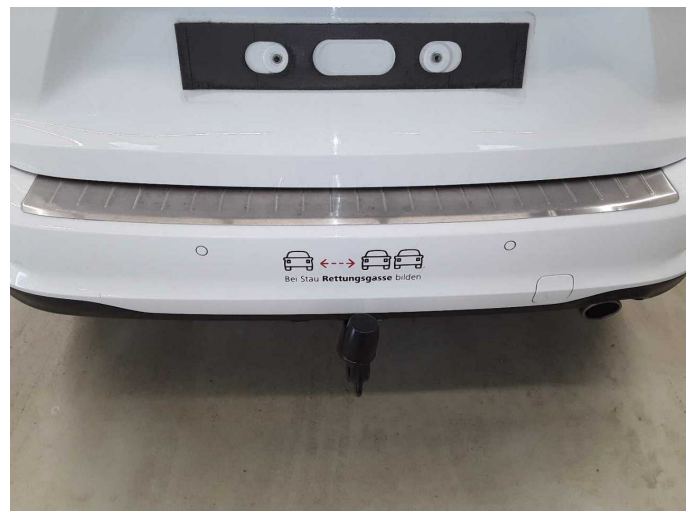
**Damage 5:** Rear bumper: Rear bumper - Glued / labelled - De-glue / neutralise

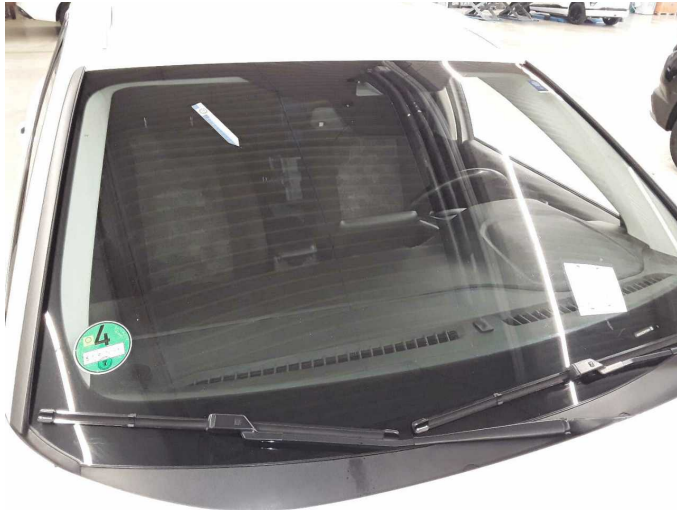
**Damage 6:** Vehicle glazing: Windscreen (Mehrkosten möglich) - Stone chips - Smart repair

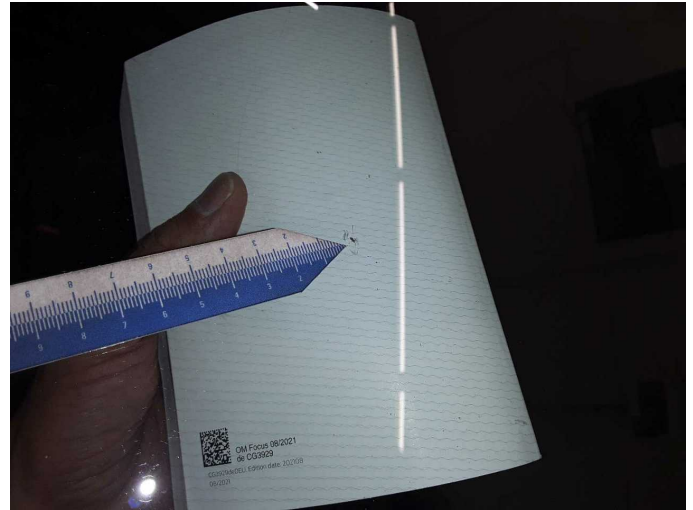
**Damage 6:** Vehicle glazing: Windscreen (Mehrkosten möglich) - Stone chips - Smart repair

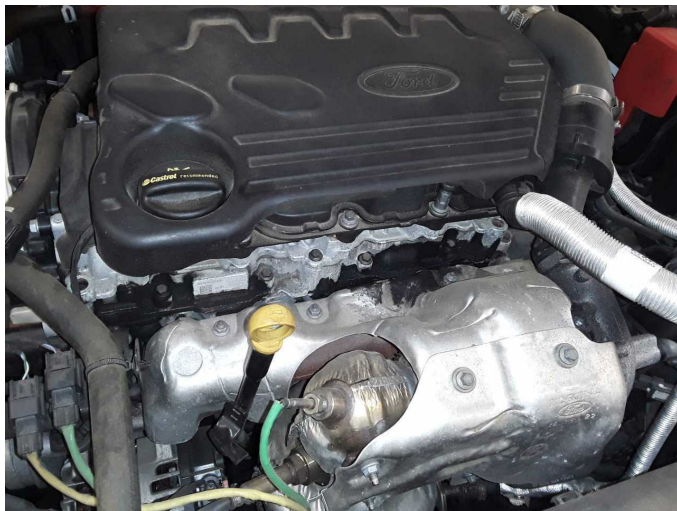
**Damage 7:** Engine: Engine (Ölspuren erkennbar) - Soiled - Diagnosed and repair if necessary

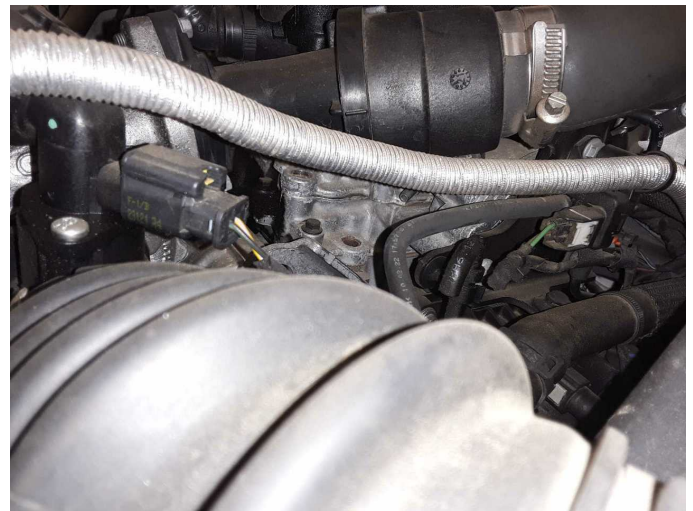
**Damage 7:** Engine: Engine (Ölspuren erkennbar) - Soiled - Diagnosed and repair if necessary

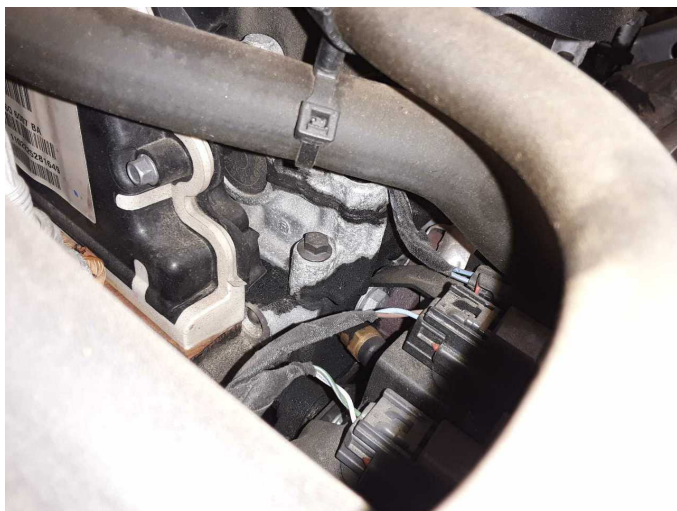
**Damage 7:** Engine: Engine (Ölspuren erkennbar) - Soiled - Diagnosed and repair if necessary

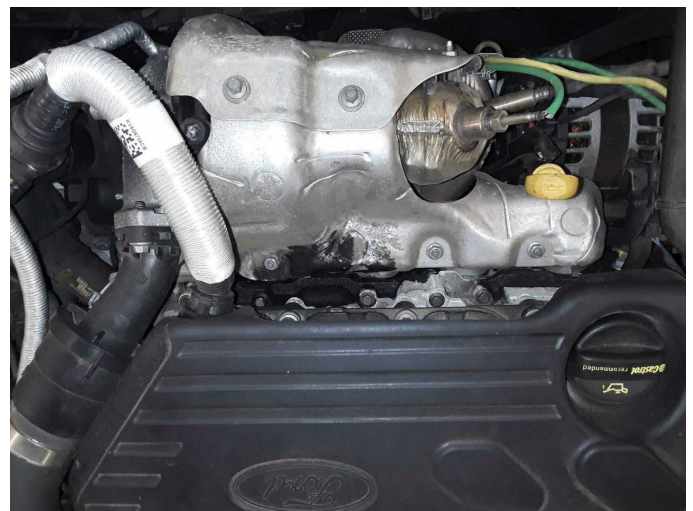
**Damage 7:** Engine: Engine (Ölspuren erkennbar) - Soiled - Diagnosed and repair if necessary

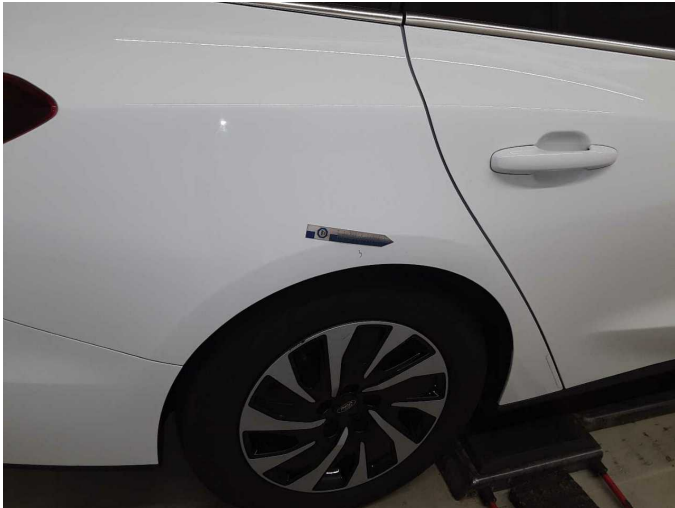
**Damage 8:** Side panel - rear right side: Side panel - Scratch(es) - Smart repair

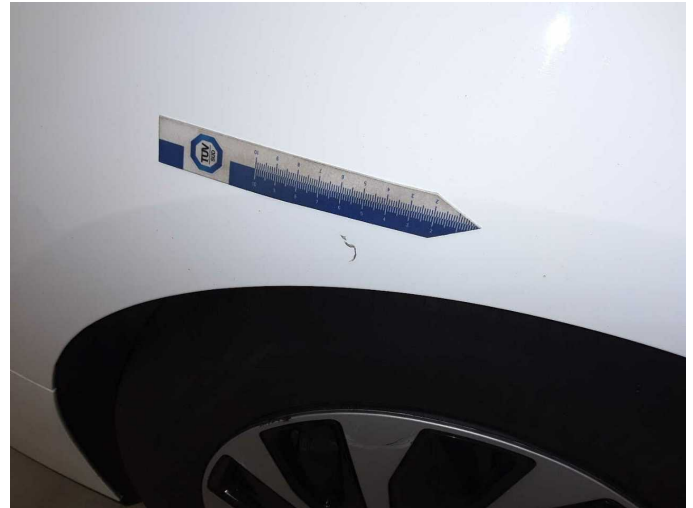
**Damage 8:** Side panel - rear right side: Side panel - Scratch(es) - Smart repair

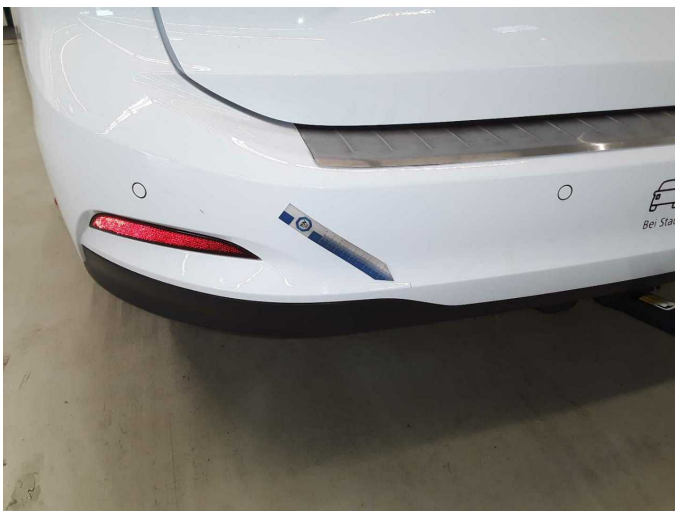
**Damage 9:** Rear bumper: Rear bumper - Scratch(es) - Smart repair

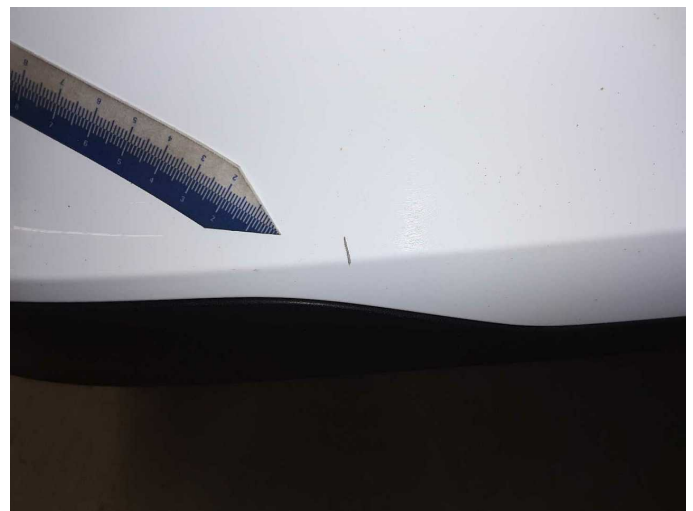
**Damage 9:** Rear bumper: Rear bumper - Scratch(es) - Smart repair

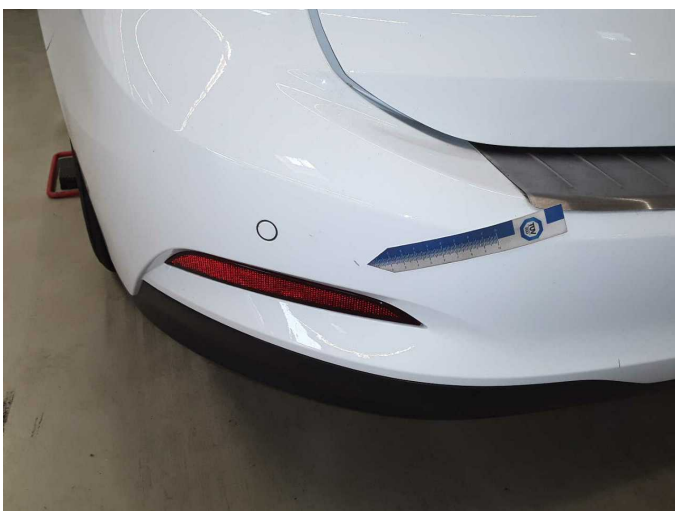
**Damage 9:** Rear bumper: Rear bumper - Scratch(es) - Smart repair

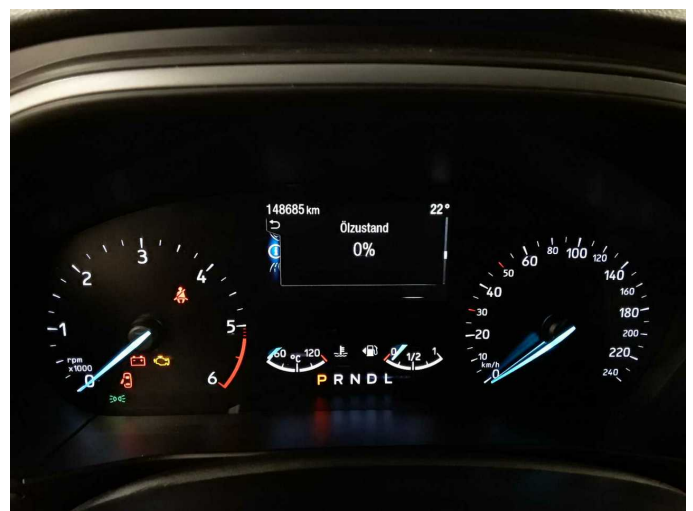
**Damage 10:** Misc.: Inspection / maintenance - Due - Perform

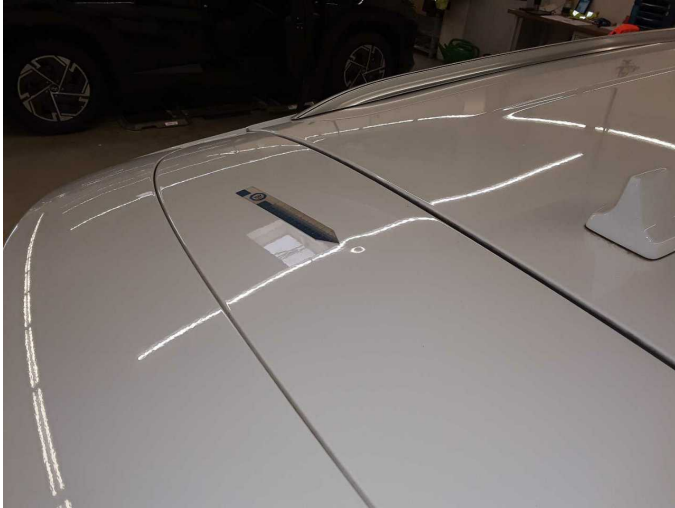
**Damage 11:** Body: Body (Hagelschaden) - dent(s) - Repair

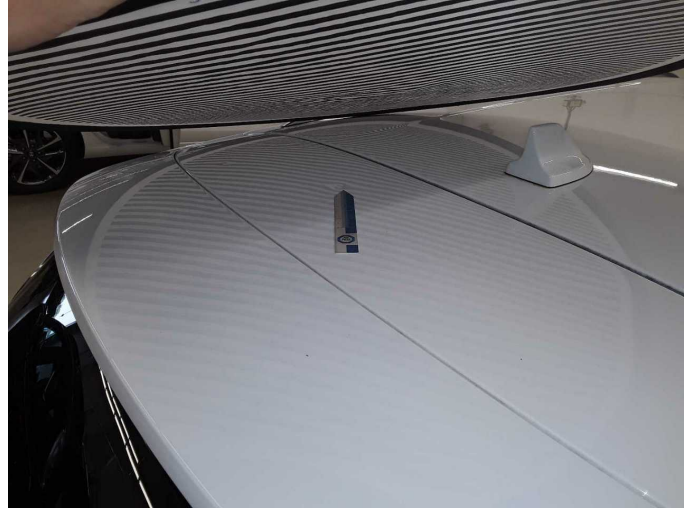
**Damage 11:** Body: Body (Hagelschaden) - dent(s) - Repair

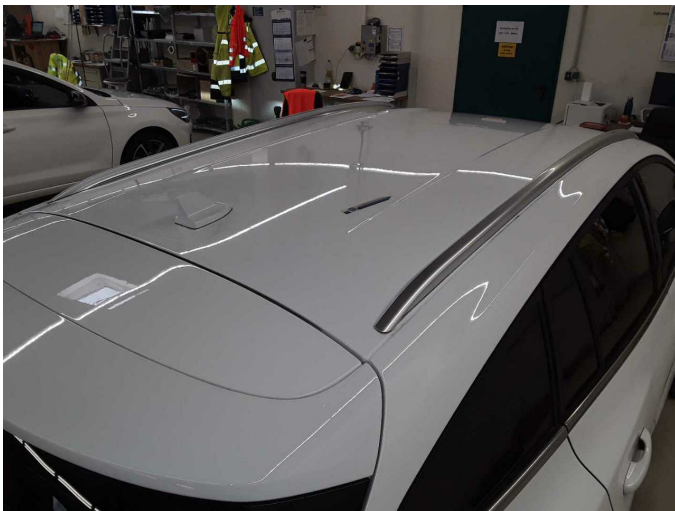
**Damage 11:** Body: Body (Hagelschaden) - dent(s) - Repair

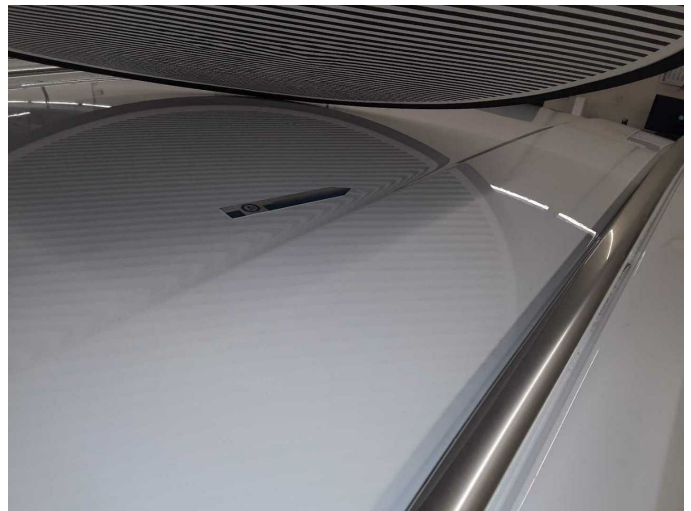
**Damage 11:** Body: Body (Hagelschaden) - dent(s) - Repair

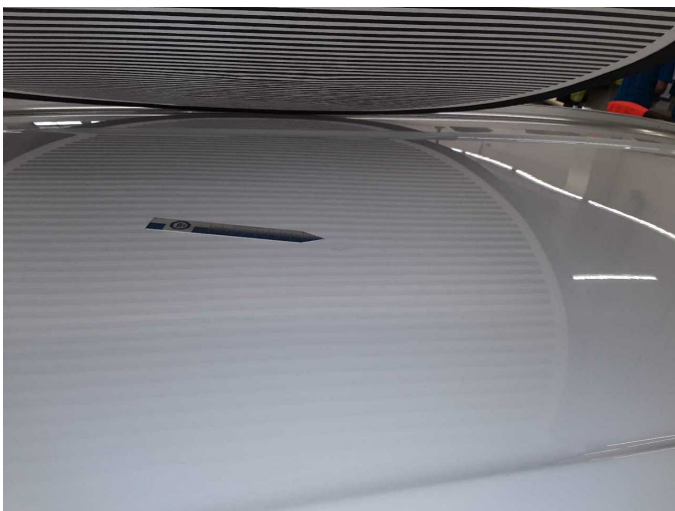
**Damage 11:** Body: Body (Hagelschaden) - dent(s) - Repair

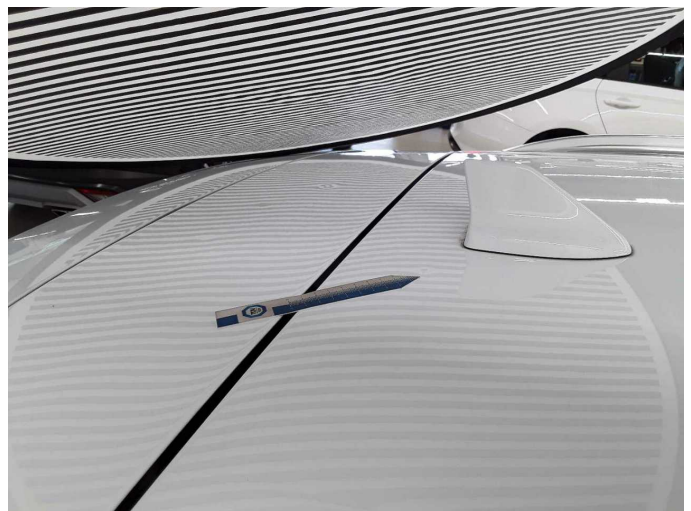
**Damage 11:** Body: Body (Hagelschaden) - dent(s) - Repair

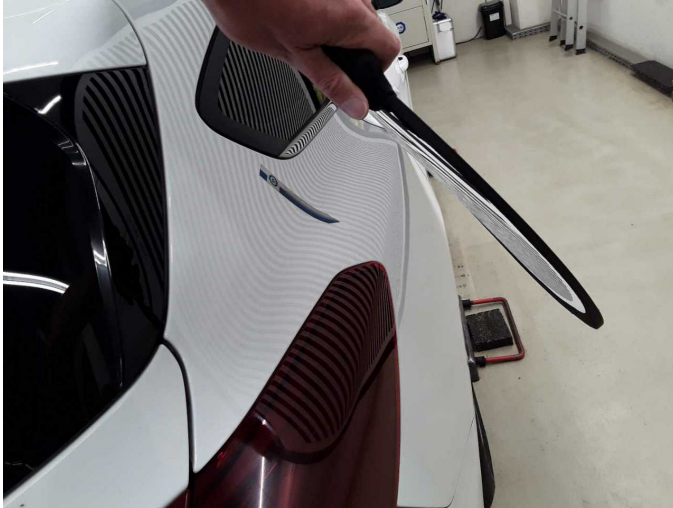
**Damage 11:** Body: Body (Hagelschaden) - dent(s) - Repair

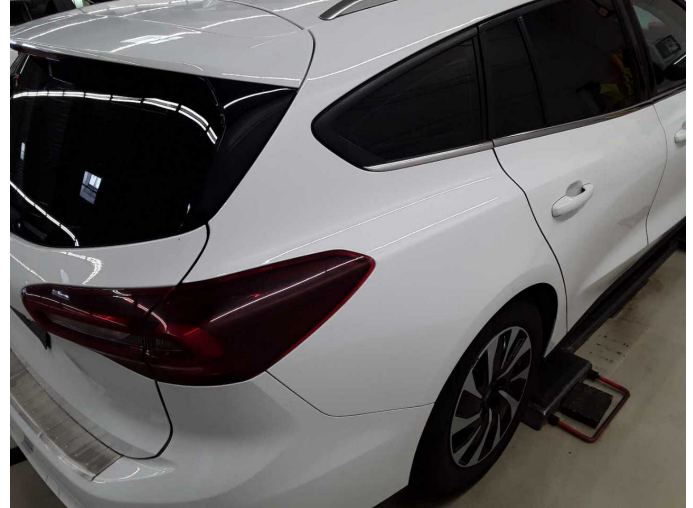
**Damage 11:** Body: Body (Hagelschaden) - dent(s) - Repair

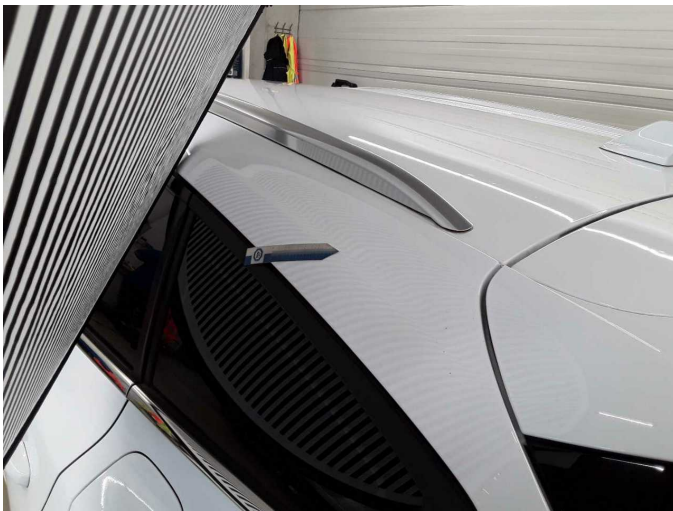
**Damage 11:** Body: Body (Hagelschaden) - dent(s) - Repair

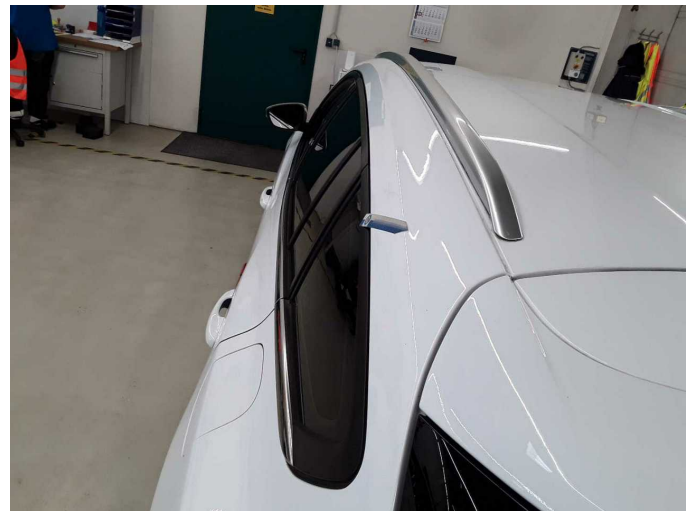
**Damage 11:** Body: Body (Hagelschaden) - dent(s) - Repair

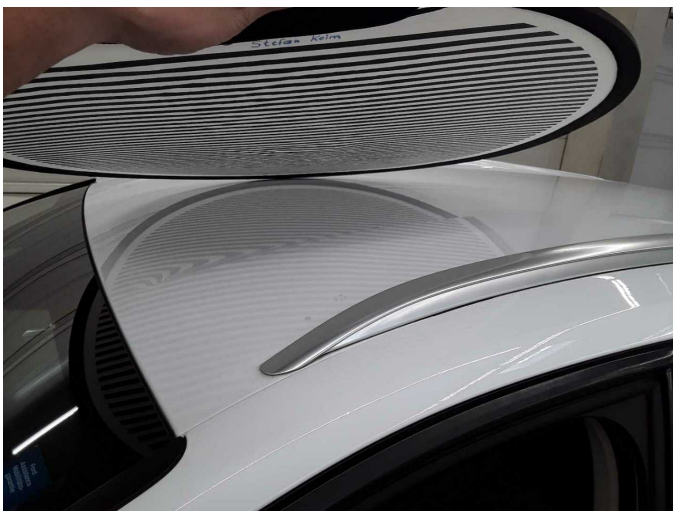
**Damage 11:** Body: Body (Hagelschaden) - dent(s) - Repair

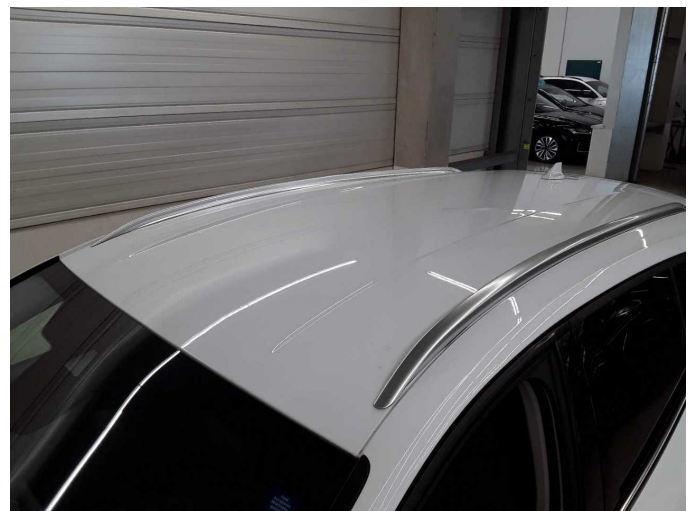
**Damage 11:** Body: Body (Hagelschaden) - dent(s) - Repair

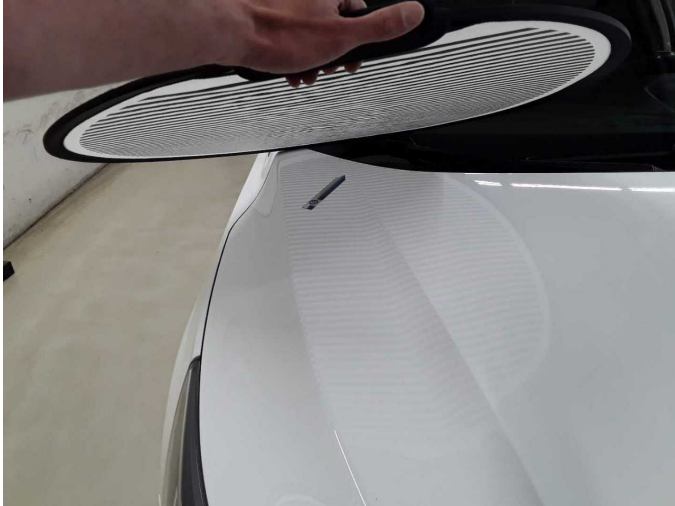
**Damage 11:** Body: Body (Hagelschaden) - dent(s) - Repair

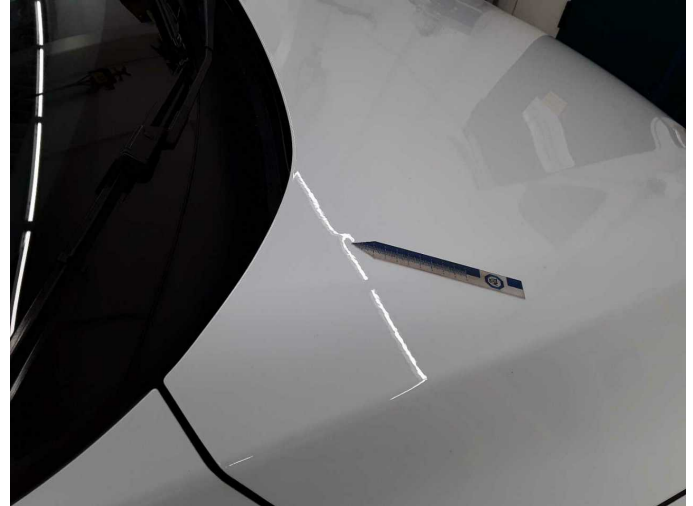
**Damage 11:** Body: Body (Hagelschaden) - dent(s) - Repair

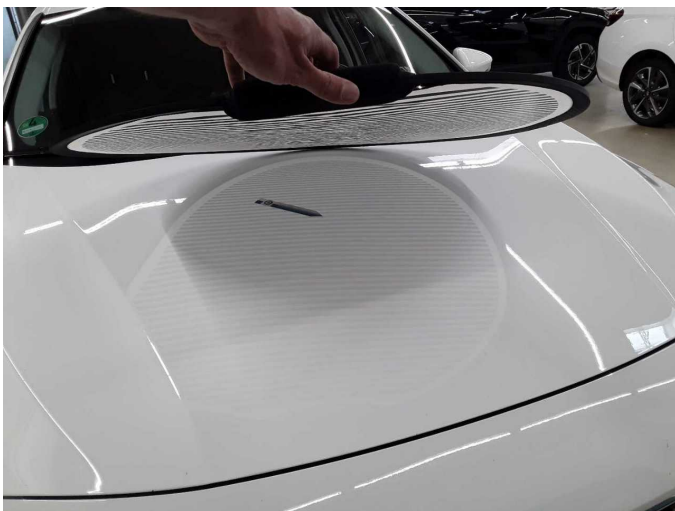
**Damage 11:** Body: Body (Hagelschaden) - dent(s) - Repair

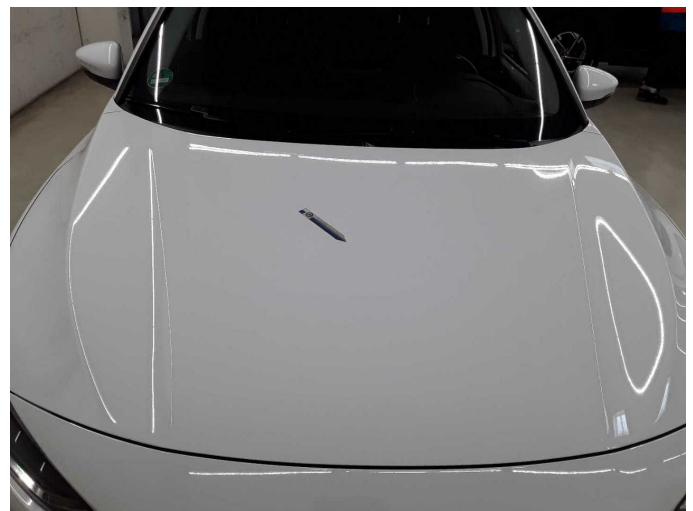
**Damage 11:** Body: Body (Hagelschaden) - dent(s) - Repair

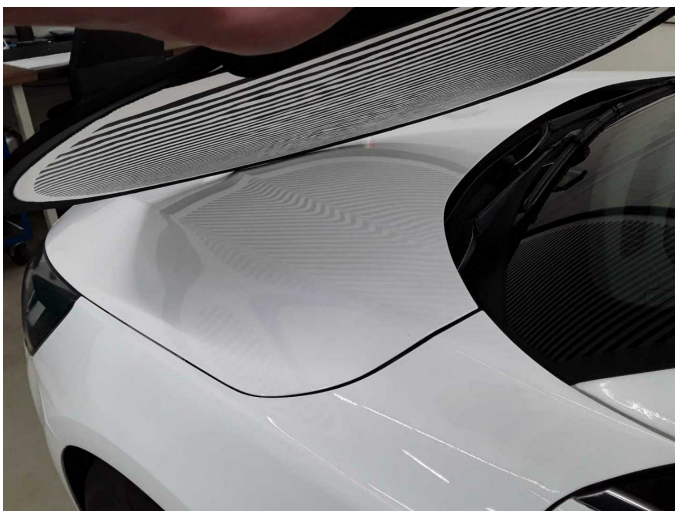
**Damage 11:** Body: Body (Hagelschaden) - dent(s) - Repair

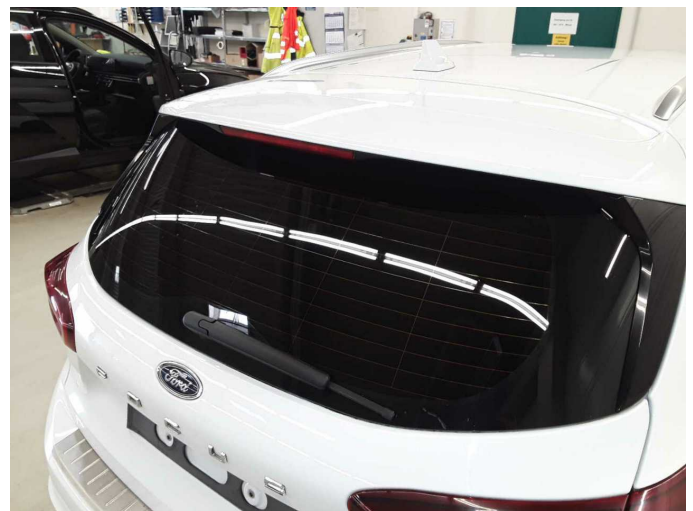
**Wear and tear 1:** Vehicle glazing: Rear window (+Seitenscheiben, Tönungsfolie, ohne Nachweis) - Glued / labelled - No deduction

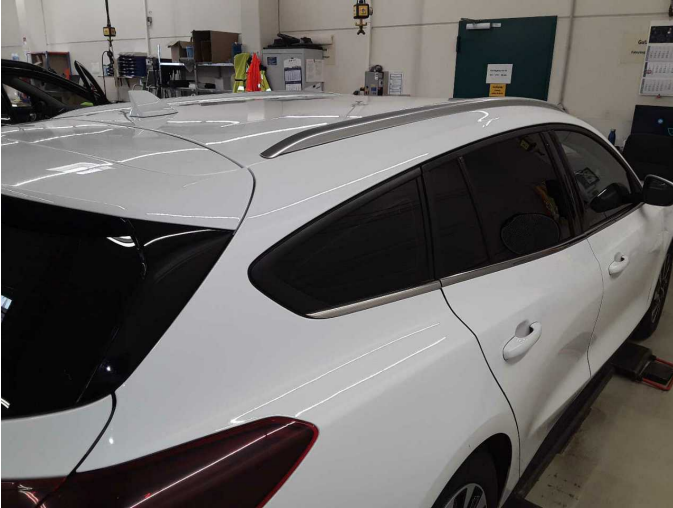
**Wear and tear 1:** Vehicle glazing: Rear window (+Seitenscheiben, Tönungsfolie, ohne Nachweis) - Glued / labelled - No deduction

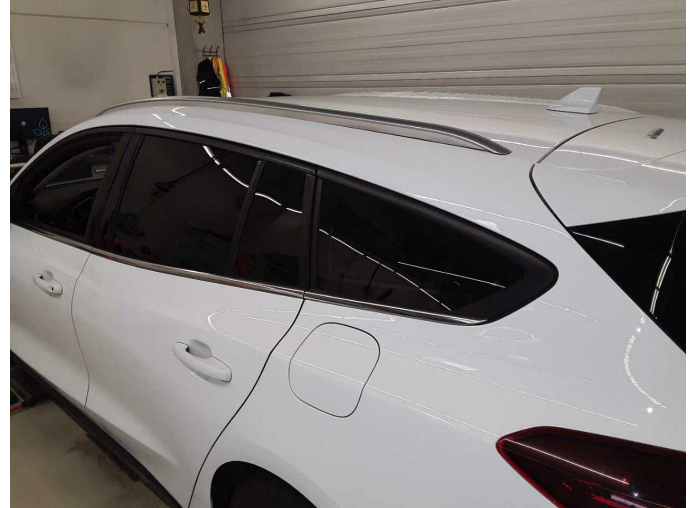
**Wear and tear 1:** Vehicle glazing: Rear window (+Seitenscheiben, Tönungsfolie, ohne Nachweis) - Glued / labelled - No deduction

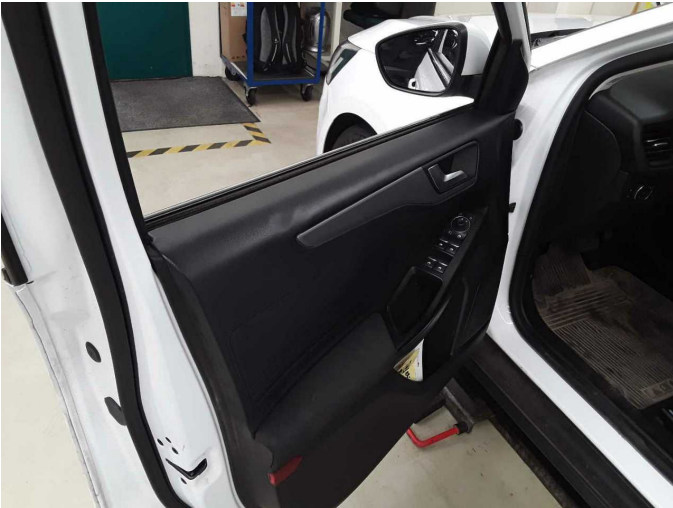
**Wear and tear 2:** Trim / covers: Door trim - front left side - dent(s) - No deduction
