Expertise

Protocol number: 45769961
Order No. / Reference: 26479632
Inspection date: 2 Jun 2026

Model: Traveller L2 2.0 BlueHDi 180 EAT8 Business

VIN: VF3VEEHZ8LZ083636

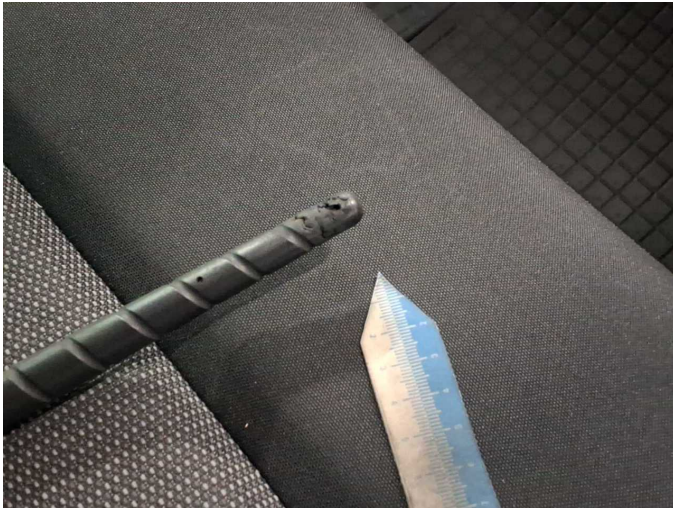
Damage 1: Roof: Stub aerial - Damage caused by marten / rodent - Replace

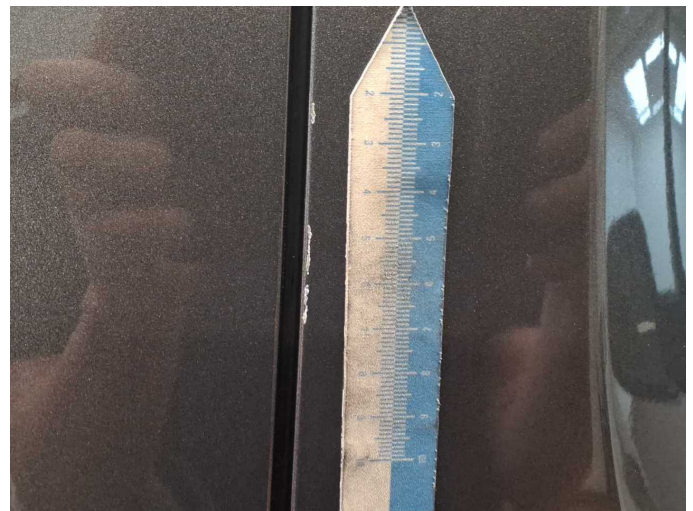
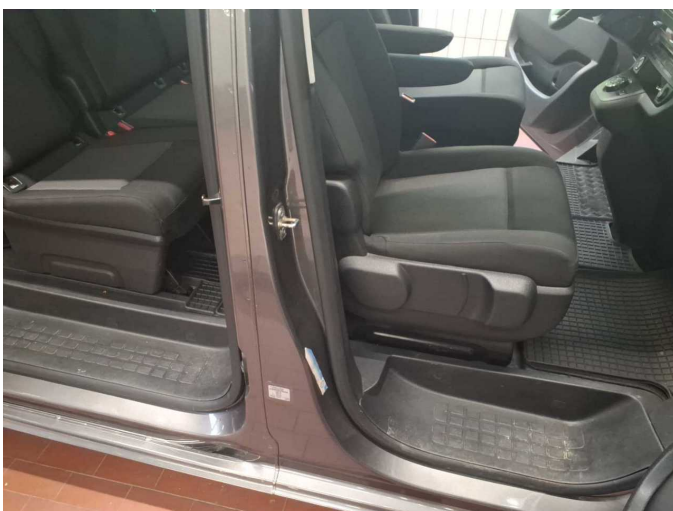
Damage 3: Door - front right side: Door edge - Scratch(es) - Smart repair

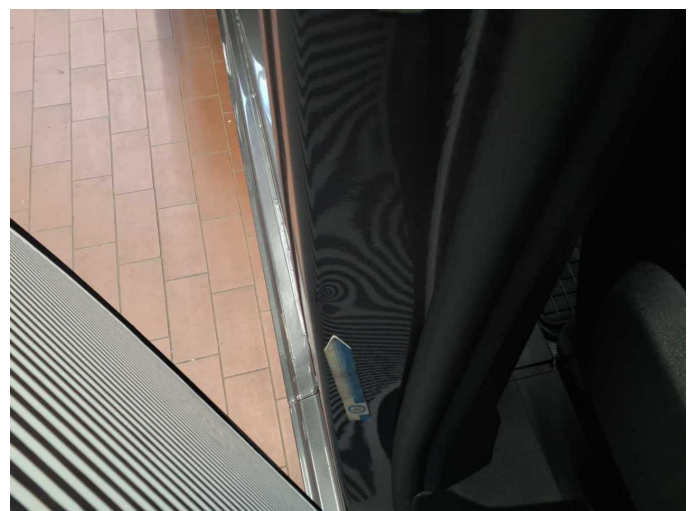
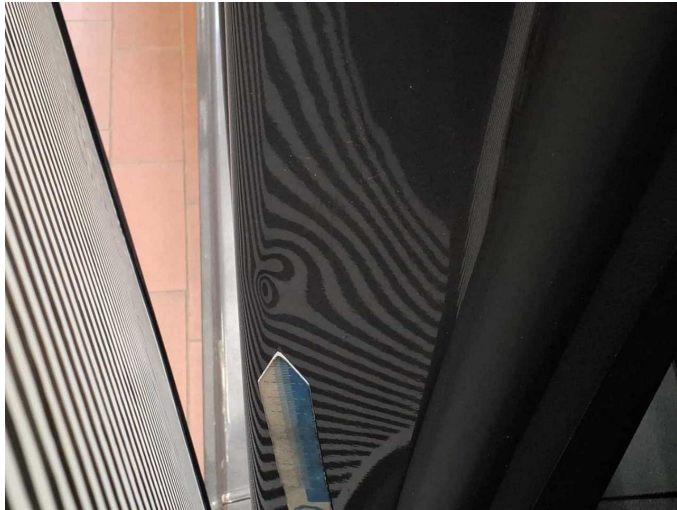
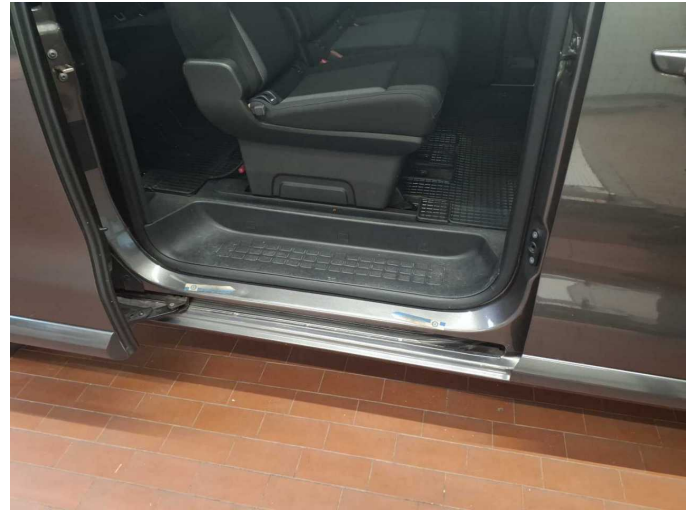
Damage 4: Body: B-pillar - right side - dent(s) - Smooth repair work

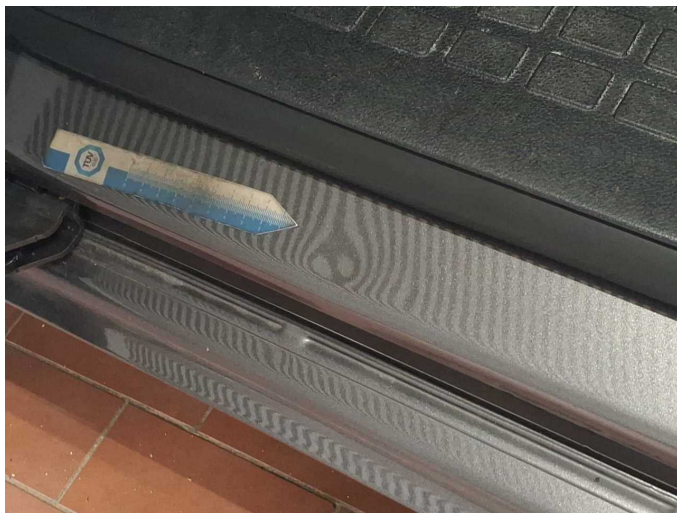
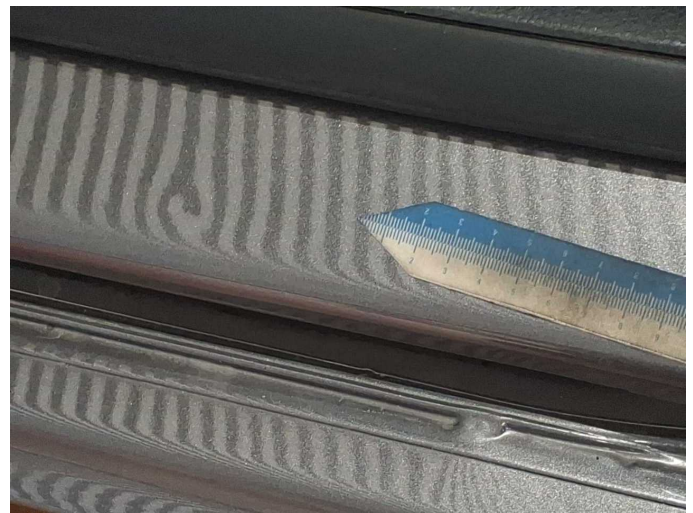
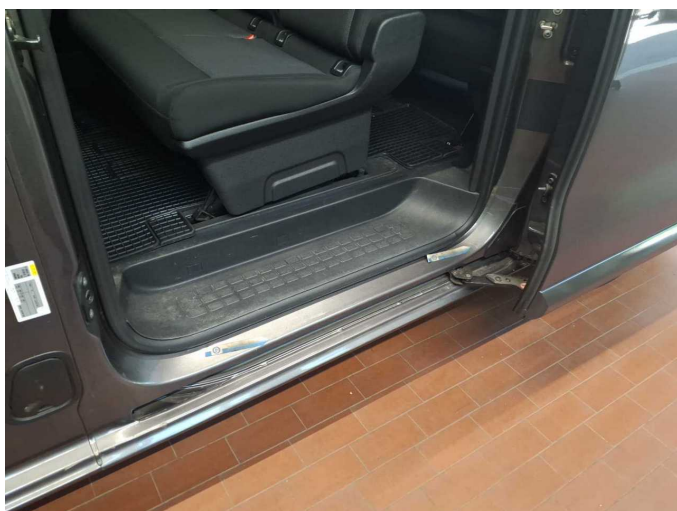
Damage 5: Side panel - rear right side: Sill - dent(s) - Smooth repair work

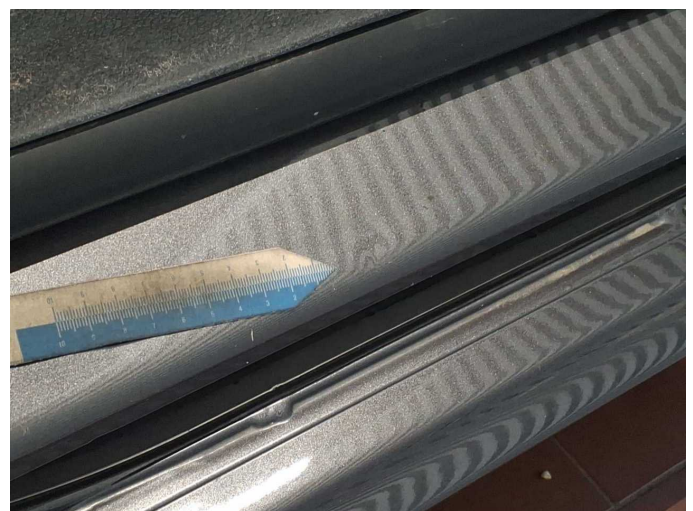
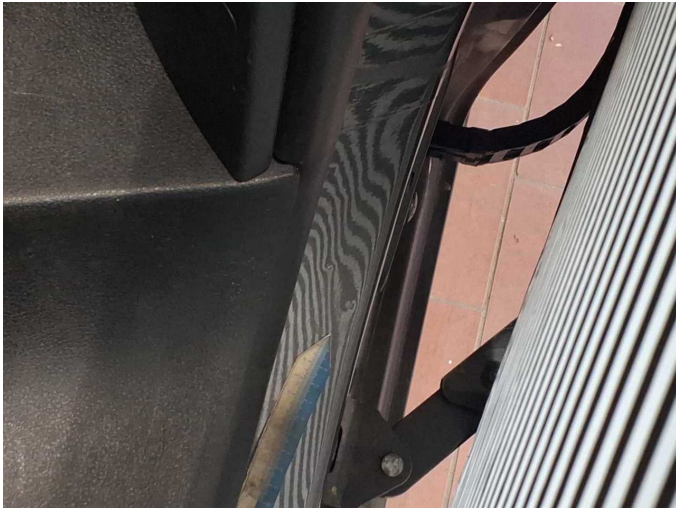
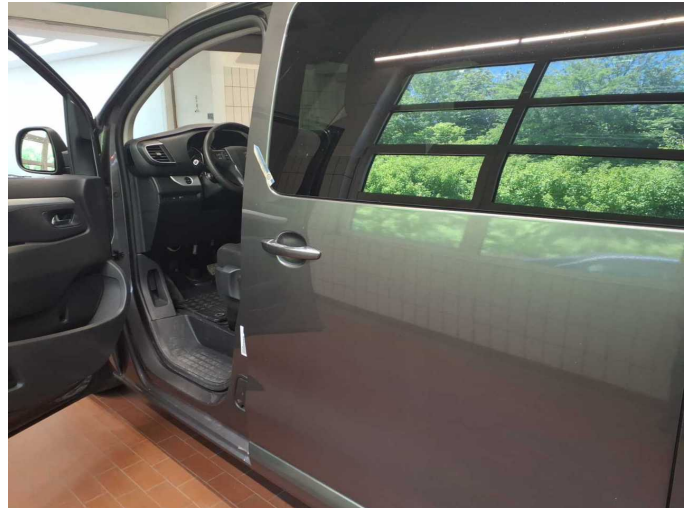
Damage 6: Side panel - rear left side: Sill - dent(s) - Smart repair

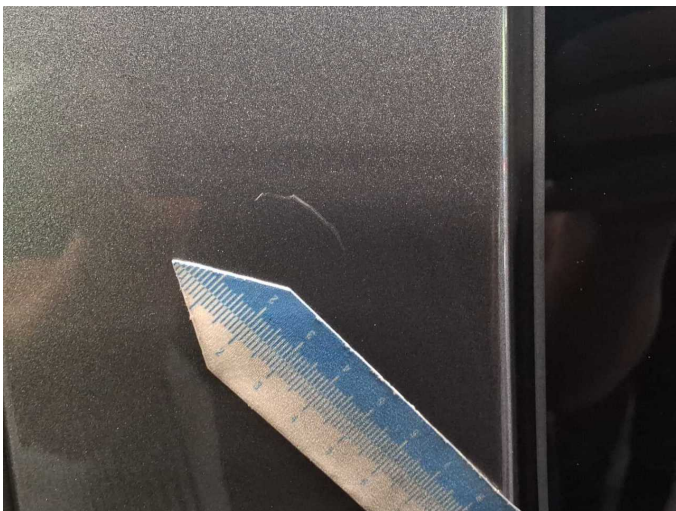
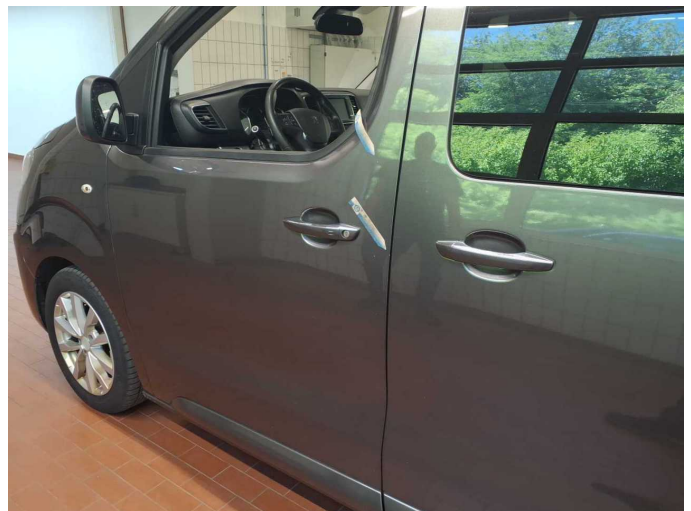
Damage 7: Sliding door - left side: Sliding door with glass panel - Scratch(es) - Smart repair

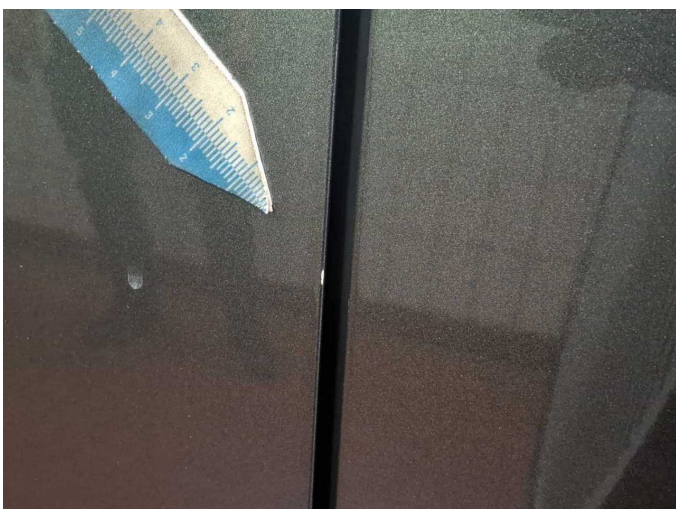
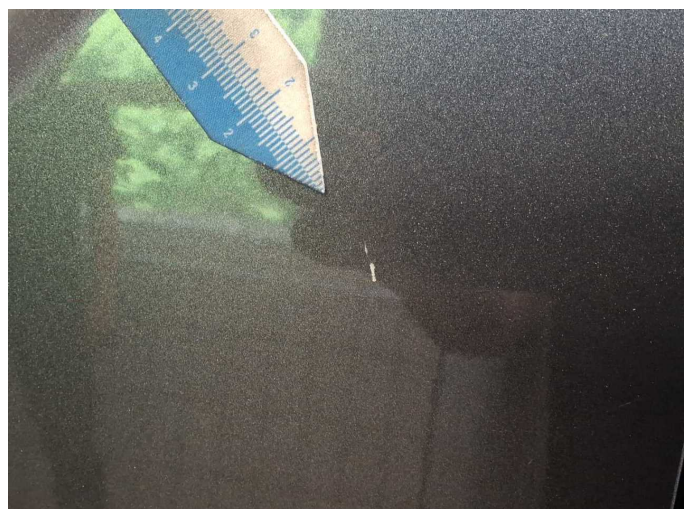
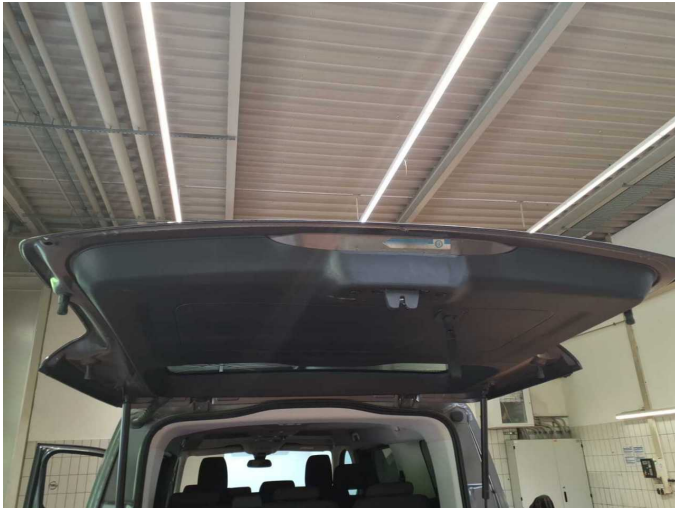
Damage 8: Door - front left side: Door - Scratch(es) - Smart repair

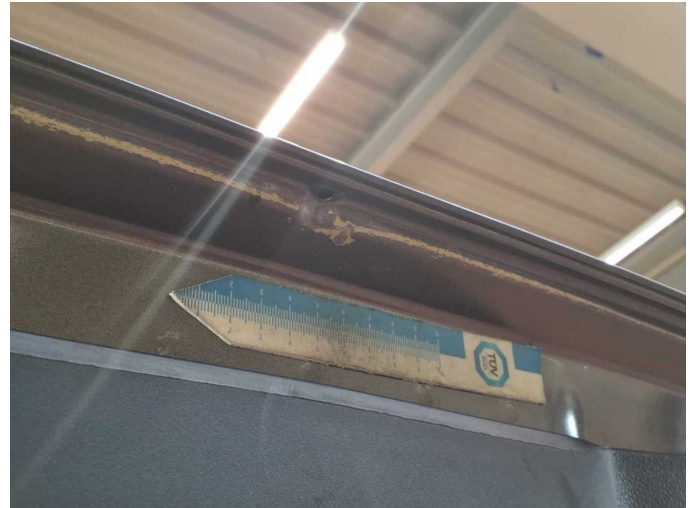
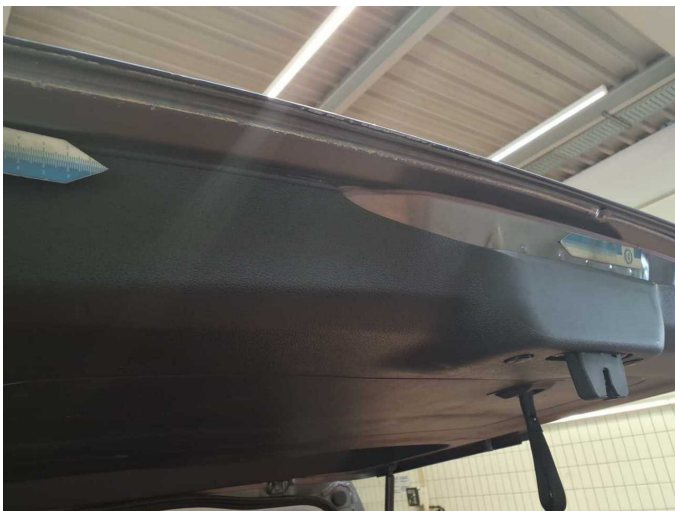
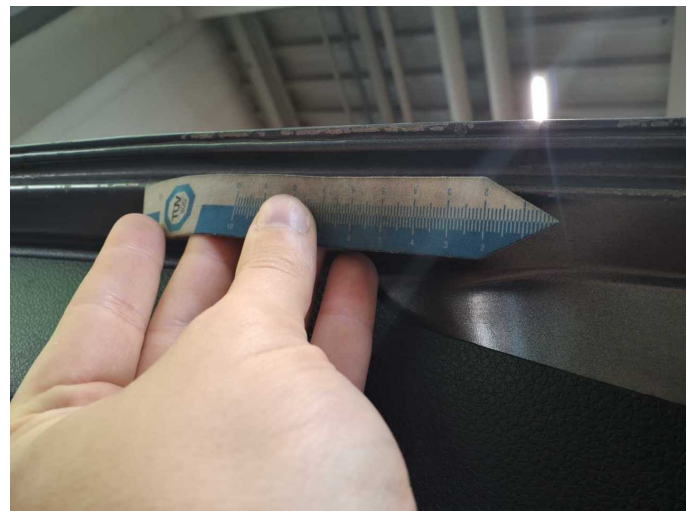
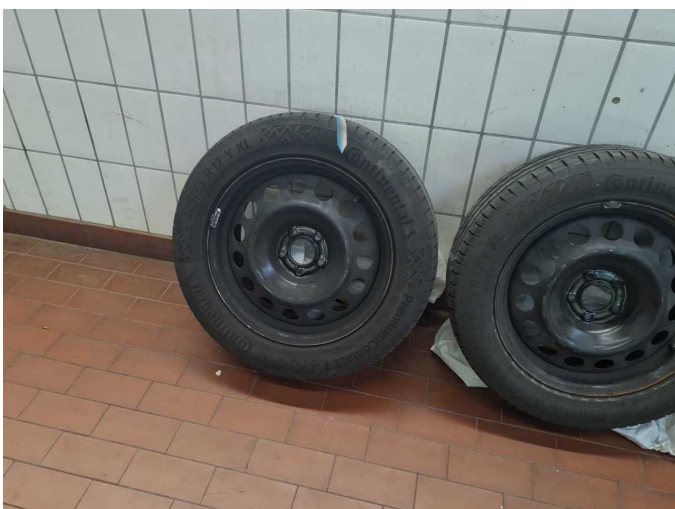
Damage 9: Boot lid / rear door: Boot lid - Scratch(es) - Smart repair

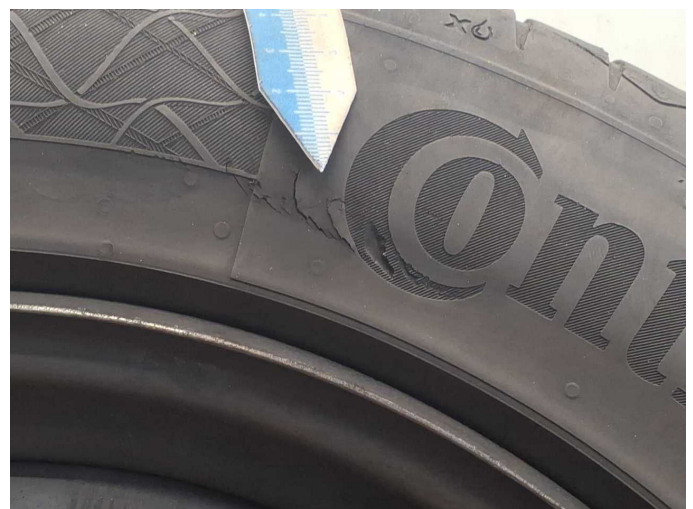
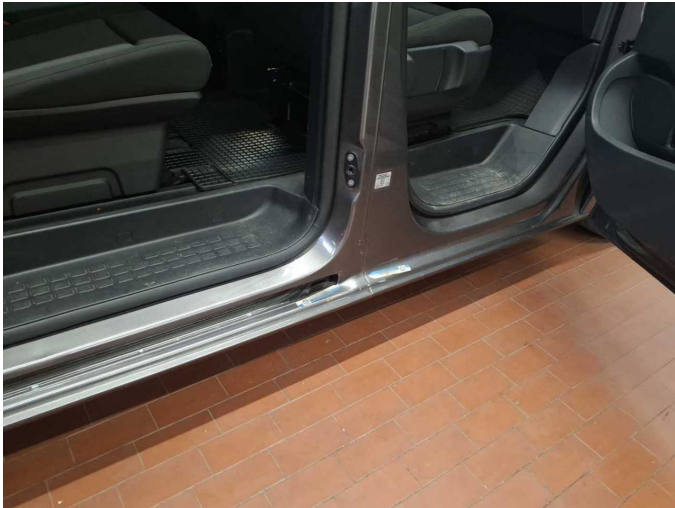
Damage 10: 2nd wheel set: 1 tyre - Broken / torn - Replace

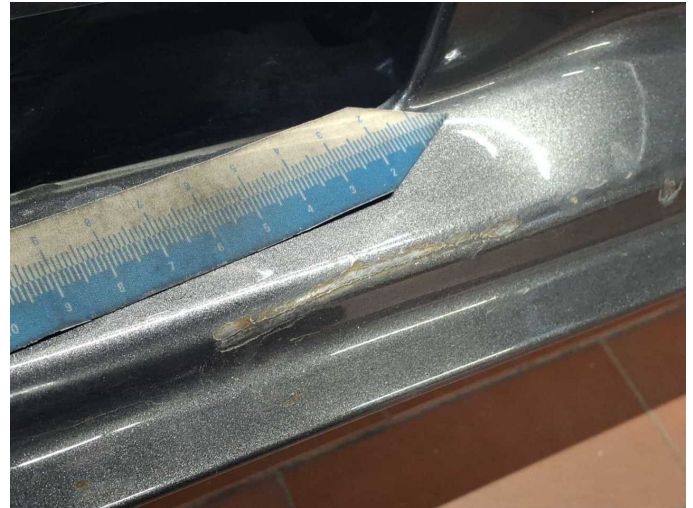
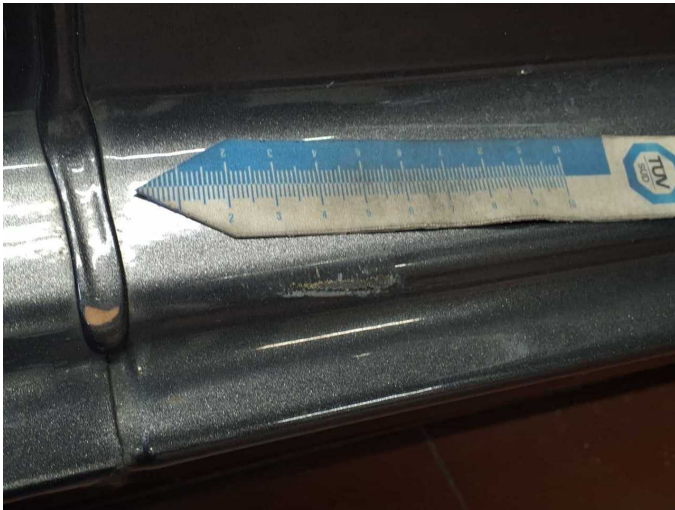
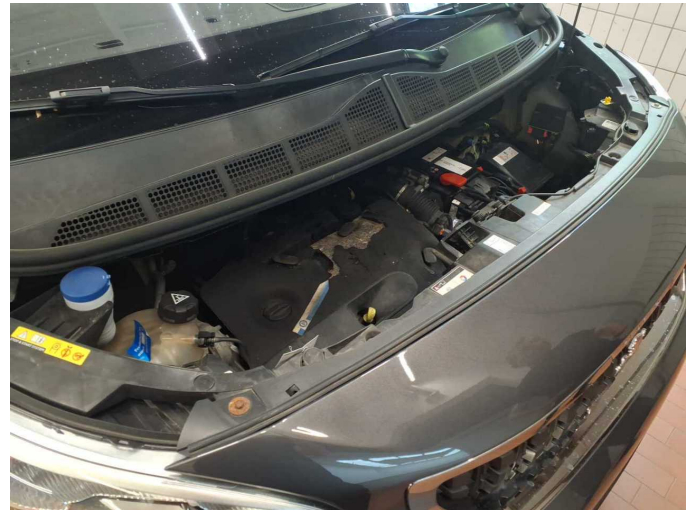
Damage 11: Sill - right side: Sill - Scratch(es) - Smart repair

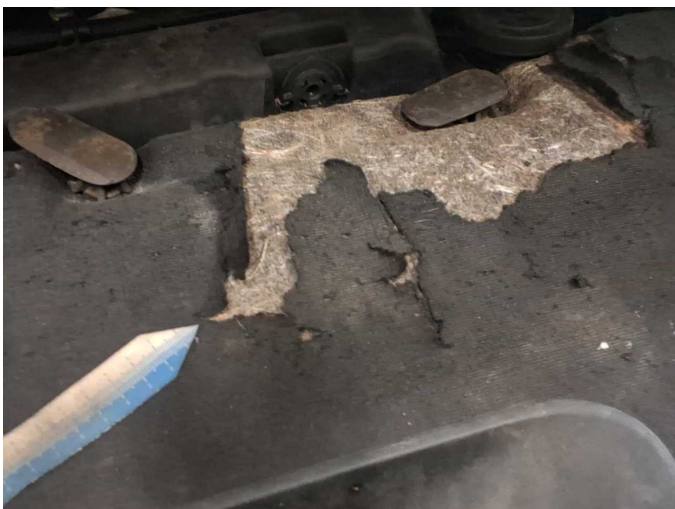
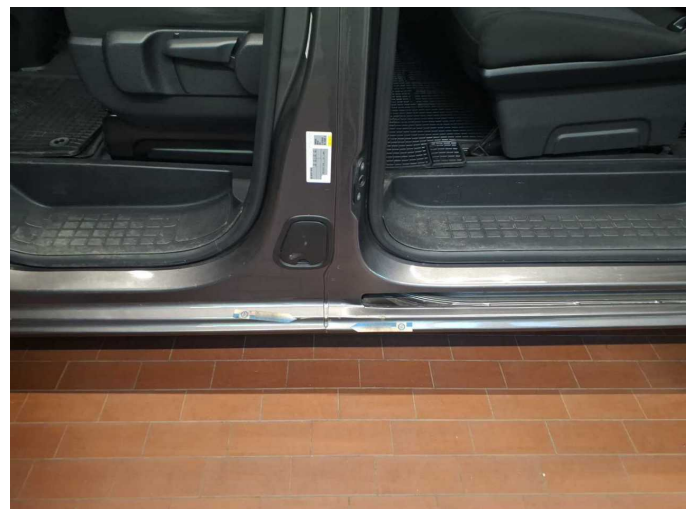
Damage 12: Engine: Engine cover - Damage caused by marten / rodent - Replace

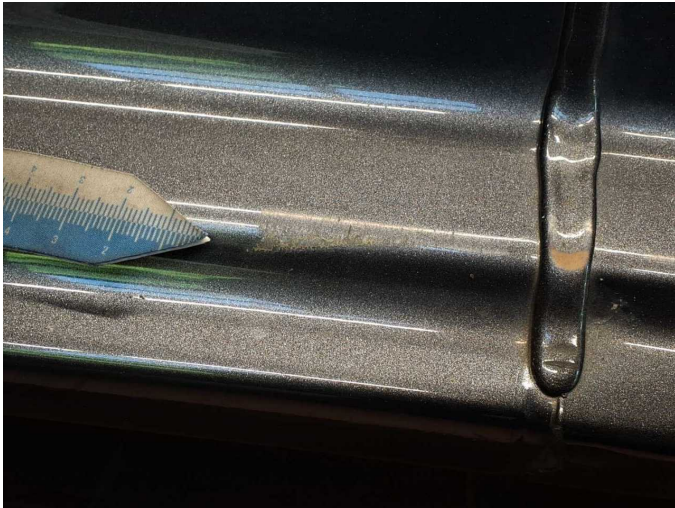
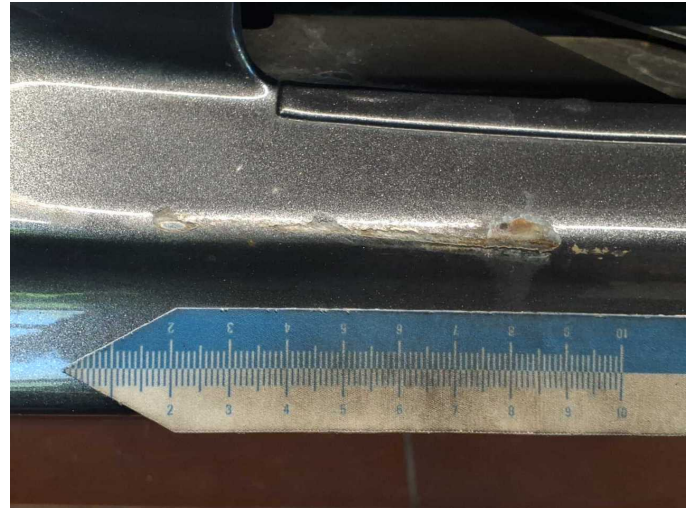
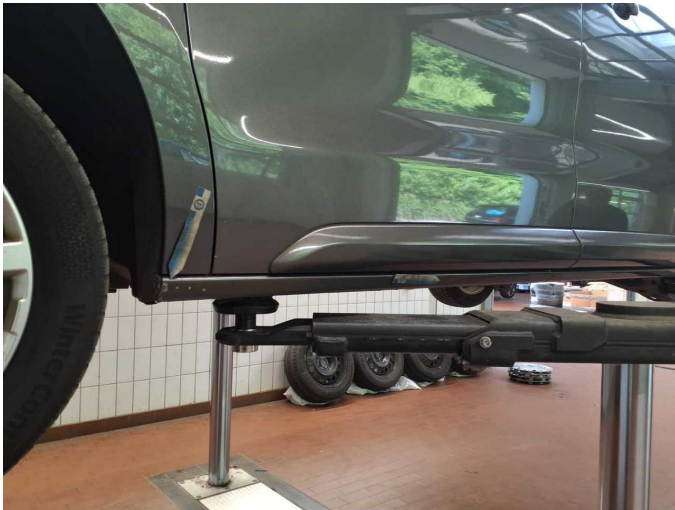
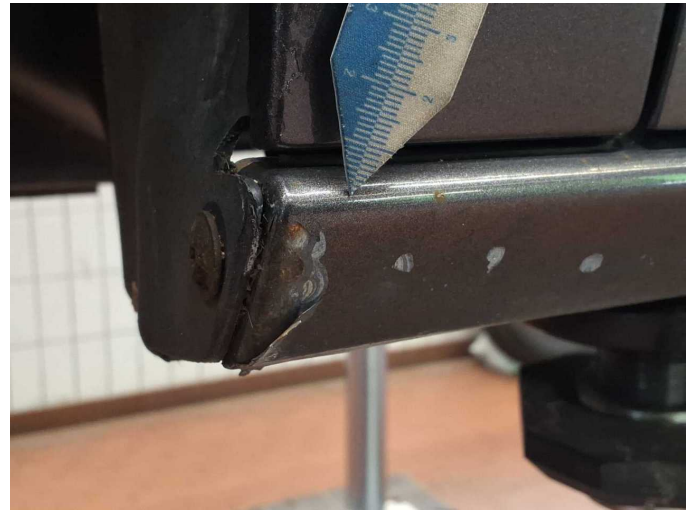
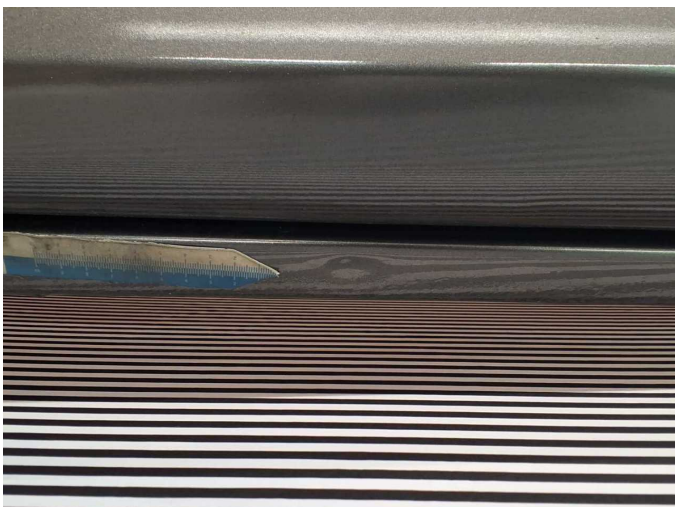
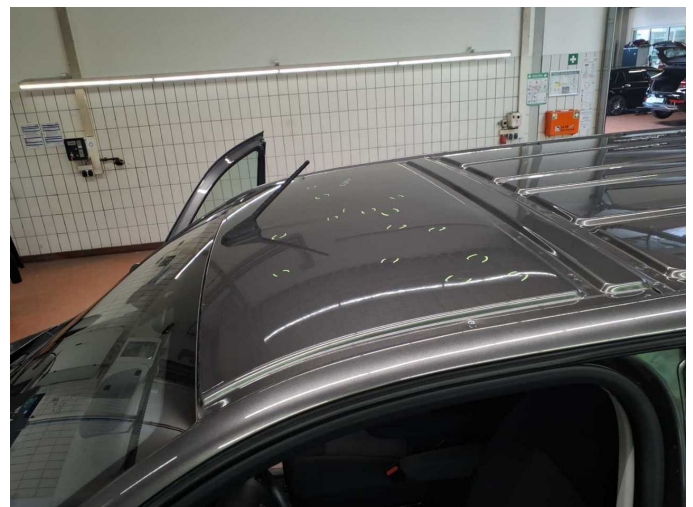
Damage 13: Sill - left side: Sill - Dent / paintcoat damage - Repair and paint

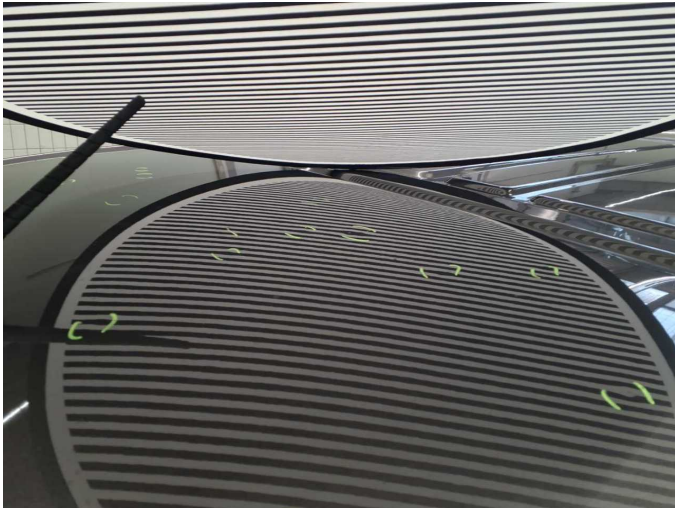
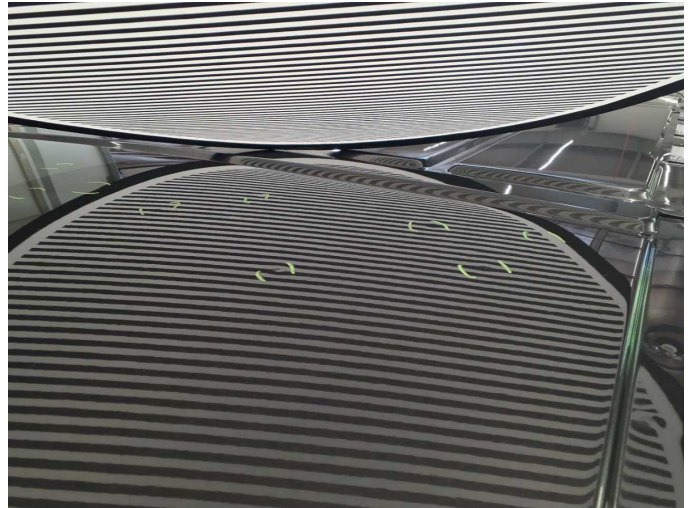
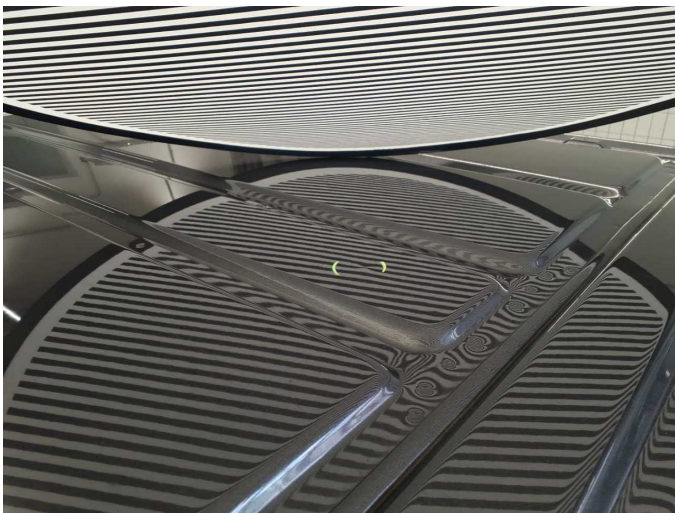
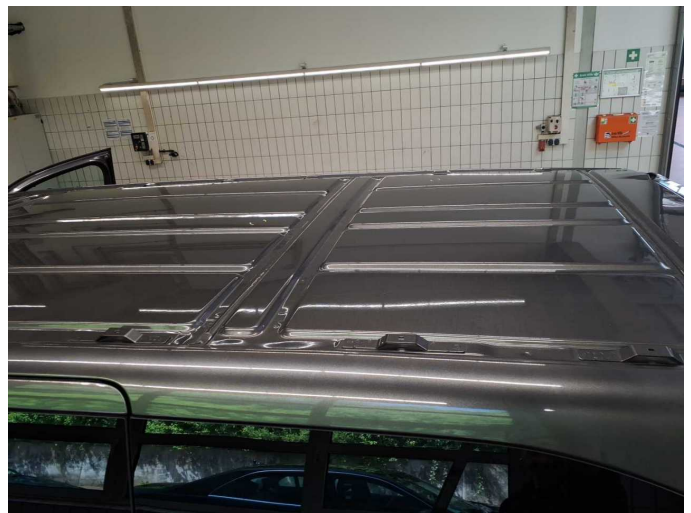
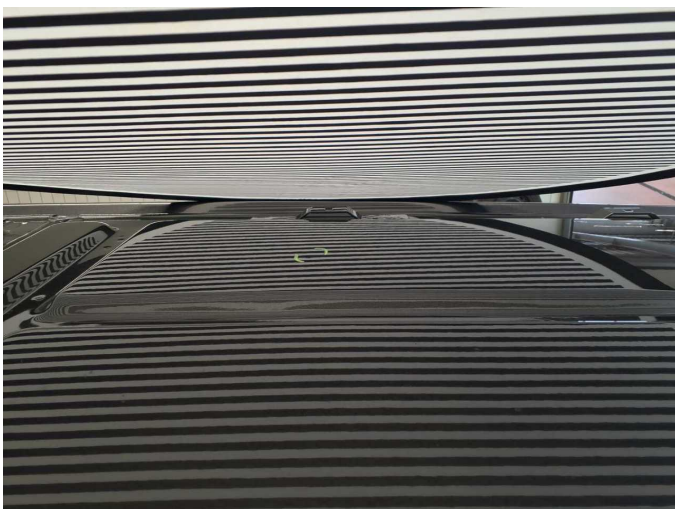
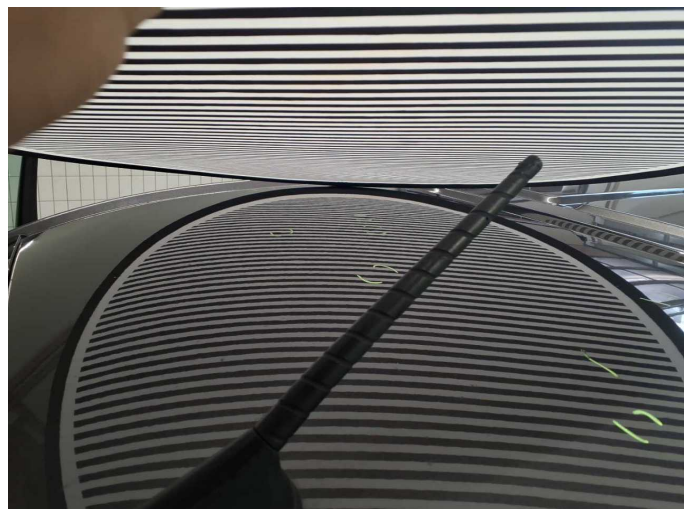
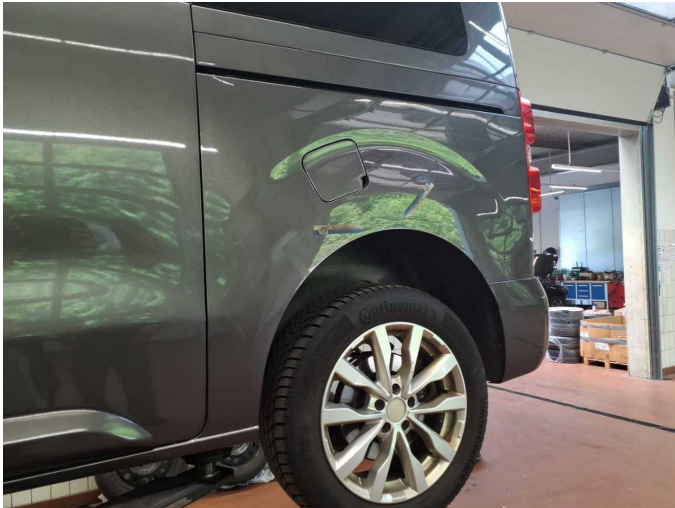
Damage 14: Roof: Roof - Damage by hail - Smooth repair work

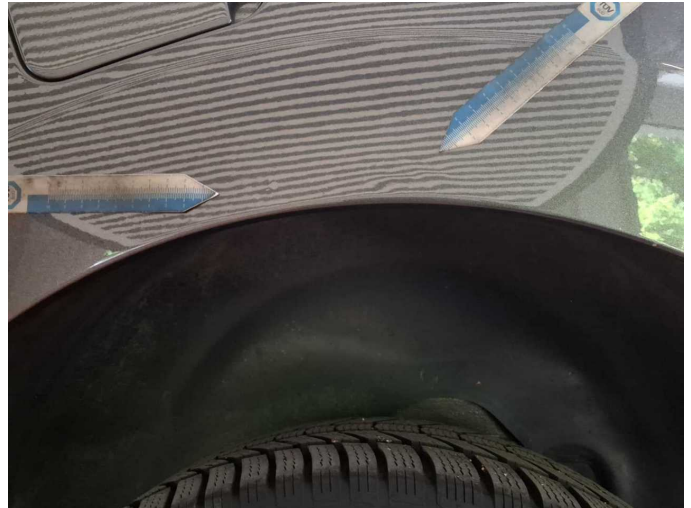
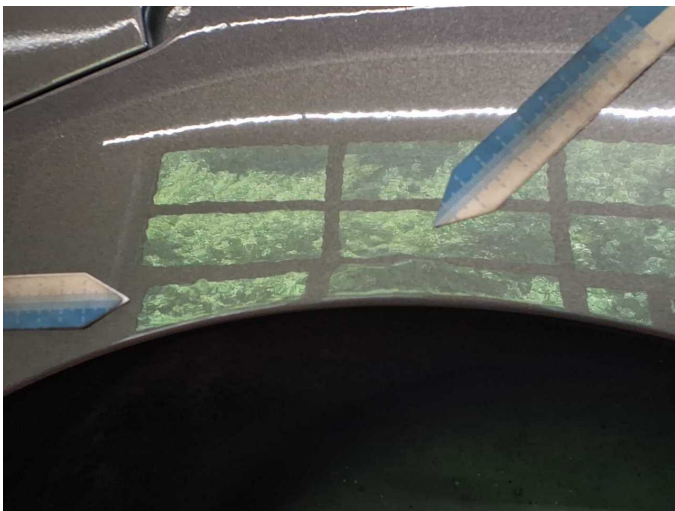
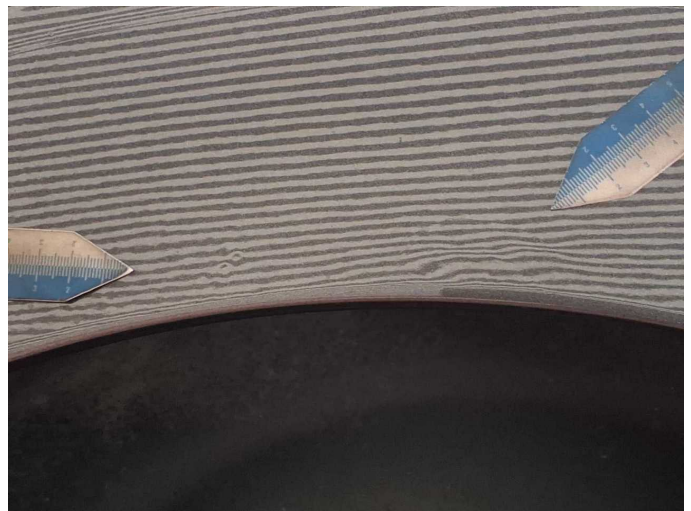
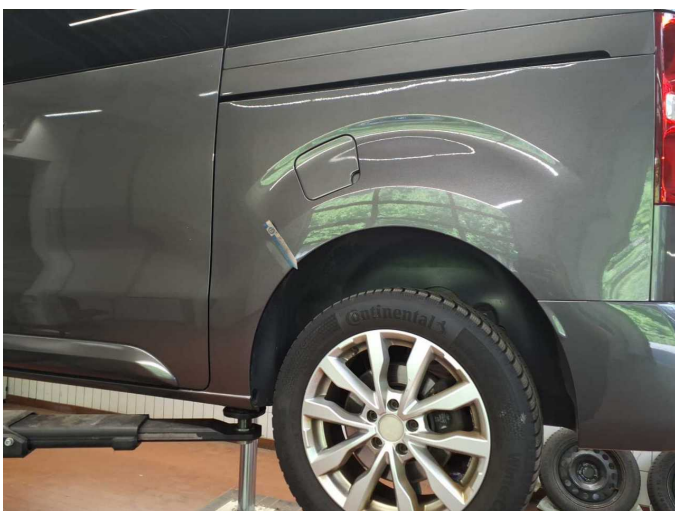
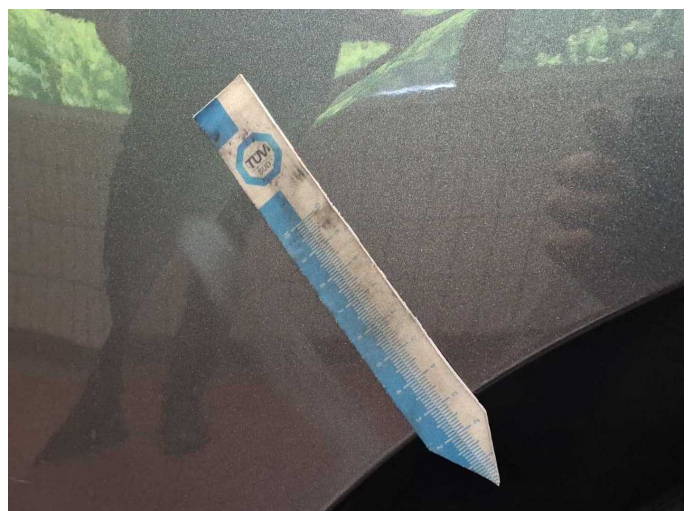
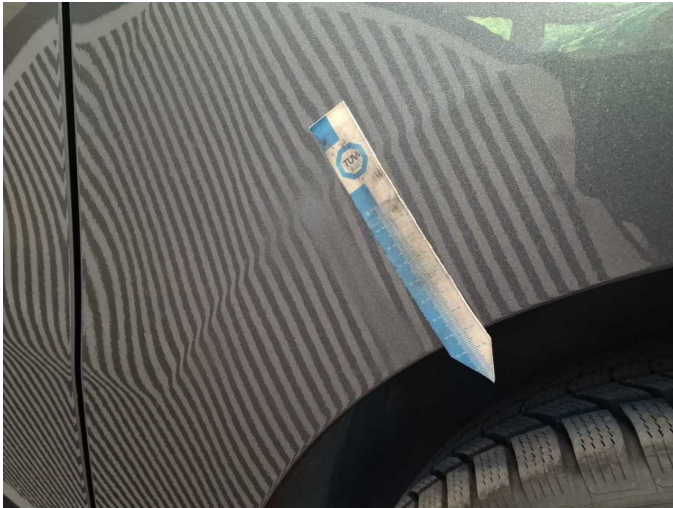
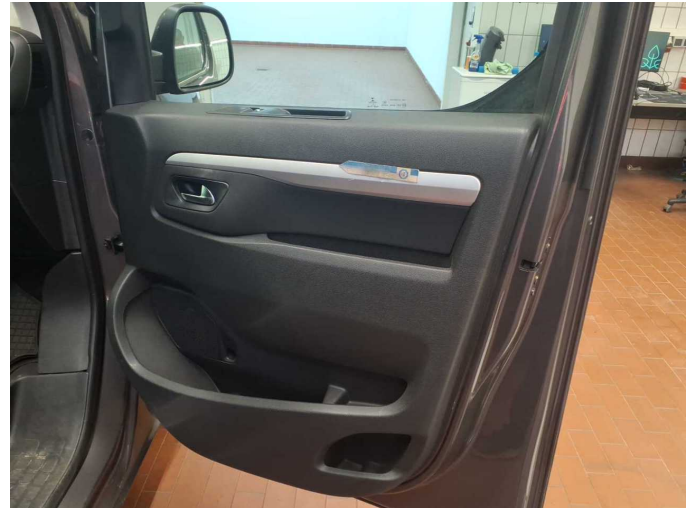
Damage 15: Side panel - rear left side: Side panel (Lack wellig) - Unprofessionally repaired - Repair and paint

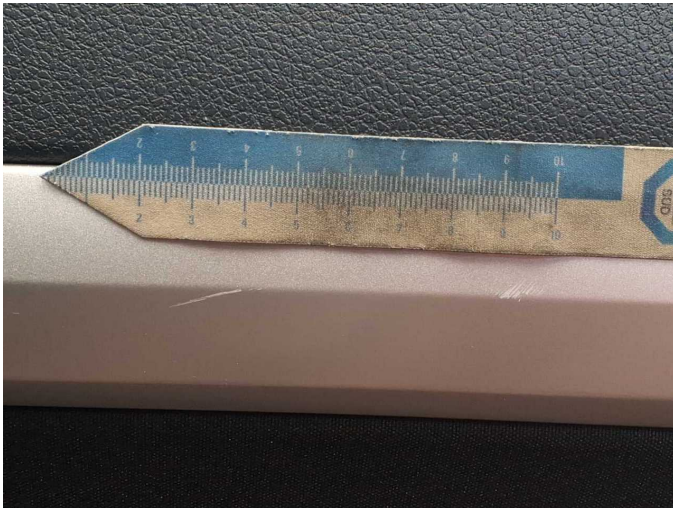
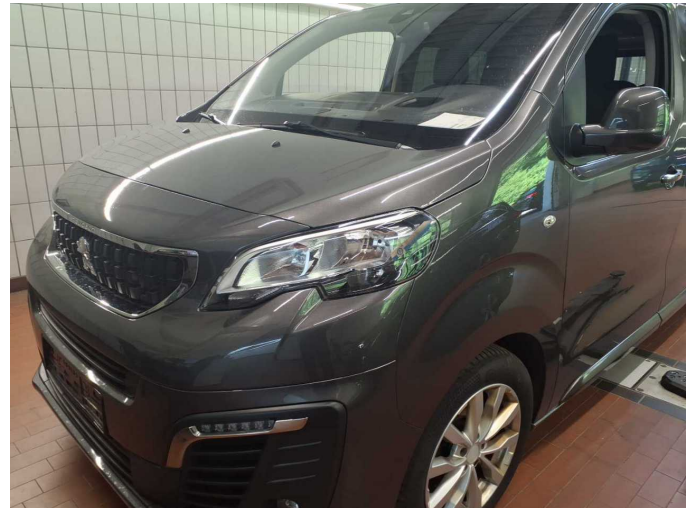
Wear and tear 3: Trim / covers: Door trim - front right side - Scratch(es) - No deduction

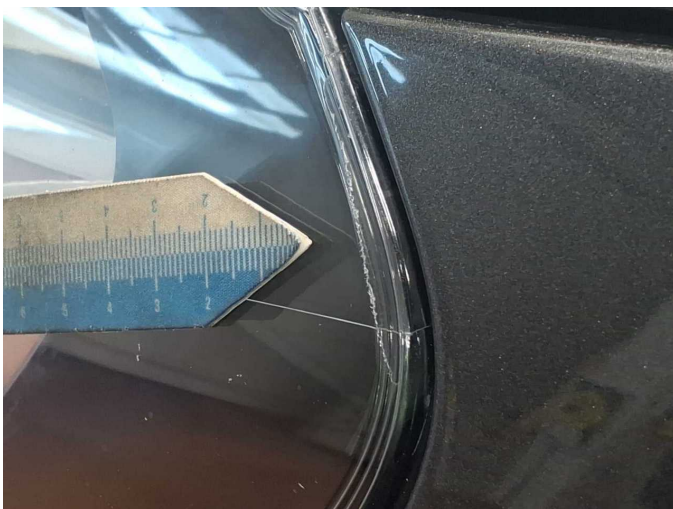
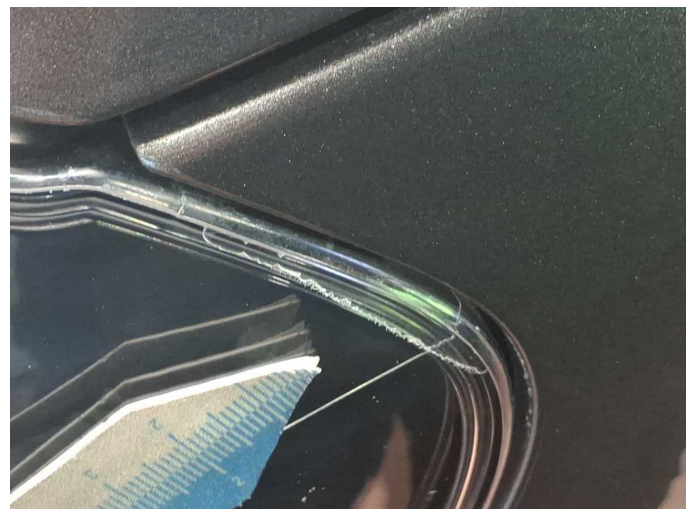
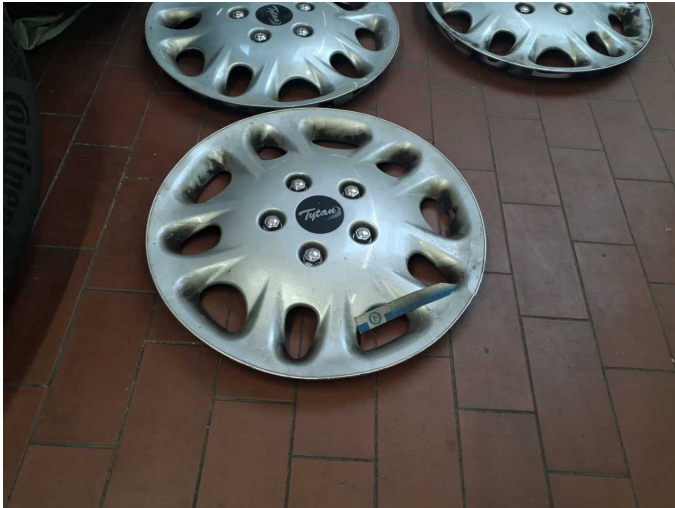
Wear and tear 8: Headlight: Headlight - left side - Scratch(es) - No deduction

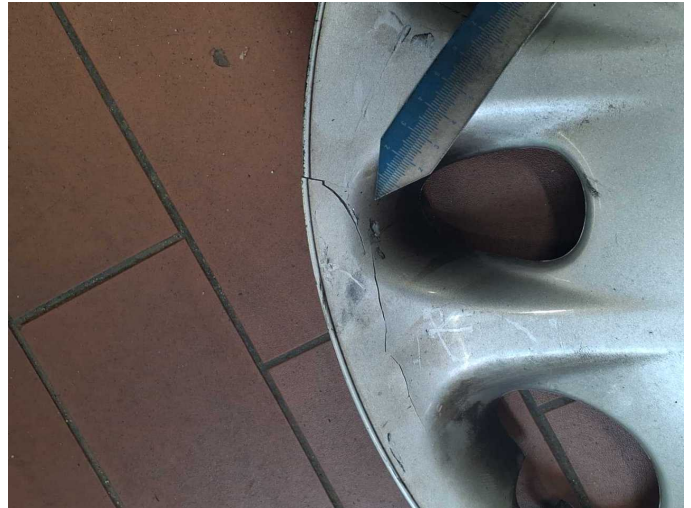
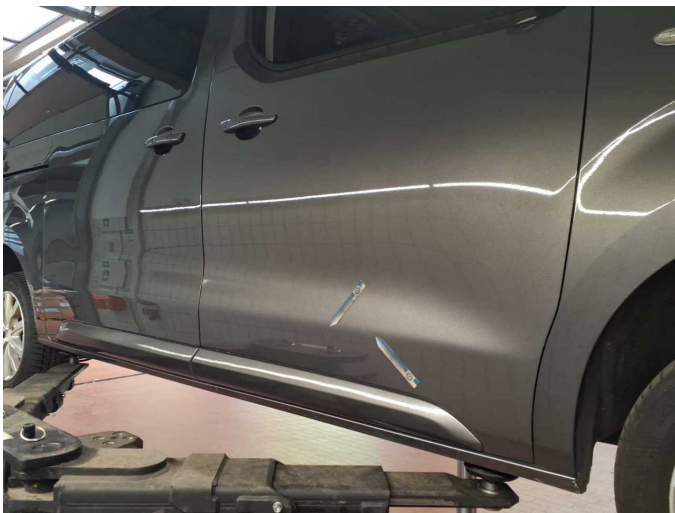
Wear and tear 9: 2nd wheel set: 1 wheel cover (Zubehör) - Broken / torn
- No deduction

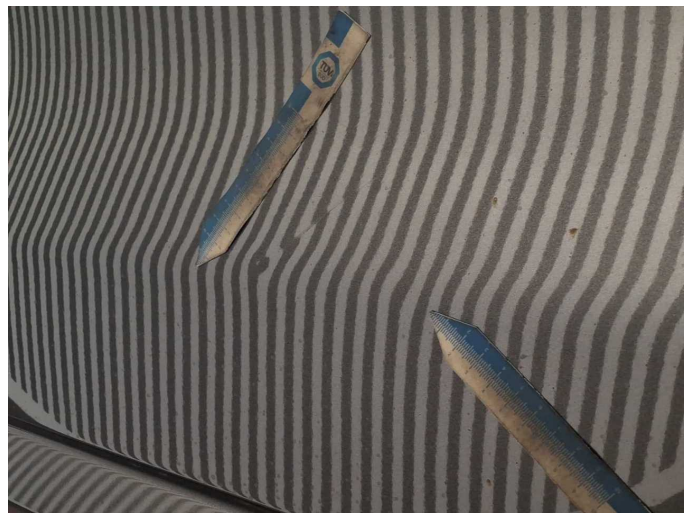
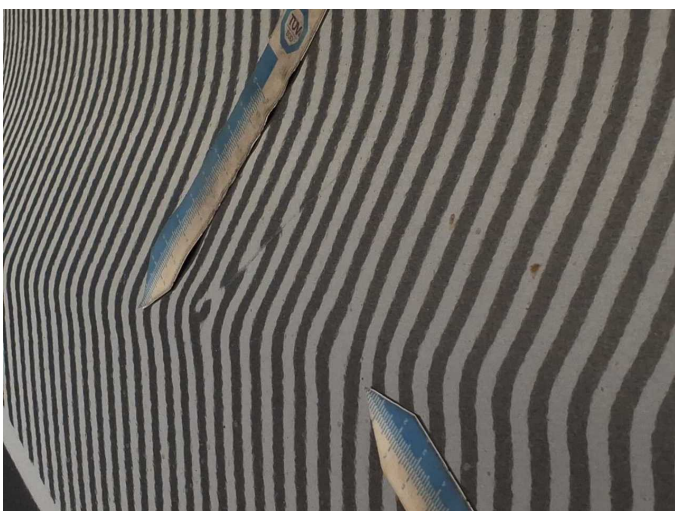
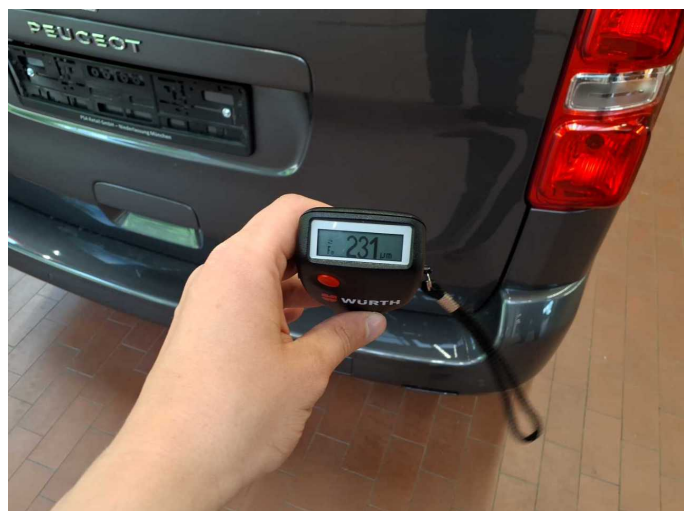
Wear and tear 10: Door - front right side: Door - dent(s) - No deduction
