## Expertise

Protocol number: 45929153  
Order No. / Reference: 26428759  
Inspection date: 13 Jun 2026

Manufacturer: Opel

Model: Astra 1.5 D Automatik Business Edition

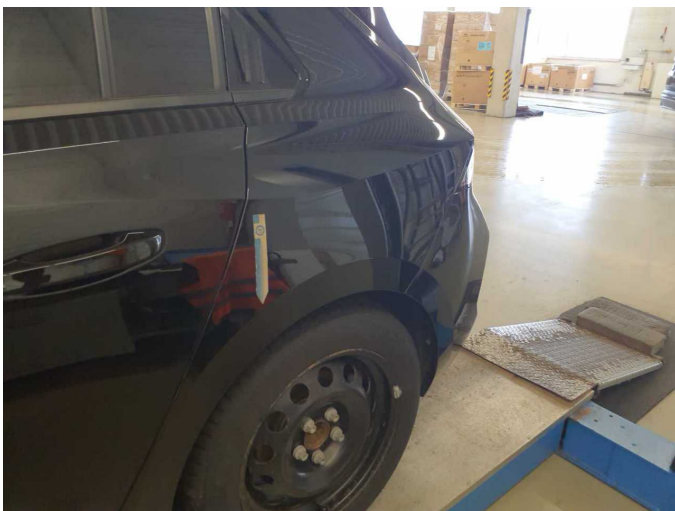
Damage 2: Side panel - rear left side: Side panel - dent(s) - Smart repair

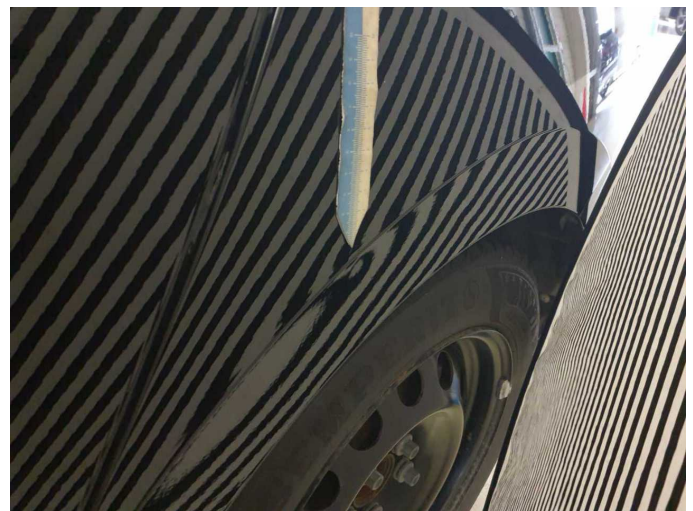
Damage 2: Side panel - rear left side: Side panel - dent(s) - Smart repair

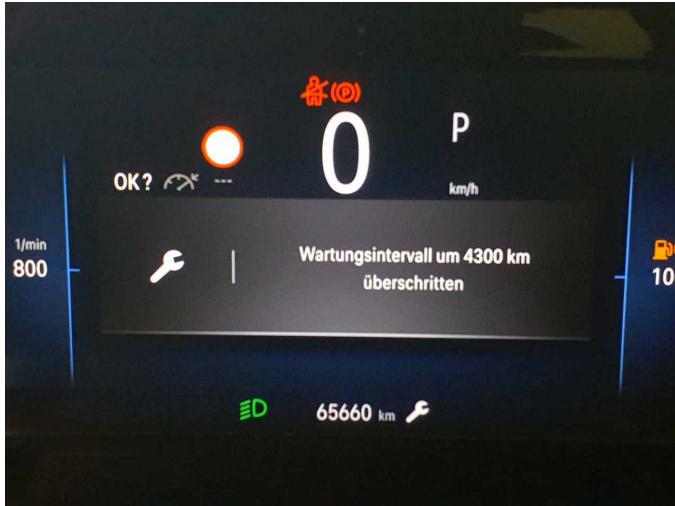
**Damage 3:** Misc.: Inspection / maintenance - Due - Replace

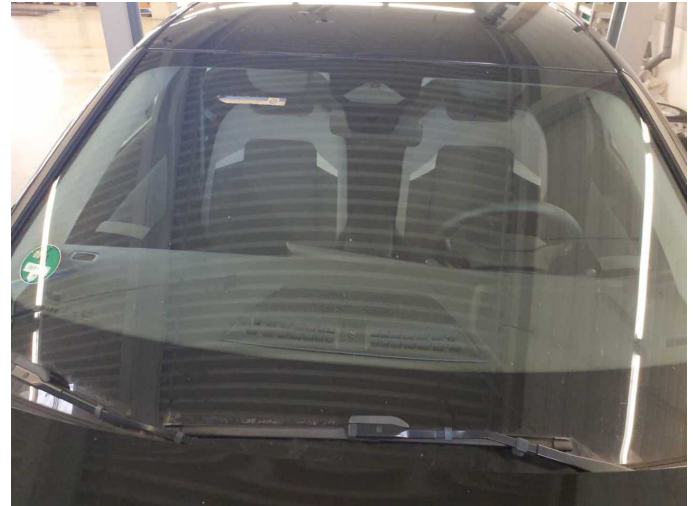
**Damage 4:** Vehicle glazing: Windscreen with lane departure assistant - Broken / torn - Replace

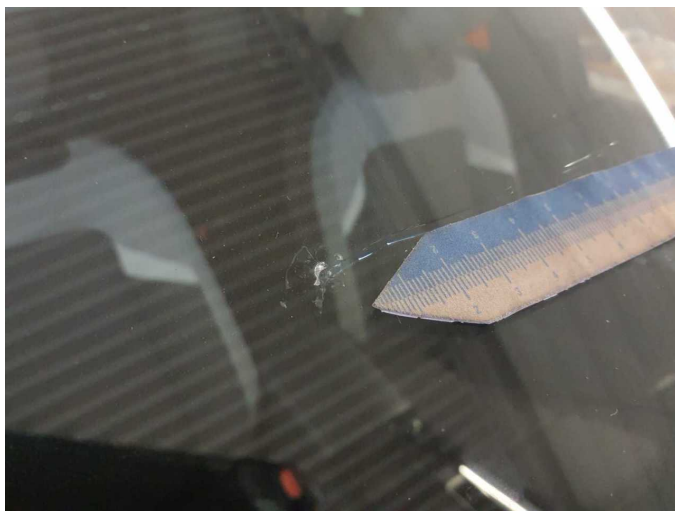
**Damage 4:** Vehicle glazing: Windscreen with lane departure assistant - Broken / torn - Replace

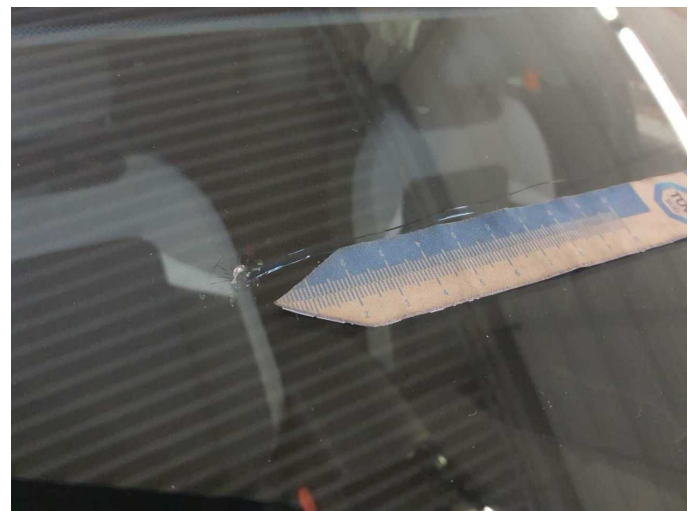
**Damage 4:** Vehicle glazing: Windscreen with lane departure assistant - Broken / torn - Replace

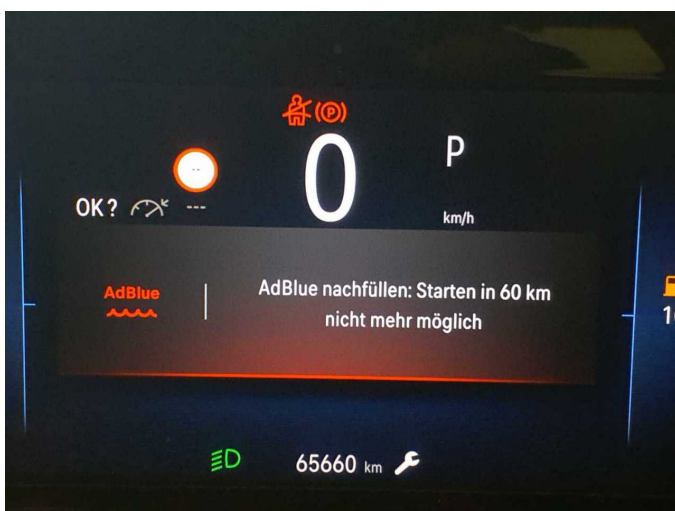
**Wear and tear 1:** Exhaust system: AdBlue tank - Empty - No deduction
