## Expertise

Protocol number: 45930845  
Order No. / Reference: 26489621  
Inspection date: 12 Jun 2026

Model: Citan 111 CDI lang

VIN: W1V4156031U296868

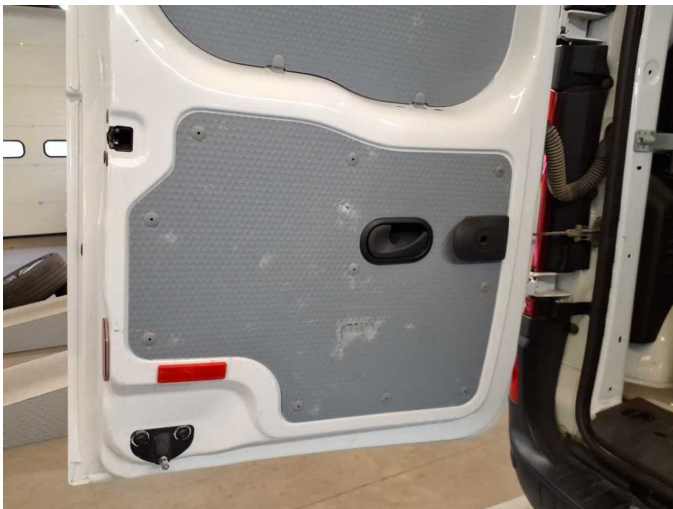
| No. | Component group | Description |
|---|---|---|
| 1 | Trim / covers | Boot lid - interior trim - Broken / torn - Replace |

Damage 1: Trim / covers: Boot lid - interior trim - Broken / torn - Replace

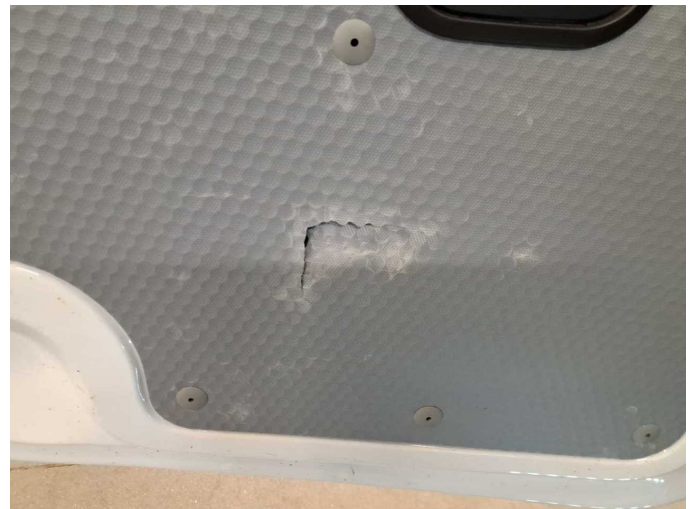
Damage 1: Trim / covers: Boot lid - interior trim - Broken / torn - Replace

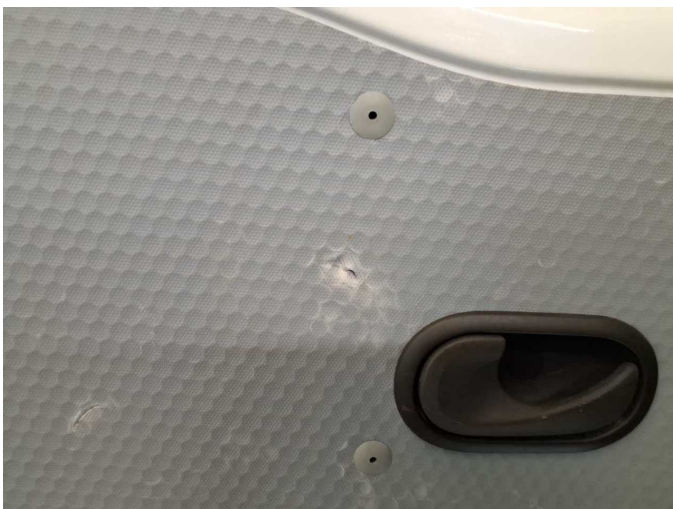
Damage 1: Trim / covers: Boot lid - interior trim - Broken / torn - Replace

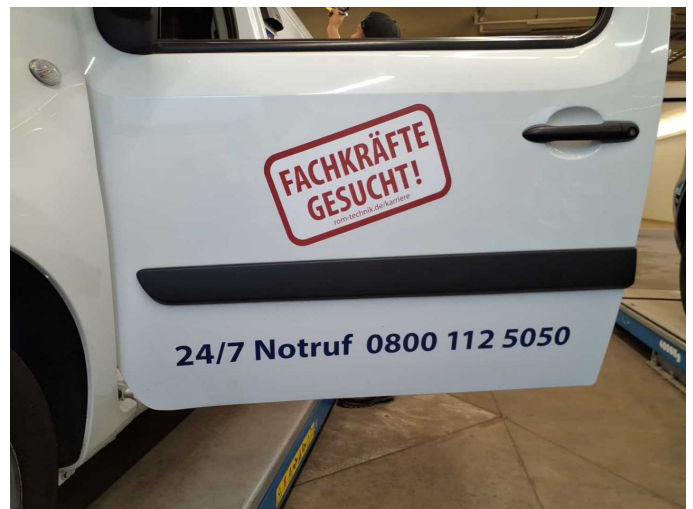
| No. | Component group | Description |
|---|---|---|
| 2 | Body | Body - Glued / labelled - De-glue / neutralise |

Damage 2: Body: Body - Glued / labelled - De-glue / neutralise

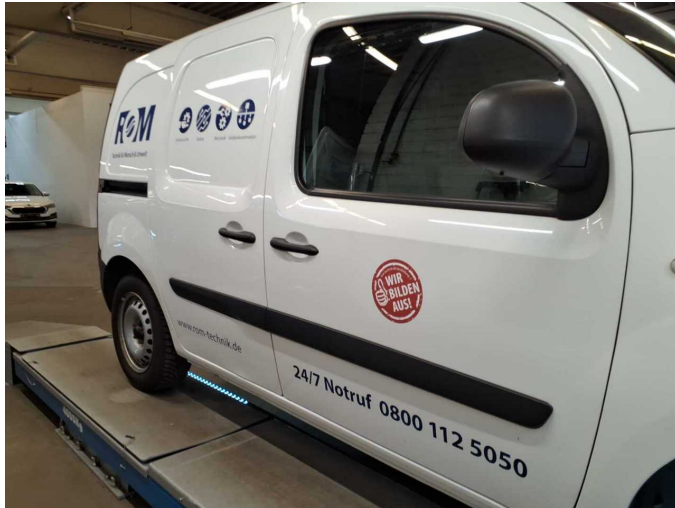
Damage 2: Body: Body - Glued / labelled - De-glude / neutralise

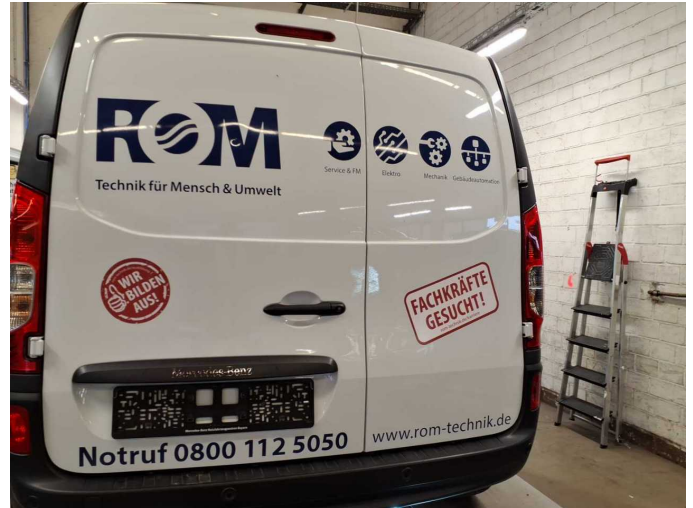
Damage 2: Body: Body - Glued / labelled - De-glude / neutralise

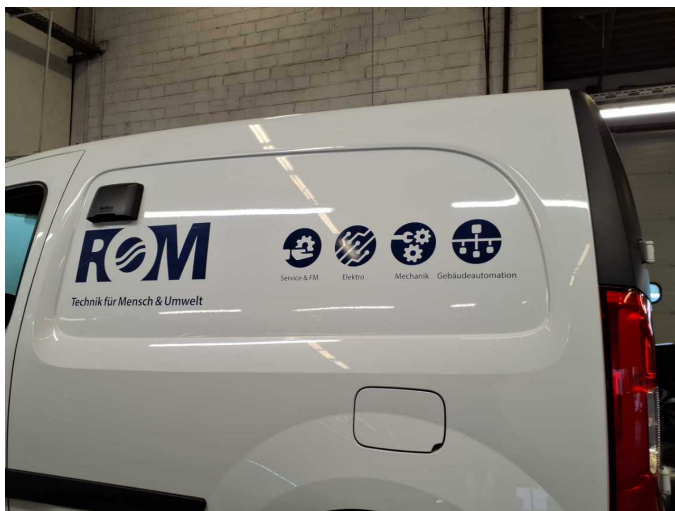
Damage 2: Body: Body - Glued / labelled - De-glude / neutralise

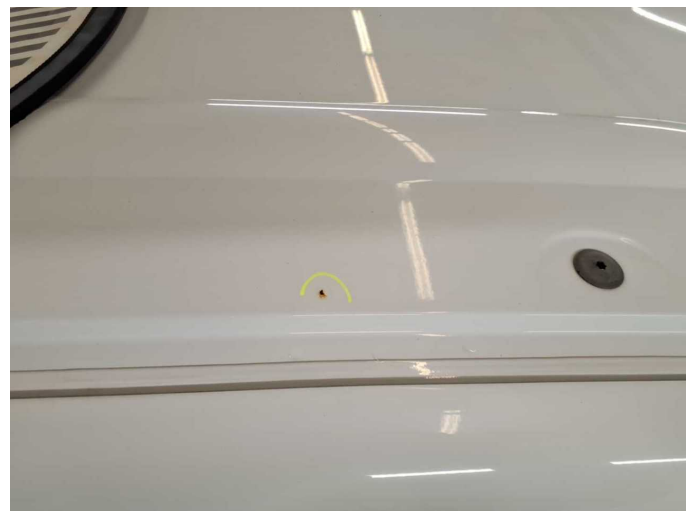
| No. | Component group | Description |
|---|---|---|
| 3 | Roof | Roof - Corrosion - Paint |

Damage 3: Roof: Roof - Corrosion - Paint

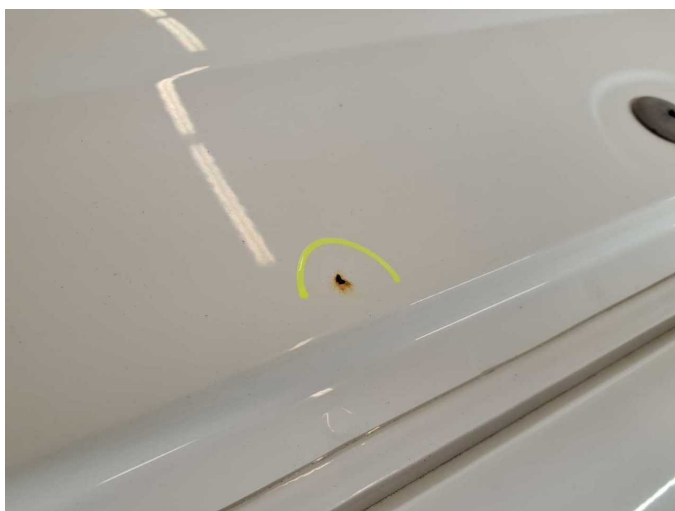
Damage 3: Roof: Roof - Corrosion - Paint

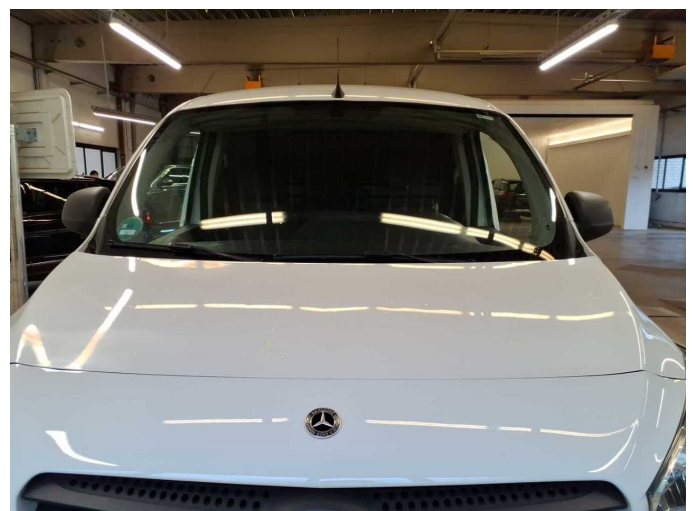
| No. | Component group | Description |
|---|---|---|
| 4 | Body | Body - Damage by hail - Smooth repair work |

Damage 4: Body: Body - Damage by hail - Smooth repair work

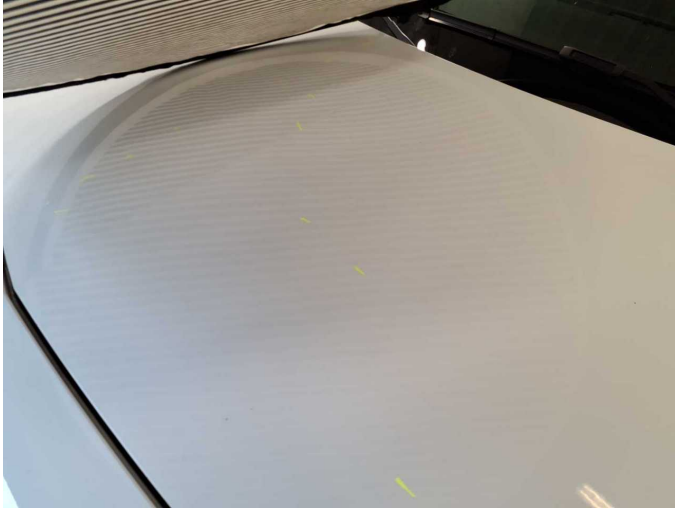
**Damage 4:** Body: Body - Damage by hail - Smooth repair work

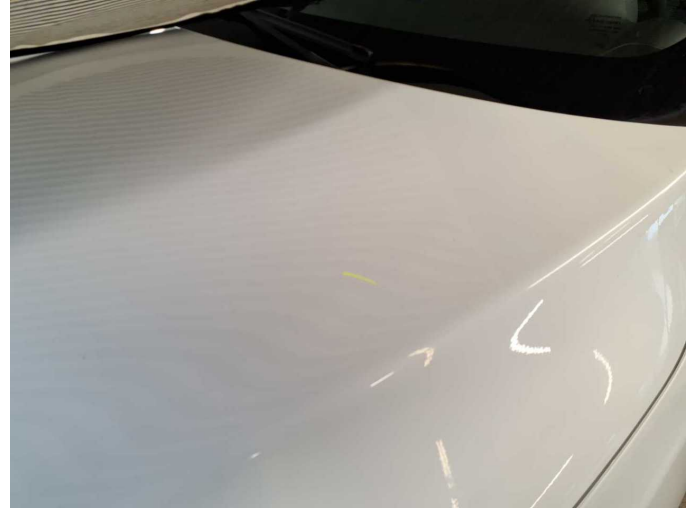
**Damage 4:** Body: Body - Damage by hail - Smooth repair work

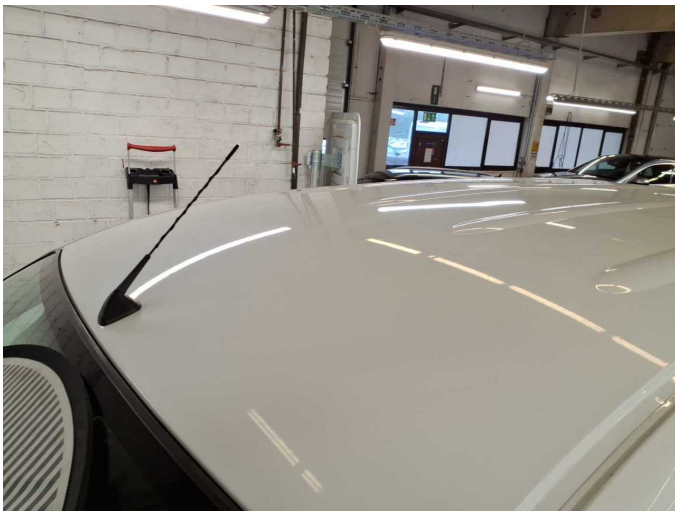
**Damage 4:** Body: Body - Damage by hail - Smooth repair work

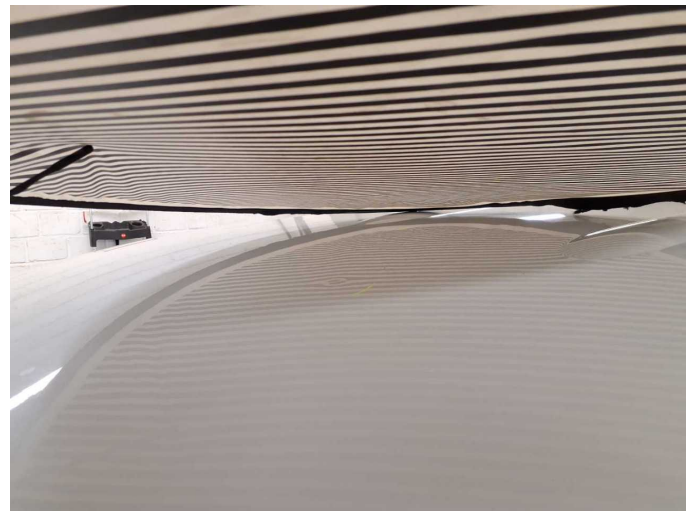
**Damage 4:** Body: Body - Damage by hail - Smooth repair work

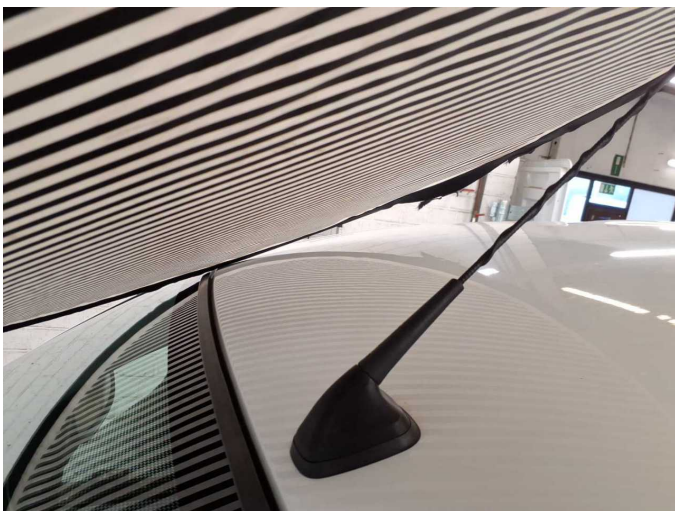
**Damage 4:** Body: Body - Damage by hail - Smooth repair work

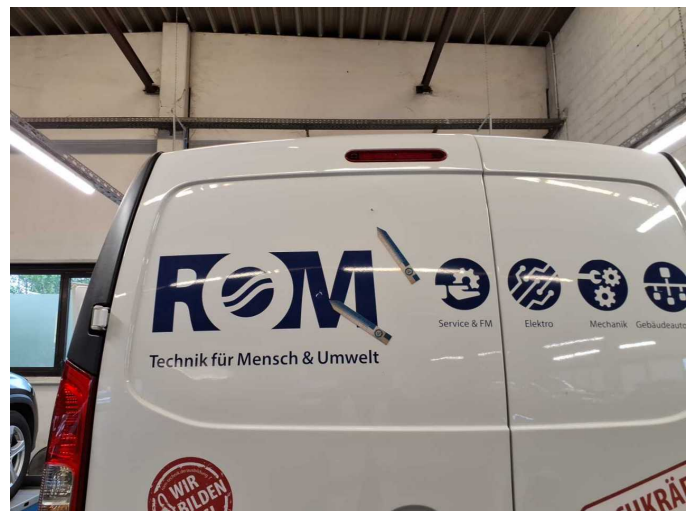
| No. | Component group | Description |
|---|---|---|
| 5 | Boot lid / rear door | Rear door - left side - Dent / paintcoat damage - Paint |

**Damage 5:** Boot lid / rear door: Rear door - left side - Dent / paintcoat damage - Paint

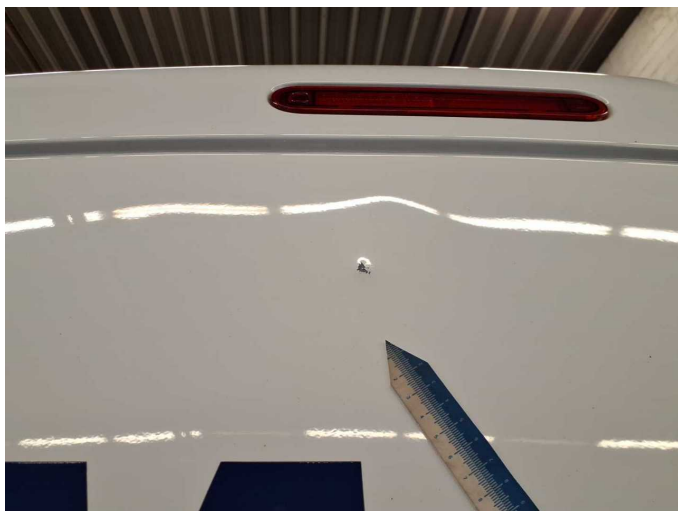
**Damage 5:** Boot lid / rear door: Rear door - left side - Dent / paintcoat damage - Paint

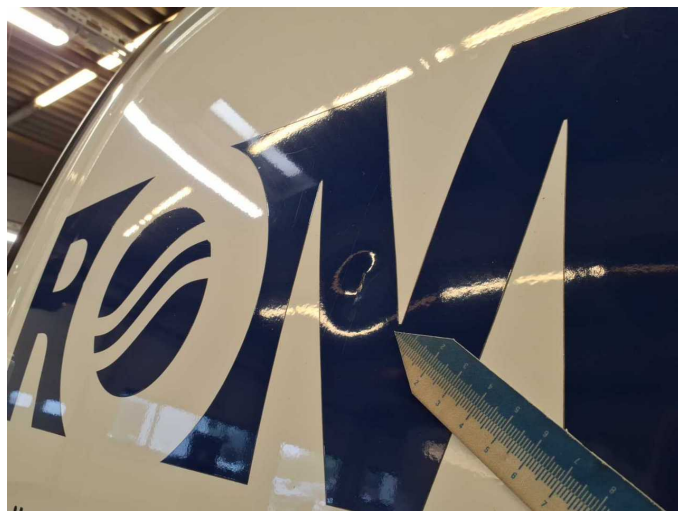
**Damage 5:** Boot lid / rear door: Rear door - left side - Dent / paintcoat damage - Paint

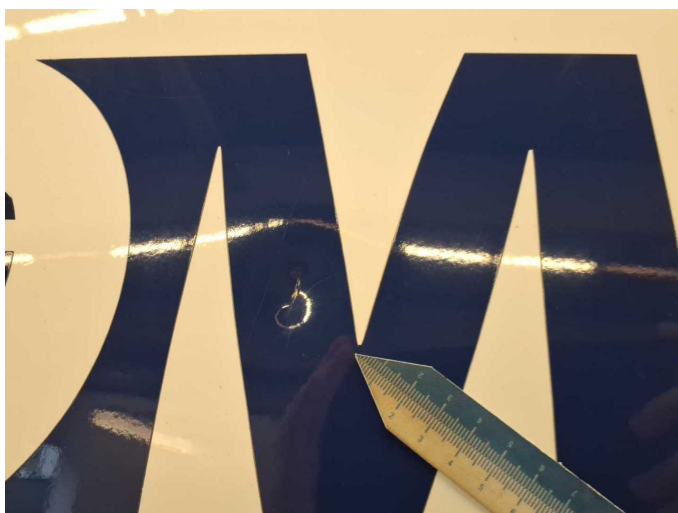
**Damage 5:** Boot lid / rear door: Rear door - left side - Dent / paintcoat damage - Paint
