Expertise

Protocol number: 46161280
Order No. / Reference: 26437526
Inspection date: 24 Jun 2026

Model: Jumpy e-Spacetourer XL (75 kWh) Feel

VIN: VF7VZZKXZPZ088528

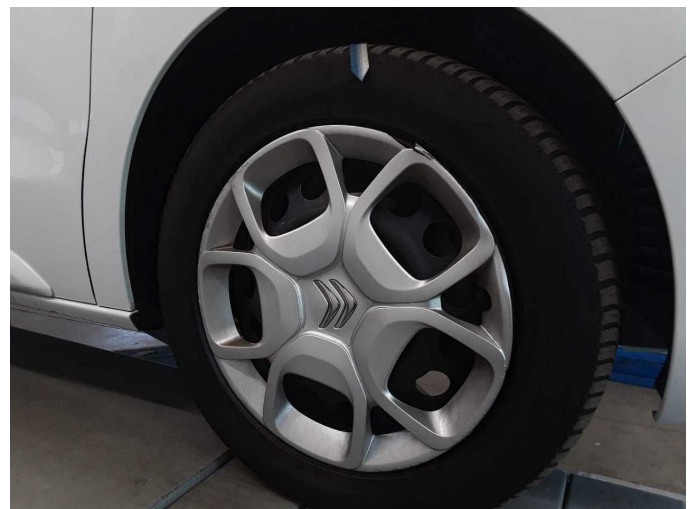
Damage 2: Wheel / tyres: Wheel cover - front right side - Broken / torn - Replace

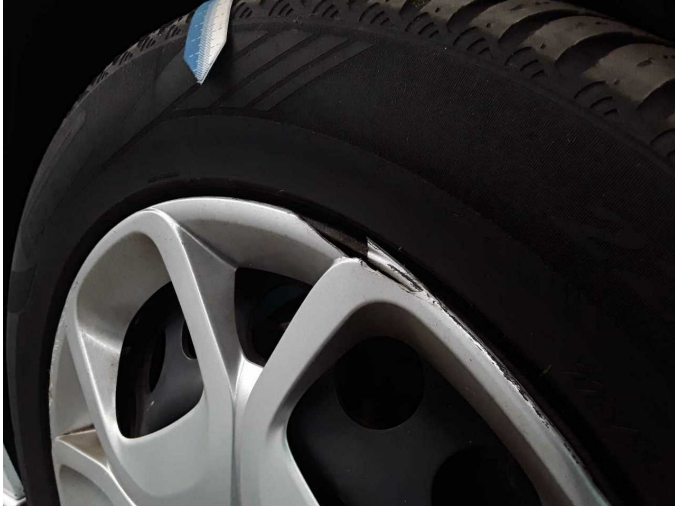
Damage 2: Wheel / tyres: Wheel cover - front right side - Broken / torn - Replace

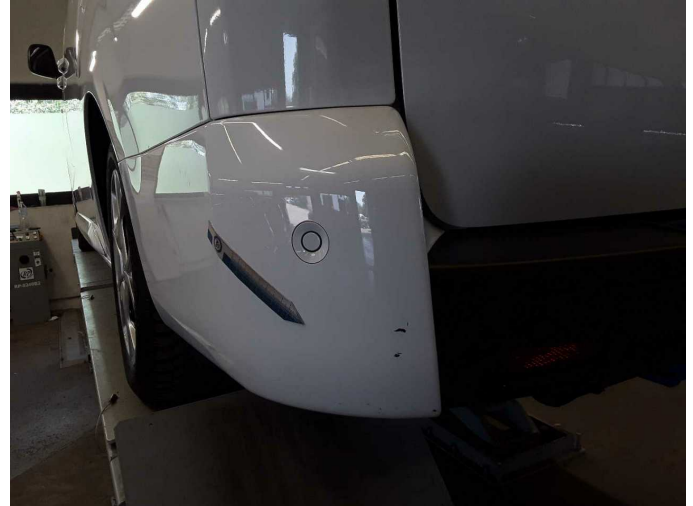
Damage 3: Rear bumper: Rear bumper - Scratch(es) - Smart repair

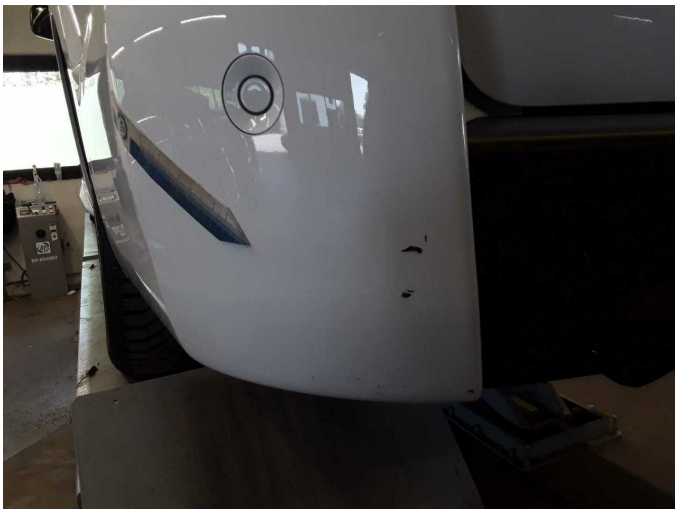
Damage 3: Rear bumper: Rear bumper - Scratch(es) - Smart repair

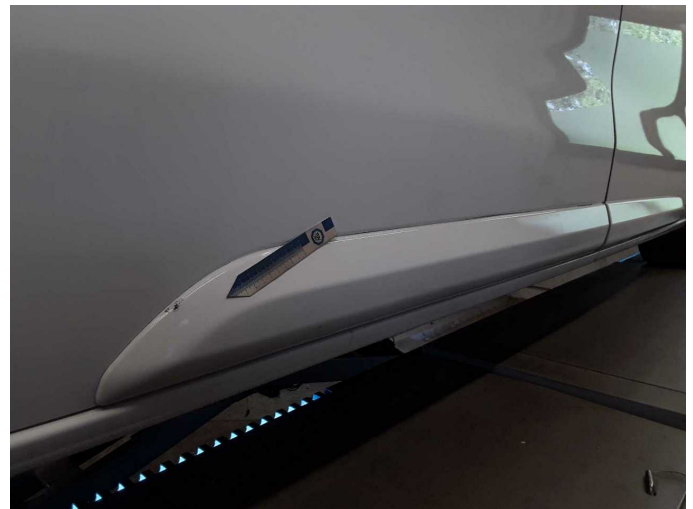
Damage 4: Door - rear right side: Brightware - lower - Scratched - Smart repair

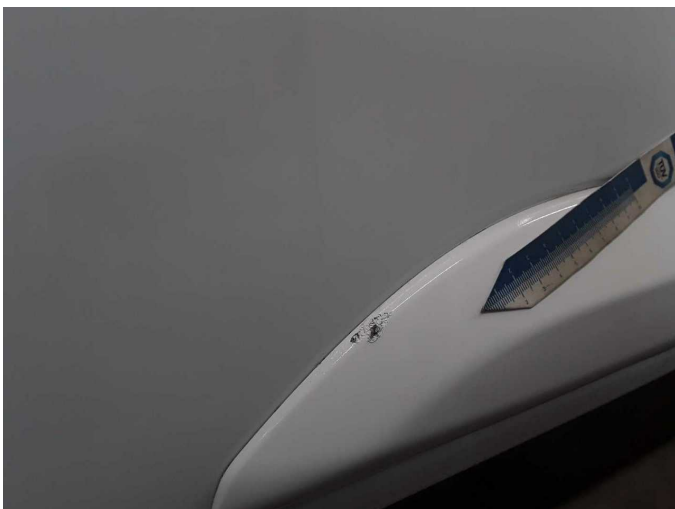
Damage 4: Door - rear right side: Brightware - lower - Scratched - Smart repair

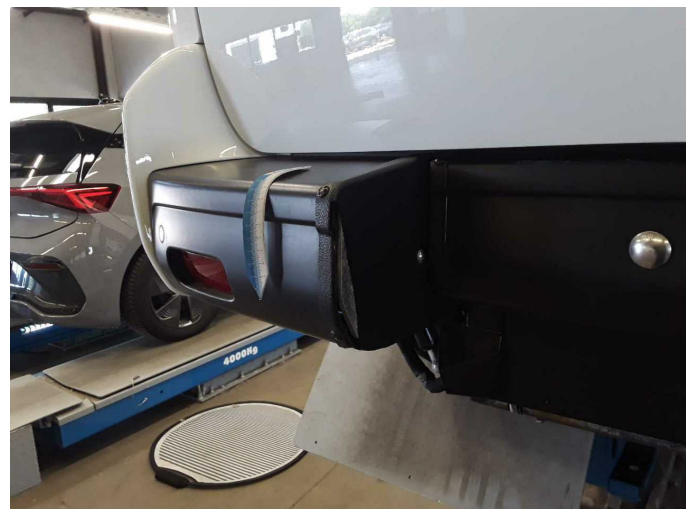
Damage 5: Rear bumper: Rear bumper (Abdeckung, Umbau, Be-Entladespuren) - Damaged - Loss in value

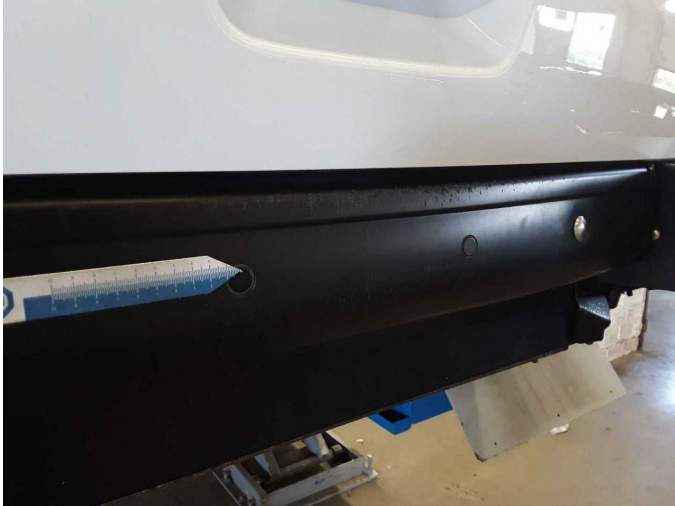
Damage 5: Rear bumper: Rear bumper (Abdeckung, Umbau, Be-Entladespuren) - Damaged - Loss in value

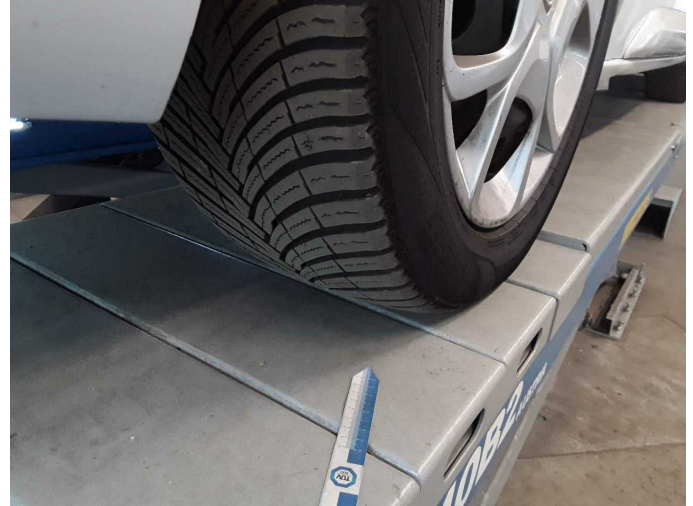
Damage 6: Wheel / tyres: Tyre - front - Worn - Replace

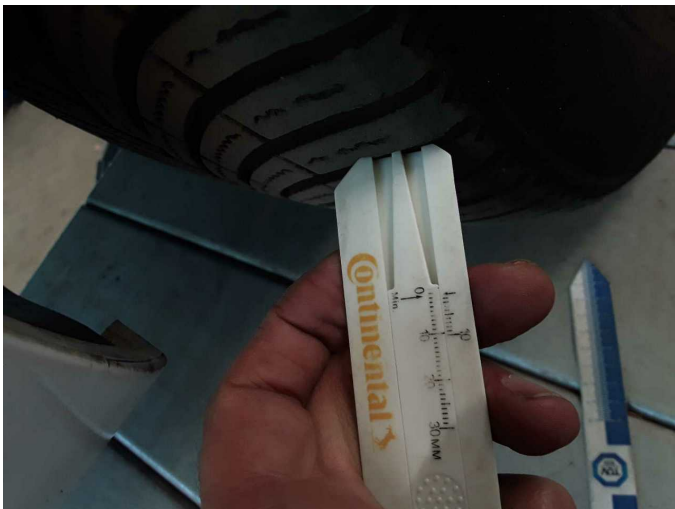
Damage 6: Wheel / tyres: Tyre - front - Worn - Replace

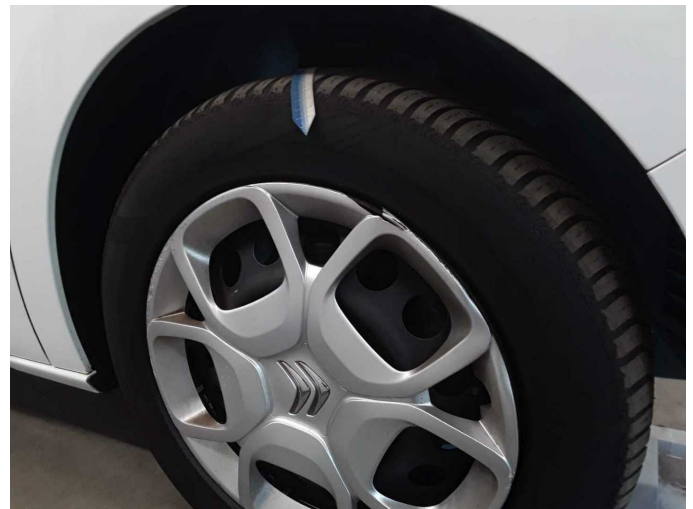
Damage 6: Wheel / tyres: Tyre - front - Worn - Replace

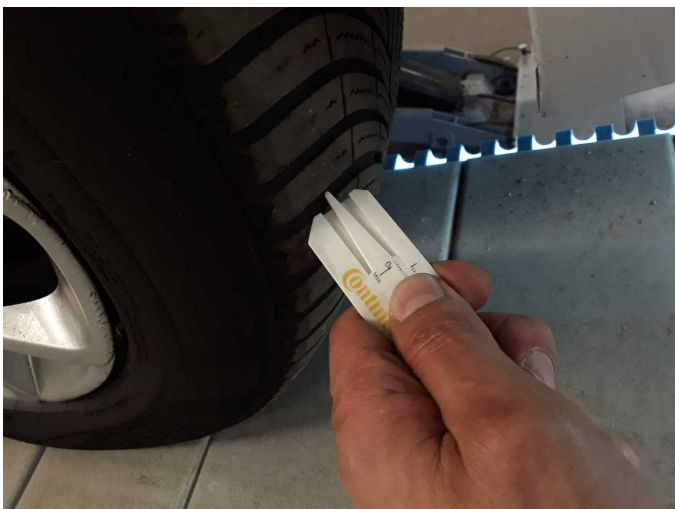
Damage 6: Wheel / tyres: Tyre - front - Worn - Replace

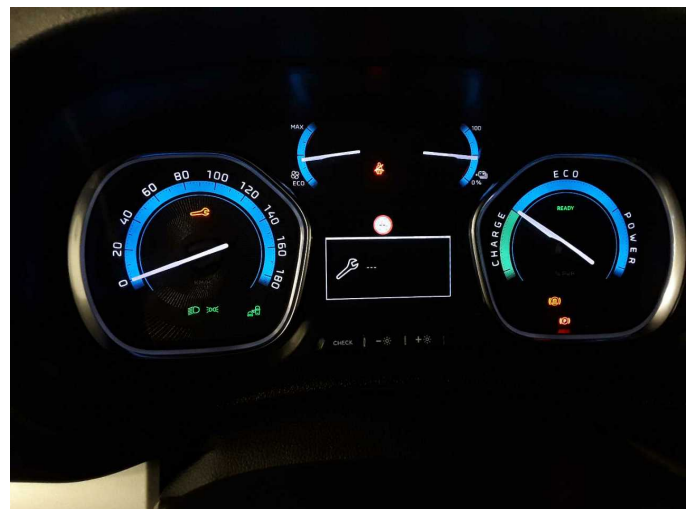
Damage 7: Misc.: Inspection / maintenance - Due - Perform

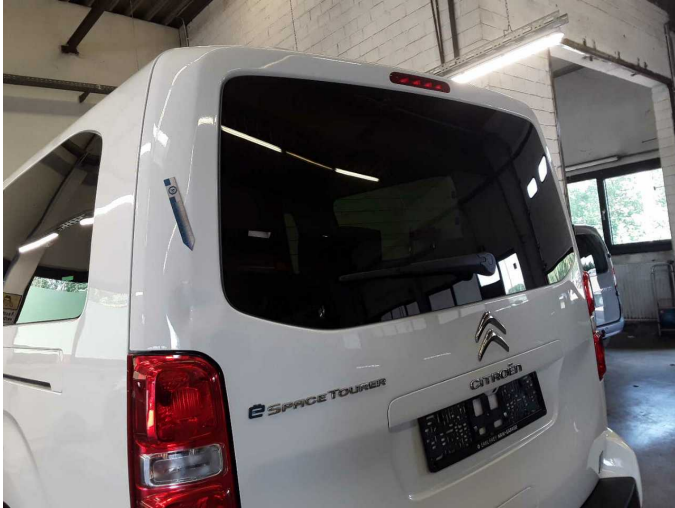
Damage 8: Boot lid / rear door: Boot lid - Deformed - Repair and paint

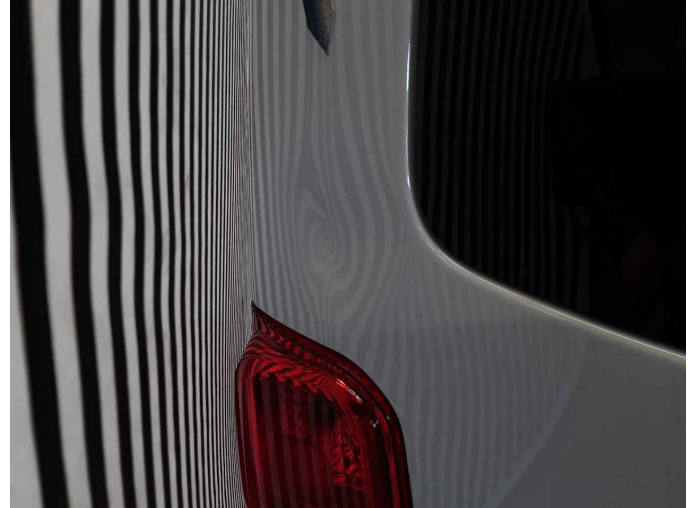
Damage 8: Boot lid / rear door: Boot lid - Deformed - Repair and paint

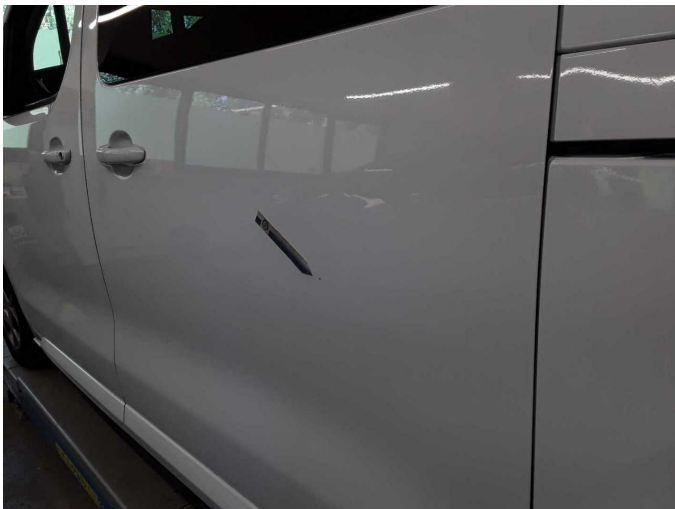
Wear and tear 1: Sliding door - left side: Sliding door - Stone chips - No deduction

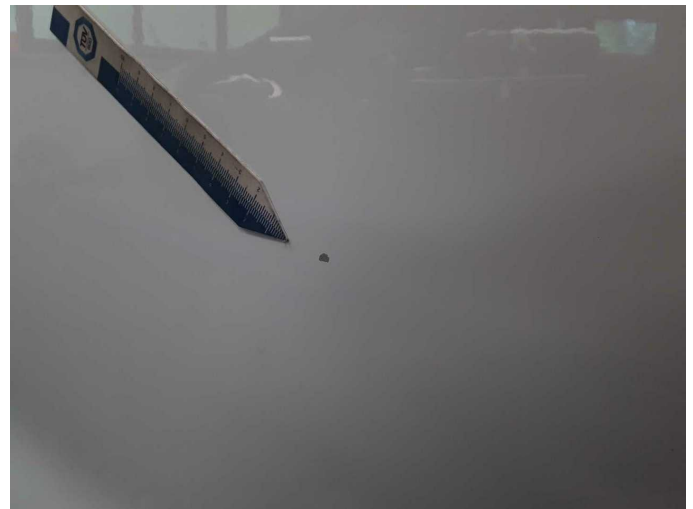
Wear and tear 1: Sliding door - left side: Sliding door - Stone chips - No deduction

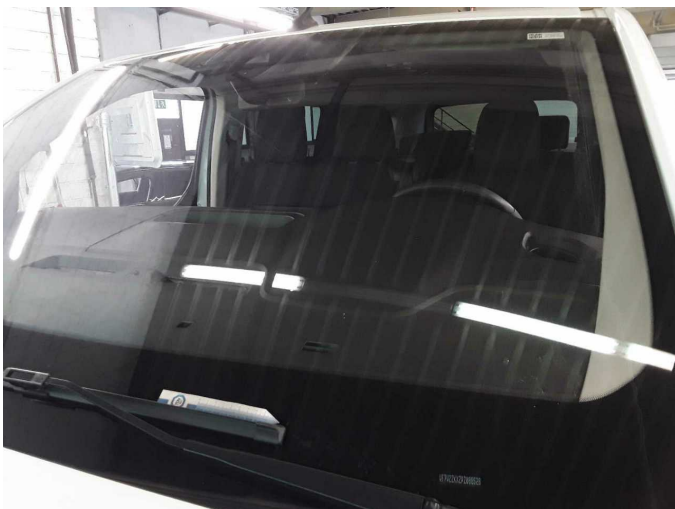
Wear and tear 2: Vehicle glazing: Windscreen - Stone chips - No deduction

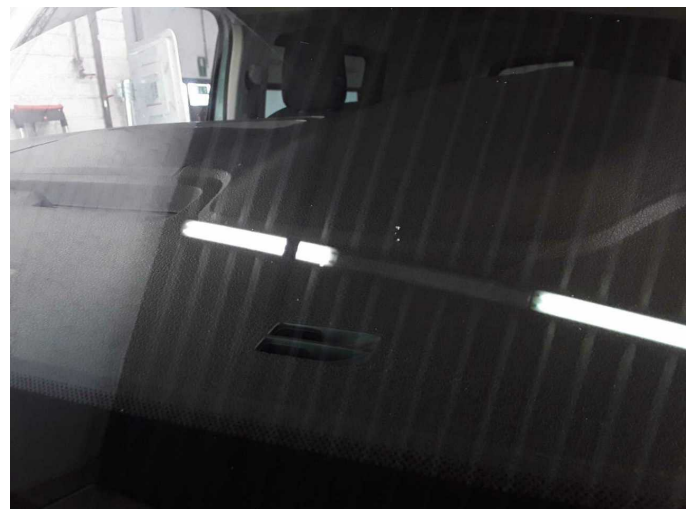
Wear and tear 2: Vehicle glazing: Windscreen - Stone chips - No deduction
