Expertise

Protocol number: 46626124  
Order No. / Reference: 26692272  
Inspection date: 21 Jul 2026

Manufacturer: Peugeot

Model: 5008 BlueHDi 130 EAT8 Allure

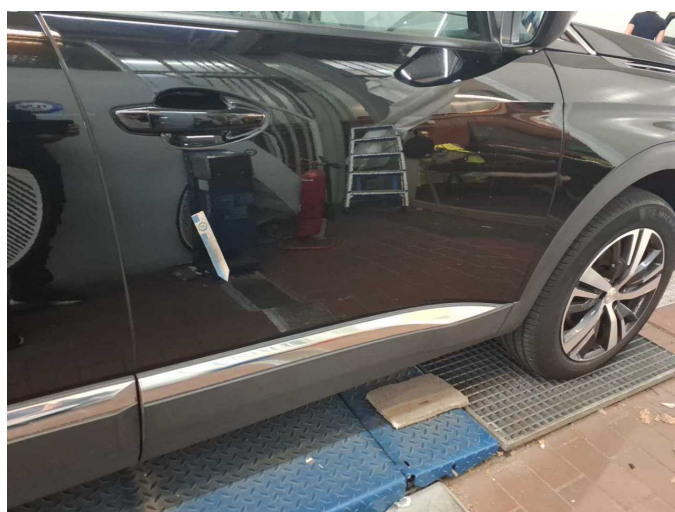
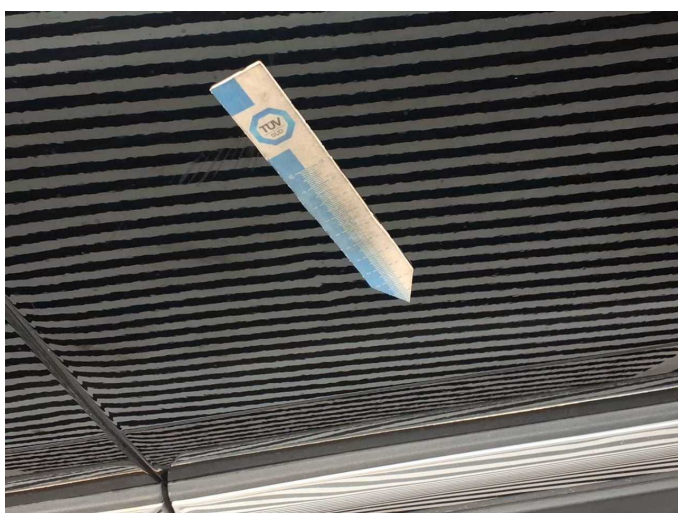
| No. | Component group | Description |
|---|---|---|
| 1 | Door - front right side | Door - dent(s) - Smart repair |

**Damage 1:** Door - front right side: Door - dent(s) - Smart repair

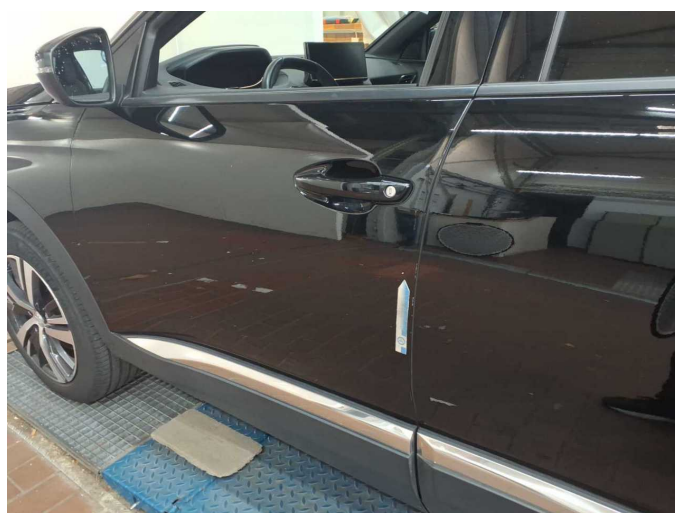
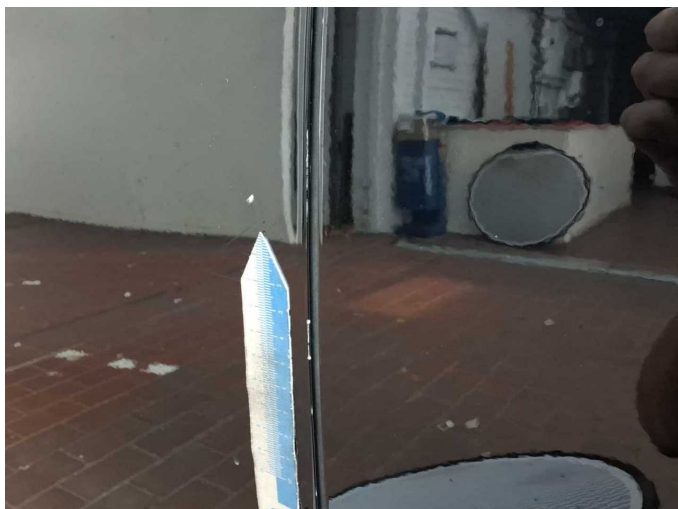
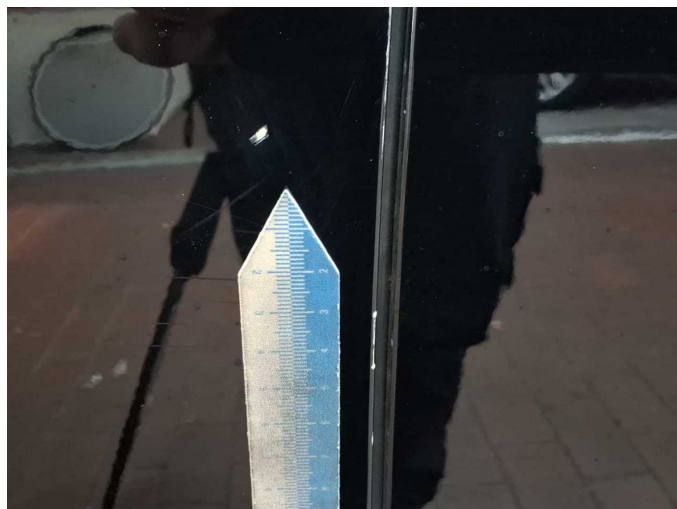
| No. | Component group | Description |
|---|---|---|
| 2 | Door - front left side | Door edge - Scratch(es) - Smart repair |

**Damage 2:** Door - front left side: Door edge - Scratch(es) - Smart repair

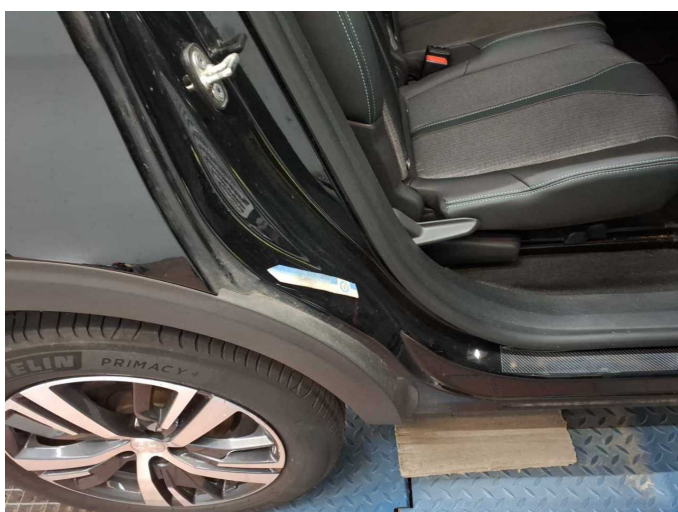
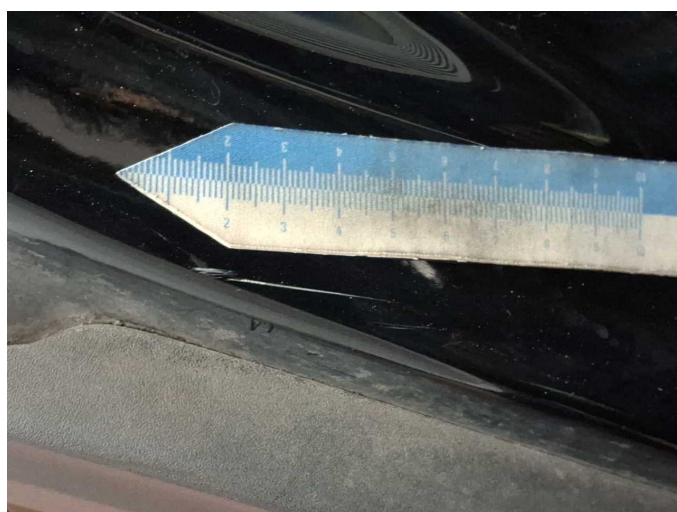
| No. | Component group | Description |
|---|---|---|
| 3 | Side panel - rear right side | Sill - Scratch(es) - Smart repair |

**Damage 3:** Side panel - rear right side: Sill - Scratch(es) - Smart repair

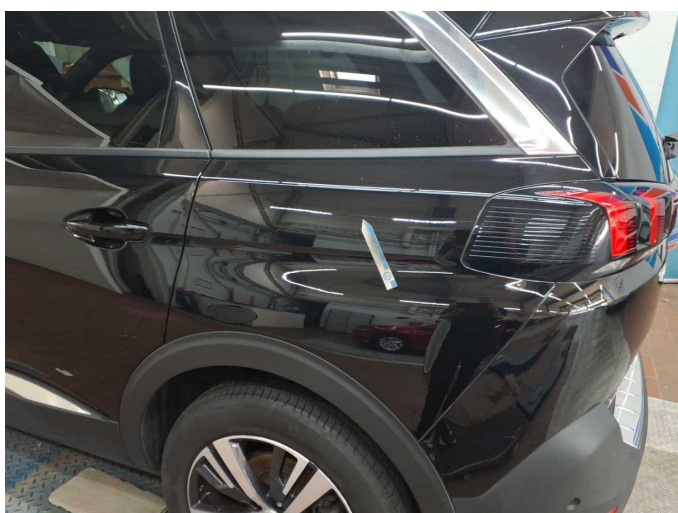
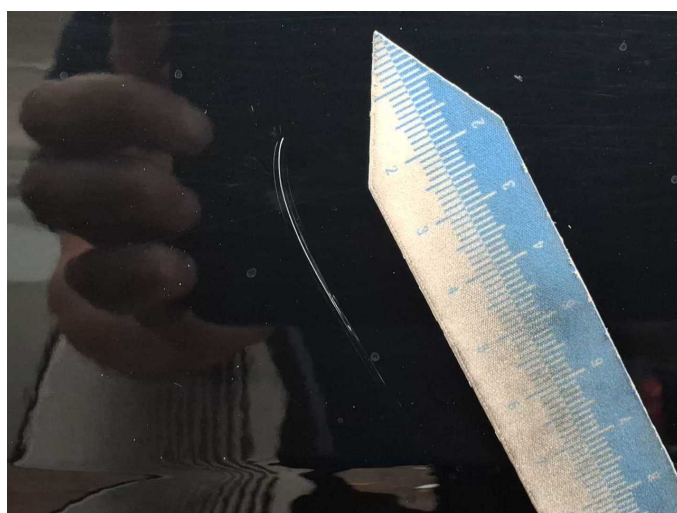
| No. | Component group | Description |
|---|---|---|
| 4 | Side panel - rear left side | Side panel - Scratch(es) - Smart repair |

**Damage 4:** Side panel - rear left side: Side panel - Scratch(es) - Smart repair

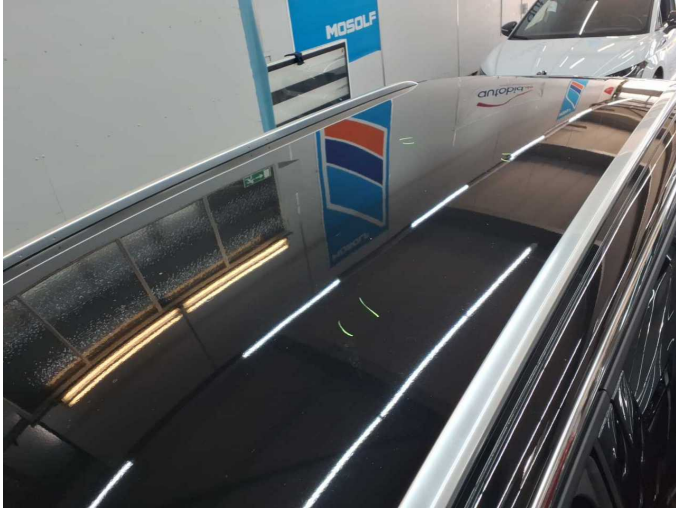
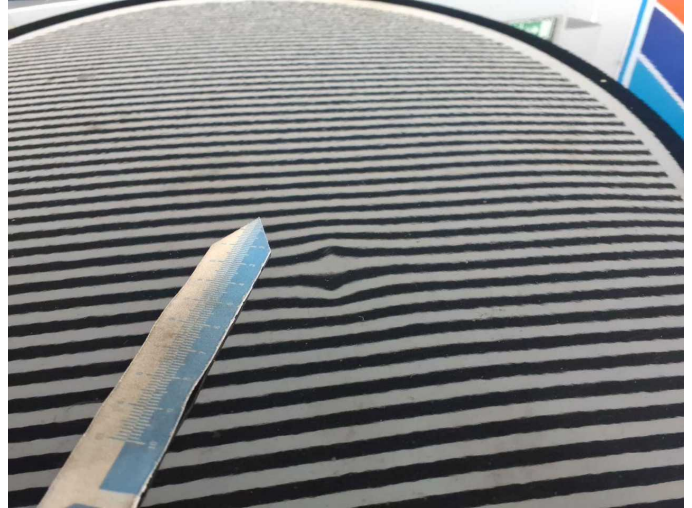
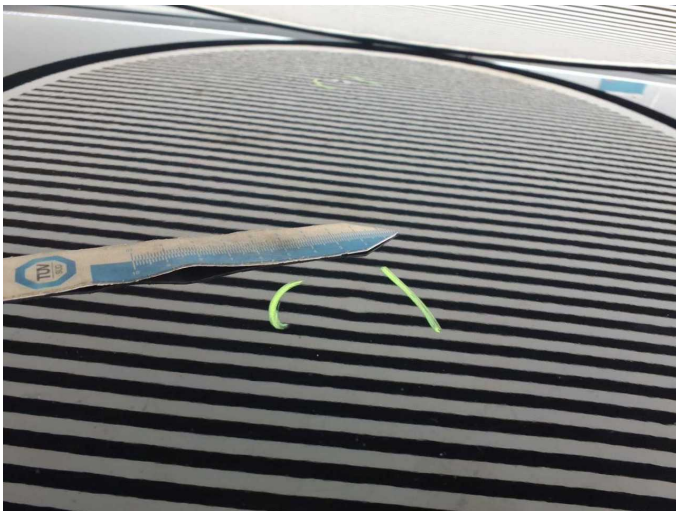
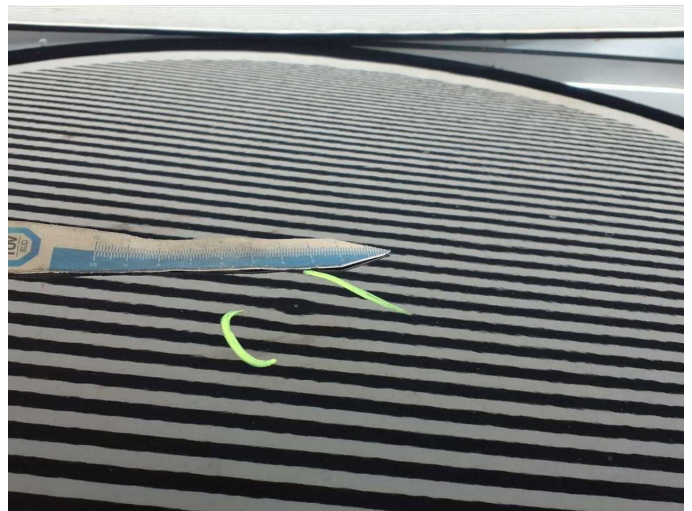
| No. | Component group | Description |
|---|---|---|
| 5 | Roof | Roof - dent(s) - Smooth repair work |

**Damage 5:** Roof: Roof - dent(s) - Smooth repair work

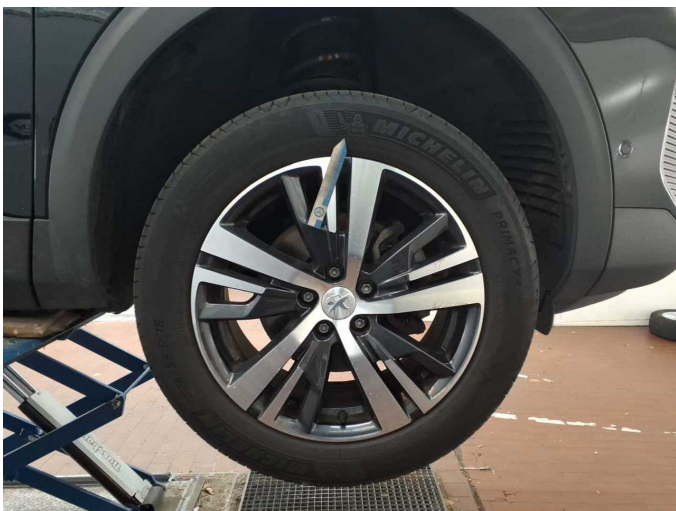
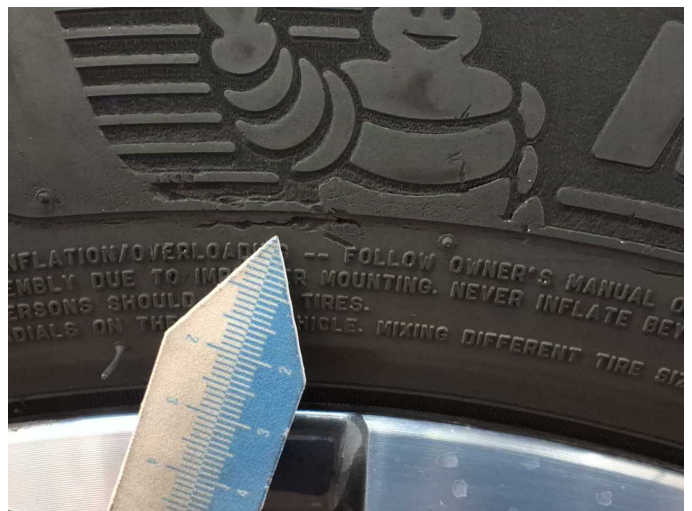
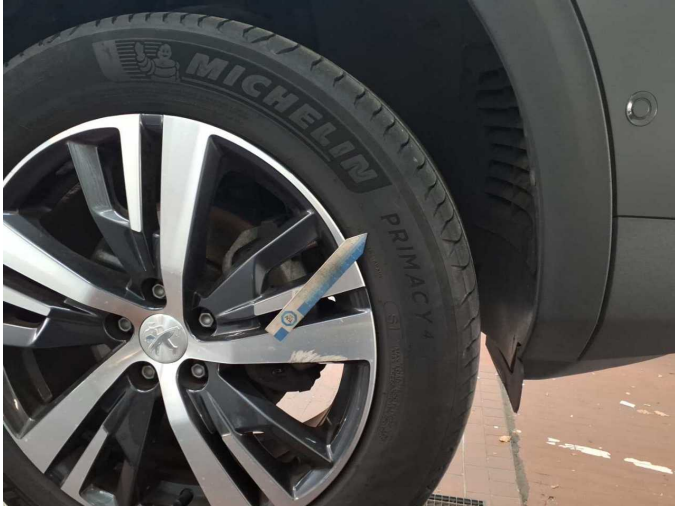
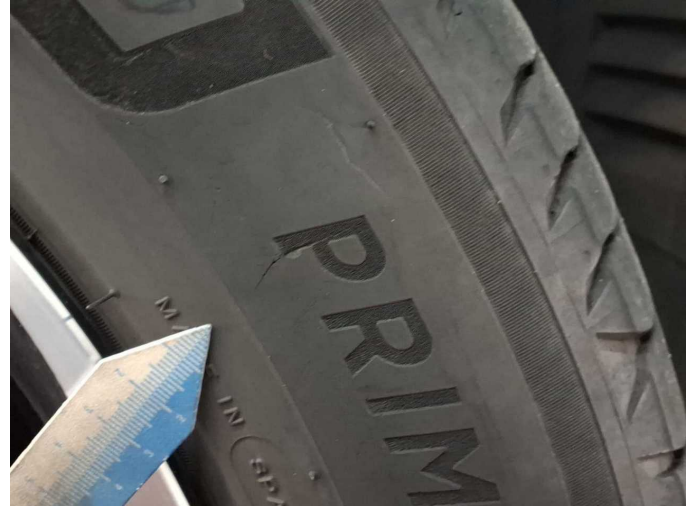
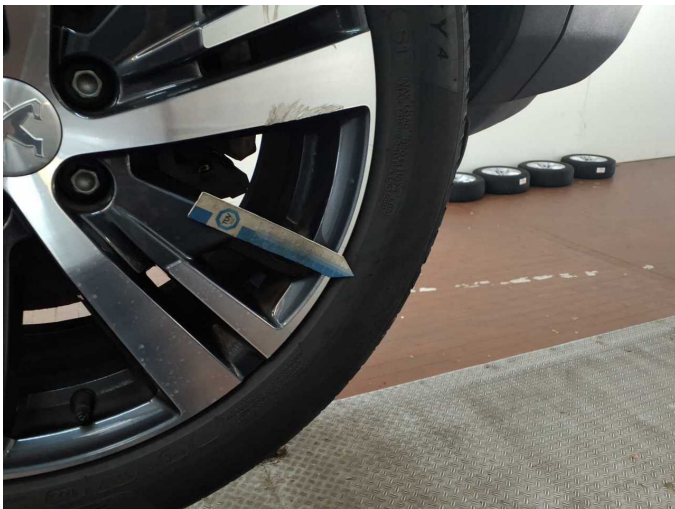
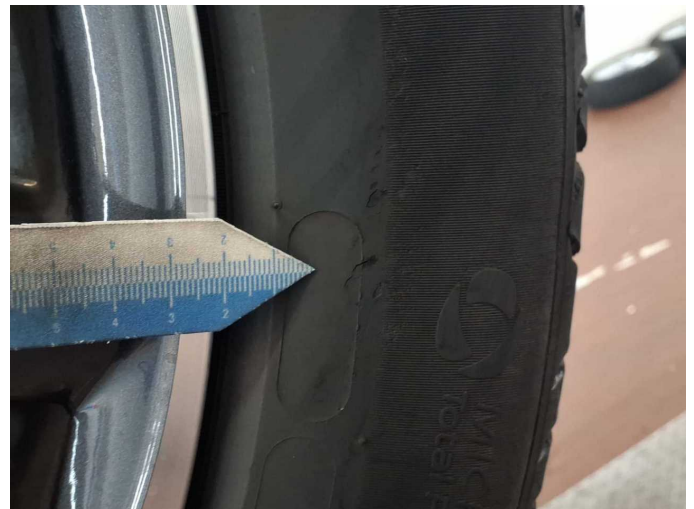
| No. | Component group | Description |
|---|---|---|
| 6 | Wheel / tyres | Tyre - front right side - Broken / torn - Replace |

**Damage 6:** Wheel / tyres: Tyre - front right side - Broken / torn - Replace

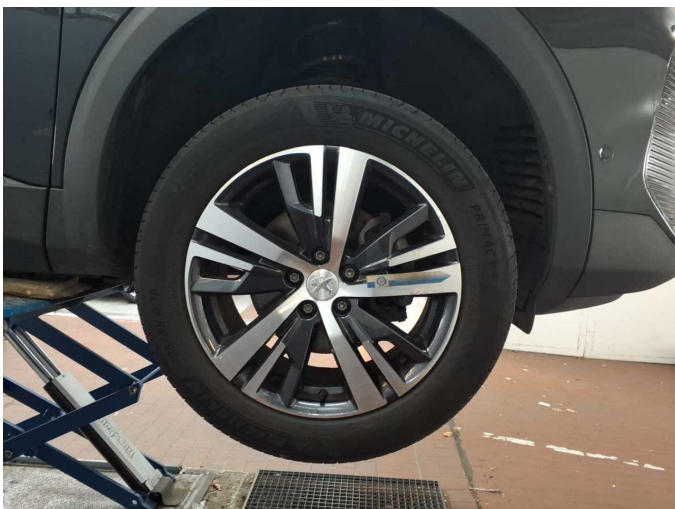
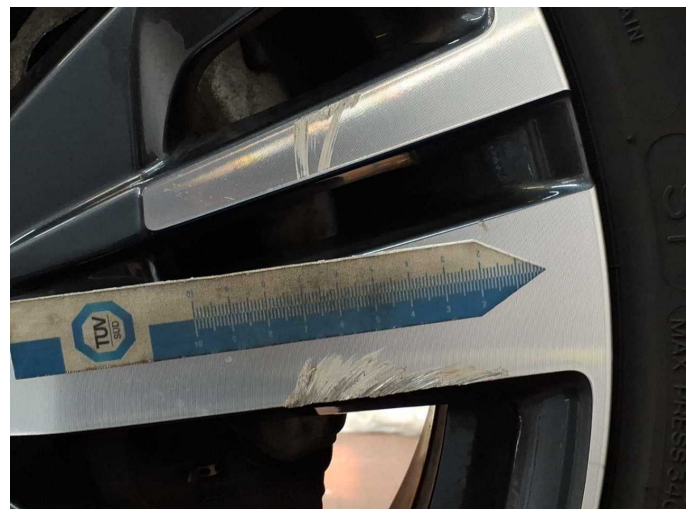
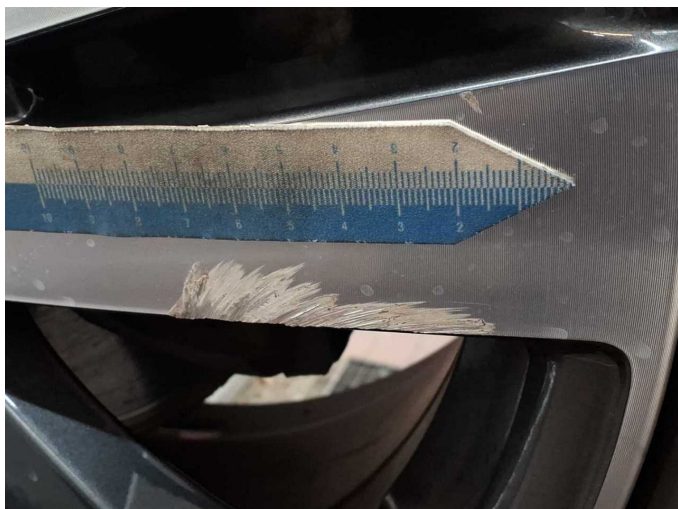
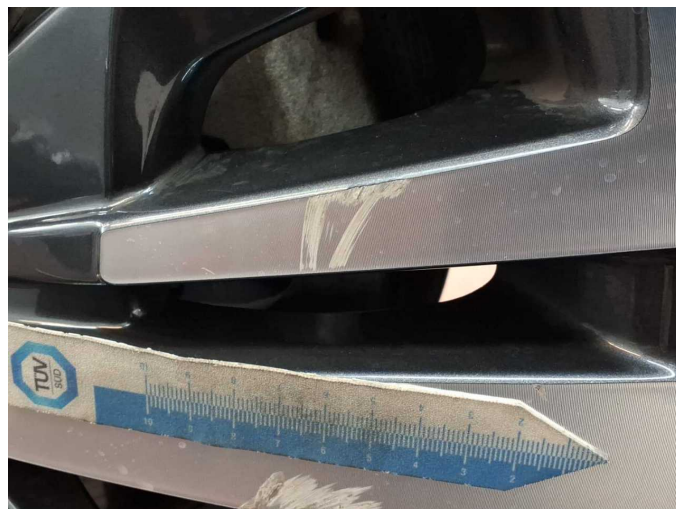
| No. | Component group | Description |
|---|---|---|
| 7 | Wheel / tyres | Alloy rim - front right side - Scratched - Replace |

**Damage 7:** Wheel / tyres: Alloy rim - front right side - Scratched - Replace

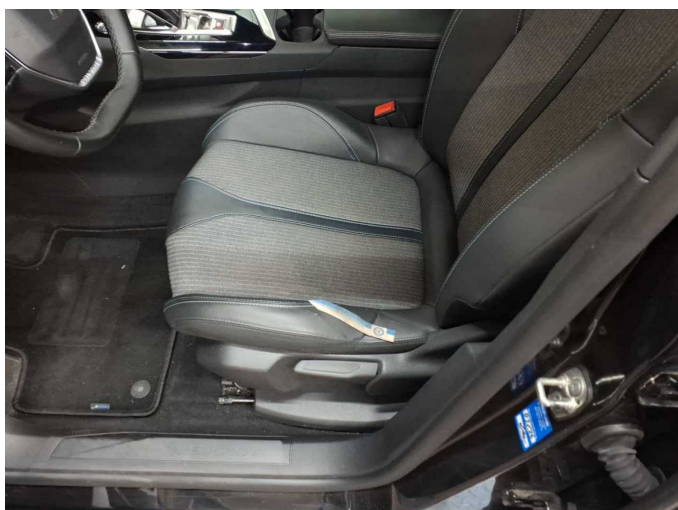
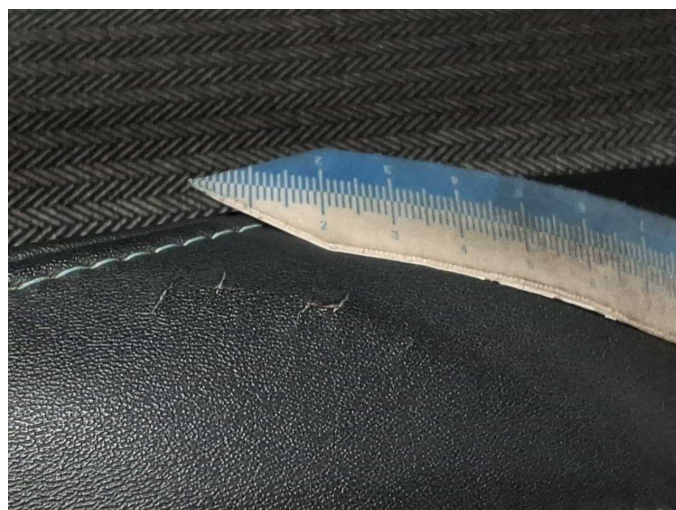
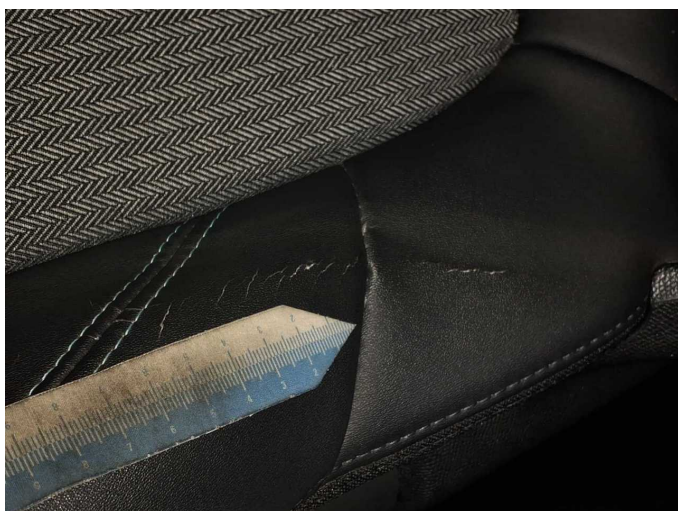
| No. | Component group | Description |
|---|---|---|
| 8 | Seat - front | Seat cover - left side - Porous / cracked - Replace |

**Damage 8:** Seat - front: Seat cover - left side - Porous / cracked - Replace

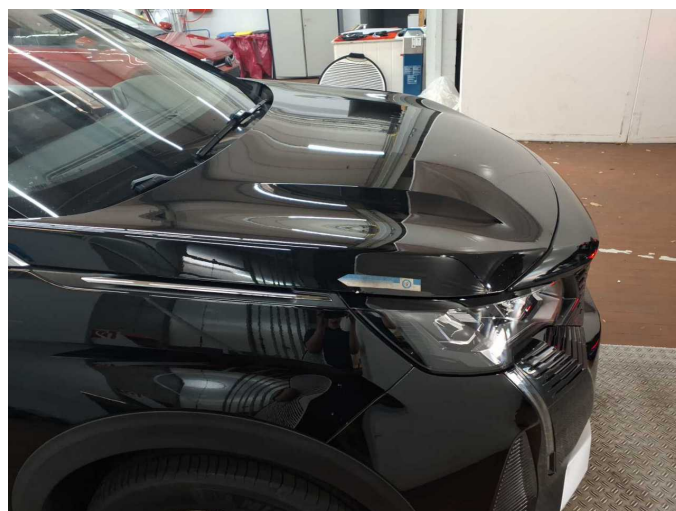
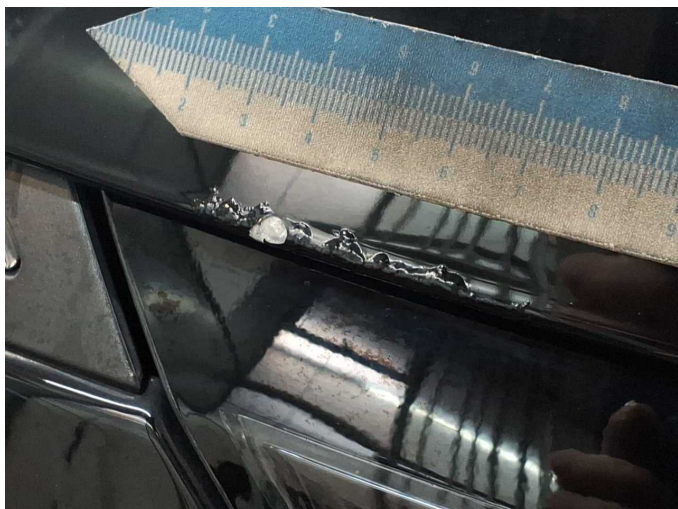
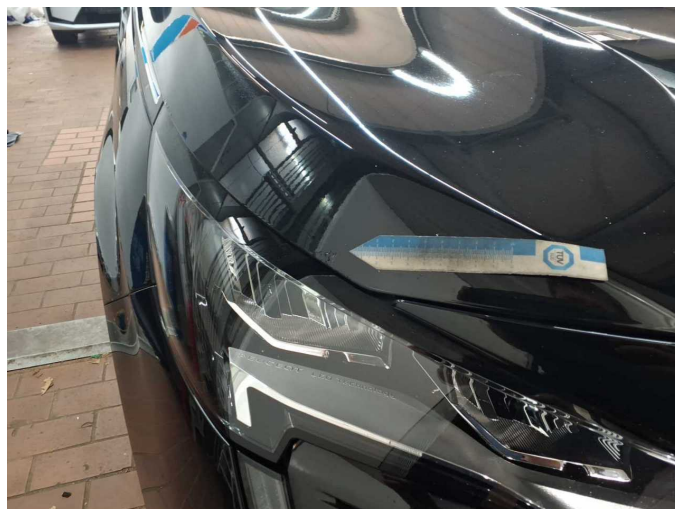
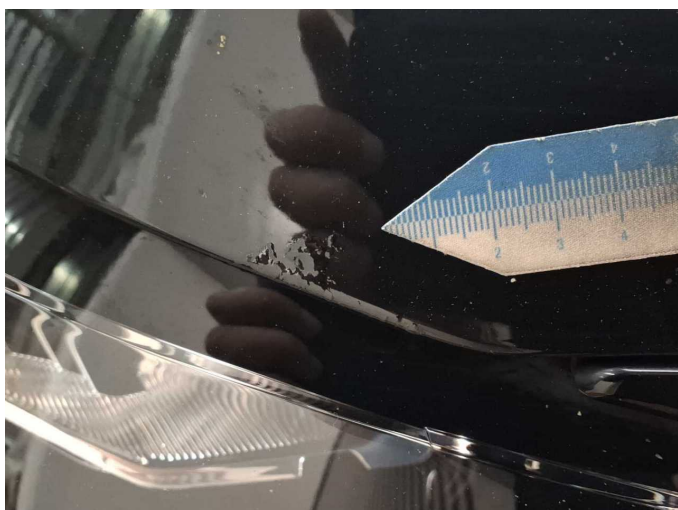
| No. | Component group | Description |
|---|---|---|
| 9 | Bonnet | Bonnet - Paint defect - Paint |

**Damage 9:** Bonnet: Bonnet - Paint defect - Paint

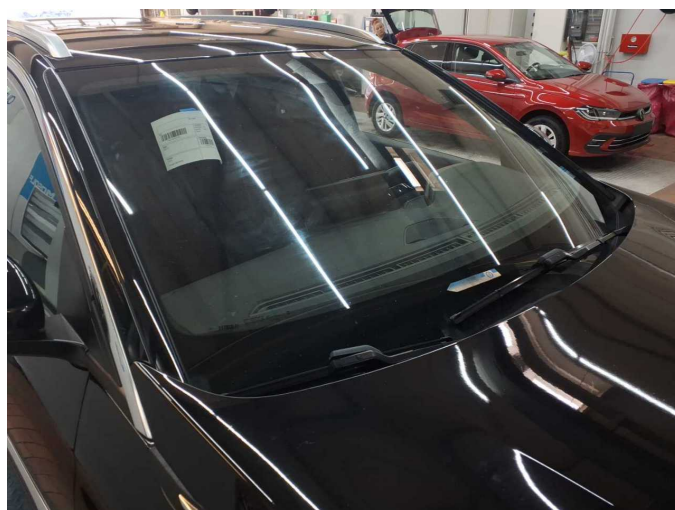
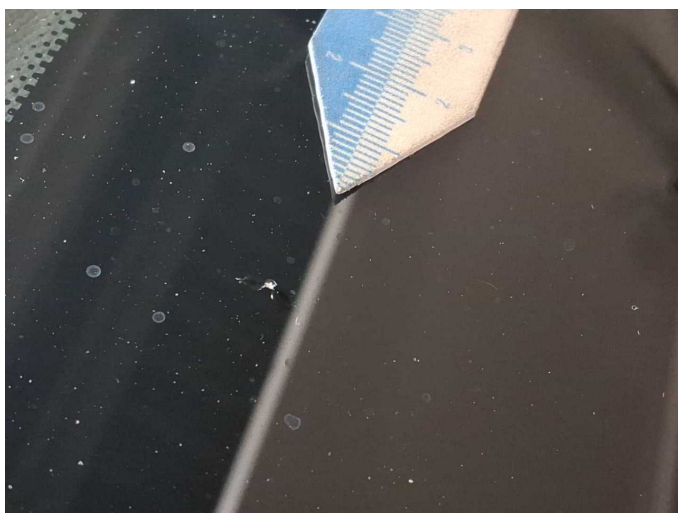
| No. | Component group | Description |
|---|---|---|
| 10 | Vehicle glazing | Windscreen - Stone chips - Replace |

**Damage 10:** Vehicle glazing: Windscreen - Stone chips - Replace
