Expertise

Protocol number: 46193319
Order No. / Reference: 25933671
Inspection date: 27 May 2026

Model: Vito 116 CDI Lang HA PRO

VIN: W1VVLBEZ7T4565206

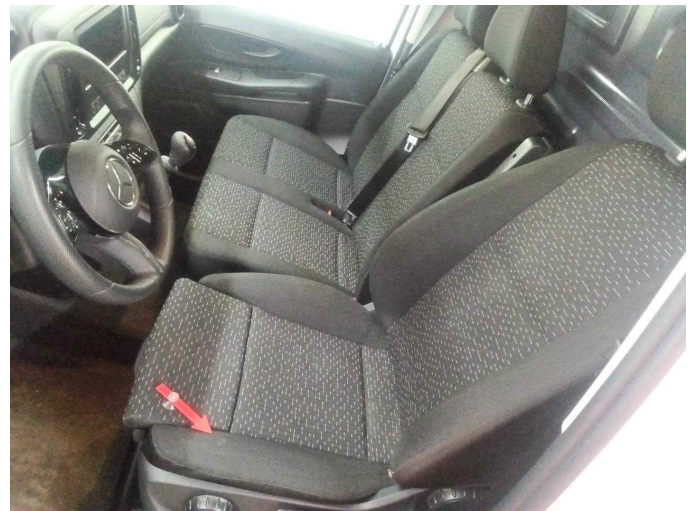
Damage 2: Seat - front: Seat - Soiled - Clean

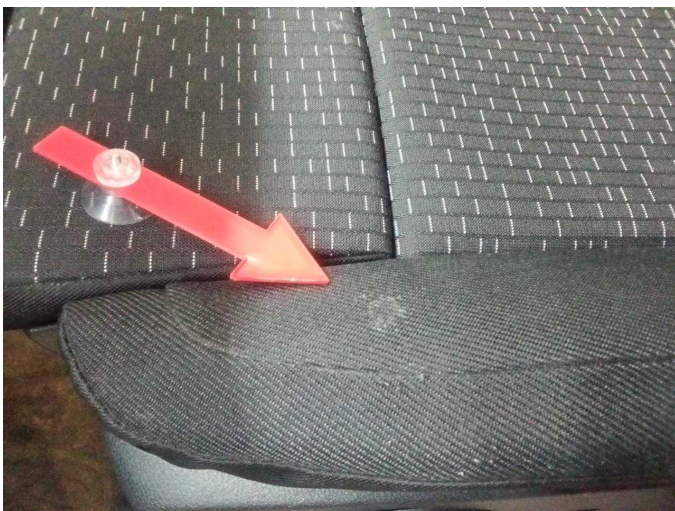
Damage 2: Seat - front: Seat - Soiled - Clean

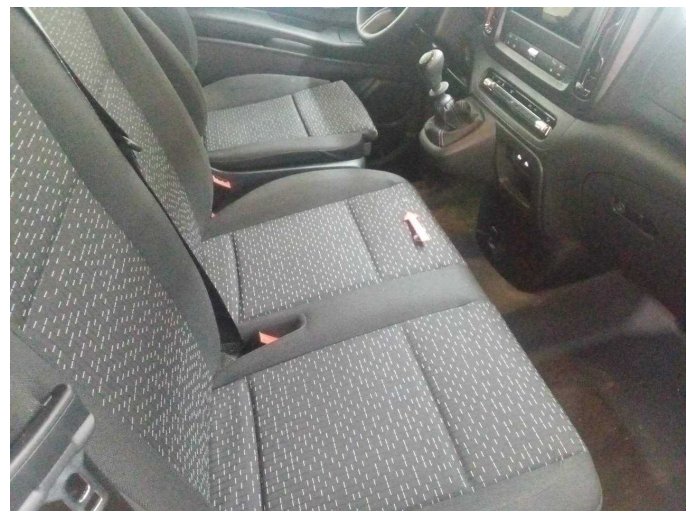
Damage 2: Seat - front: Seat - Soiled - Clean

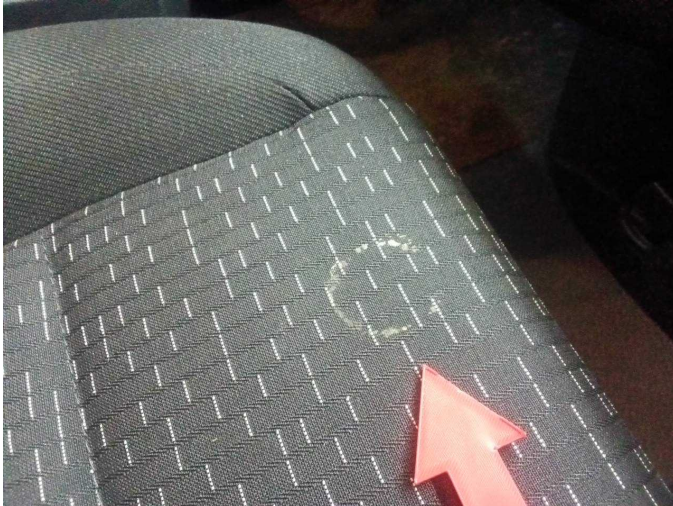
Damage 2: Seat - front: Seat - Soiled - Clean

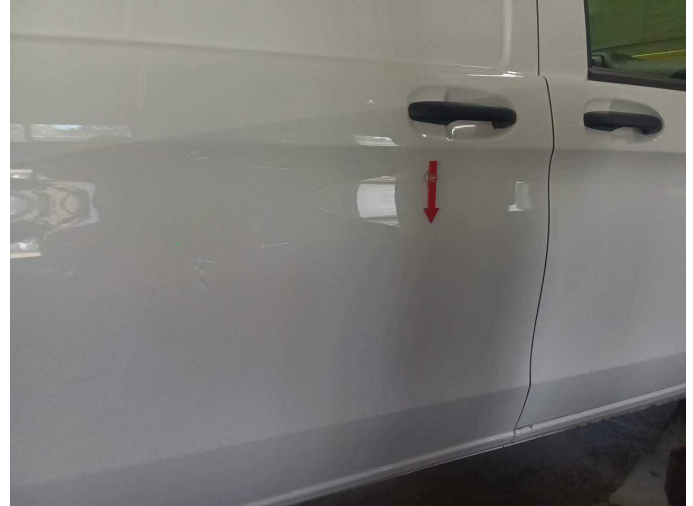
Damage 3: Sliding door, right: Sliding door - dent(s) - Smooth repair work

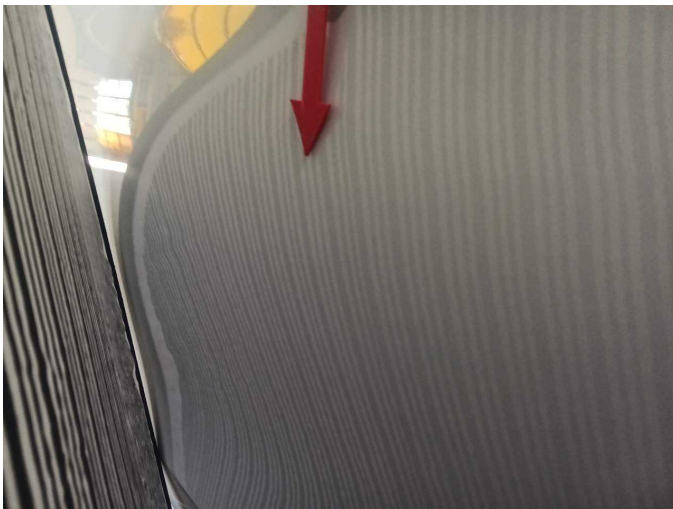
Damage 3: Sliding door, right: Sliding door - dent(s) - Smooth repair work

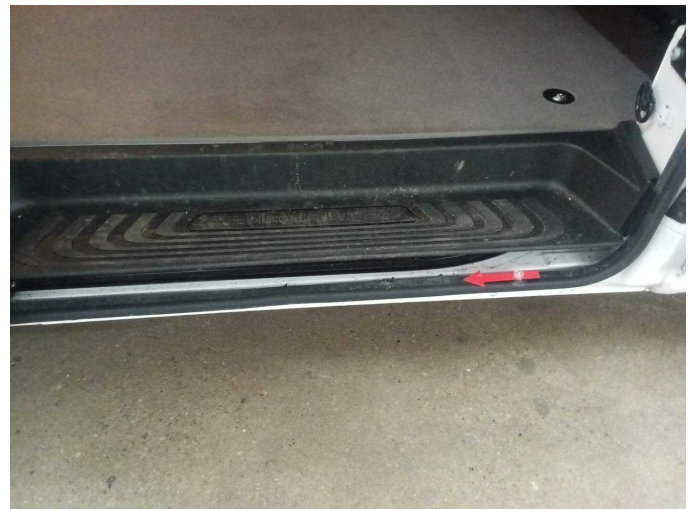
Damage 4: Sliding door, right: Door seal - Broken / torn - Replace

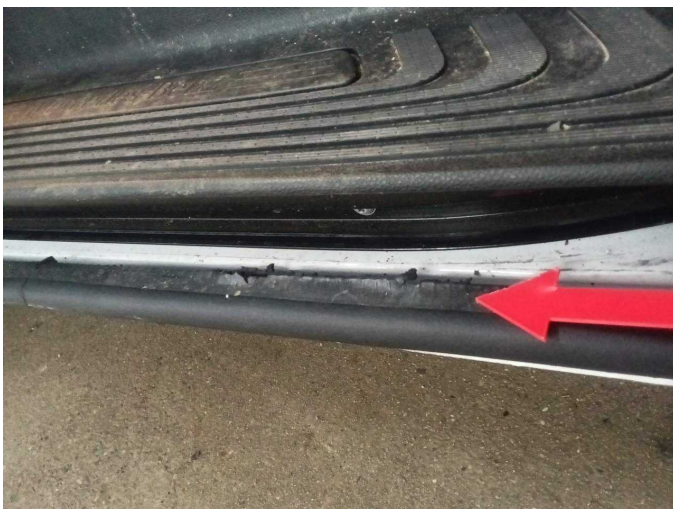
Damage 4: Sliding door, right: Door seal - Broken / torn - Replace

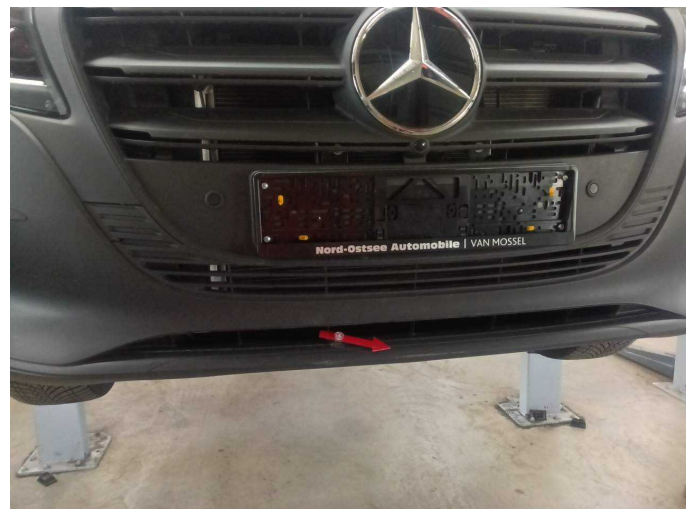
Damage 5: Front bumper: Front bumper - Scratched - Replace

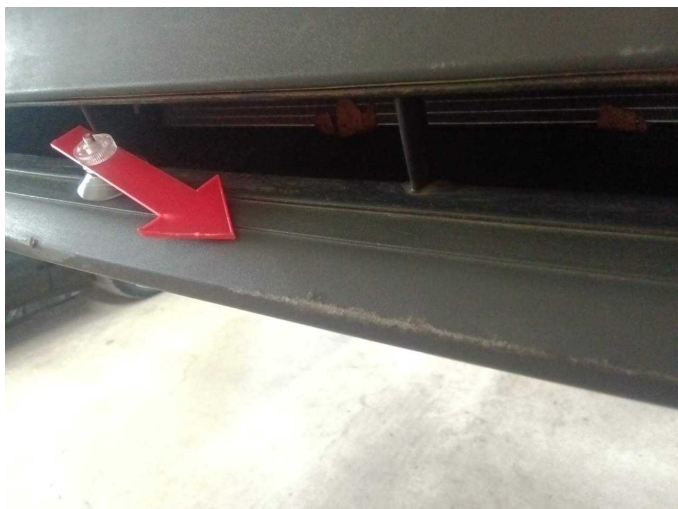
Damage 5: Front bumper: Front bumper - Scratched - Replace

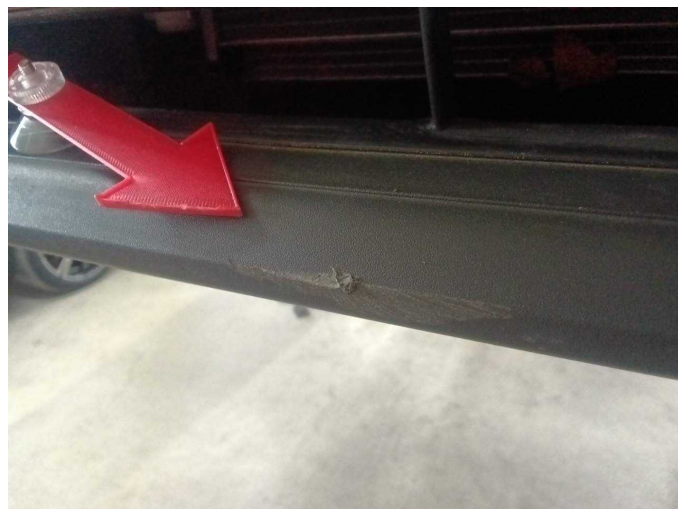
Damage 5: Front bumper: Front bumper - Scratched - Replace
