## Expertise

Protocol number: 46188801  
Order No. / Reference: 26497077  
Inspection date: 29 Jun 2026

Manufacturer: Ford

Model: Transit Custom 320 L2H1 LKW VA Trend

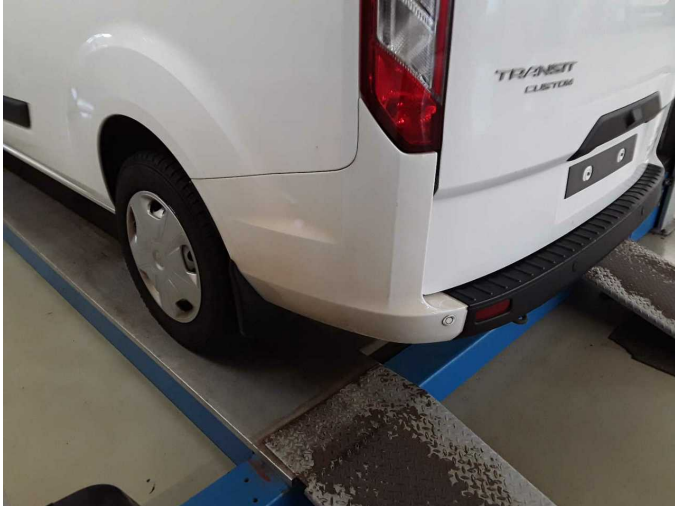
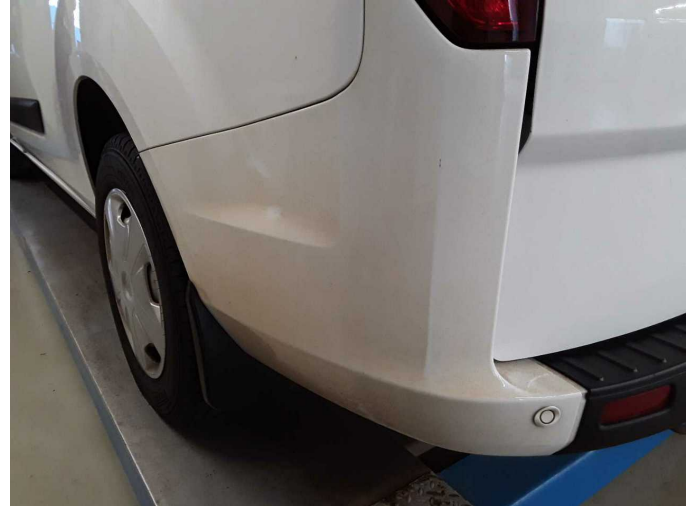
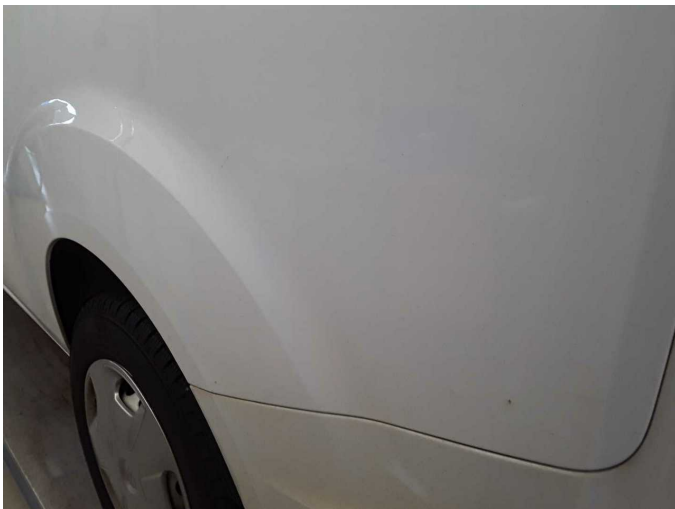
**Damage 1:** Rear bumper: Bumper - rear left side (inkl. Seitenwand links, Bremsenstaub) - Soiled - Clean

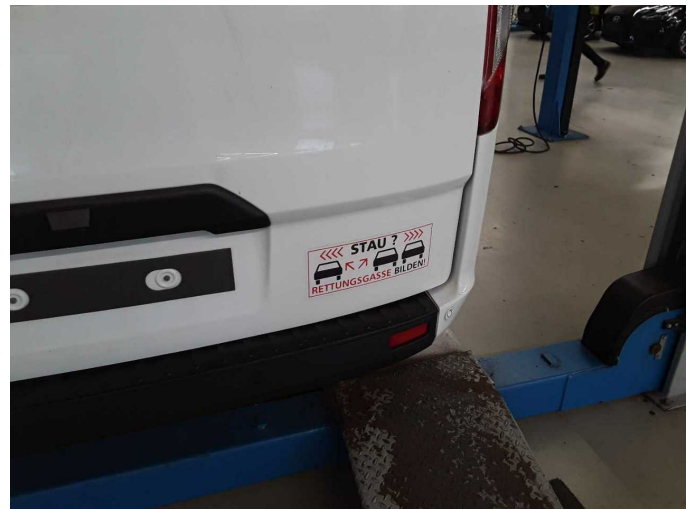
**Damage 2:** Body: Body (Zusatzkosten können entstehen) - Glued / labelled - De-glue / neutralise

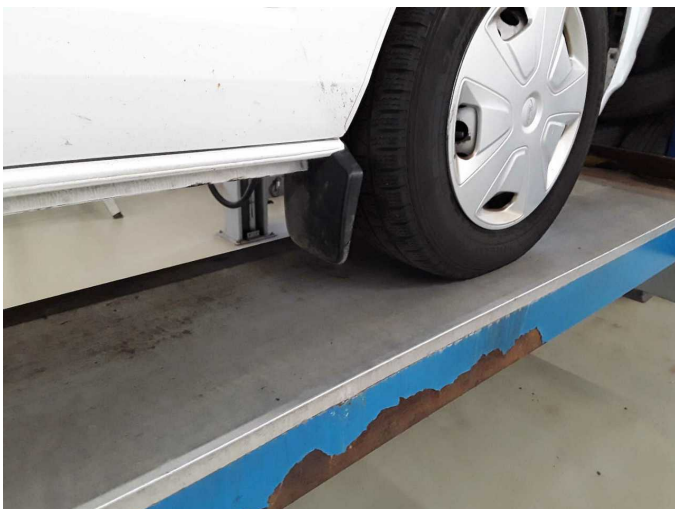
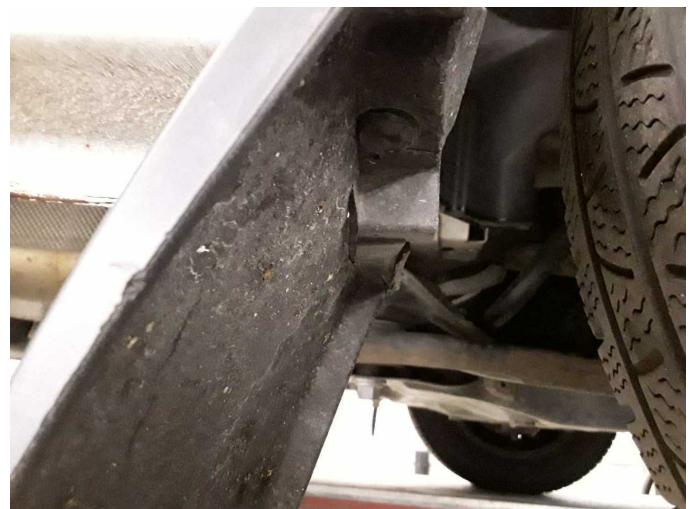
**Damage 3:** Mudguard - right side: Mud flap - Broken / torn - Replace

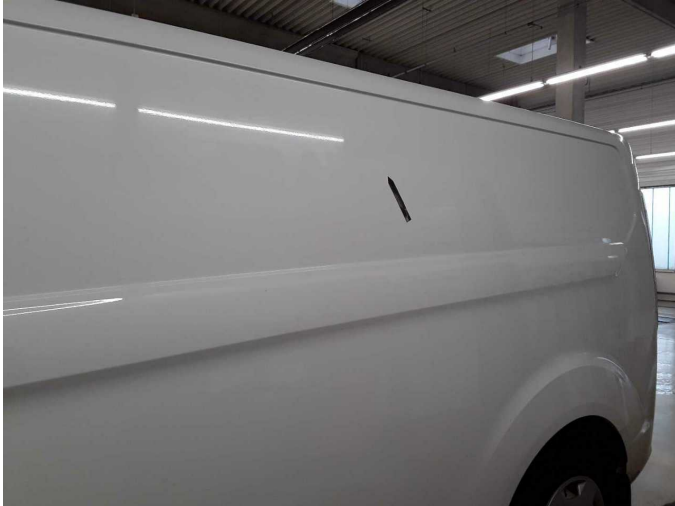
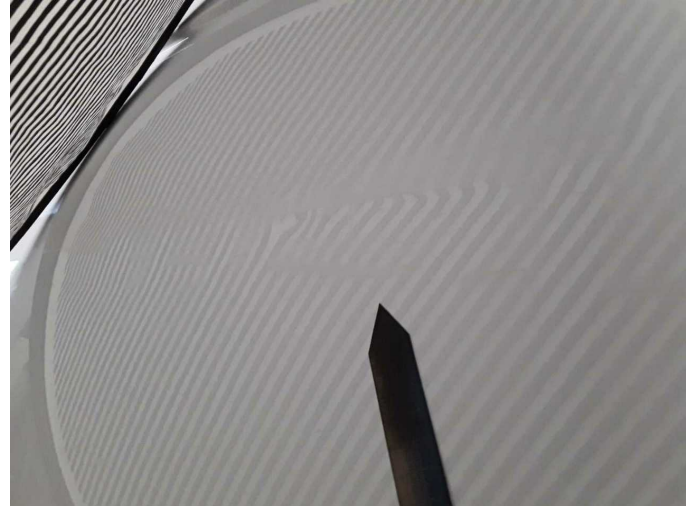
**Damage 4:** Side panel - rear left side: Side panel - dent(s) - Smart repair

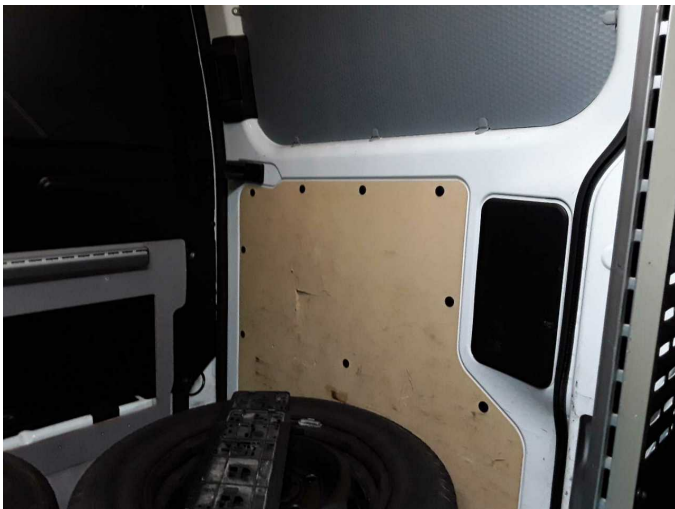
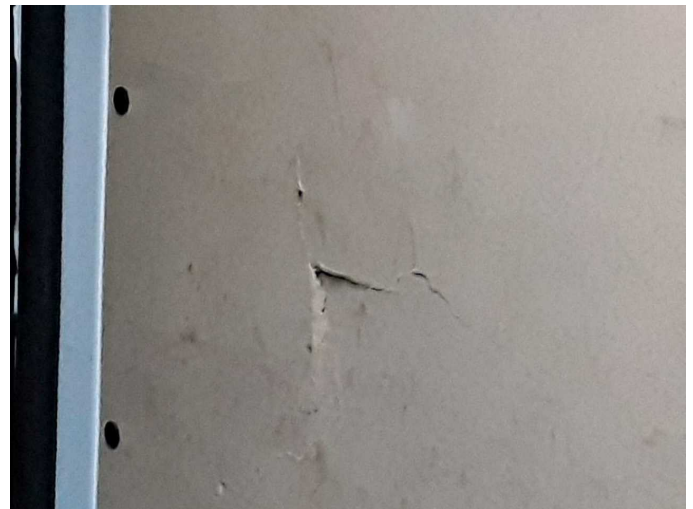
**Damage 5:** Sliding door, right: Trim plywood - lower - Broken / torn - Replace

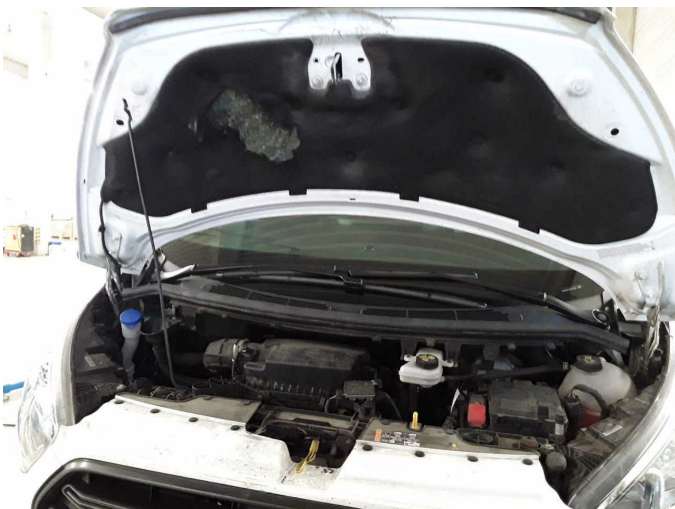
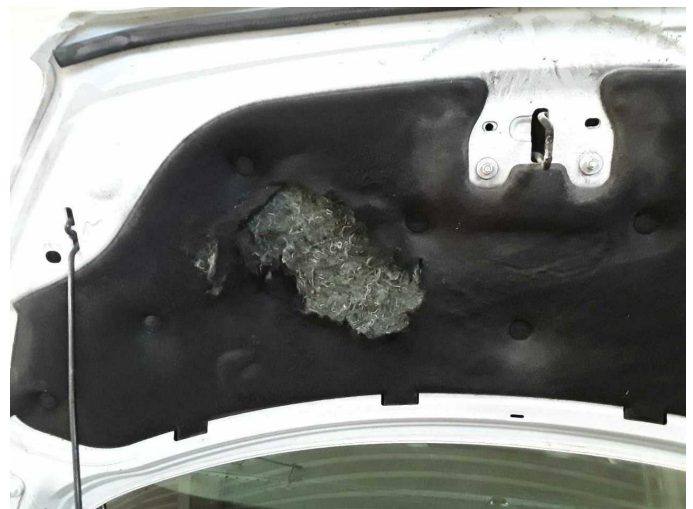
**Damage 6:** Bonnet: Insulation lining - Damage caused by marten / rodent - Replace

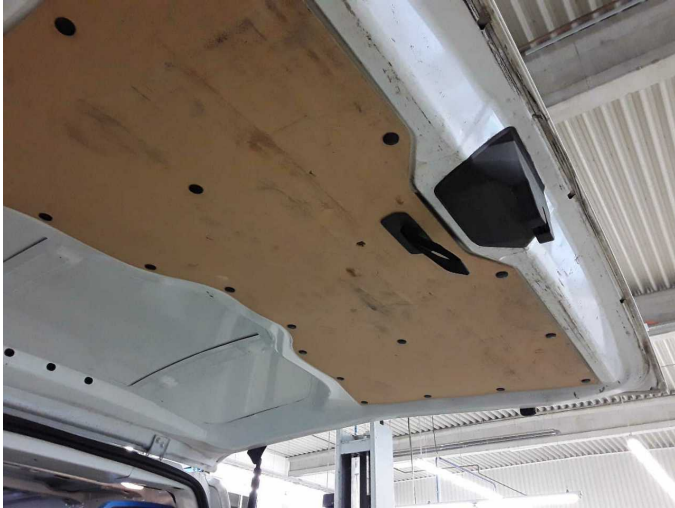
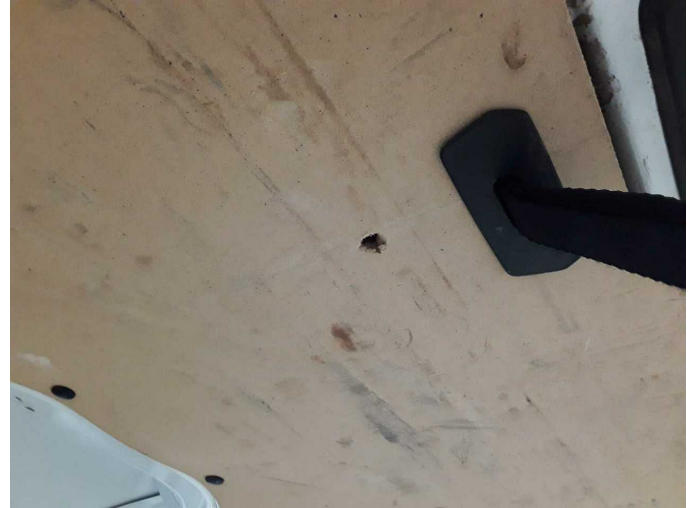
**Damage 7:** Boot lid / rear door: Trim rear door - plywood - lower - Broken / torn - Replace

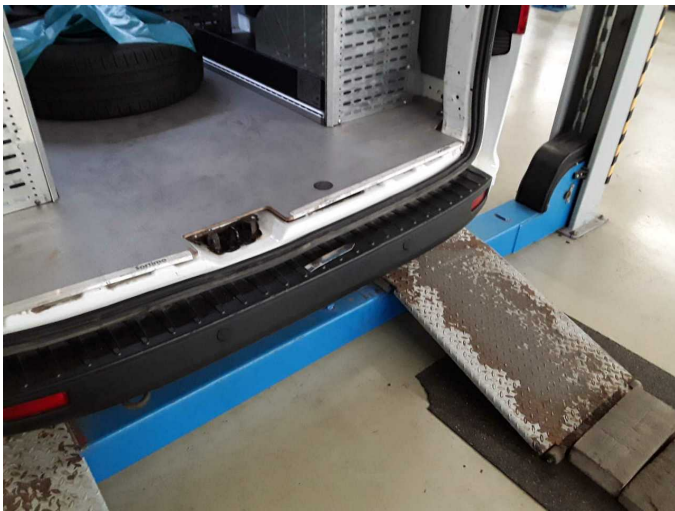
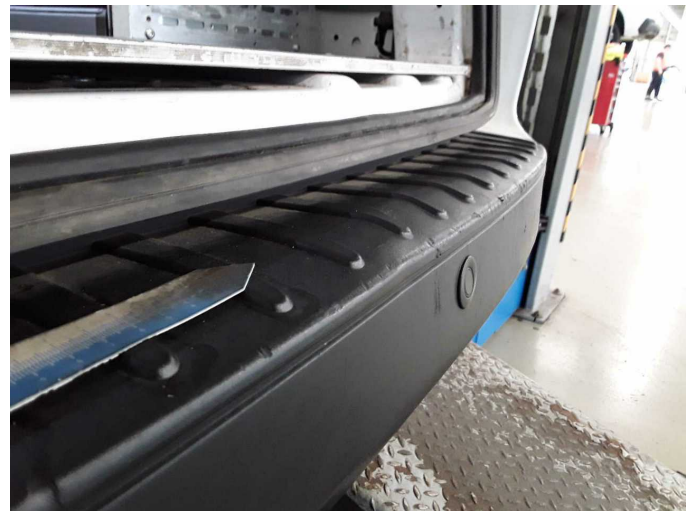
**Damage 8:** Rear bumper: Bumper - rear centre - Deformed - Replace

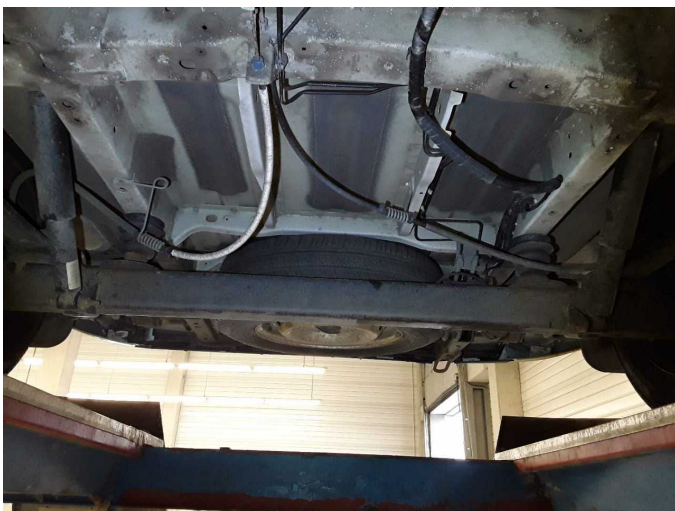
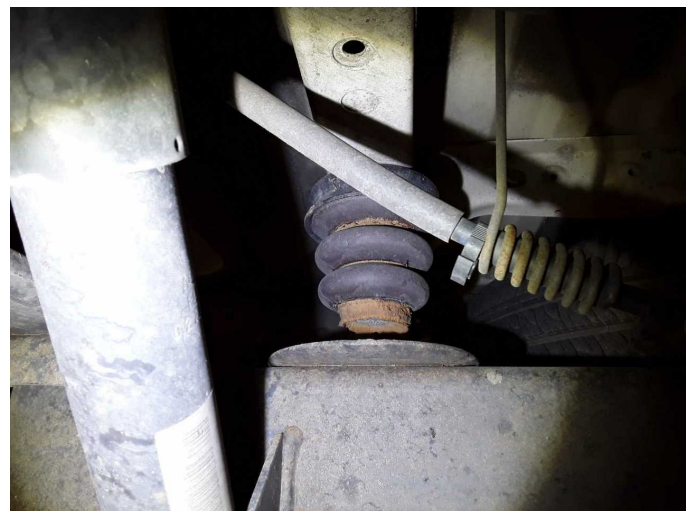
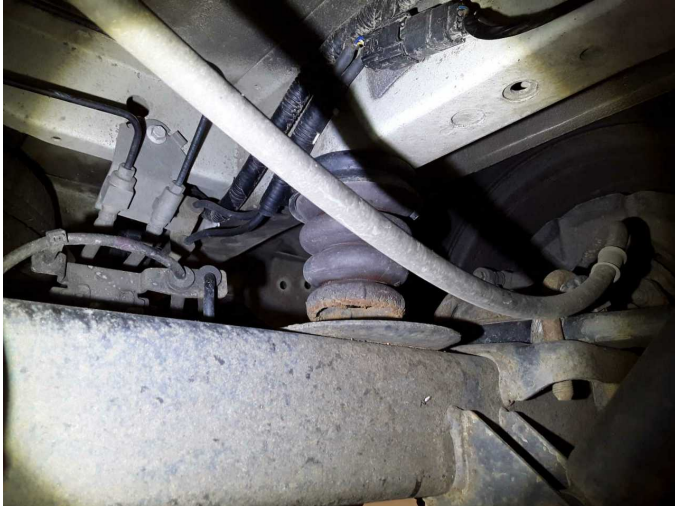
**Damage 9:** Rear axle: Leaf spring - right side (Anschlagpuffer links und rechts) - Porous / cracked - Replace

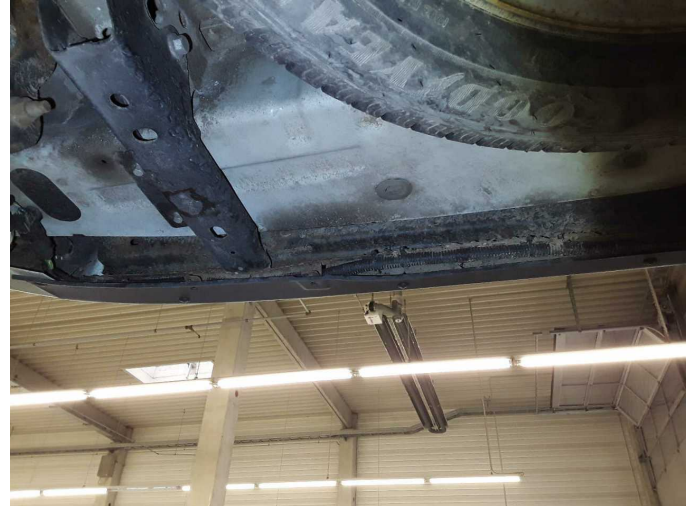
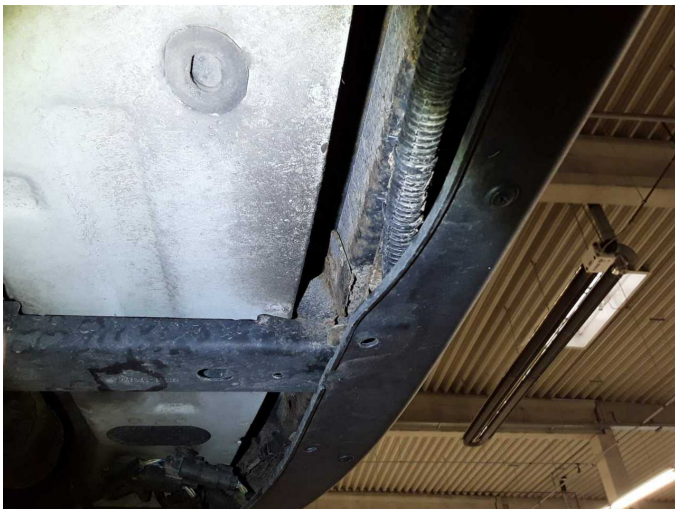
**Damage 10:** Rear bumper: Support - Deformed - Replace

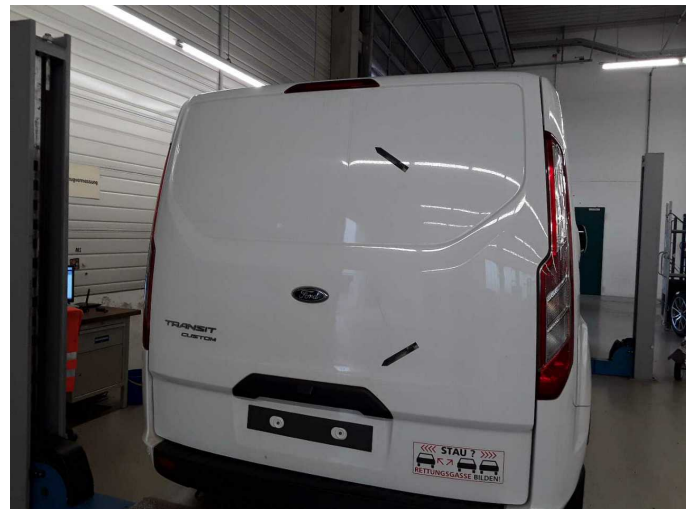
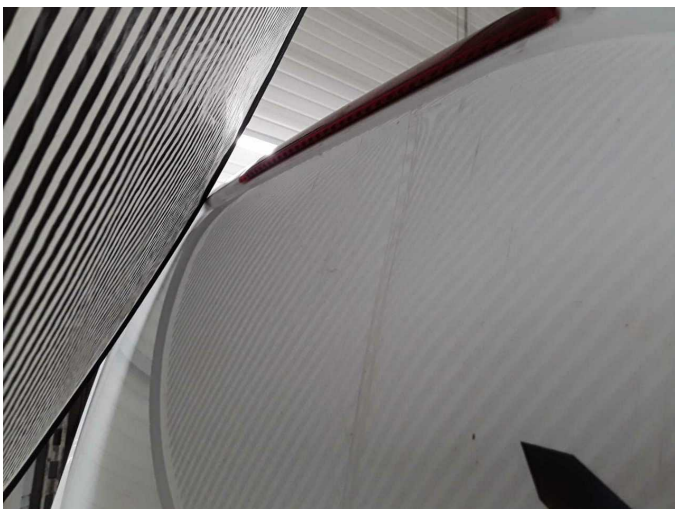
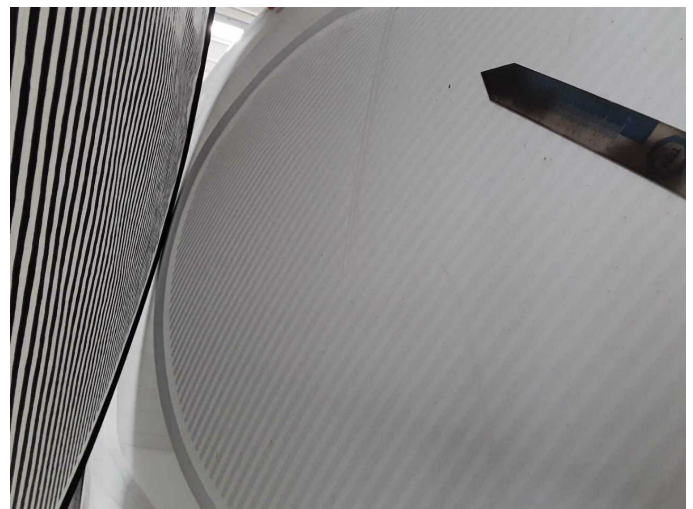
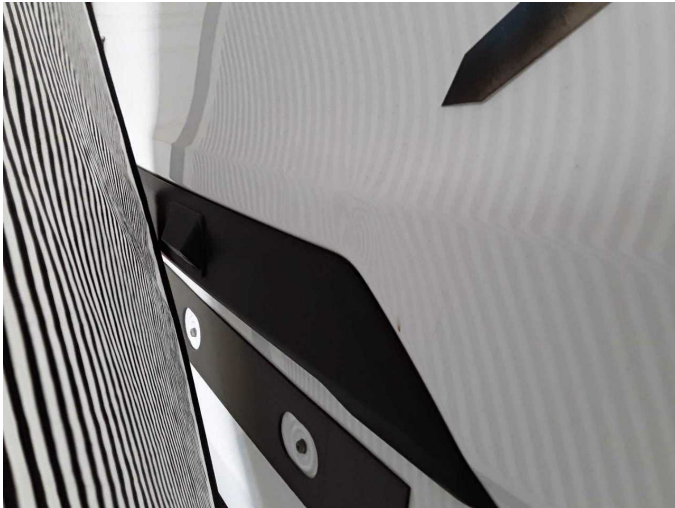
**Damage 11:** Boot lid / rear door: Boot lid - Dent / paintcoat damage - Repair and paint

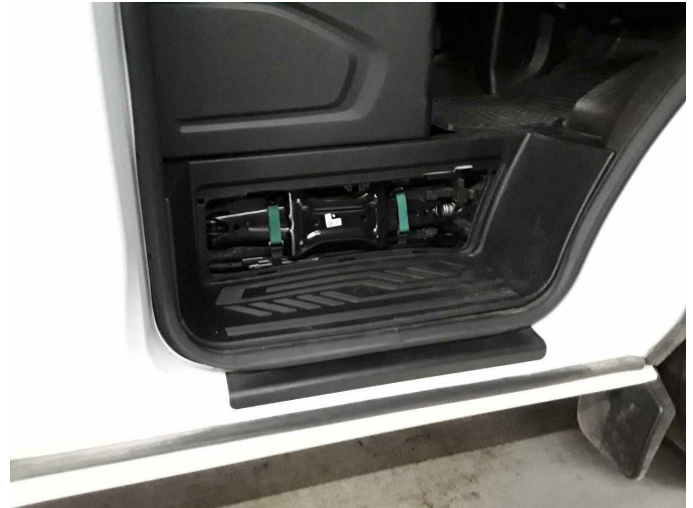
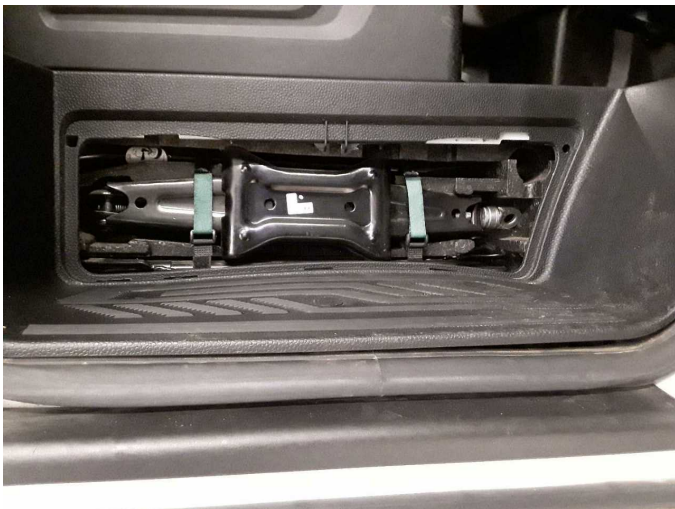
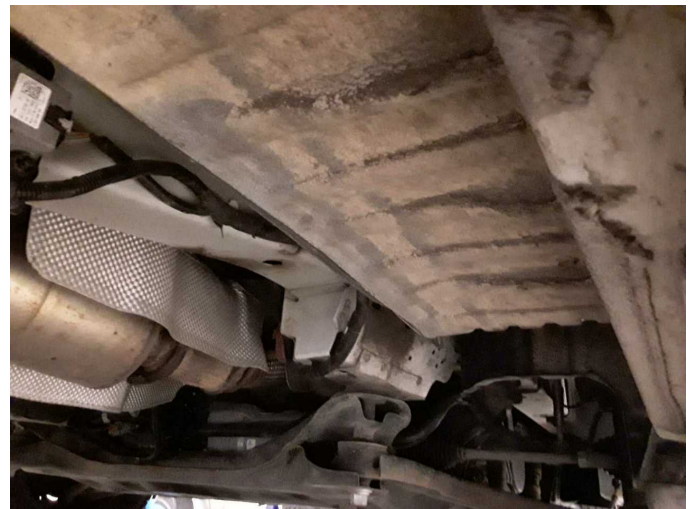
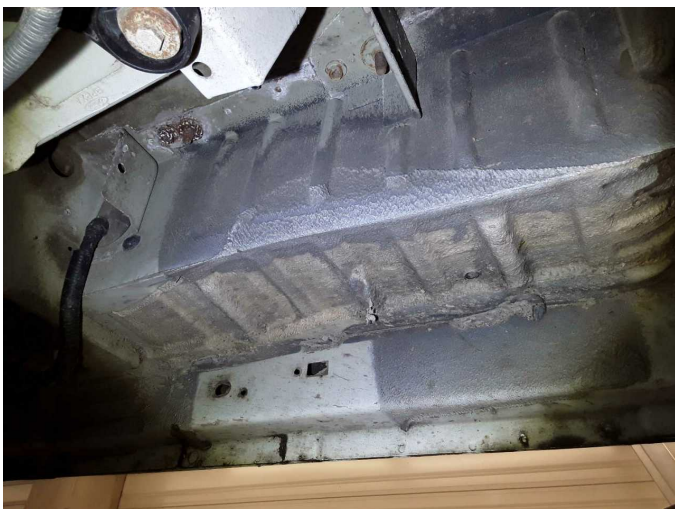
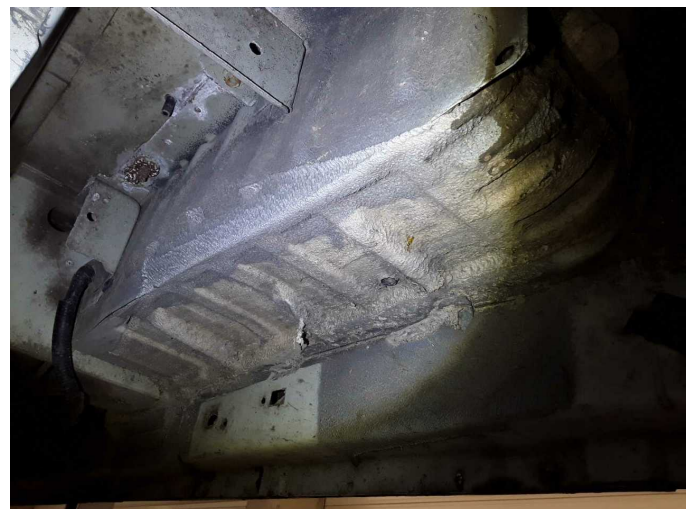
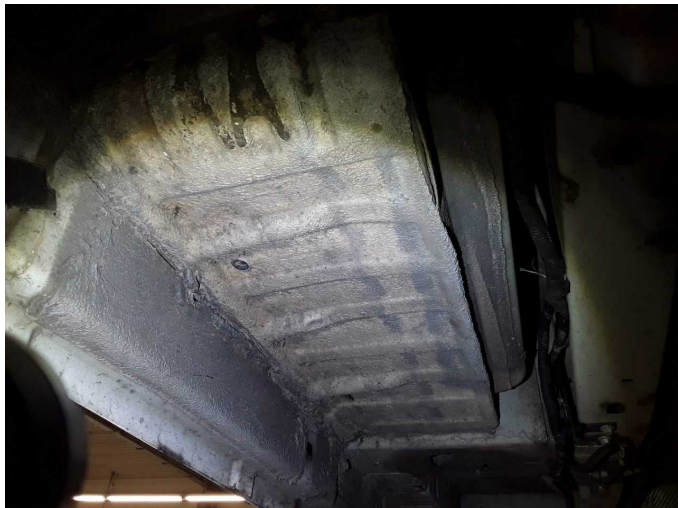
**Damage 12:** Body: Underbody (Einstieg rechts) - Deformed - Replace

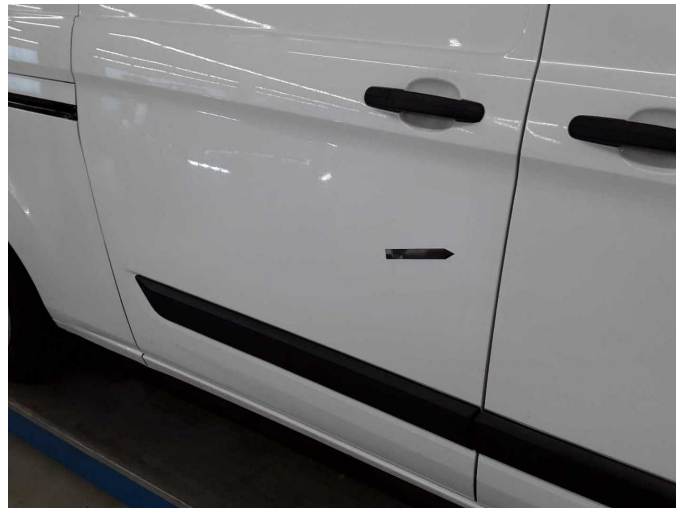
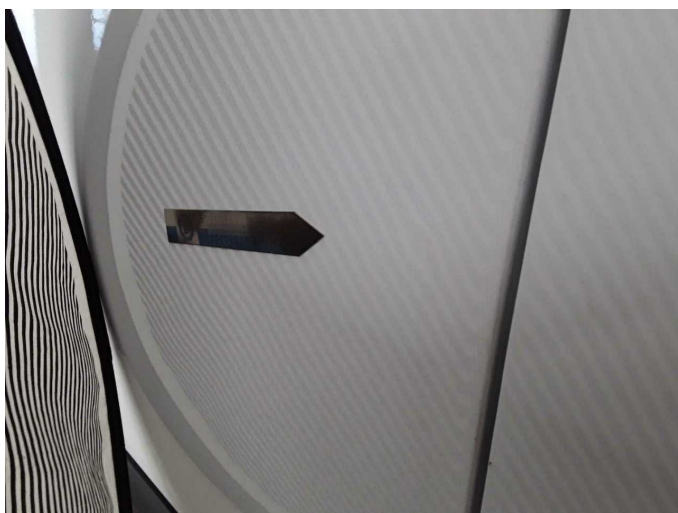
**Wear and tear 1:** Sliding door, right: Sliding door - dent(s) - No deduction
