Expertise

Protocol number: 46053842
Order No. / Reference: 26518963
Inspection date: 17 Jun 2026

Manufacturer: Seat

Model: Cupra Born 170kW/77kWh

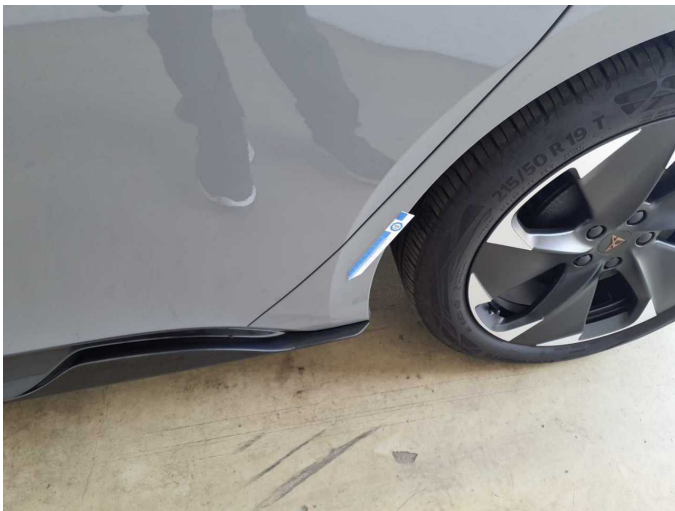
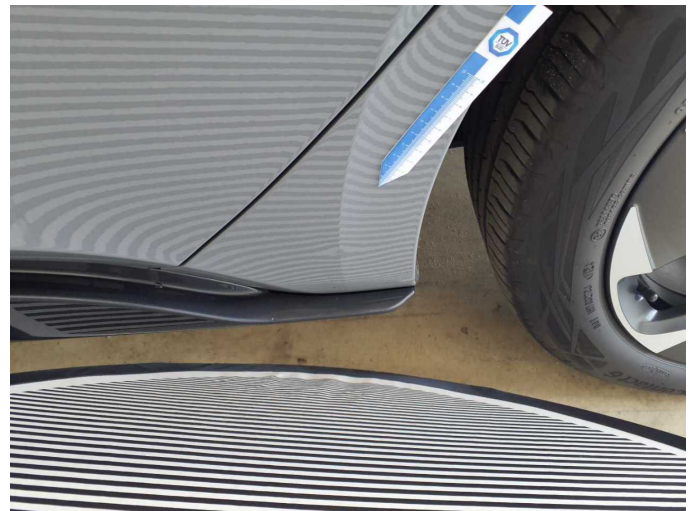
No.	Component group	Description
1	Side panel - rear left side	Elbow - dent(s) - Smart repair
2	Wing mirror - right side	Cap - Scratched - Paint
3	Wheel / tyres	Tyre - front right side (nicht fahrbereit) - Damaged - Replace

Damage 1: Side panel - rear left side: Elbow - dent(s) - Smart repair

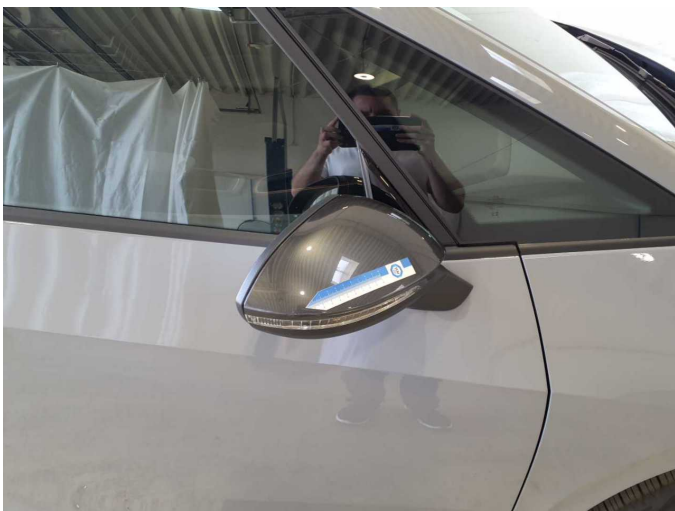
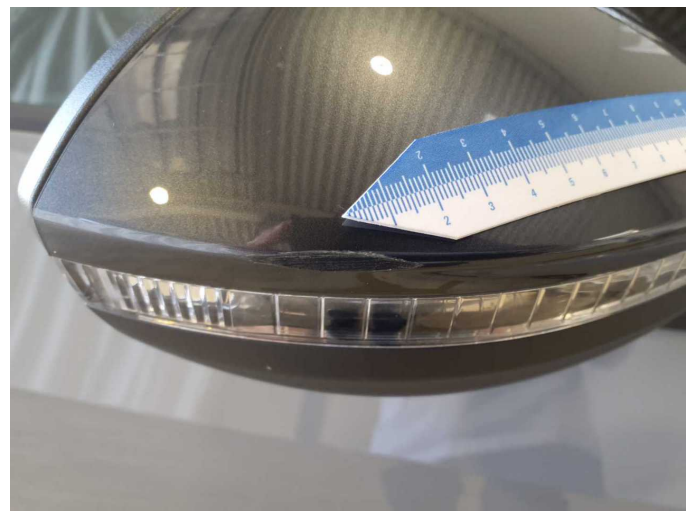
Damage 2: Wing mirror - right side: Cap - Scratched - Paint

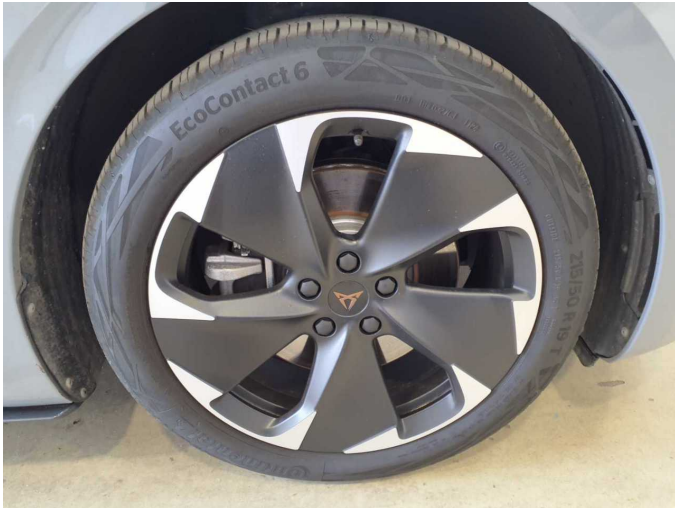
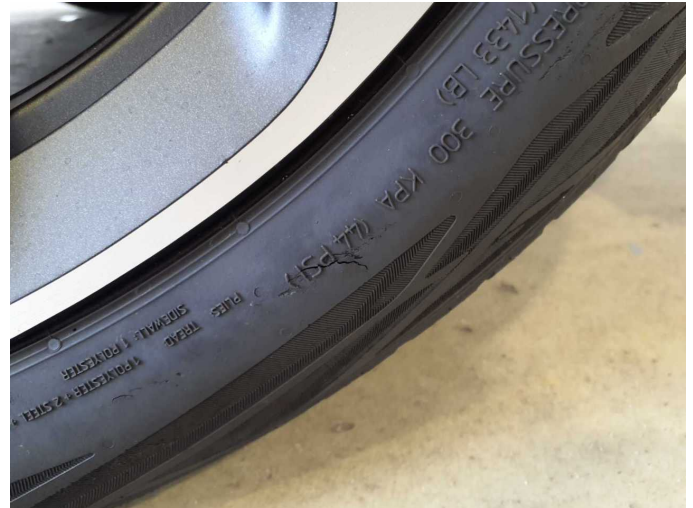
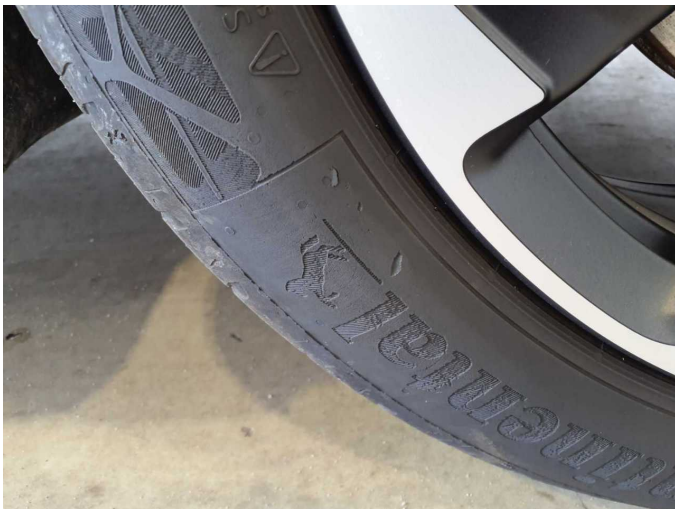
Damage 3: Wheel / tyres: Tyre - front right side (nicht fahrbereit) - Damaged - Replace

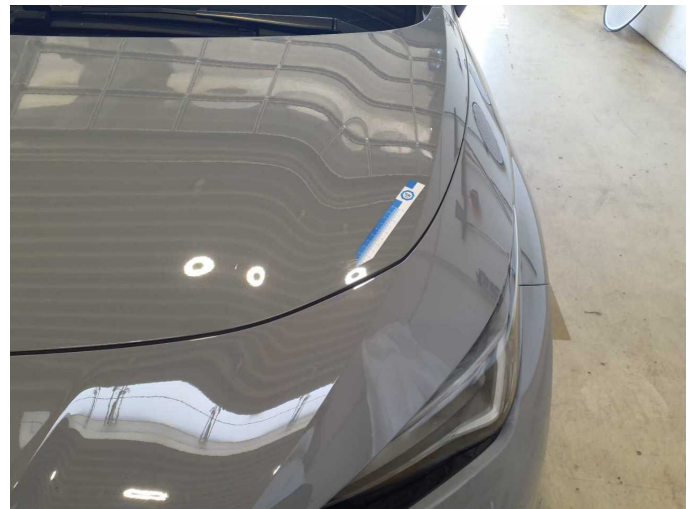
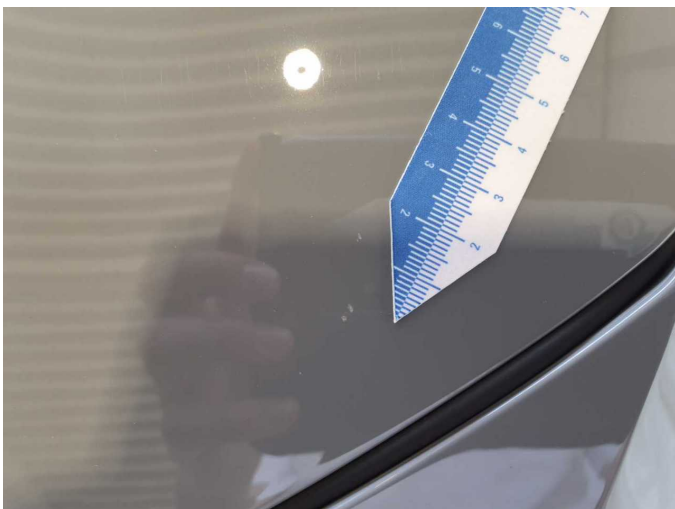
No.	Component group	Description
1	Bonnet	Bonnet - Stone chips - Cover / polish

Wear and tear 1: Bonnet: Bonnet - Stone chips - Cover / polish
