Expertise

Protocol number: 45807319
Order No. / Reference: 26324921
Inspection date: 26 May 2026

Model: Leon Sportstourer 2.0 TDI DSG FR

VIN: VSSZZKLZNR033539

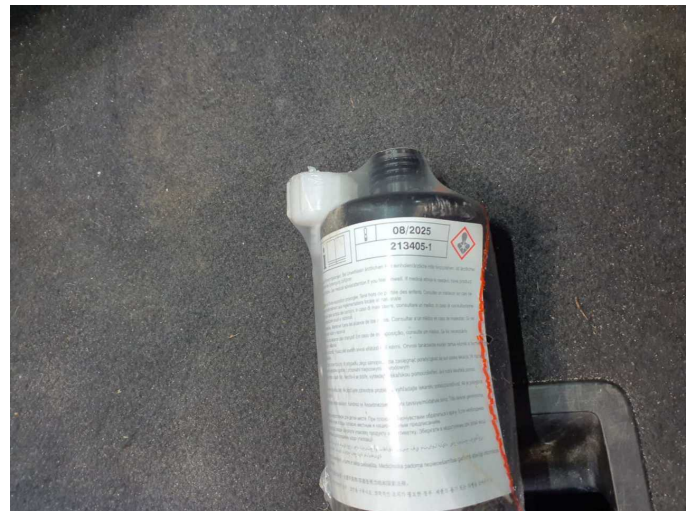
Damage 1: Equipment: Tirefit filler - Expired - Replace

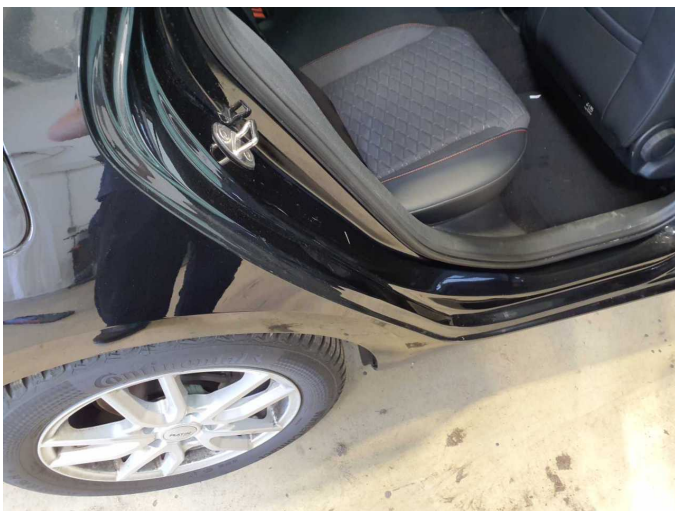
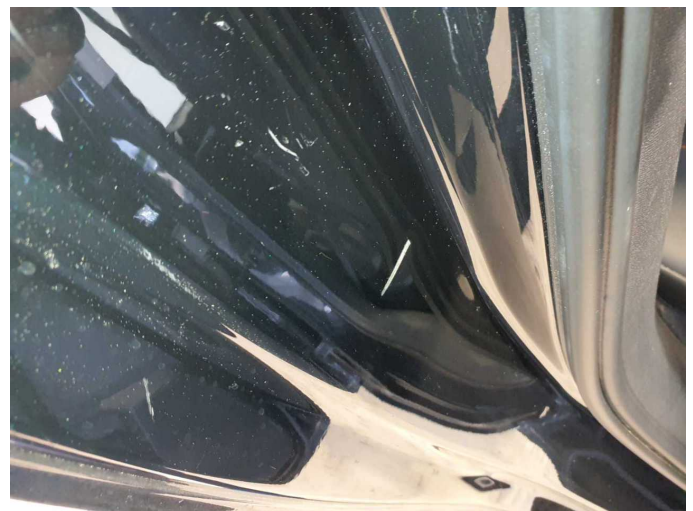
Damage 2: Side panel - rear right side: Sill - Dent / paintcoat damage - Smart repair

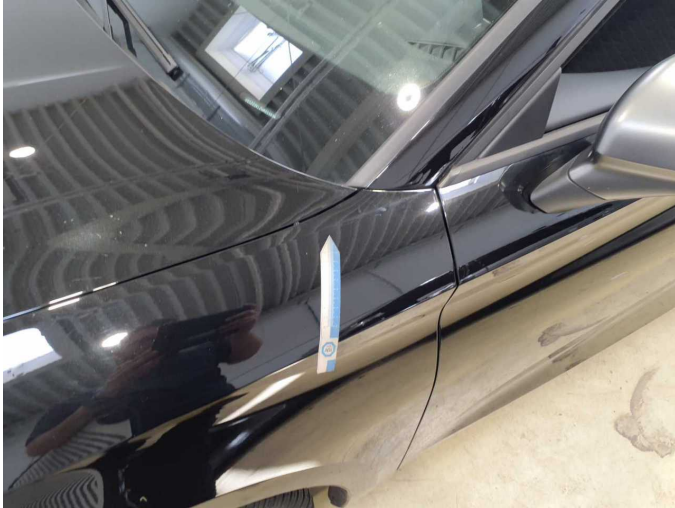
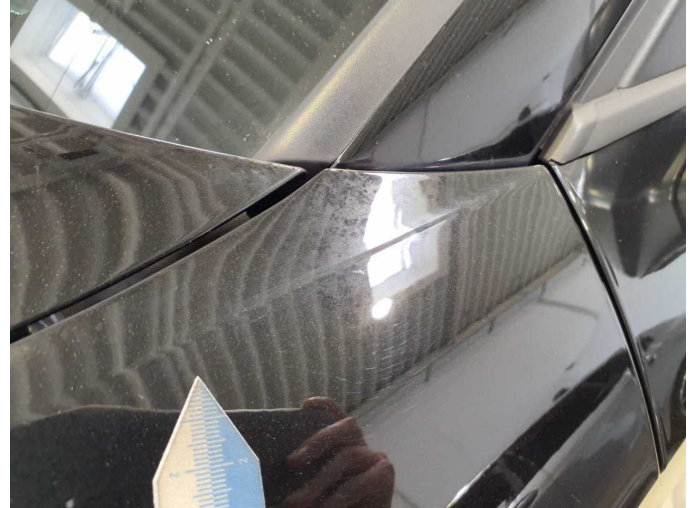
Damage 3: Mudguard - left side: Mudguard - left side (Lacknebel) - Paint defect - Conditioning

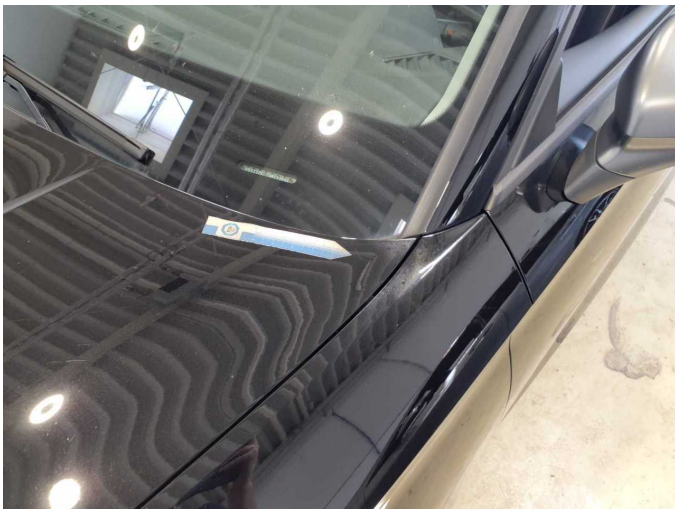
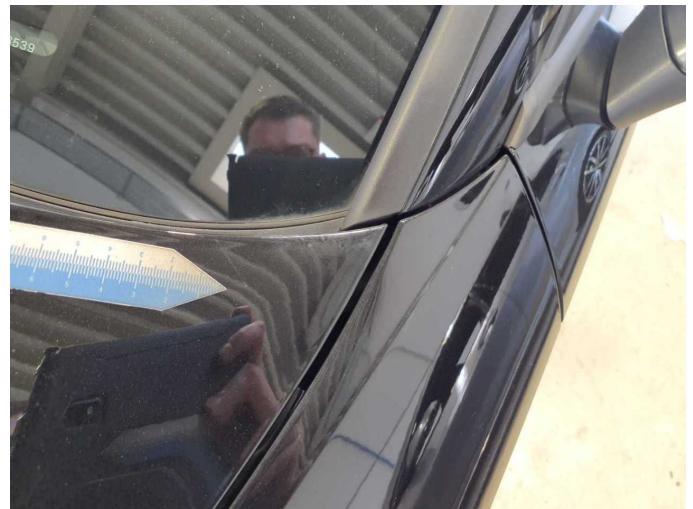
Damage 4: Bonnet: Bonnet (Lacknebel) - Paint defect - Conditioning

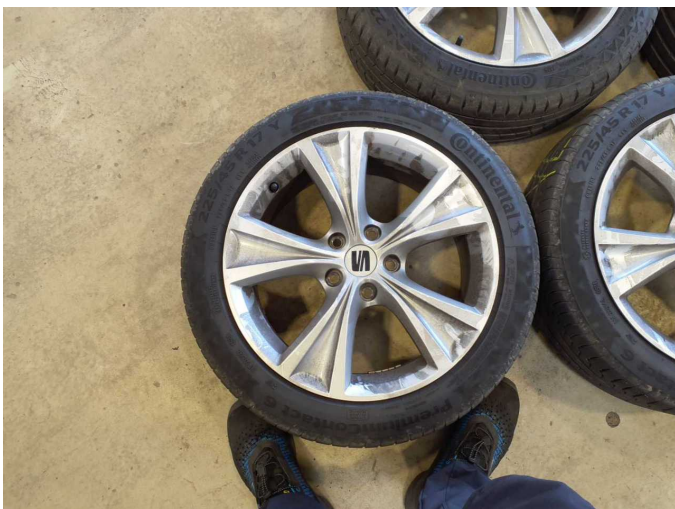
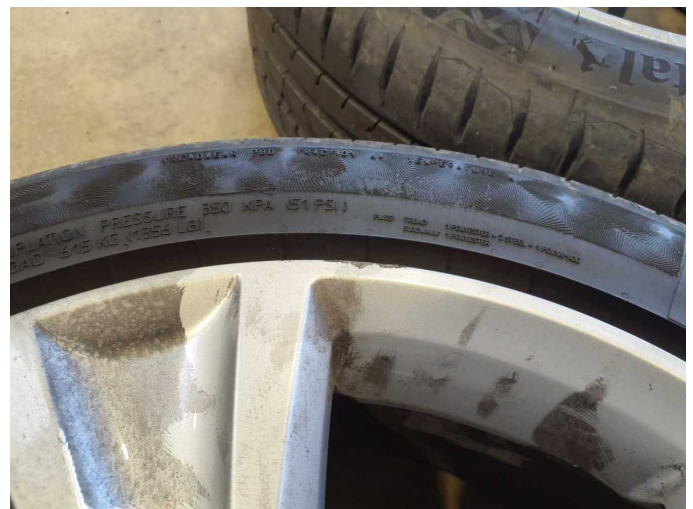
Damage 5: 2nd wheel set: 1 alloy rim - Scratch(es) - Loss in value

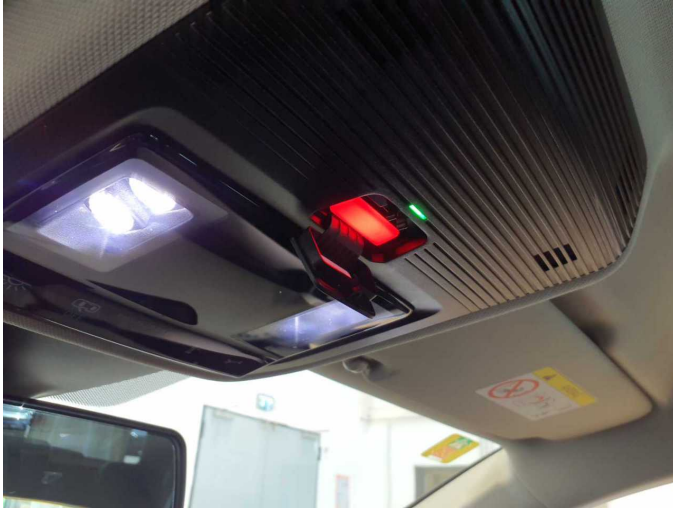
Damage 6: Trim / covers: Trim / covers - Broken / torn - Replace

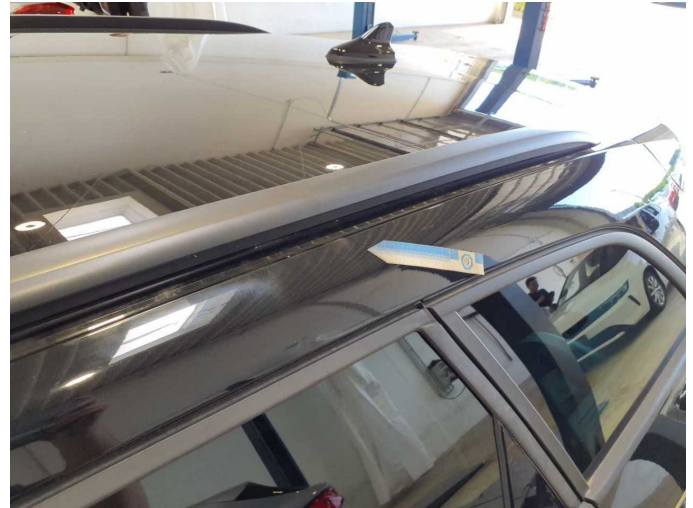
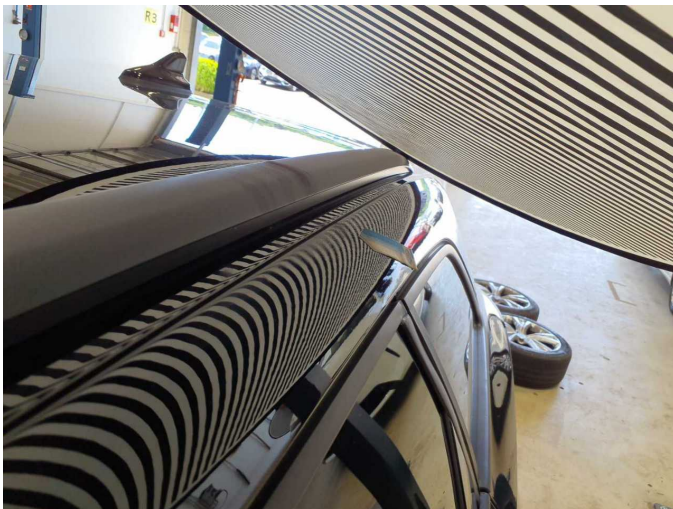
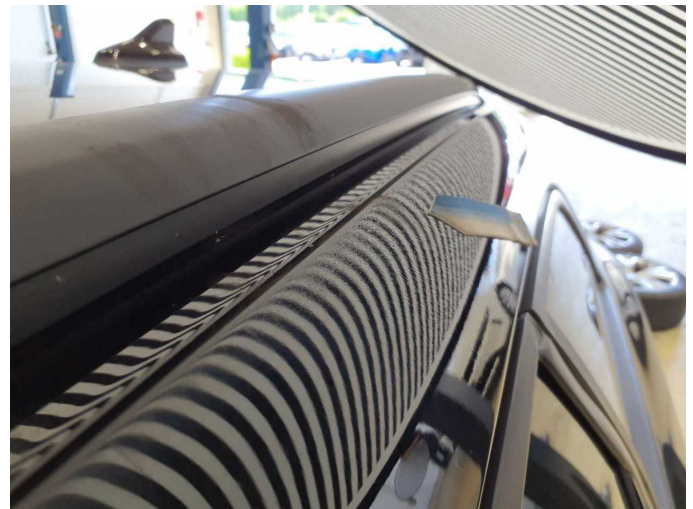
Roof rail - left side	189 µm	Roof rail - right side	197 µm
Side panel - rear left side	294 µm	Side panel - rear right side	192 µm

Damage 7: Roof: Roof rail - left side (Orangenhaut) - Unprofessionally repaired - Repair and paint

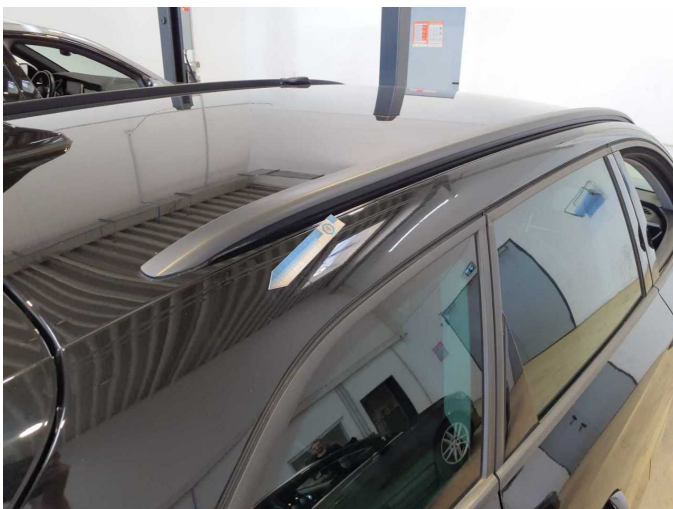
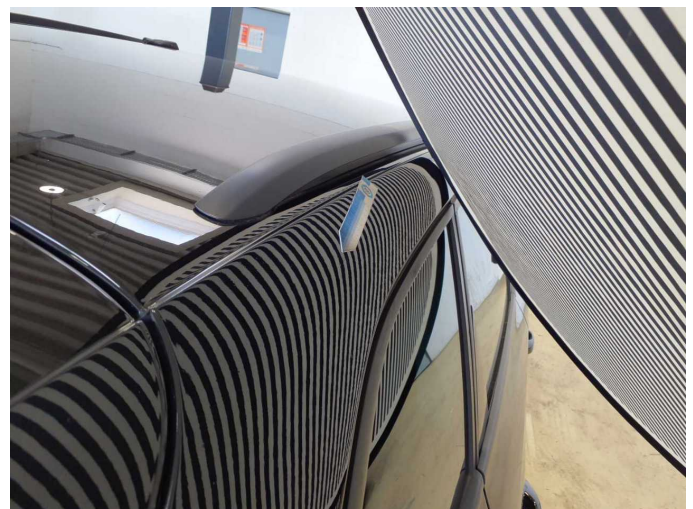
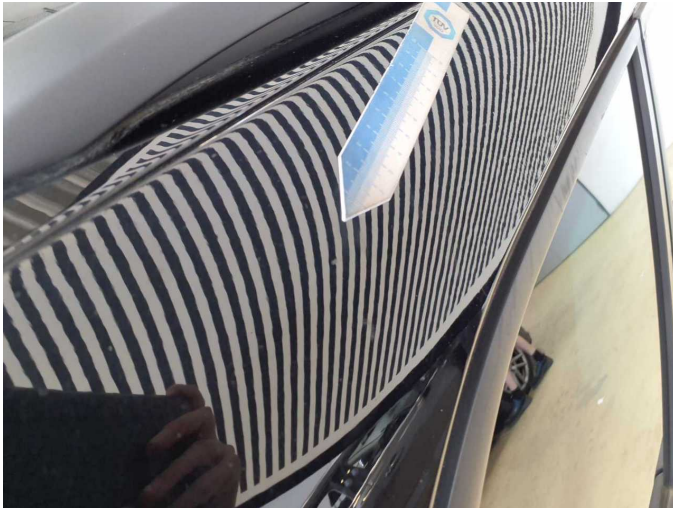
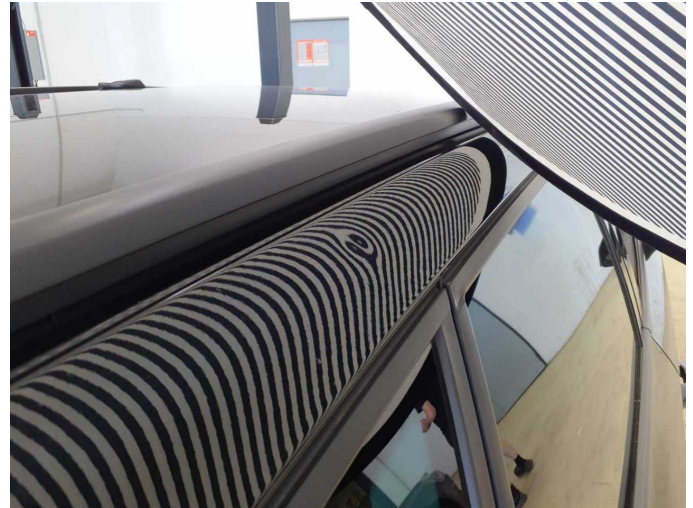
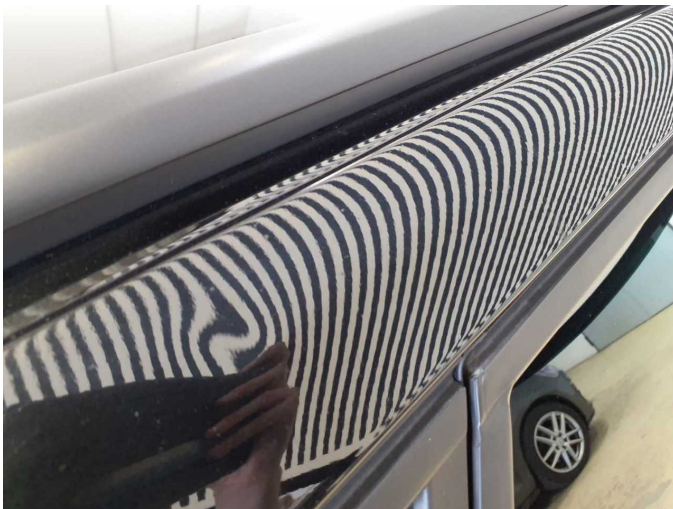
Damage 8: Roof: Roof rail - right side (Einschlüsse) - Unprofessionally repaired - Repair and paint

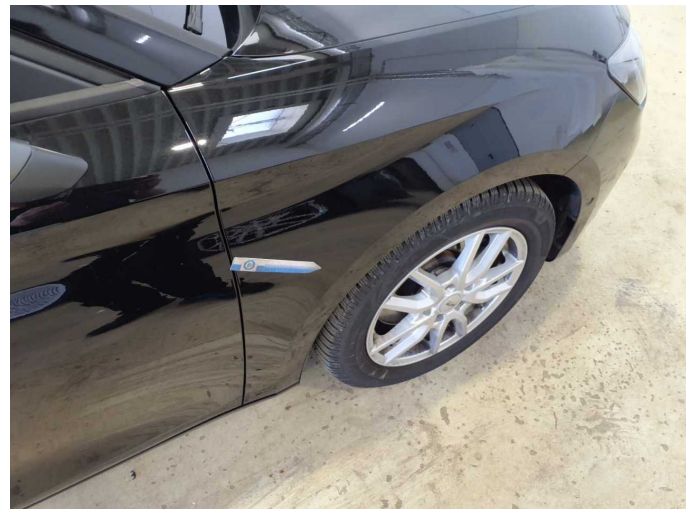
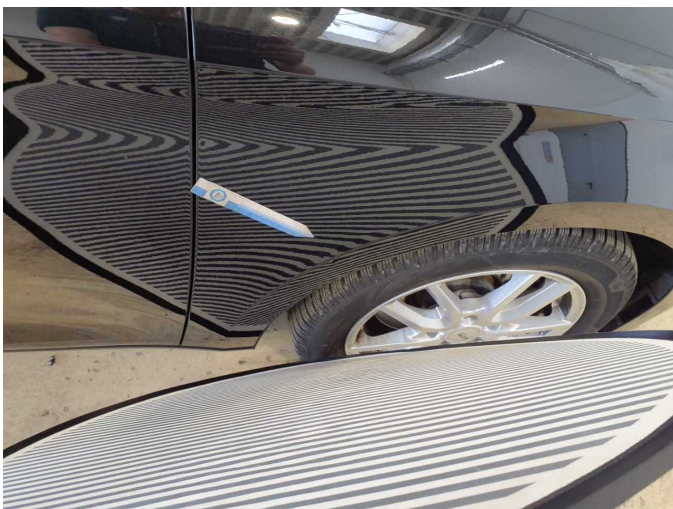
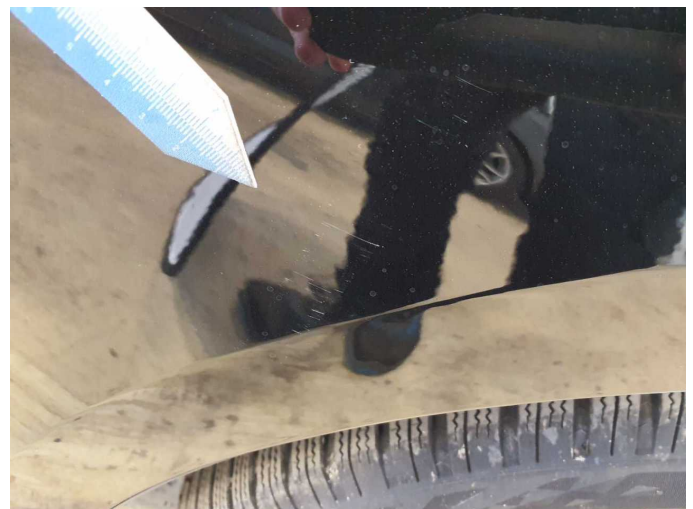
Damage 9: Mudguard - right side: Mudguard - right side - Dent / paintcoat damage - Repair and paint

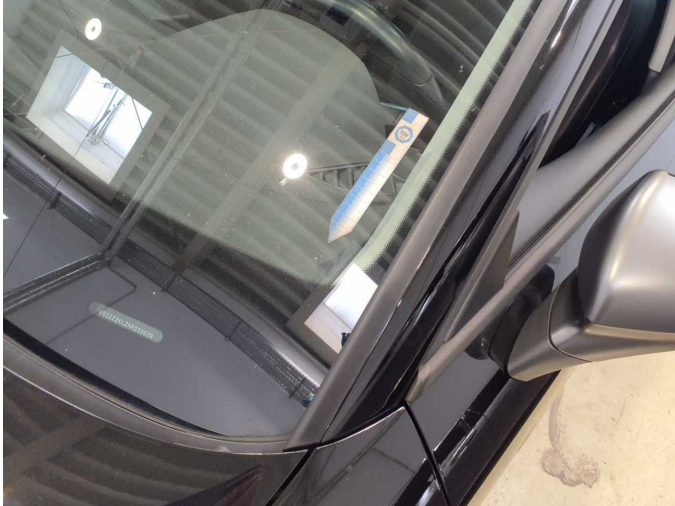
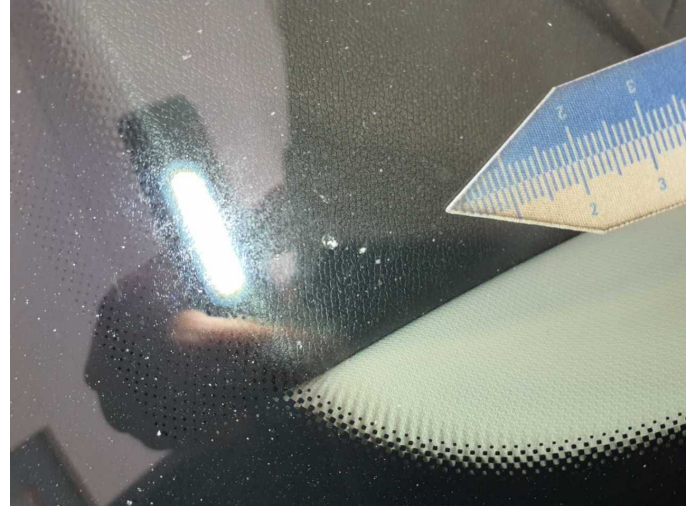
Wear and tear 3: Vehicle glazing: Windscreen - Stone chips - No deduction
