Expertise

Protocol number: 46839071  
Order No. / Reference: 26578038  
Inspection date: 31 Jul 2026

Manufacturer: Volkswagen

Model: Touran 2.0 TDI SCR DSG Comfortline

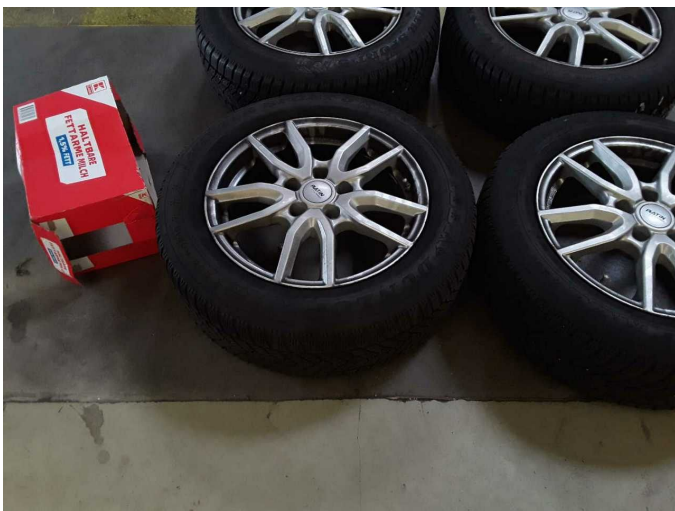
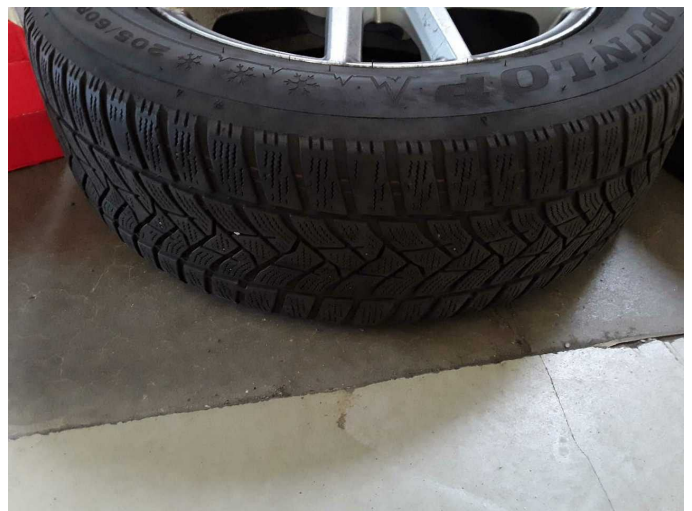
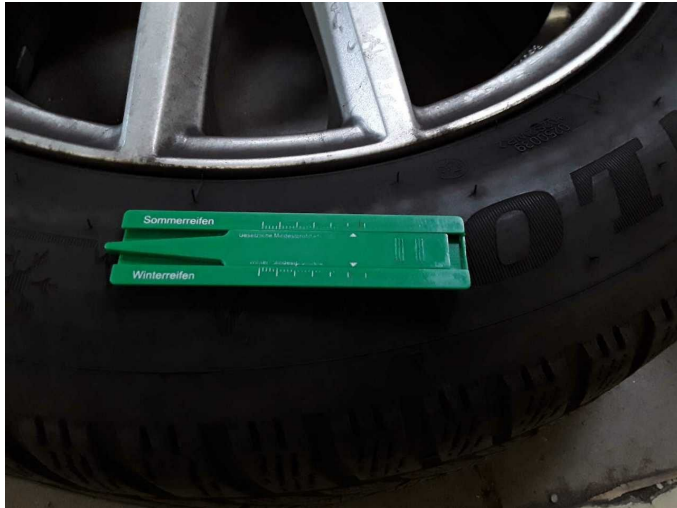
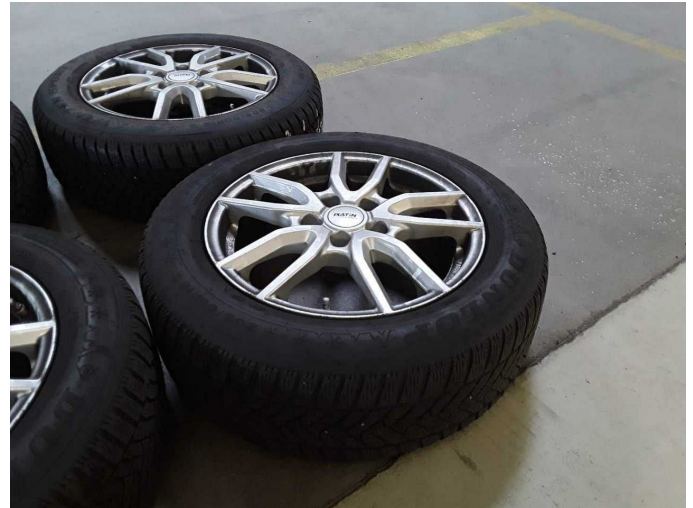
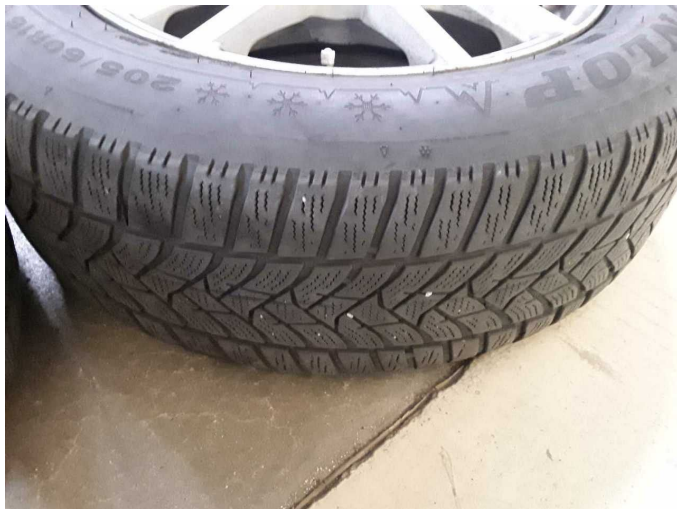
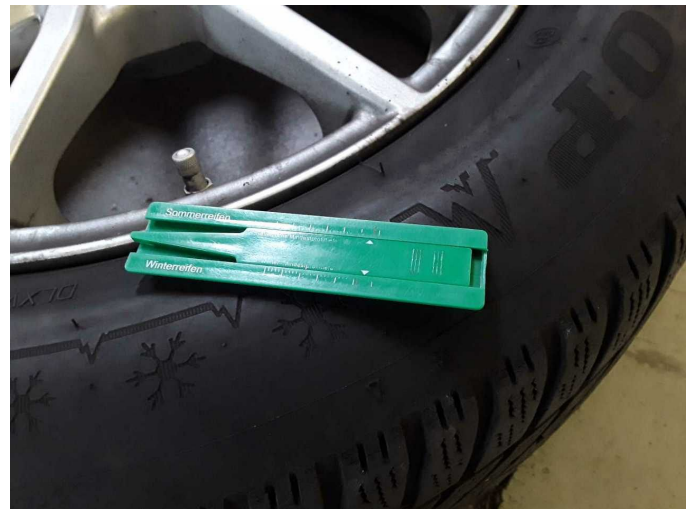
| No. | Component group | Description |
|---|---|---|
| 1 | 2nd wheel set | 2 tyres (<4mm, gehören nicht zur Ausstattung) - does not meet manufacturer specifications - No deduction |

**Damage 1:** 2nd wheel set: 2 tyres (<4mm, gehören nicht zur Ausstattung)  
- does not meet manufacturer specifications - No deduction

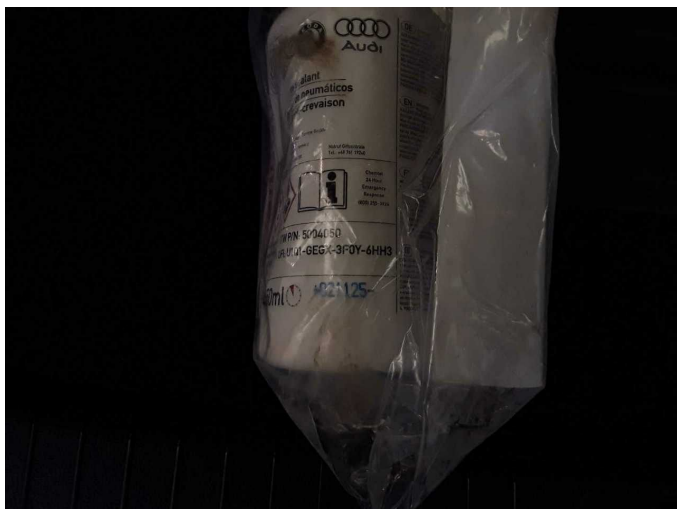
| No. | Component group | Description |
|---|---|---|
| 2 | Equipment | Tirefit filler - Expired - Replace |

**Damage 2:** Equipment: Tirefit filler - Expired - Replace

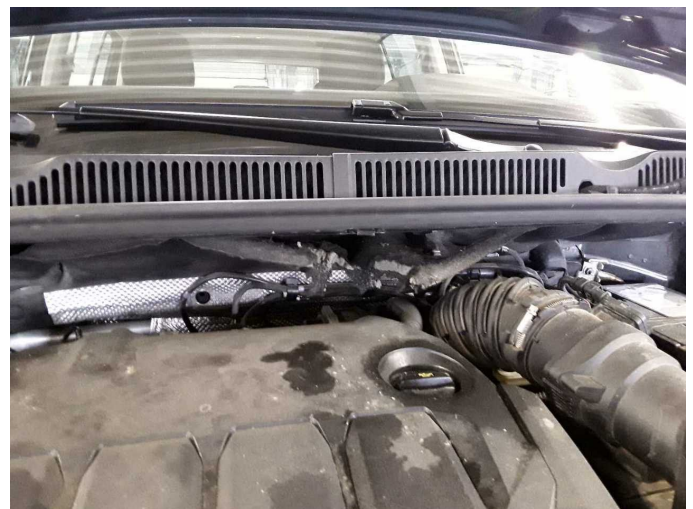
| No. | Component group | Description |
|---|---|---|
| 3 | Body | Firewall trim (Dämpfung außen) - Damage caused by marten / rodent - Replace |

**Damage 3:** Body: Firewall trim (Dämpfung außen) - Damage caused by marten / rodent - Replace

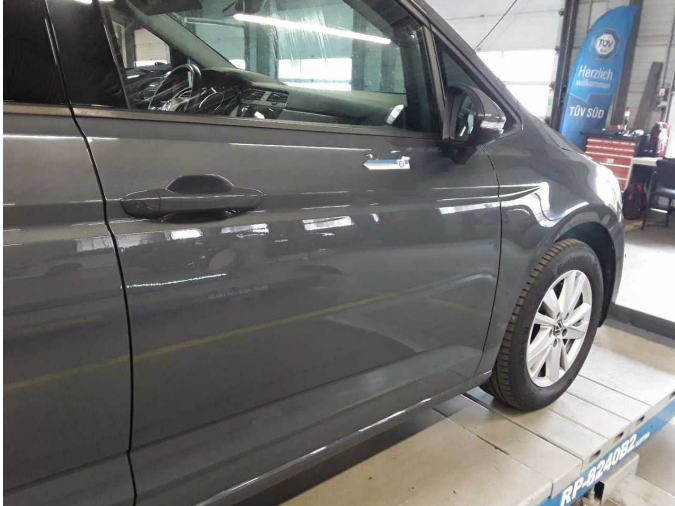
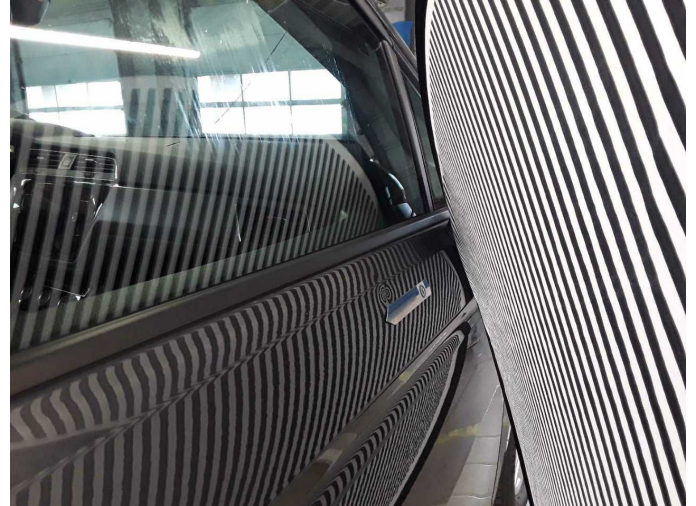
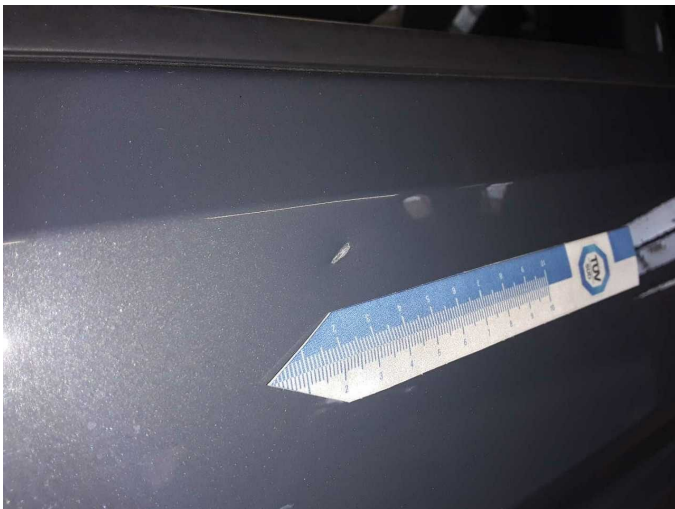
| No. | Component group | Description |
|---|---|---|
| 4 | Door - front right side | Door - Dent / paintcoat damage - Repair and paint |

**Damage 4:** Door - front right side: Door - Dent / paintcoat damage - Repair and paint

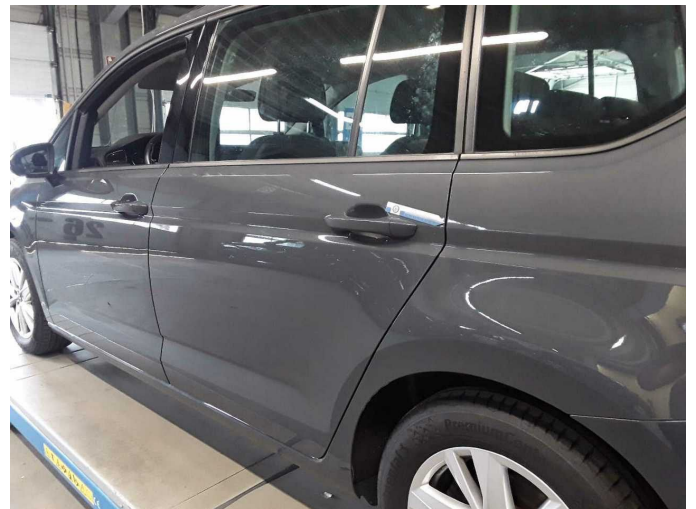
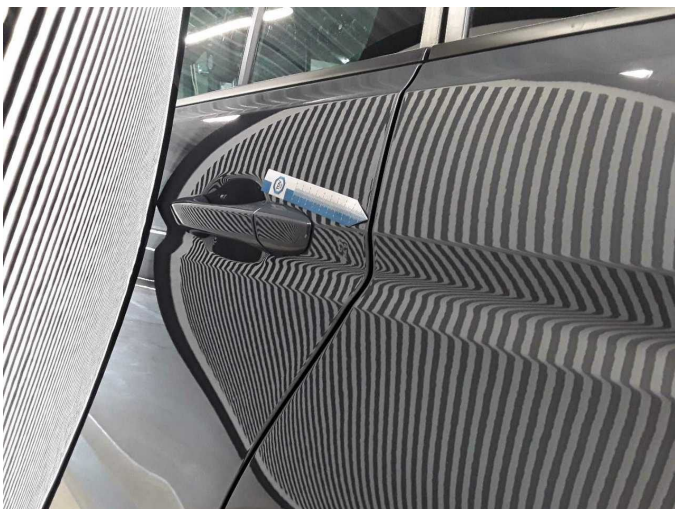
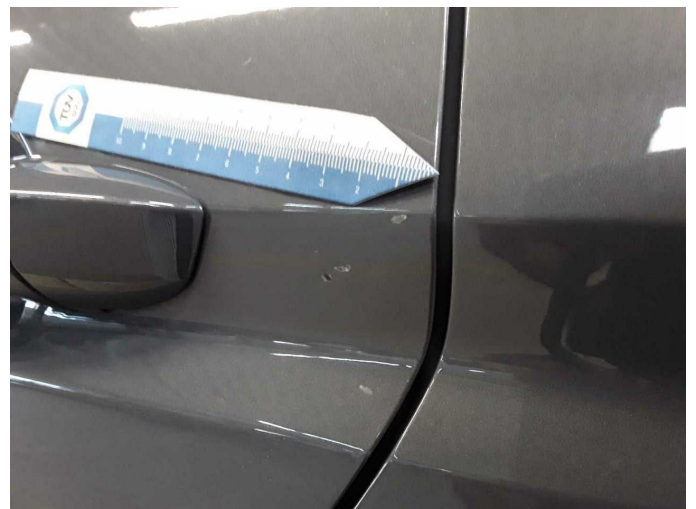
| No. | Component group | Description |
|---|---|---|
| 5 | Door - rear left side | Door - Dent / paintcoat damage - Repair and paint |

**Damage 5:** Door - rear left side: Door - Dent / paintcoat damage - Repair and paint

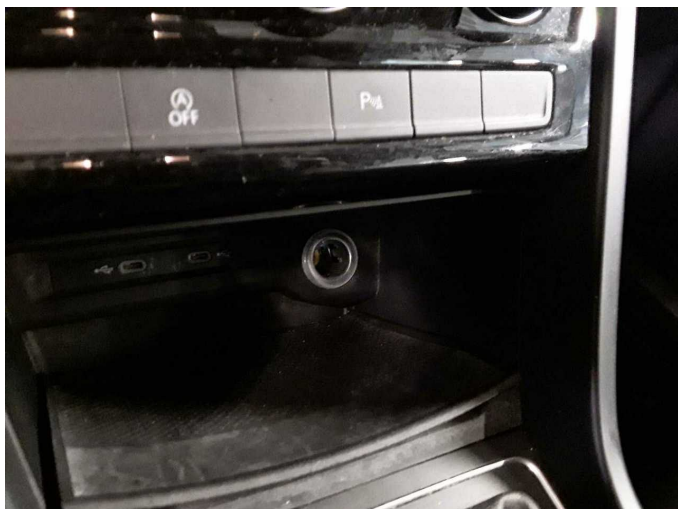
Interior - Cigarette lighter

**Missing part 1:** Interior: Cigarette lighter - Missing - Replace

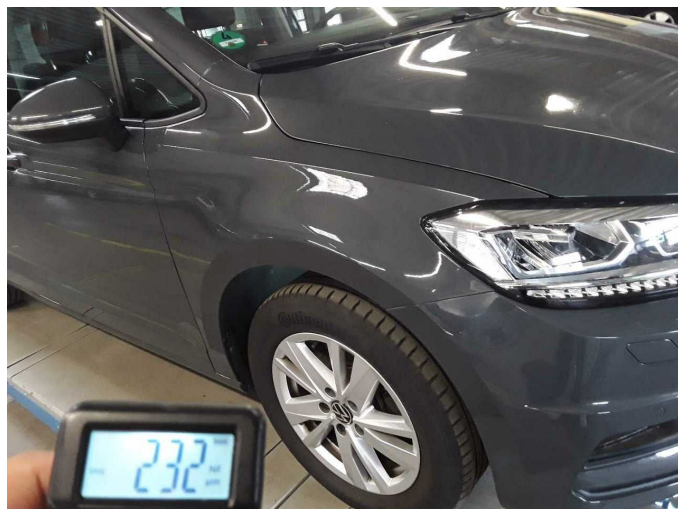
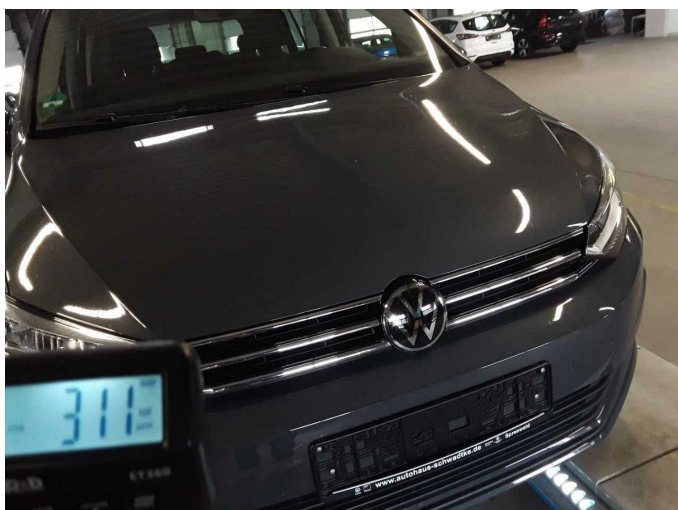
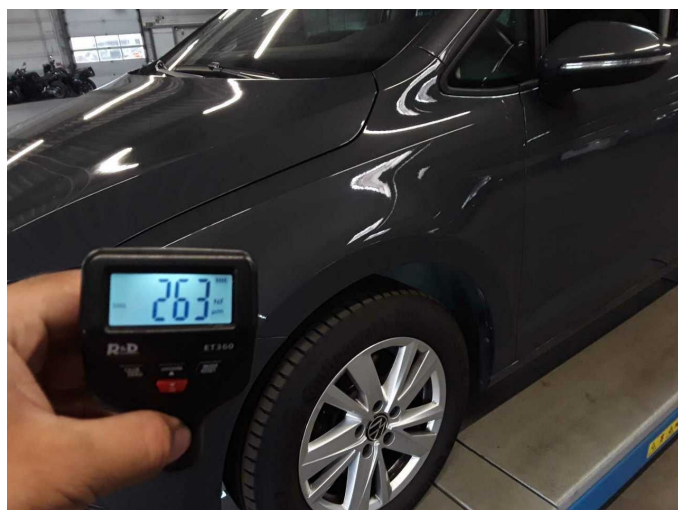
- 1 Mudguard - left side, Mudguard - right side, Bonnet

**Repainting 1:** Mudguard - left side, Mudguard - right side, Bonnet
