Protocol number: 46032667
Order No. / Reference: 26485002
Inspection date: 17 Jun 2026

Manufacturer: Volkswagen

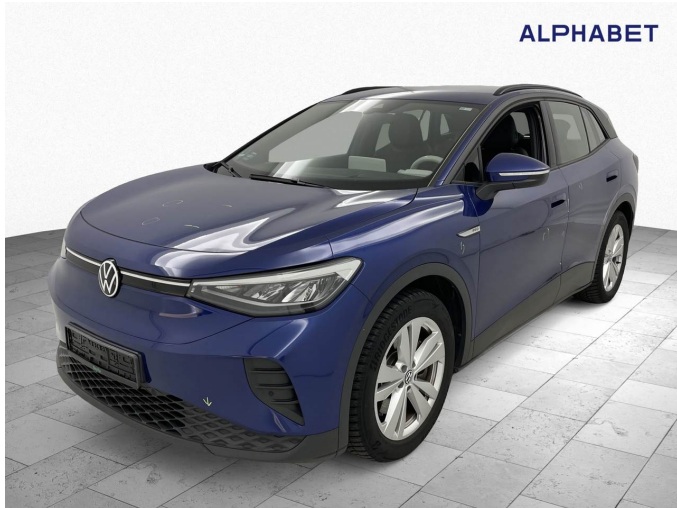
Figure 1: Diagonal front (left)

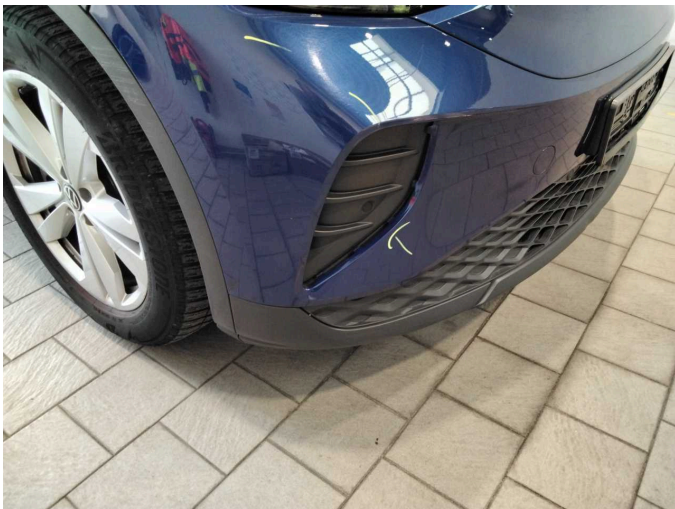
Damage 1: Front bumper: Front bumper - Malposition - Set / adjust

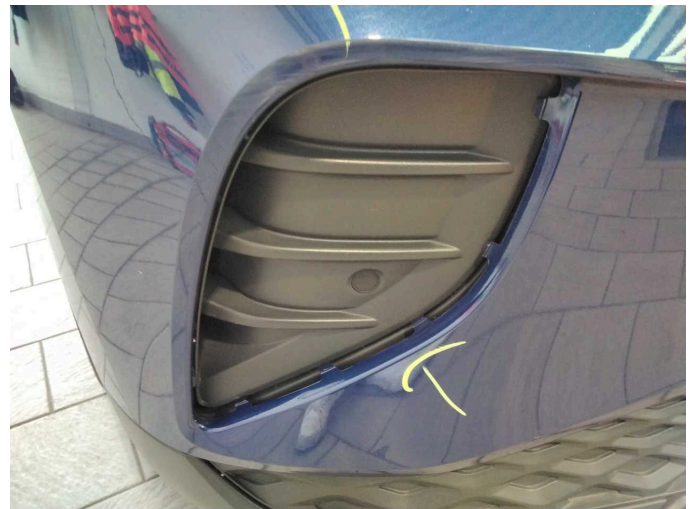
Damage 1: Front bumper: Front bumper - Malposition - Set / adjust

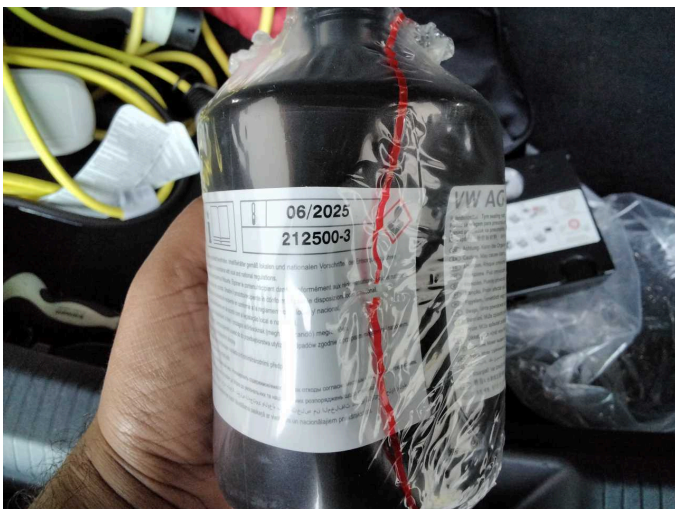
Damage 2: Equipment: Tirefit filler - Expired - Replace

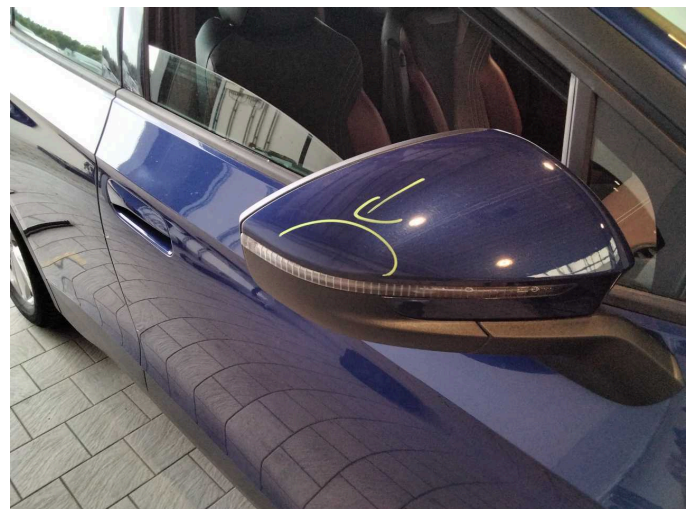
Damage 3: Wing mirror - right side: Cap - Scratch(es) - Smart repair

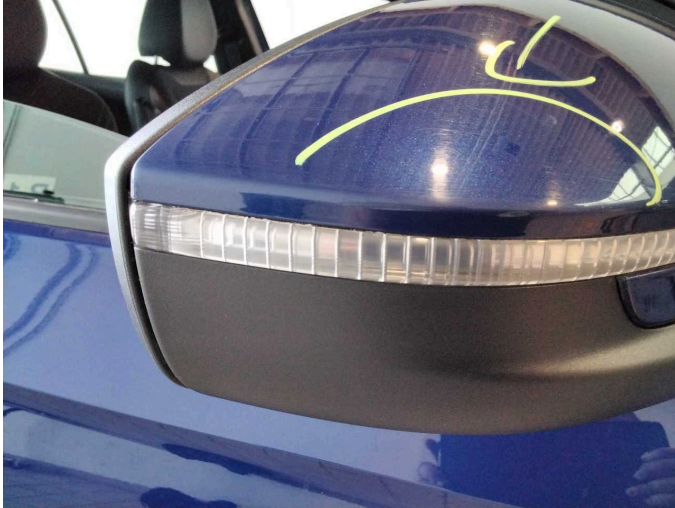
Damage 3: Wing mirror - right side: Cap - Scratch(es) - Smart repair

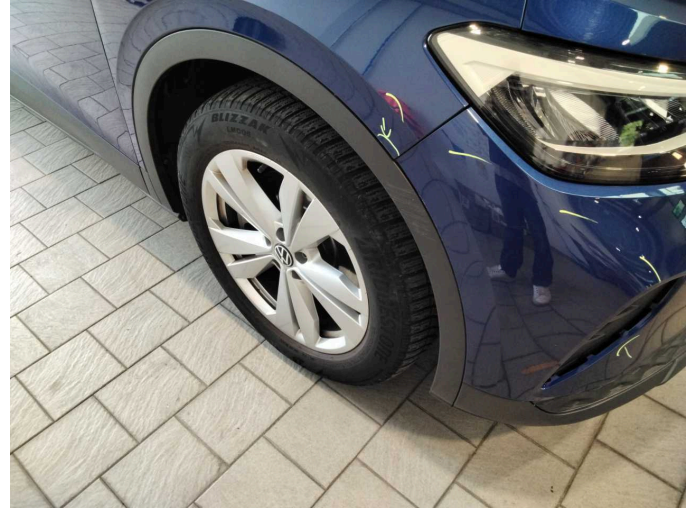
Damage 4: Mudguard - right side: Wheel well extension - Scratch(es) - Loss in value

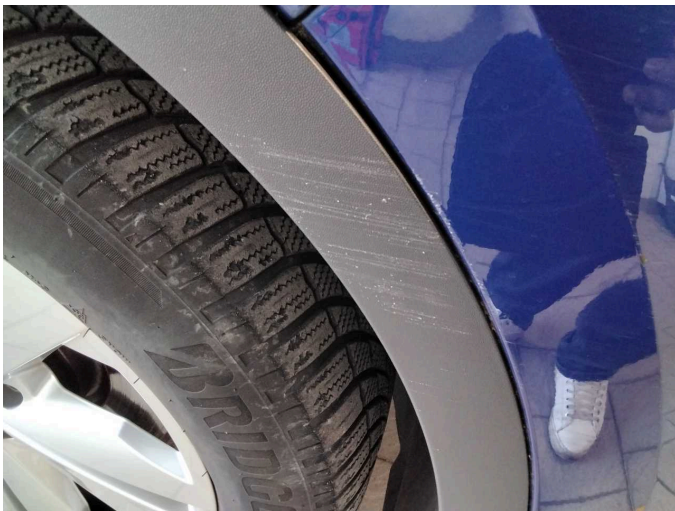
Damage 4: Mudguard - right side: Wheel well extension - Scratch(es) - Loss in value

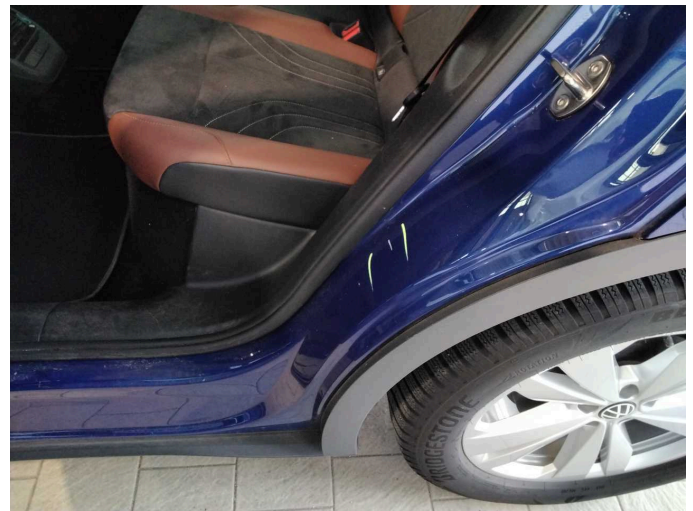
Damage 5: Body: C-pillar - left side - Scratch(es) - Smart repair

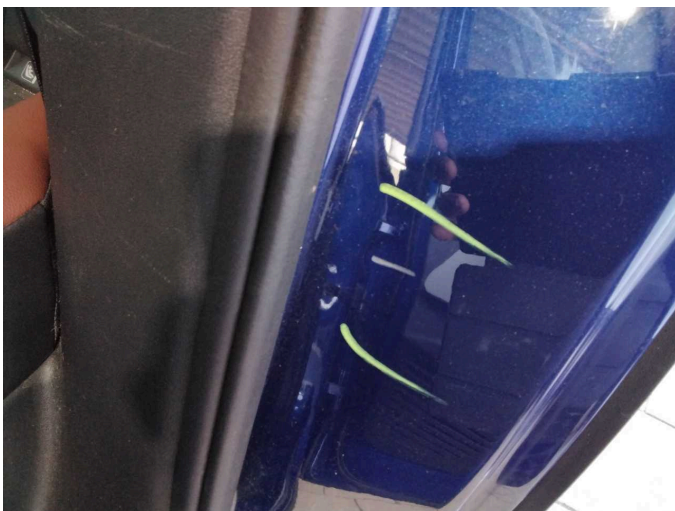
Damage 5: Body: C-pillar - left side - Scratch(es) - Smart repair

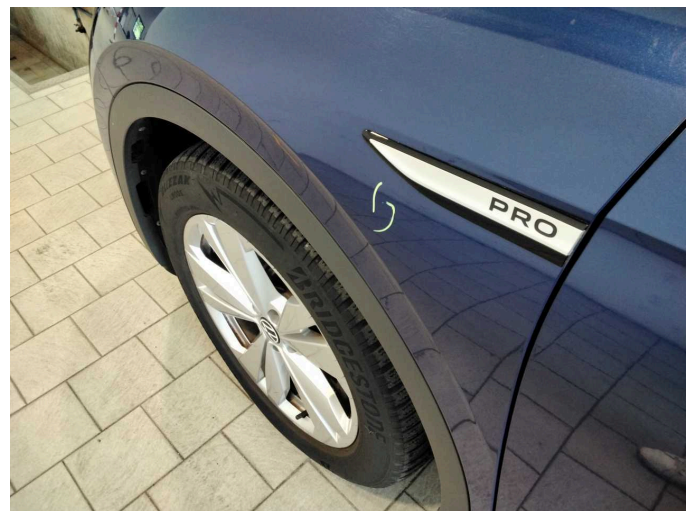
Damage 6: Mudguard - left side: Mudguard - left side - Dent / paintcoat damage - Smart repair

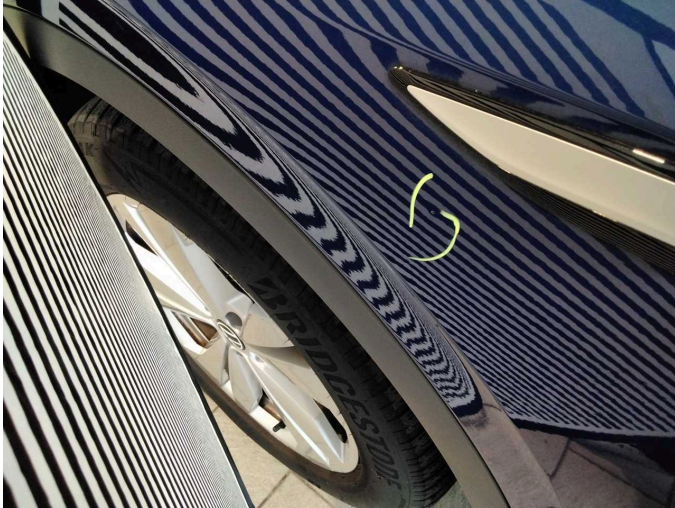
Damage 6: Mudguard - left side: Mudguard - left side - Dent / paintcoat damage - Smart repair

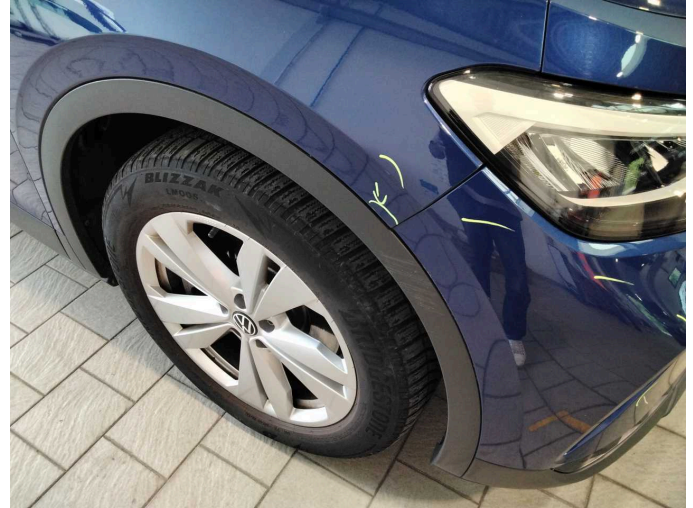
Damage 7: Mudguard - right side: Mudguard - right side - Scratch(es) - Smart repair

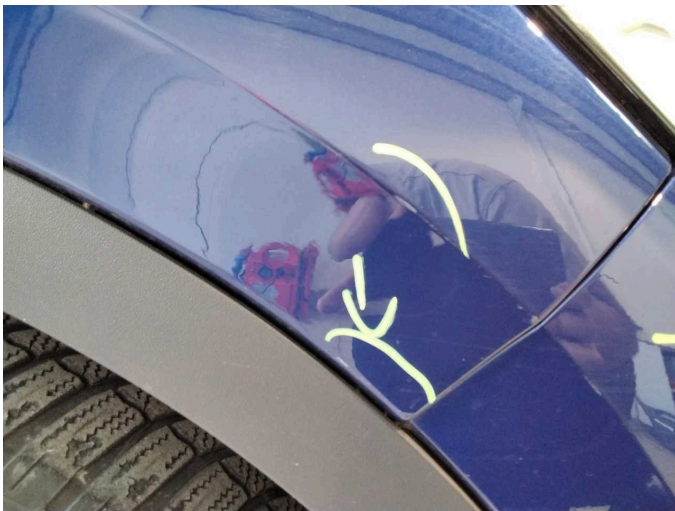
Damage 7: Mudguard - right side: Mudguard - right side - Scratch(es) - Smart repair

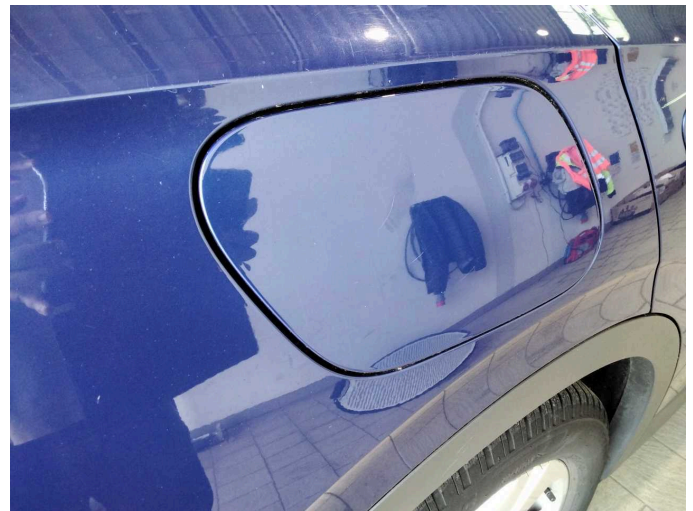
Damage 8: Fuel system: Tank cap - Scratch(es) - Smart repair

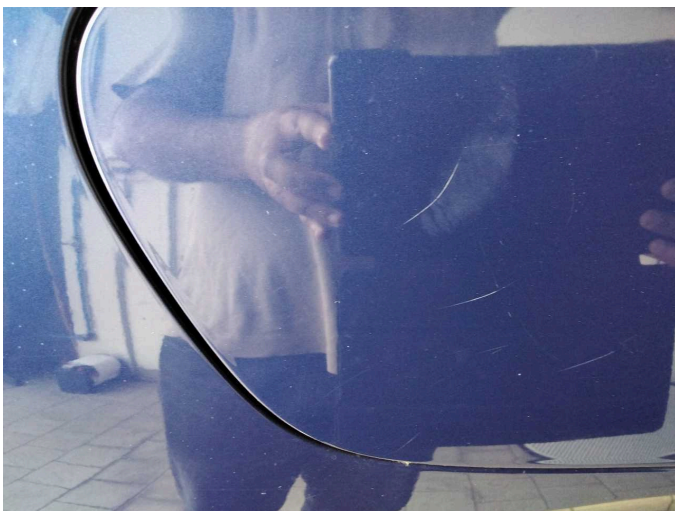
Damage 8: Fuel system: Tank cap - Scratch(es) - Smart repair

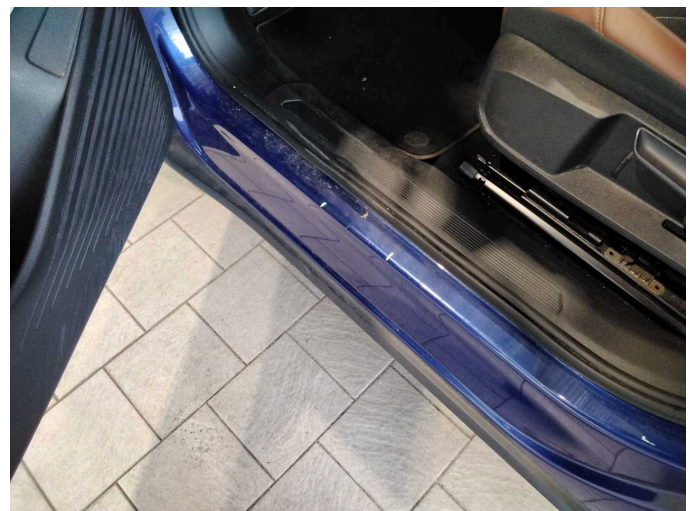
Damage 9: Sill - left side: Sill - Scratch(es) - Smart repair

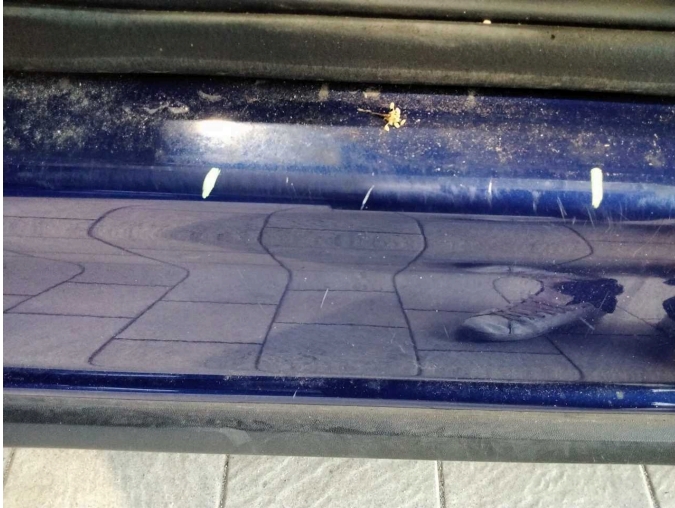
Damage 9: Sill - left side: Sill - Scratch(es) - Smart repair

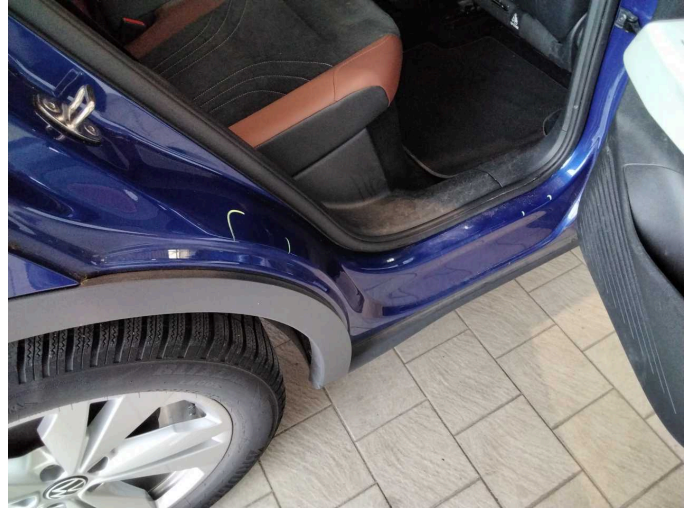
Damage 10: Body: C-pillar - right side - Dent / paintcoat damage - Smart repair

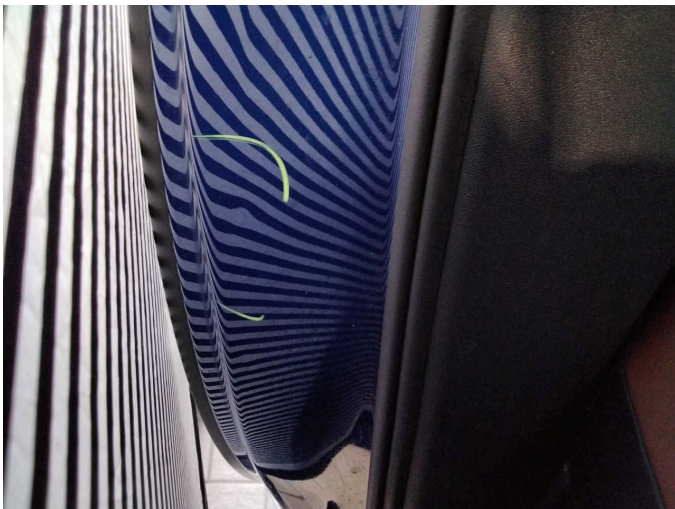
Damage 10: Body: C-pillar - right side - Dent / paintcoat damage - Smart repair

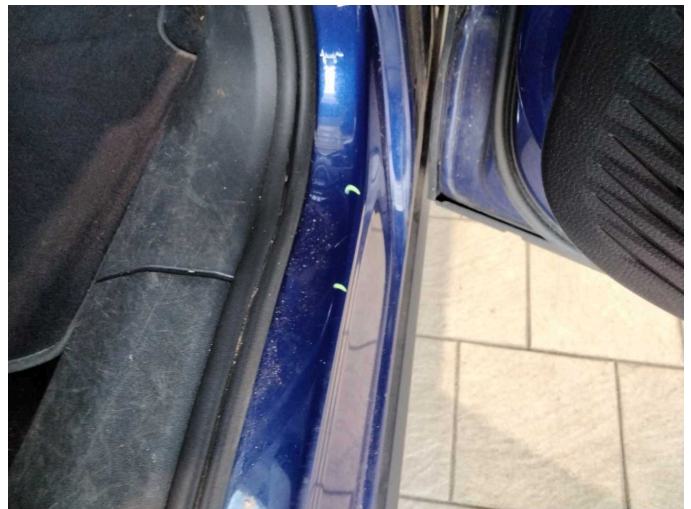
Damage 10: Body: C-pillar - right side - Dent / paintcoat damage - Smart repair

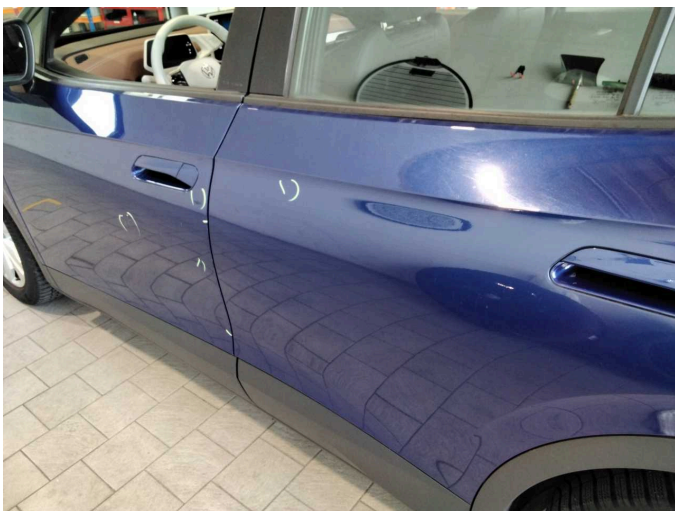
Damage 11: Door - rear left side: Door - Dent / paintcoat damage - Smart repair

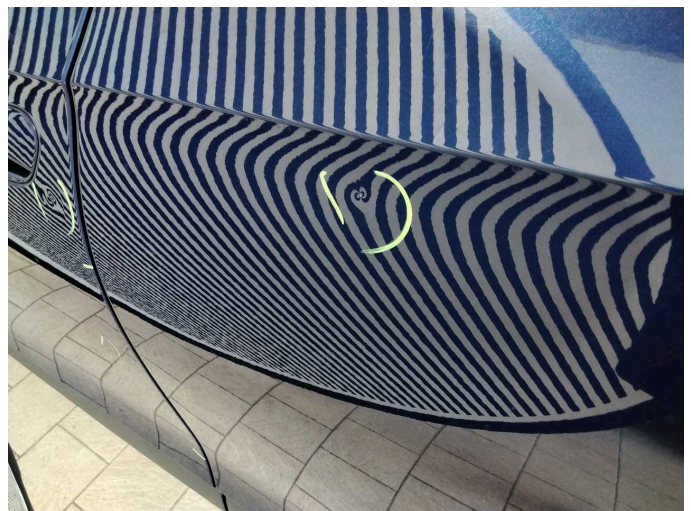
Damage 11: Door - rear left side: Door - Dent / paintcoat damage - Smart repair

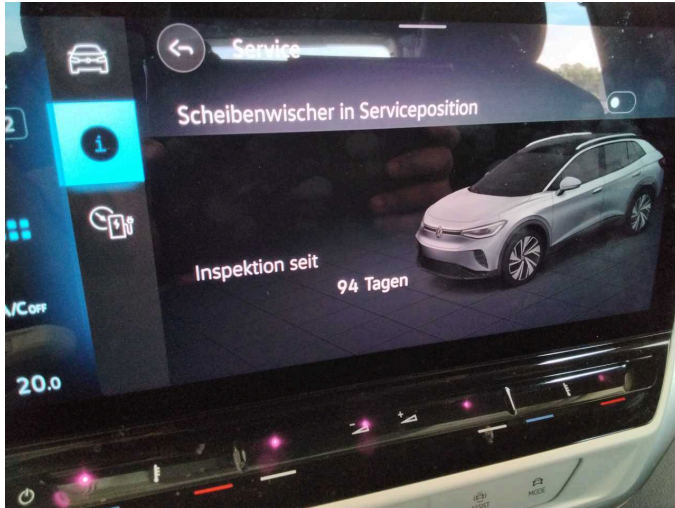
Damage 12: Misc.: Inspection / maintenance - Due - Perform

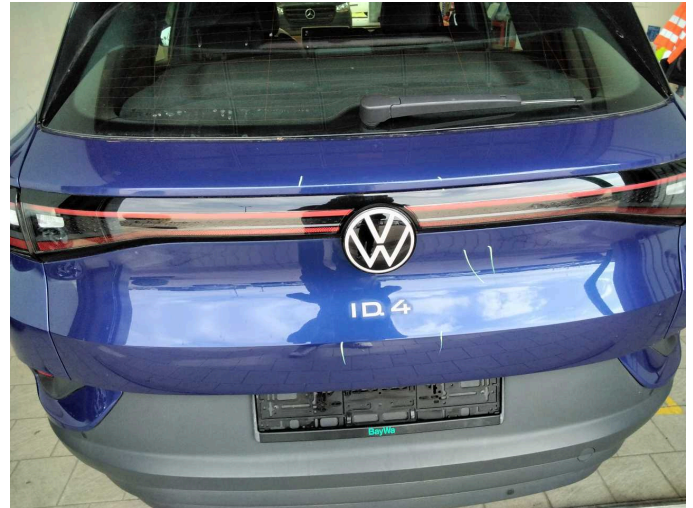
Damage 13: Boot lid / rear door: Boot lid - Scratch(es) - Paint

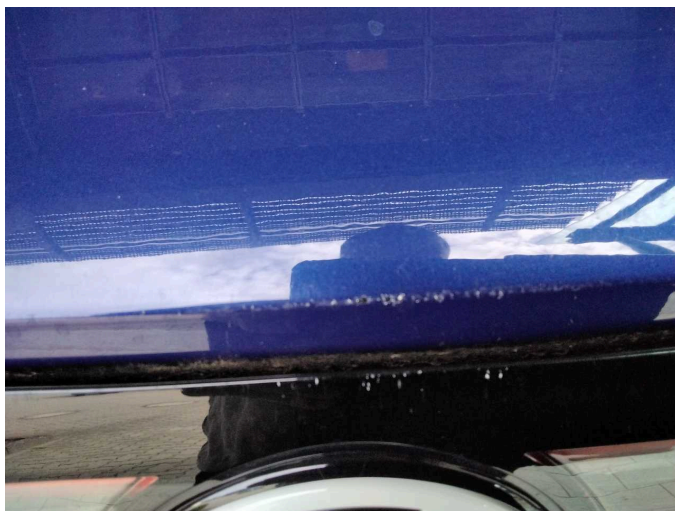
Damage 13: Boot lid / rear door: Boot lid - Scratch(es) - Paint

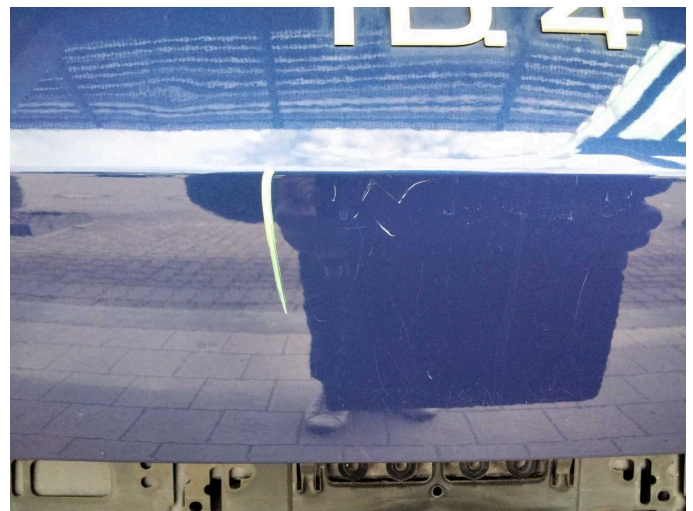
Damage 13: Boot lid / rear door: Boot lid - Scratch(es) - Paint

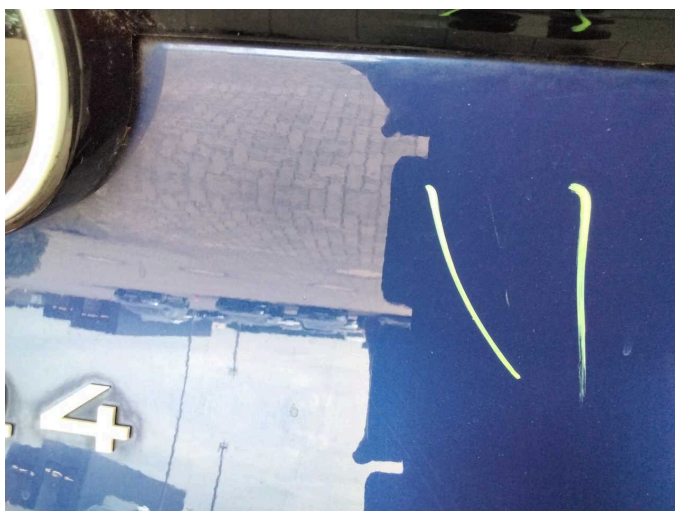
Damage 13: Boot lid / rear door: Boot lid - Scratch(es) - Paint

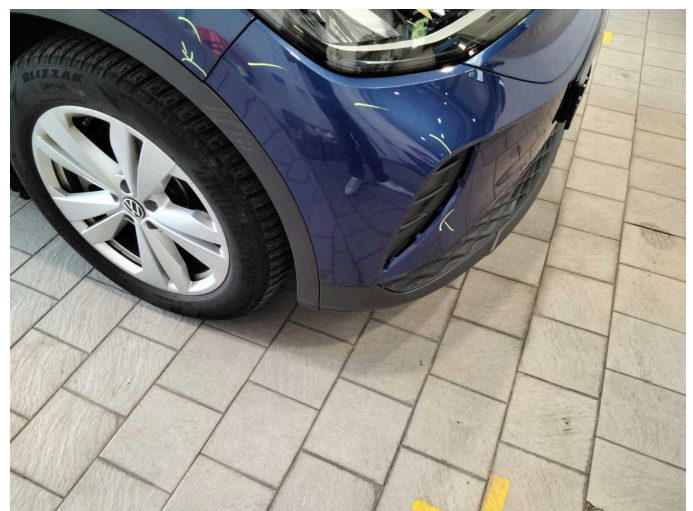
Damage 14: Front bumper: Front bumper - Scratch(es) - Paint

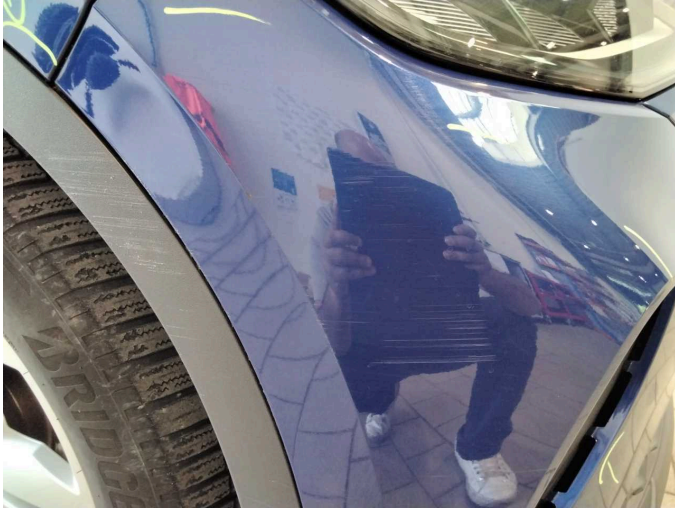
Damage 14: Front bumper: Front bumper - Scratch(es) - Paint

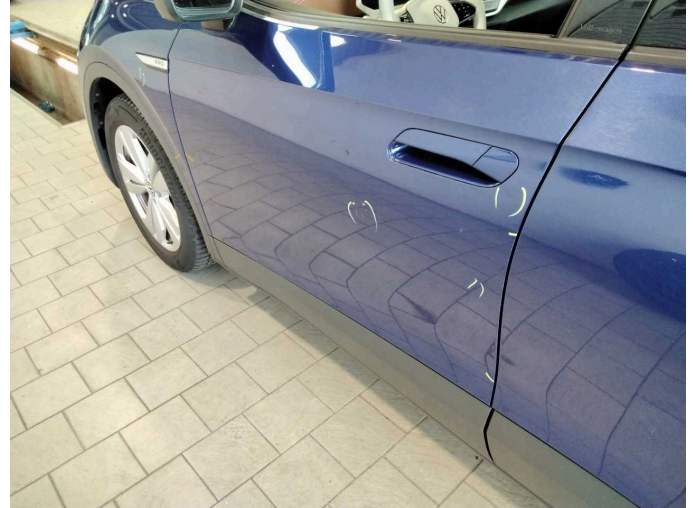
Damage 15: Door - front left side: Door - Dent / paintcoat damage - Repair and paint

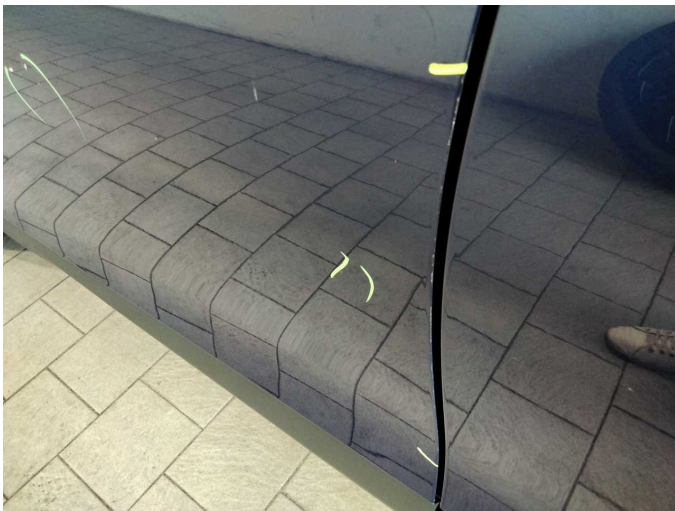
Damage 15: Door - front left side: Door - Dent / paintcoat damage - Repair and paint

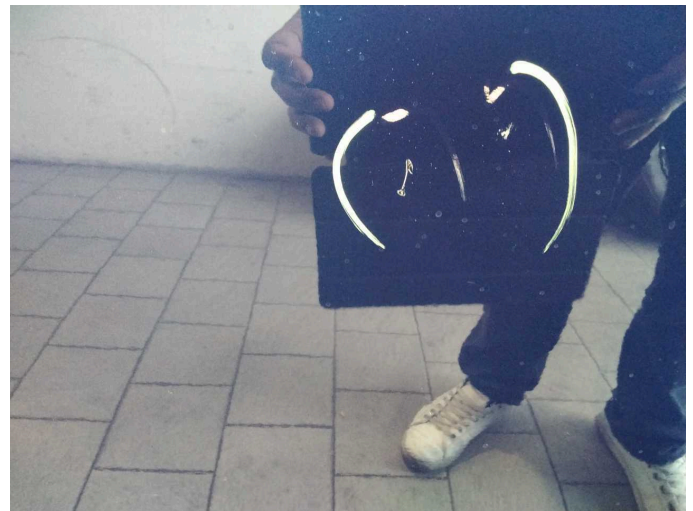
Damage 15: Door - front left side: Door - Dent / paintcoat damage - Repair and paint

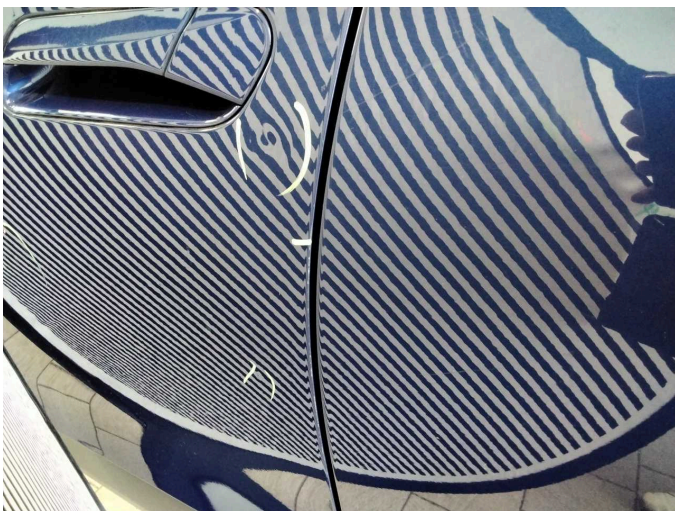
Damage 15: Door - front left side: Door - Dent / paintcoat damage - Repair and paint

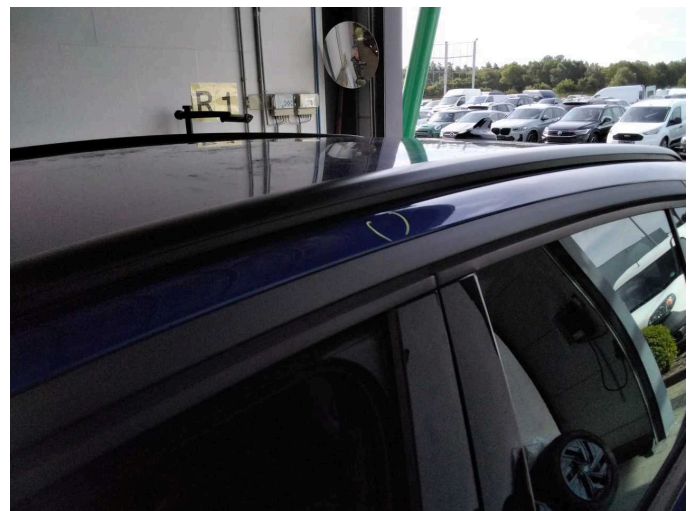
Damage 16: Body: Body - Damage by hail - repair according to calculation

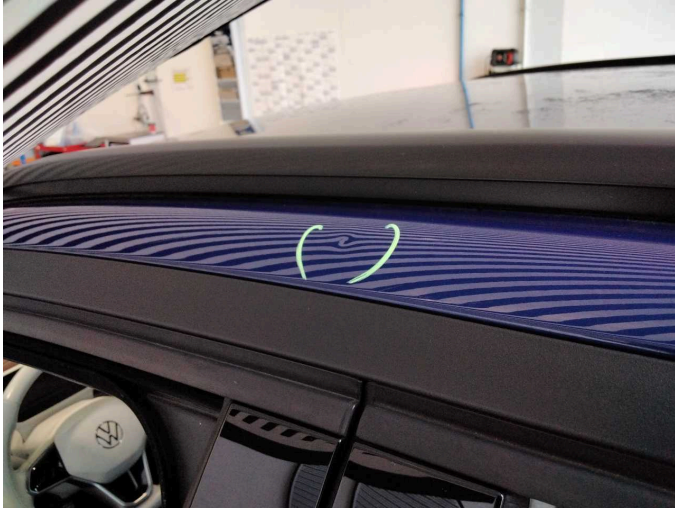
Damage 16: Body: Body - Damage by hail - repair according to calculation

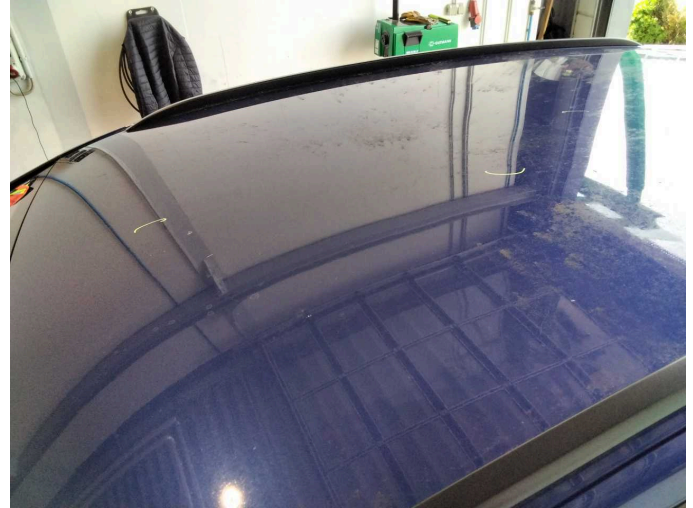
Damage 16: Body: Body - Damage by hail - repair according to calculation

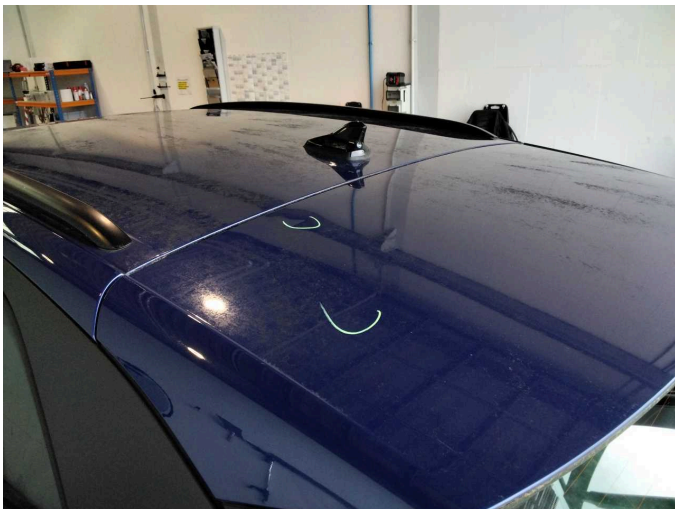
Damage 16: Body: Body - Damage by hail - repair according to calculation

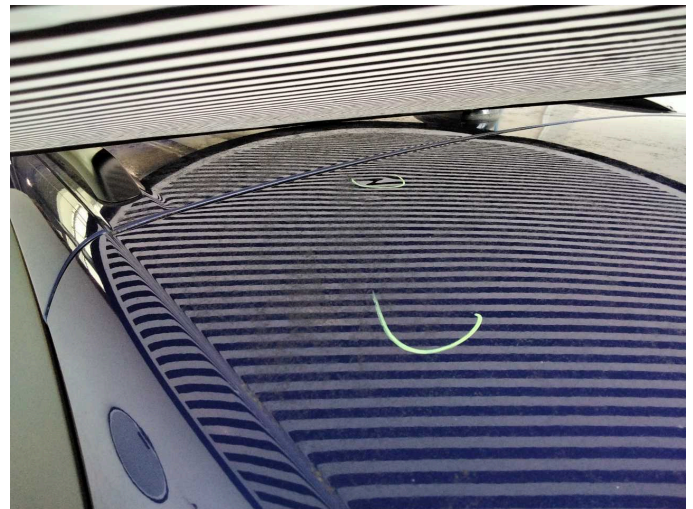
Damage 16: Body: Body - Damage by hail - repair according to calculation

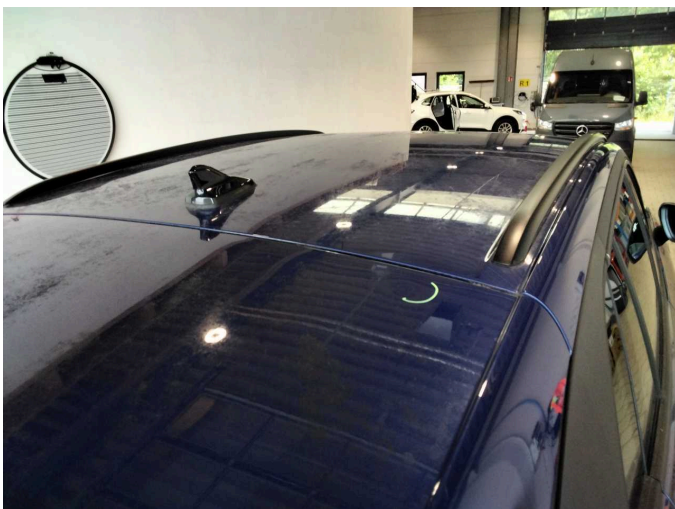
Damage 16: Body: Body - Damage by hail - repair according to calculation

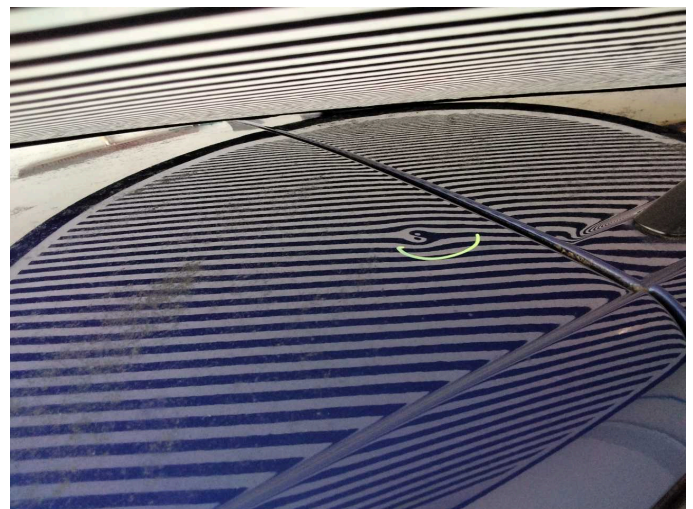
Damage 16: Body: Body - Damage by hail - repair according to calculation

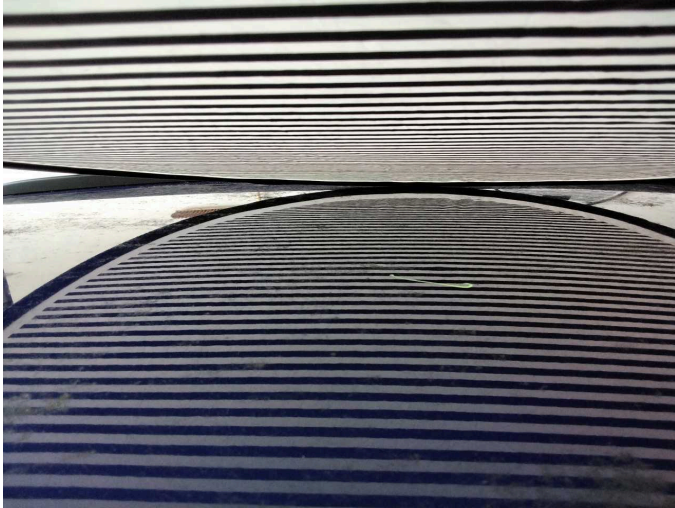
Damage 16: Body: Body - Damage by hail - repair according to calculation

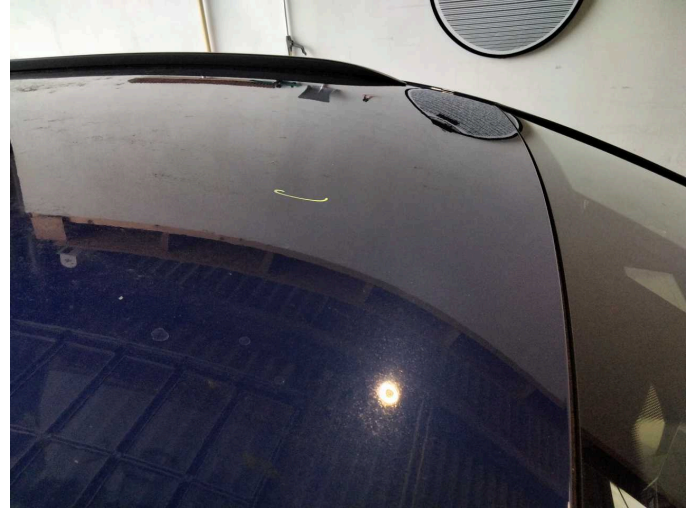
Damage 16: Body: Body - Damage by hail - repair according to calculation

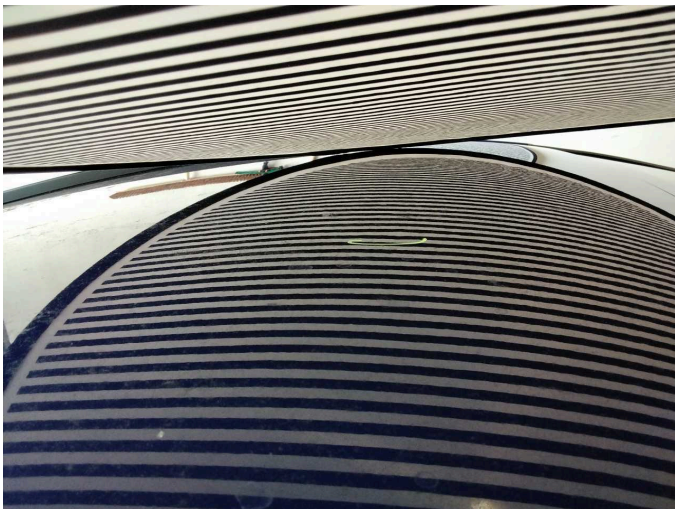
Damage 16: Body: Body - Damage by hail - repair according to calculation

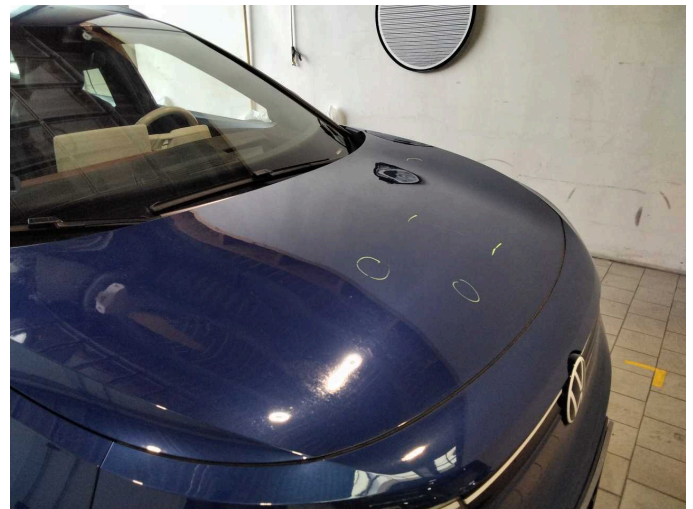
Damage 16: Body: Body - Damage by hail - repair according to calculation

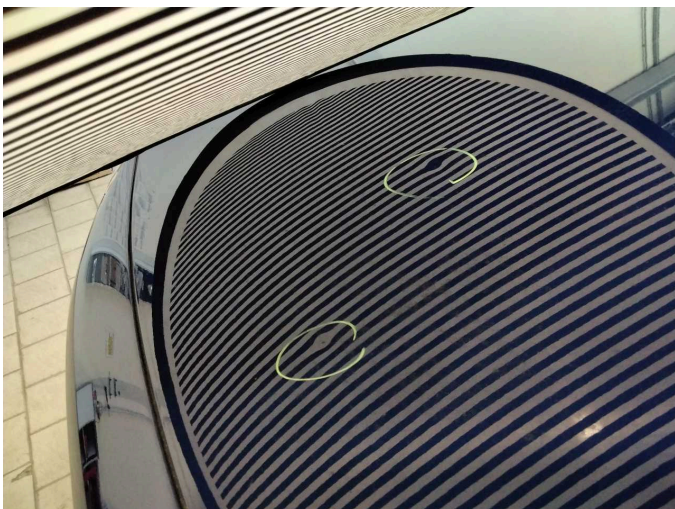
Damage 16: Body: Body - Damage by hail - repair according to calculation

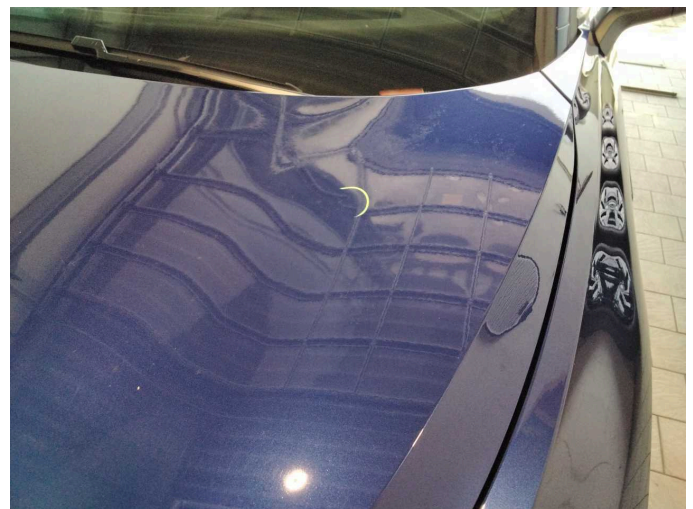
Damage 16: Body: Body - Damage by hail - repair according to calculation

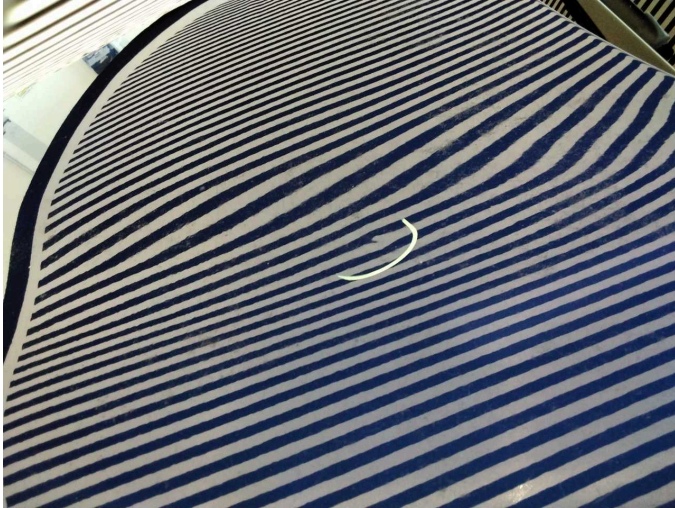
Damage 16: Body: Body - Damage by hail - repair according to calculation

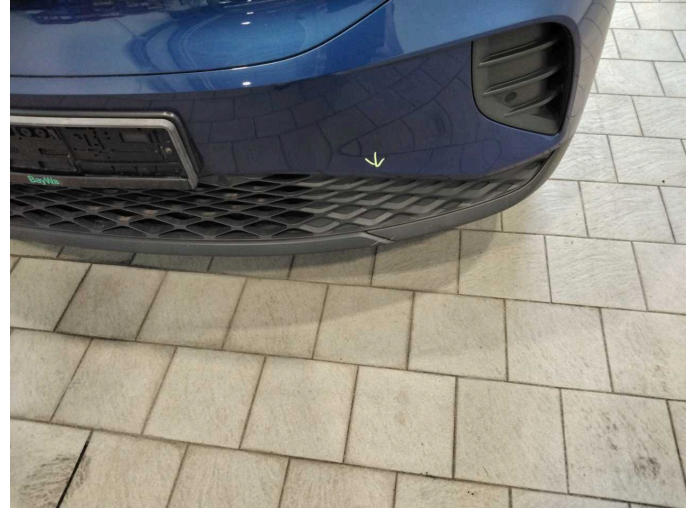
Wear and tear 1: Front bumper: Spoiler - Scratch(es) - No deduction

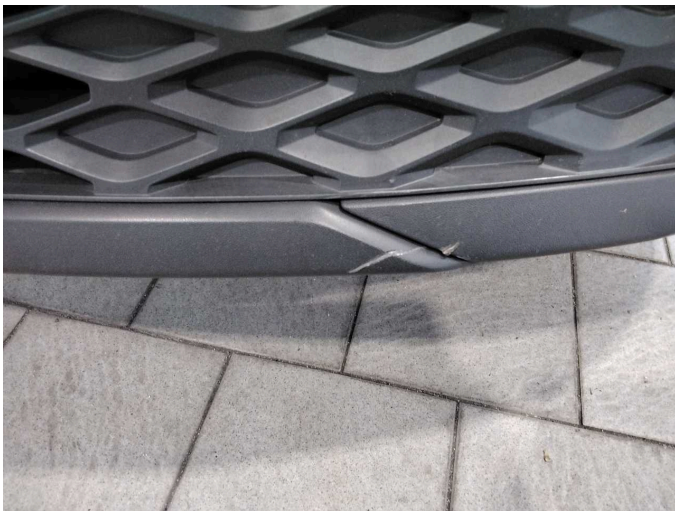
Wear and tear 1: Front bumper: Spoiler - Scratch(es) - No deduction

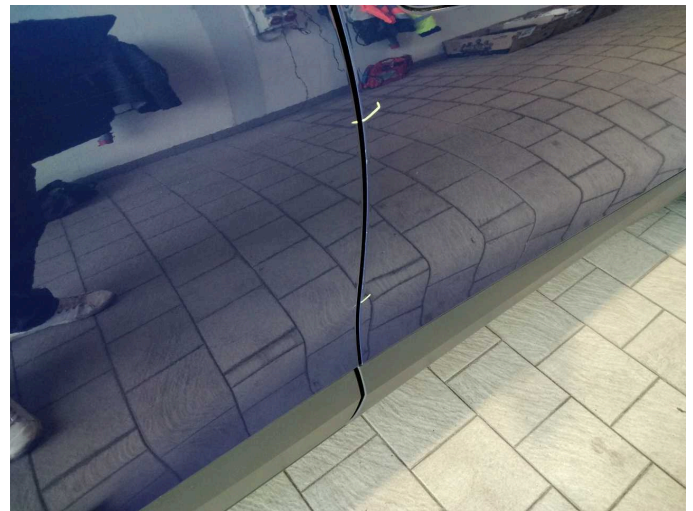
Wear and tear 2: Door - front right side: Door edge - Scratch(es) - Cover / polish

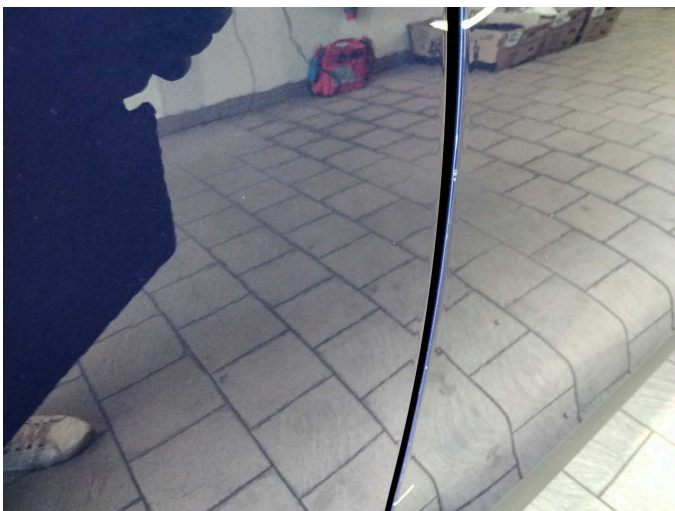
Wear and tear 2: Door - front right side: Door edge - Scratch(es) - Cover / polish

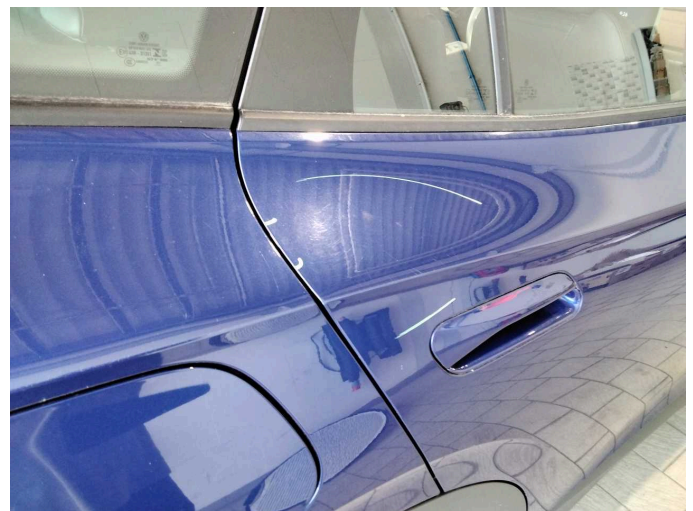
Wear and tear 3: Door - rear right side: Door - Scratch(es) - Cover / polish

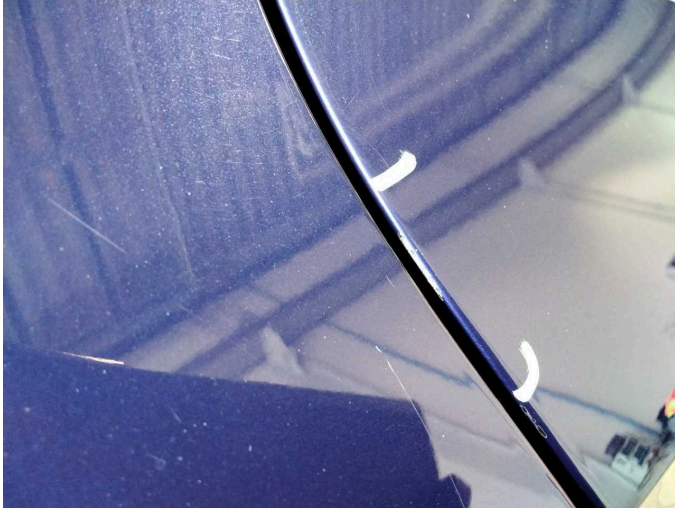
Wear and tear 3: Door - rear right side: Door - Scratch(es) - Cover / polish

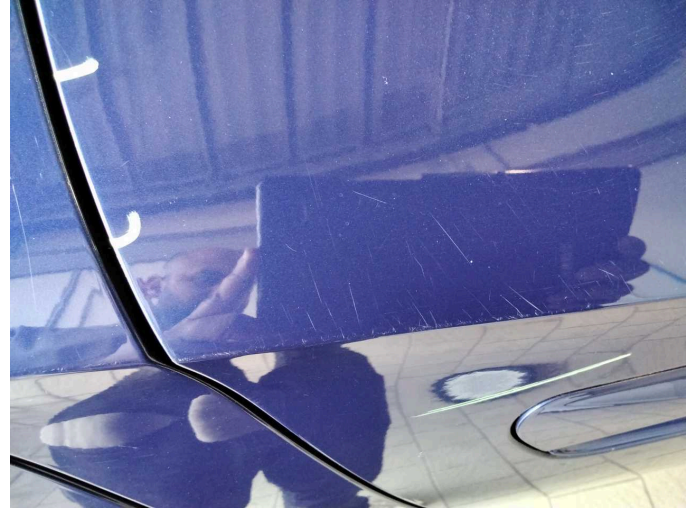
Wear and tear 3: Door - rear right side: Door - Scratch(es) - Cover / polish

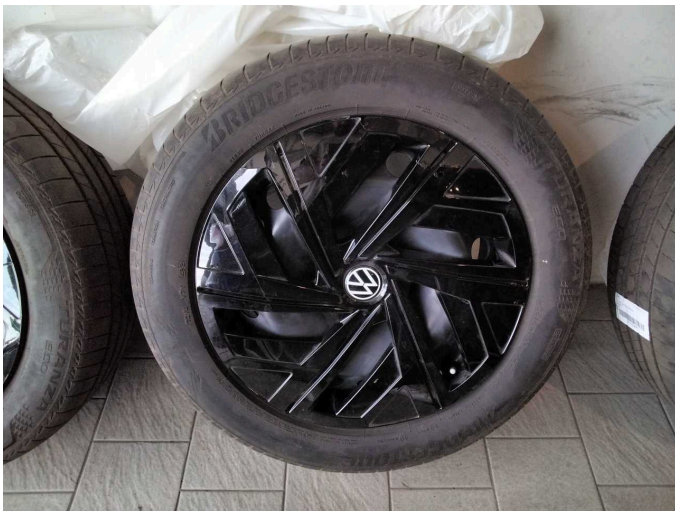
Wear and tear 4: 2nd wheel set: 2 wheel covers - Broken / torn - No deduction

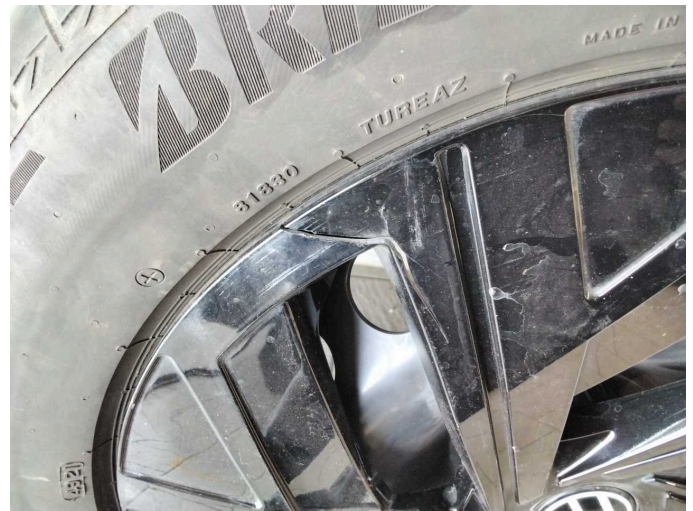
Wear and tear 4: 2nd wheel set: 2 wheel covers - Broken / torn - No deduction

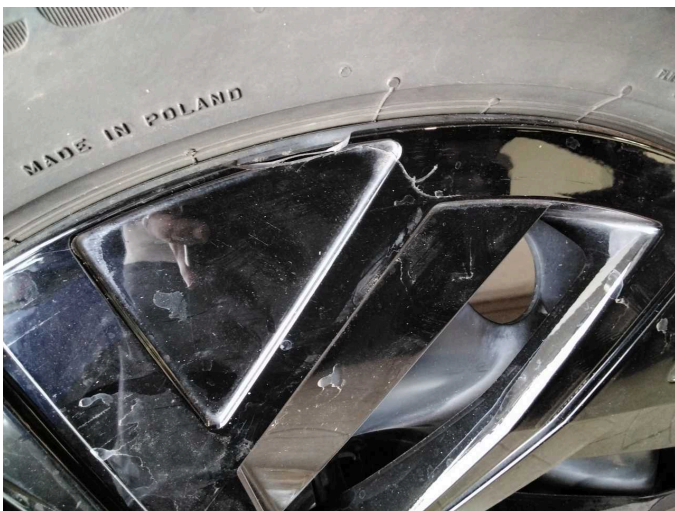
Wear and tear 4: 2nd wheel set: 2 wheel covers - Broken / torn - No deduction

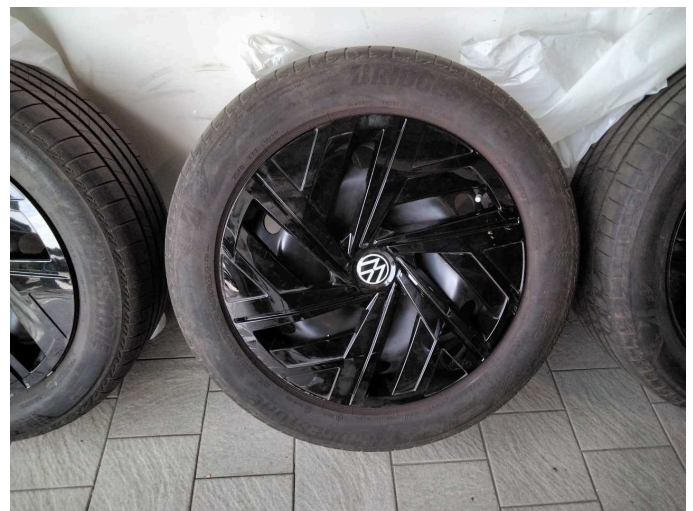
Wear and tear 4: 2nd wheel set: 2 wheel covers - Broken / torn - No deduction

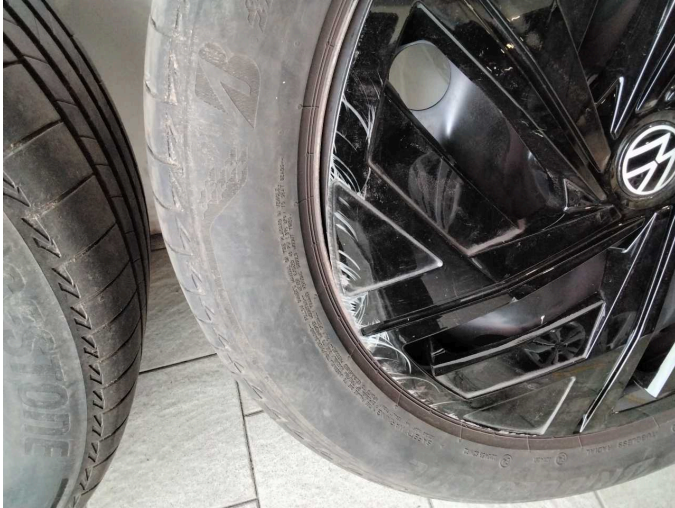
Wear and tear 4: 2nd wheel set: 2 wheel covers - Broken / torn - No deduction
