## Expertise

Protocol number: 45753942  
Order No. / Reference: 26450066  
Inspection date: 1 Jun 2026

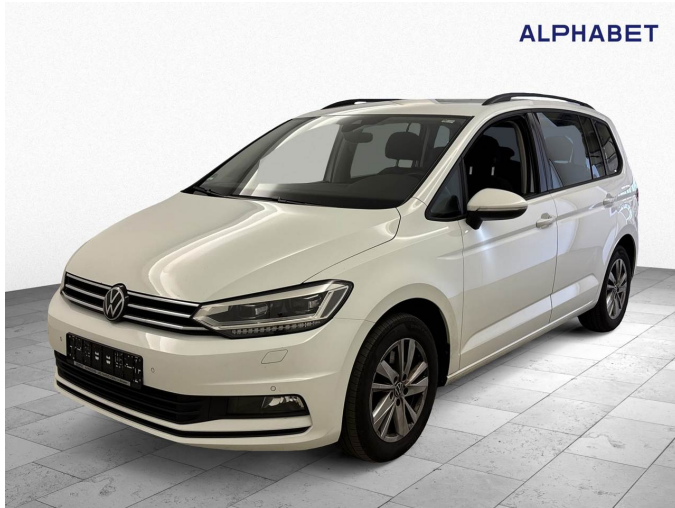
Figure 1: Diagonal front (left)

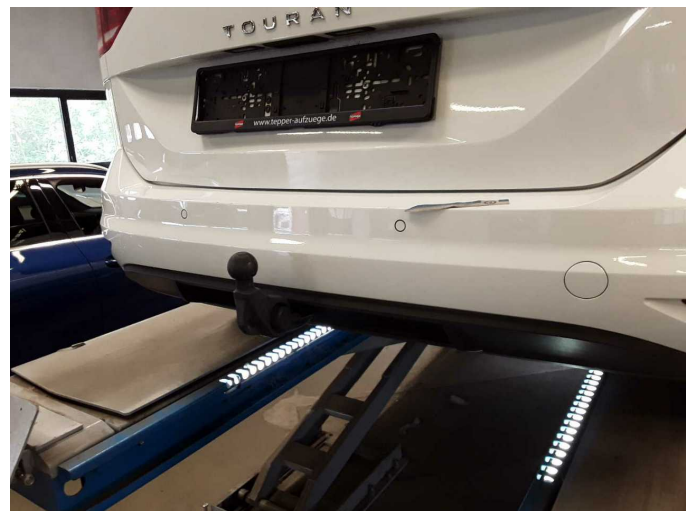
Damage 1: Rear bumper: Rear bumper - Scratch(es) - Paint

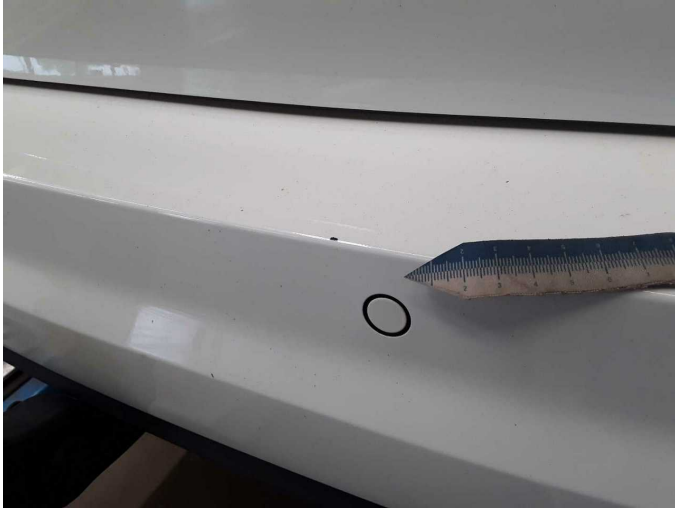
**Damage 1:** Rear bumper: Rear bumper - Scratch(es) - Paint

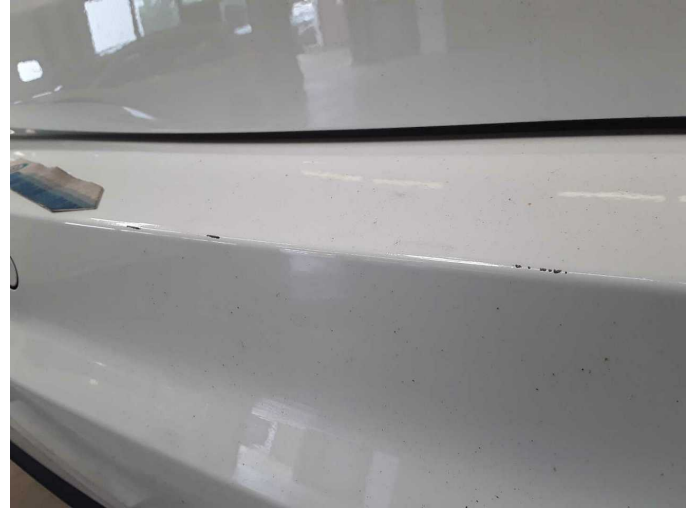
**Damage 1:** Rear bumper: Rear bumper - Scratch(es) - Paint

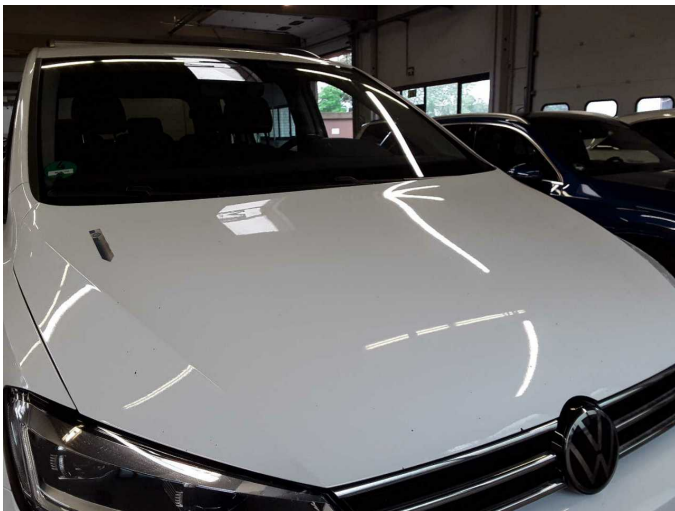
**Damage 2:** Bonnet: Bonnet (Sandstrahleffekt) - Stone chips - Paint

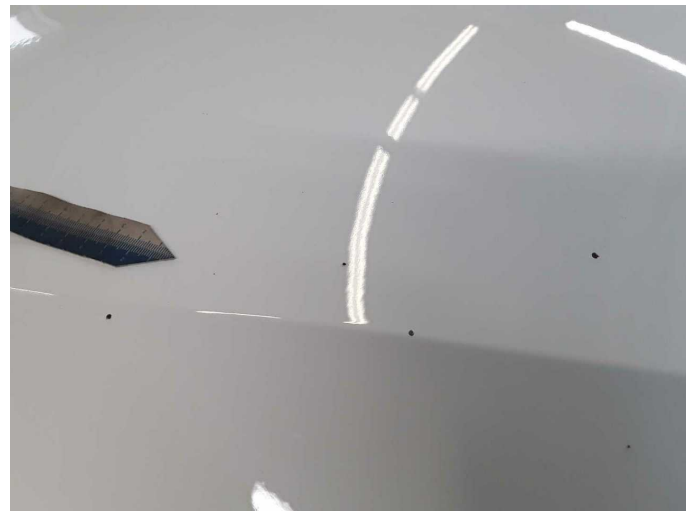
**Damage 2:** Bonnet: Bonnet (Sandstrahleffekt) - Stone chips - Paint

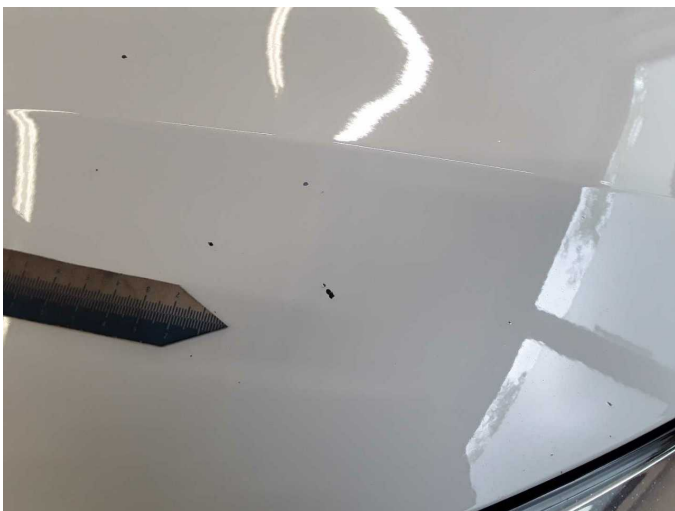
**Damage 2:** Bonnet: Bonnet (Sandstrahleffekt) - Stone chips - Paint

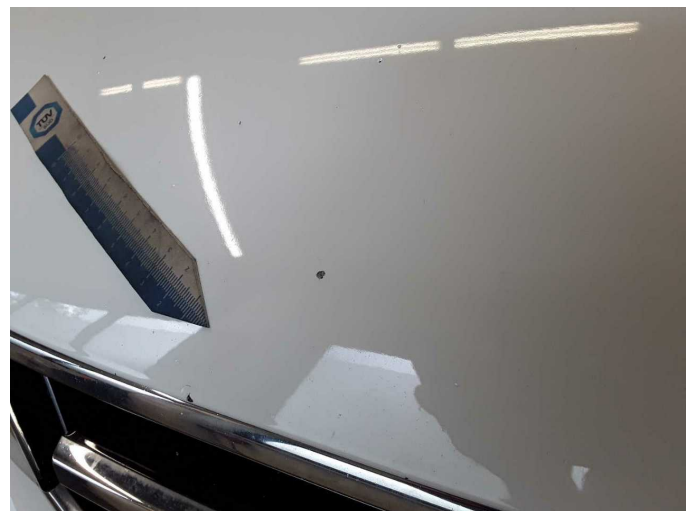
**Damage 2:** Bonnet: Bonnet (Sandstrahleffekt) - Stone chips - Paint

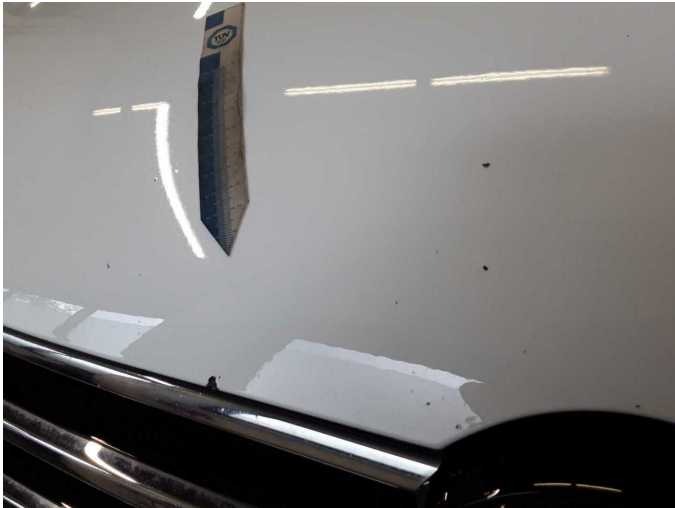
**Damage 2:** Bonnet: Bonnet (Sandstrahleffekt) - Stone chips - Paint

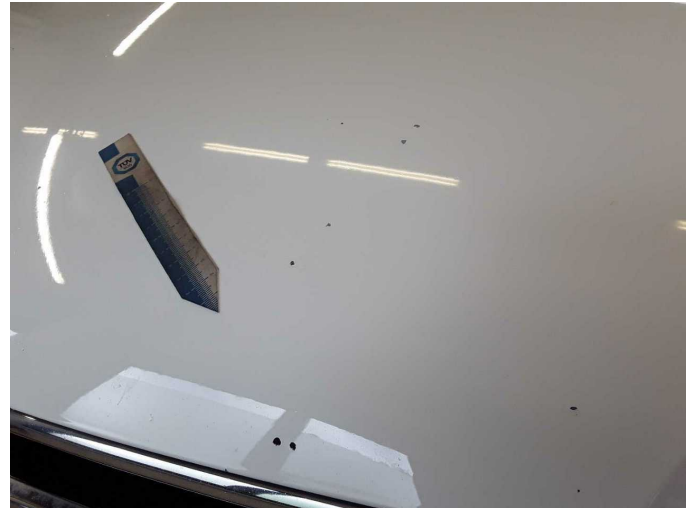
**Damage 2:** Bonnet: Bonnet (Sandstrahleffekt) - Stone chips - Paint

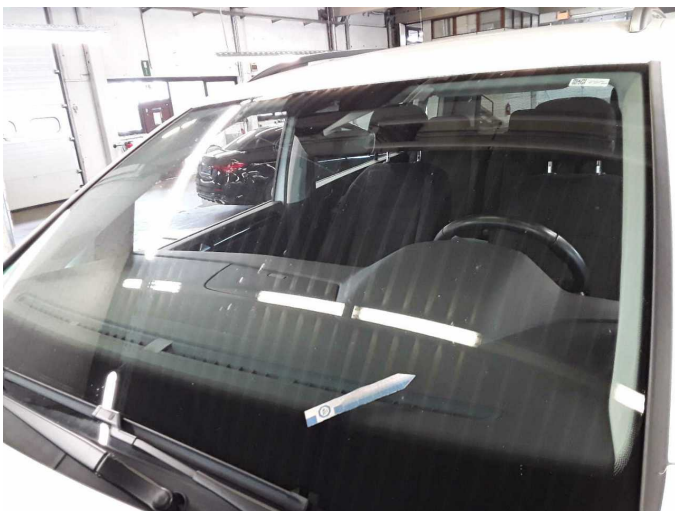
**Wear and tear 2:** Vehicle glazing: Windscreen - Stone chips - No deduction

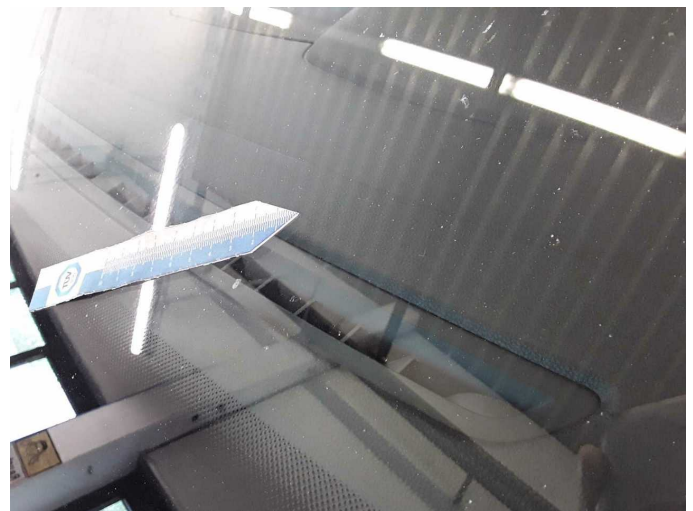
**Wear and tear 2:** Vehicle glazing: Windscreen - Stone chips - No deduction

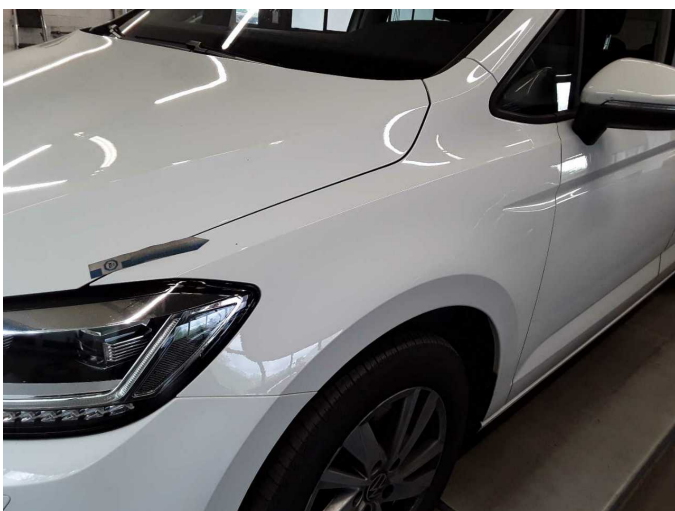
**Wear and tear 3:** Mudguard - left side: Mudguard - left side - Stone chips - No deduction

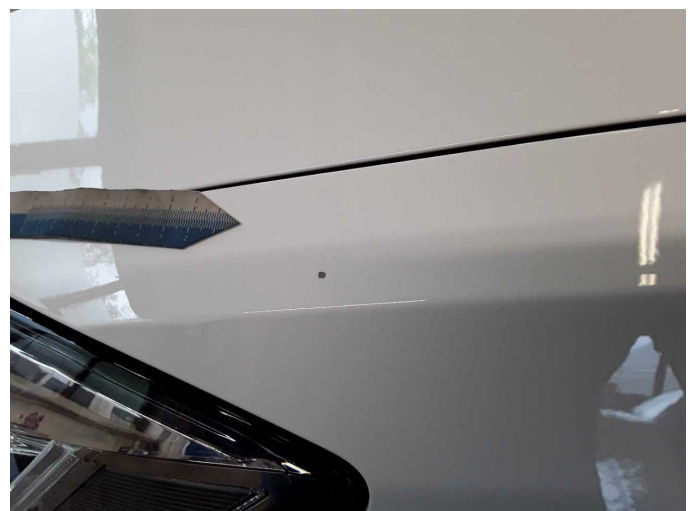
**Wear and tear 3:** Mudguard - left side: Mudguard - left side - Stone chips - No deduction

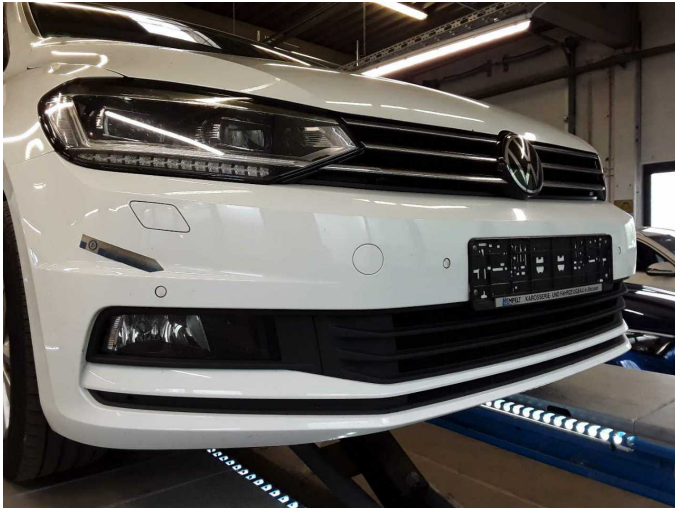
**Wear and tear 4:** Front bumper: Front bumper - Stone chips - No deduction

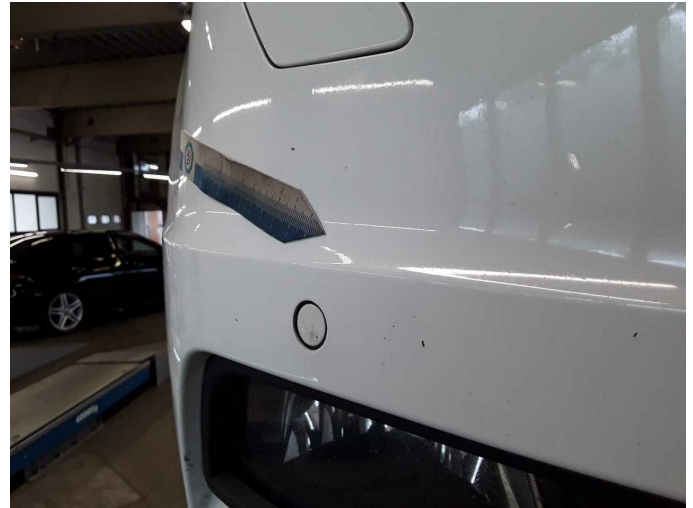
**Wear and tear 4:** Front bumper: Front bumper - Stone chips - No deduction

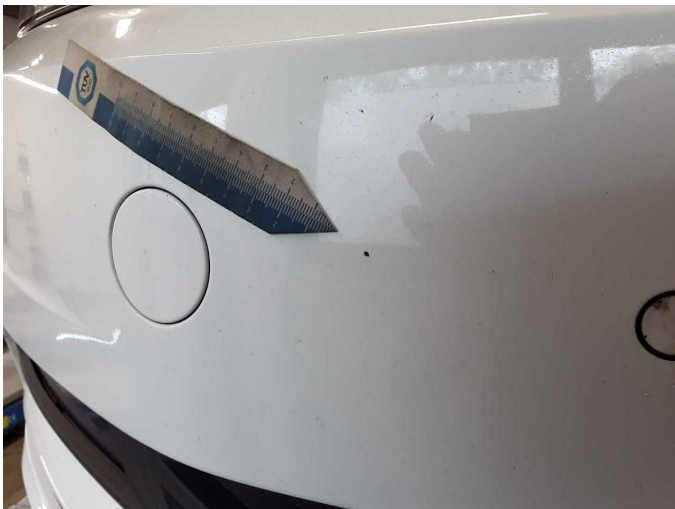
**Wear and tear 4:** Front bumper: Front bumper - Stone chips - No deduction

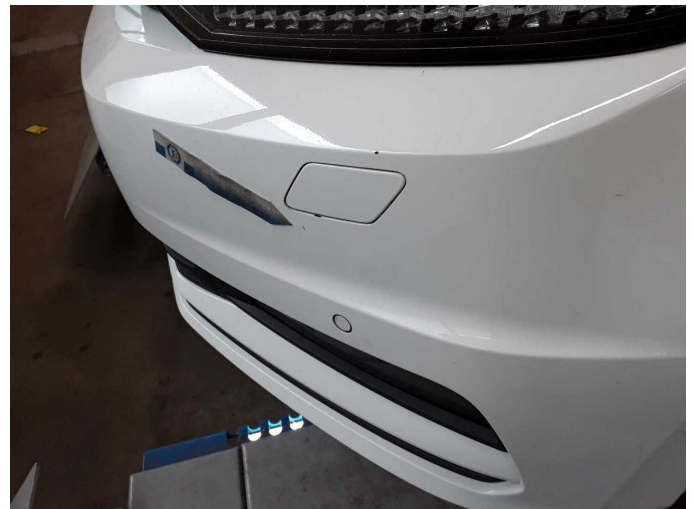
**Wear and tear 4:** Front bumper: Front bumper - Stone chips - No deduction

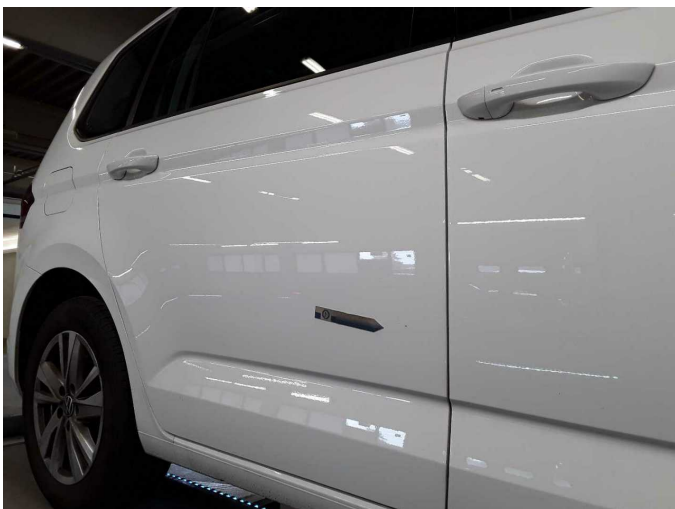
**Wear and tear 5:** Door - rear right side: Door - Stone chips - No deduction

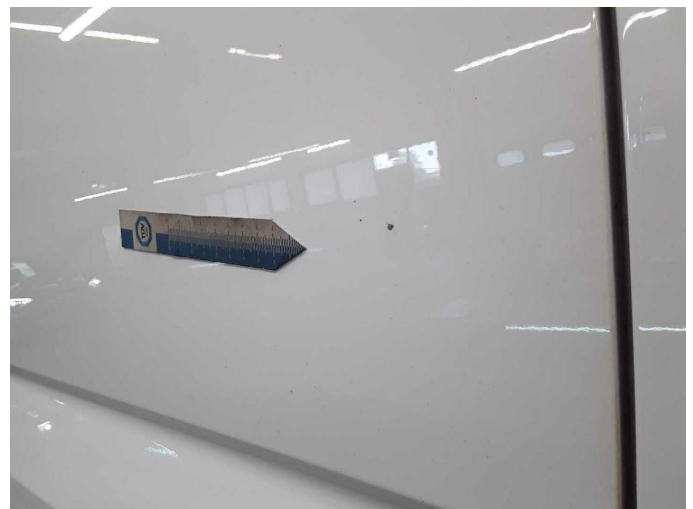
**Wear and tear 5:** Door - rear right side: Door - Stone chips - No deduction

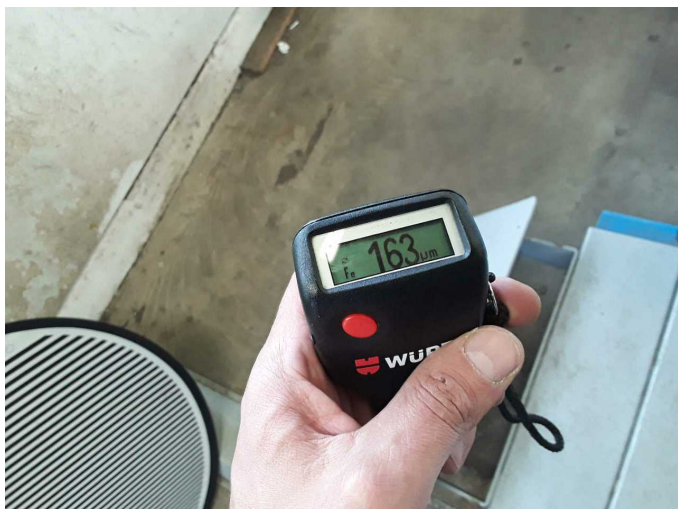
Repainting 1: Bonnet
