Protocol number: 46293334
Order No. / Reference: 26509882
Inspection date: 24 Jun 2026

Manufacturer: Ford

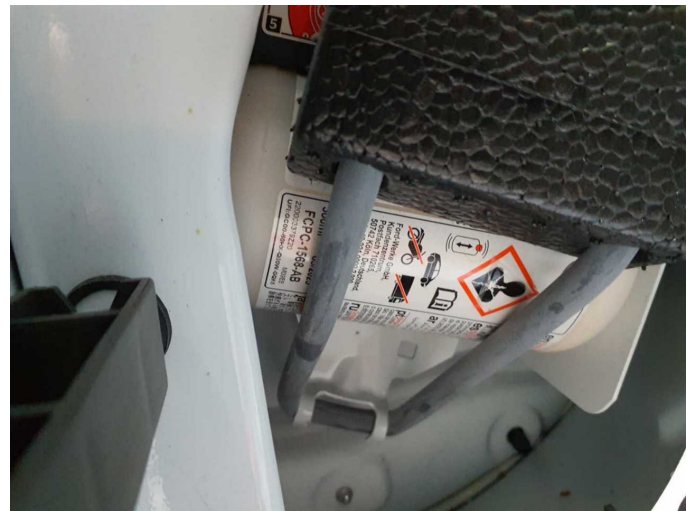
Damage 1: Equipment: Tirefit filler - Expired - Replace

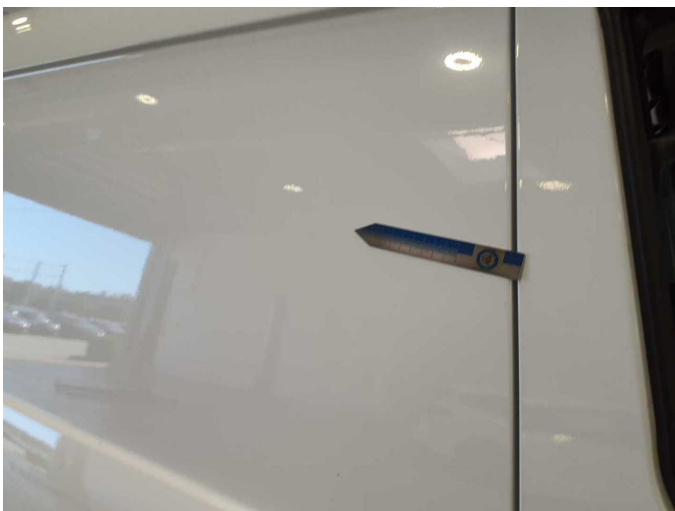
Damage 2: Side panel - rear right side: Side panel - dent(s) - Smooth repair work

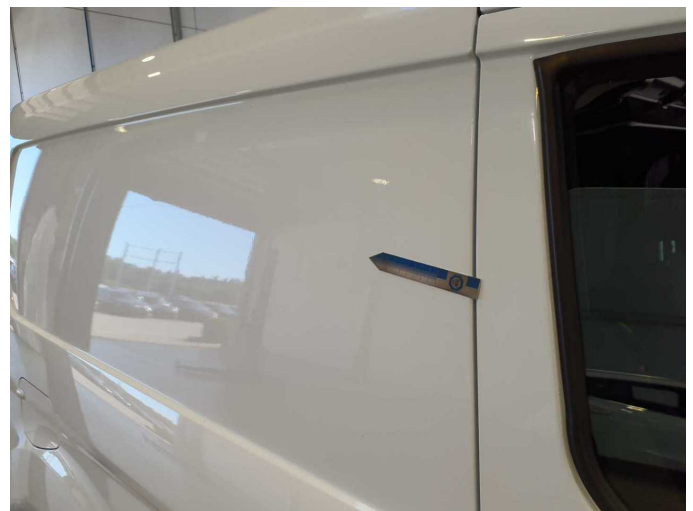
Damage 2: Side panel - rear right side: Side panel - dent(s) - Smooth repair work

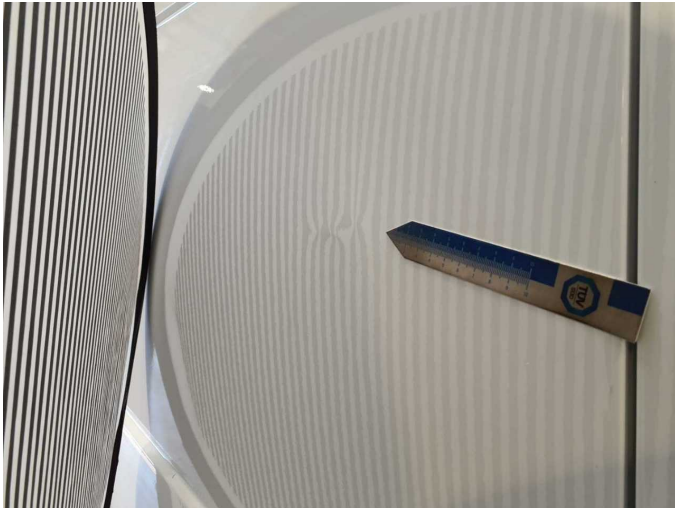
Damage 2: Side panel - rear right side: Side panel - dent(s) - Smooth repair work

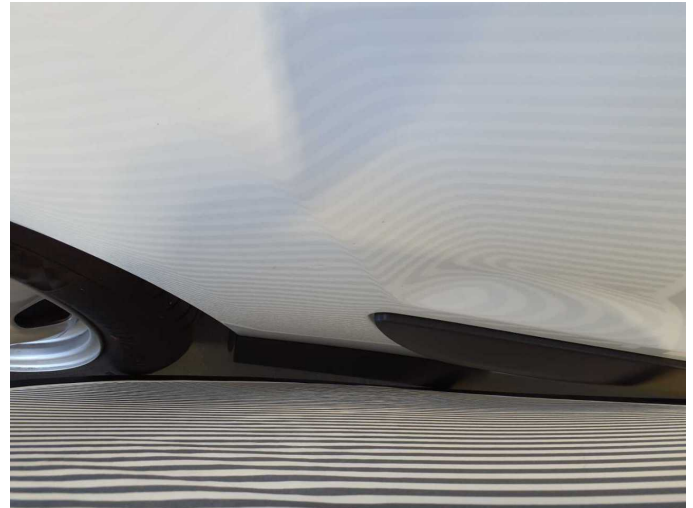
Damage 2: Side panel - rear right side: Side panel - dent(s) - Smooth repair work

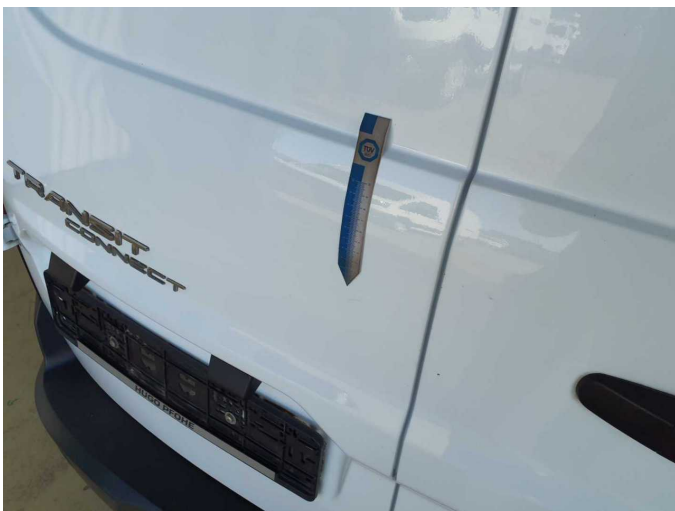
Damage 3: Boot lid / rear door: Rear door - left side - Scratch(es) - Smart repair

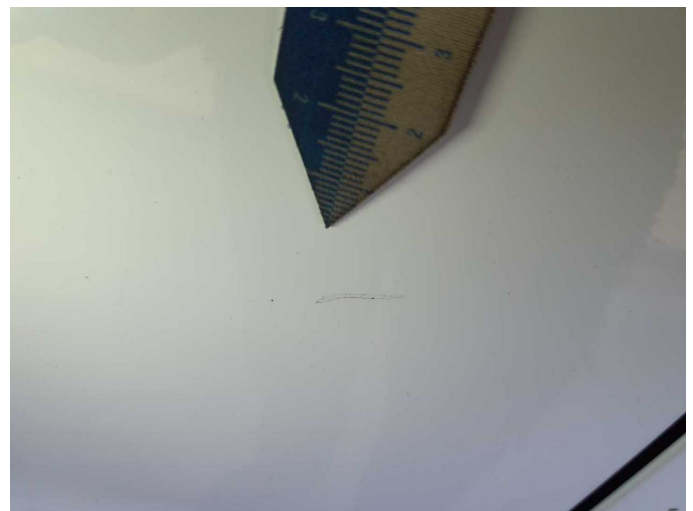
Damage 3: Boot lid / rear door: Rear door - left side - Scratch(es) - Smart repair

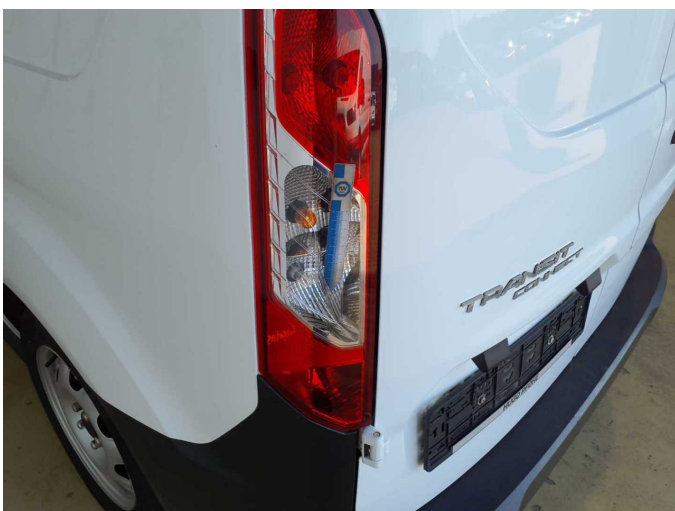
Damage 4: Tail light: Tail lamp - left side - Scratch(es) - Replace

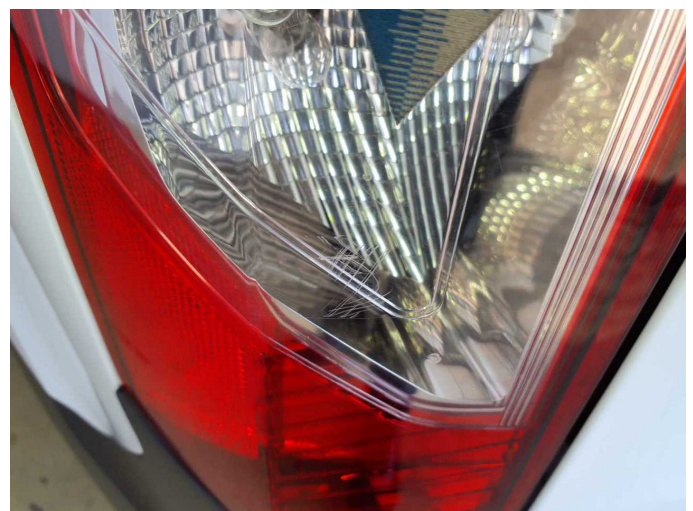
Damage 4: Tail light: Tail lamp - left side - Scratch(es) - Replace

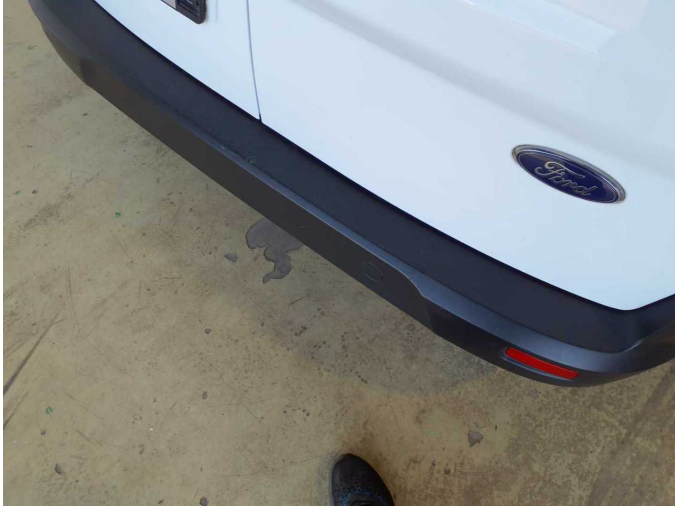
Damage 5: Rear bumper: Rear bumper - Scratch(es) - Replace

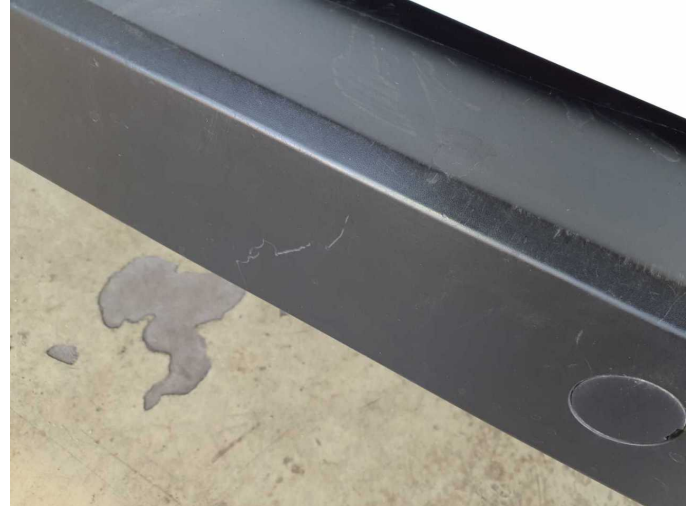
Damage 5: Rear bumper: Rear bumper - Scratch(es) - Replace

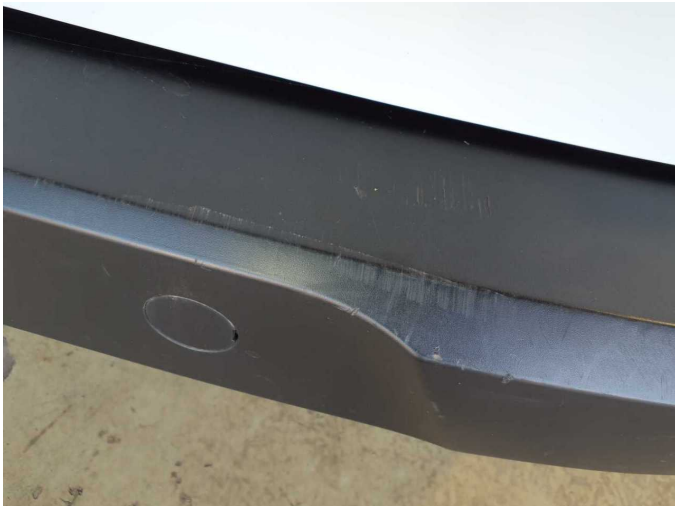
Damage 5: Rear bumper: Rear bumper - Scratch(es) - Replace

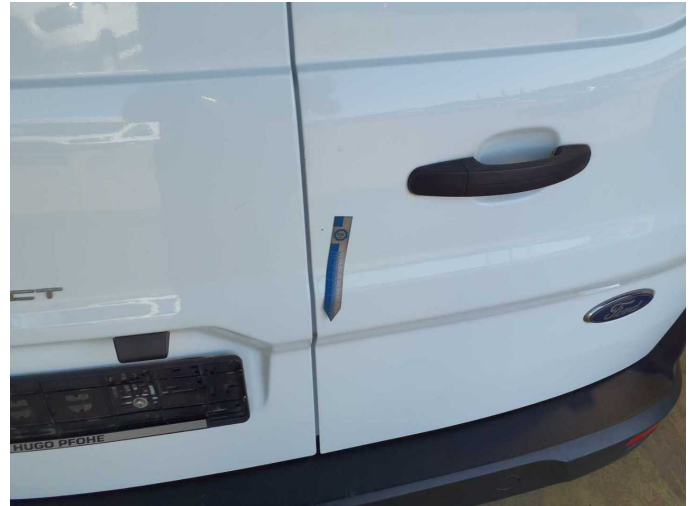
Damage 6: Boot lid / rear door: Rear door - right side - Dent / paintcoat damage - Paint

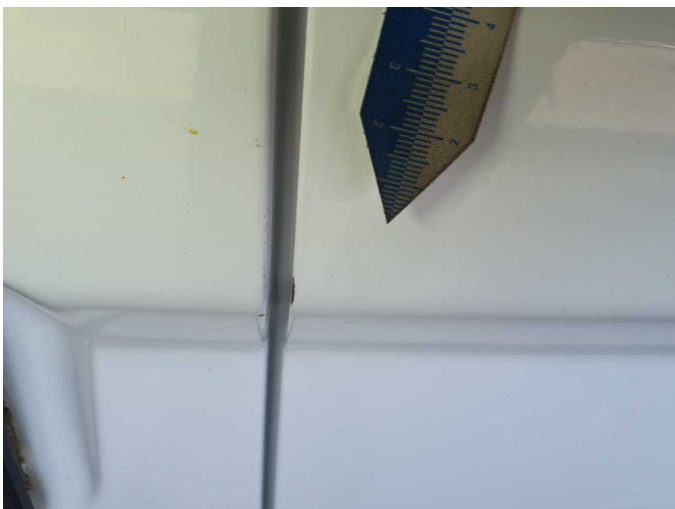
Damage 6: Boot lid / rear door: Rear door - right side - Dent / paintcoat damage - Paint

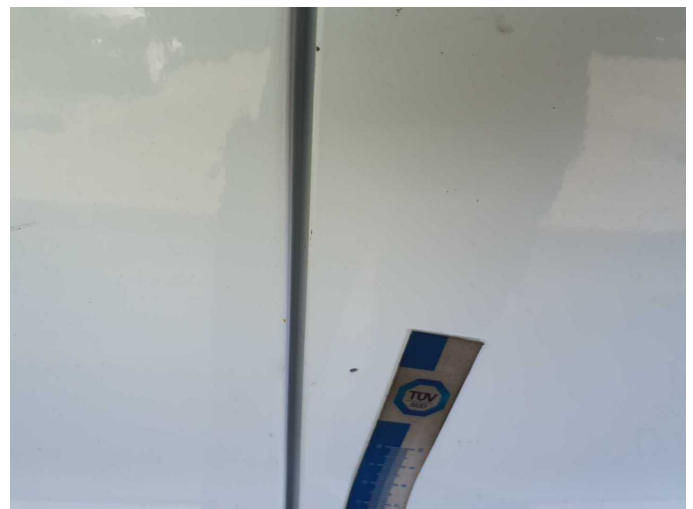
Damage 6: Boot lid / rear door: Rear door - right side - Dent / paintcoat damage - Paint

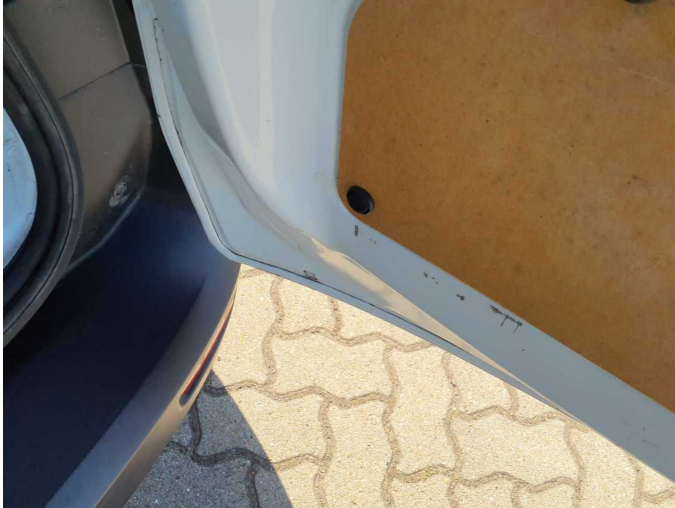
Damage 6: Boot lid / rear door: Rear door - right side - Dent / paintcoat damage - Paint

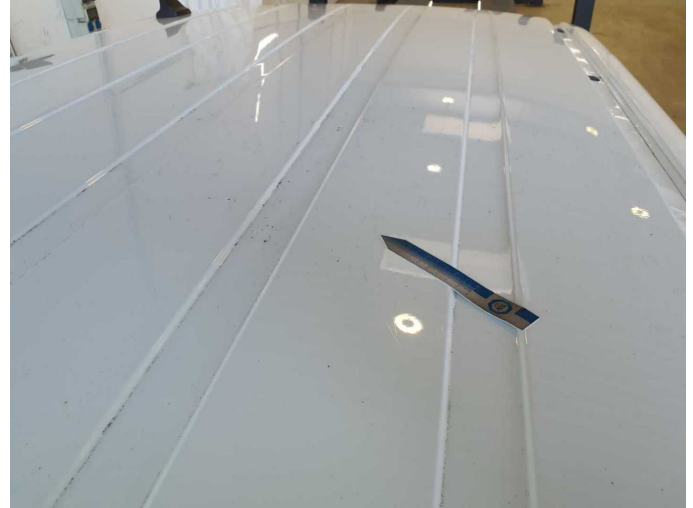
Damage 7: Roof: Roof - Scratch(es) - Paint

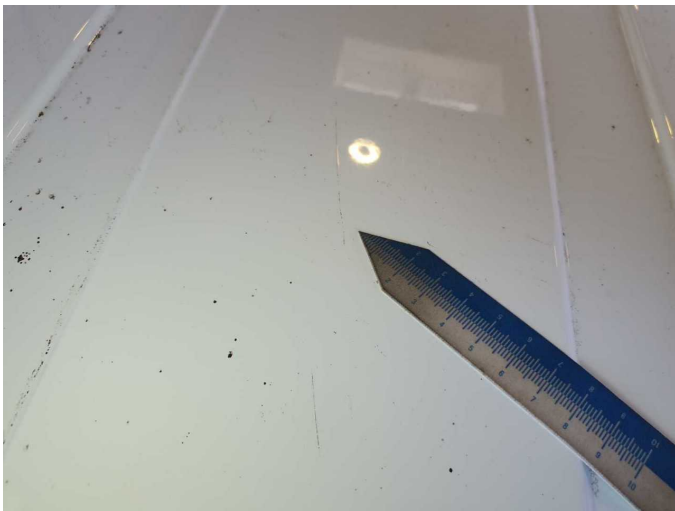
Damage 7: Roof: Roof - Scratch(es) - Paint
