Protocol number: 46340482
Order No. / Reference: 26660267
Inspection date: 2 Jul 2026

Manufacturer: Ford

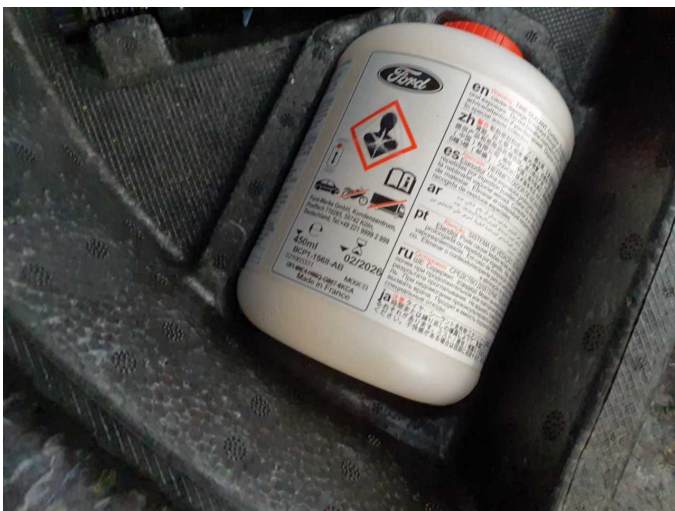
Damage 1: Equipment: Tirefit filler - Expired - Replace

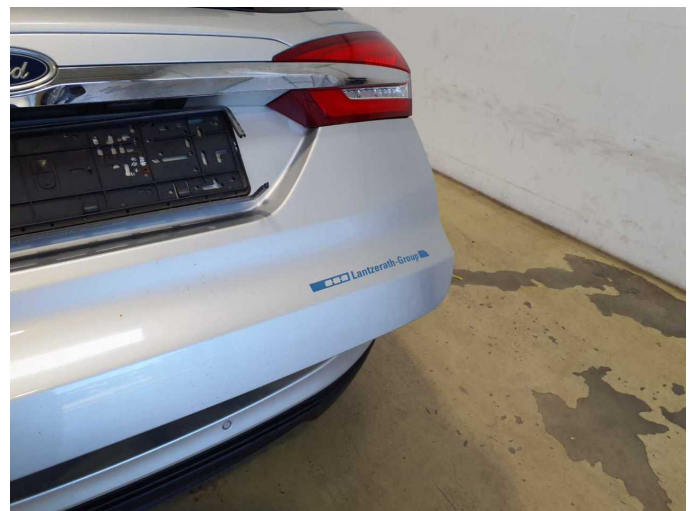
Damage 2: Boot lid / rear door: Boot lid - Glued / labelled - De-glue / neutralise

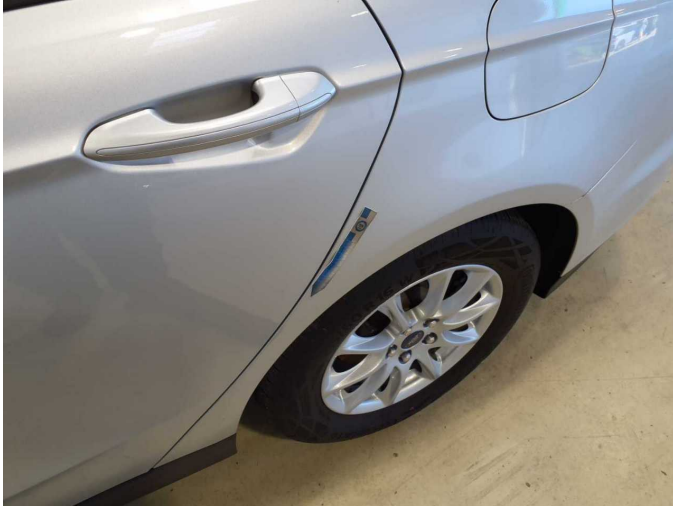
Damage 3: Side panel - rear left side: Side panel - dent(s) - Smooth repair work

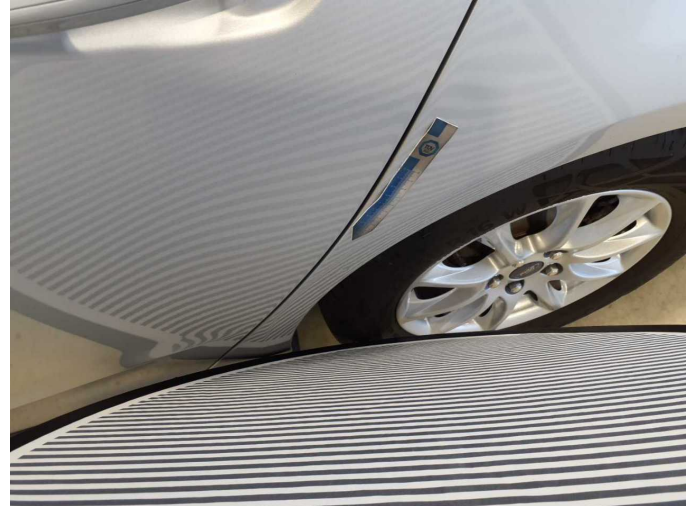
Damage 3: Side panel - rear left side: Side panel - dent(s) - Smooth repair work

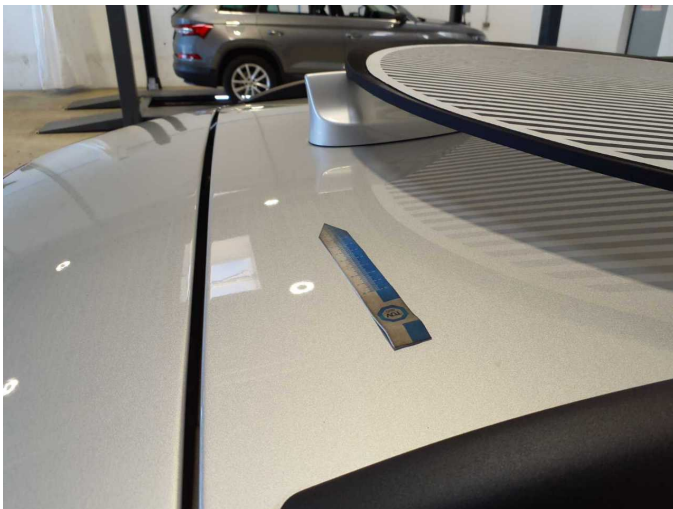
Damage 4: Roof: Roof - dent(s) - Smooth repair work

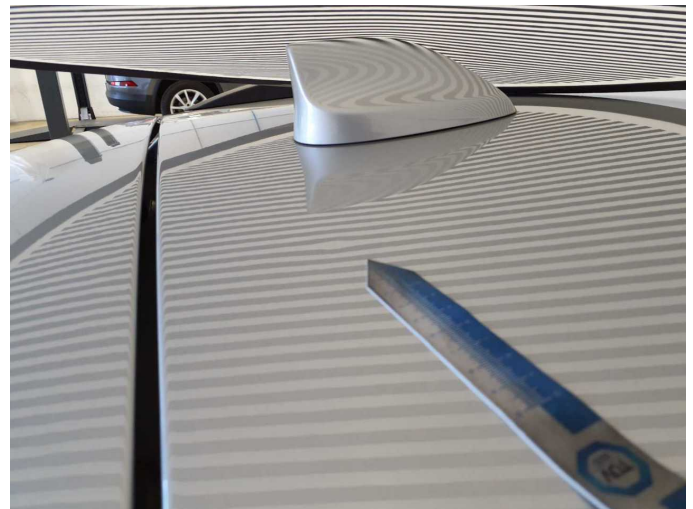
Damage 4: Roof: Roof - dent(s) - Smooth repair work

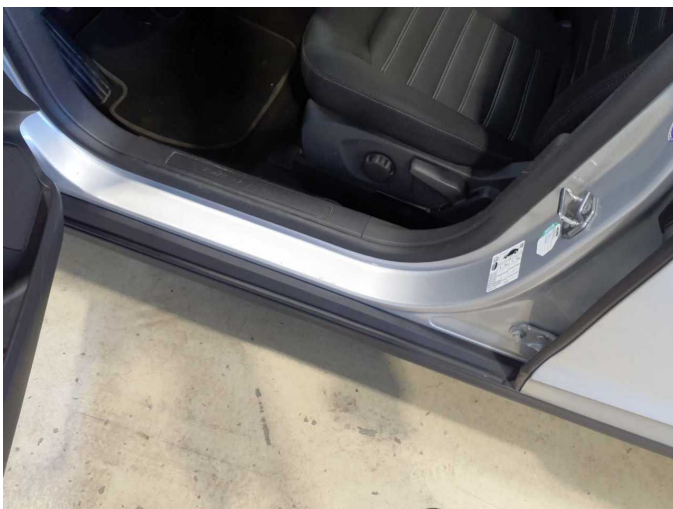
Damage 5: Sill - left side: Sill - Scratch(es) - Smart repair

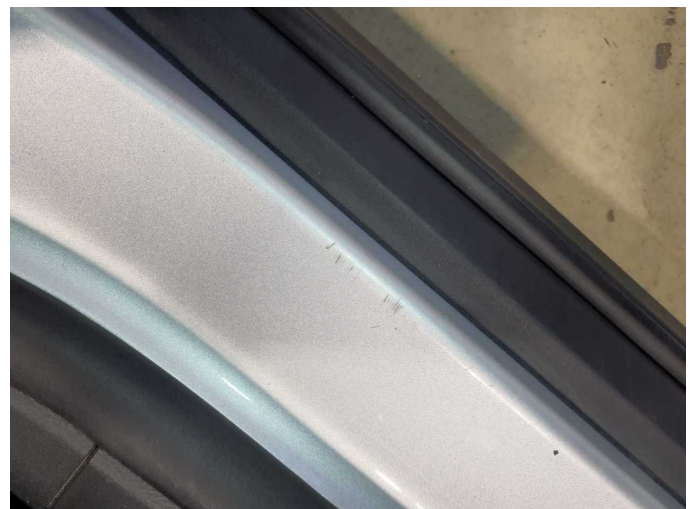
Damage 5: Sill - left side: Sill - Scratch(es) - Smart repair

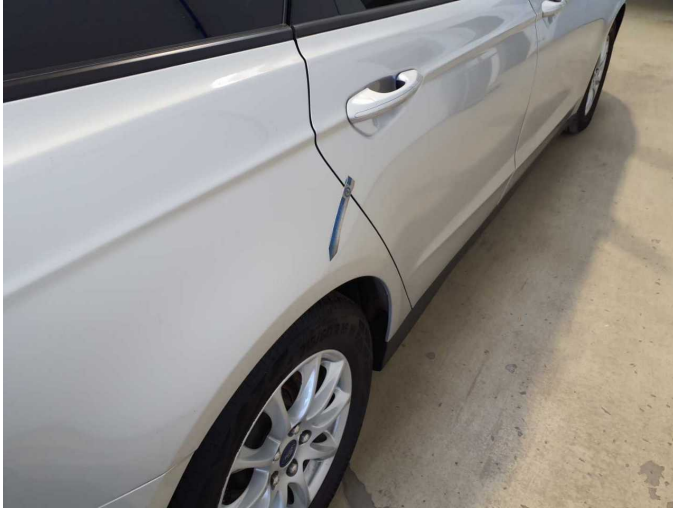
Damage 6: Side panel - rear right side: Side panel - dent(s) - Smart repair

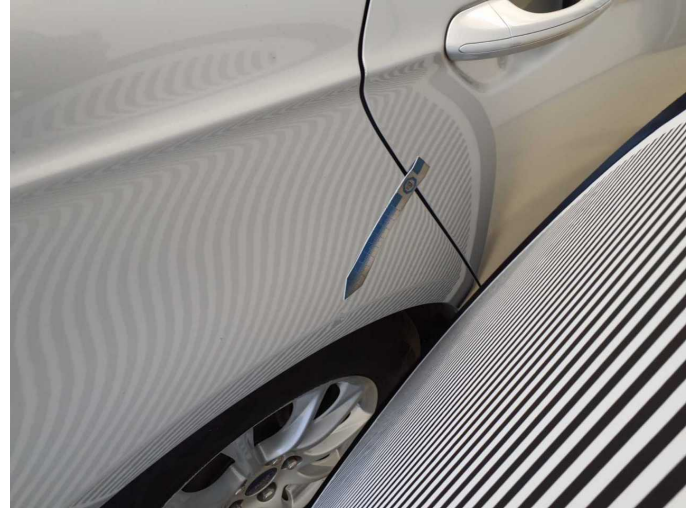
Damage 6: Side panel - rear right side: Side panel - dent(s) - Smart repair

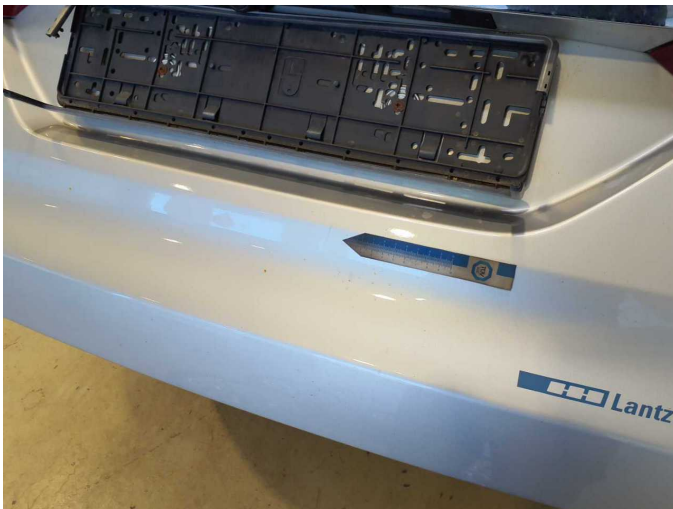
Damage 7: Boot lid / rear door: Boot lid - Scratch(es) - Smart repair

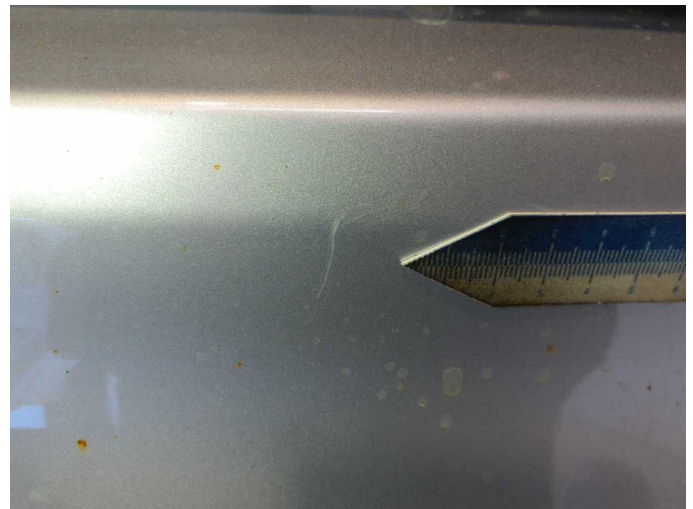
Damage 7: Boot lid / rear door: Boot lid - Scratch(es) - Smart repair

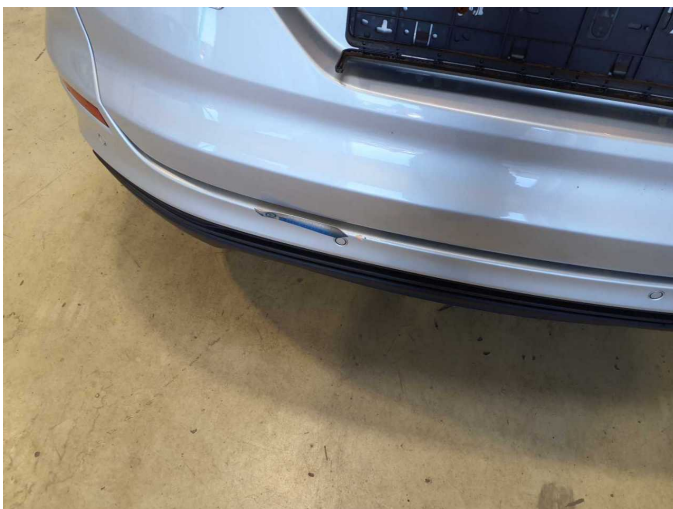
Damage 8: Rear bumper: Rear bumper - Scratch(es) - Smart repair

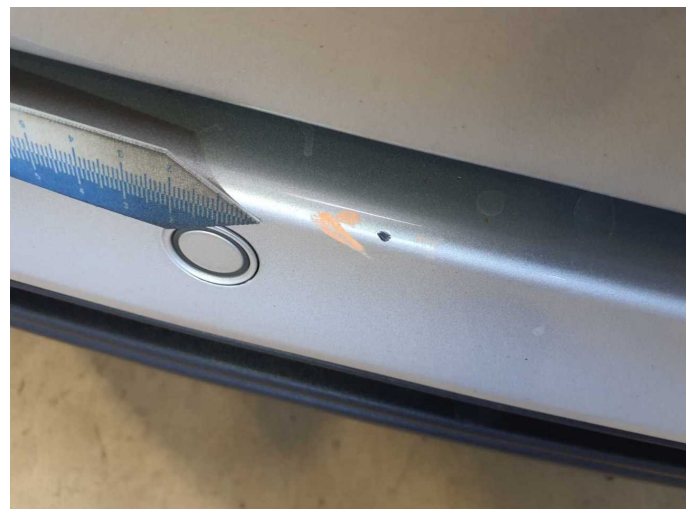
Damage 8: Rear bumper: Rear bumper - Scratch(es) - Smart repair

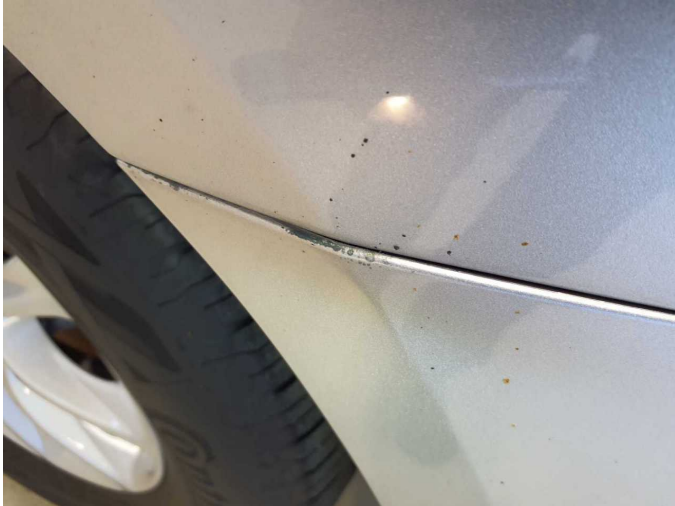
Damage 8: Rear bumper: Rear bumper - Scratch(es) - Smart repair

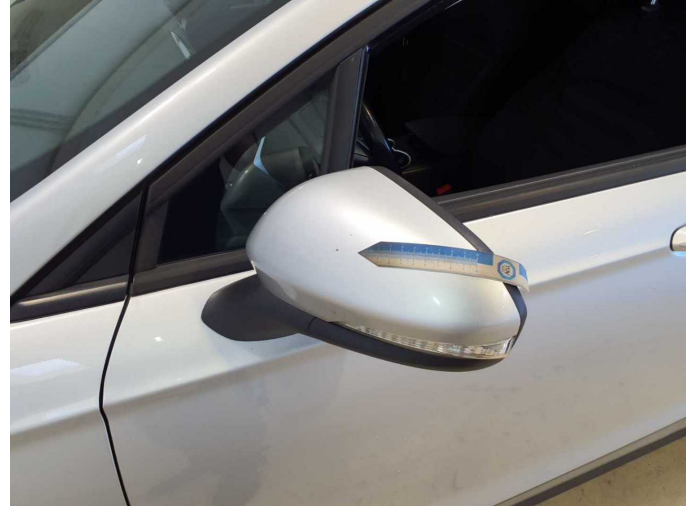
Damage 9: Wing mirror - left side: Cap - Stone chips - Smart repair

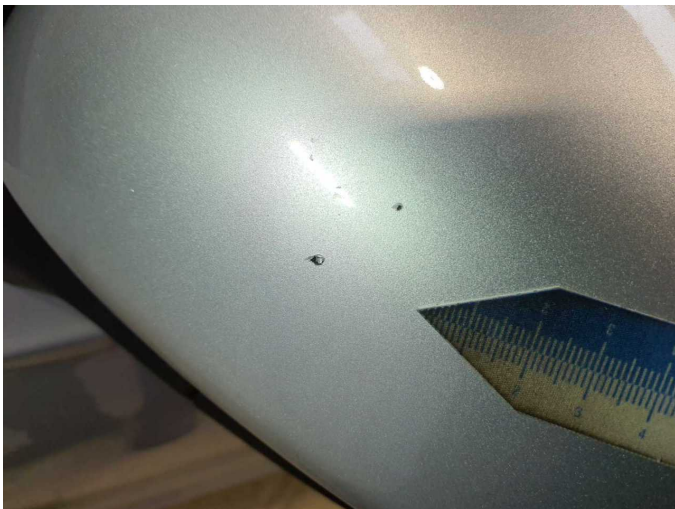
Damage 9: Wing mirror - left side: Cap - Stone chips - Smart repair

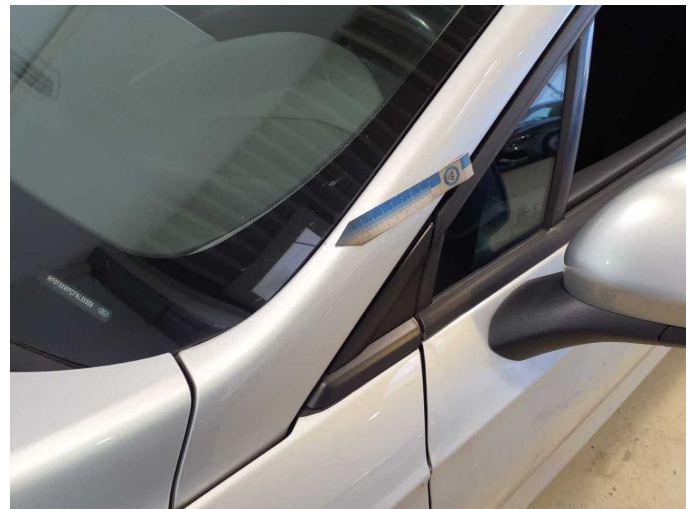
Damage 10: Body: A-pillar - left side - Stone chips - Smart repair

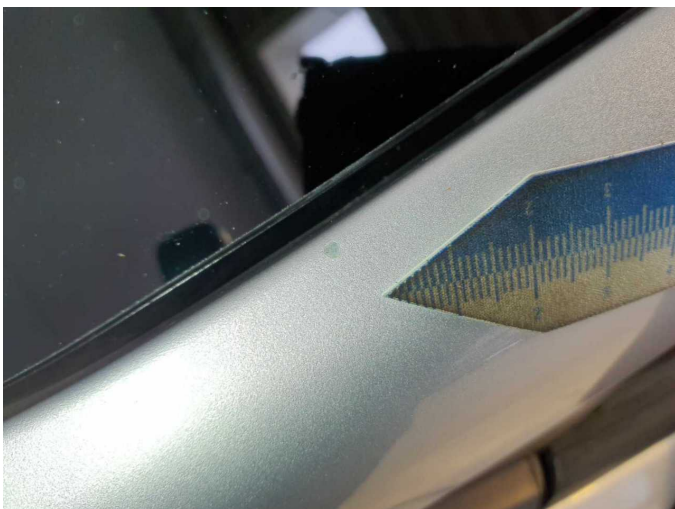
Damage 10: Body: A-pillar - left side - Stone chips - Smart repair

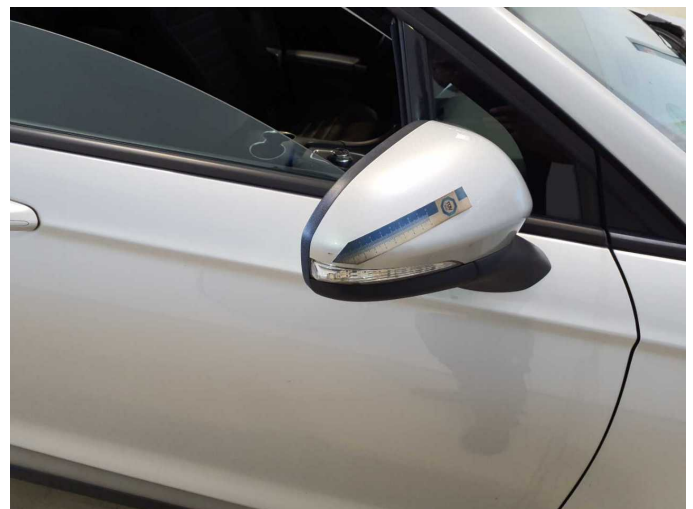
Damage 11: Wing mirror - right side: Cap - Scratch(es) - Smart repair

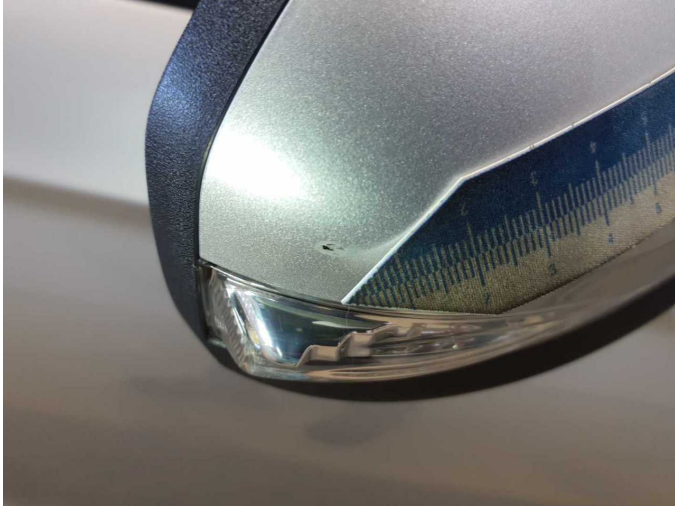
Damage 11: Wing mirror - right side: Cap - Scratch(es) - Smart repair

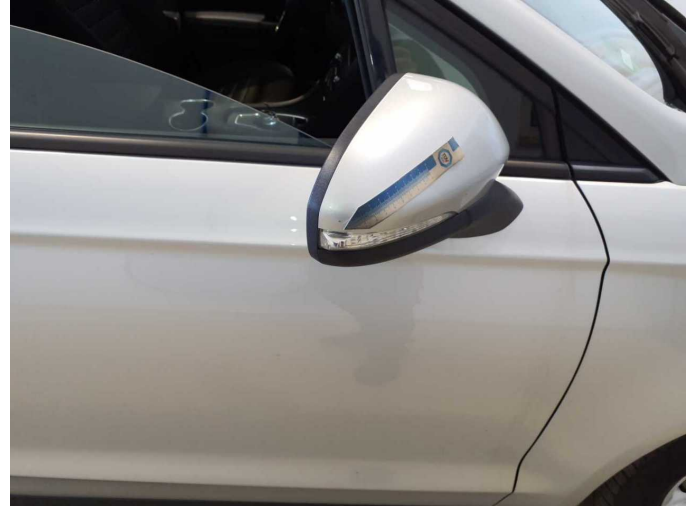
Damage 12: Indicator - front: Mirror - right side - Scratch(es) - Replace

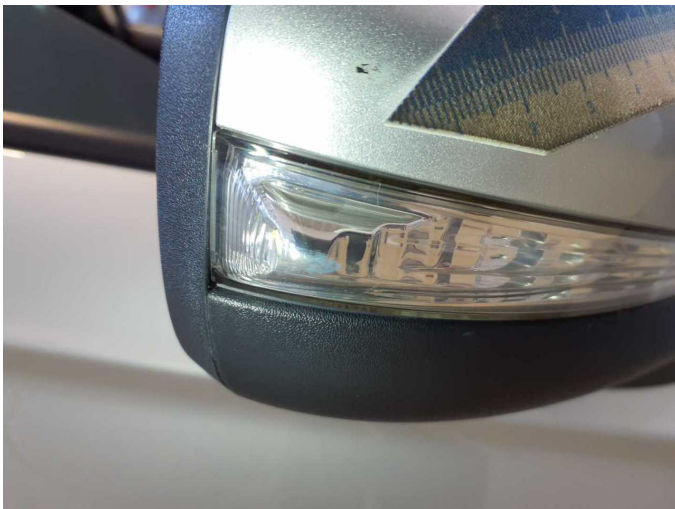
Damage 12: Indicator - front: Mirror - right side - Scratch(es) - Replace

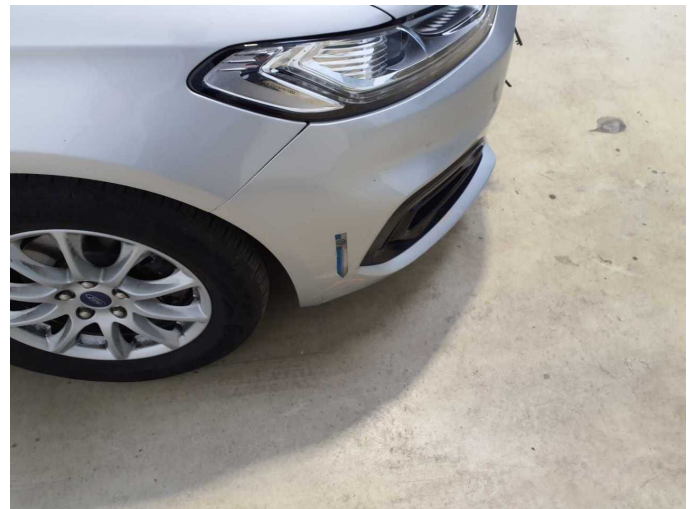
Damage 13: Front bumper: Front bumper - Dent / paintcoat damage - Repair and paint

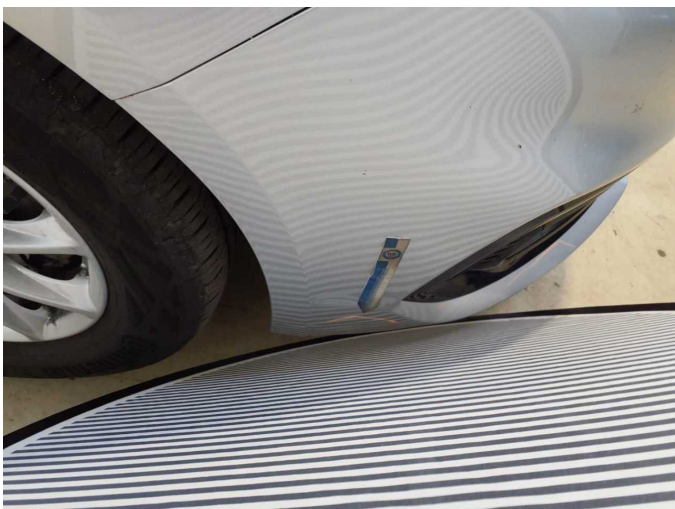
Damage 13: Front bumper: Front bumper - Dent / paintcoat damage - Repair and paint

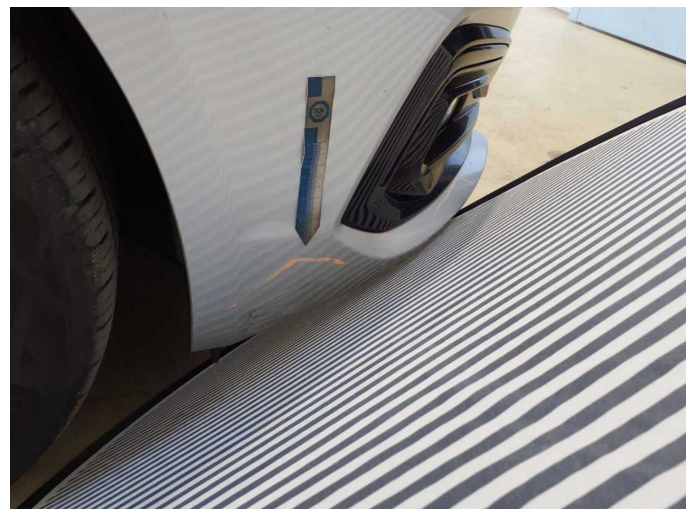
Damage 13: Front bumper: Front bumper - Dent / paintcoat damage - Repair and paint

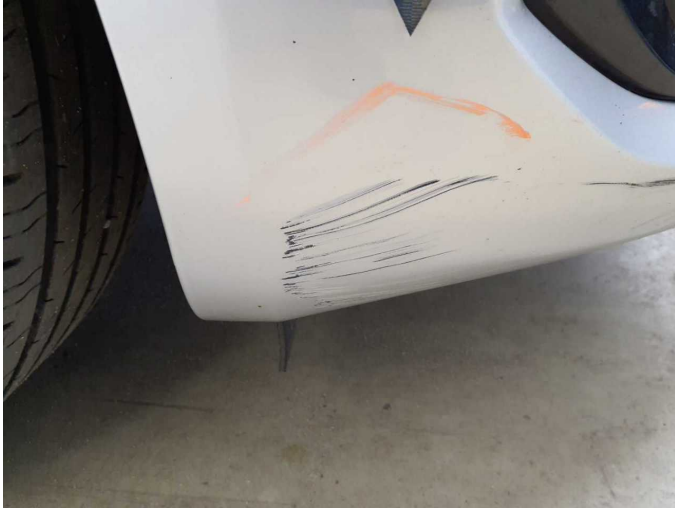
Damage 13: Front bumper: Front bumper - Dent / paintcoat damage - Repair and paint

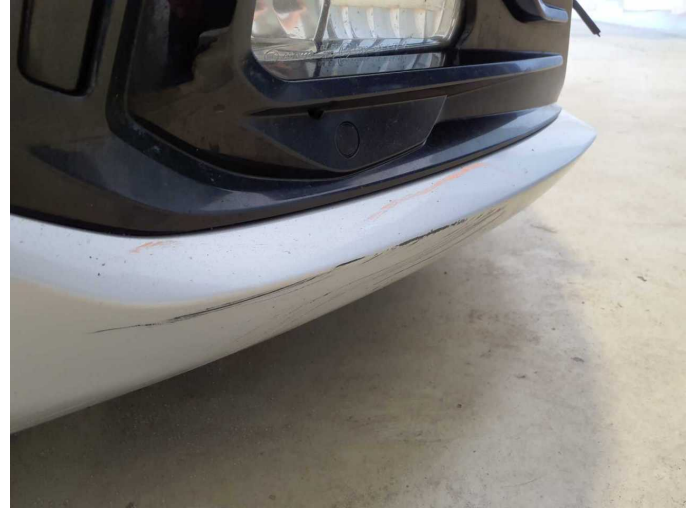
Damage 13: Front bumper: Front bumper - Dent / paintcoat damage - Repair and paint

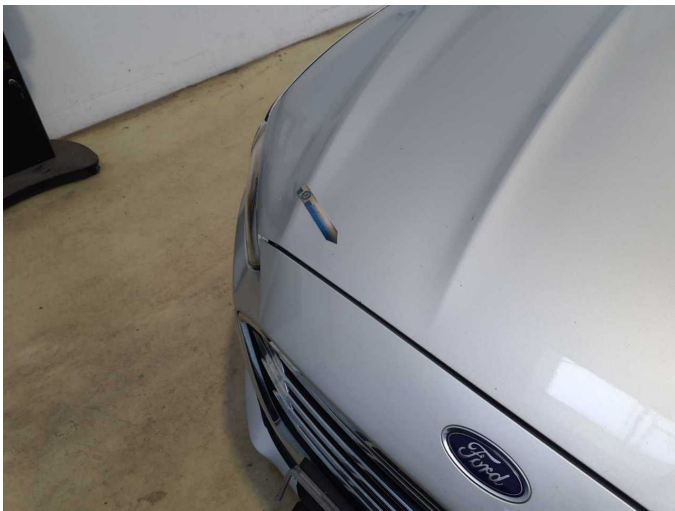
Damage 14: Bonnet: Bonnet - dent(s) - Repair and paint

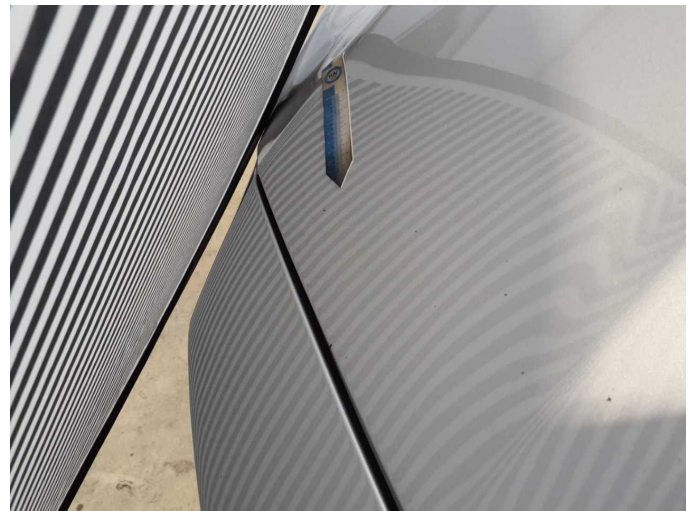
Damage 14: Bonnet: Bonnet - dent(s) - Repair and paint

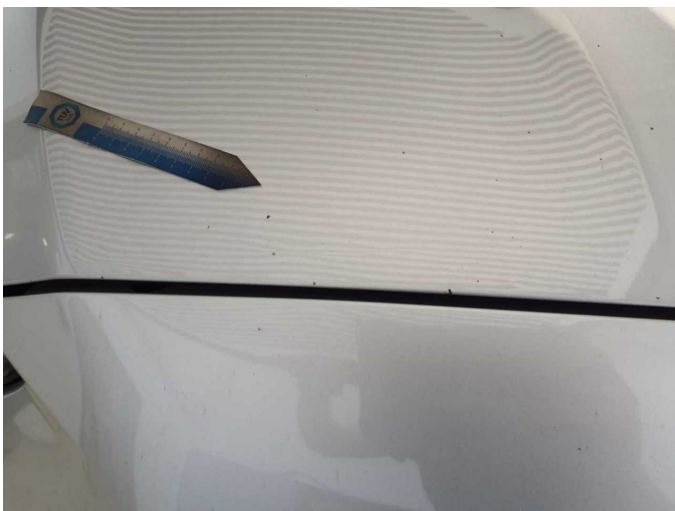
Damage 14: Bonnet: Bonnet - dent(s) - Repair and paint

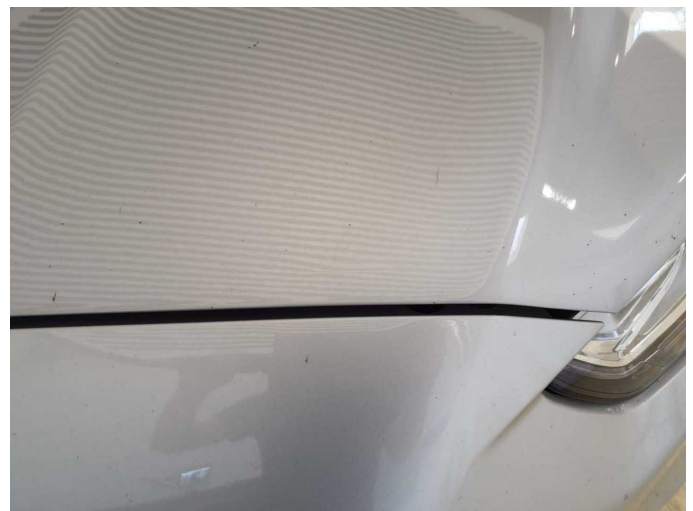
Damage 14: Bonnet: Bonnet - dent(s) - Repair and paint
