## Expertise

Protocol number: 46340658  
Order No. / Reference: 26653150  
Inspection date: 2 Jul 2026

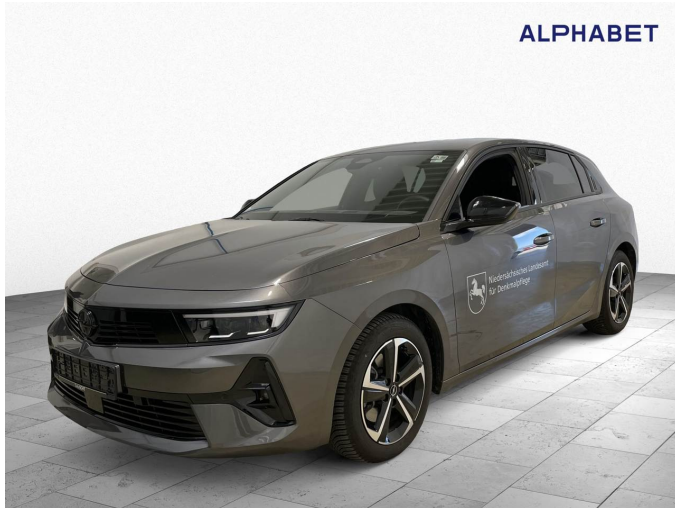
Figure 1: Diagonal front (left)

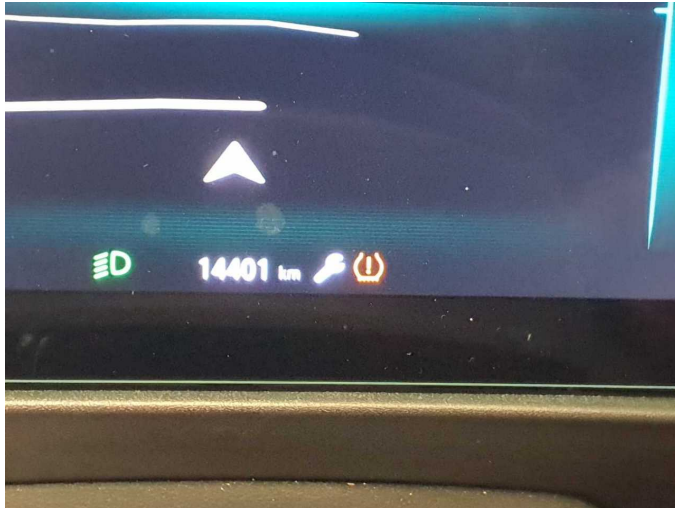
**Damage 1:** Wheel / tyres: Pressure sensor (Reifendruckkontrollsystem) - on - Diagnosed and repair if necessary

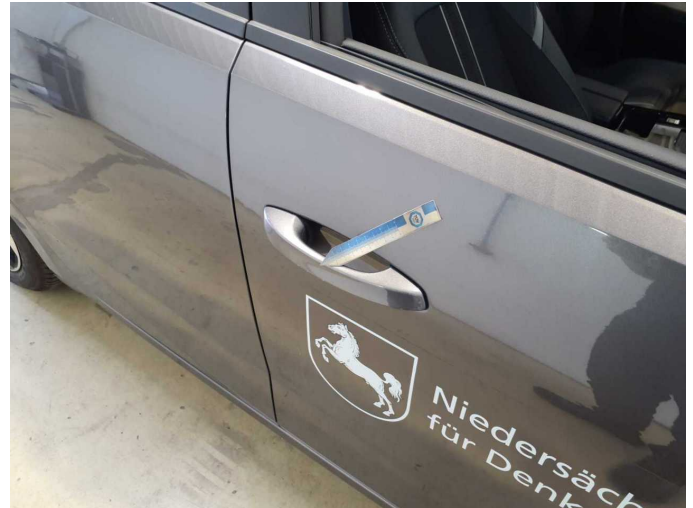
**Damage 2:** Door - front right side: Door handle - outside - Scratch(es) - Paint

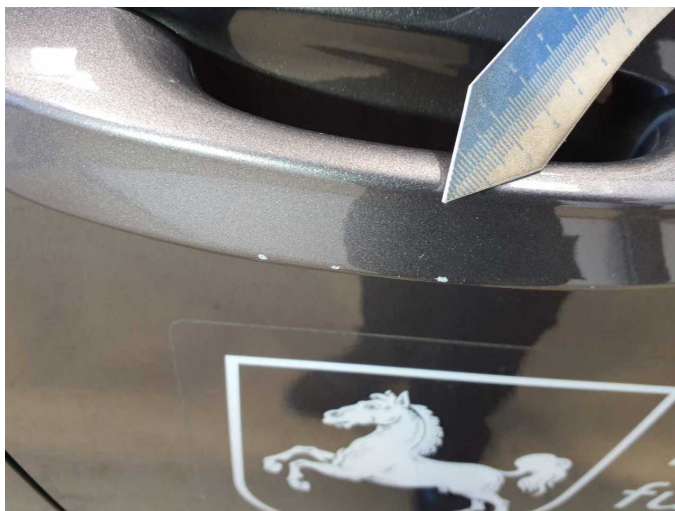
**Damage 2:** Door - front right side: Door handle - outside - Scratch(es) - Paint

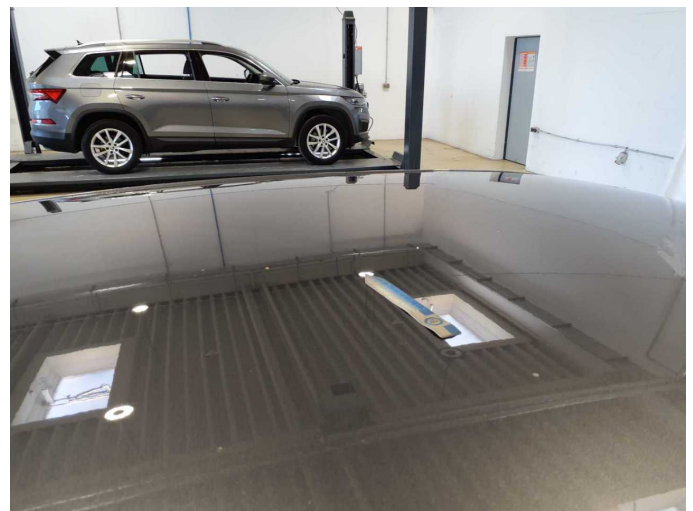
**Damage 3:** Roof: Roof - dent(s) - Smooth repair work

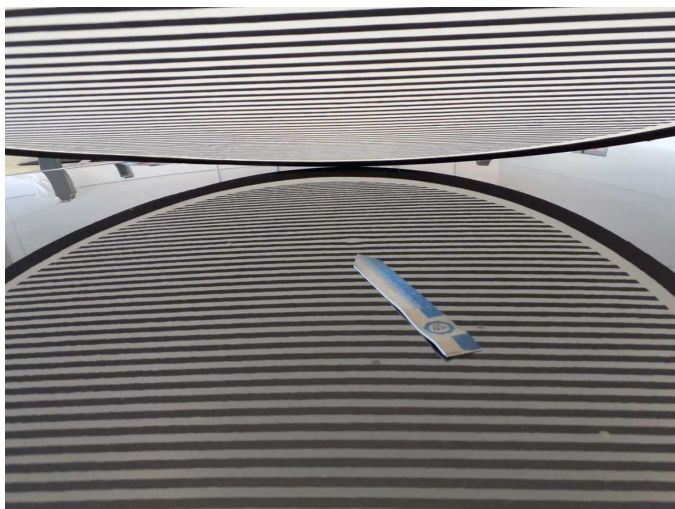
**Damage 3:** Roof: Roof - dent(s) - Smooth repair work

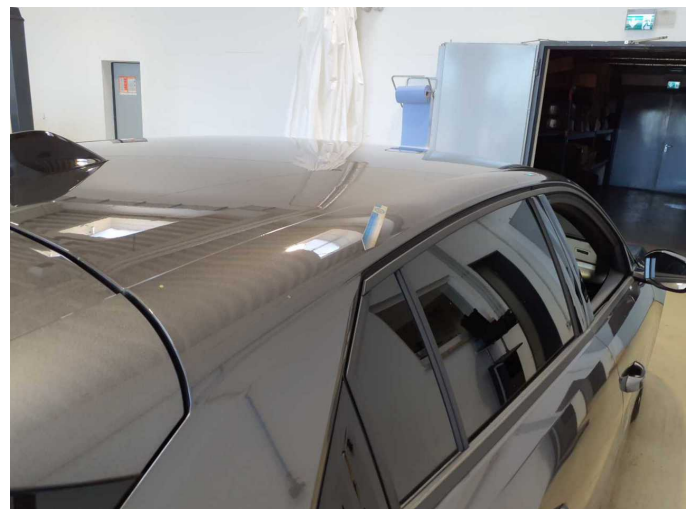
**Damage 4:** Roof: Roof rail - right side - dent(s) - Smart repair

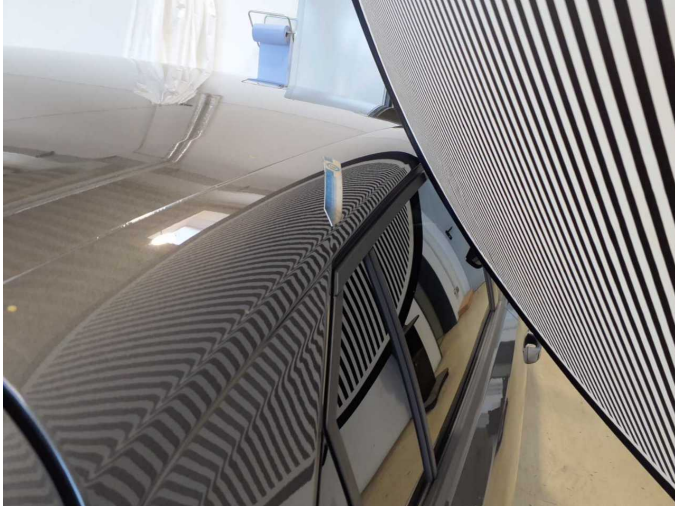
**Damage 4:** Roof: Roof rail - right side - dent(s) - Smart repair

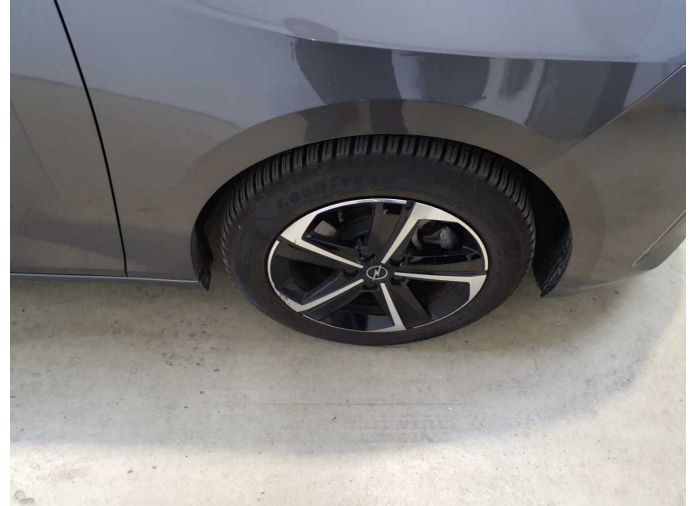
**Damage 5:** Wheel / tyres: Tyre - front right side - Broken / torn - Replace

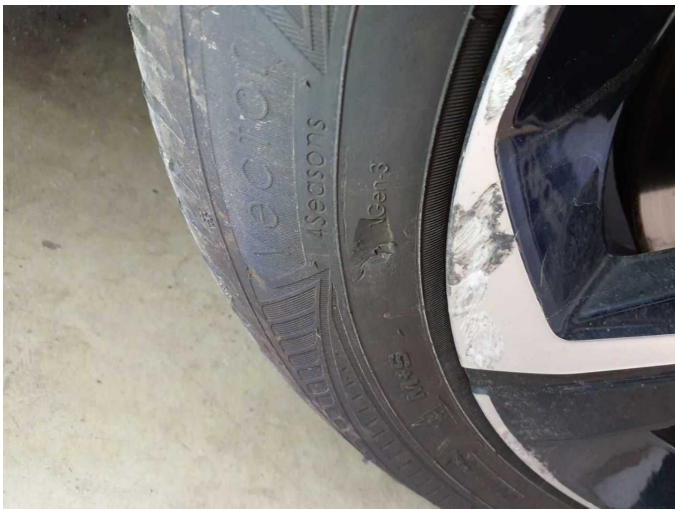
**Damage 5:** Wheel / tyres: Tyre - front right side - Broken / torn - Replace

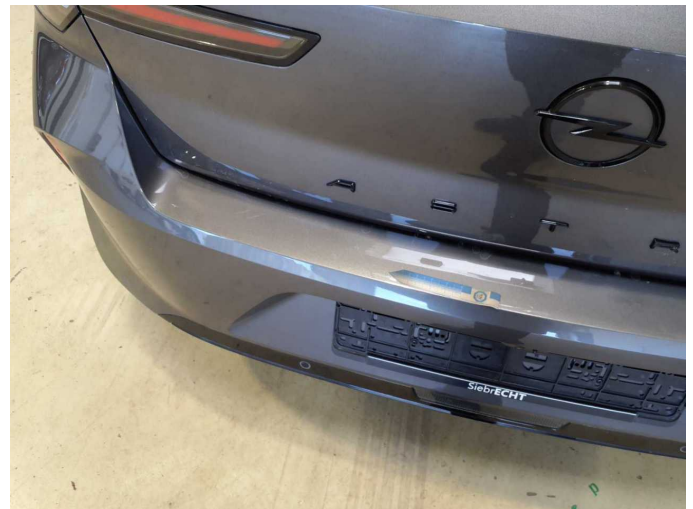
**Damage 6:** Rear bumper: Rear bumper - Scratch(es) - Smart repair

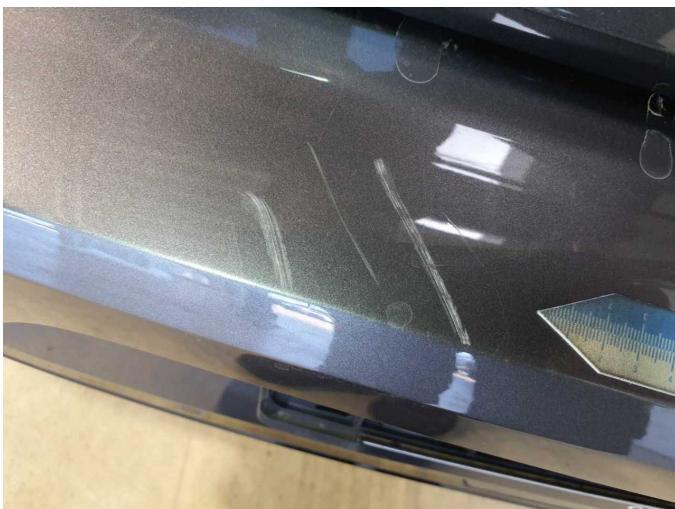
**Damage 6:** Rear bumper: Rear bumper - Scratch(es) - Smart repair

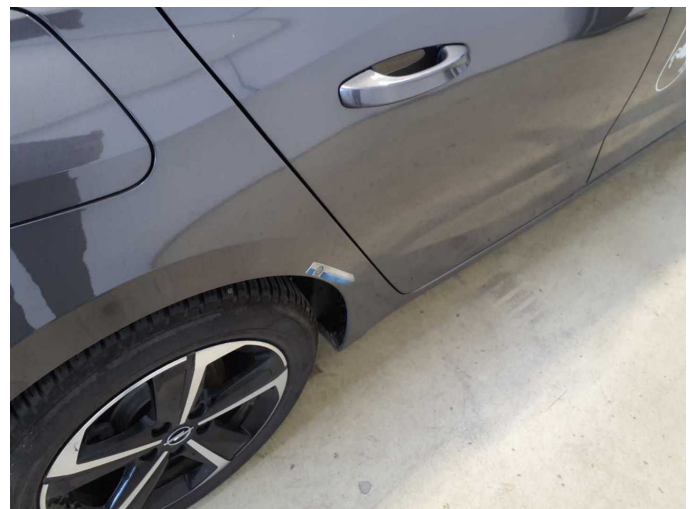
**Damage 7:** Side panel - rear right side: Side panel - dent(s) - Smooth repair work

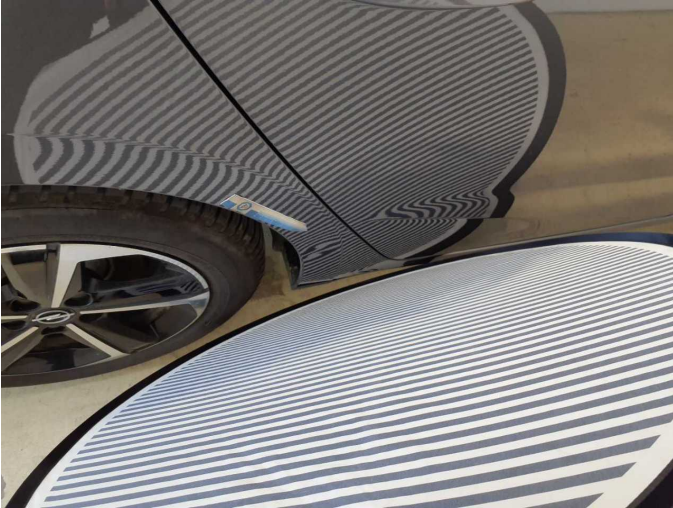
**Damage 7:** Side panel - rear right side: Side panel - dent(s) - Smooth repair work

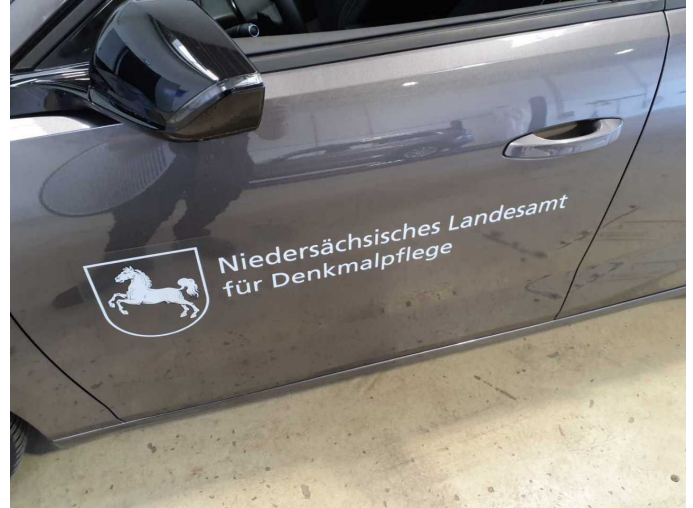
**Damage 8:** Body: Body - Glued / labelled - De-glue / neutralise

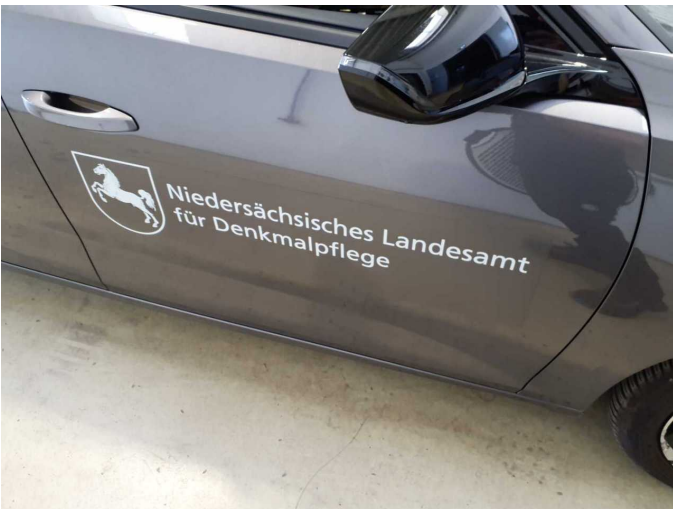
**Damage 8:** Body: Body - Glued / labelled - De-glue / neutralise

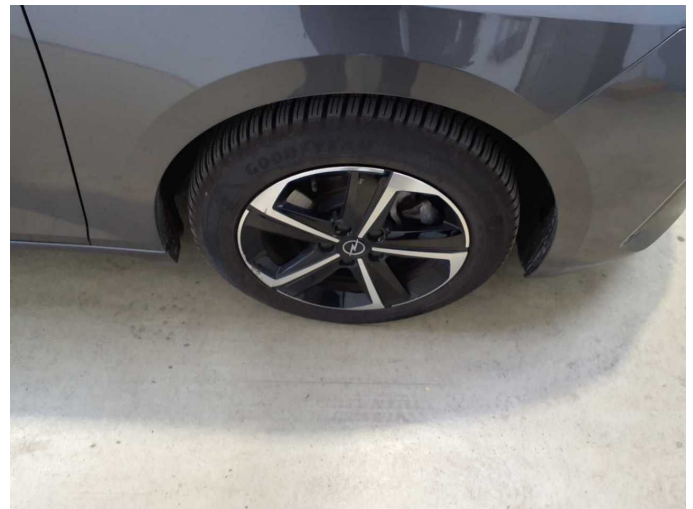
**Damage 9:** Wheel / tyres: Alloy rim - front right side - Scratch(es) - Replace

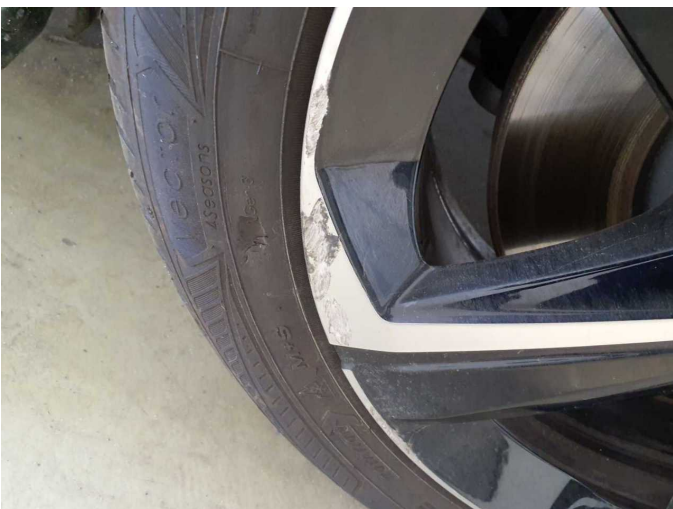
**Damage 9:** Wheel / tyres: Alloy rim - front right side - Scratch(es) - Replace

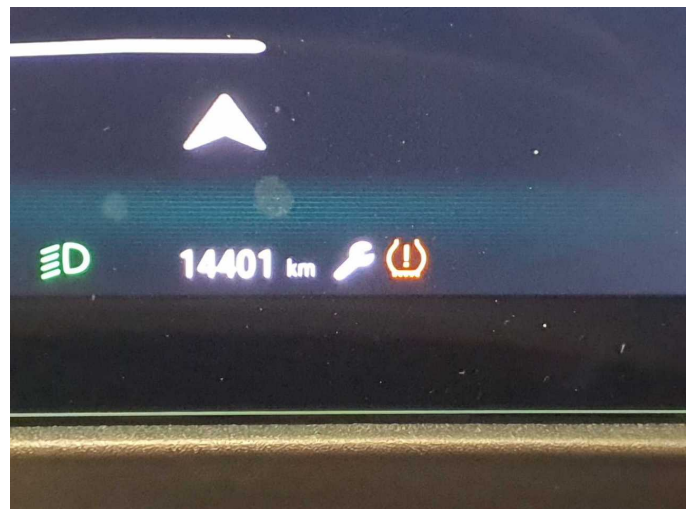
**Damage 10:** Misc.: Inspection / maintenance - Due - Perform
