Protocol number: 46276434
Order No. / Reference: 26574287
Inspection date: 30 Jun 2026

Manufacturer: Ford

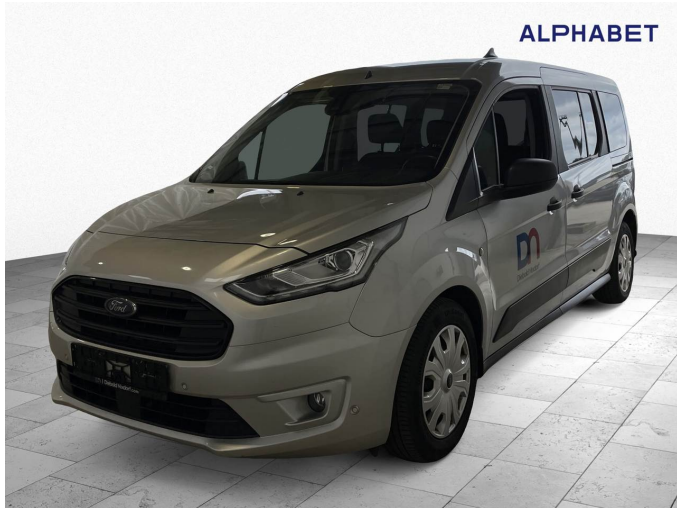
Figure 1: Diagonal front (left)

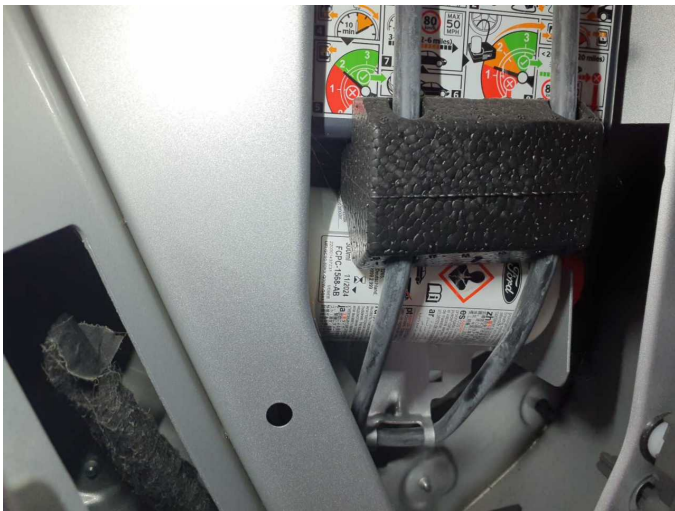
Damage 2: Equipment: Tirefit filler - Expired - Replace

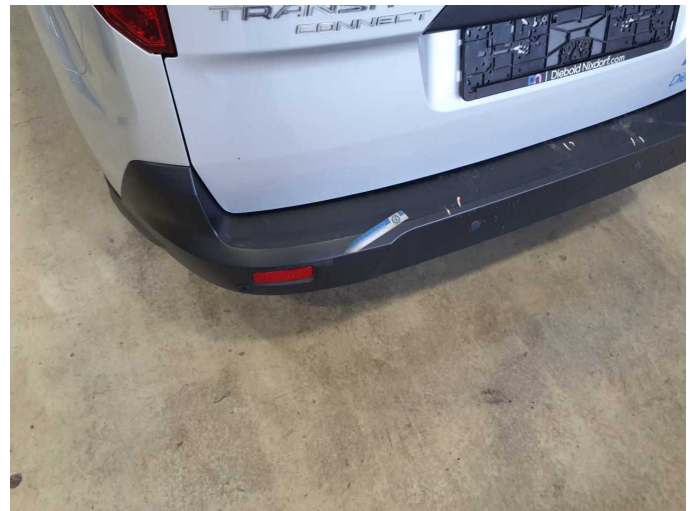
Damage 3: Rear bumper: Rear bumper (unpainted) - Scratch(es) - Loss in value

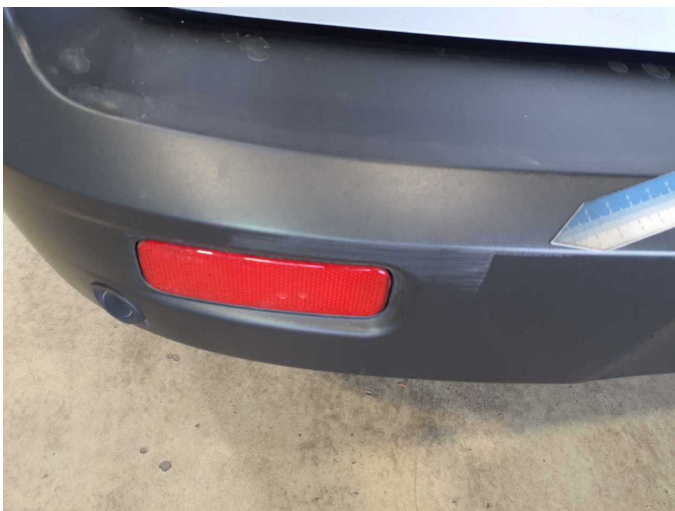
Damage 3: Rear bumper: Rear bumper (unpainted) - Scratch(es) - Loss in value

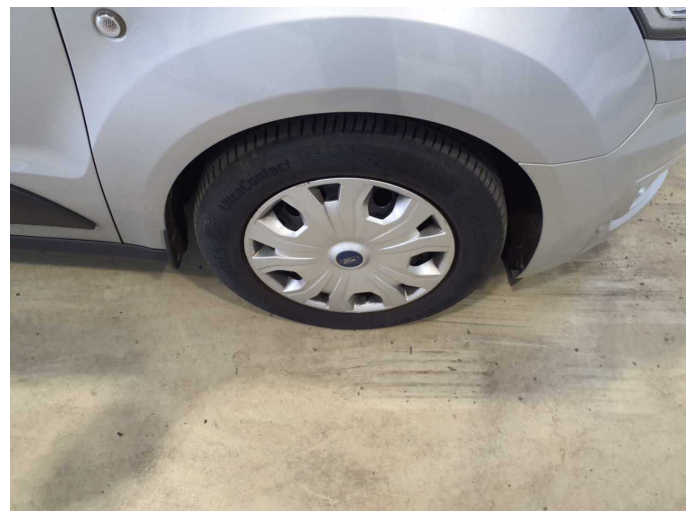
Damage 4: Wheel / tyres: Tyre - front right side (nicht fahrbereit) - Broken / torn - Replace

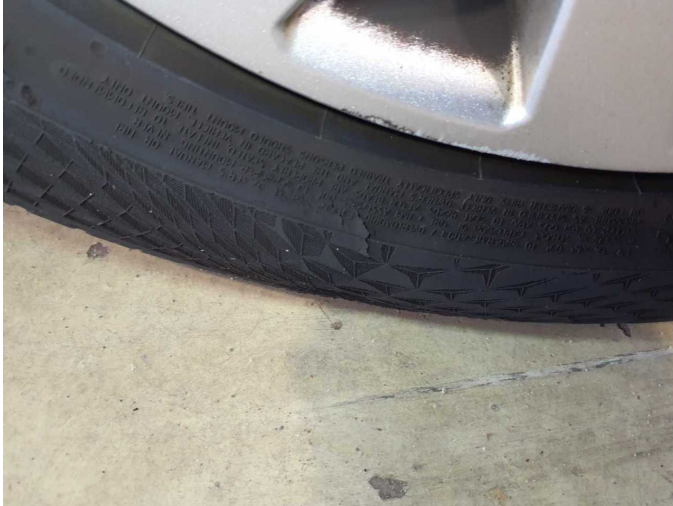
Damage 4: Wheel / tyres: Tyre - front right side (nicht fahrbereit) - Broken / torn - Replace

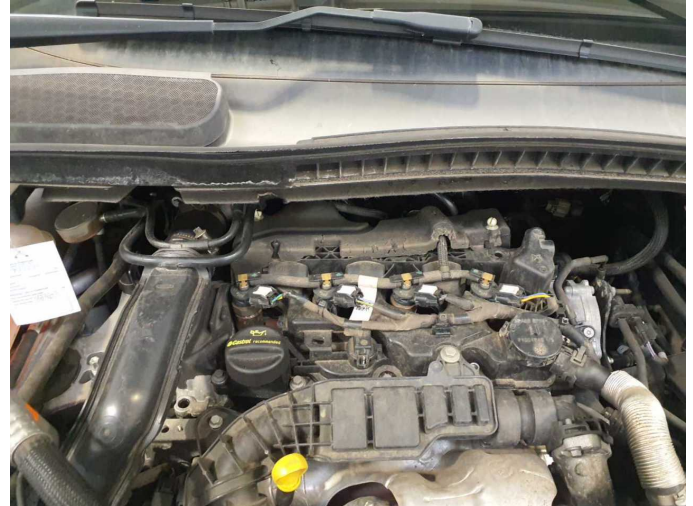
Damage 5: Engine: Engine cover - Broken / torn - Replace

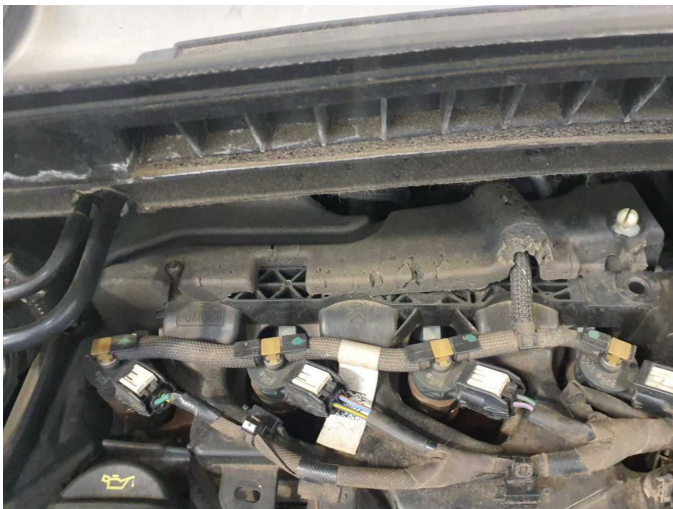
Damage 5: Engine: Engine cover - Broken / torn - Replace

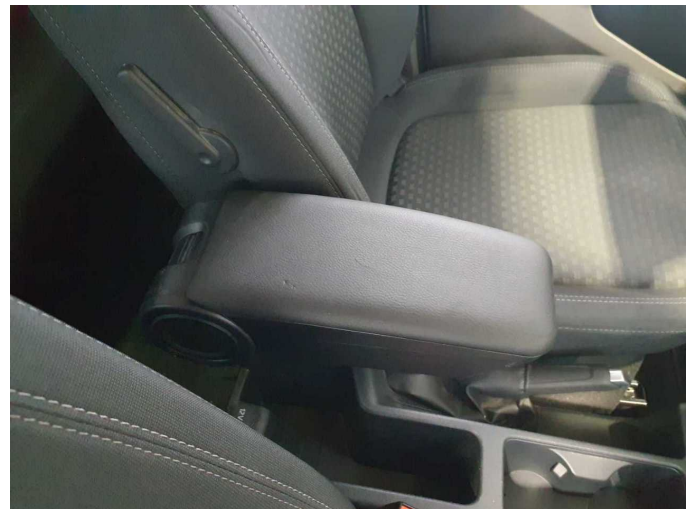
Damage 6: Seat - front: armrests - Scratch(es) - Smart repair

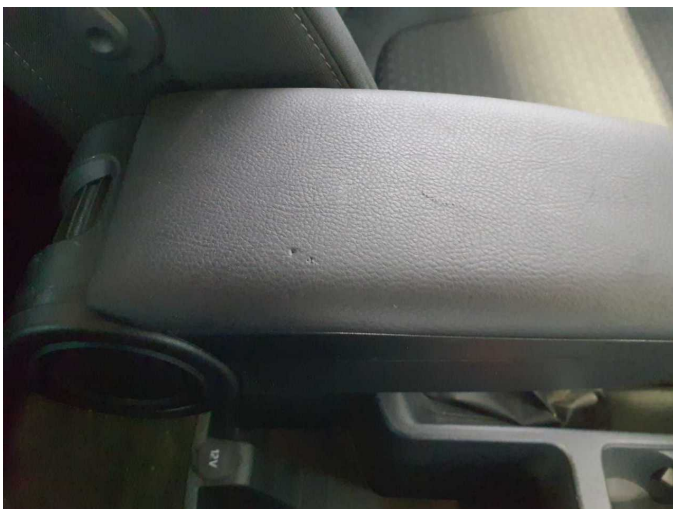
Damage 6: Seat - front: armrests - Scratch(es) - Smart repair

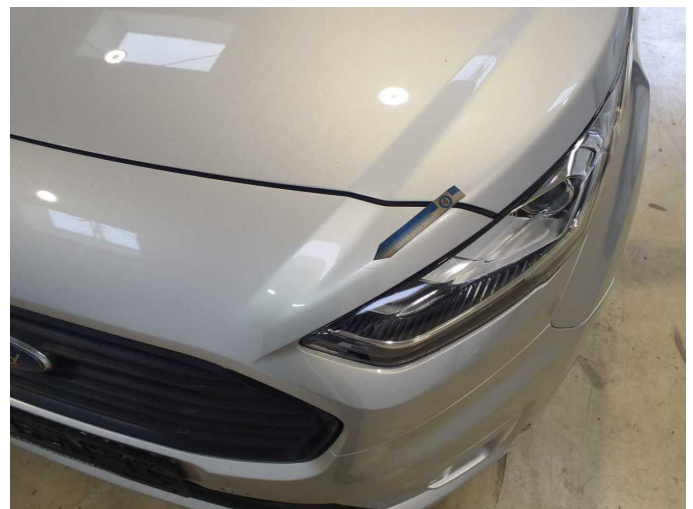
Damage 7: Front bumper: Front bumper - Dent / paintcoat damage - Loss in value

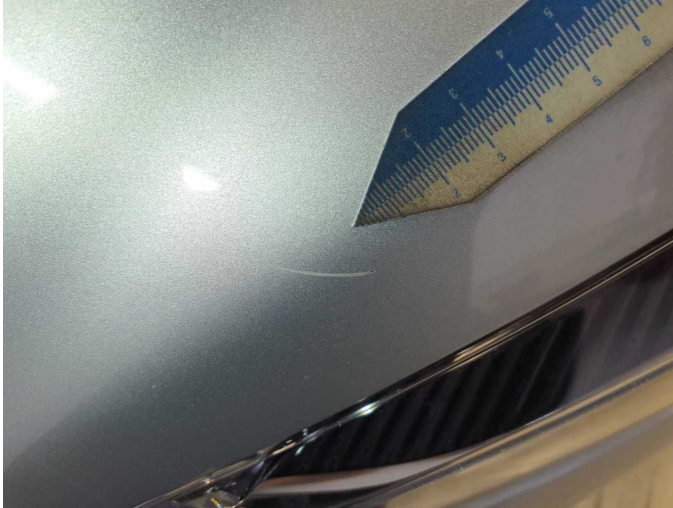
Damage 7: Front bumper: Front bumper - Dent / paintcoat damage - Loss in value

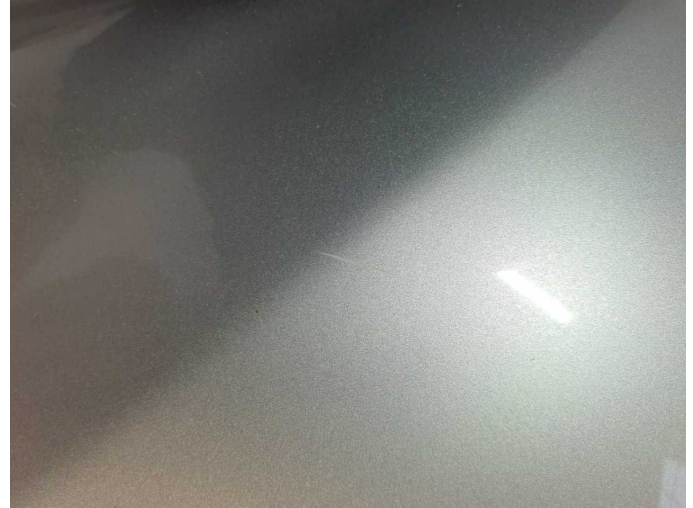
Damage 7: Front bumper: Front bumper - Dent / paintcoat damage - Loss in value

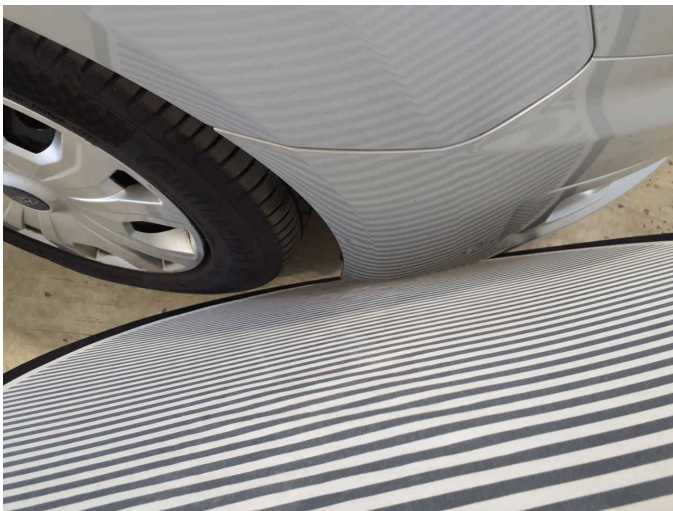
Damage 7: Front bumper: Front bumper - Dent / paintcoat damage - Loss in value

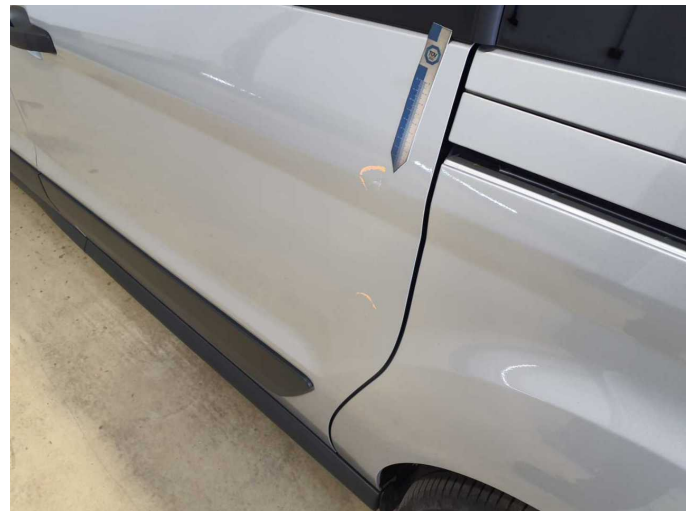
Damage 8: Sliding door - left side: Sliding door - Dent / paintcoat damage - Smart repair

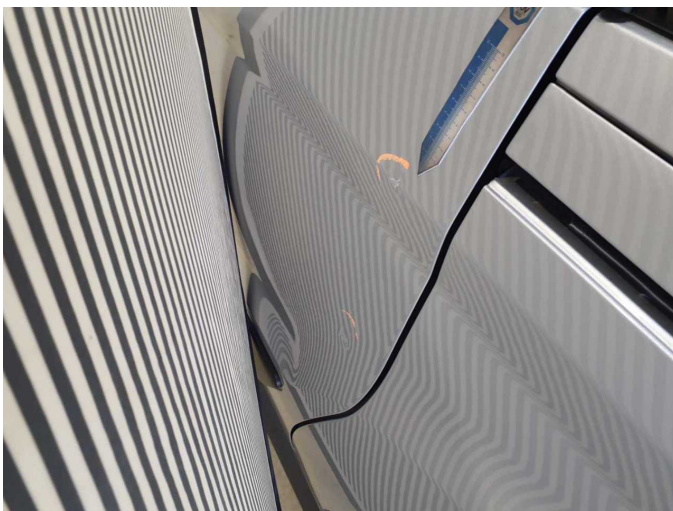
Damage 8: Sliding door - left side: Sliding door - Dent / paintcoat damage - Smart repair

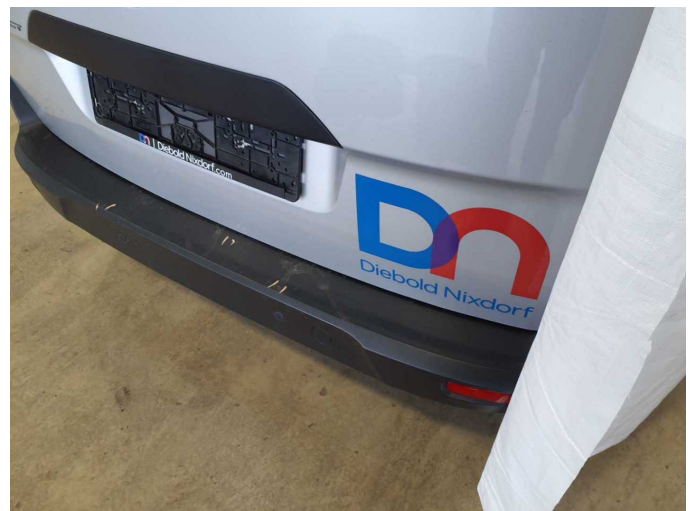
Damage 9: Body: Body - Glued / labelled - De-glue / neutralise

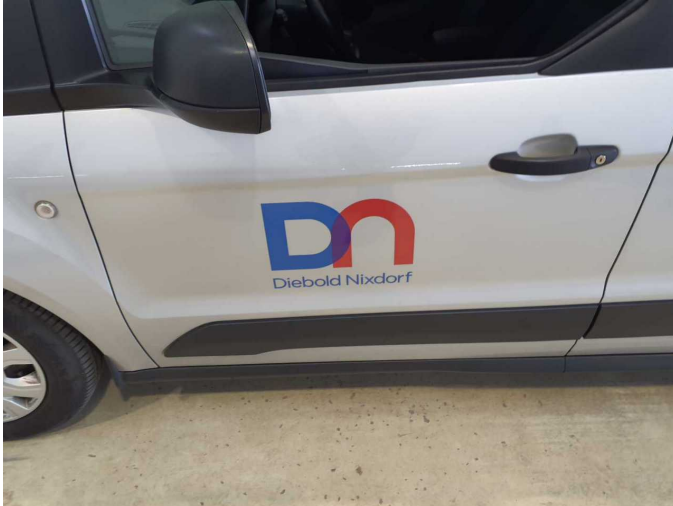
Damage 9: Body: Body - Glued / labelled - De-glude / neutralise

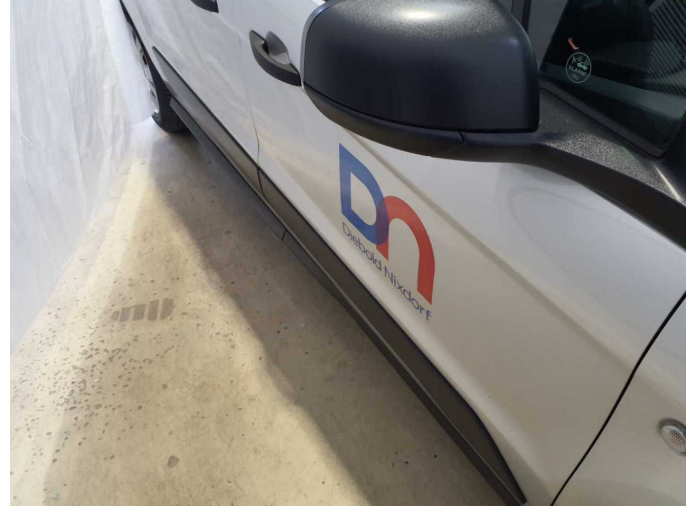
Damage 9: Body: Body - Glued / labelled - De-glude / neutralise

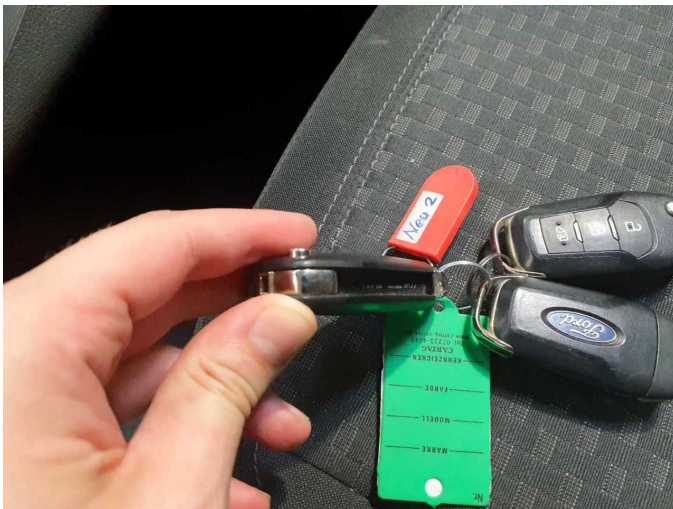
Damage 10: Equipment: Vehicle key - Broken / torn - Replace

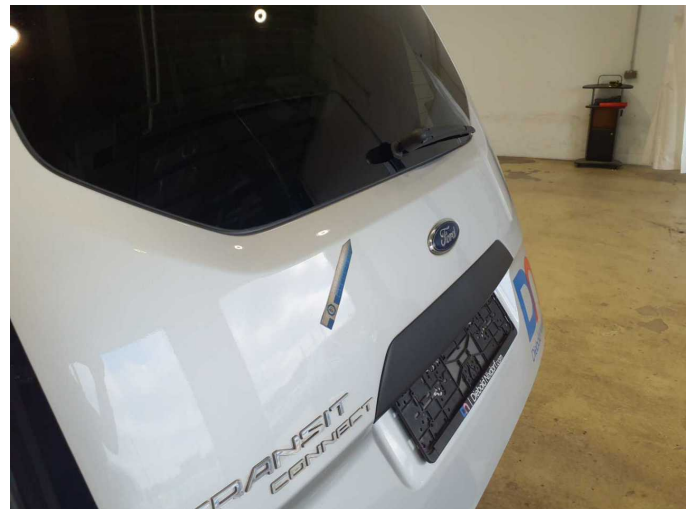
Damage 11: Boot lid / rear door: Boot lid - Dent / paintcoat damage - Repair and paint

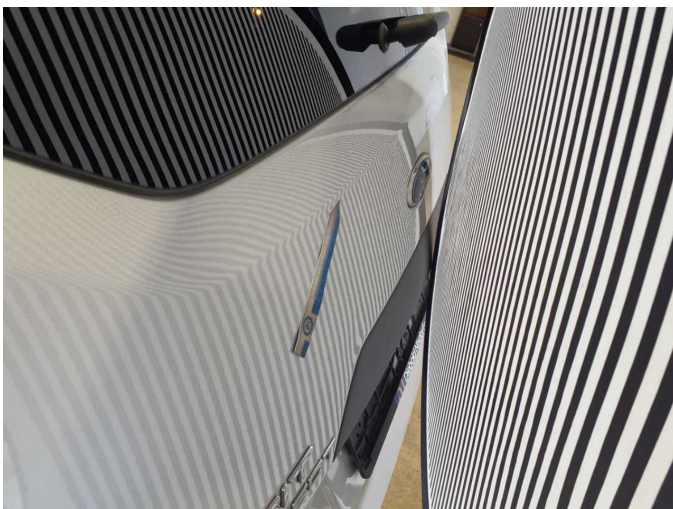
Damage 11: Boot lid / rear door: Boot lid - Dent / paintcoat damage - Repair and paint

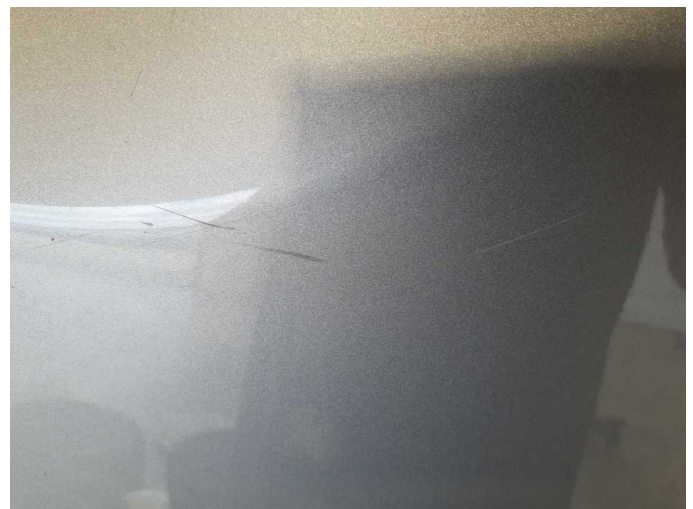
Damage 11: Boot lid / rear door: Boot lid - Dent / paintcoat damage - Repair and paint

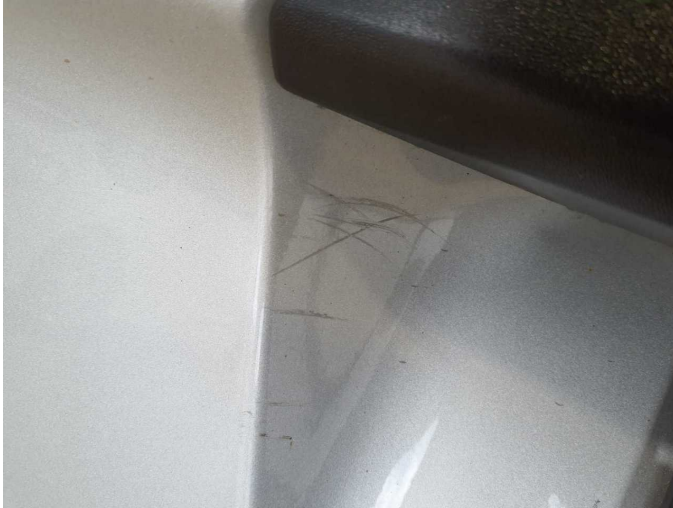
Damage 11: Boot lid / rear door: Boot lid - Dent / paintcoat damage - Repair and paint

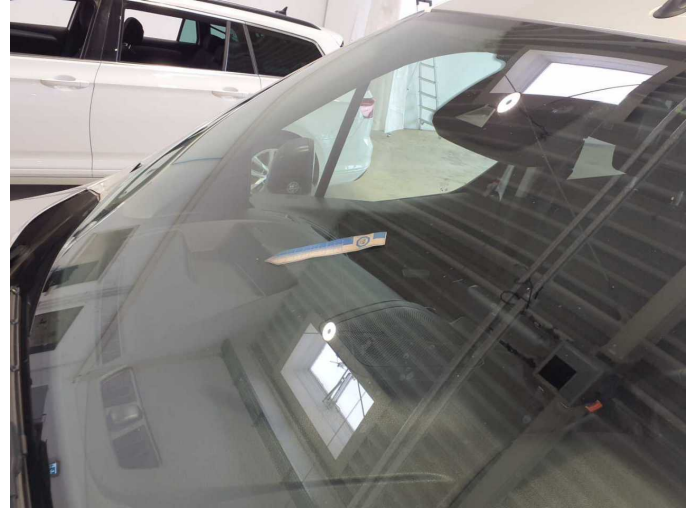
Damage 12: Vehicle glazing: Windscreen - Broken / torn - repair according to calculation

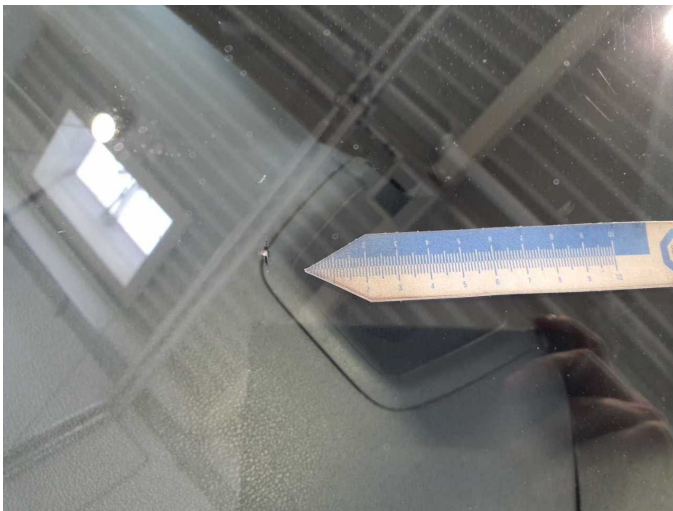
Damage 12: Vehicle glazing: Windscreen - Broken / torn - repair according to calculation

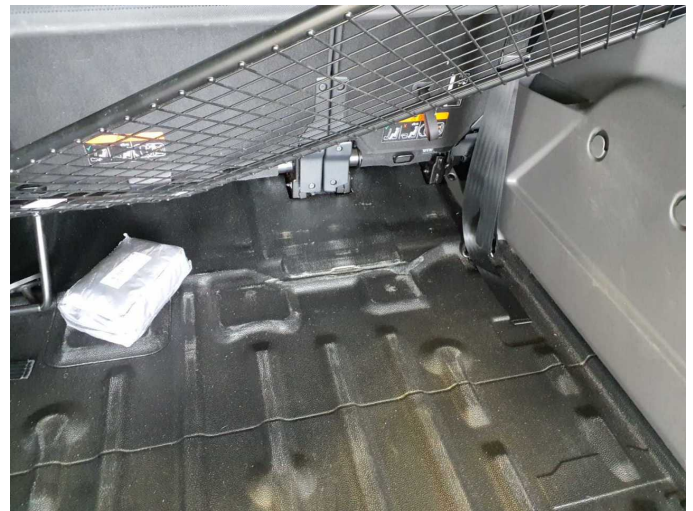
Wear and tear 3: Rear of vehicle: Boot floor (Einlegeboden) - Broken / torn - No deduction

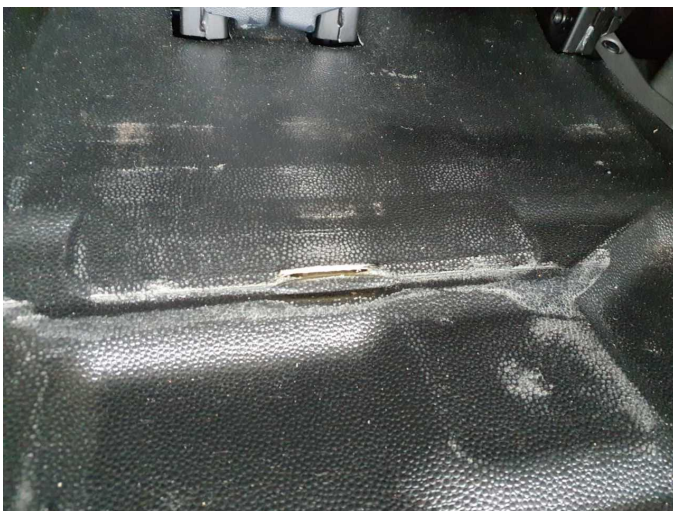
Wear and tear 3: Rear of vehicle: Boot floor (Einlegeboden) - Broken / torn - No deduction

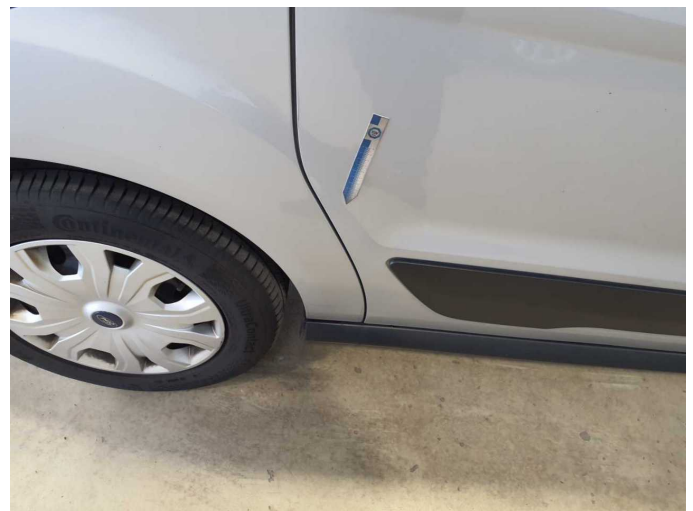
Wear and tear 4: Door - front right side: Door - Scratch(es) - Cover / polish

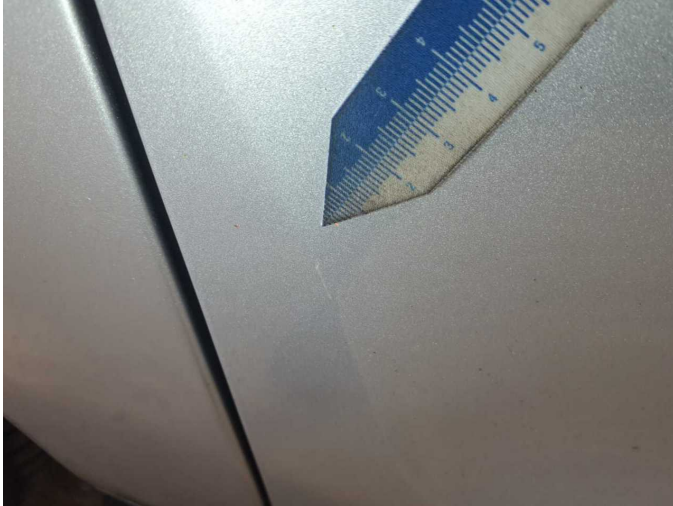
Wear and tear 4: Door - front right side: Door - Scratch(es) - Cover / polish

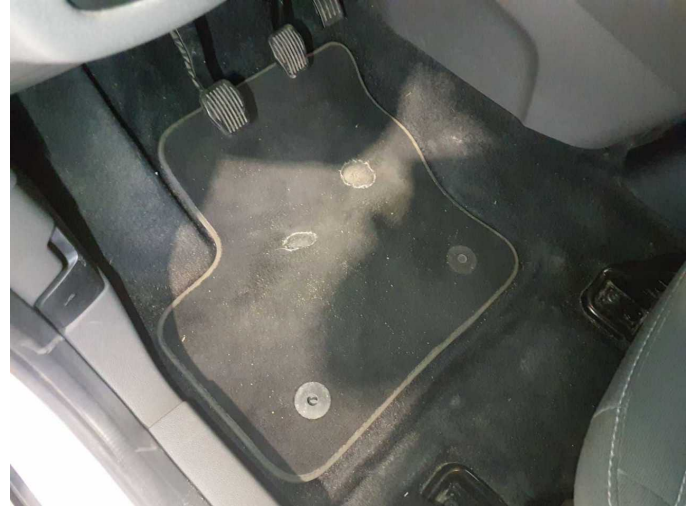
Wear and tear 5: Trim / covers: Floor mats - Broken / torn - No deduction

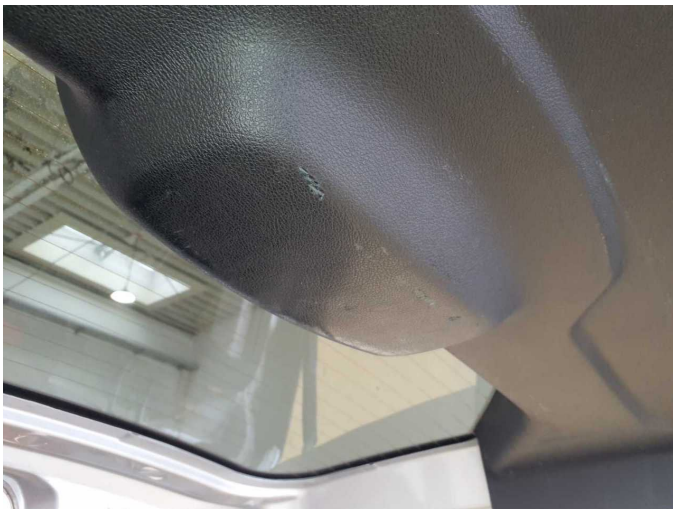
Wear and tear 6: Trim / covers: Boot lid - interior trim - Scratch(es) - Smart repair

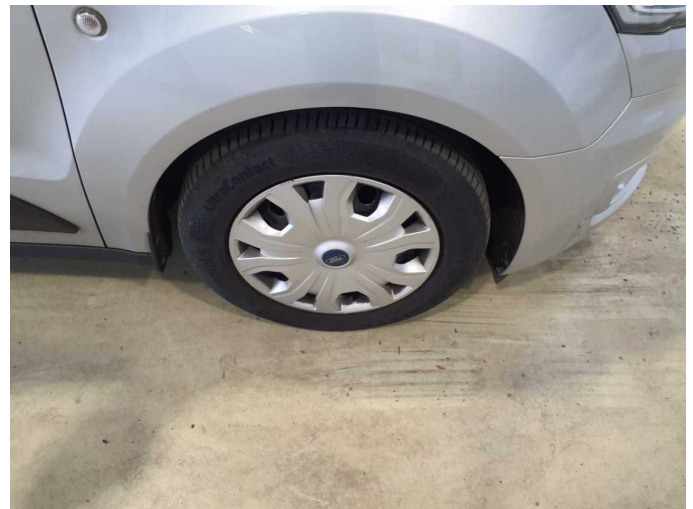
Wear and tear 7: Wheel / tyres: Wheel cover - front right side - Scratch(es) - No deduction

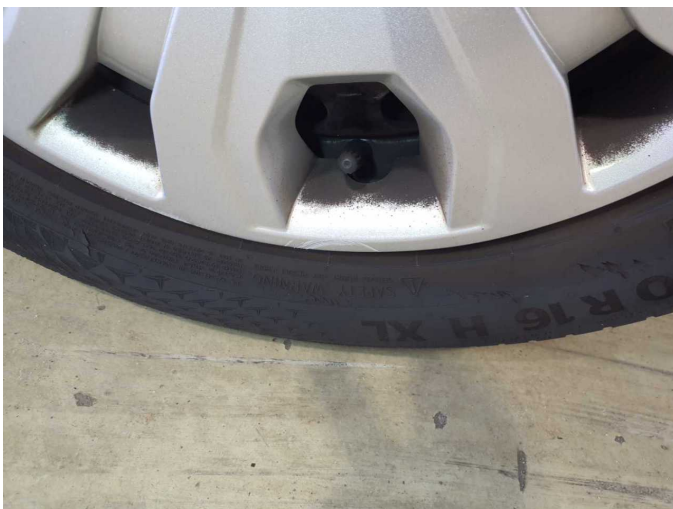
Wear and tear 7: Wheel / tyres: Wheel cover - front right side - Scratch(es) - No deduction

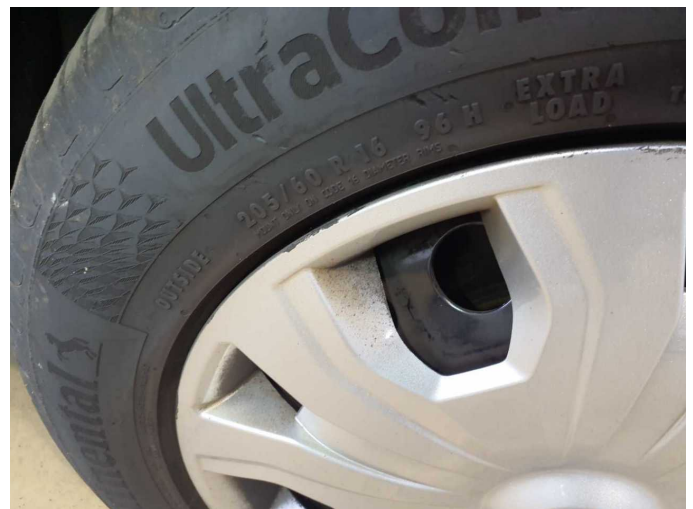
Wear and tear 7: Wheel / tyres: Wheel cover - front right side - Scratch(es) - No deduction

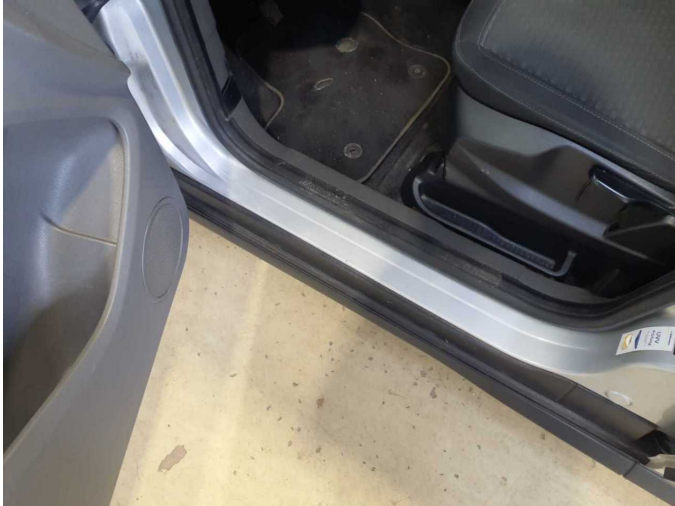
Wear and tear 8: Sill - left side: Sill - Scratch(es) - No deduction

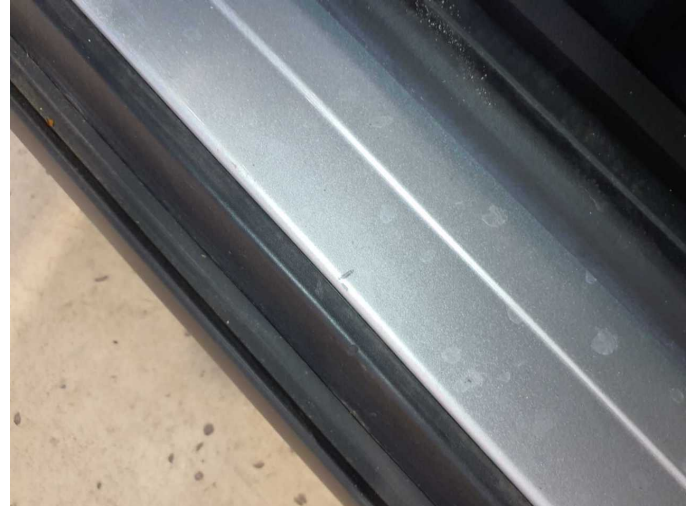
Wear and tear 8: Sill - left side: Sill - Scratch(es) - No deduction

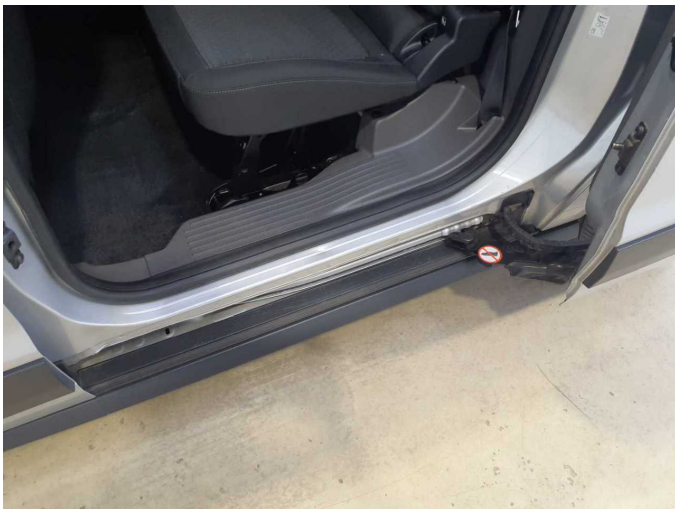
Wear and tear 9: Side panel - rear left side: Sill - Dent / paintcoat damage - No deduction

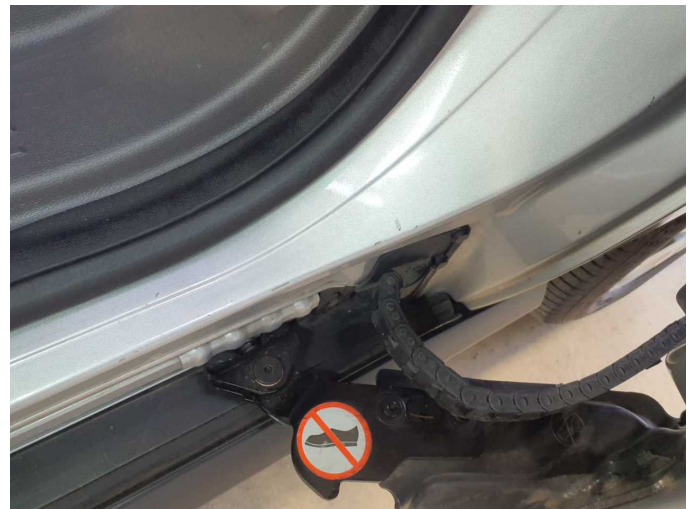
Wear and tear 9: Side panel - rear left side: Sill - Dent / paintcoat damage - No deduction

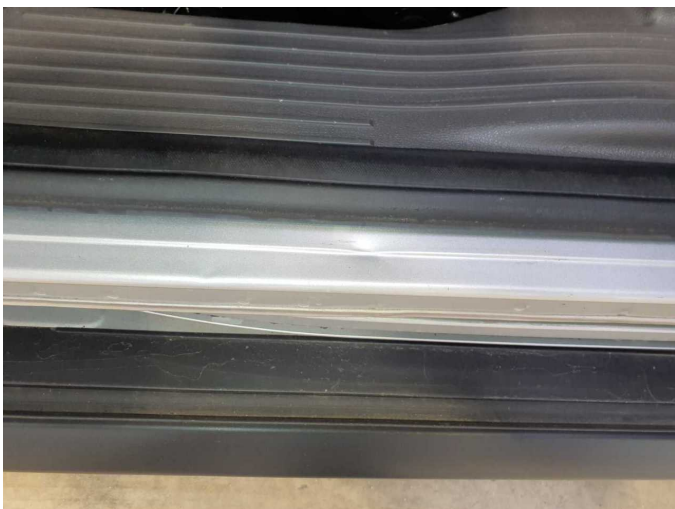
Wear and tear 9: Side panel - rear left side: Sill - Dent / paintcoat damage - No deduction

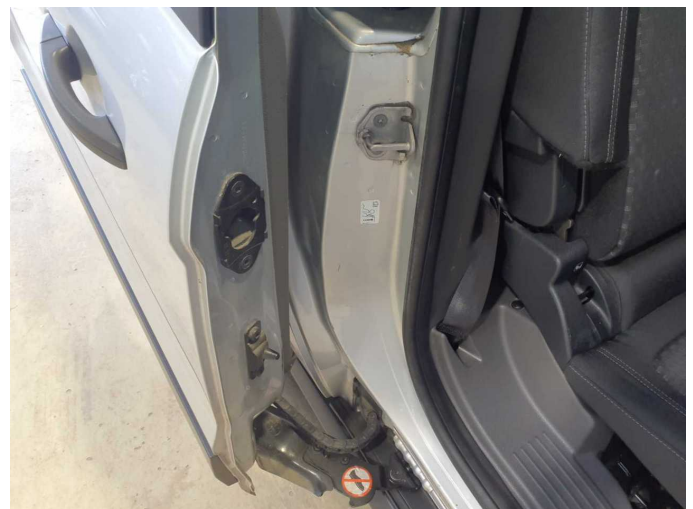
Wear and tear 10: Side panel - rear right side: Sill - Scratch(es) - No deduction

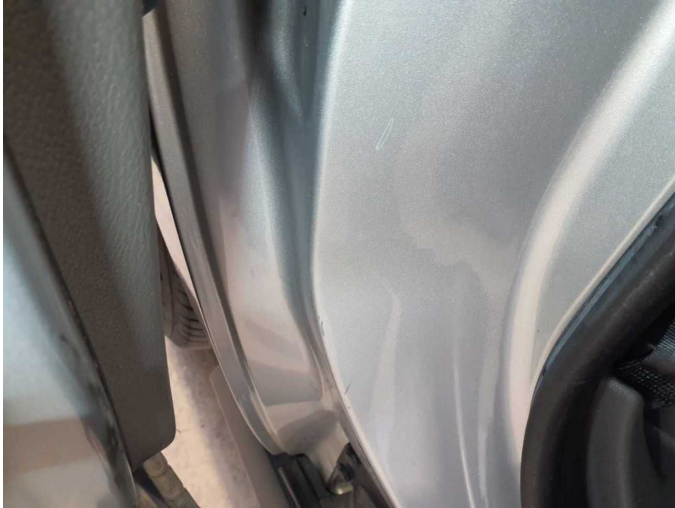
Wear and tear 10: Side panel - rear right side: Sill - Scratch(es) - No deduction

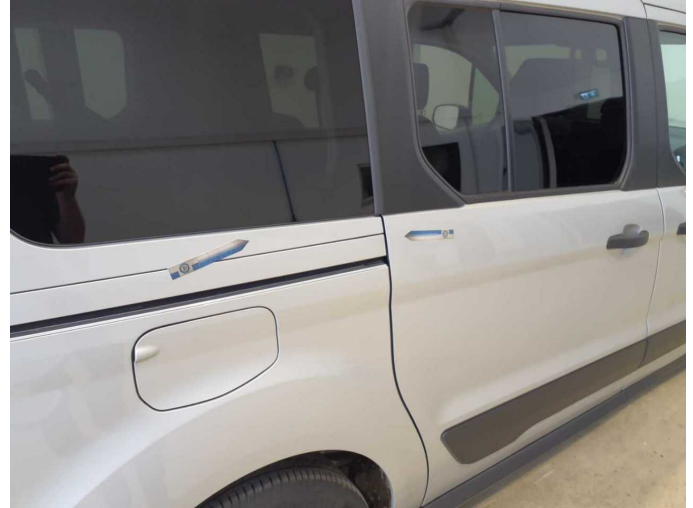
Accident 1: Side right
