Expertise

Protocol number: 47118308  
Order No. / Reference: 26766486  
Inspection date: 17 Aug 2026

Model: Passat Variant 1.4 TSI Plug-In-Hybrid DSG GTE

VIN: WVVZZZ3CZPE034015

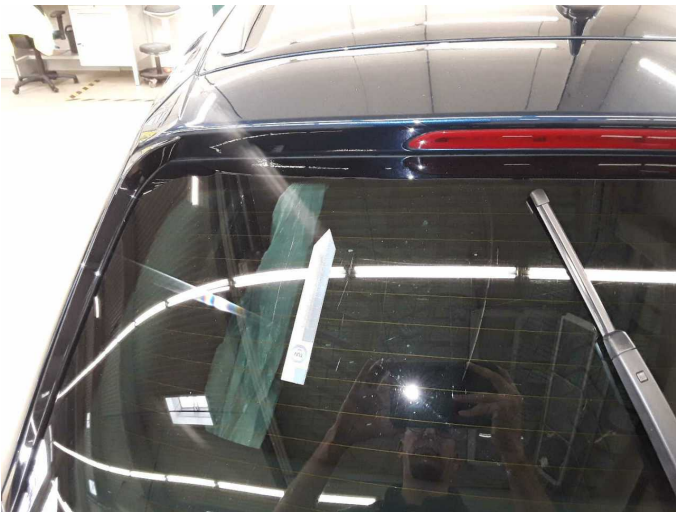
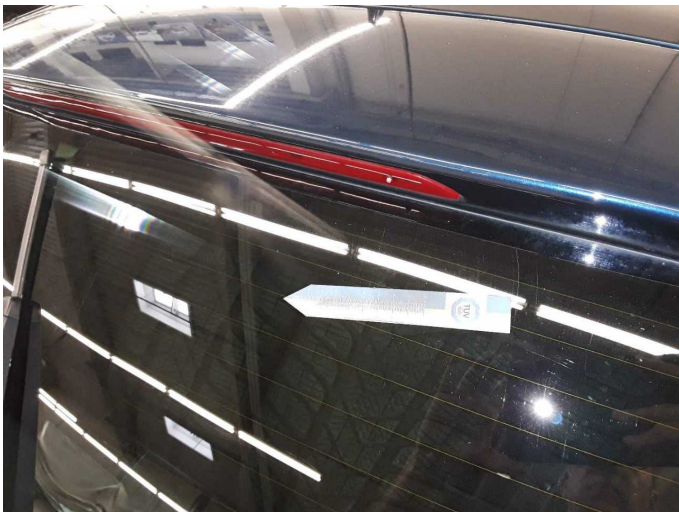
| No. | Component group | Description |
|---|---|---|
| 1 | Vehicle glazing | Rear window - Scratch(es) - Loss in value |

Damage 1: Vehicle glazing: Rear window - Scratch(es) - Loss in value

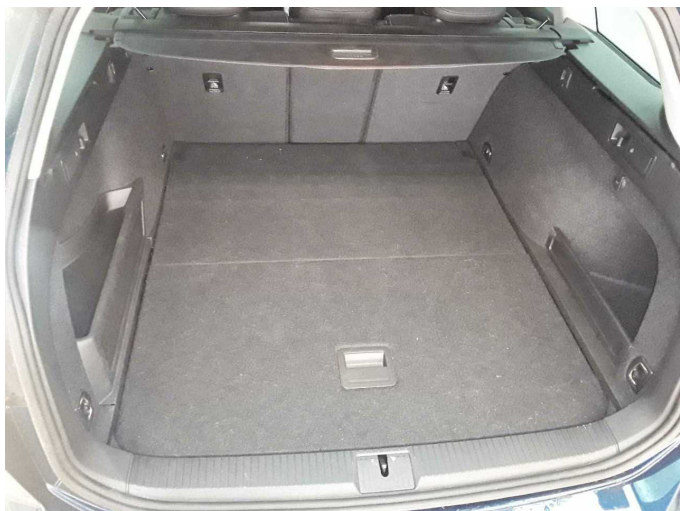
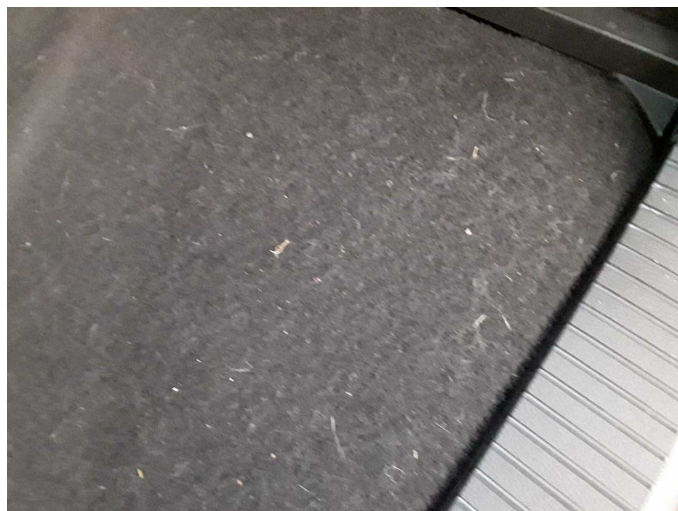
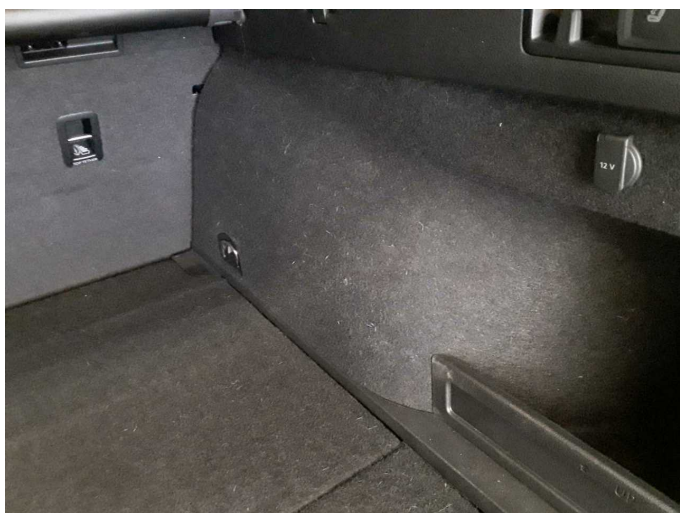
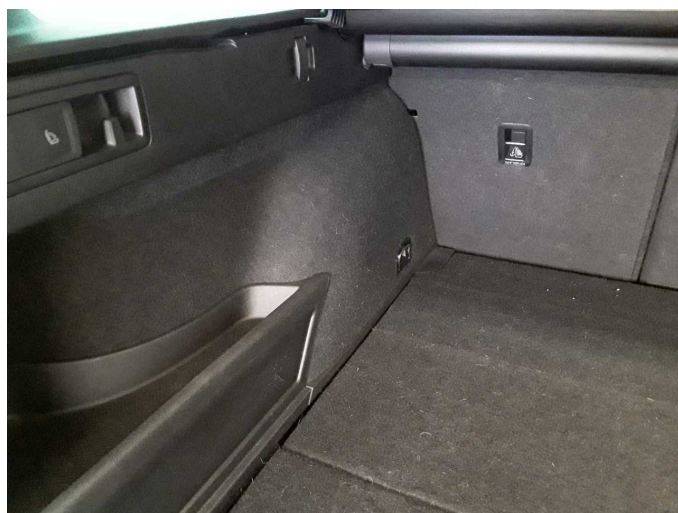
| No. | Component group | Description |
|---|---|---|
| 2 | Interior | Interior (Tiergeruch) - Odour - Ozone treatment |

**Damage 2:** Interior: Interior (Tiergeruch) - Odour - Ozone treatment

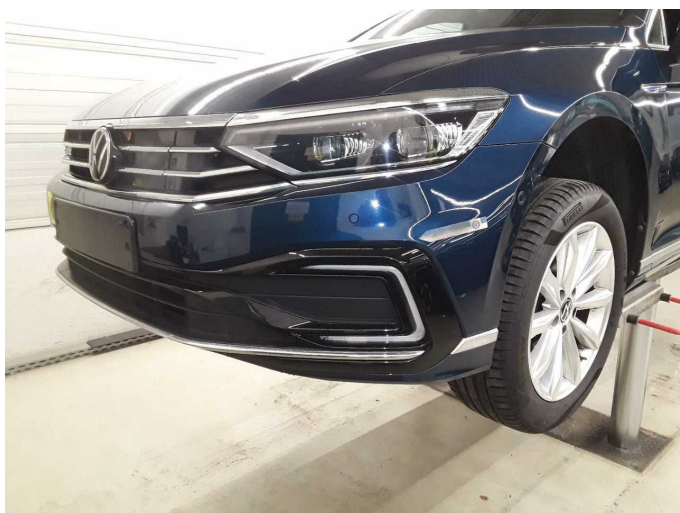
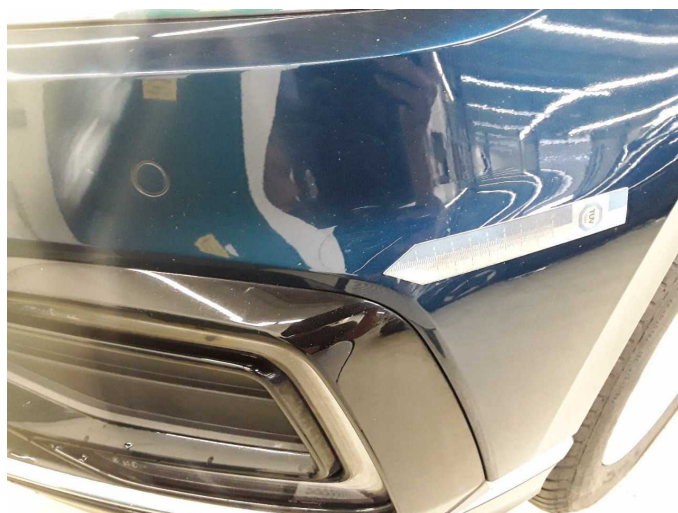
| No. | Component group | Description |
|---|---|---|
| 3 | Front bumper | Front bumper - Scratch(es) - Smart repair |

**Damage 3:** Front bumper: Front bumper - Scratch(es) - Smart repair

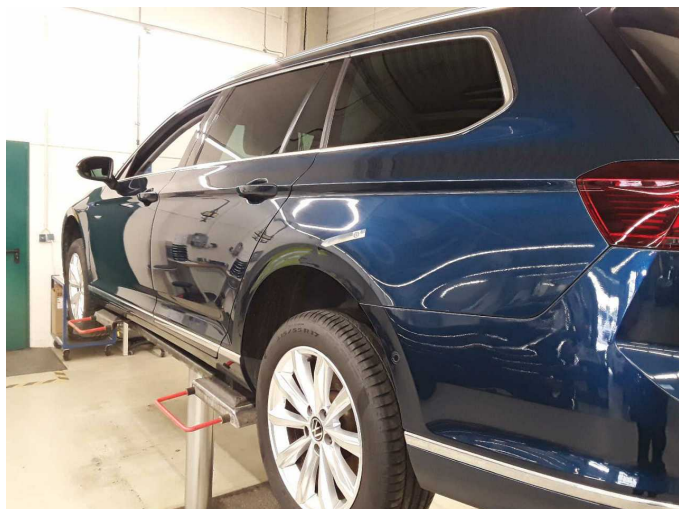
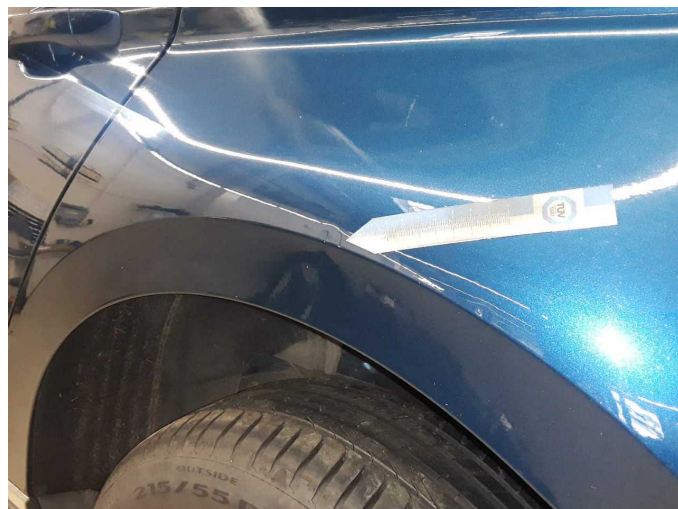
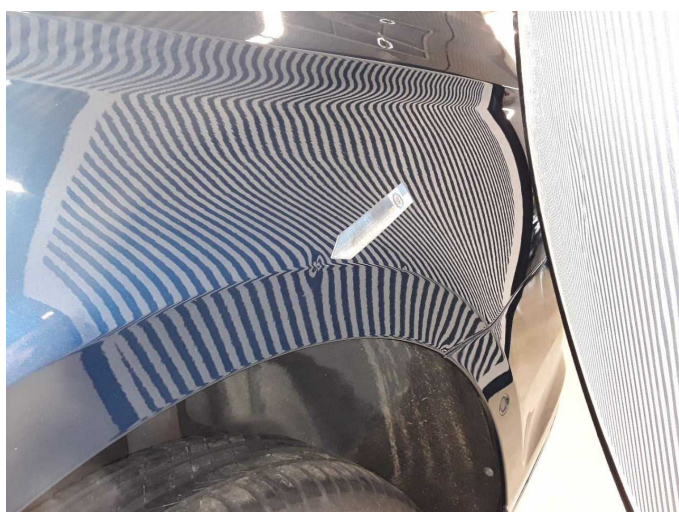
| No. | Component group | Description |
|---|---|---|
| 4 | Side panel - rear left side | Side panel (2x) - Dent / paintcoat damage - Smart repair |

**Damage 4:** Side panel - rear left side: Side panel (2x) - Dent / paintcoat damage - Smart repair

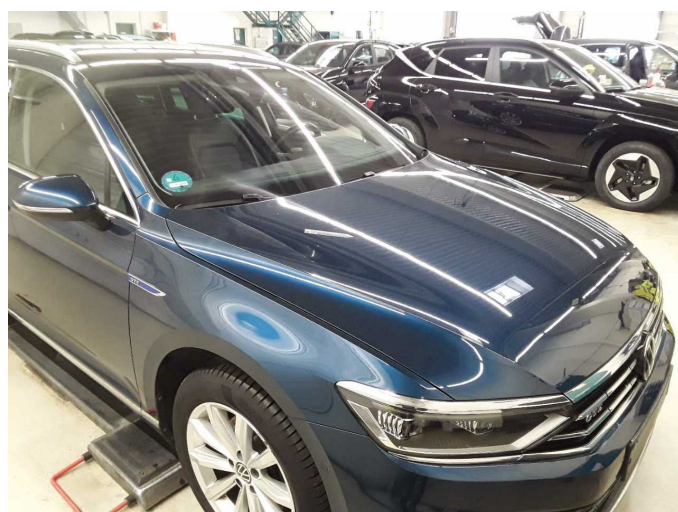
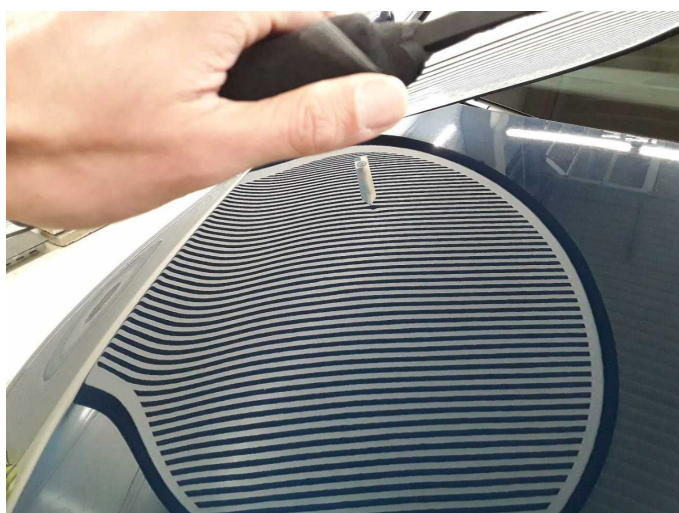
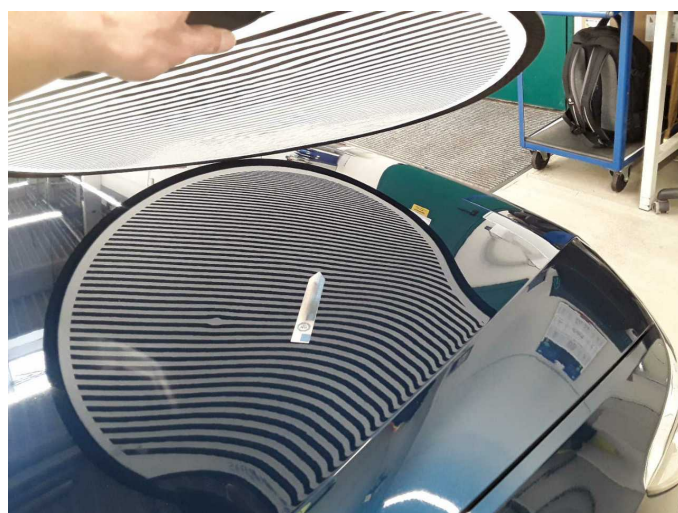
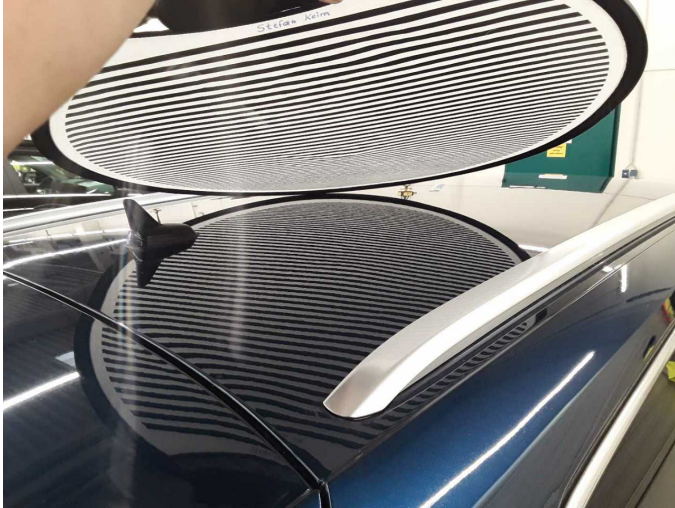
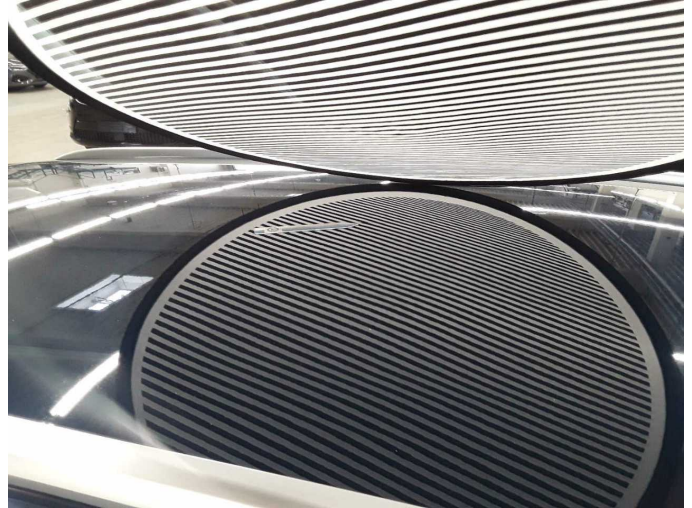
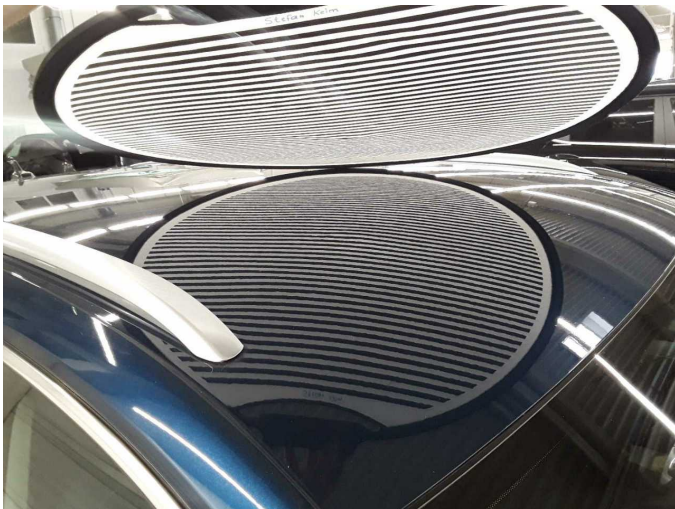
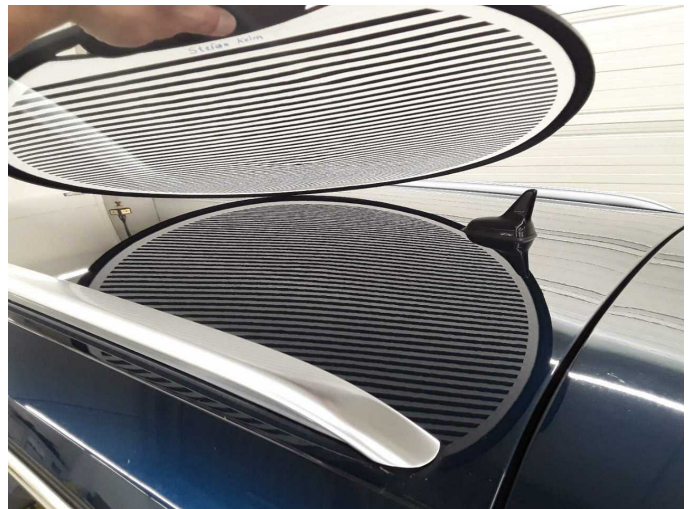
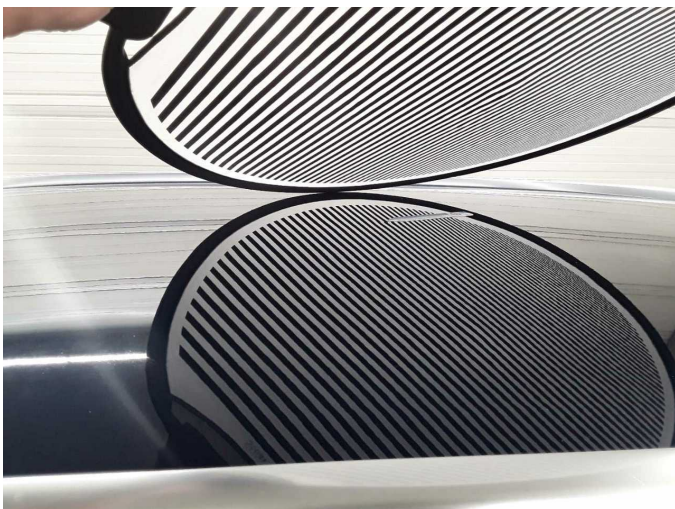
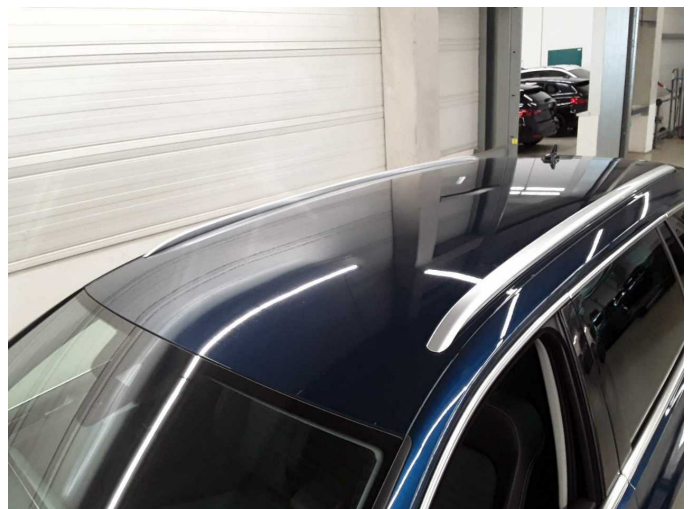
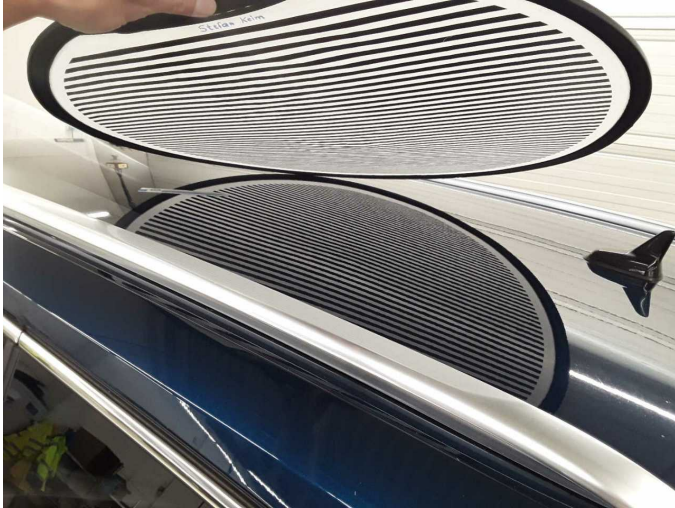
| No. | Component group | Description |
|---|---|---|
| 5 | Body | Body (Hagelschaden) - dent(s) - Smooth repair work |

**Damage 5:** Body: Body (Hagelschaden) - dent(s) - Smooth repair work

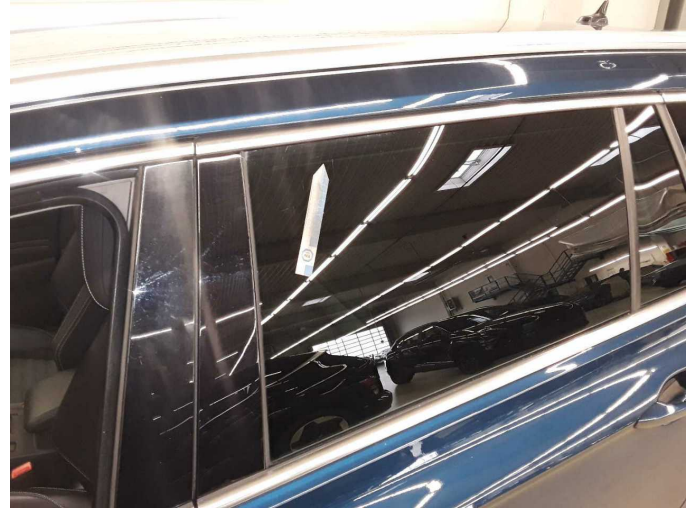
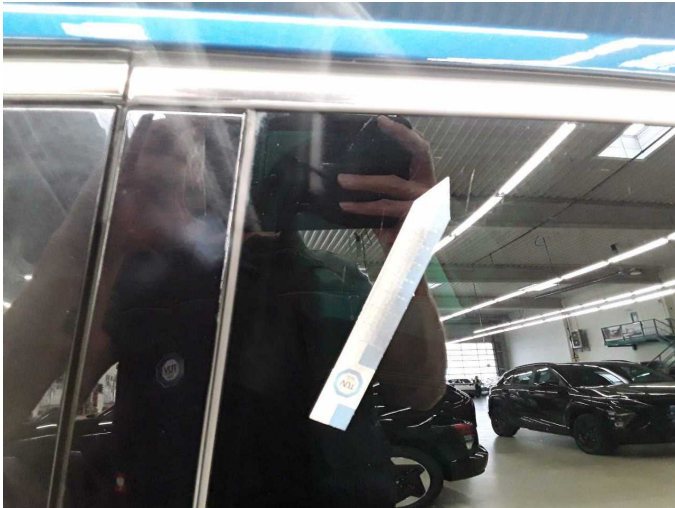
| No. | Component group | Description |
|---|---|---|
| 1 | Vehicle glazing | Side window - rear left side - Scratch(es) - No deduction |

**Wear and tear 1:** Vehicle glazing: Side window - rear left side - Scratch(es) - No deduction

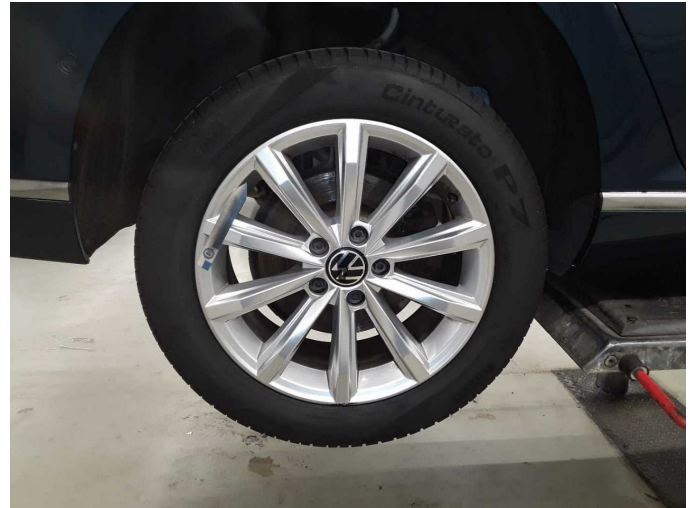
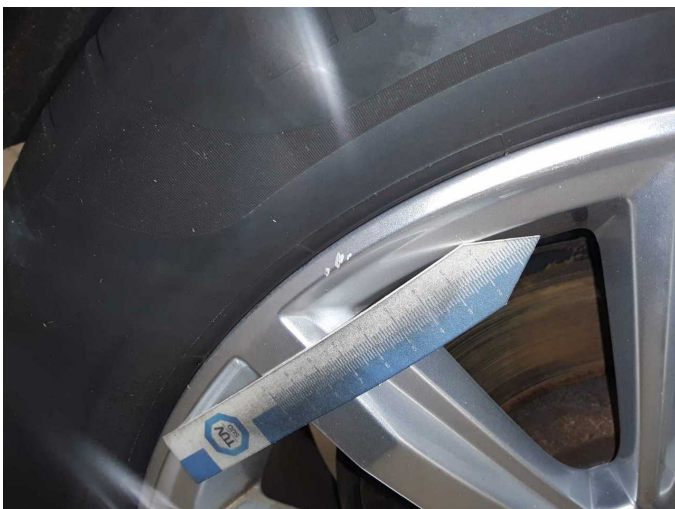
| No. | Component group | Description |
|---|---|---|
| 2 | Wheel / tyres | Alloy rim - rear right side - Scratch(es) - No deduction |

**Wear and tear 2:** Wheel / tyres: Alloy rim - rear right side - Scratch(es) - No deduction

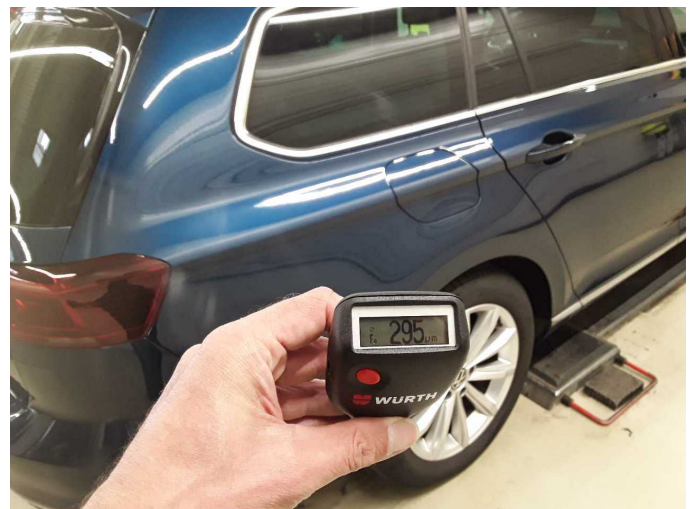
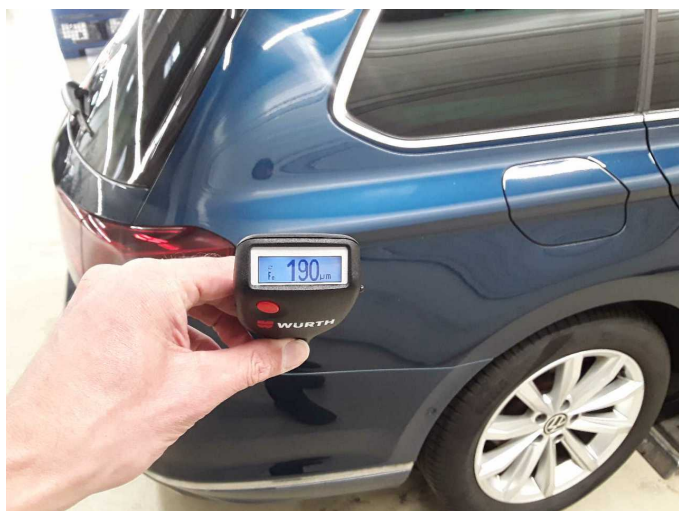
| No. | Repainting |
|---|---|
| 1 | Side panel - rear right side, Door - rear right side, Professionally carried out |

**Side panel - rear right side:** 295 µm

**Side panel - rear right side: 295 µm**

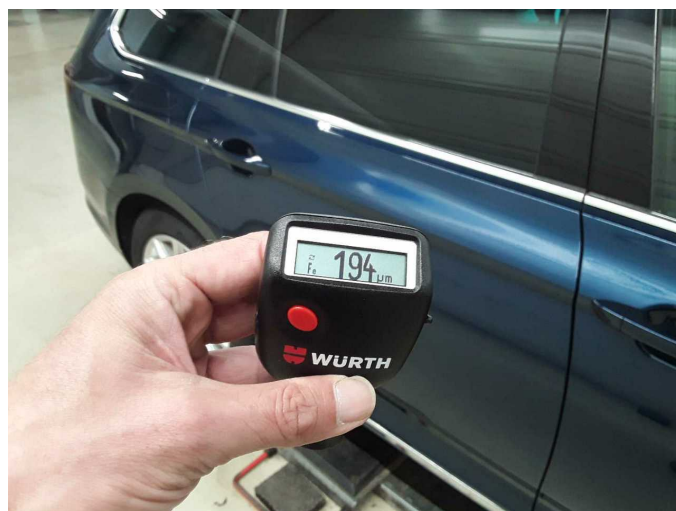
**Door - rear right side: 194 µm**
