Expertise

Protocol number: 46626891  
Order No. / Reference: 26689471  
Inspection date: 21 Jul 2026

Manufacturer: Skoda  
VIN: TMBJC9NY4PF069960

Model: Enyaq iV 80

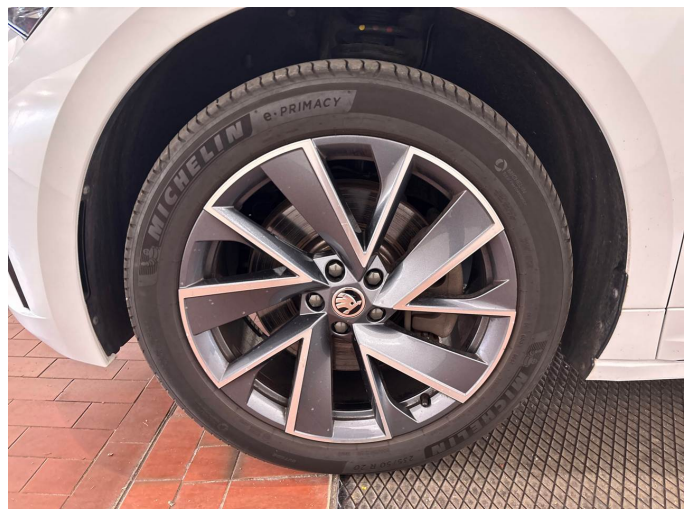
Figure 12: Mounted tyres

| # | Tyre size | Type of tyre | Manufacturer | Tread depth |
|---|---|---|---|---|
| 1) | 235/50 R20 100T | Summer tyres on Light alloy | Michelin | 5mm / 5mm |
| 2) | 235/50 R20 100T | Summer tyres on Light alloy | Michelin | 4mm / 4mm |

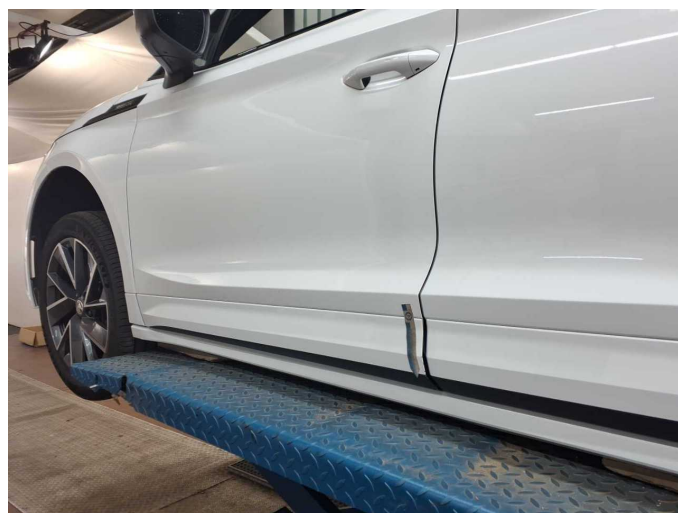
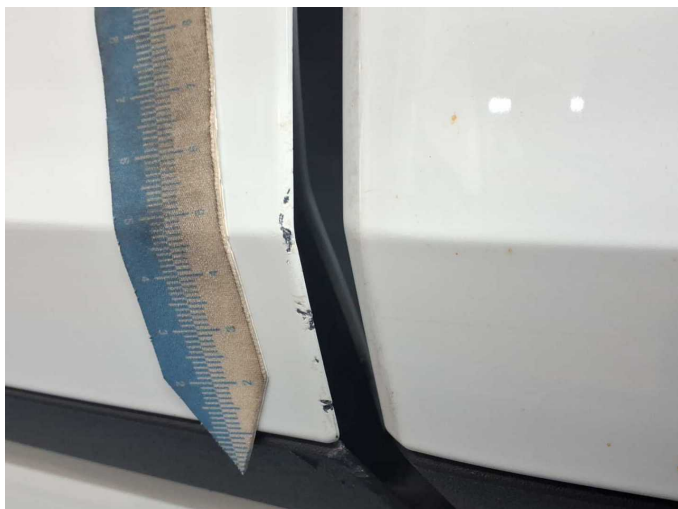
| No. | Component group | Description |
|---|---|---|
| 1 | Door - front left side | Brightware - lower - Scratch(es) - Smart repair |

**Damage 1:** Door - front left side: Brightware - lower - Scratch(es) - Smart repair

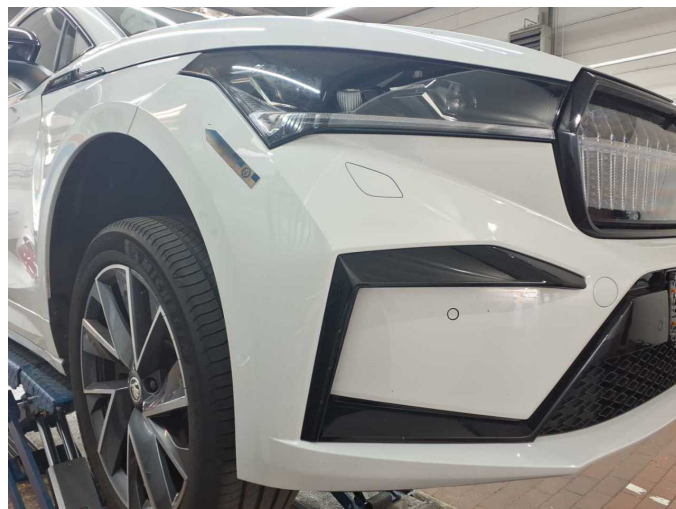
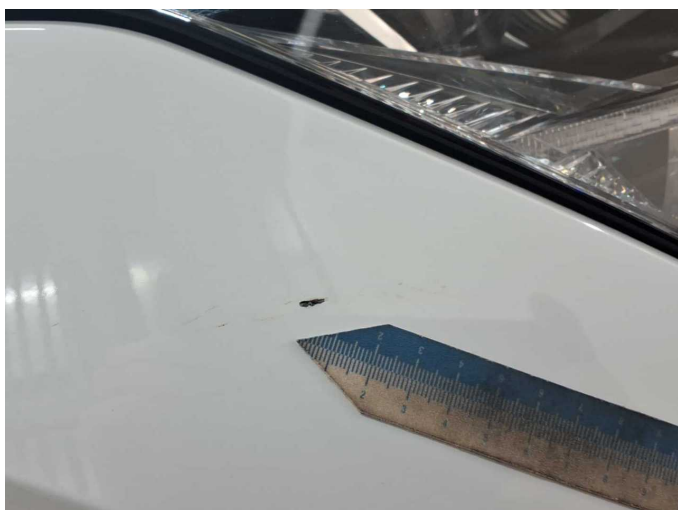
| No. | Component group | Description |
|---|---|---|
| 2 | Front bumper | Front bumper - Scratch(es) - Smart repair |

**Damage 2:** Front bumper: Front bumper - Scratch(es) - Smart repair

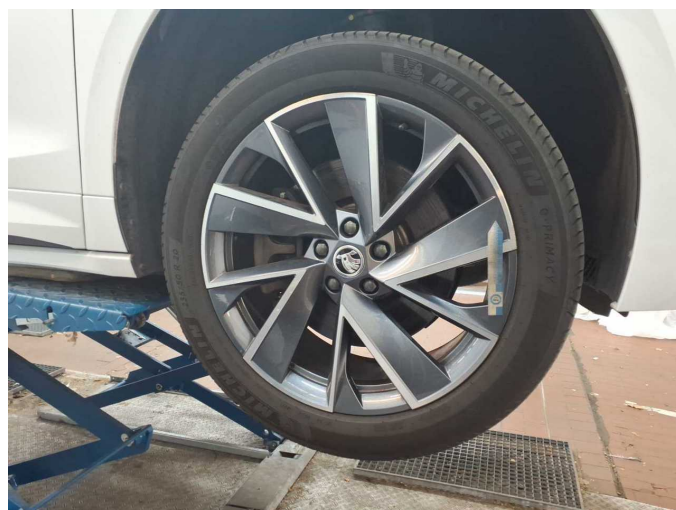
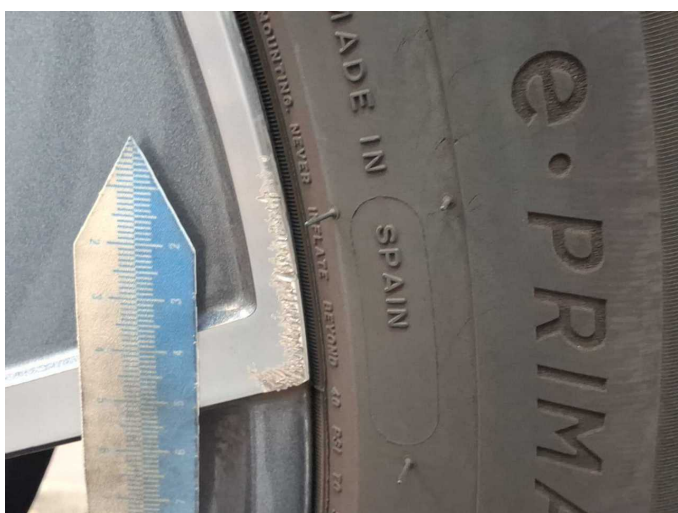
| No. | Component group | Description |
|---|---|---|
| 3 | Wheel / tyres | Alloy rim - front right side - Scratched - Loss in value |

**Damage 3:** Wheel / tyres: Alloy rim - front right side - Scratched - Loss in value

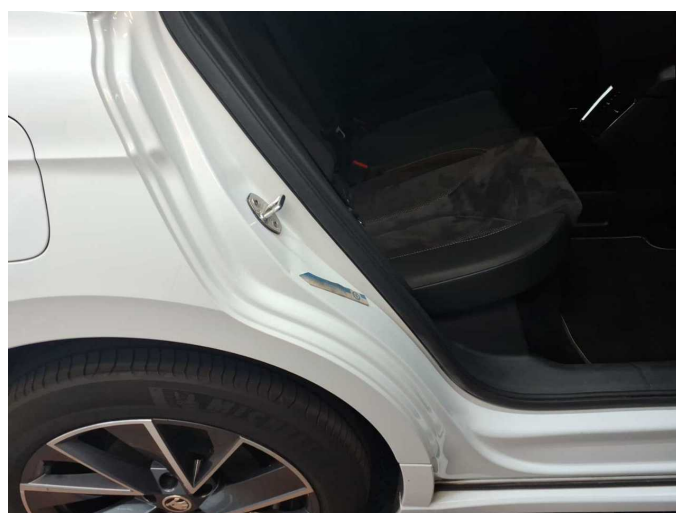
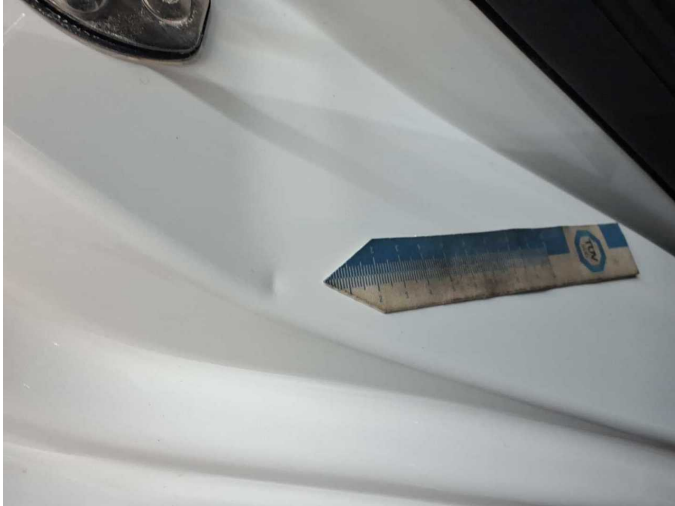
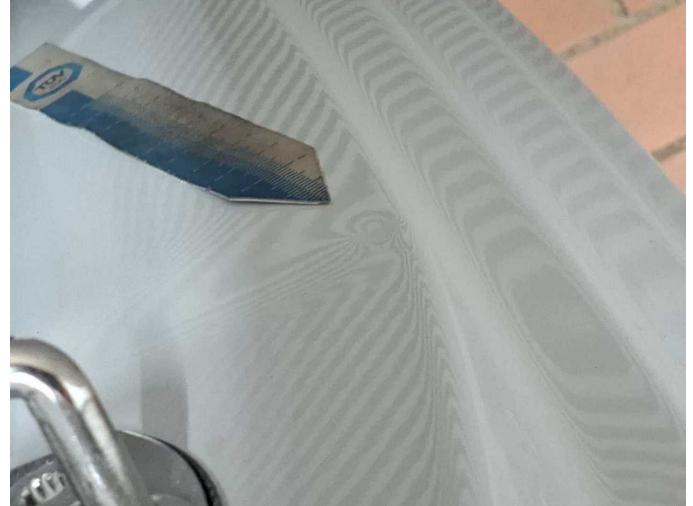
| No. | Component group | Description |
|---|---|---|
| 4 | Side panel - rear right side | Sill - dent(s) - Smart repair |

**Damage 4:** Side panel - rear right side: Sill - dent(s) - Smart repair

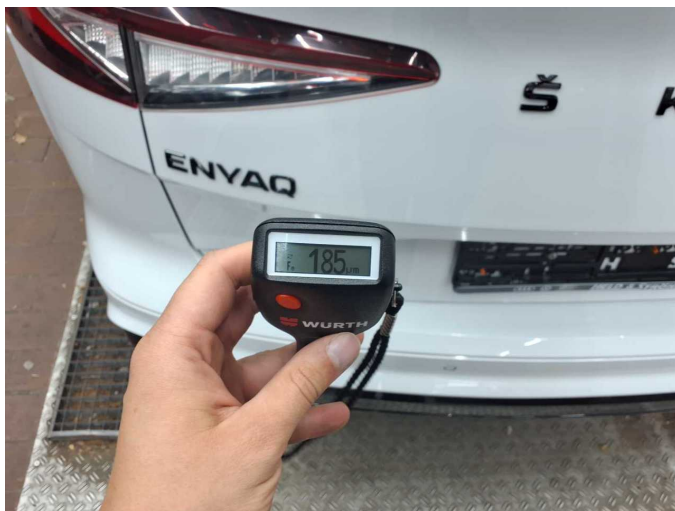
| No. | Repainting |
|---|---|
| 1 | Boot lid / rear door, Professionally carried out, Invoice of repair done Non-existent |

| Boot lid / rear door | 185 µm |

**Repainting 1:** Boot lid / rear door
