Expertise

Manufacturer: Volkswagen

Model: Tiguan 2.0 TSI OPF 4Motion DSG R-Line

VIN: WVGZZZ5N4PW505144

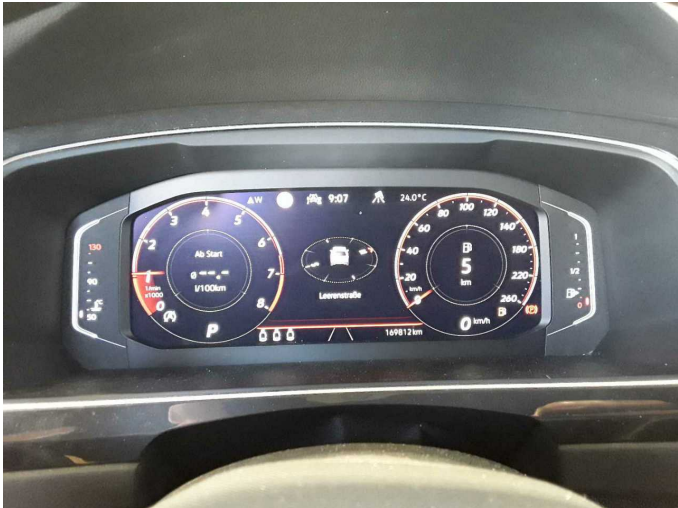
| Vehicle details | |
|---|---|
| Mileage (Read) | 169,812 km |

Figure 7: Instrument cluster

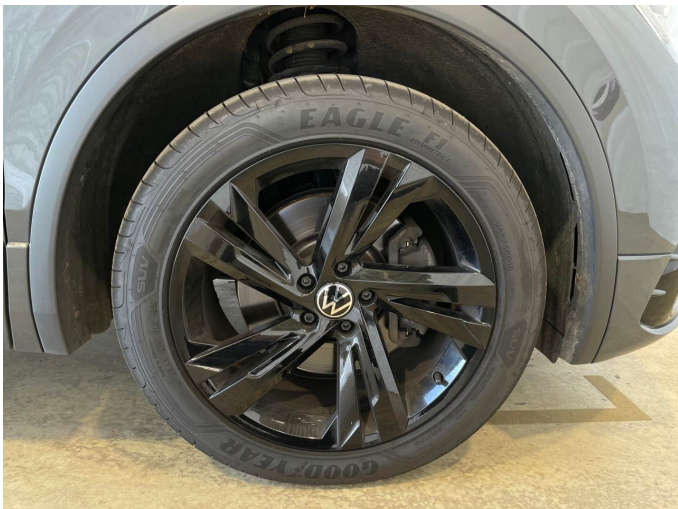
| # | Tyre size | Type of tyre | Manufacturer | Tread depth |
|---|---|---|---|---|
| 1) | 255/45 R19 100V | Summer tyres on Light alloy | Goodyear | 7mm / 7mm |
| 2) | 255/45 R19 100V | Summer tyres on Light alloy | Goodyear | 7mm / 7mm |

Figure 12: Mounted tyres

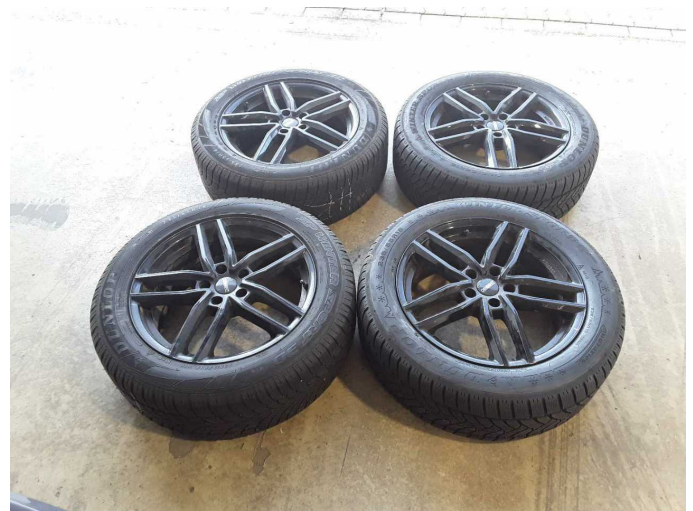
| # | Tyre size | Type of tyre | Manufacturer | Tread depth |
|---|---|---|---|---|
| 1) | 235/55 R18 100H | Winter tyres on Light alloy | Dunlop | 5mm / 5mm |
| 2) | 235/55 R18 100H | Winter tyres on Light alloy | Dunlop | 8mm / 8mm |

Figure 16: Additional tyres

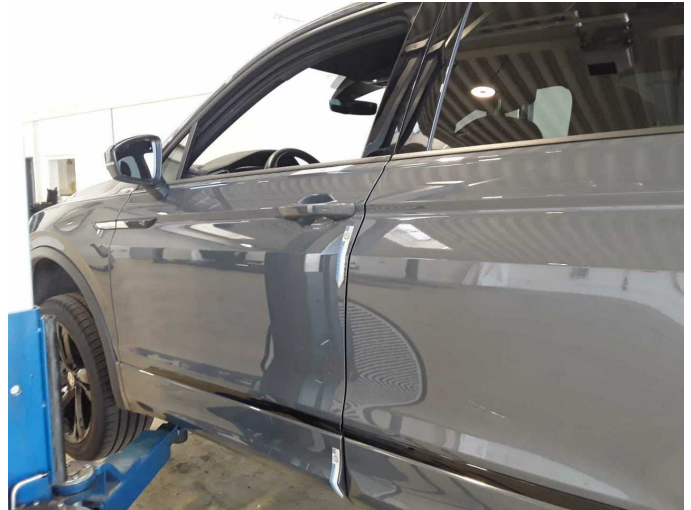
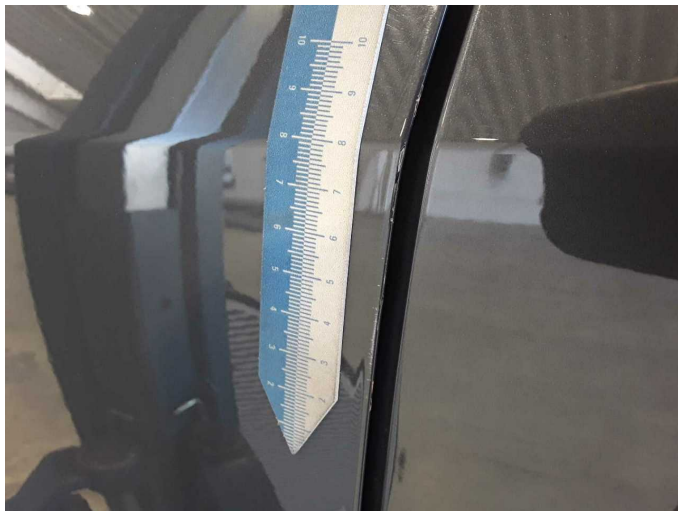
| No. | Component group | Description |
|---|---|---|
| 1 | Door - front left side | Door edge - Scratch(es) - Smart repair |

**Damage 1:** Door - front left side: Door edge - Scratch(es) - Smart repair

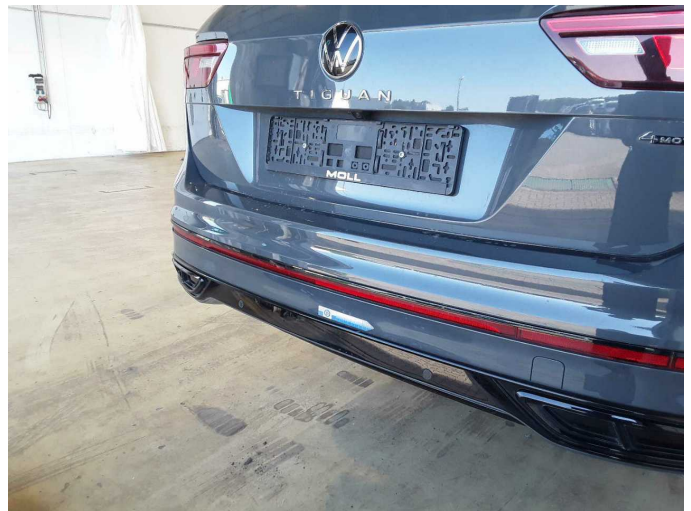
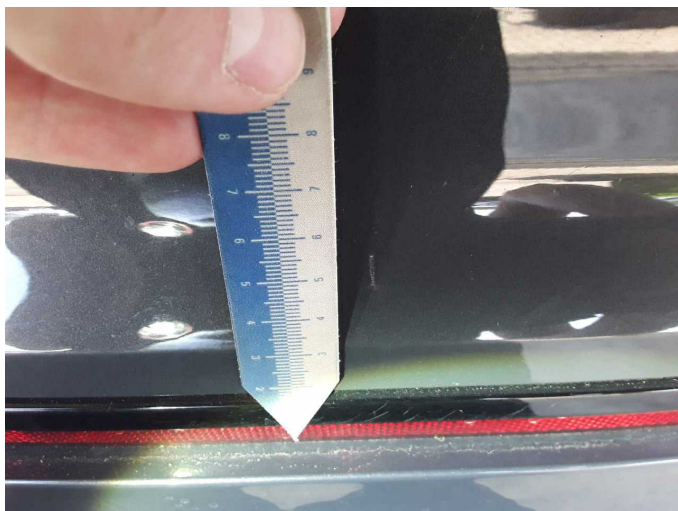
| No. | Component group | Description |
|---|---|---|
| 2 | Rear bumper | Rear bumper - Scratch(es) - Smart repair |

**Damage 2:** Rear bumper: Rear bumper - Scratch(es) - Smart repair

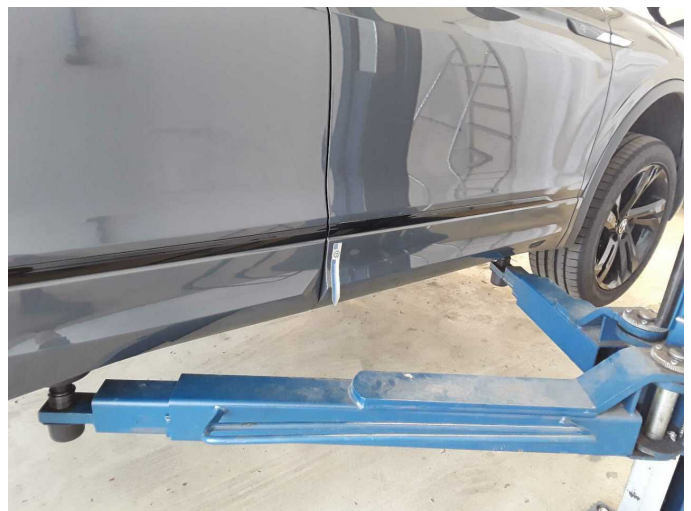
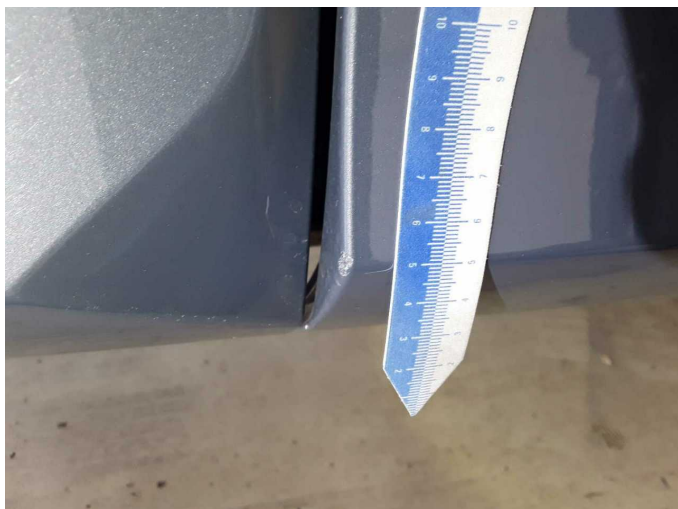
| No. | Component group | Description |
|---|---|---|
| 3 | Door - front right side | Brightware - lower - Scratch(es) - Smart repair |

**Damage 3:** Door - front right side: Brightware - lower - Scratch(es) - Smart repair

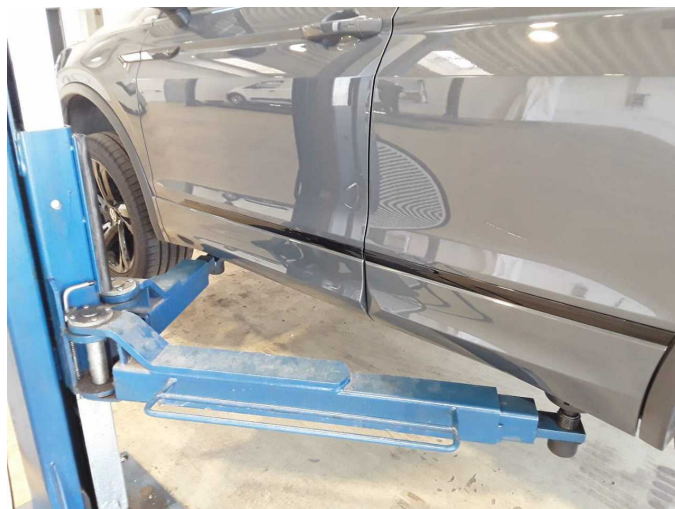
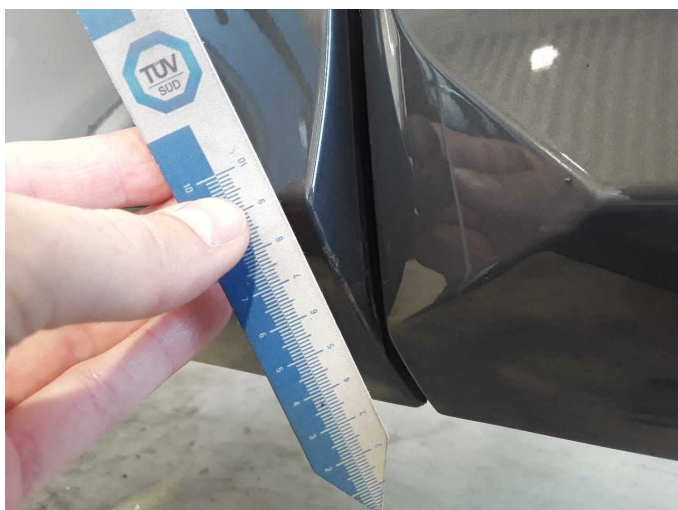
| No. | Component group | Description |
|---|---|---|
| 4 | Door - front left side | Brightware - lower - Scratch(es) - Smart repair |

**Damage 4:** Door - front left side: Brightware - lower - Scratch(es) - Smart repair

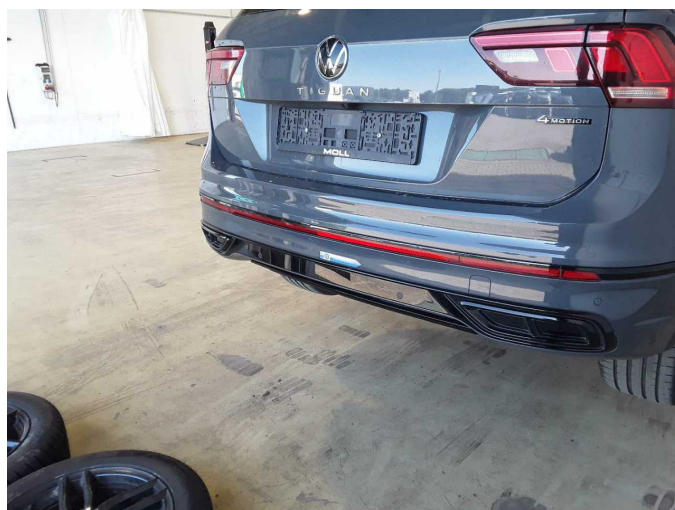
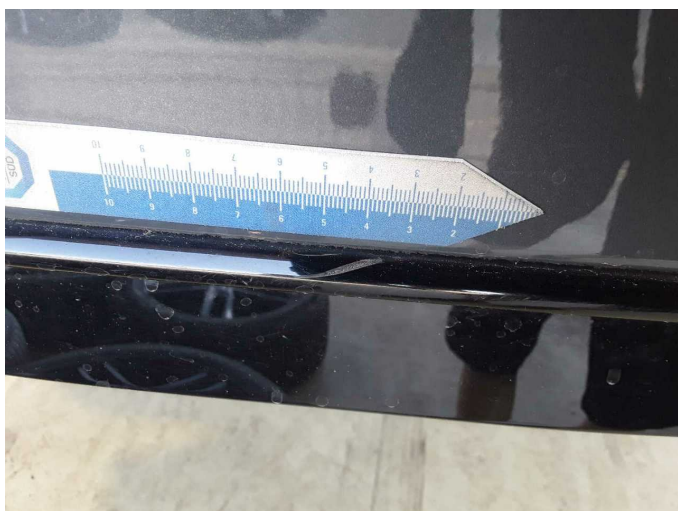
| No. | Component group | Description |
|---|---|---|
| 5 | Rear bumper | Spoiler - Scratch(es) - Smart repair |

**Damage 5:** Rear bumper: Spoiler - Scratch(es) - Smart repair

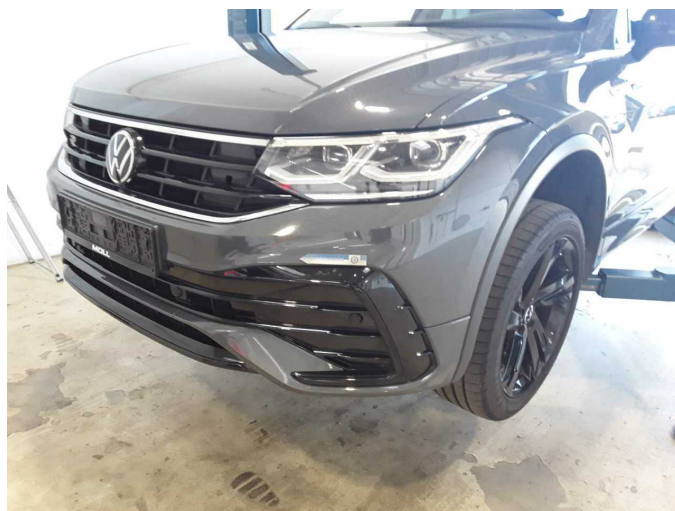
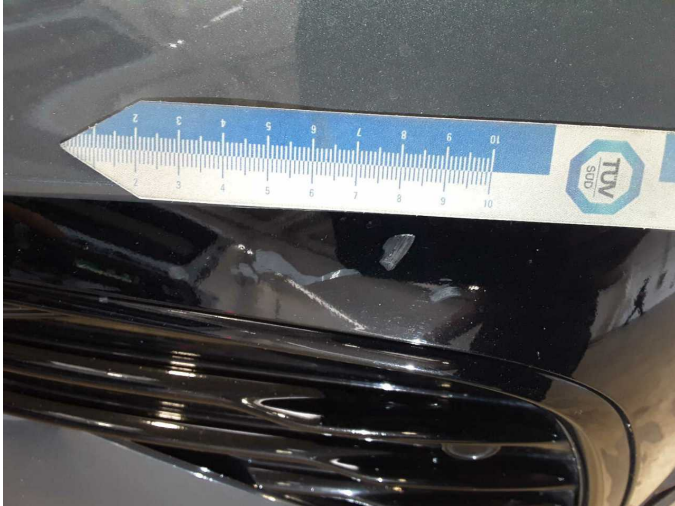
| No. | Component group | Description |
|---|---|---|
| 6 | Front bumper | Cover bumper - front - Scratch(es) - Smart repair |

**Damage 6:** Front bumper: Cover bumper - front - Scratch(es) - Smart repair

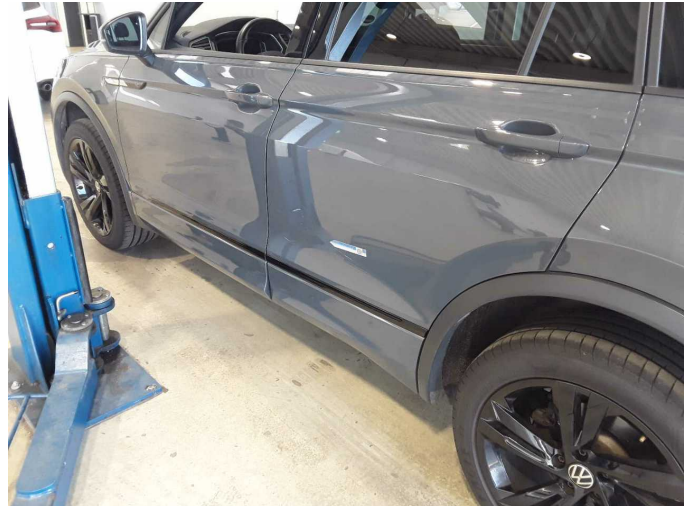
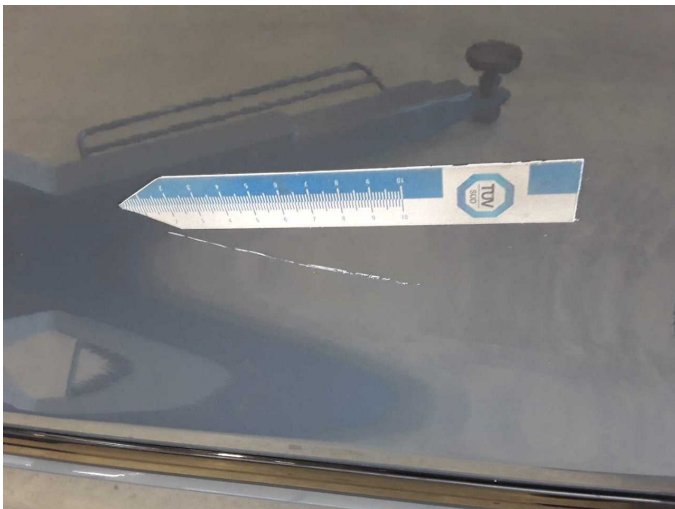
| No. | Component group | Description |
|---|---|---|
| 7 | Door - rear left side | Door - Scratch(es) - Paint |

**Damage 7:** Door - rear left side: Door - Scratch(es) - Paint

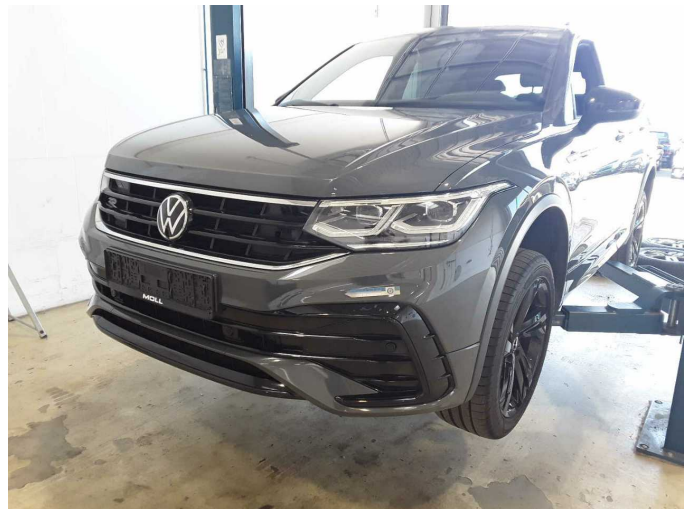
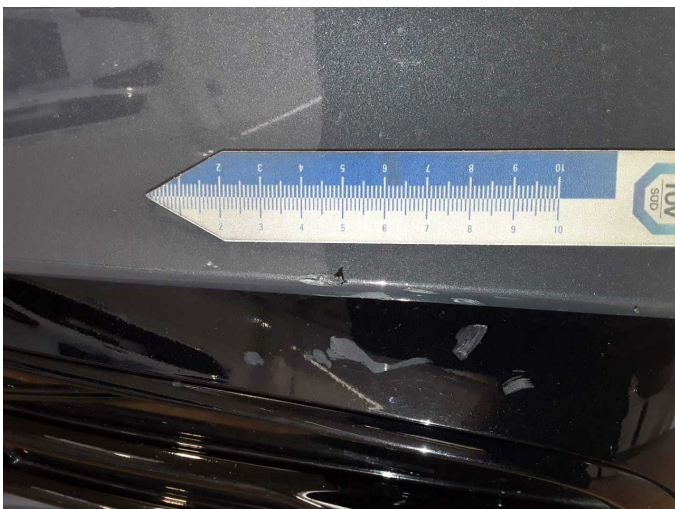
| No. | Component group | Description |
|---|---|---|
| 8 | Front bumper | Front bumper - Scratch(es) - Paint |

**Damage 8:** Front bumper: Front bumper - Scratch(es) - Paint

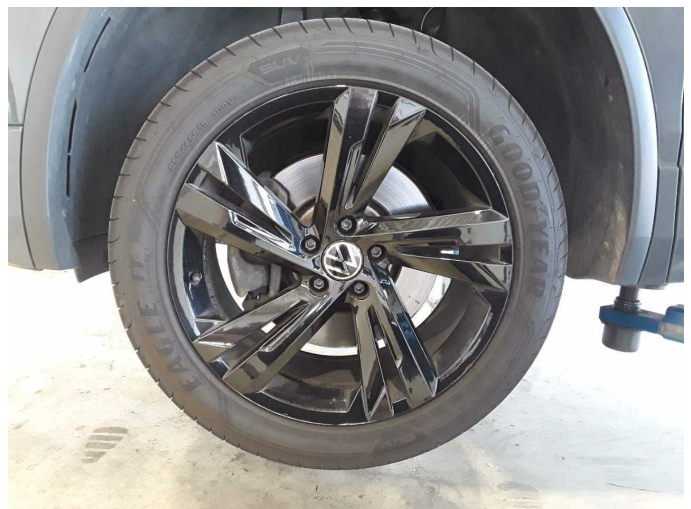
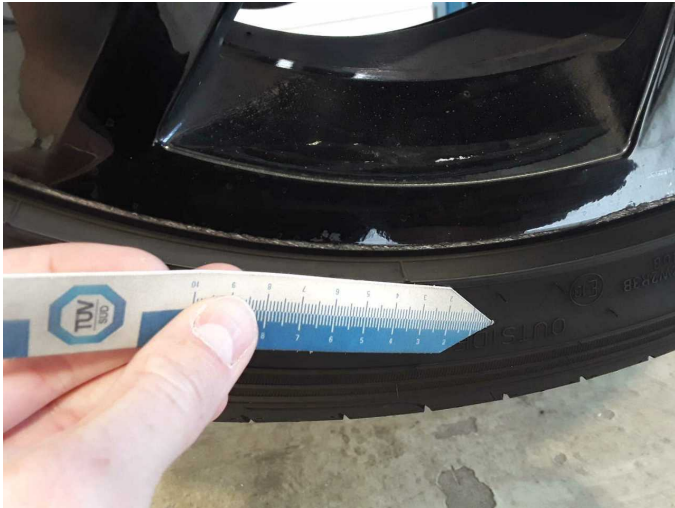
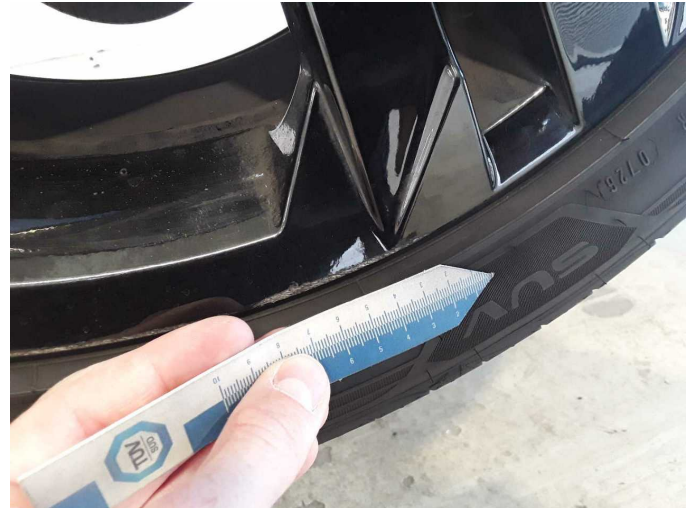
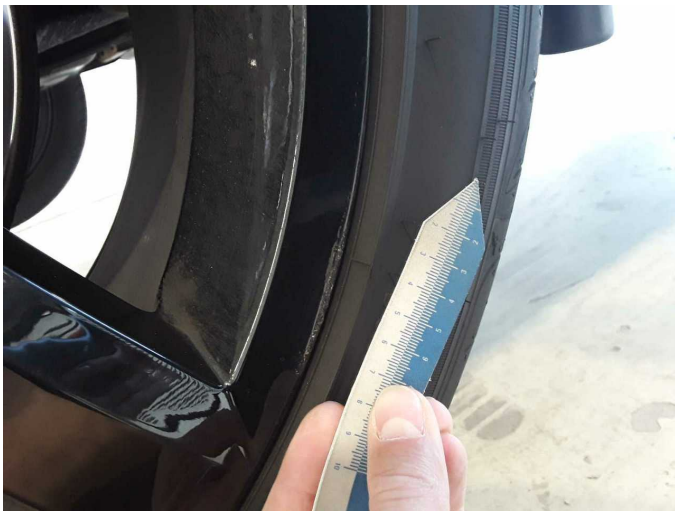
| No. | Component group | Description |
|---|---|---|
| 9 | Wheel / tyres | Alloy rim - front left side - Scratch(es) - Replace |

**Damage 9:** Wheel / tyres: Alloy rim - front left side - Scratch(es) - Replace
