Expertise

Protocol number: 46056801  
Order No. / Reference: 26512411  
Inspection date: 18 Jun 2026

Manufacturer: Volkswagen  
VIN: WVGZZZ5NZNW505310

Model: Tiguan 2.0 TDI SCR DSG R-Line

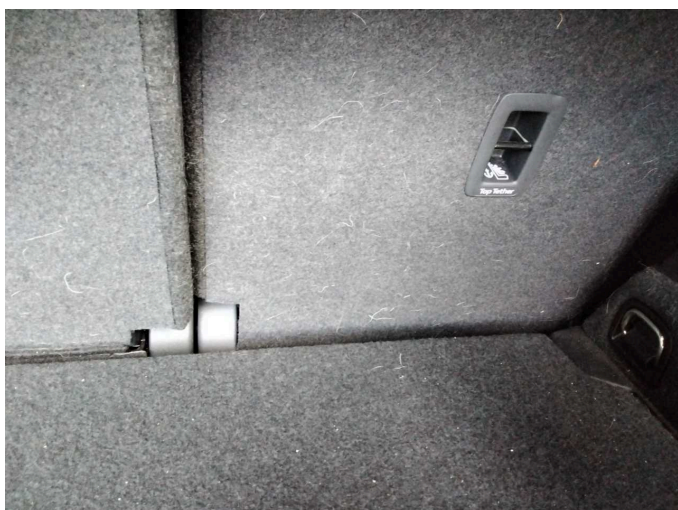
| No. | Component group | Description |
|---|---|---|
| 1 | Interior | Interior (Tierhaare) - Soiled - Clean |

**Damage 1:** Interior: Interior (Tierhaare) - Soiled - Clean

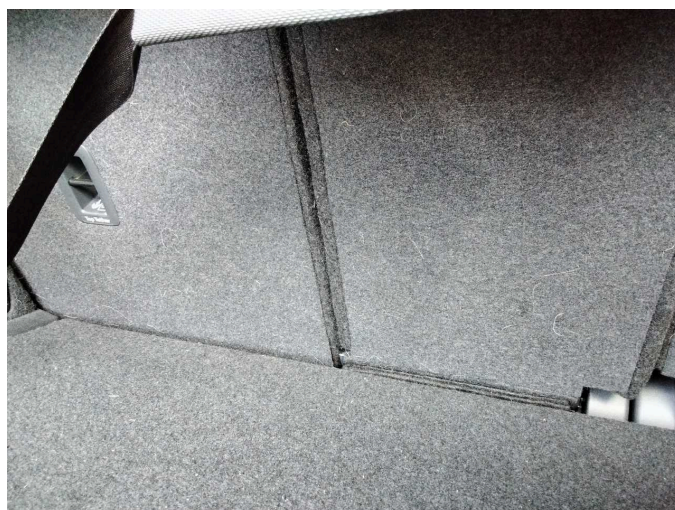
**Damage 1:** Interior: Interior (Tierhaare) - Soiled - Clean

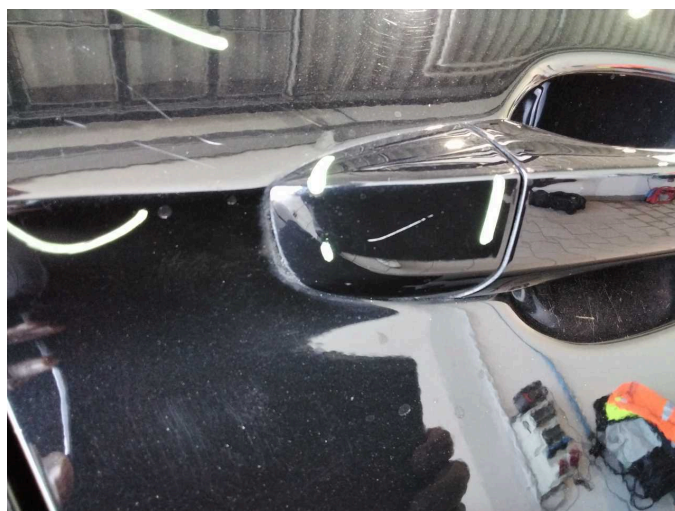
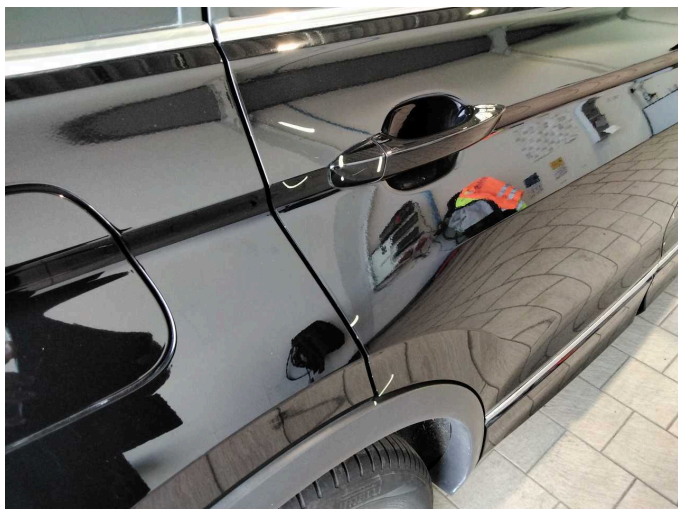
| No. | Component group | Description |
|---|---|---|
| 2 | Door - rear right side | Door handle - outside - Scratch(es) - Smart repair |

**Damage 2:** Door - rear right side: Door handle - outside - Scratch(es) - Smart repair

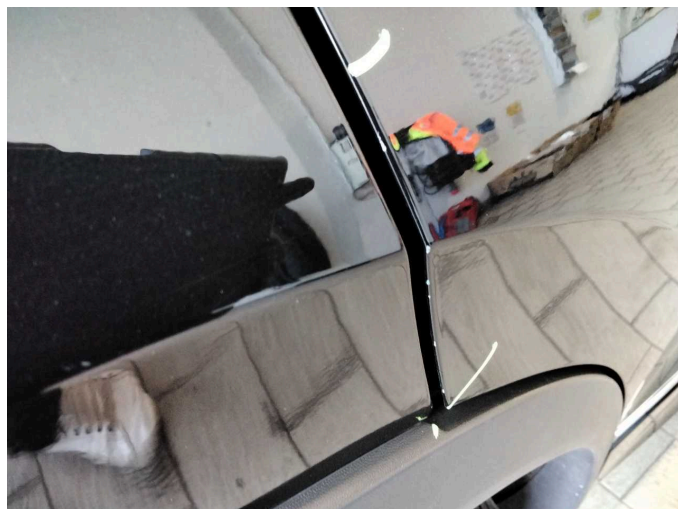
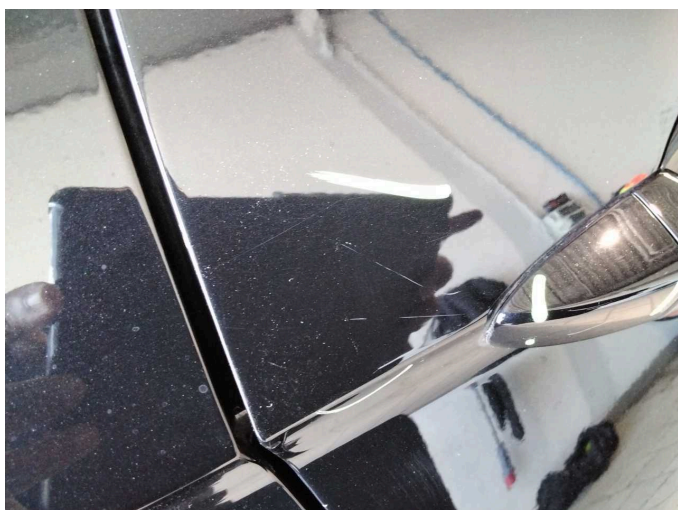
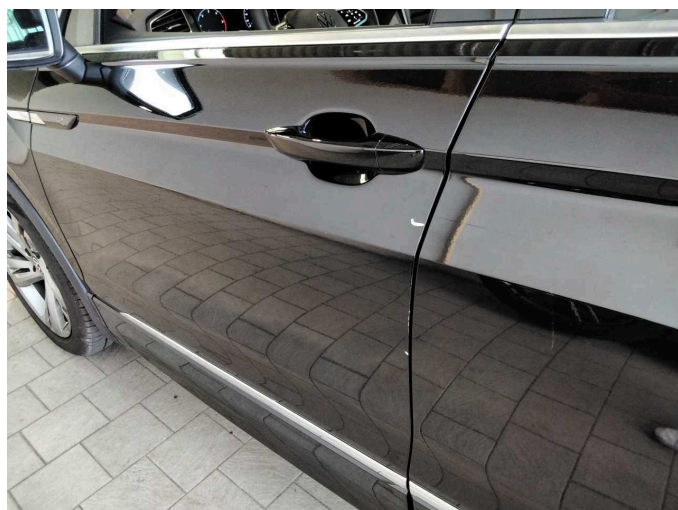
| No. | Component group | Description |
|---|---|---|
| 3 | Door - rear right side | Door edge - Scratch(es) - Smart repair |

**Damage 3:** Door - rear right side: Door edge - Scratch(es) - Smart repair

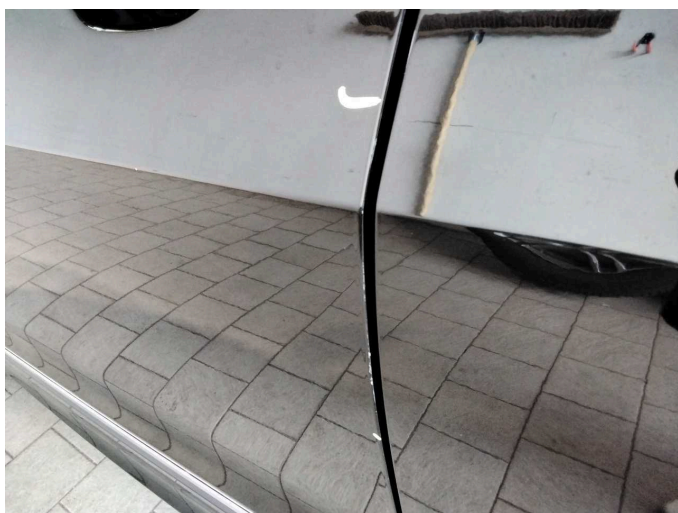
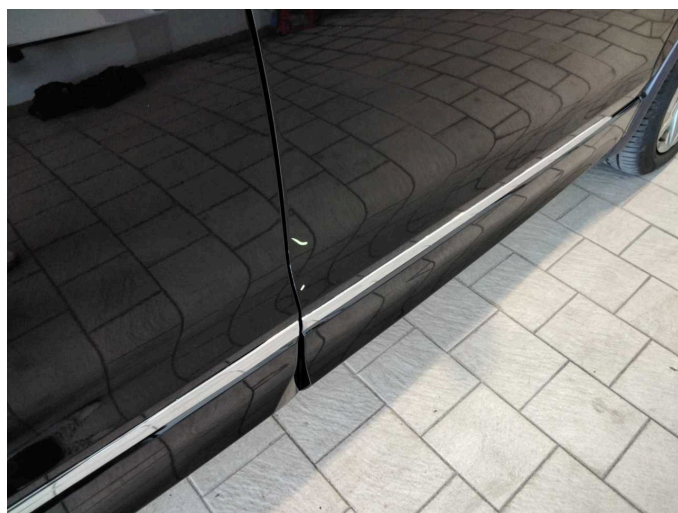
| No. | Component group | Description |
|---|---|---|
| 4 | Door - front left side | Door edge - Scratch(es) - Smart repair |

**Damage 4:** Door - front left side: Door edge - Scratch(es) - Smart repair

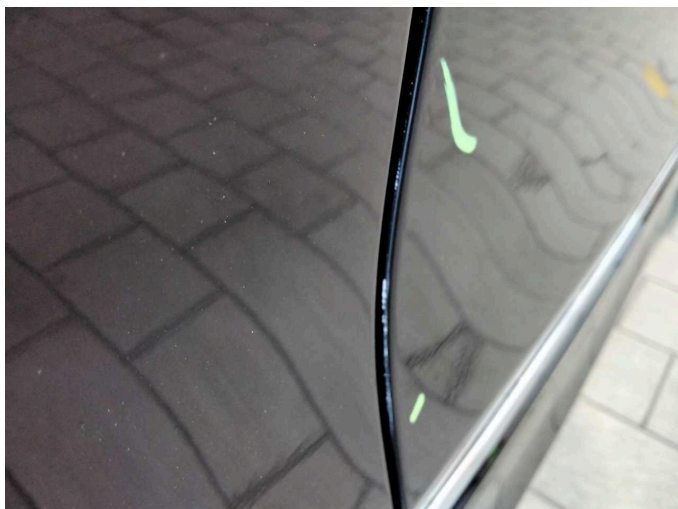
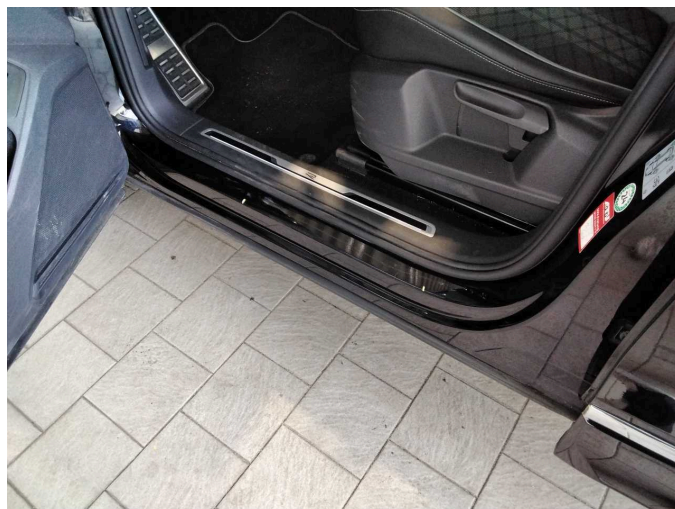
| No. | Component group | Description |
|---|---|---|
| 5 | Door - front right side | Door edge - Scratch(es) - Smart repair |

**Damage 5:** Door - front right side: Door edge - Scratch(es) - Smart repair

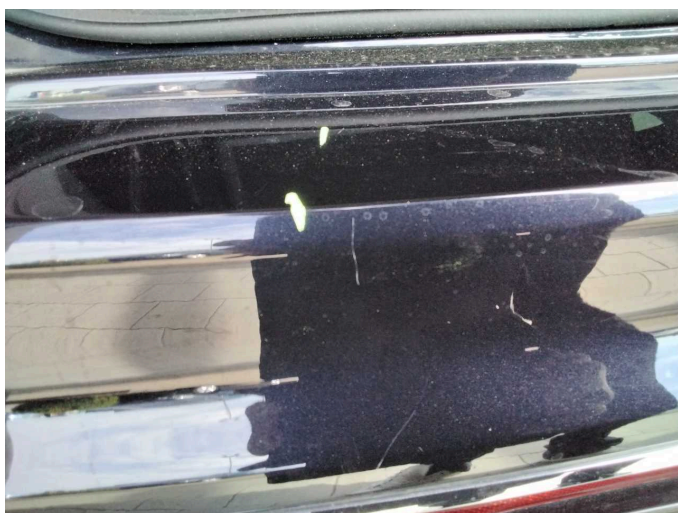
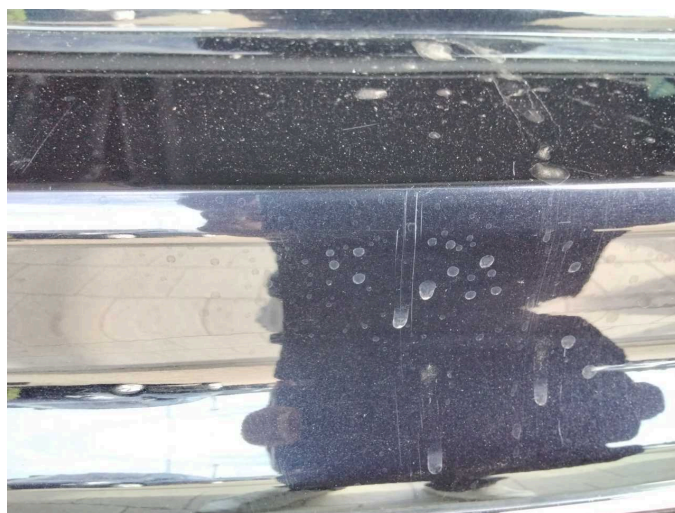
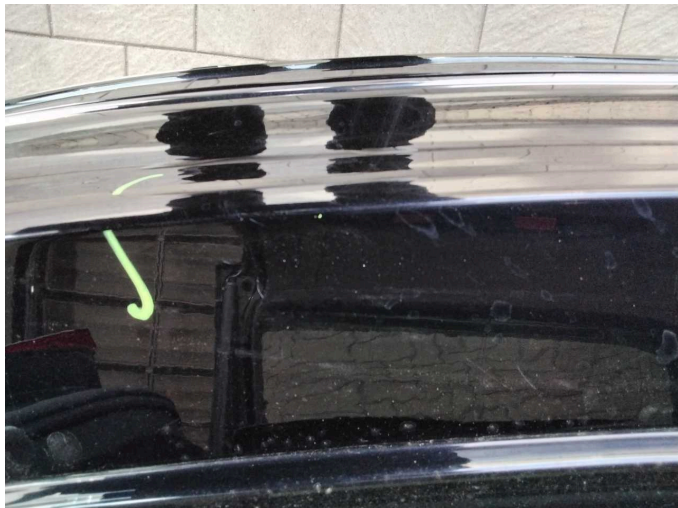
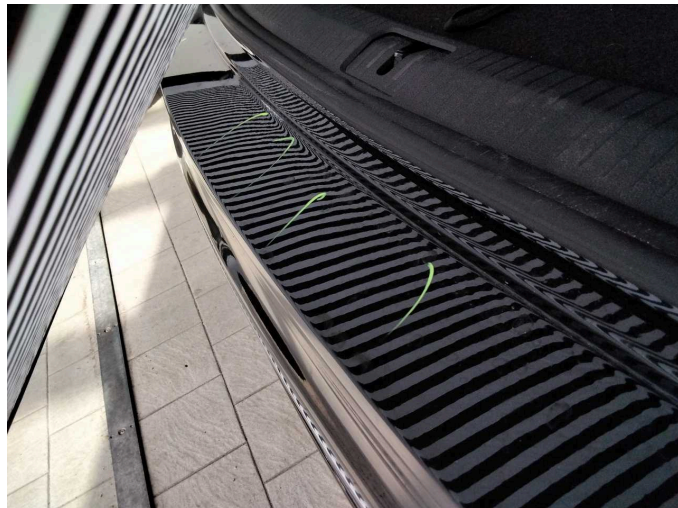
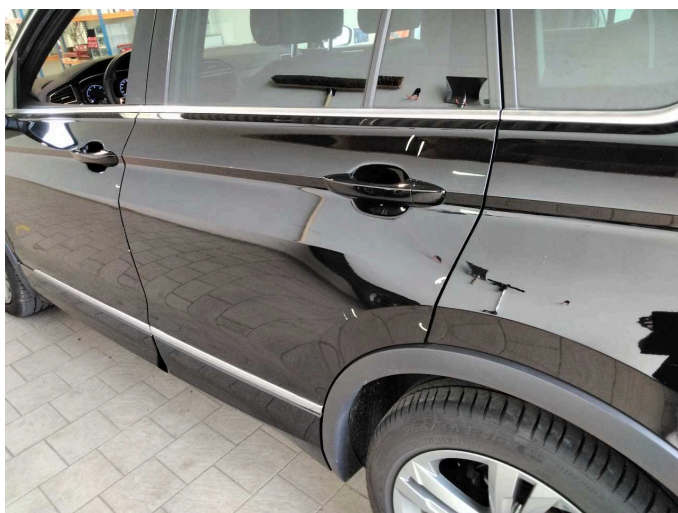
| No. | Component group | Description |
|---|---|---|
| 7 | Rear bumper | Rear bumper - Dent / paintcoat damage - Repair and paint |

**Damage 7:** Rear bumper: Rear bumper - Dent / paintcoat damage - Repair and paint

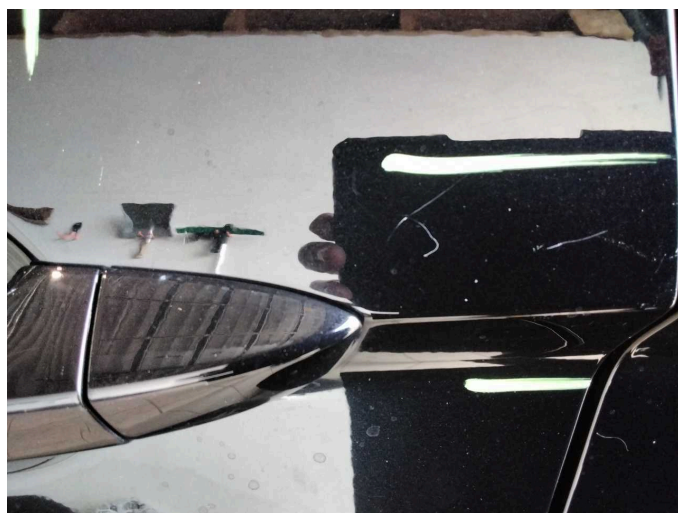
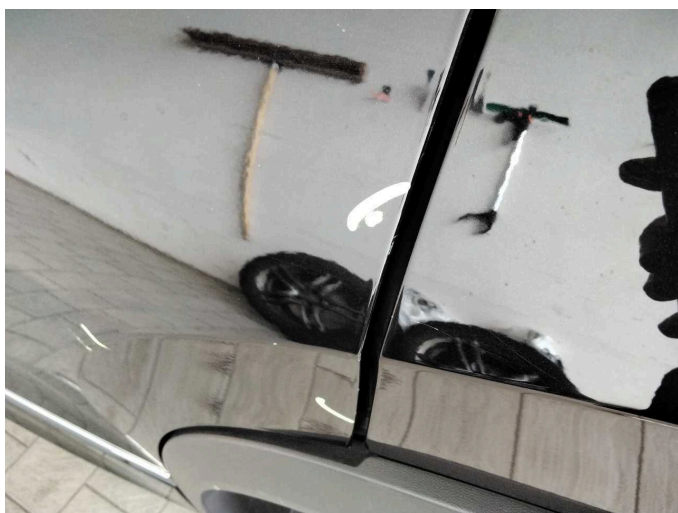
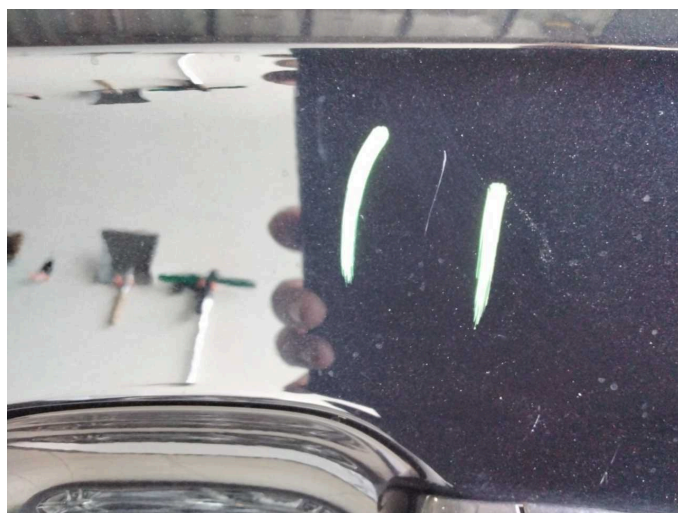
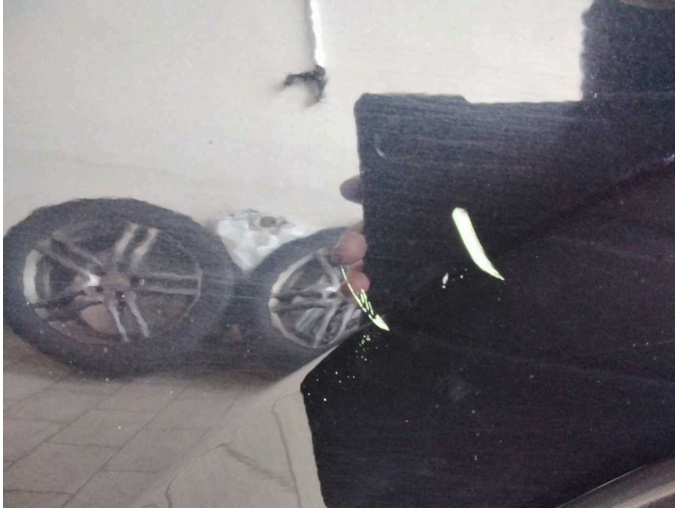
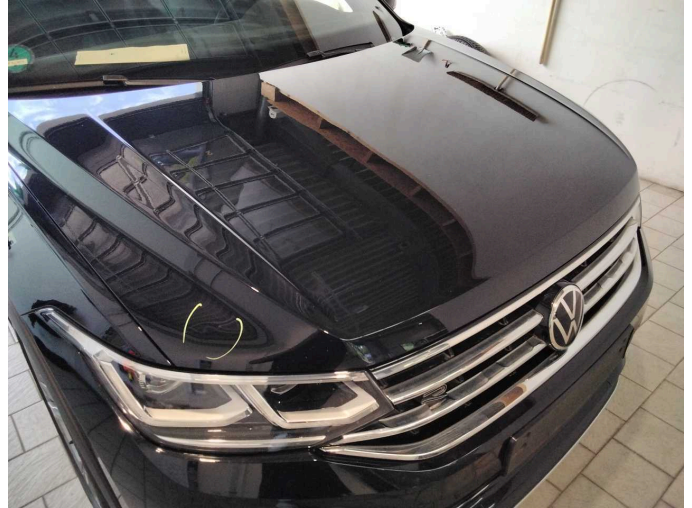
| No. | Component group | Description |
|---|---|---|
| 8 | Door - rear left side | Door - Scratch(es) - Paint |

**Damage 8:** Door - rear left side: Door - Scratch(es) - Paint

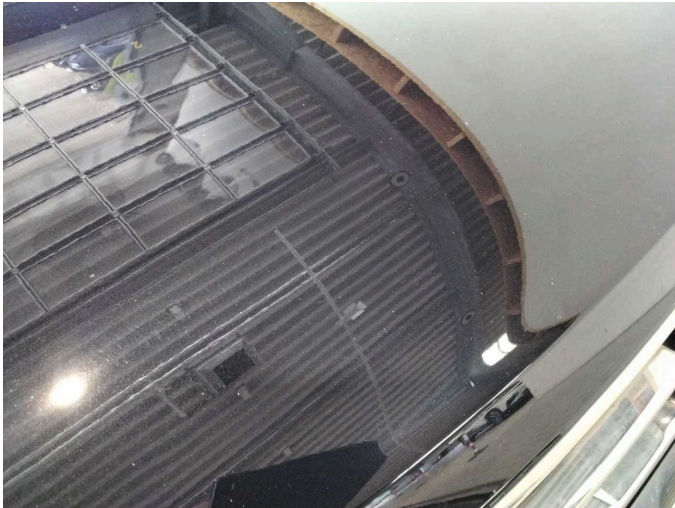
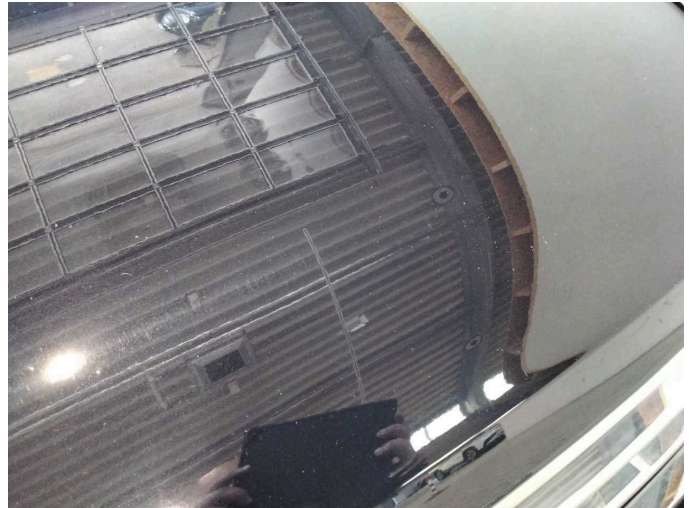
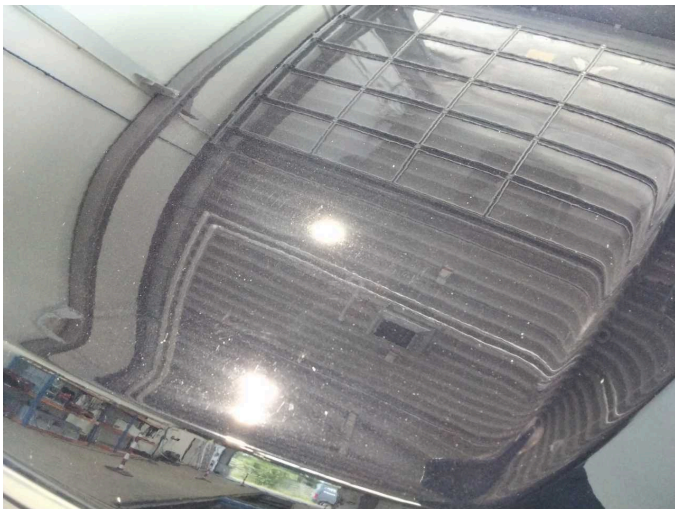
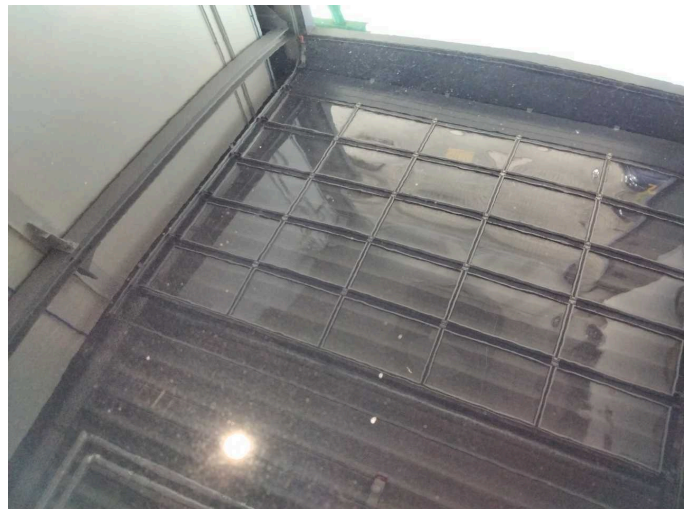
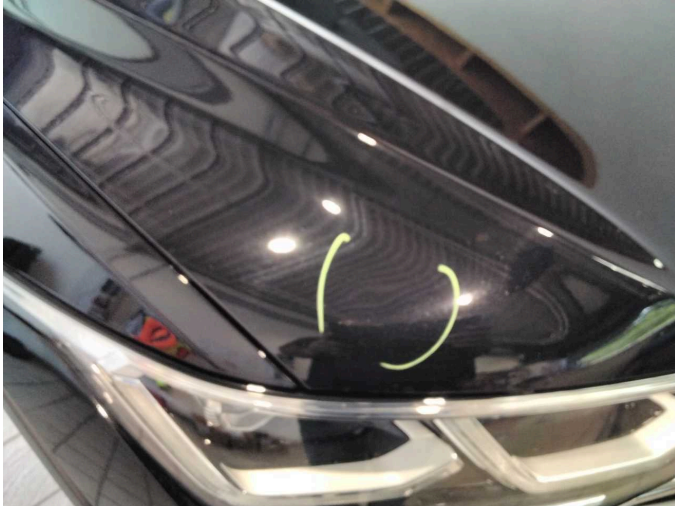
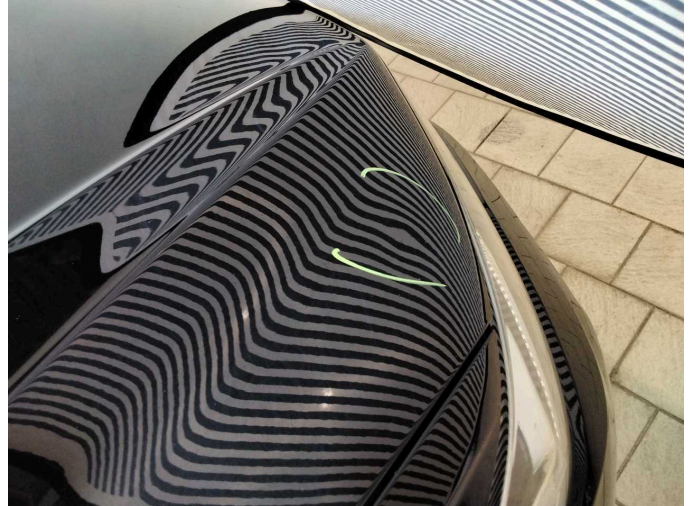
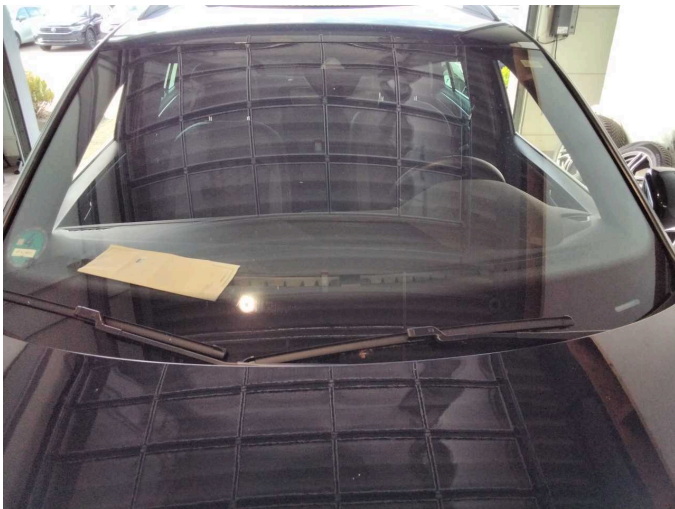
| No. | Component group | Description |
|---|---|---|
| 9 | Bonnet | Bonnet - Dent / paintcoat damage - Repair and paint |

**Damage 9:** Bonnet: Bonnet - Dent / paintcoat damage - Repair and paint

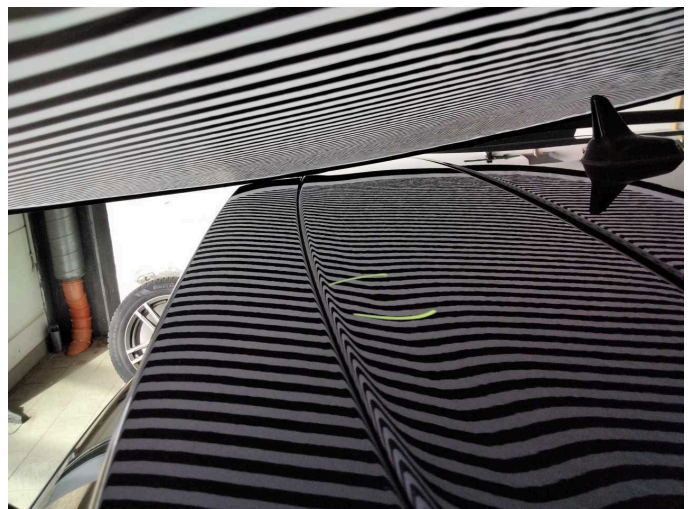
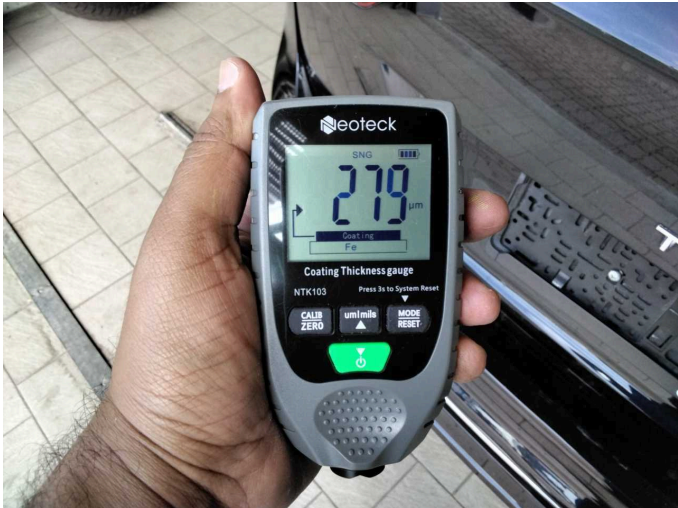
| No. | Component group | Description |
|---|---|---|
| 3 | Boot lid / rear door | Boot lid - dent(s) - No deduction |

**Wear and tear 3:** Boot lid / rear door: Boot lid - dent(s) - No deduction

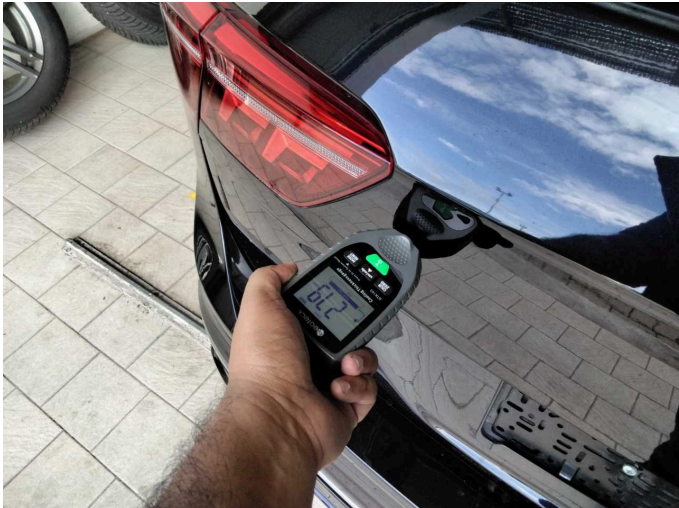
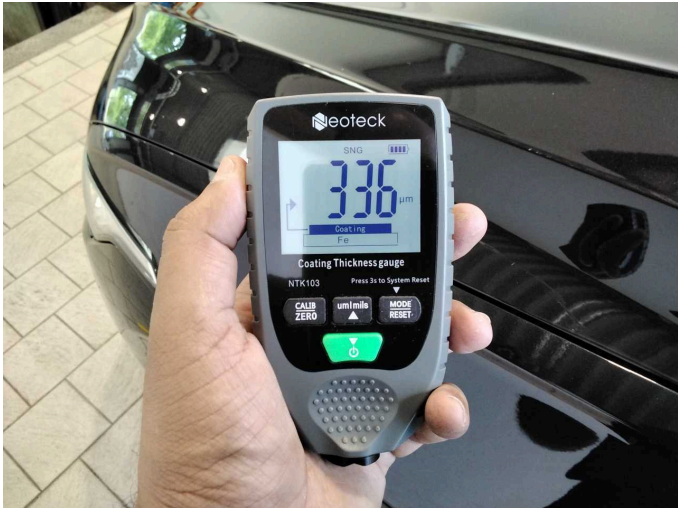
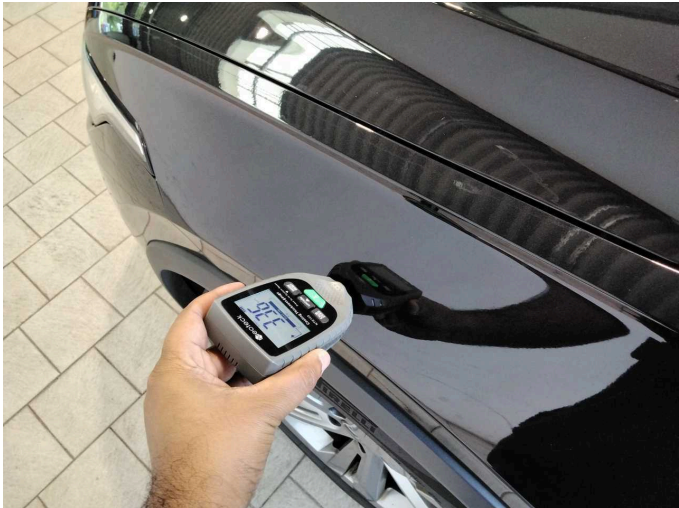
| No. | Repainting |
|---|---|
| 1 | Boot lid / rear door, Mudguard - left side, Professionally carried out, Invoice of repair done |

| Boot lid / rear door | 279 µm | Mudguard - left side | 336 µm |

Repainting 1: Boot lid / rear door, Mudguard - left side
