Expertise

Protocol number: 46548989  
Order No. / Reference: 26599984  
Inspection date: 15 Jul 2026

Manufacturer: Skoda  
VIN: TMBLK8NX0NY073809

Model: Octavia Combi 2.0 TDI DSG 4x4 Scout

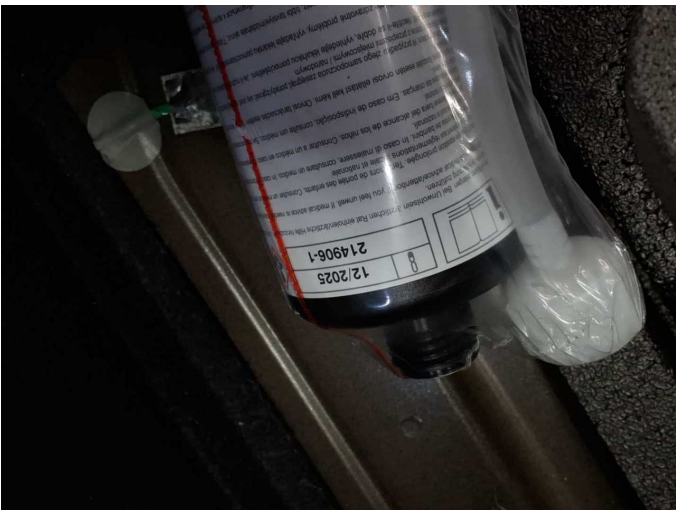
| No. | Component group | Description |
|---|---|---|
| 1 | Equipment | Tirefit filler - Expired - Replace |

Damage 1: Equipment: Tirefit filler - Expired - Replace

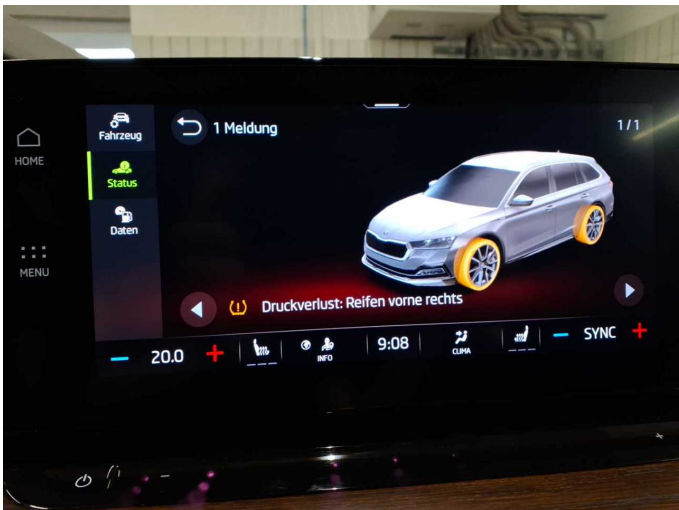
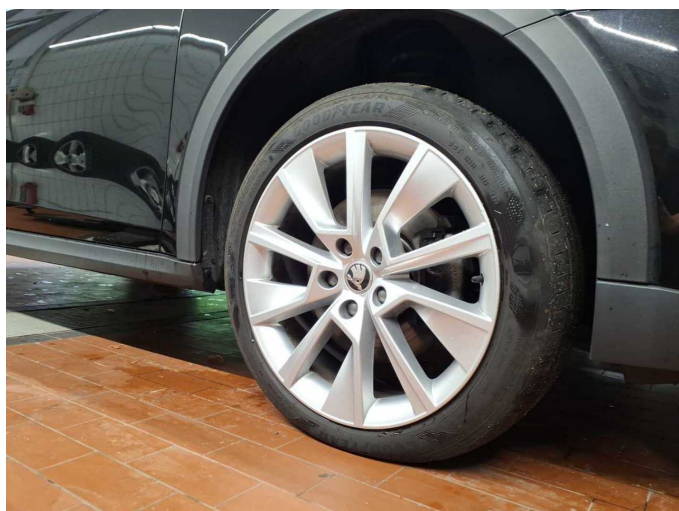
| No. | Component group | Description |
|---|---|---|
| 2 | Wheel / tyres | Tyre - front right side (Druckverlust; Mehrkosten können entstehen) - Perform diagnosis |

Damage 2: Wheel / tyres: Tyre - front right side (Druckverlust: Mehrkosten können entstehen) - Perform diagnosis

**Damage 2:** Wheel / tyres: Tyre - front right side (Druckverlust; Mehrkosten können entstehen) - Perform diagnosis

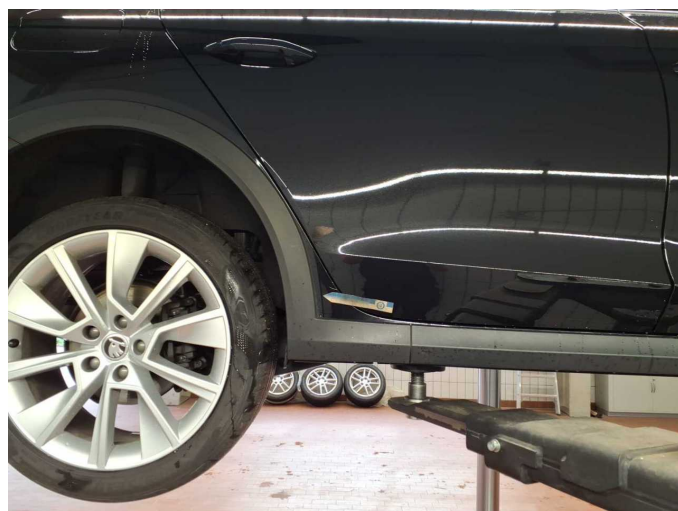
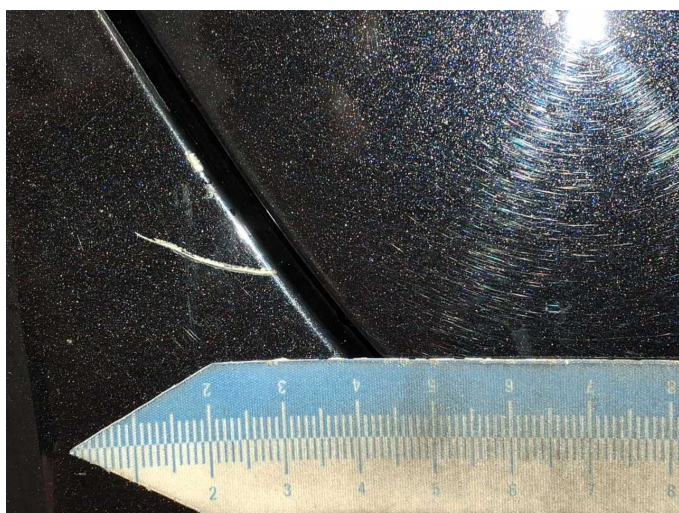
| No. | Component group | Description |
|---|---|---|
| 3 | Side panel - rear right side | Elbow - Scratch(es) - Smart repair |

**Damage 3:** Side panel - rear right side: Elbow - Scratch(es) - Smart repair

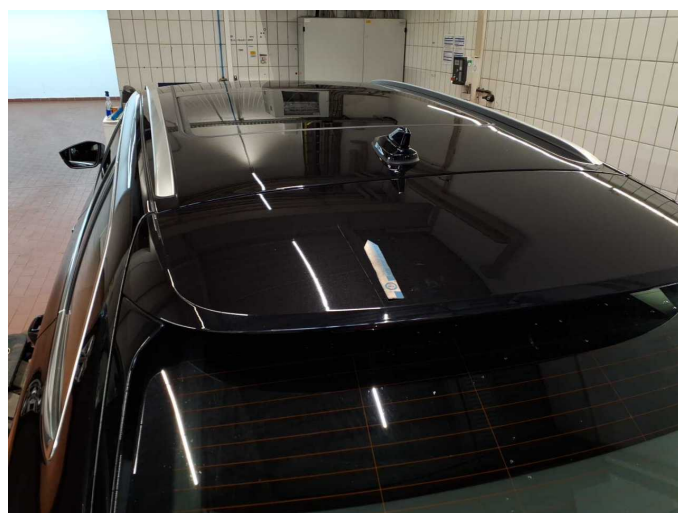
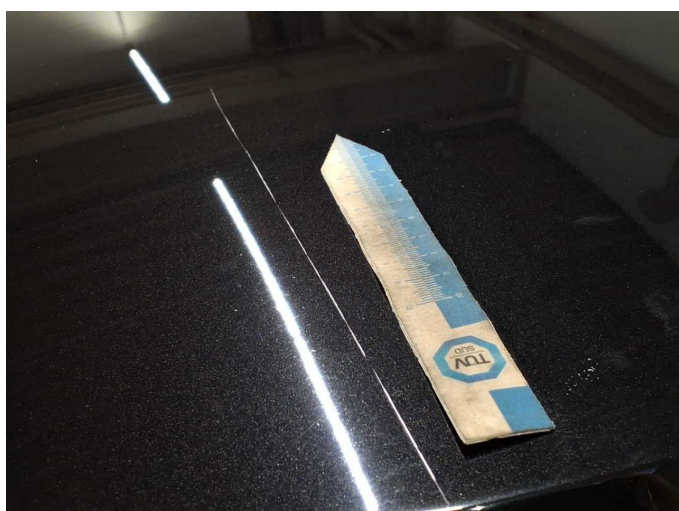
| No. | Component group | Description |
|---|---|---|
| 4 | Boot lid / rear door | Rear spoiler - Scratch(es) - Paint |

**Damage 4:** Boot lid / rear door: Rear spoiler - Scratch(es) - Paint

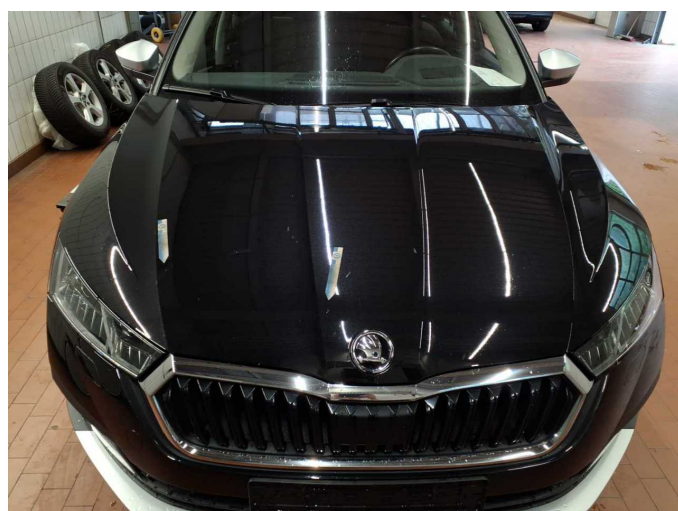
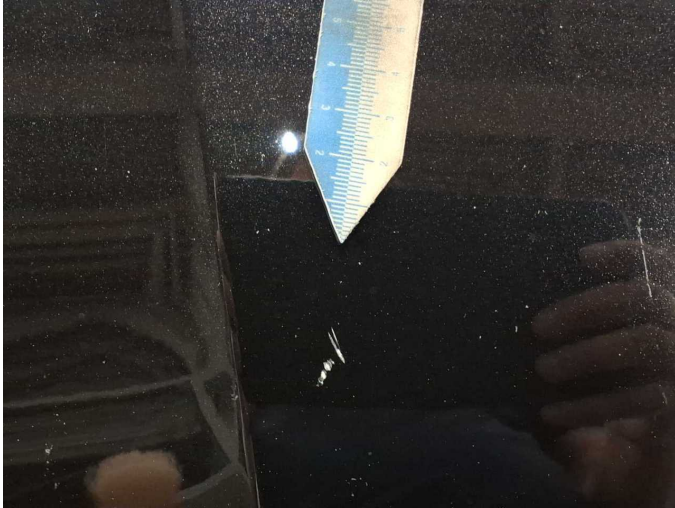
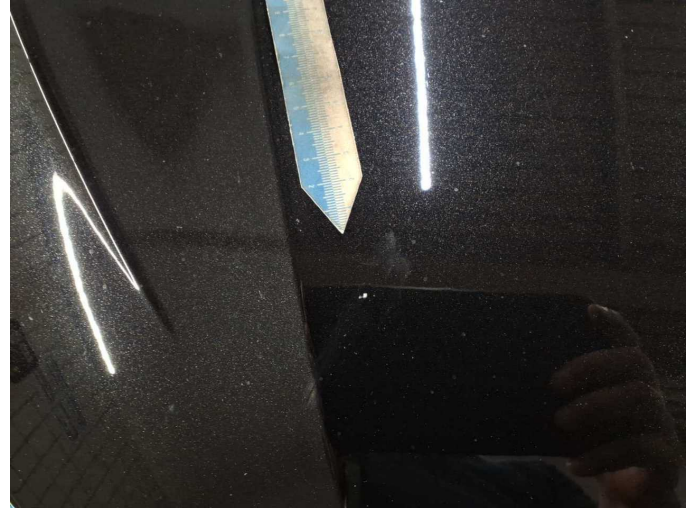
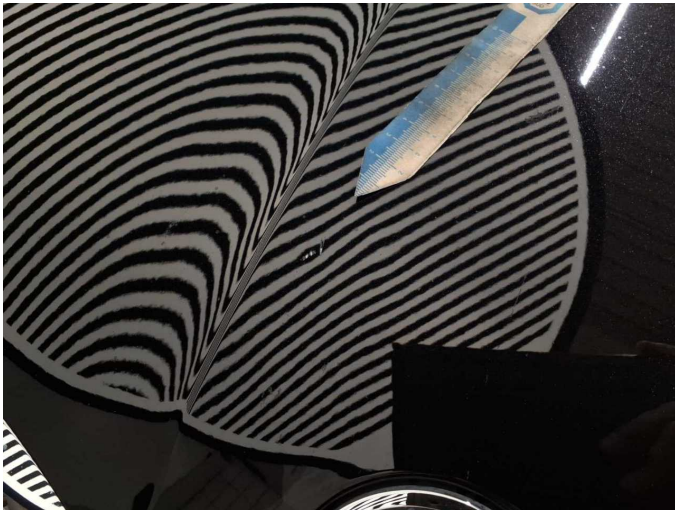
| No. | Component group | Description |
|---|---|---|
| 5 | Bonnet | Bonnet - Stone chips - Repair and paint |

**Damage 5:** Bonnet: Bonnet - Stone chips - Repair and paint

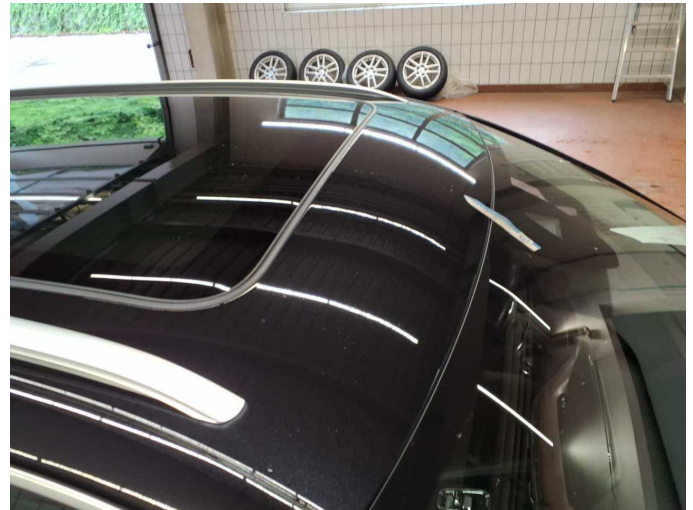
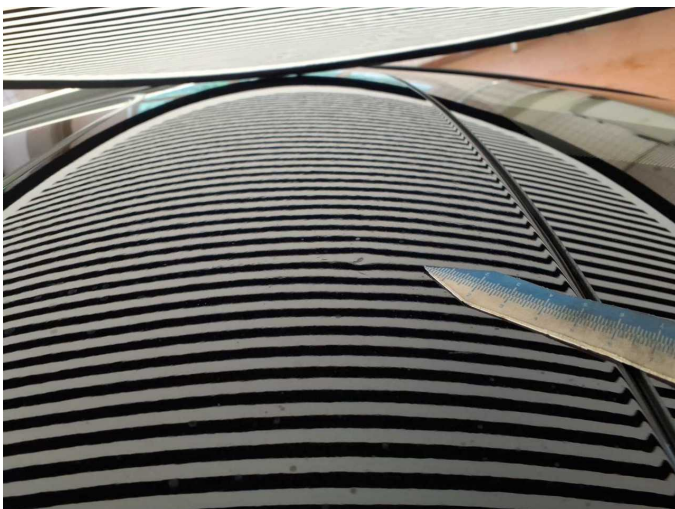
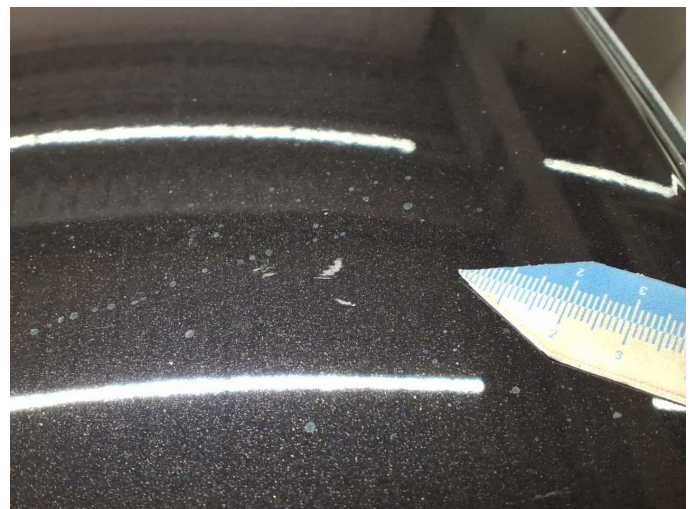
| No. | Component group | Description |
|---|---|---|
| 1 | Roof | Roof - dent(s) - No deduction |

**Wear and tear 1:** Roof: Roof - dent(s) - No deduction

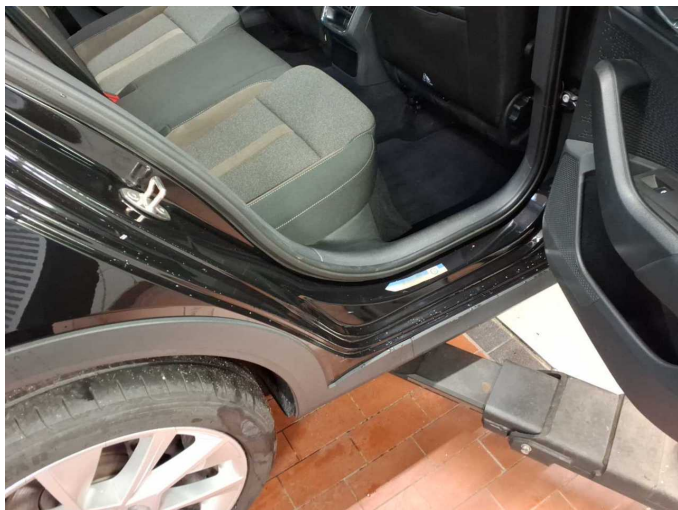
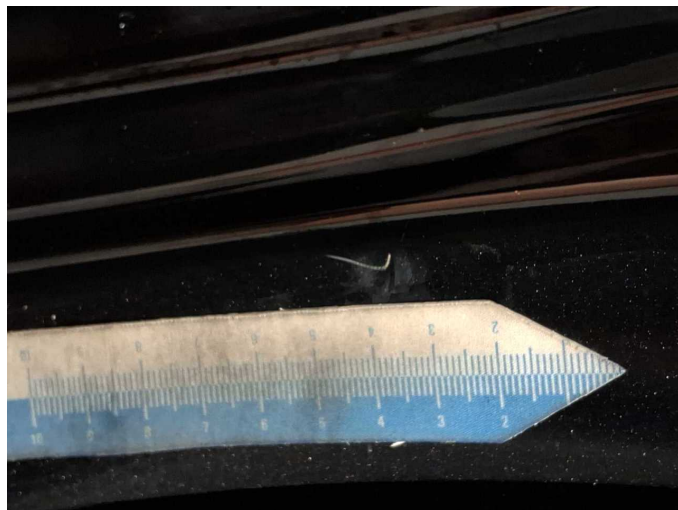
| No. | Component group | Description |
|---|---|---|
| 2 | Side panel - rear right side | Sill - Scratch(es) - No deduction |

**Wear and tear 2:** Side panel - rear right side: Sill - Scratch(es) - No deduction

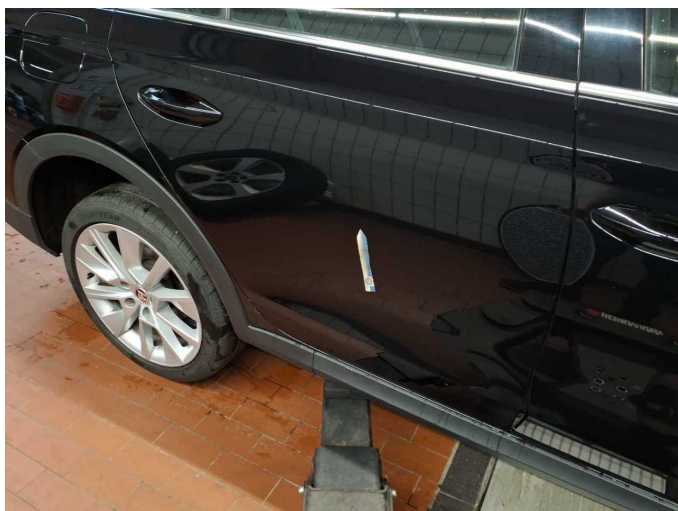
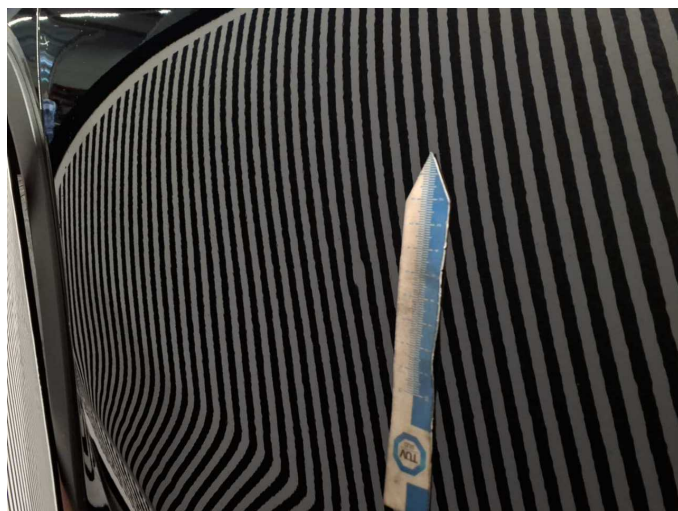
| No. | Component group | Description |
|---|---|---|
| 3 | Door - rear right side | Door - dent(s) - No deduction |

**Wear and tear 3:** Door - rear right side: Door - dent(s) - No deduction
