Expertise

Protocol number: 45554698
Order No. / Reference: 26059219
Inspection date: 13 May 2026

Model: Focus Turnier 2.0 EcoBlue Start-Stopp-System Aut.
COOL&CONNECT

VIN: WF0PXXGCHPLE19456

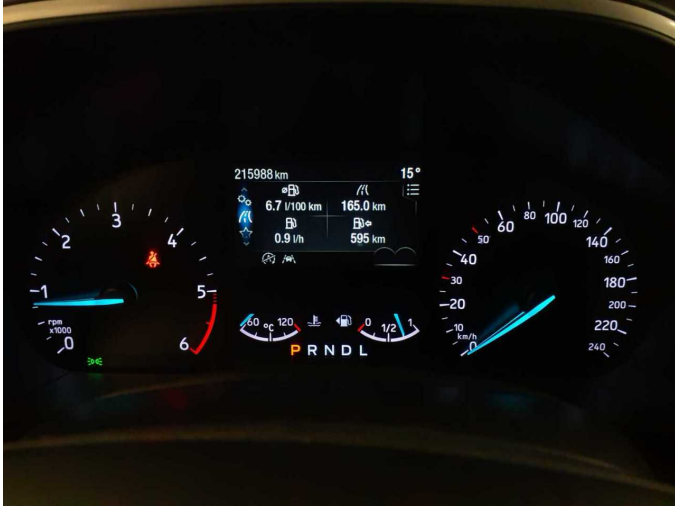
Figure 7: Instrument cluster

Vehicle Identification number	WF0PXXGCHPLE19456
Mileage (Read)	215,988 km
First registration	11 Sept 2020
Number of holders	1
Next periodical technical inspection	10/2027
(Report on hand)

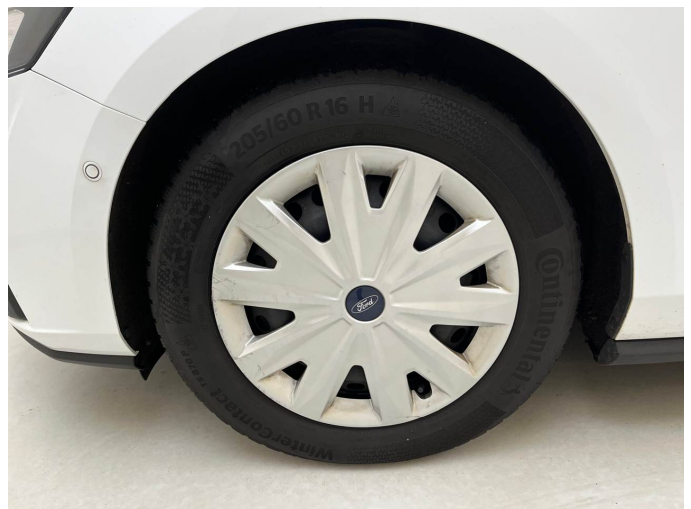
Figure 12: Mounted tyres

#	Tyre size	Type of tyre	Manufacturer	Tread depth
1)	205/60 R16 92H	Winter tyres on Steel rim with wheel cover	Continental	6mm / 6mm
2)	205/60 R16 92H	Winter tyres on Steel rim with wheel cover	Continental	7mm / 7mm

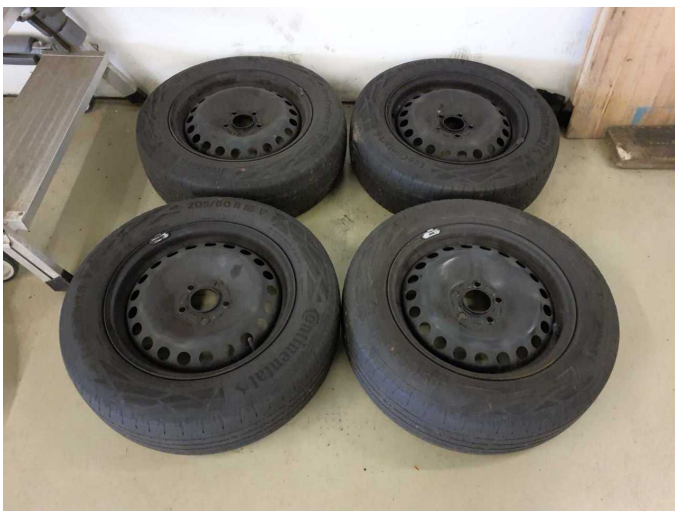
Figure 17: Additional tyres

#	Tyre size	Type of tyre	Manufacturer	Tread depth
1)	205/60 R16 92V	Summer tyres on Steel	Continental	4mm / 4mm
2)	205/60 R16 92V	Summer tyres on Steel	Continental	4mm / 4mm

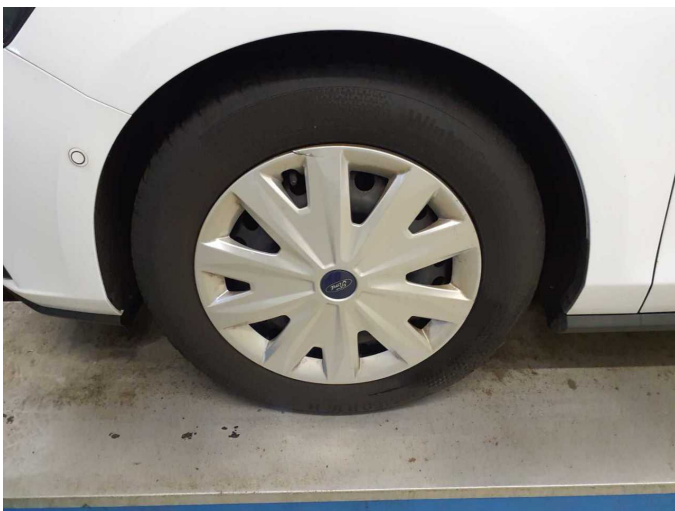
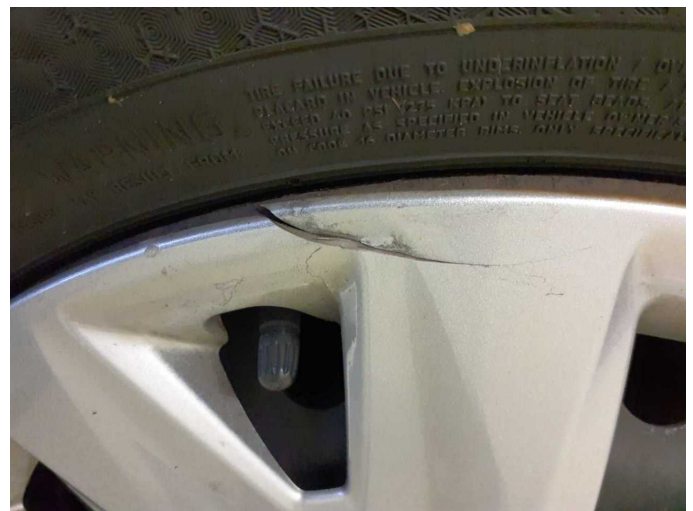
Damage 1: Wheel / tyres: Wheel cover - front left side - Broken / torn - Replace

No.	Component group	Description
1	Wheel / tyres	Wheel cover - front left side - Broken / torn - Replace
2	Door - front left side	Door - dent(s) - Smart repair
3	Body	Body (Flugrost) - Soiled - Clean
4	Bonnet	Bonnet (+ Korrosion) - Paint defect - Repair and paint

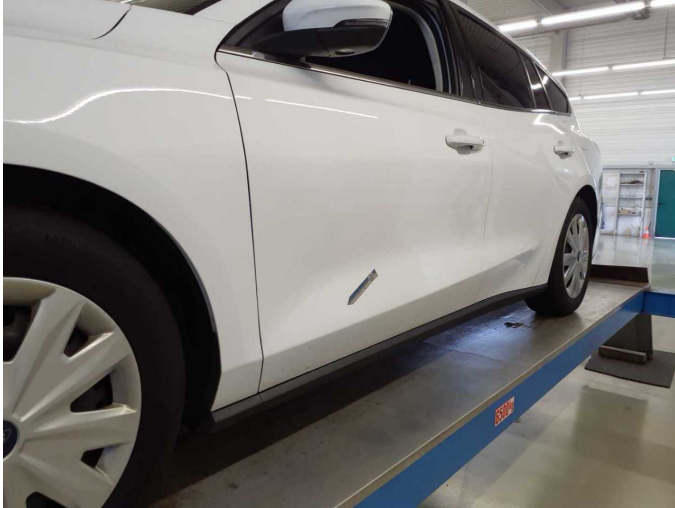
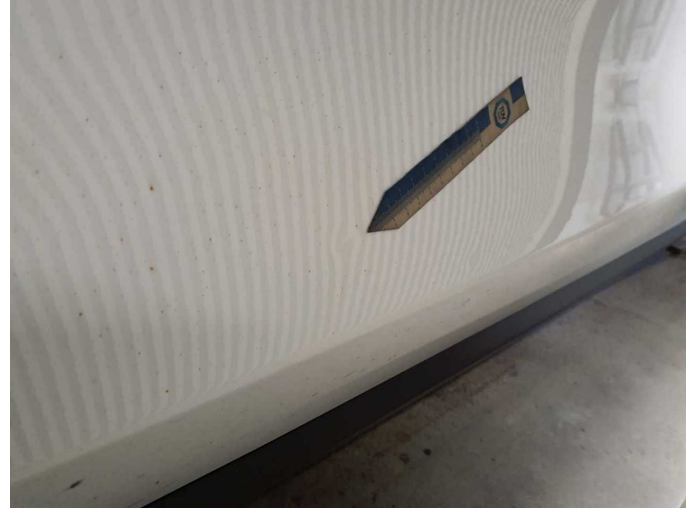
Damage 2: Door - front left side: Door - dent(s) - Smart repair

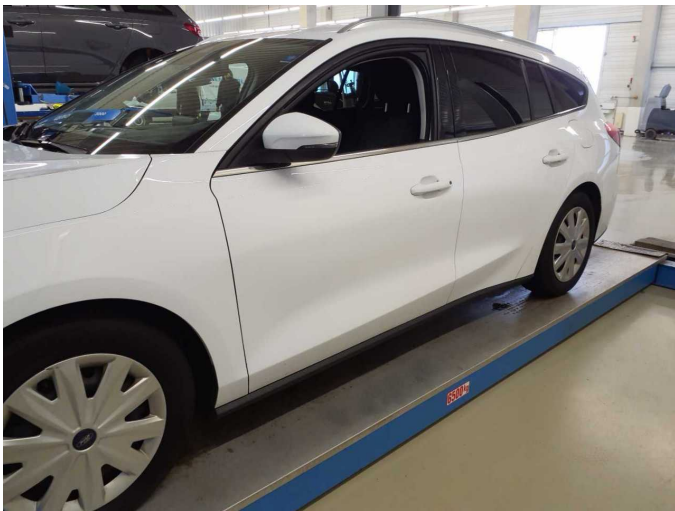
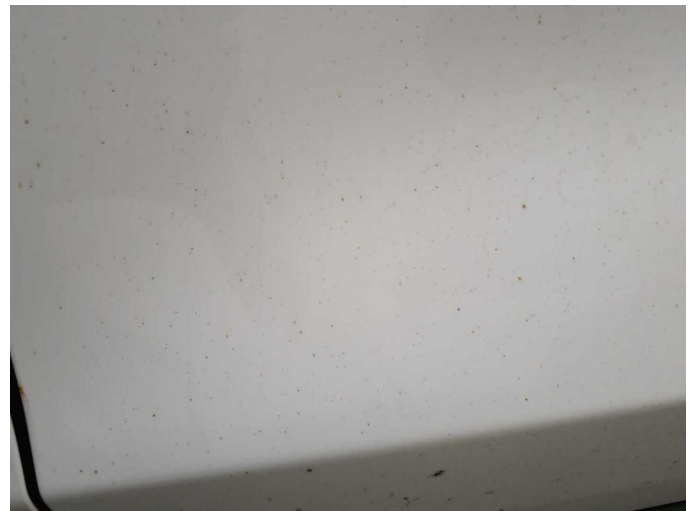
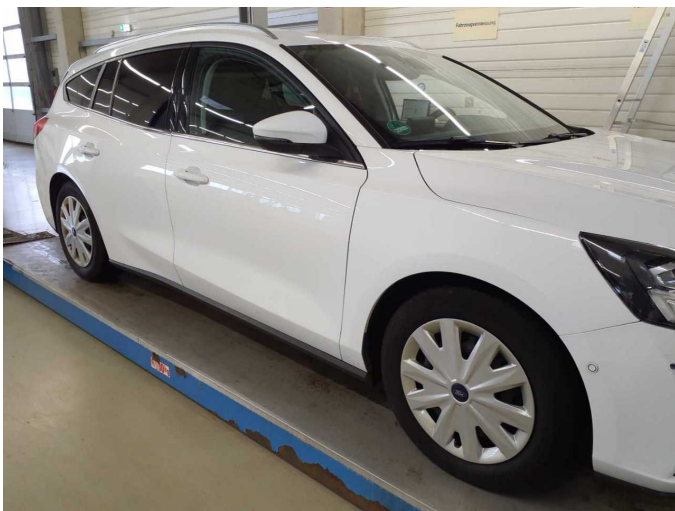
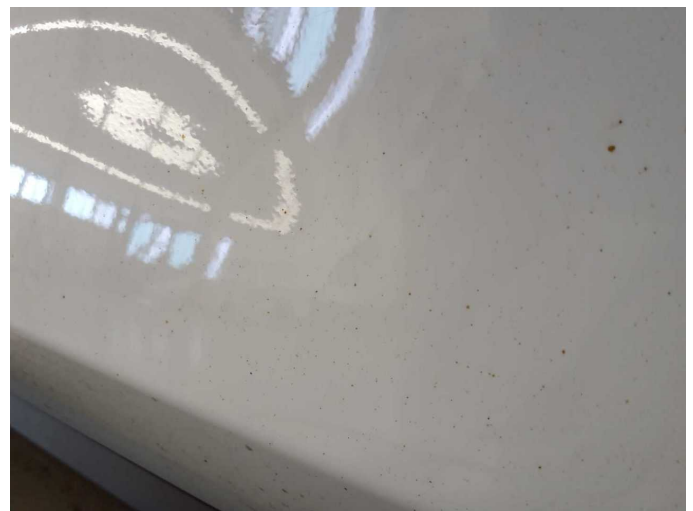
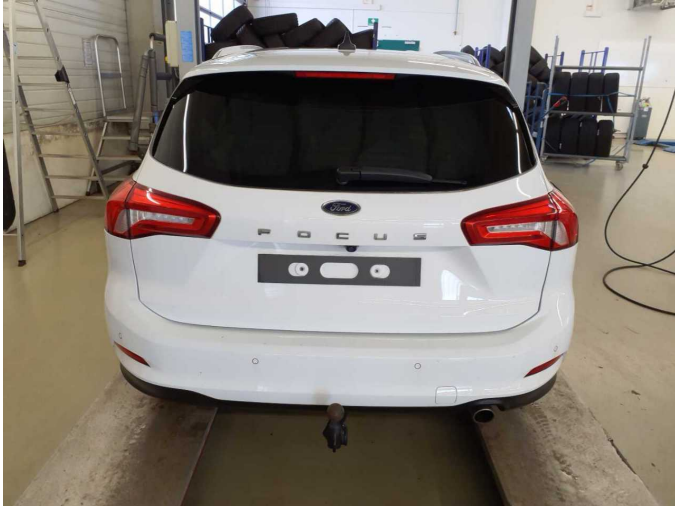
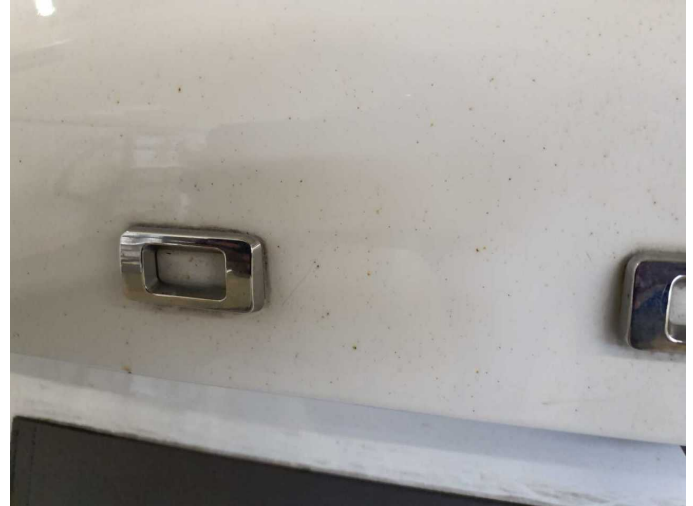
Damage 3: Body: Body (Flugrost) - Soiled - Clean

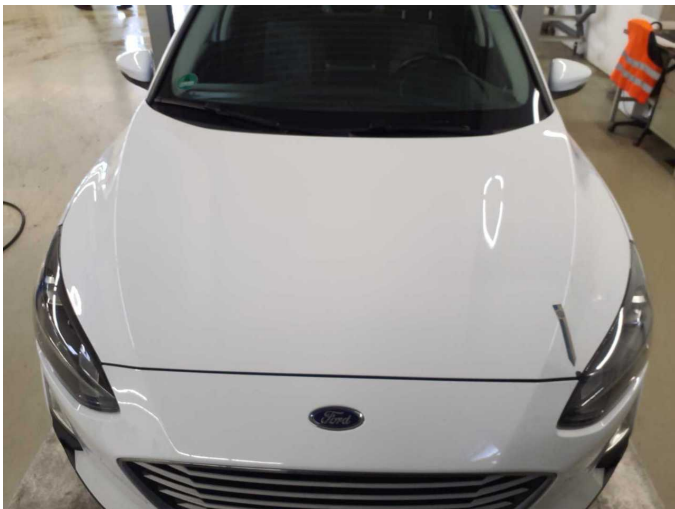
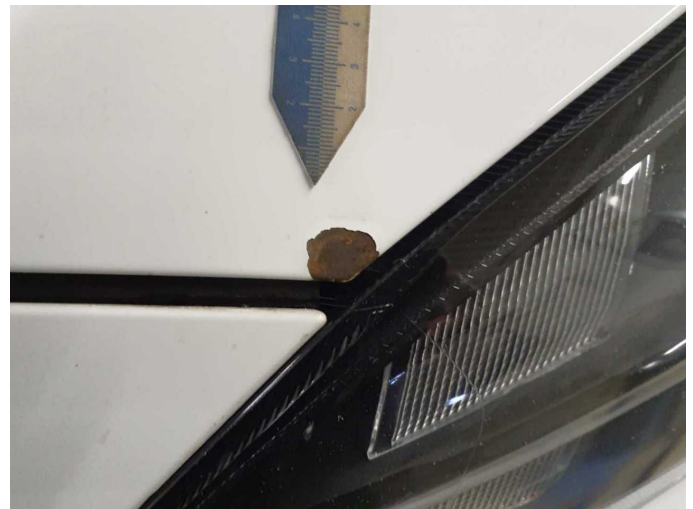
Damage 4: Bonnet: Bonnet (+ Korrosion) - Paint defect - Repair and paint
