Expertise

Protocol number: 46101807
Order No. / Reference: 26528144
Inspection date: 17 Jun 2026

Manufacturer: Ford

Model: Focus 1.5 EcoBlue Start-Stopp-System Aut. TITANIUM X

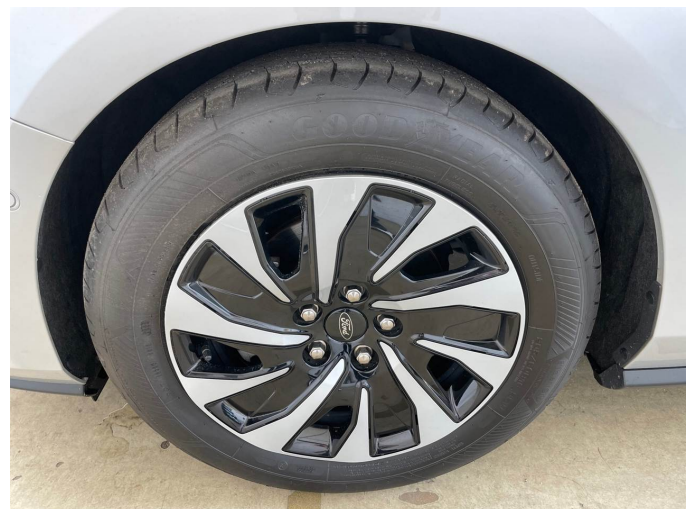
Figure 12: Mounted tyres

#	Tyre size	Type of tyre	Manufacturer	Tread depth
1)	205/60 R16 92V	Summer tyres on Steel rim with wheel cover	Goodyear	6mm / 6mm
2)	205/60 R16 92V	Summer tyres on Steel rim with wheel cover	Goodyear	6mm / 6mm

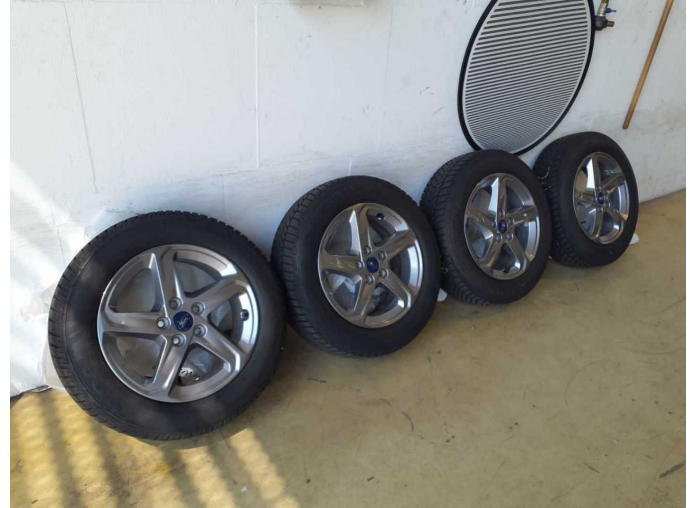
Figure 14: Additional tyres

#	Tyre size	Type of tyre	Manufacturer	Tread depth
1)	205/60 R16 92H	Winter tyres on Light alloy	Fulda	7mm / 7mm
2)	205/60 R16 92H	Winter tyres on Light alloy	Fulda	7mm / 7mm

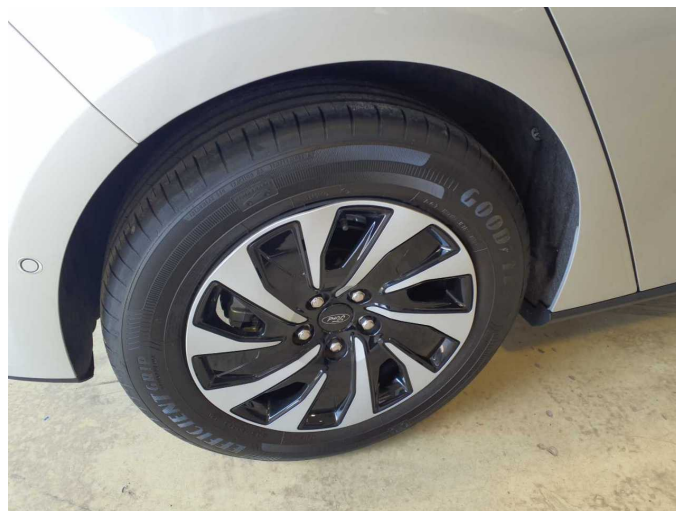
Damage 2: Wheel / tyres: Wheel cover - rear right side - Deformed - Replace

No.	Component group	Description
1	Wheel / tyres	Wheel cover - rear left side - Deformed - Replace
2	Wheel / tyres	Wheel cover - rear right side - Deformed - Replace
3	Misc.	Main inspection - Due - Perform
