Expertise

Protocol number: 46515023  
Order No. / Reference: 26669341  
Inspection date: 10 Jul 2026

Manufacturer: Peugeot

Model: 208 Elektromotor 136 Allure

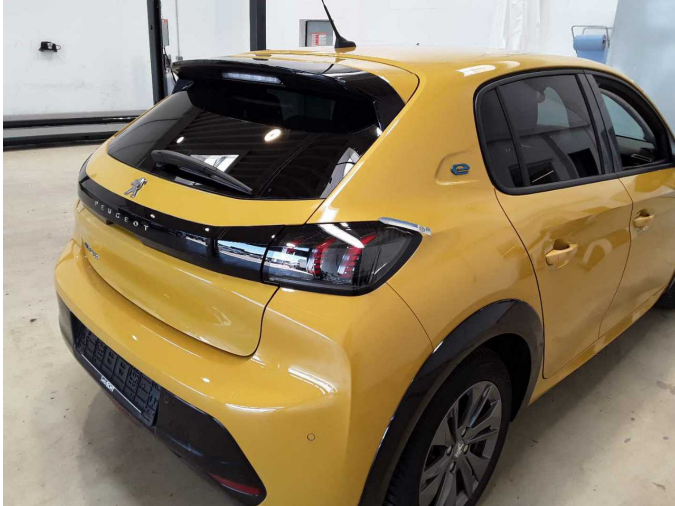
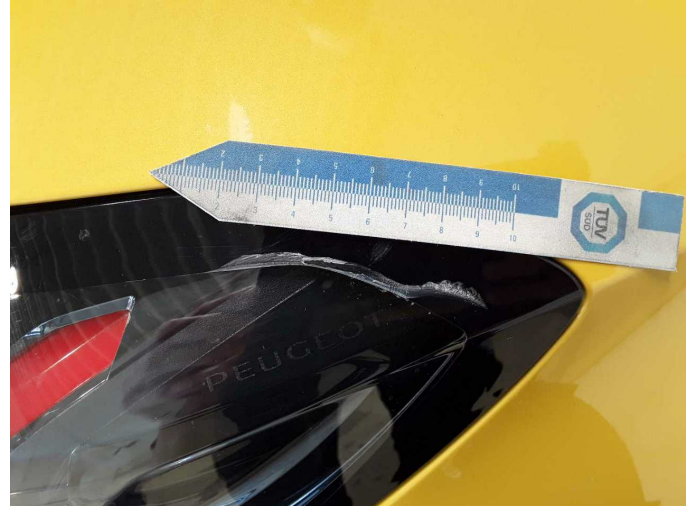
**Damage 1:** Tail light: Tail lamp - right side (Randbereich) - Scratched - Replace

| No. | Component group | Description |
|---|---|---|
| 1 | Tail light | Tail lamp - right side (Randbereich) - Scratched - Replace |

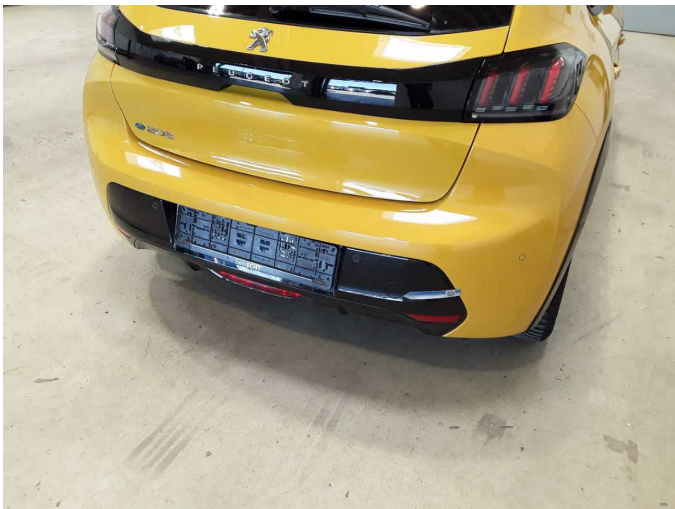
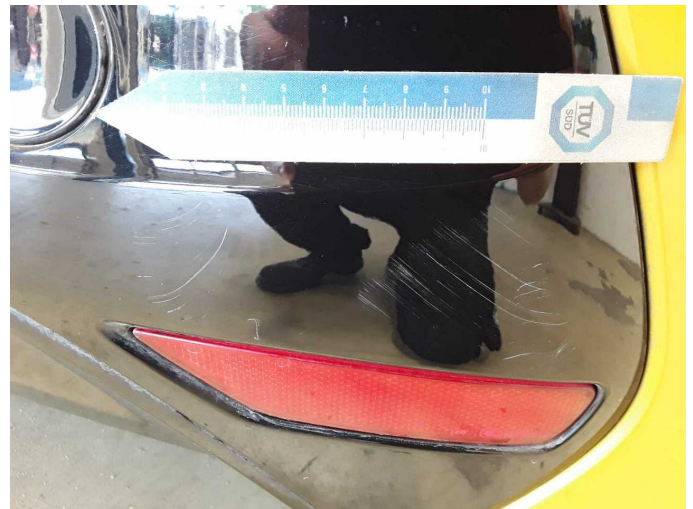
**Damage 2:** Rear bumper: Spoiler - Scratch(es) - Paint

| No. | Component group | Description |
|---|---|---|
| 2 | Rear bumper | Spoiler - Scratch(es) - Paint |

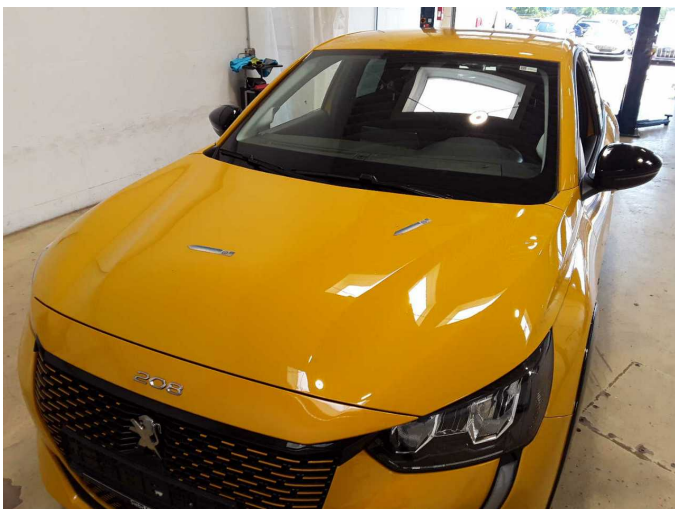
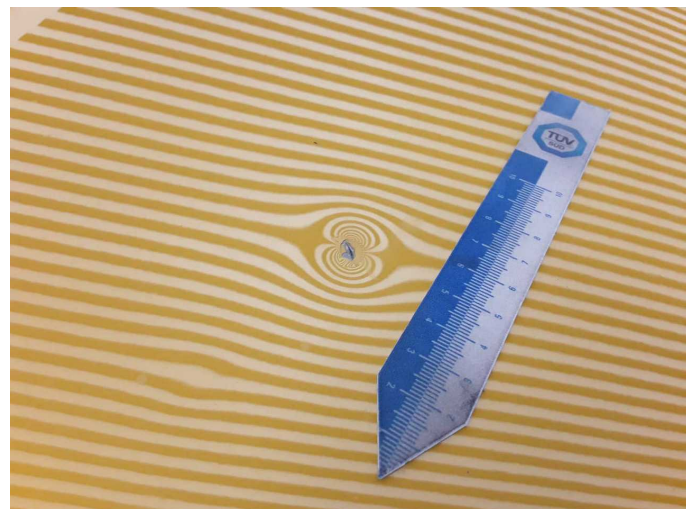
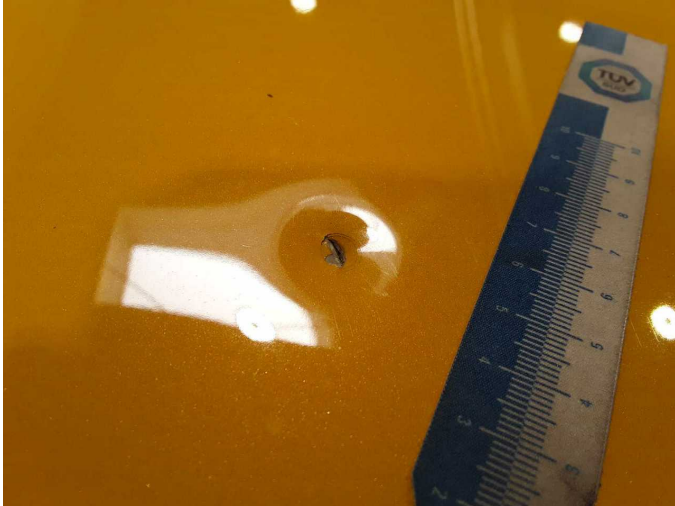
Da die stark durchgeschlagene Motorhaube nicht von Hagel so beschädigt worden sein kann- Loch vorhanden- wurde diese separat berechnet.

**Damage 3:** Bonnet: Bonnet - Damaged - repair according to calculation

| No. | Component group | Description |
|---|---|---|
| 3 | Bonnet | Bonnet - Damaged - repair according to calculation |

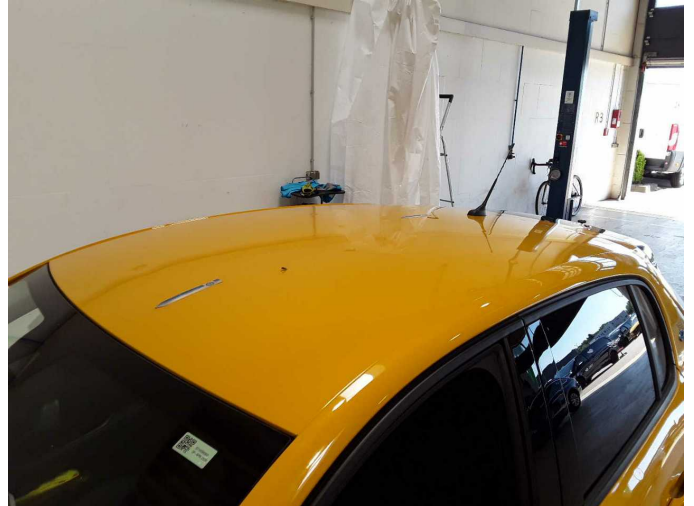
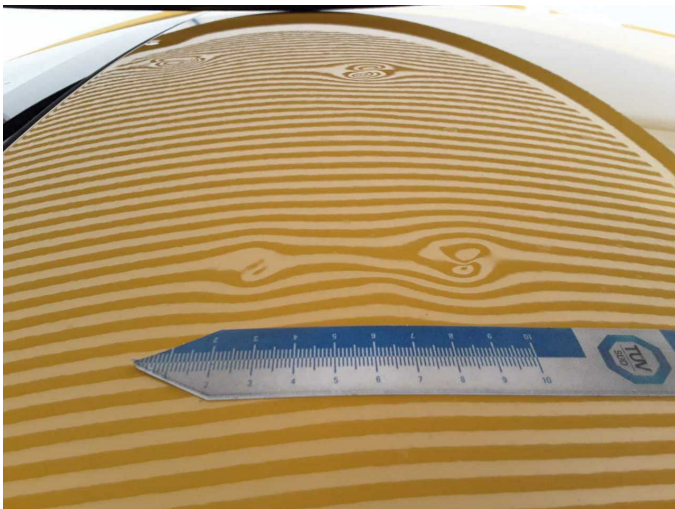
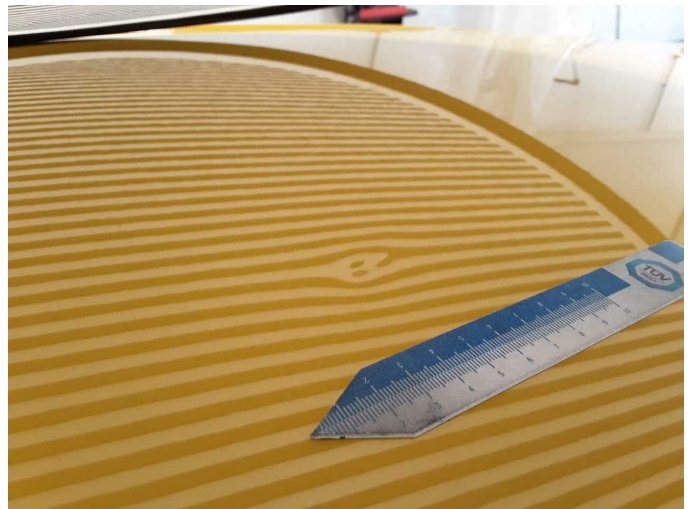
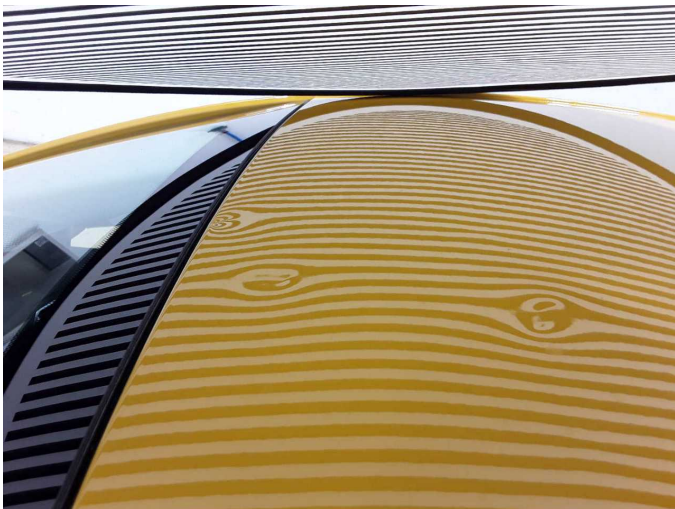
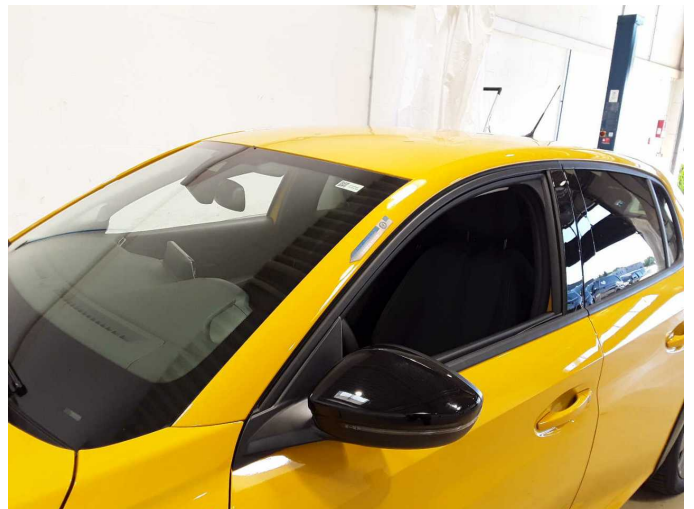
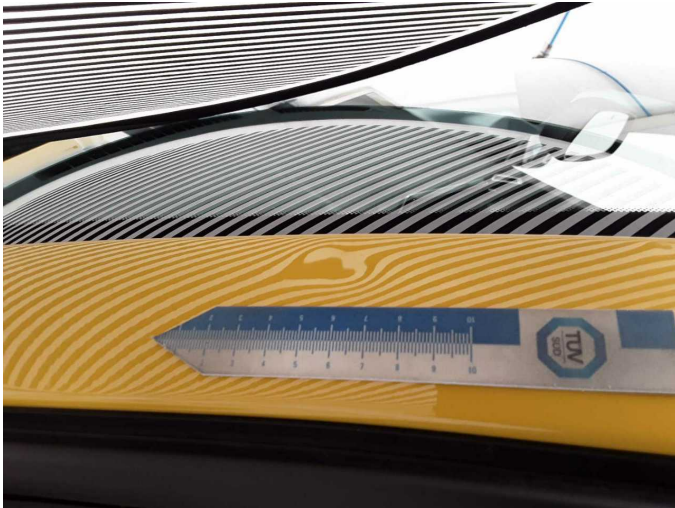
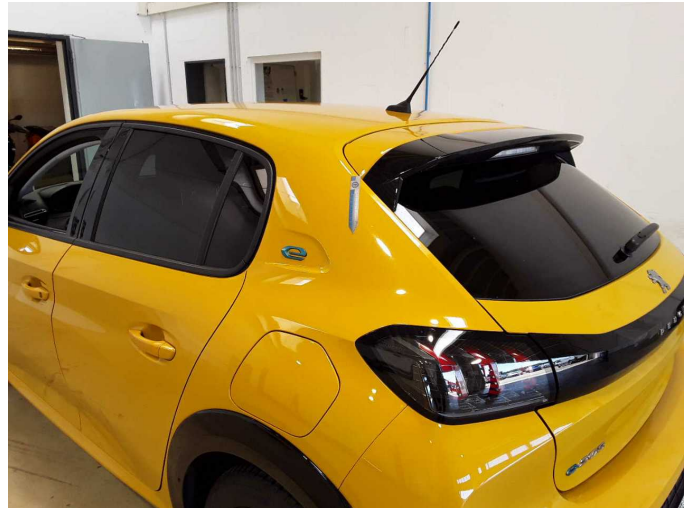
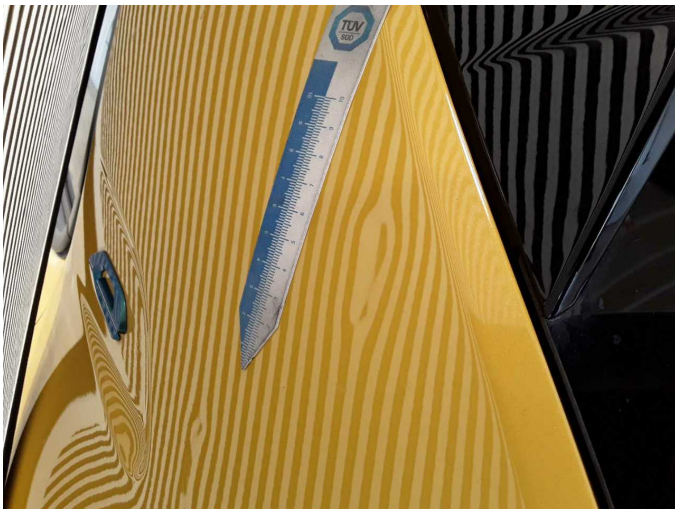
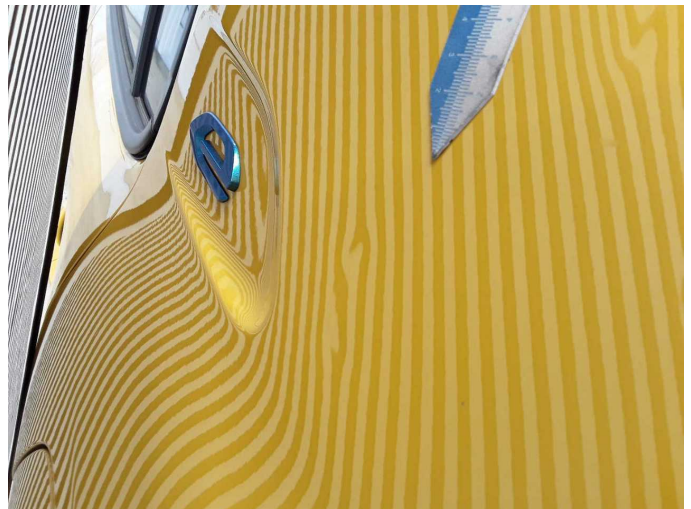
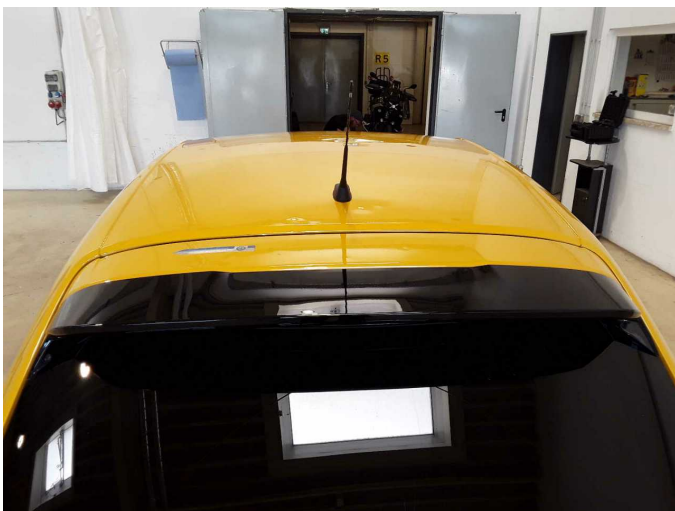
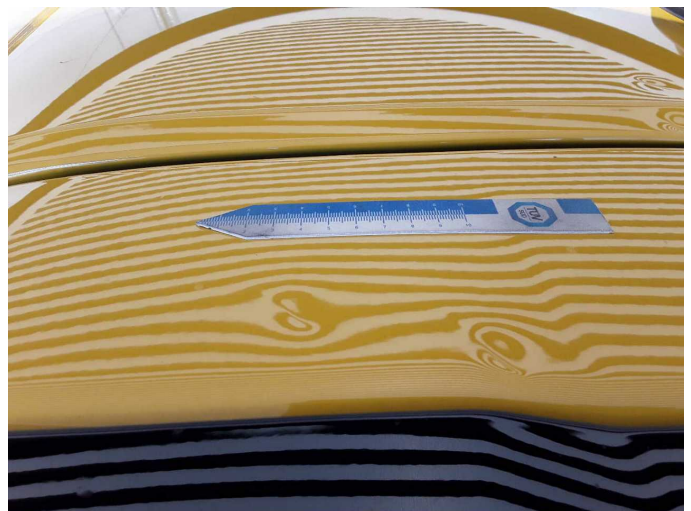
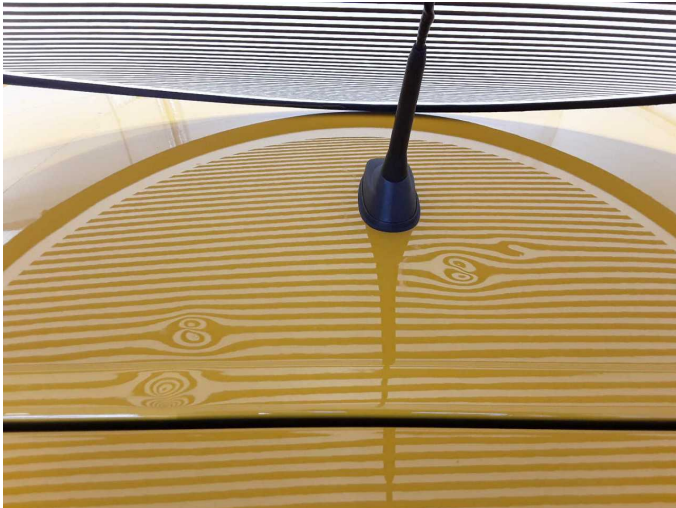
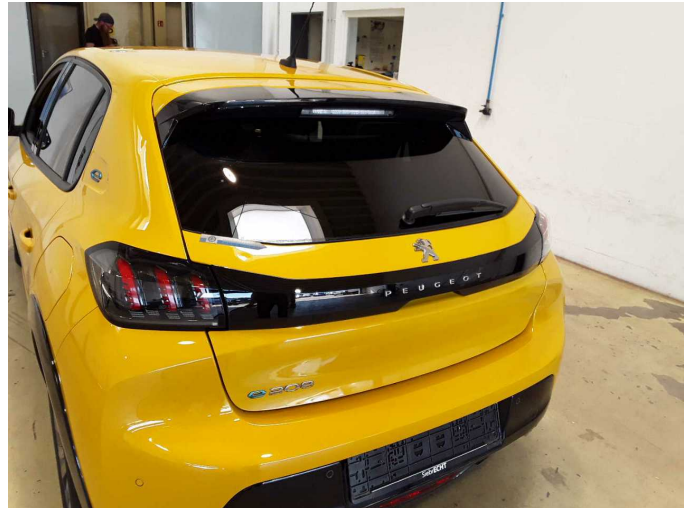
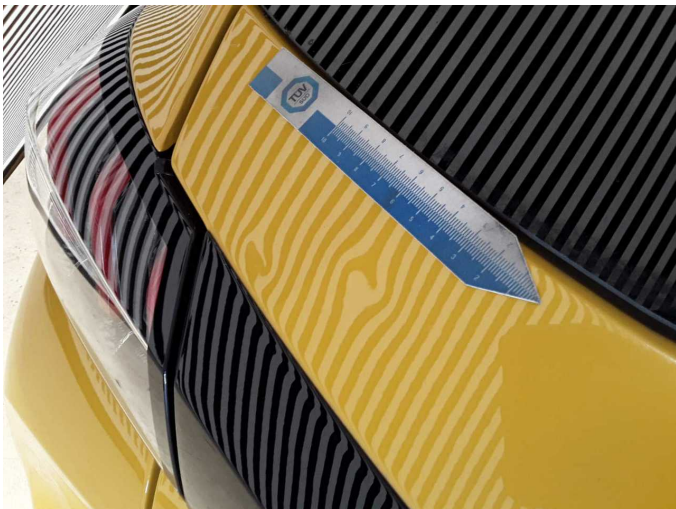
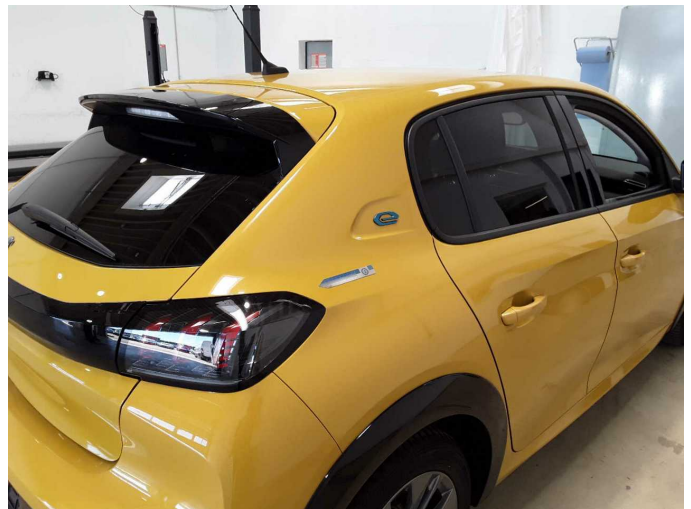
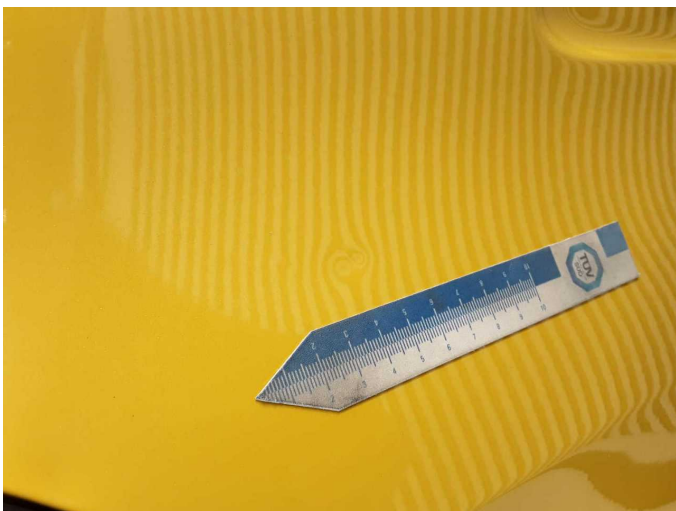
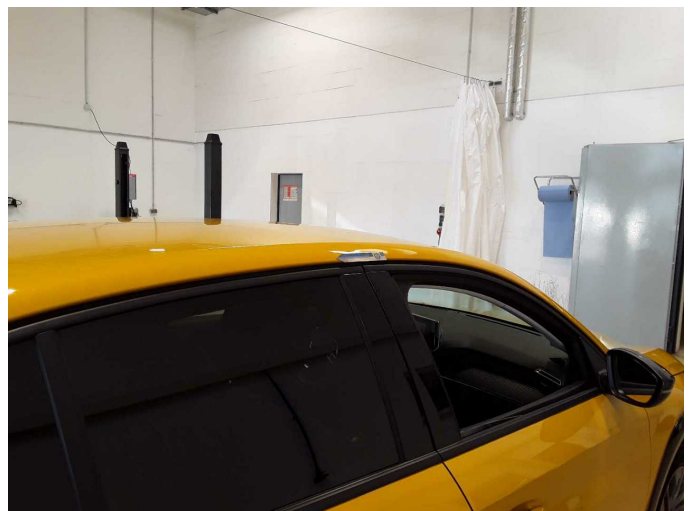
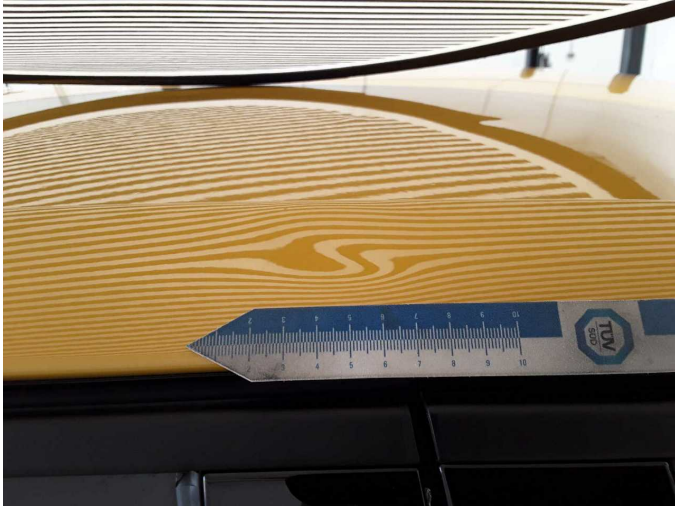
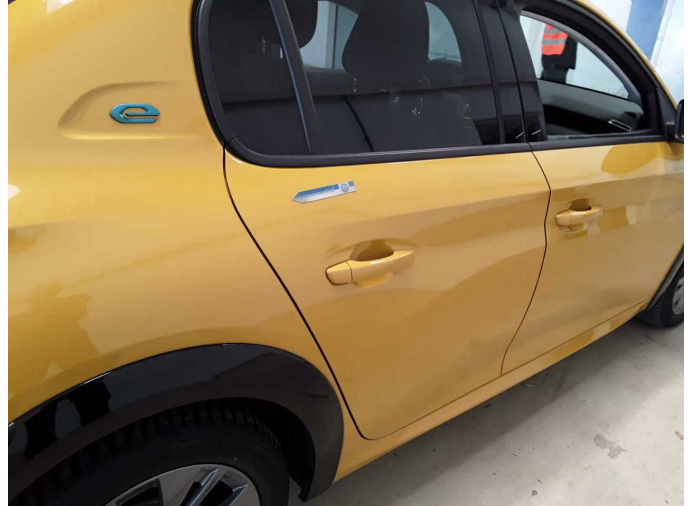
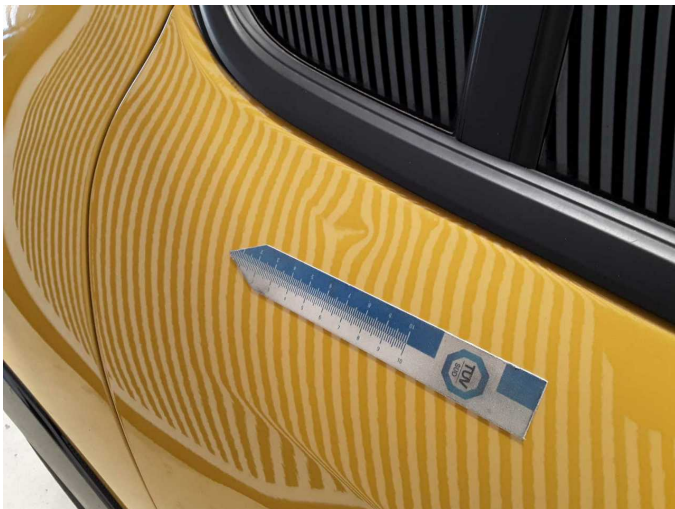
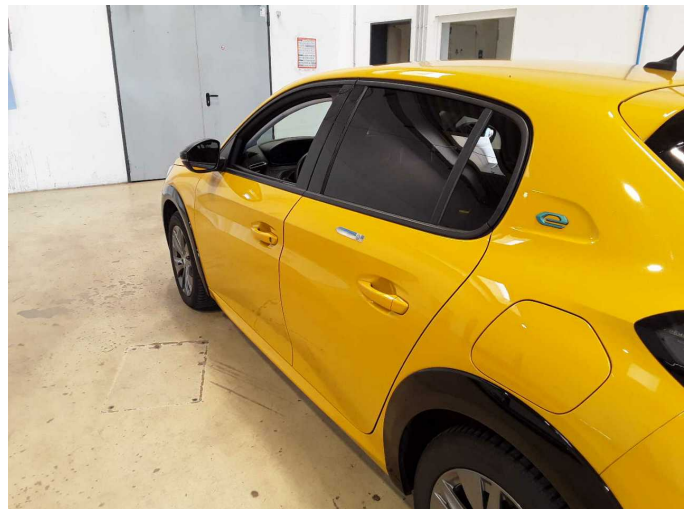
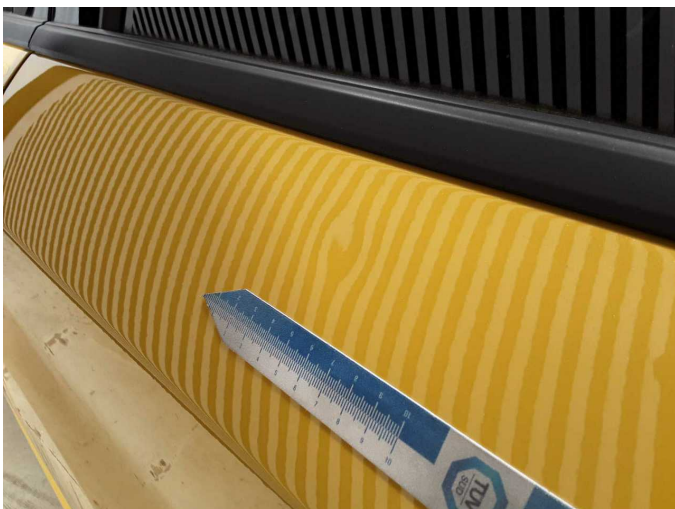
**Damage 4:** Body: Body - Damage by hail - repair according to calculation

| No. | Component group | Description |
|---|---|---|
| 4 | Body | Body - Damage by hail - repair according to calculation |

Die beigefügte Reparaturkostenkalkulation wurde nach bestem Wissen und Gewissen im demontagefreien Zustand erstellt. Es können Mehrkosten und somit Abweichung der für den Hagelschaden ausgewiesener Reparaturkosten nicht ausgeschlossen werden.
