Expertise

Protocol number: 46558070  
Order No. / Reference: 26671504  
Inspection date: 15 Jul 2026

Model: C 200 d T 9G-TRONIC Avantgarde

VIN: W1KAH0DB7PF113725

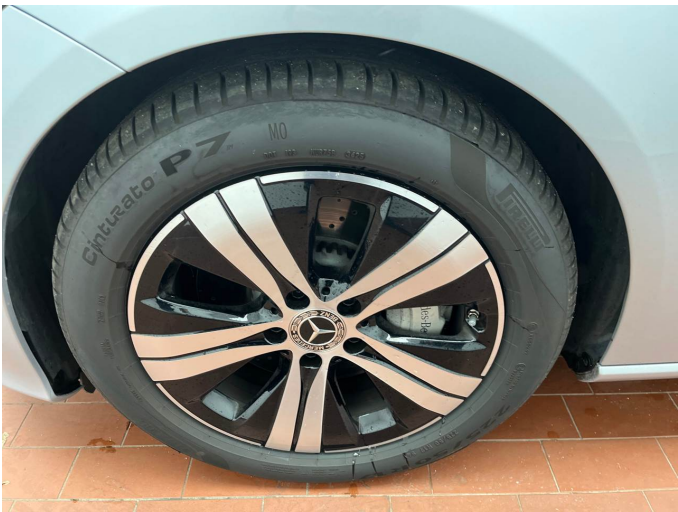
Figure 12: Mounted tyres

| # | Tyre size | Type of tyre | Manufacturer | Tread depth |
|---|---|---|---|---|
| 1) | 225/50 R17 94Y | Summer tyres on Light alloy | Pirelli | 6mm / 6mm |
| 2) | 225/50 R17 94Y | Summer tyres on Light alloy | Pirelli | 4mm / 4mm |

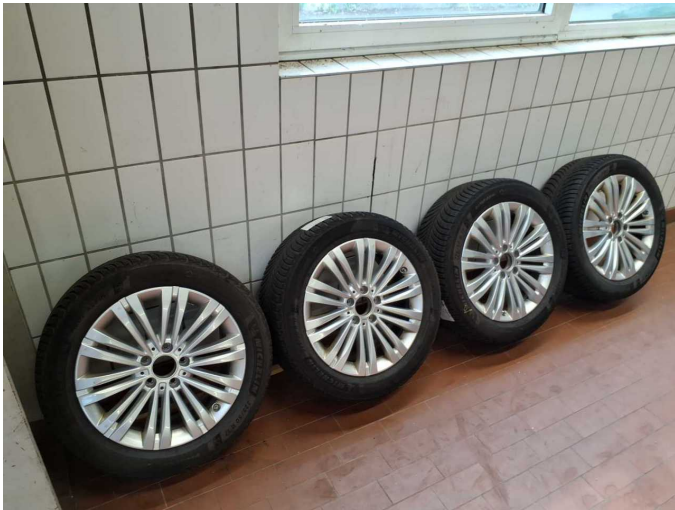
Figure 15: Additional tyres

| # | Tyre size | Type of tyre | Manufacturer | Tread depth |
|---|---|---|---|---|
| 1) | 225/50 R17 98H | Winter tyres on Light alloy | Michelin | 5mm / 5mm |
| 2) | 225/50 R17 98H | Winter tyres on Light alloy | Michelin | 6mm / 6mm |

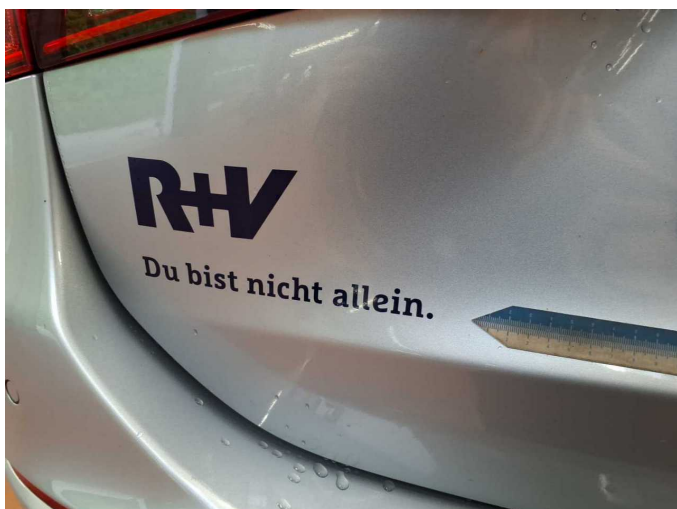
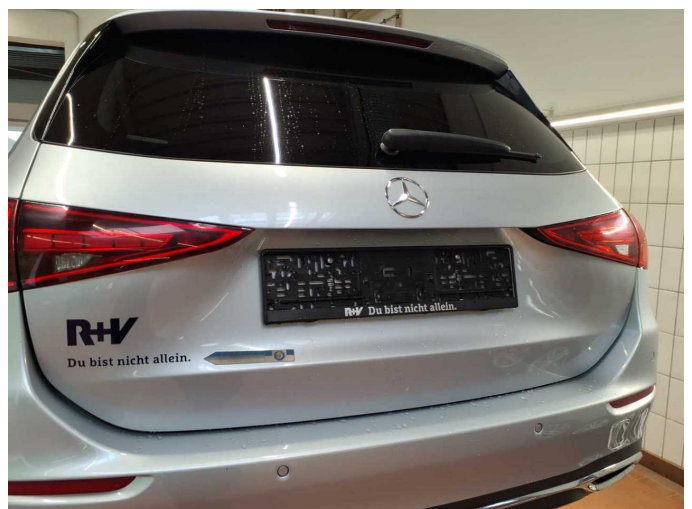
| No. | Component group | Description |
|---|---|---|
| 1 | Boot lid / rear door | Boot lid - Glued / labelled - De-glue / neutralise |

**Damage 1:** Boot lid / rear door: Boot lid - Glued / labelled - De-glue / neutralise

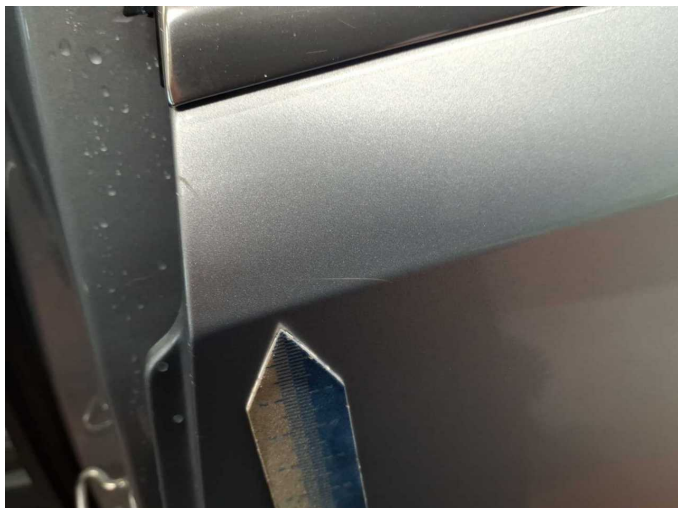
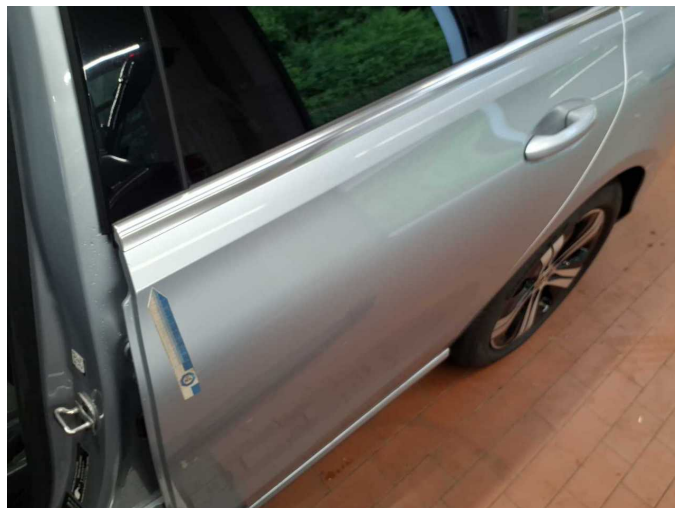
| No. | Component group | Description |
|---|---|---|
| 2 | Door - rear left side | Door - Scratch(es) - Smart repair |

**Damage 2:** Door - rear left side: Door - Scratch(es) - Smart repair

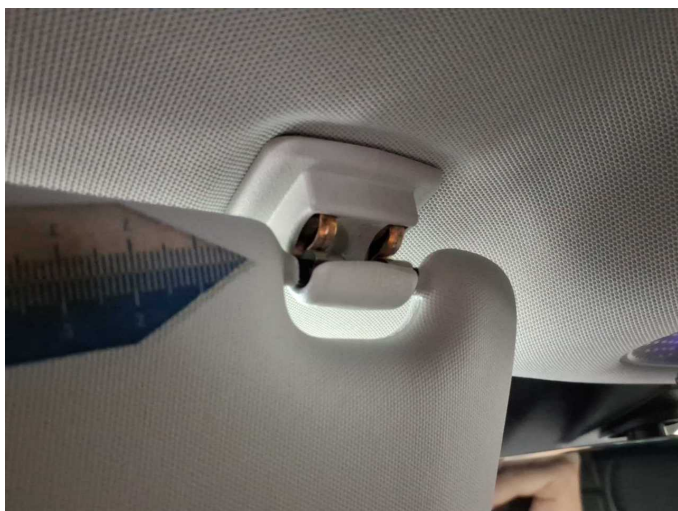
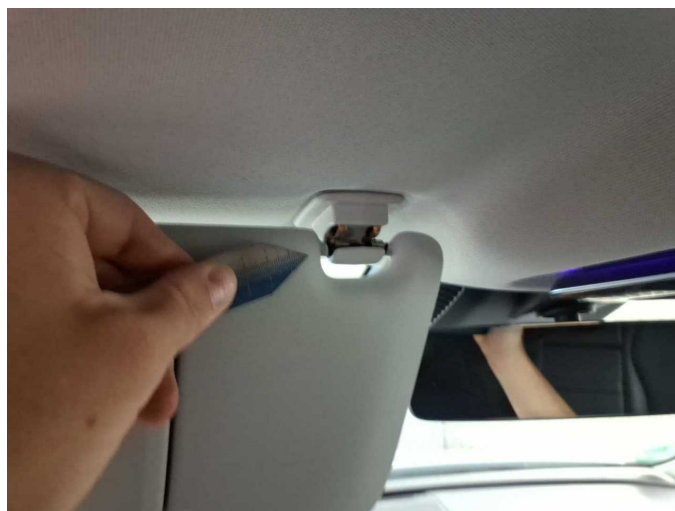
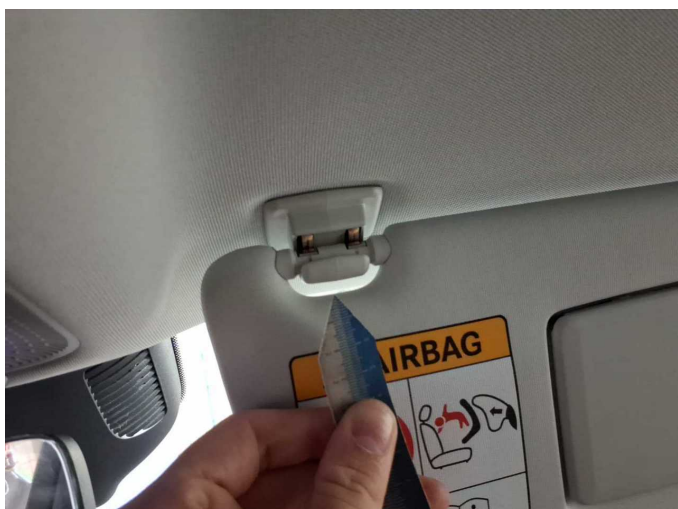
| No. | Component group | Description |
|---|---|---|
| 3 | Interior | Sun visor - left side (Kontakt für licht ohne funktion) - Sub-function - Replace |

**Damage 3:** Interior: Sun visor - left side (Kontakt für licht ohne funktion) - Sub-function - Replace

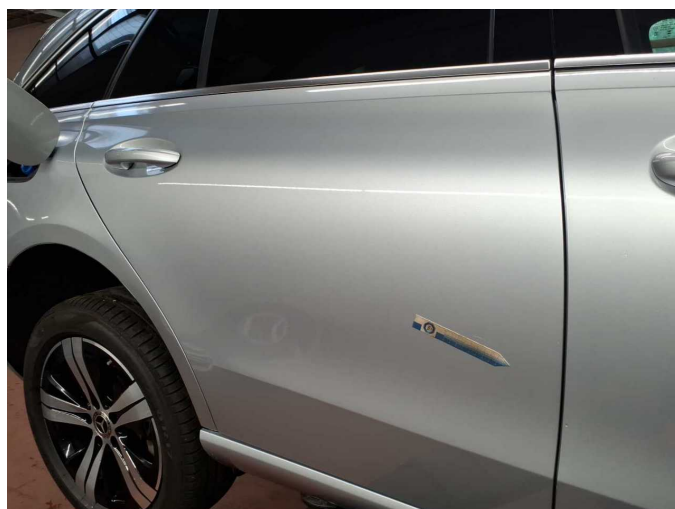
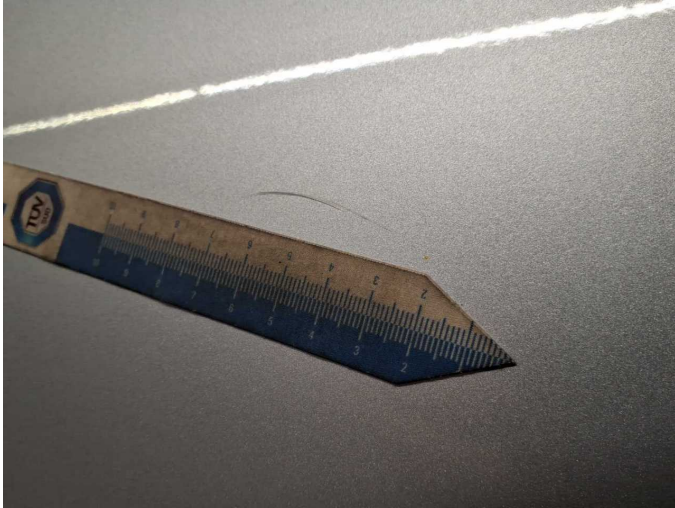
| No. | Component group | Description |
|---|---|---|
| 4 | Door - rear right side | Door - Scratch(es) - Paint |

**Damage 4:** Door - rear right side: Door - Scratch(es) - Paint

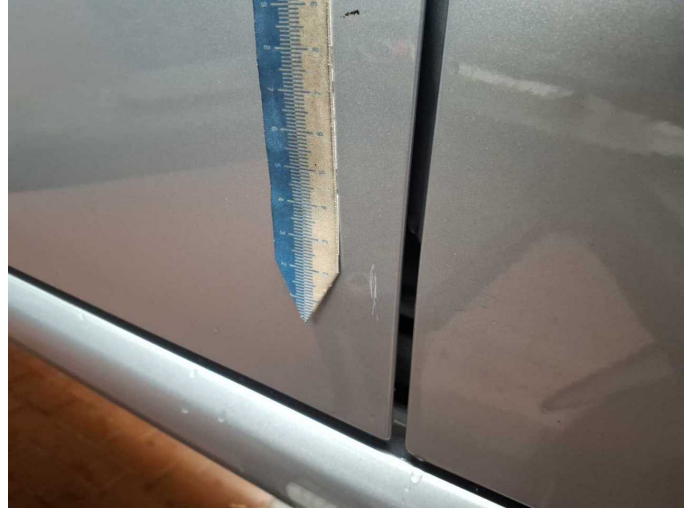
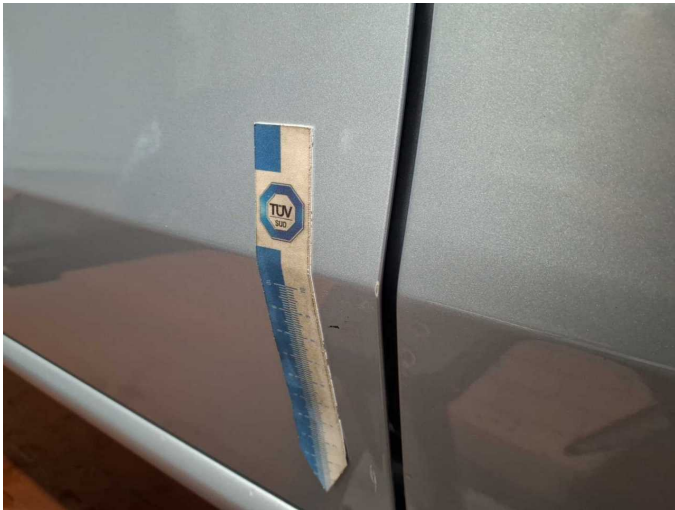
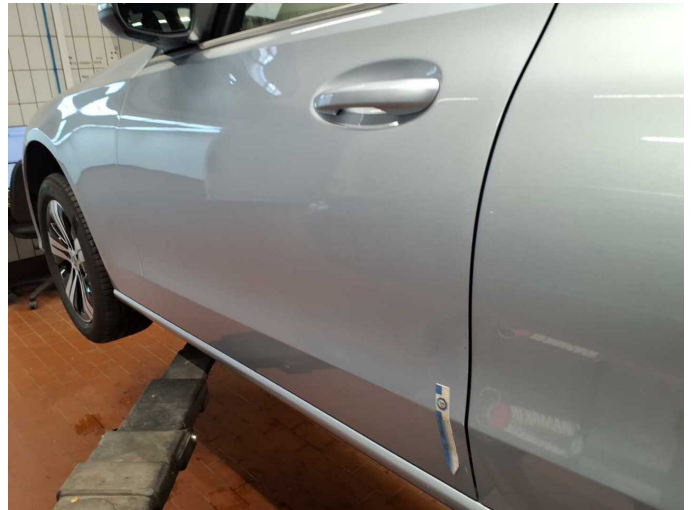
| No. | Component group | Description |
|---|---|---|
| 5 | Door - front left side | Door - Scratch(es) - Paint |

**Damage 5:** Door - front left side: Door - Scratch(es) - Paint

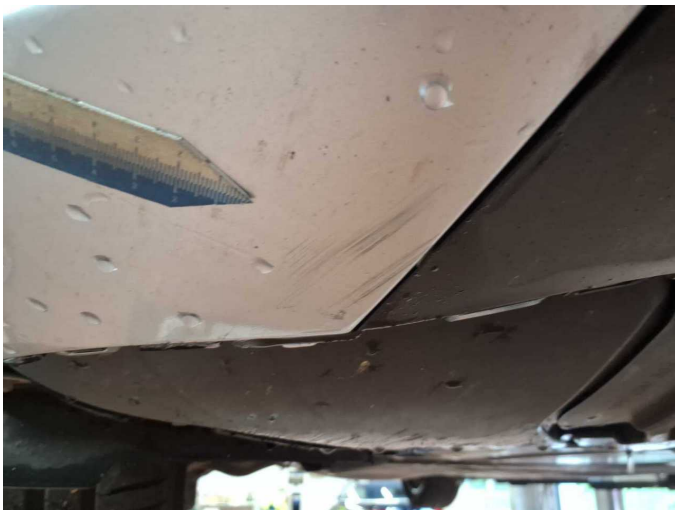
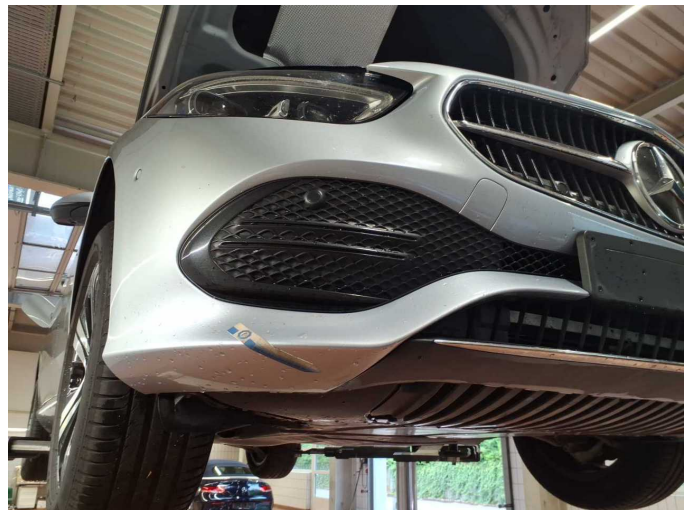
| No. | Component group | Description |
|---|---|---|
| 1 | Front bumper | Front bumper - Scratch(es) - No deduction |

**Wear and tear 1:** Front bumper: Front bumper - Scratch(es) - No deduction

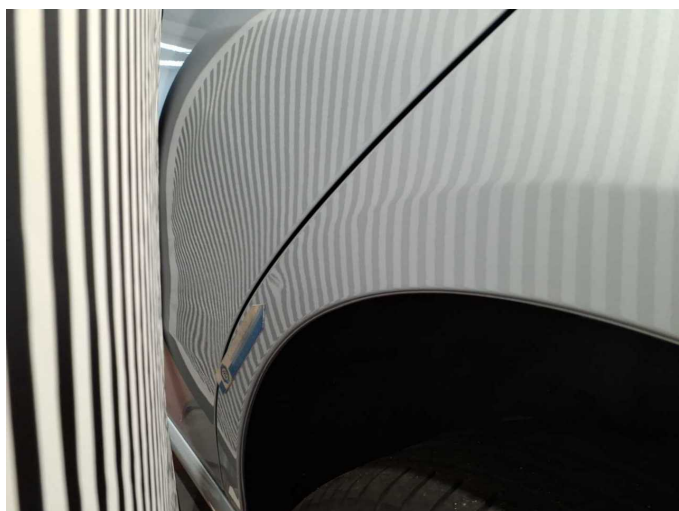
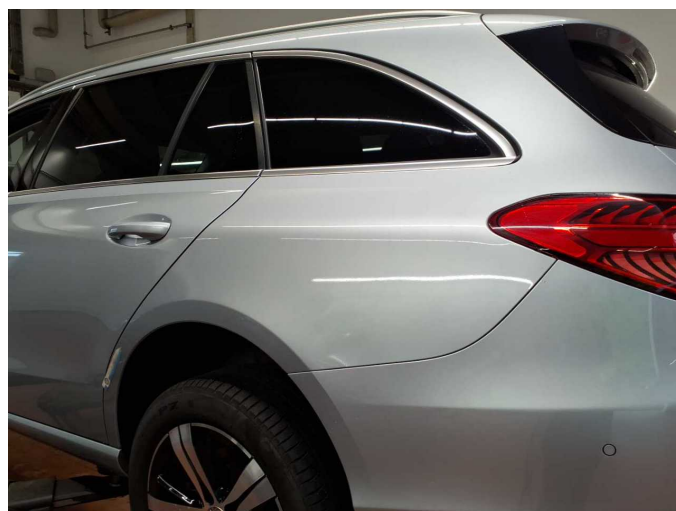
| No. | Component group | Description |
|---|---|---|
| 2 | Side panel - rear left side | Side panel - dent(s) - No deduction |

**Wear and tear 2:** Side panel - rear left side: Side panel - dent(s) - No deduction

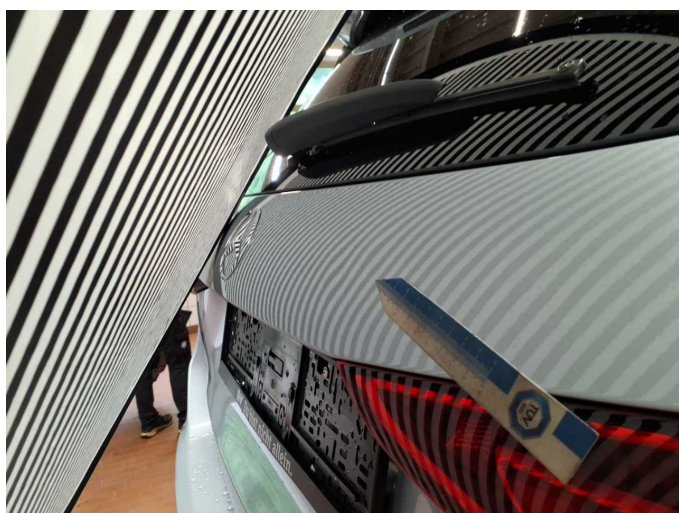
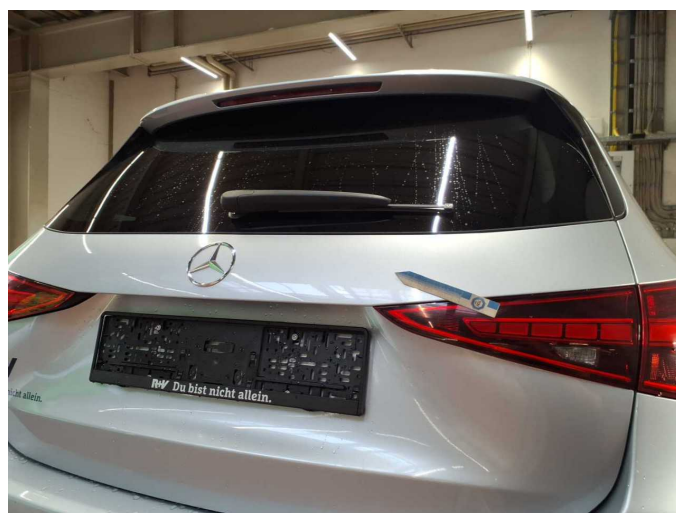
| No. | Component group | Description |
|---|---|---|
| 3 | Boot lid / rear door | Boot lid - dent(s) - No deduction |

**Wear and tear 3:** Boot lid / rear door: Boot lid - dent(s) - No deduction

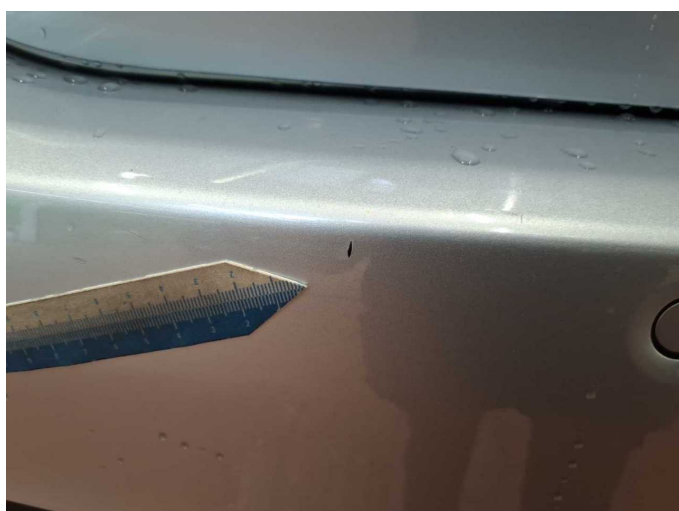
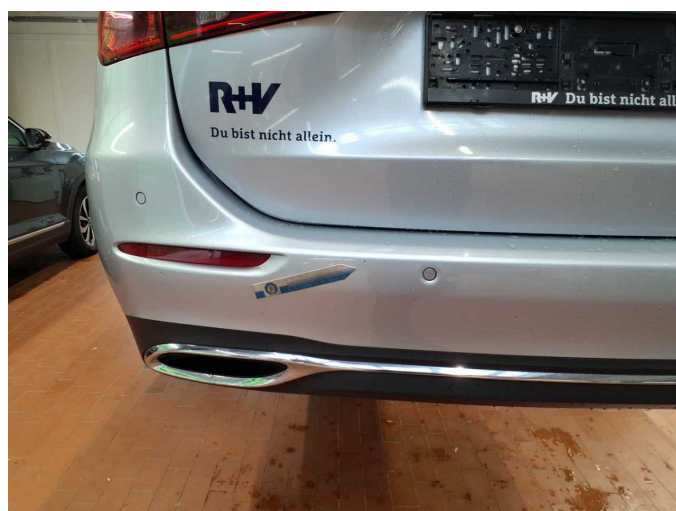
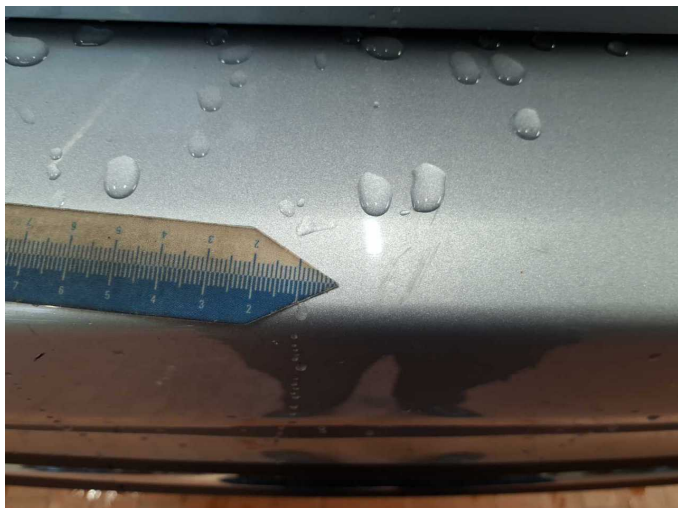
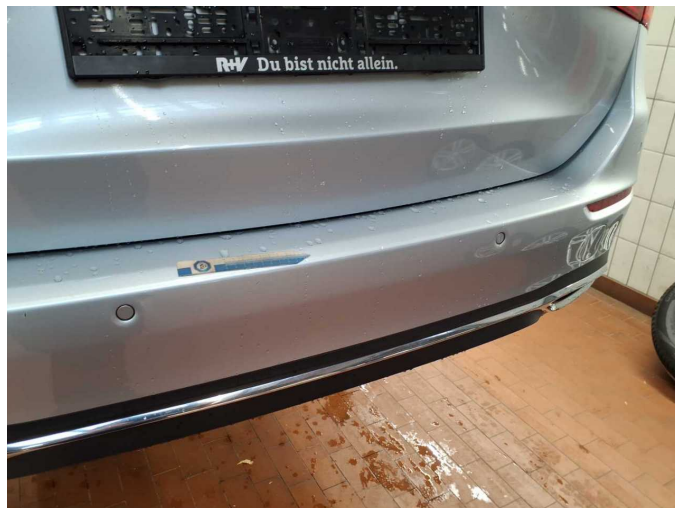
| No. | Component group | Description |
|---|---|---|
| 4 | Rear bumper | Rear bumper (Verladebereich) - Scratch(es) - No deduction |

**Wear and tear 4:** Rear bumper: Rear bumper (Verladebereich) - Scratch(es) - No deduction

**Wear and tear 4:** Rear bumper: Rear bumper (Verladebereich) -  
Scratch(es) - No deduction

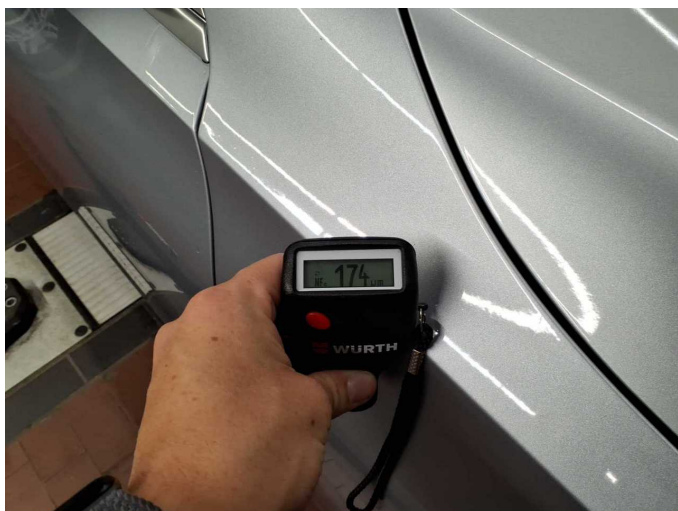
- Mudguard - right side, Professionally carried out, Invoice of repair done Non-existent
- Door - front right side, Professionally carried out, Invoice of repair done Non-existent

| Mudguard - right side | 174 µm | Door - front right side | 173 µm |

**Repainting 1:** Mudguard - right side

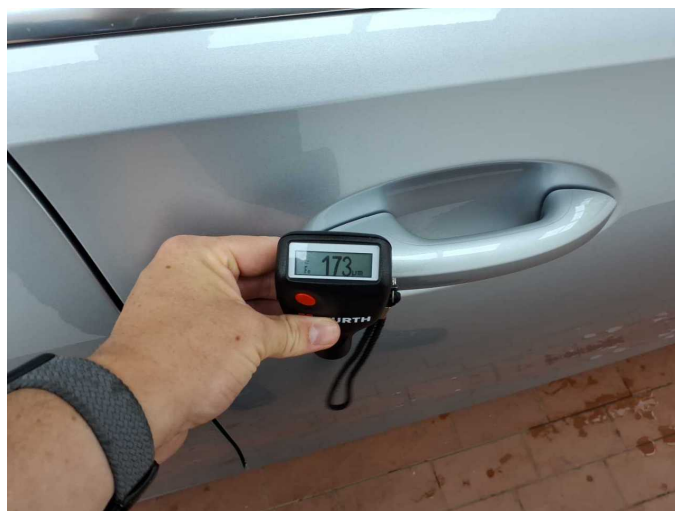
**Repainting 2:** Door - front right side
