Expertise

Protocol number: 46426043  
Order No. / Reference: 26554411  
Inspection date: 9 Jul 2026

Manufacturer: Audi

Model: A6 50 TDI quattro tiptronic sport

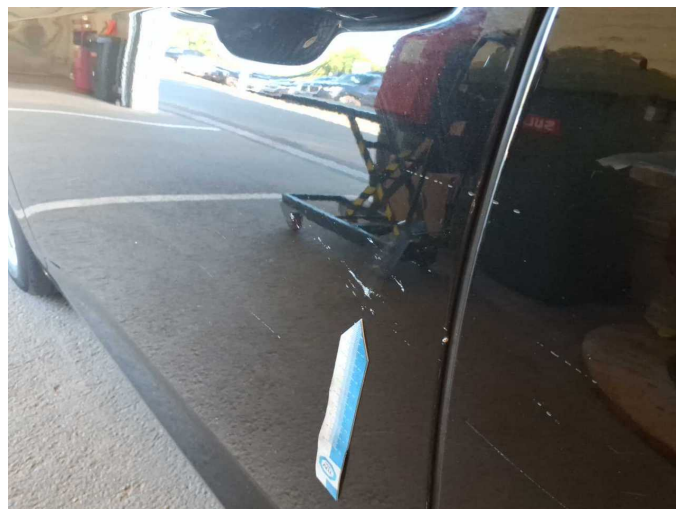
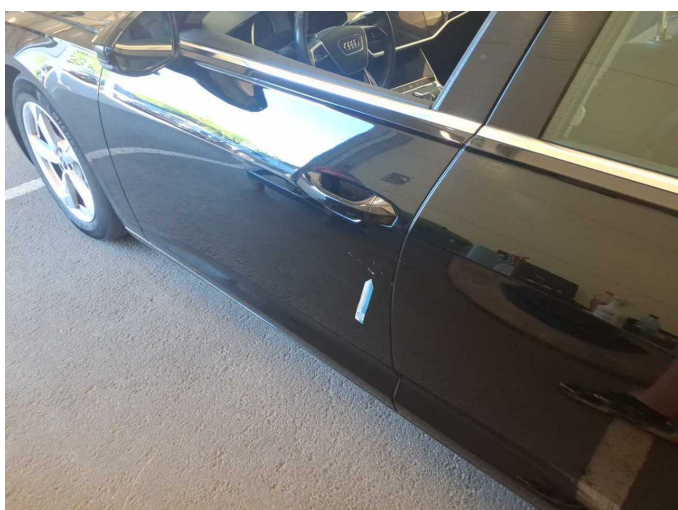
| No. | Component group | Description |
|---|---|---|
| 1 | Door - front left side | Door (Polieren) - Soiled - Smart repair |

**Damage 1:** Door - front left side: Door (Polieren) - Soiled - Smart repair

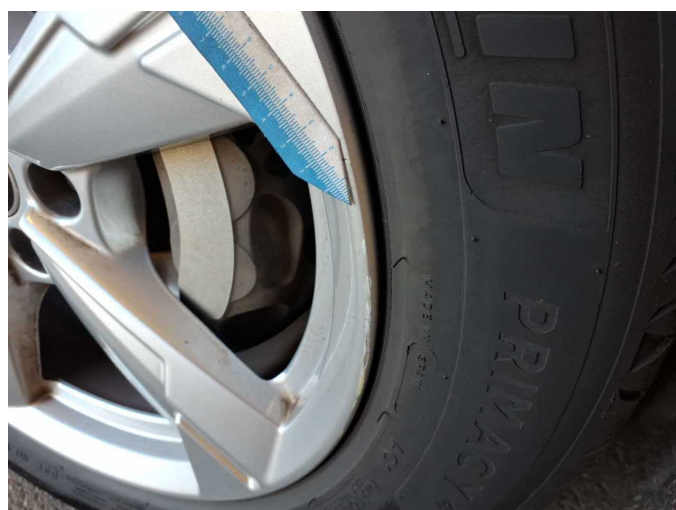
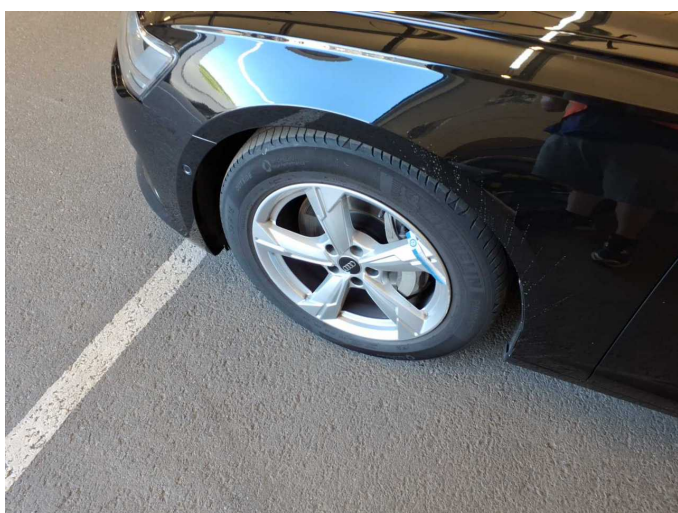
| No. | Component group | Description |
|---|---|---|
| 2 | Wheel / tyres | Alloy rim - front left side - Scratch(es) - Loss in value |

**Damage 2:** Wheel / tyres: Alloy rim - front left side - Scratch(es) - Loss in value

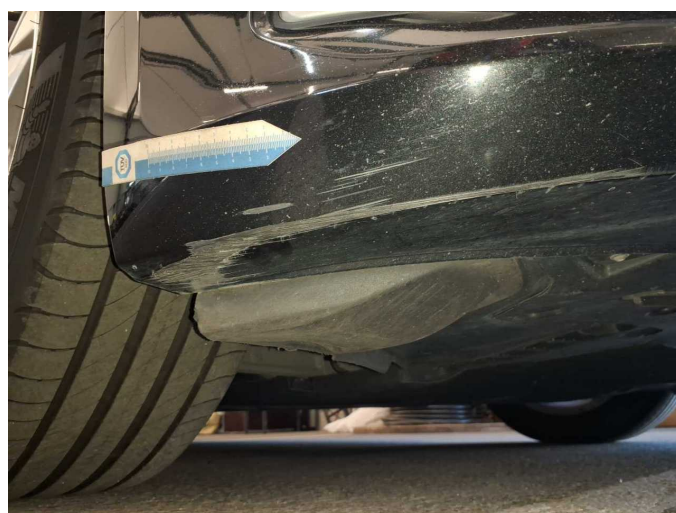
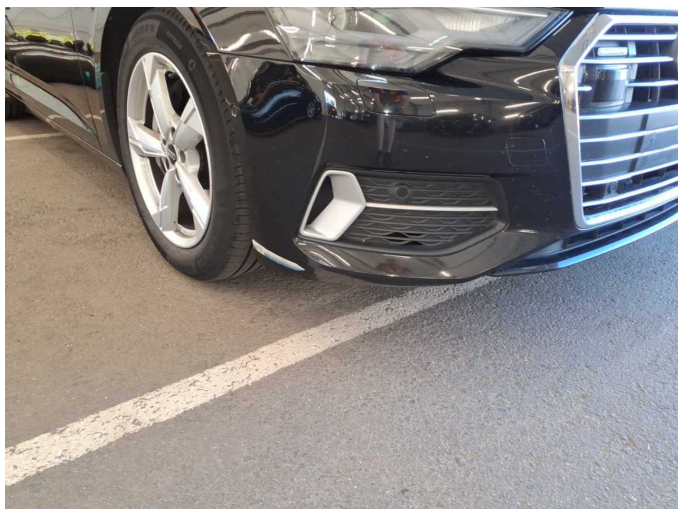
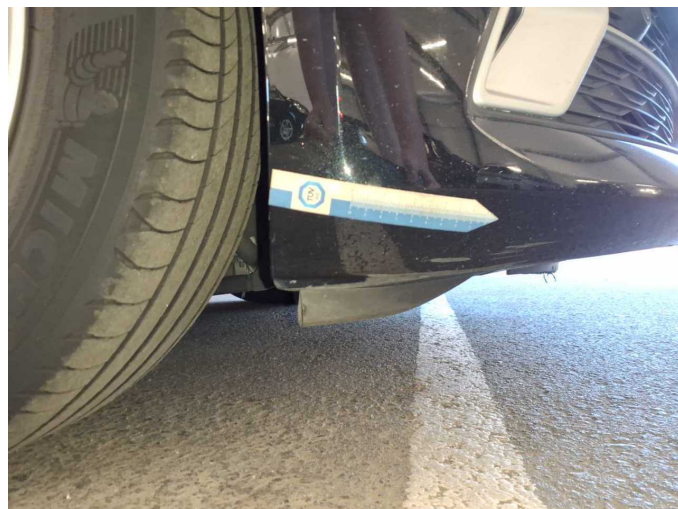
| No. | Component group | Description |
|---|---|---|
| 3 | Front bumper | Front bumper - Scratched - Repair and paint |

**Damage 3:** Front bumper: Front bumper - Scratched - Repair and paint

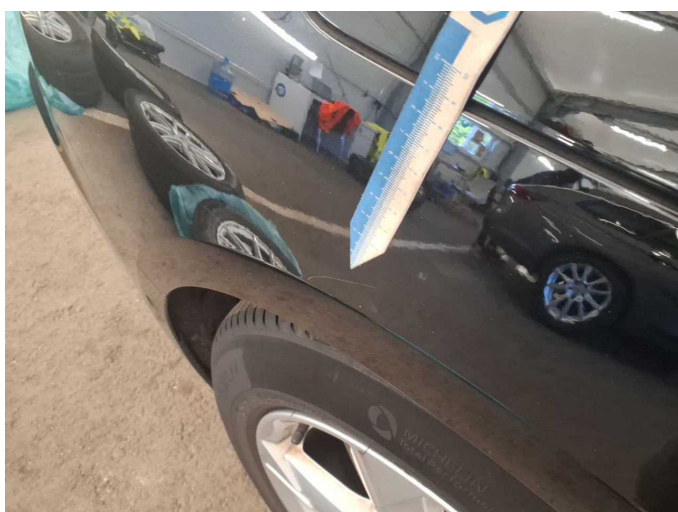
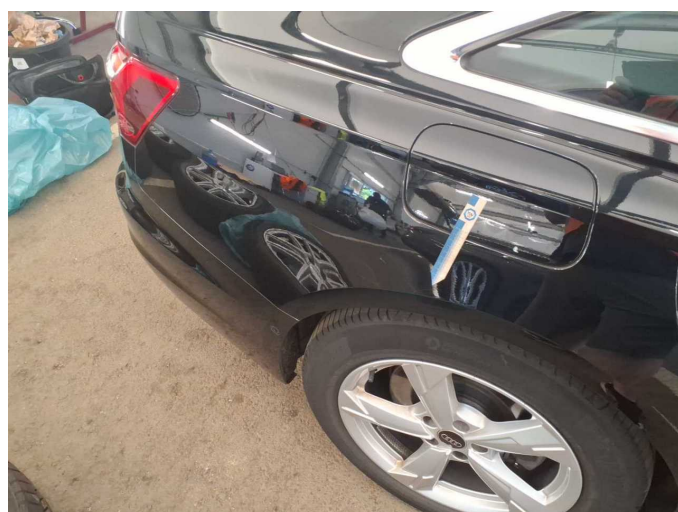
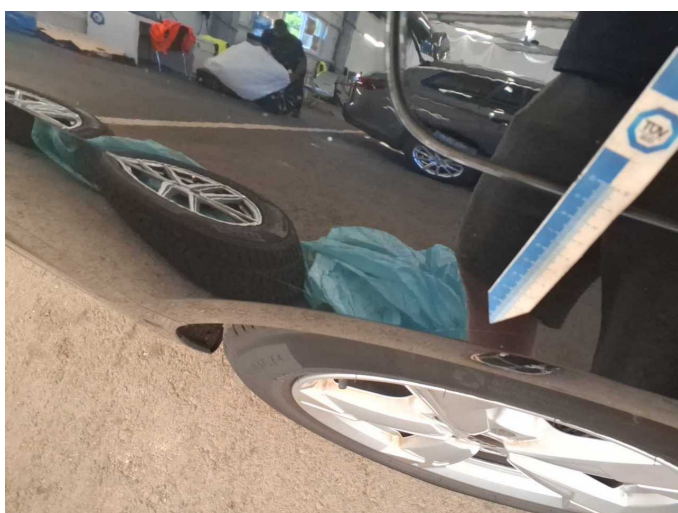
| No. | Component group | Description |
|---|---|---|
| 4 | Side panel - rear right side | Side panel - Scratch(es) - Paint |

**Damage 4:** Side panel - rear right side: Side panel - Scratch(es) - Paint

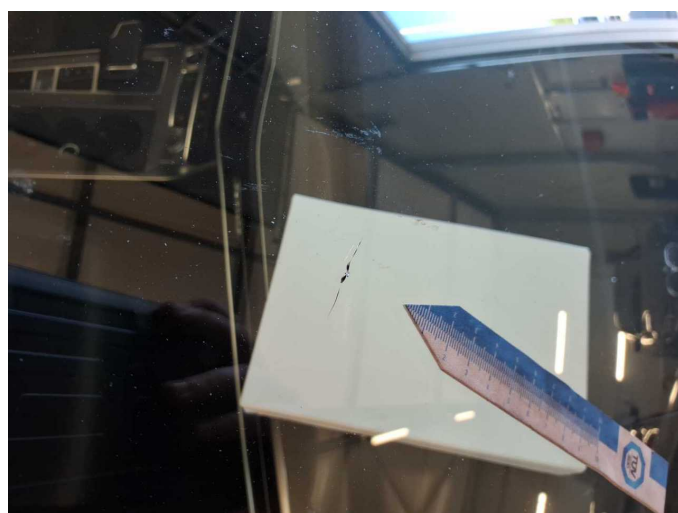
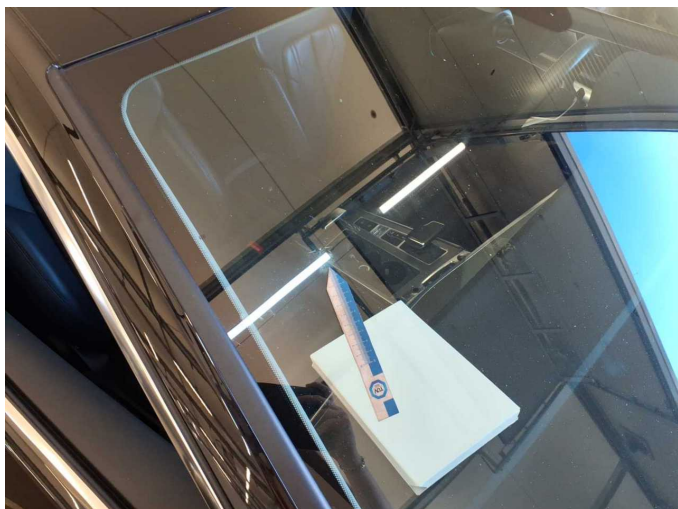
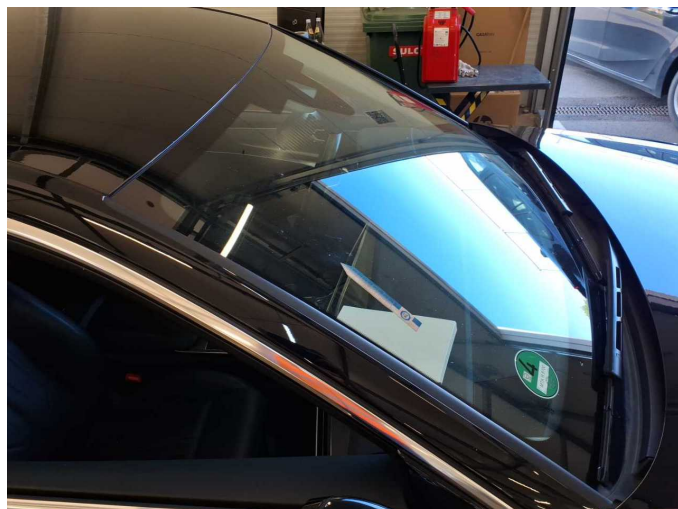
| No. | Component group | Description |
|---|---|---|
| 5 | Vehicle glazing | Windscreen - Broken / torn - Replace |

**Damage 5:** Vehicle glazing: Windscreen - Broken / torn - Replace

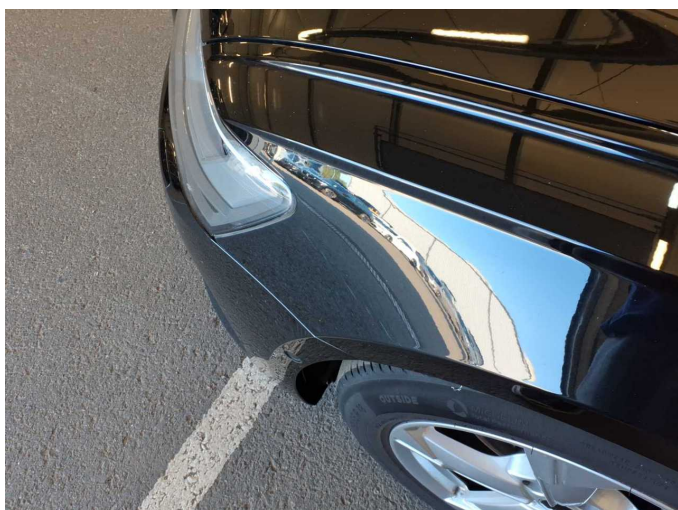
| No. | Component group | Description |
|---|---|---|
| 1 | Mudguard - left side | Mudguard - left side - Scratch(es) - No deduction |

**Wear and tear 1:** Mudguard - left side: Mudguard - left side - Scratch(es)  
- No deduction

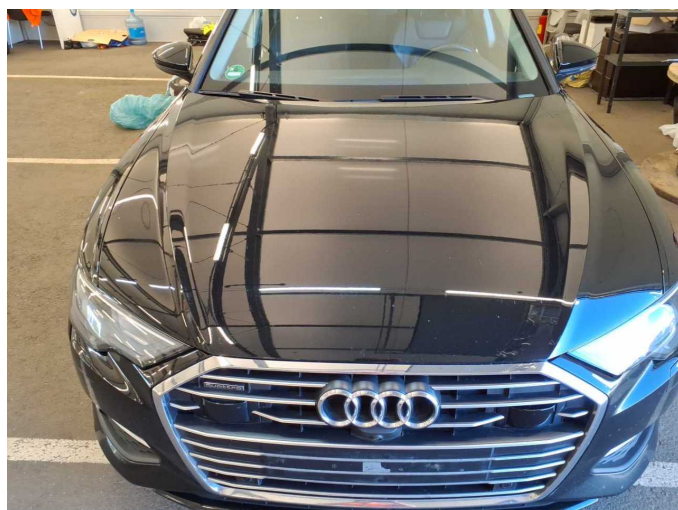
| No. | Component group | Description |
|---|---|---|
| 2 | Bonnet | Bonnet - Stone chips - No deduction |

**Wear and tear 2:** Bonnet: Bonnet - Stone chips - No deduction

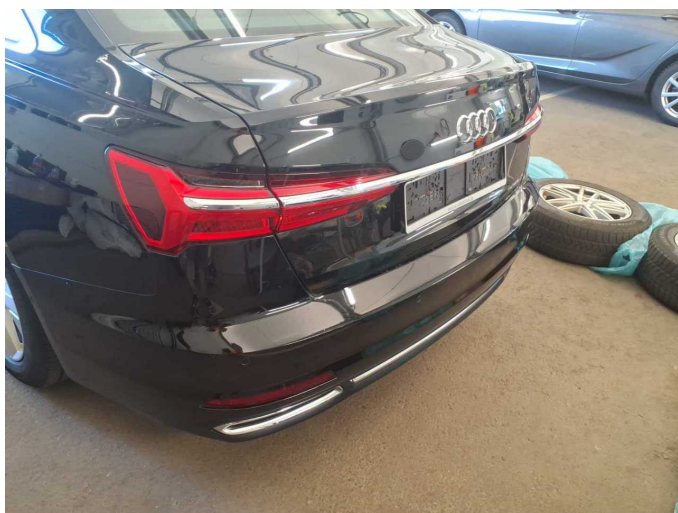
| No. | Component group | Description |
|---|---|---|
| 4 | Rear bumper | Rear bumper - Scratch(es) - No deduction |

**Wear and tear 4:** Rear bumper: Rear bumper - Scratch(es) - No deduction
