Expertise

Protocol number: 46871295  
Order No. / Reference: 26760164  
Inspection date: 4 Aug 2026

Manufacturer: Polestar

Model: 2 Single Motor 69kWh

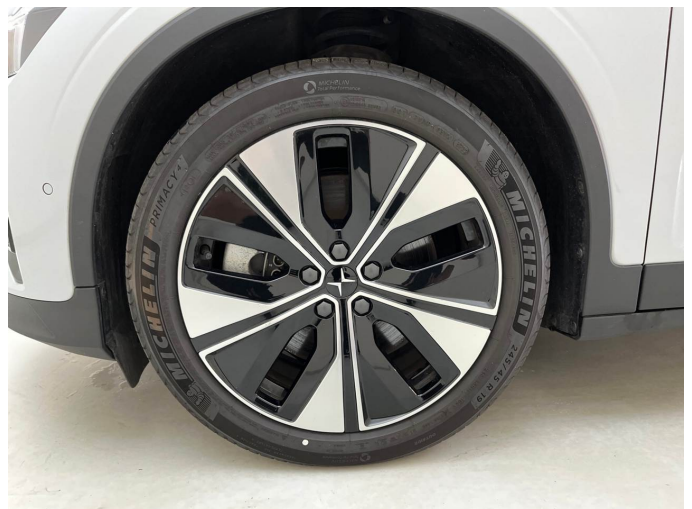
| # | Tyre size | Type of tyre | Manufacturer | Tread depth |
|---|---|---|---|---|
| 1) | 245/45 R19 102V | Summer tyres on Light alloy | Michelin | 5mm / 5mm |

Figure 12: Mounted tyres

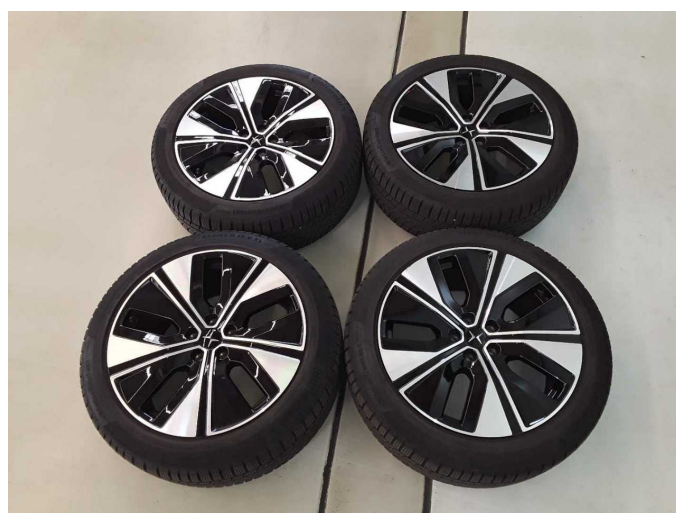
| # | Tyre size | Type of tyre | Manufacturer | Tread depth |
|---|---|---|---|---|
| 1) | 245/45 R19 102V | Winter tyres on Light alloy | Continental | 6mm / 6mm |

**Figure 18: Additional tyres**

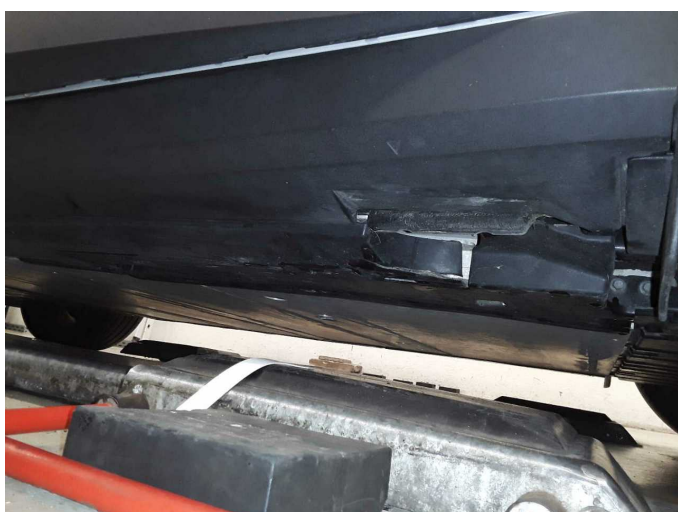
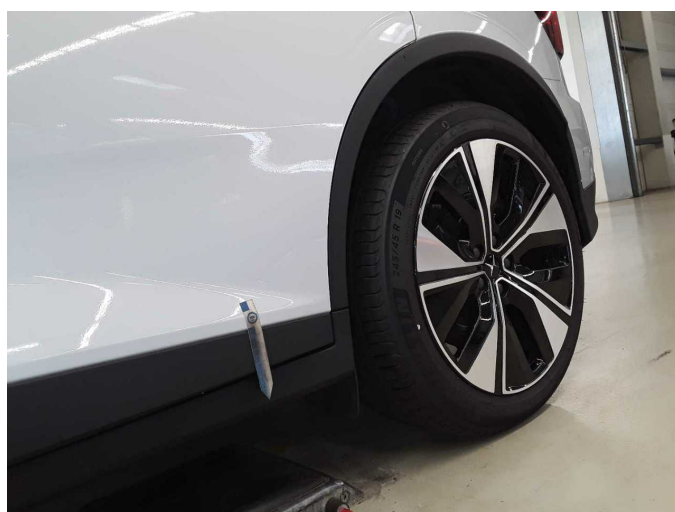
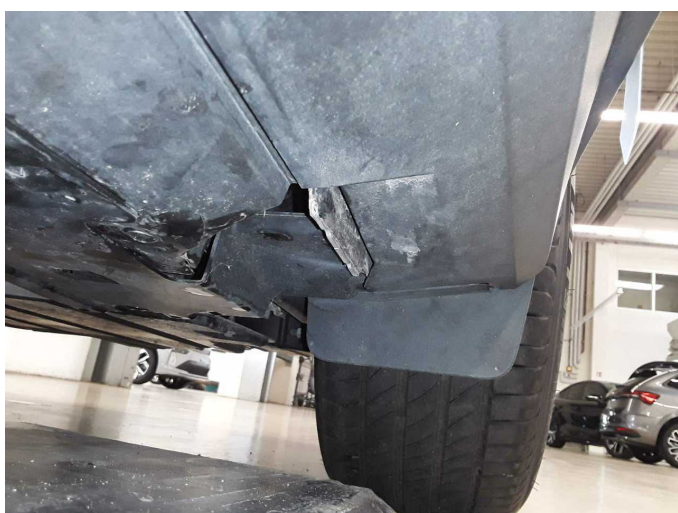
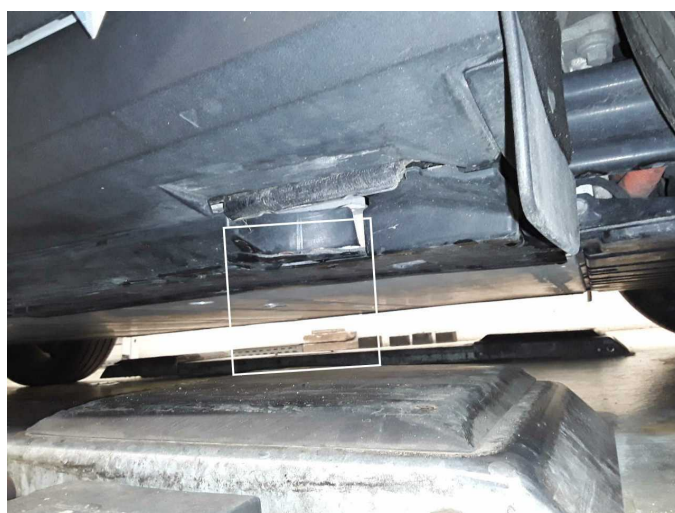
| No. | Component group | Description |
|---|---|---|
| 1 | Body | Underbody panelling - Broken / torn - Replace |

Damage 1: Body: Underbody panelling - Broken / torn - Replace

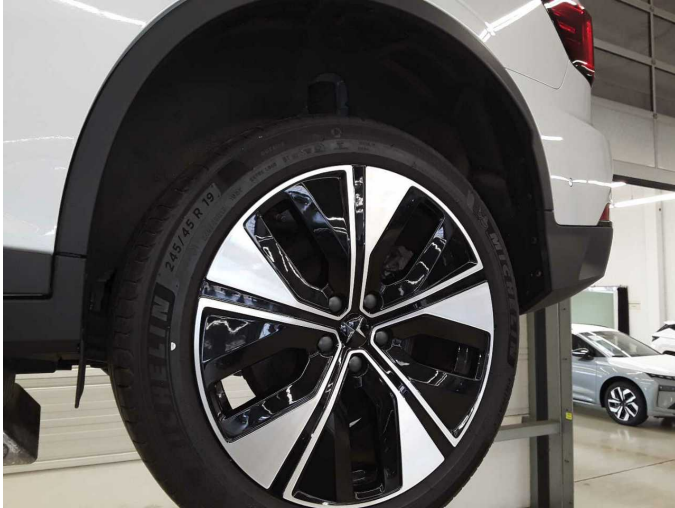
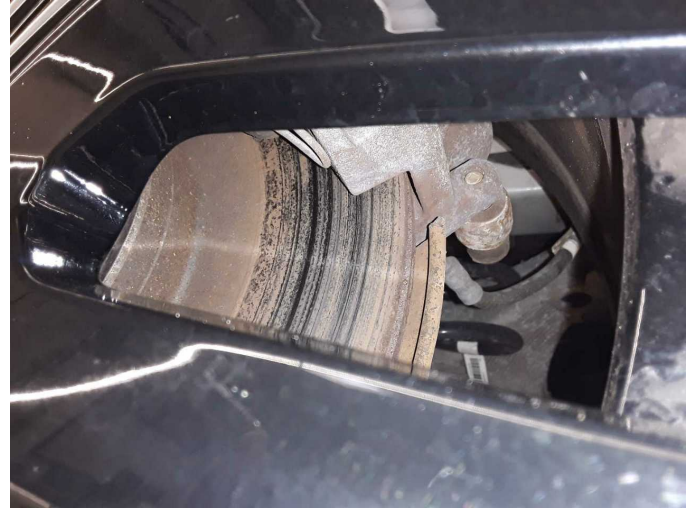
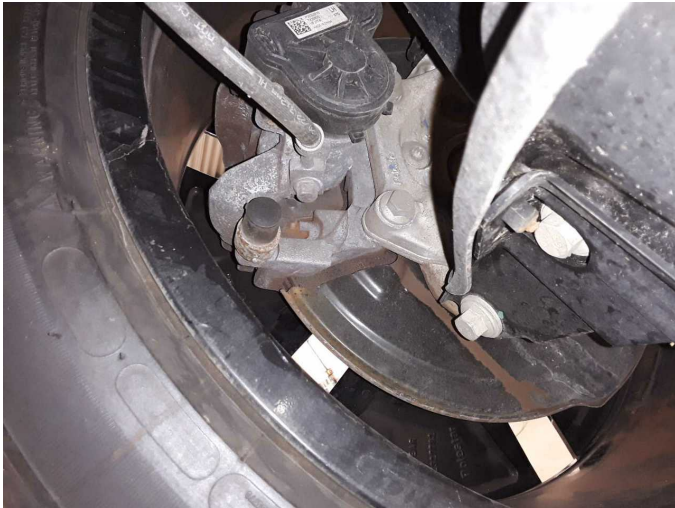
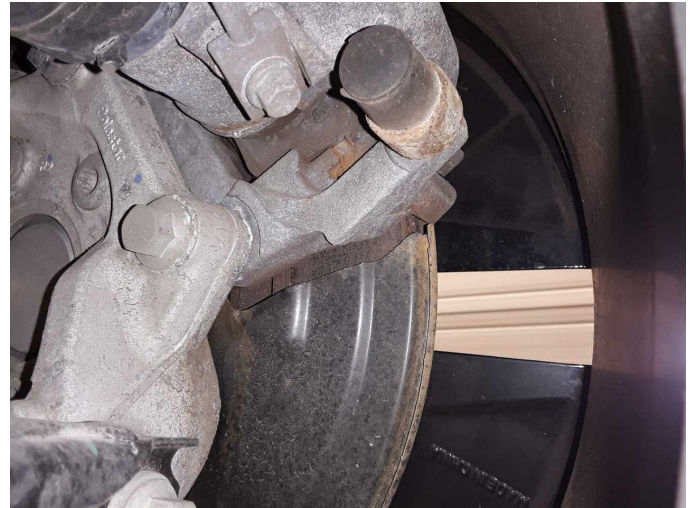
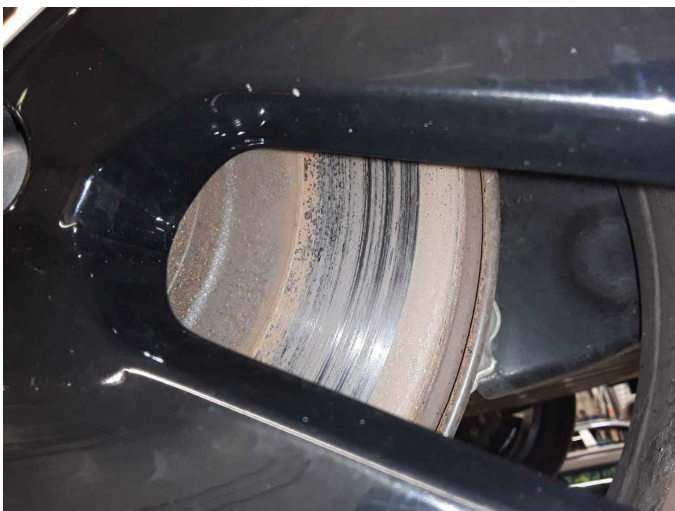
| No. | Component group | Description |
|---|---|---|
| 2 | Braking system | Brake discs and pads - rear - Corrosion - Replace |

**Damage 2:** Braking system: Brake discs and pads - rear - Corrosion - Replace

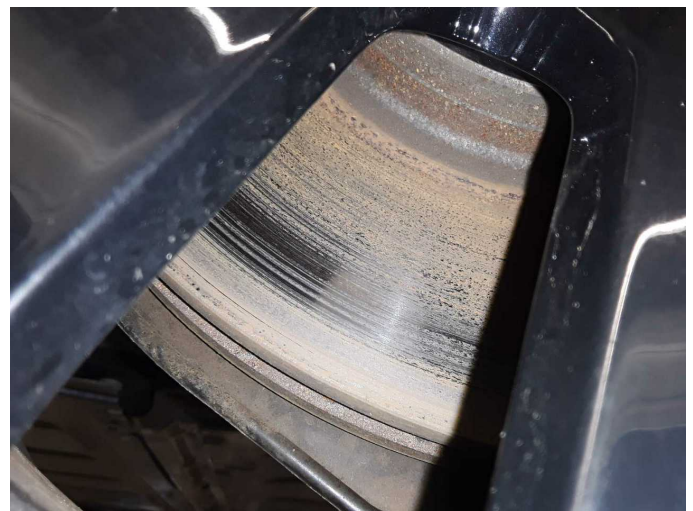
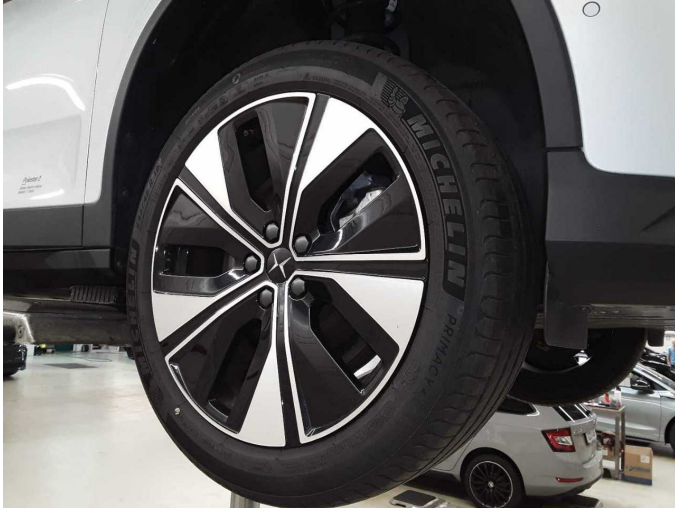
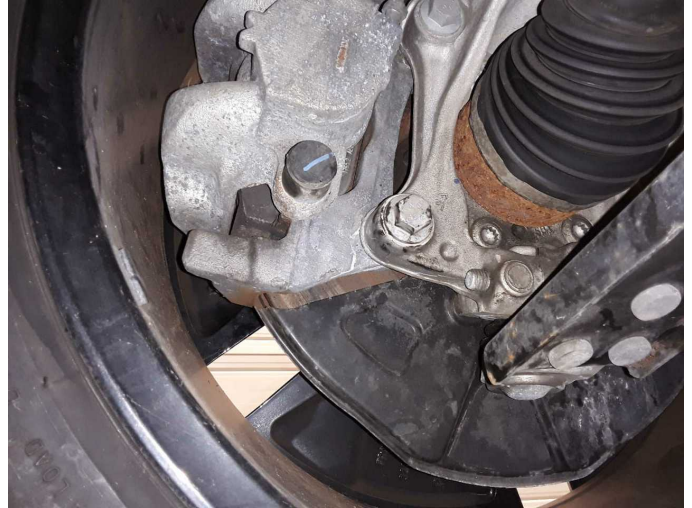
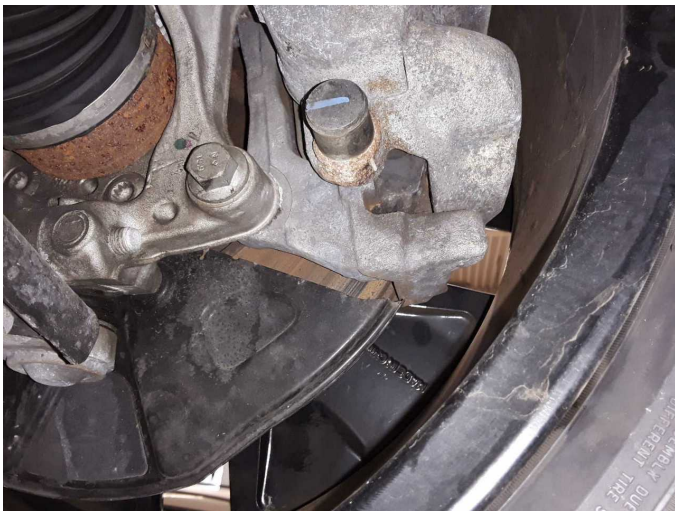
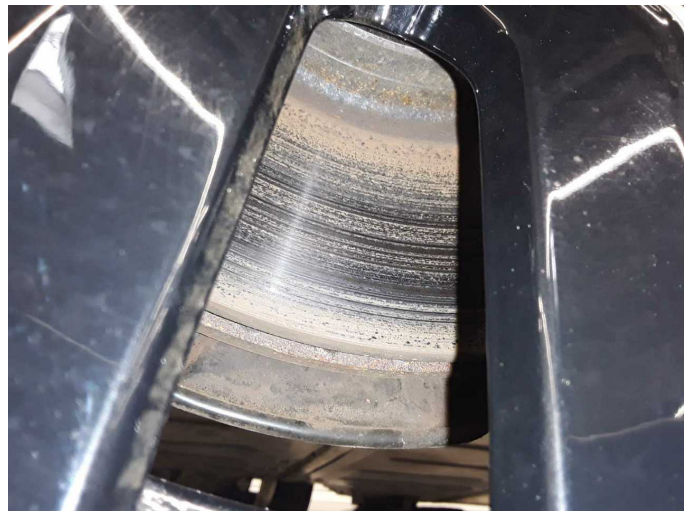
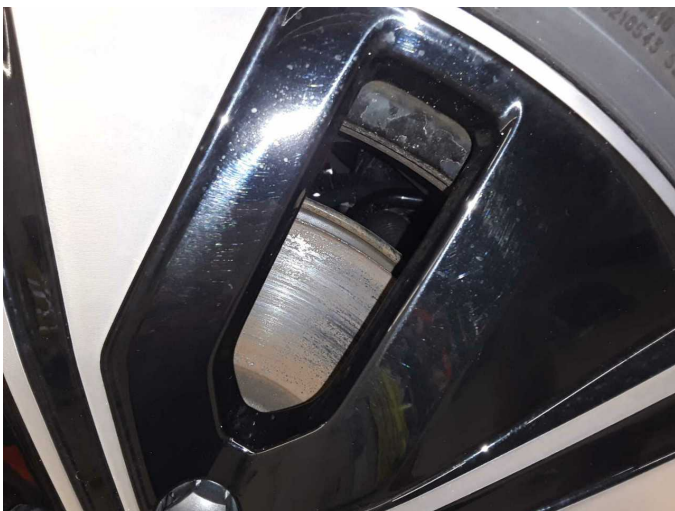
| No. | Component group | Description |
|---|---|---|
| 3 | Braking system | Brake discs and brake pads - front - Corrosion - Replace |

**Damage 3:** Braking system: Brake discs and brake pads - front - Corrosion - Replace

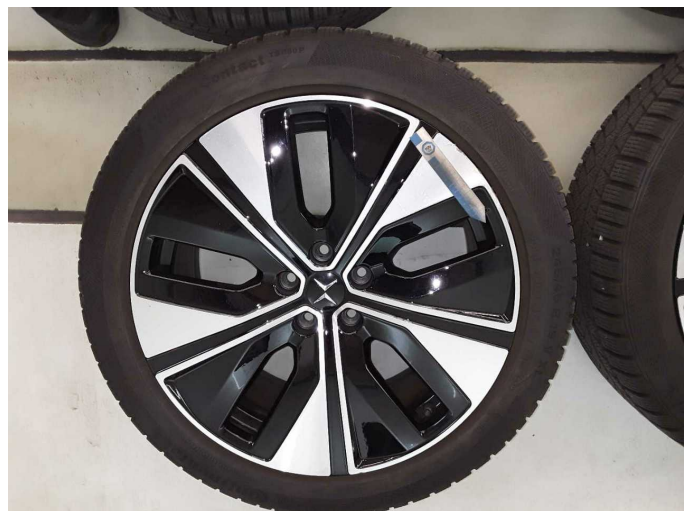
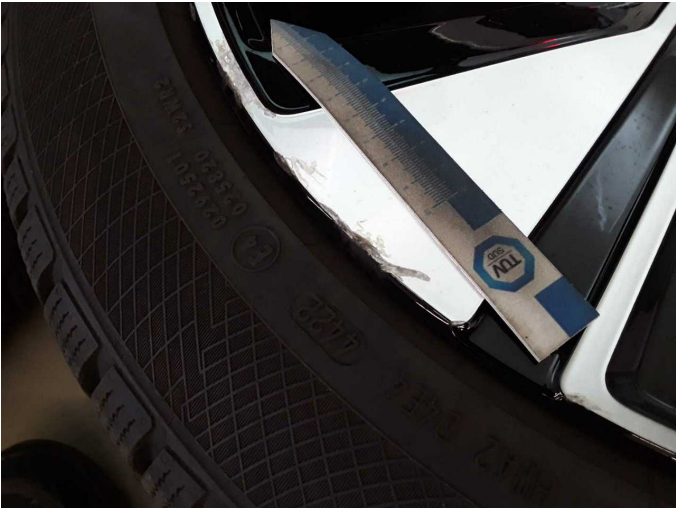
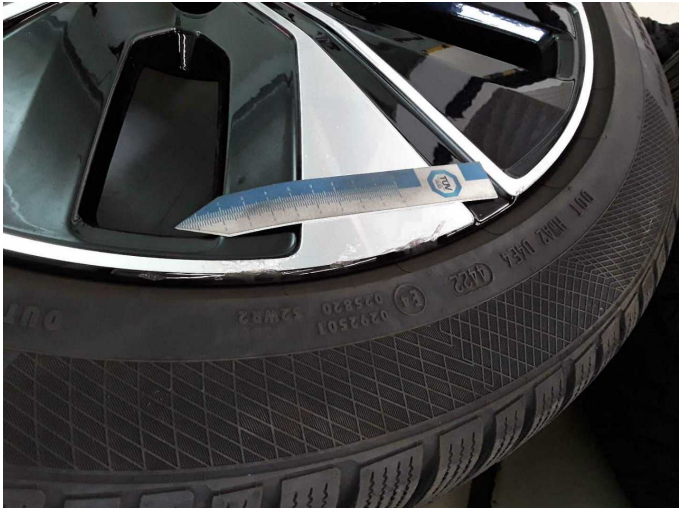
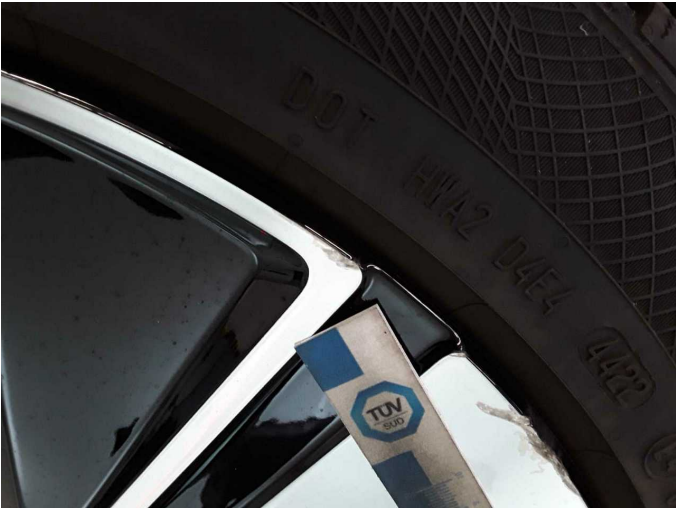
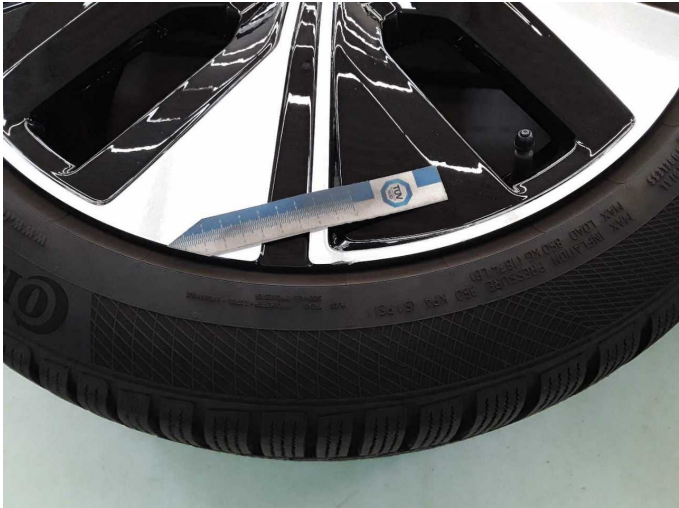
| No. | Component group | Description |
|---|---|---|
| 1 | 2nd wheel set | 1 alloy rim - Scratched - No deduction |

**Wear and tear 1:** 2nd wheel set: 1 alloy rim - Scratched - No deduction
