Protocol number: 45991416
Order No. / Reference: 26466492
Inspection date: 17 Jun 2026

Manufacturer: Skoda

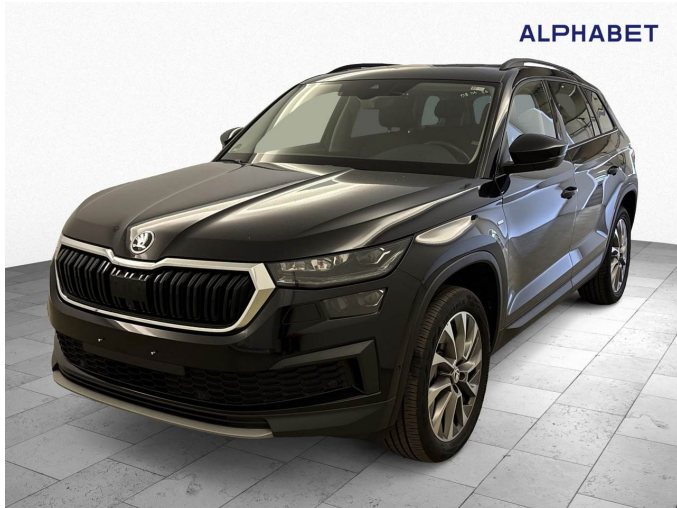
Figure 1: Diagonal front (left)

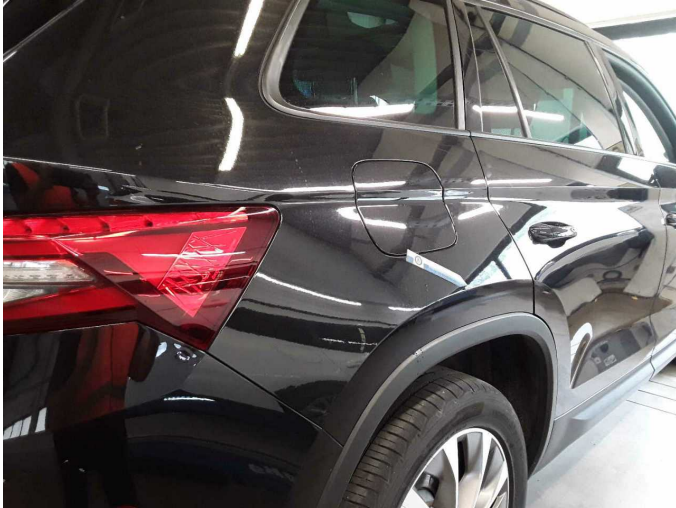
Damage 1: Side panel - rear right side: Side panel - Scratch(es) - Smart repair

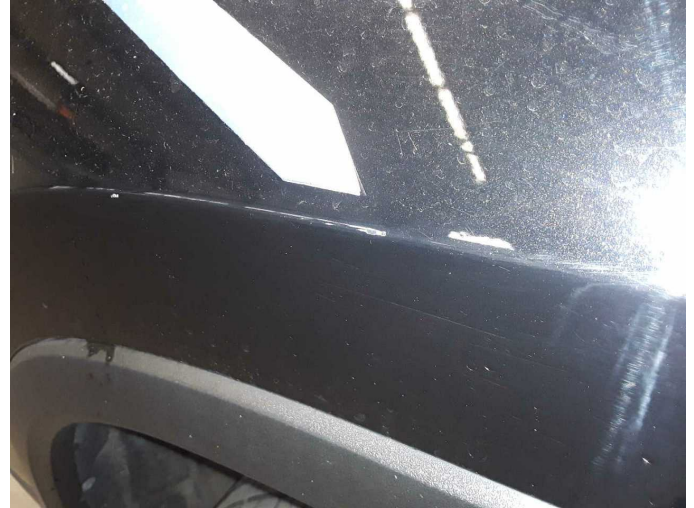
Damage 1: Side panel - rear right side: Side panel - Scratch(es) - Smart repair

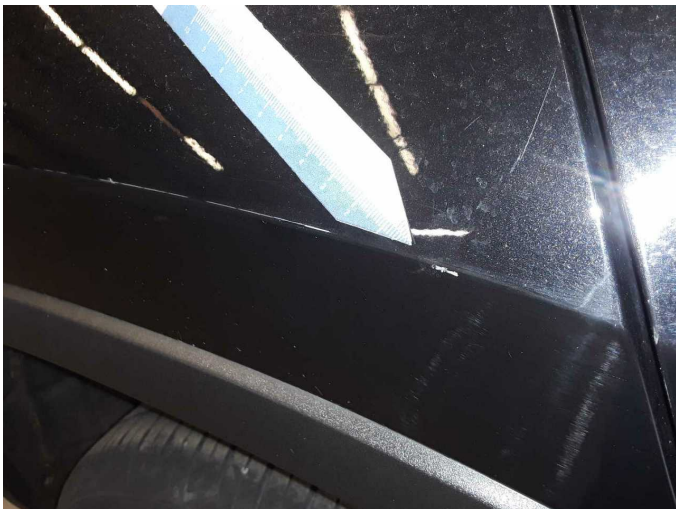
Damage 1: Side panel - rear right side: Side panel - Scratch(es) - Smart repair

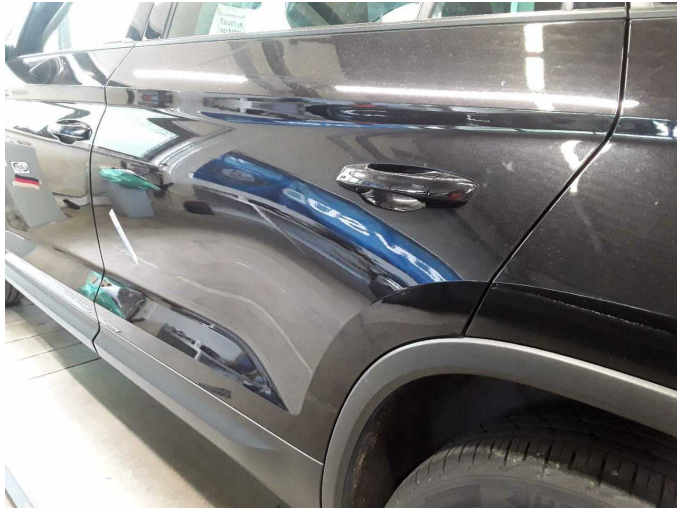
Damage 3: Door - rear left side: Door - Dent / paintcoat damage - Repair and paint

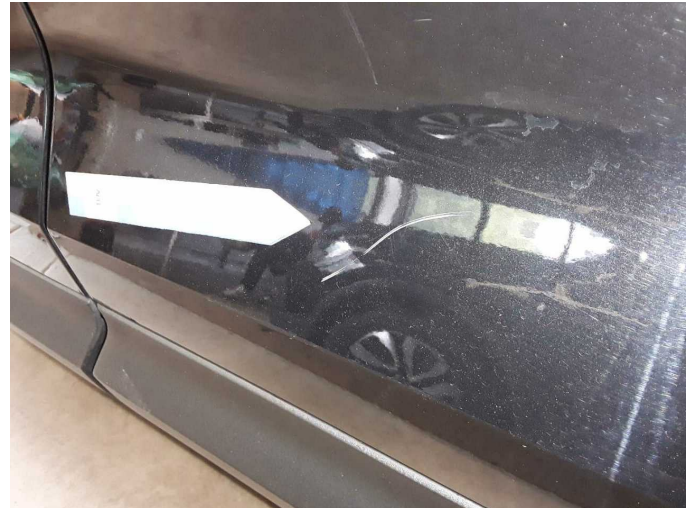
Damage 3: Door - rear left side: Door - Dent / paintcoat damage - Repair and paint

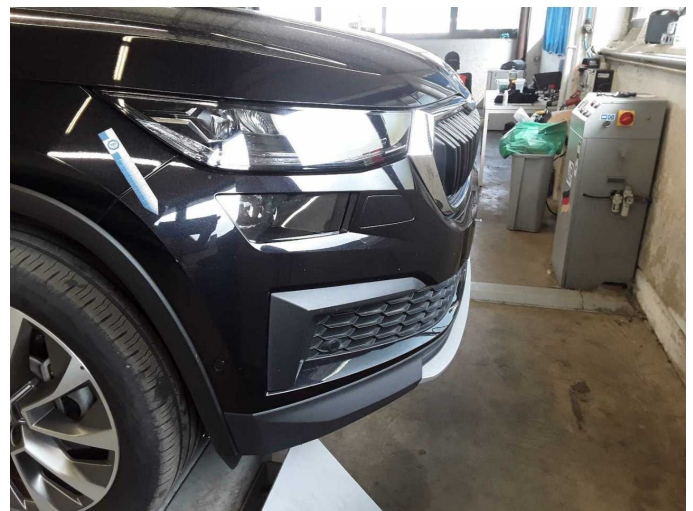
Wear and tear 1: Front bumper: Front bumper - Stone chips - No deduction

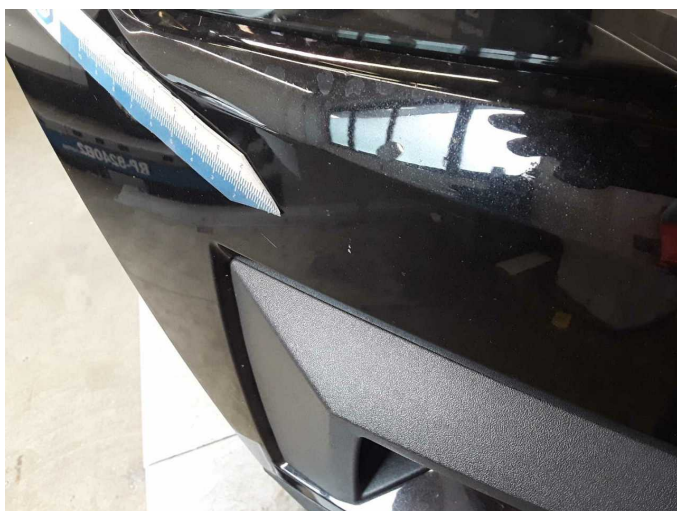
Wear and tear 1: Front bumper: Front bumper - Stone chips - No deduction

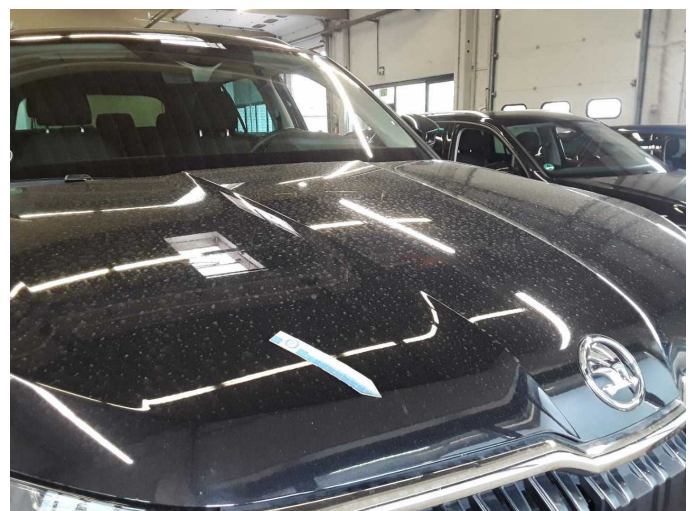
Wear and tear 2: Bonnet: Bonnet - Stone chips - No deduction

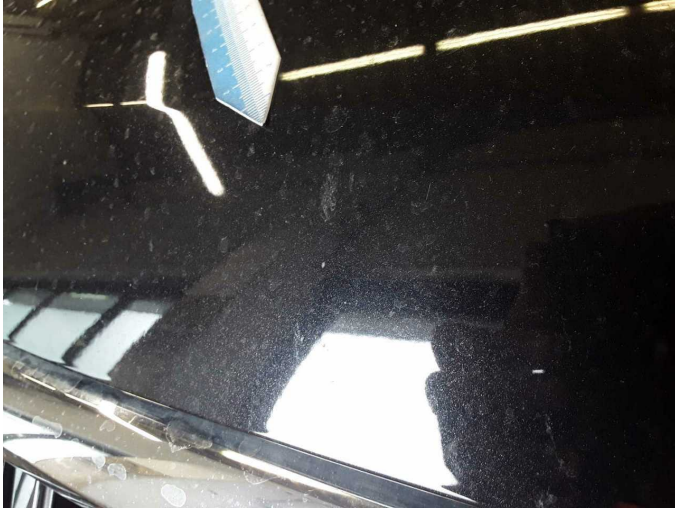
Wear and tear 2: Bonnet: Bonnet - Stone chips - No deduction

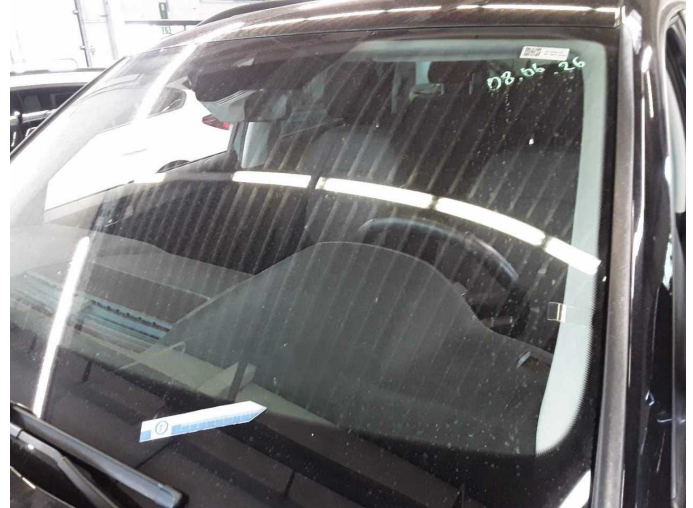
Wear and tear 3: Vehicle glazing: Windscreen - Stone chips - No deduction

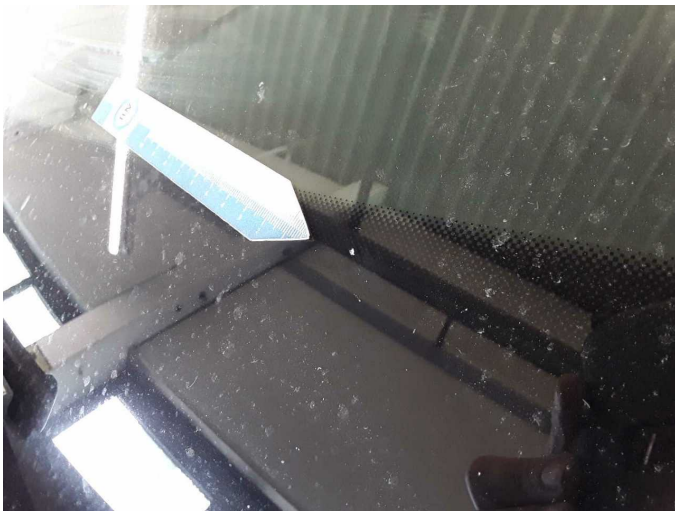
Wear and tear 3: Vehicle glazing: Windscreen - Stone chips - No deduction

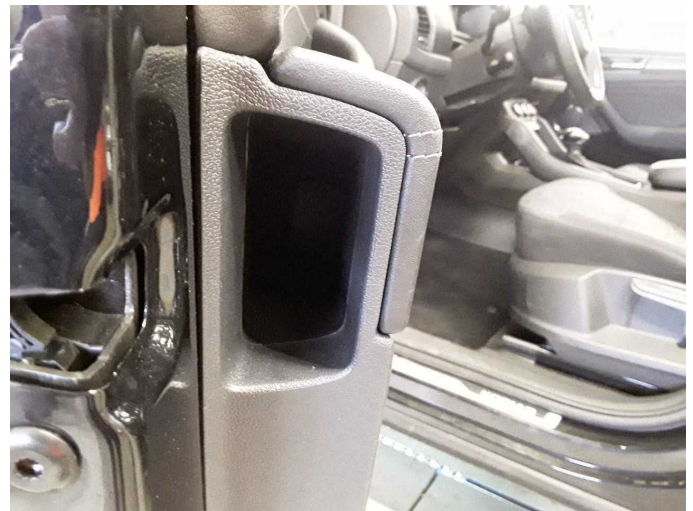
Missing part 1: Equipment: Umbrella - Missing - Replace

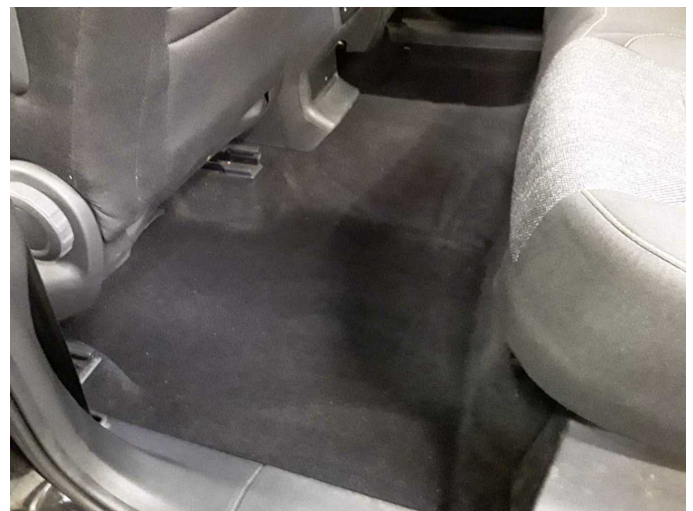
Missing part 2: Trim / covers: Floor mats - Missing - Replace
