Expertise

Protocol number: 46564636  
Order No. / Reference: 26702165  
Inspection date: 16 Jul 2026

Model: Insignia Grand Sport 2.0 Diesel Automatik Business

An order was placed to prepare a sales report for the described vehicle. This report includes the following:

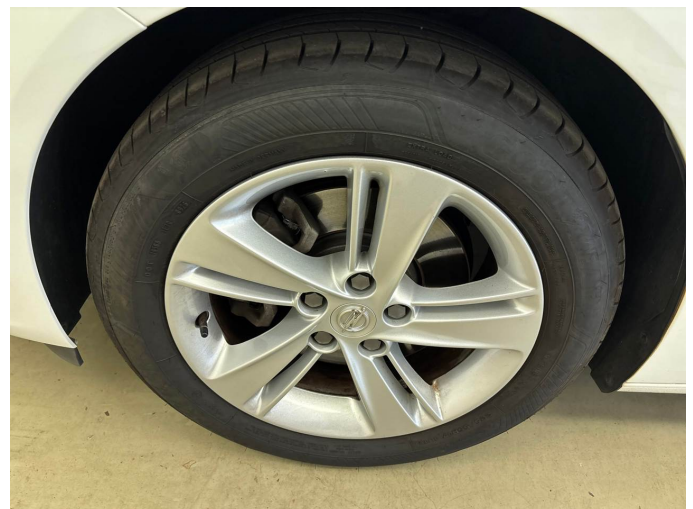
Figure 12: Mounted tyres

| # | Tyre size | Type of tyre | Manufacturer | Tread depth |
|---|---|---|---|---|
| 1) | 225/55 R17 101W | Summer tyres on Light alloy | Goodyear | 5mm / 5mm |
| 2) | 225/55 R17 101W | Summer tyres on Light alloy | Goodyear | 6mm / 6mm |

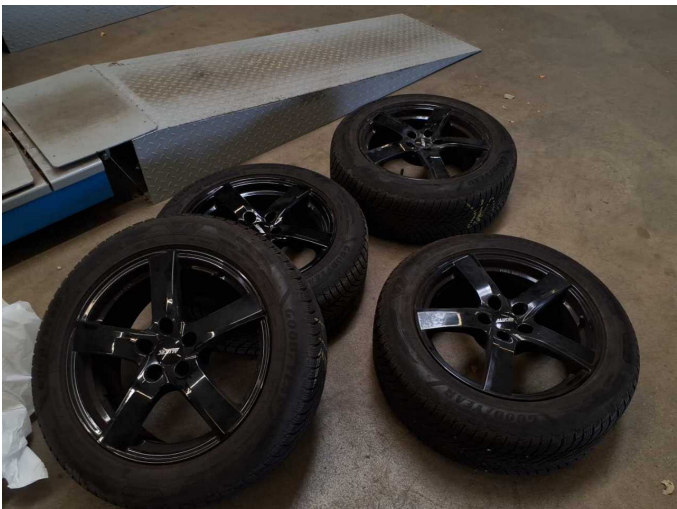
Figure 18: Additional tyres

| # | Tyre size | Type of tyre | Manufacturer | Tread depth |
|---|---|---|---|---|
| 1) | 225/55 R17 101V | Winter tyres on Light alloy | Goodyear | 6mm / 6mm |
| 2) | 225/55 R17 101V | Winter tyres on Light alloy | Goodyear | 7mm / 7mm |

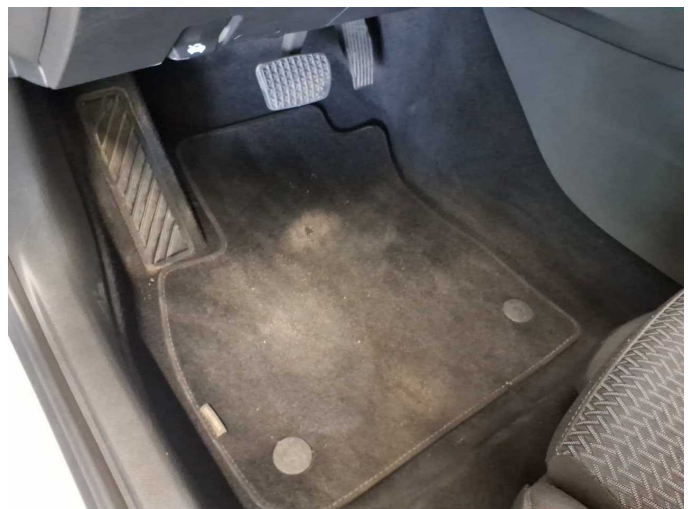
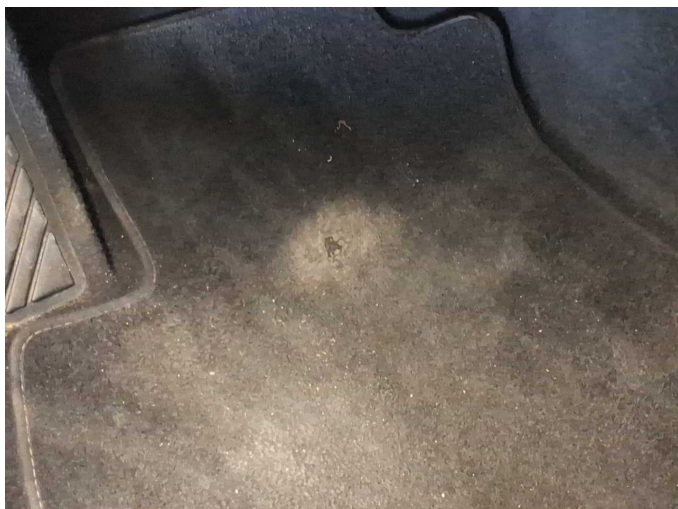
Damage 1: Trim / covers: Floor mats - Broken / torn - Replace

**Damage 1:** Trim / covers: Floor mats - Broken / torn - Replace

| No. | Component group | Description |
|---|---|---|
| 1 | Trim / covers | Floor mats - Broken / torn - Replace |

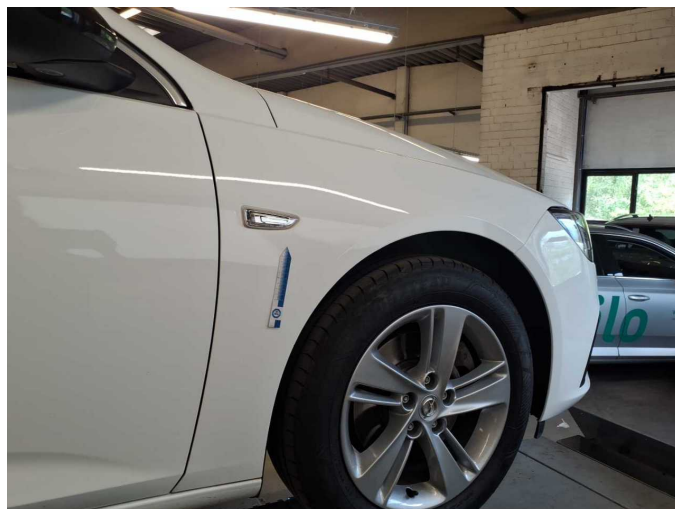
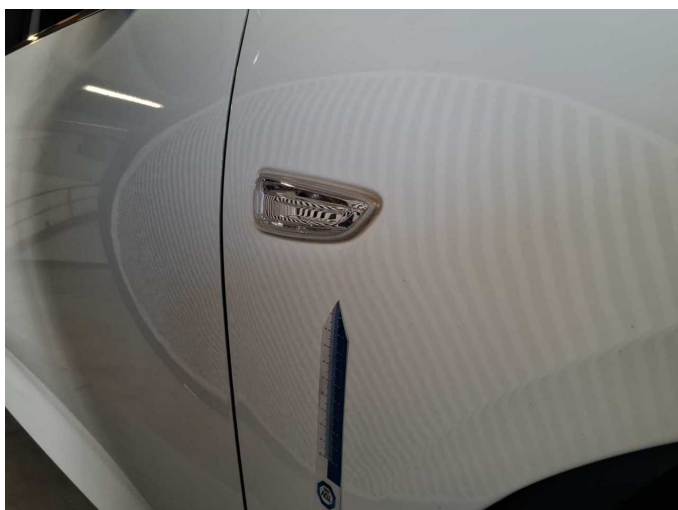
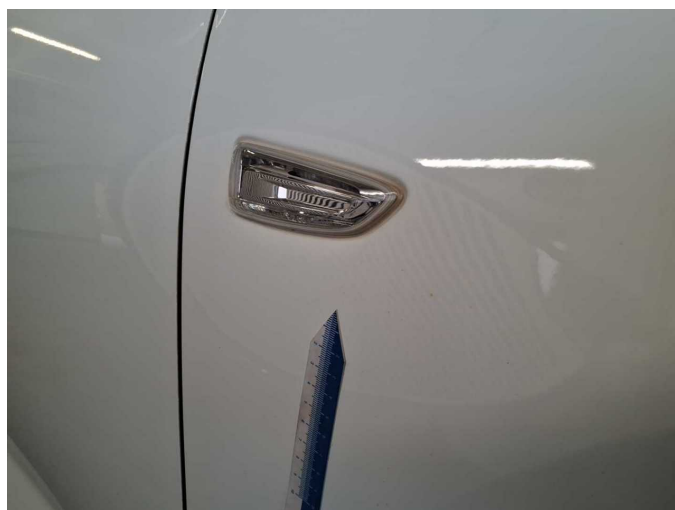
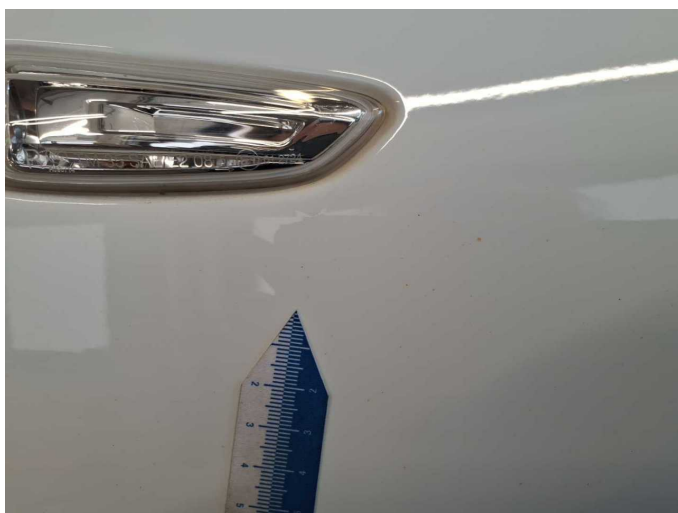
**Damage 2:** Mudguard - right side: Mudguard - right side (Lackläufer) - Paint defect - Cover / polish

| No. | Component group | Description |
|---|---|---|
| 2 | Mudguard - right side | Mudguard - right side (Lackläufer) - Paint defect - Cover / polish |

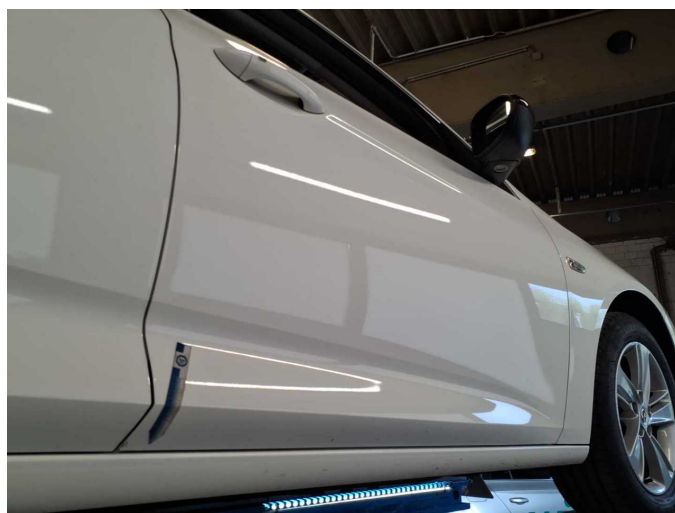
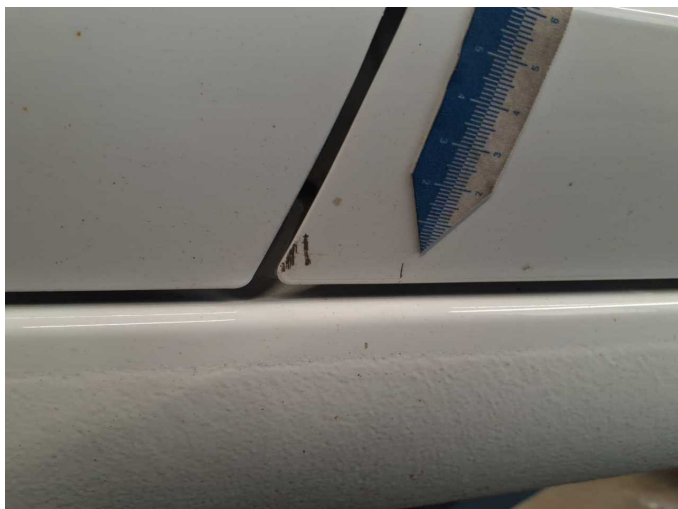
**Damage 3:** Door - front right side: Door - Scratched - Smart repair

| No. | Component group | Description |
|---|---|---|
| 3 | Door - front right side | Door - Scratched - Smart repair |

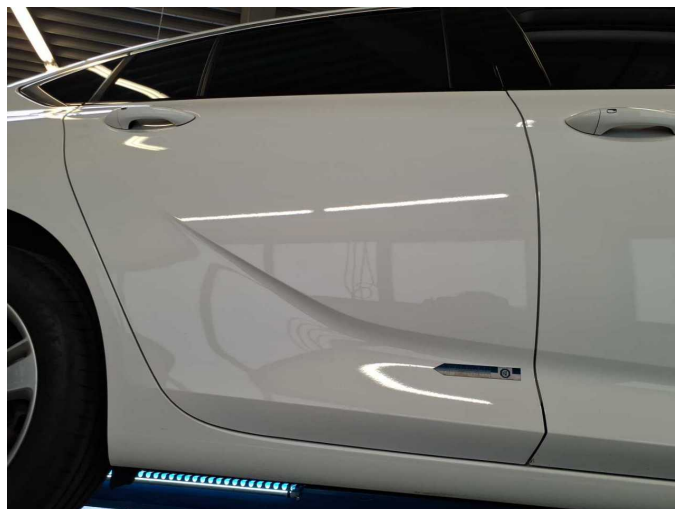
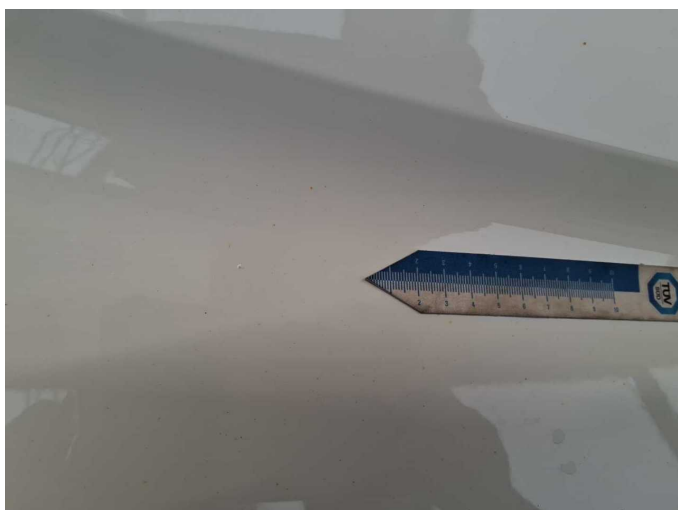
**Damage 4:** Door - rear right side: Door (Lack Pickel) - Paint defect - Smart repair

| No. | Component group | Description |
|---|---|---|
| 4 | Door - rear right side | Door (Lack Pickel) - Paint defect - Smart repair |

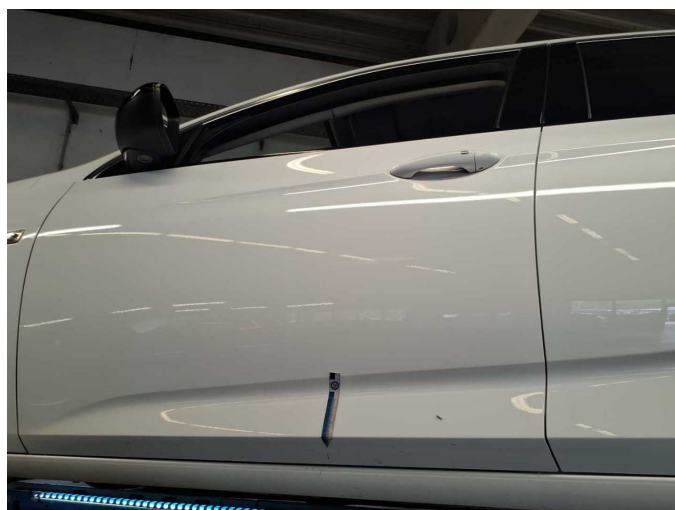
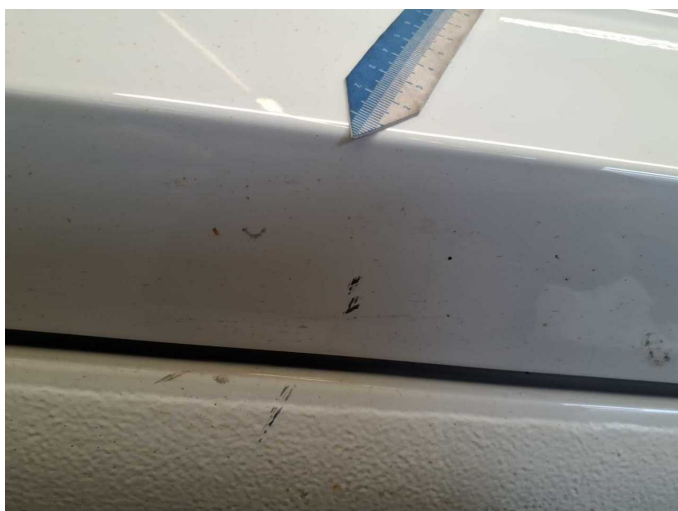
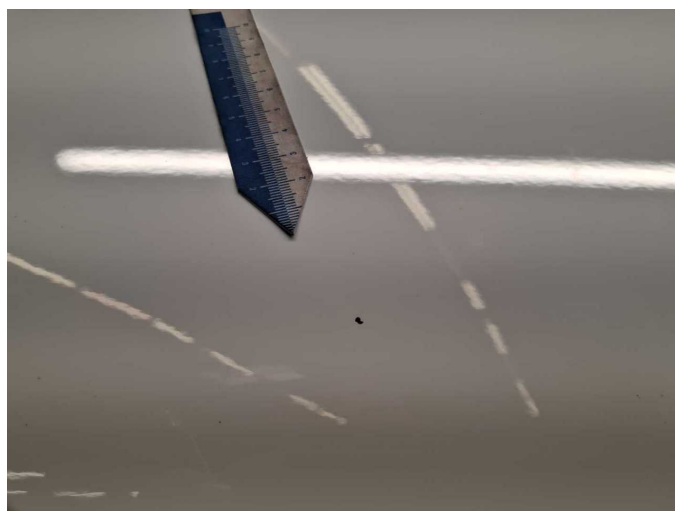
**Damage 5:** Door - front left side: Door - Scratched - Paint

| No. | Component group | Description |
|---|---|---|
| 5 | Door - front left side | Door - Scratched - Paint |

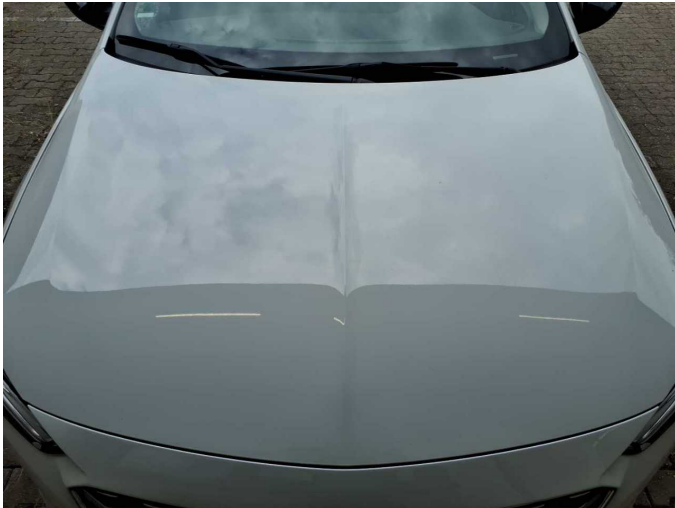
| No. | Component group | Description |
|---|---|---|
| 1 | Bonnet | Bonnet - Stone chips - No deduction |

**Wear and tear 1:** Bonnet: Bonnet - Stone chips - No deduction

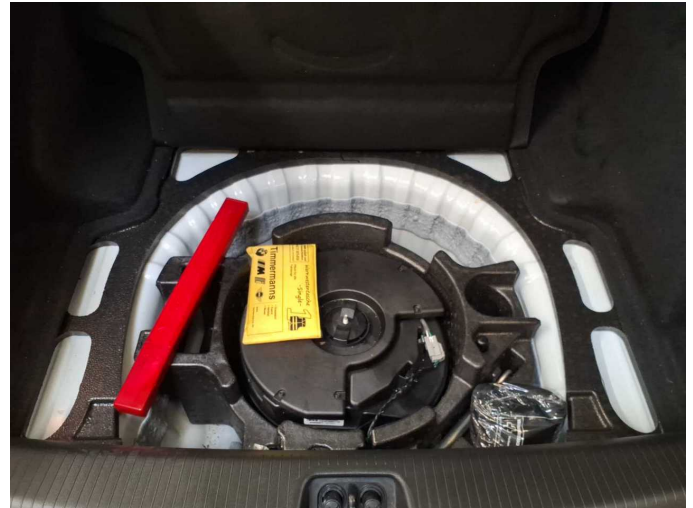
Equipment - Tirefit complete

**Missing part 1:** Equipment: Tirefit complete - Missing - Replace

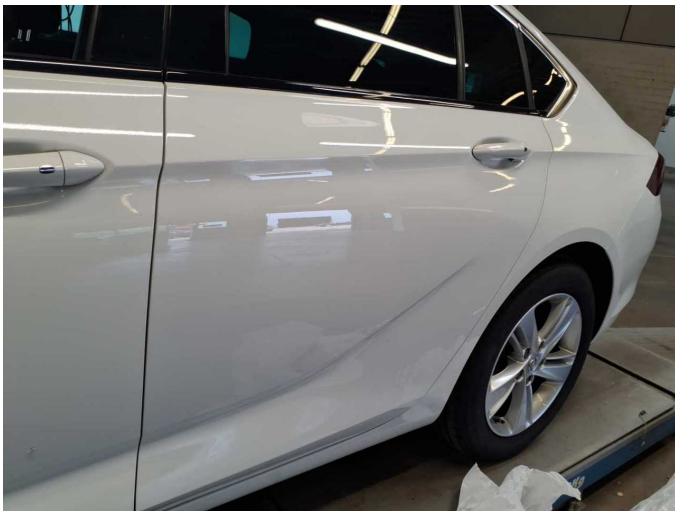
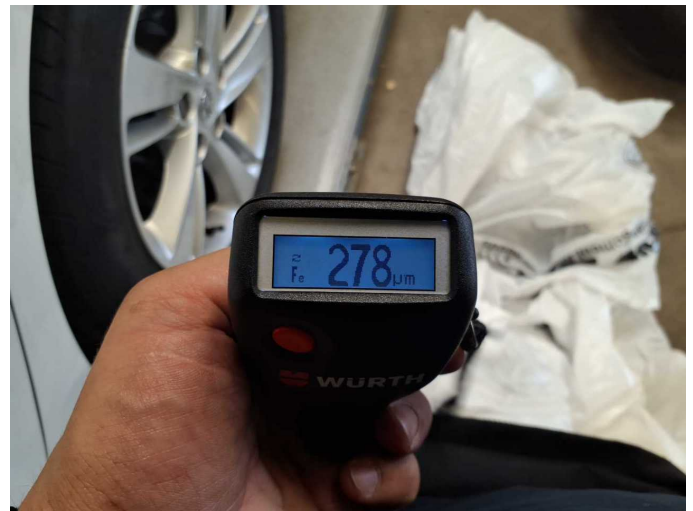
| 1 | Door - rear left side |

| Door - rear left side | 283 µm |

**Repainting 1:** Door - rear left side
