Expertise

Protocol number: 46384944  
Order No. / Reference: 26543211  
Inspection date: 7 Jul 2026

Manufacturer: Skoda  
VIN: TMBJJ7NS9P8025351

Model: Kodiaq 2.0 TDI DSG Style

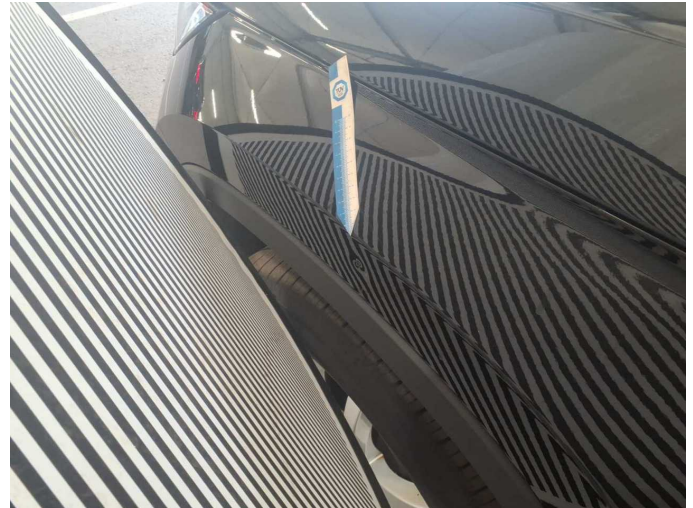
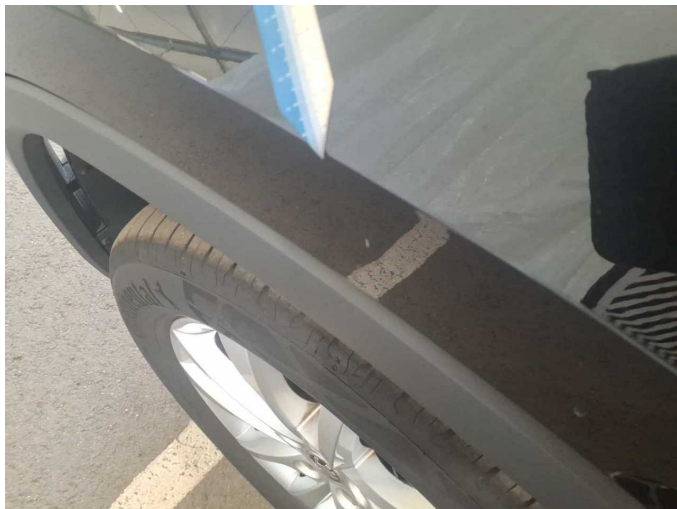
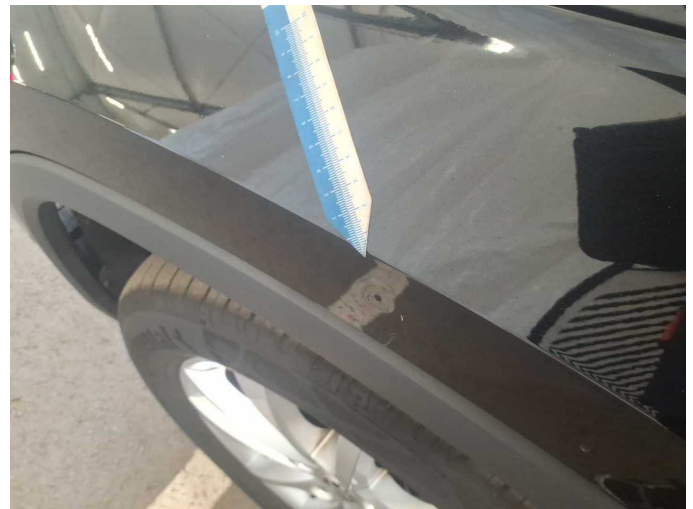
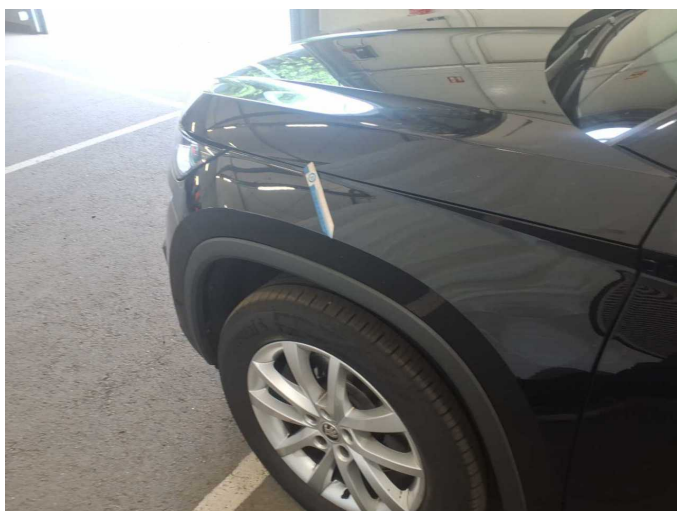
| No. | Component group | Description |
|---|---|---|
| 1 | Mudguard - left side | Mudguard - left side - Dent / paintcoat damage - Repair and paint |

**Damage 1:** Mudguard - left side: Mudguard - left side - Dent / paintcoat damage - Repair and paint

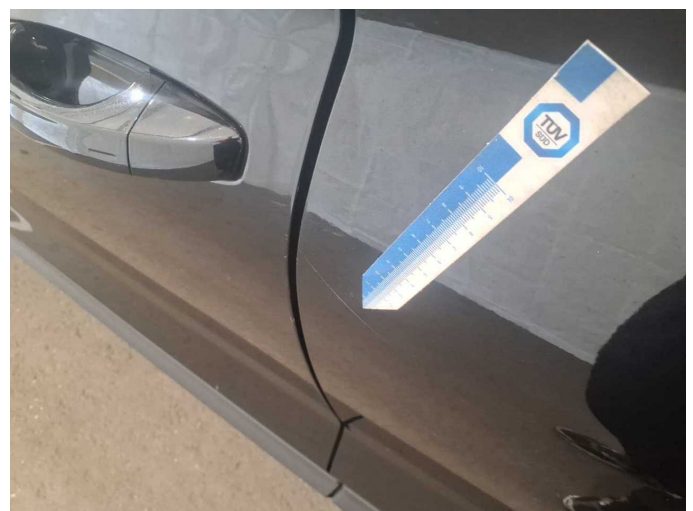
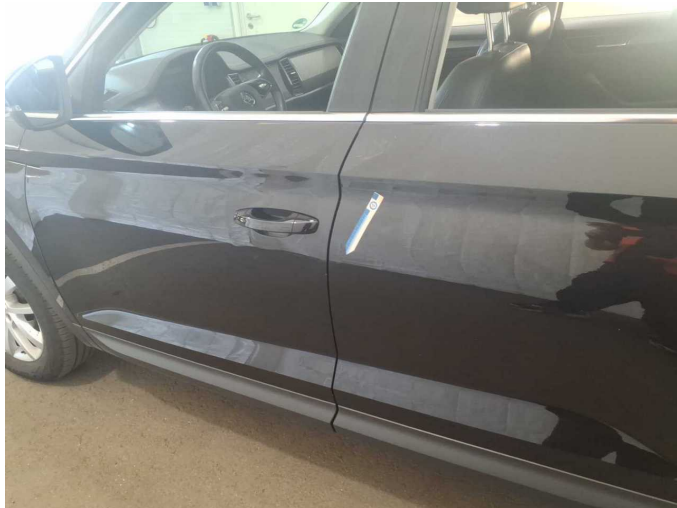
| No. | Component group | Description |
|---|---|---|
| 2 | Door - rear left side | Door - Scratch(es) - Paint |

**Damage 2:** Door - rear left side: Door - Scratch(es) - Paint

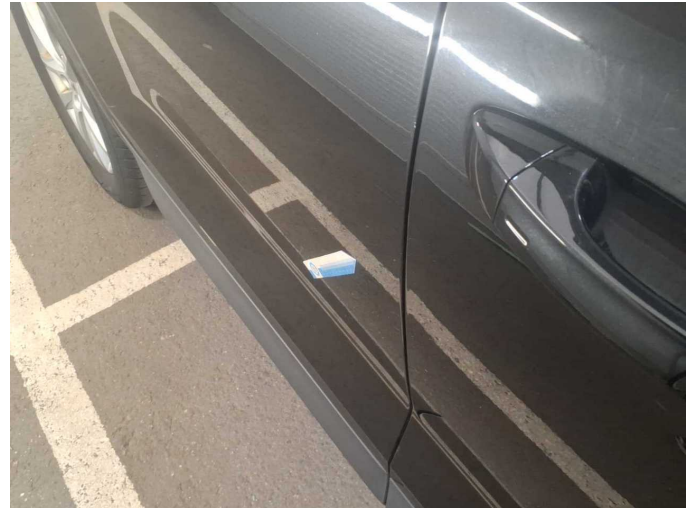
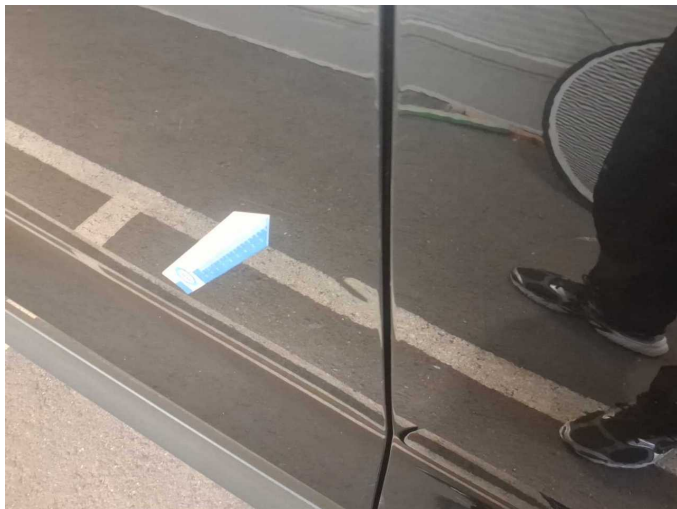
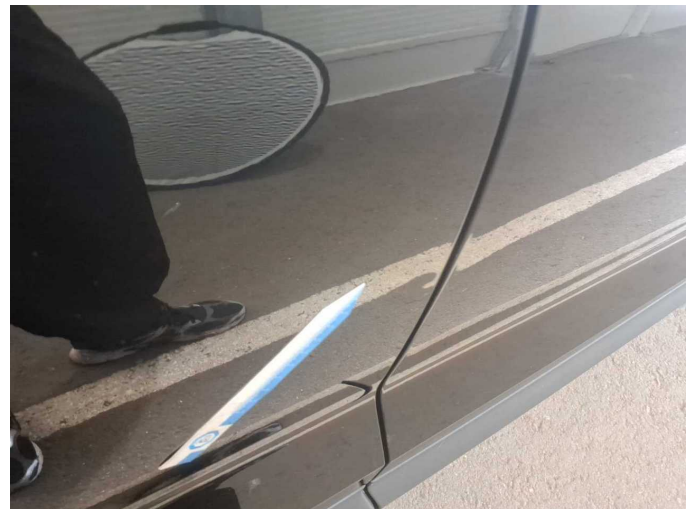
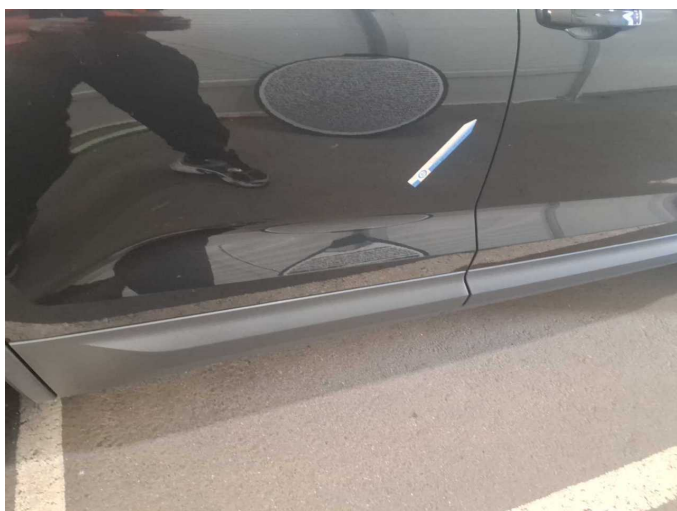
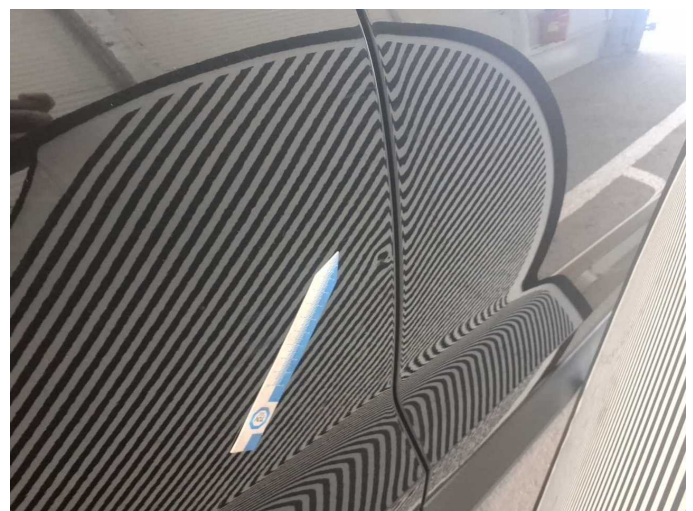
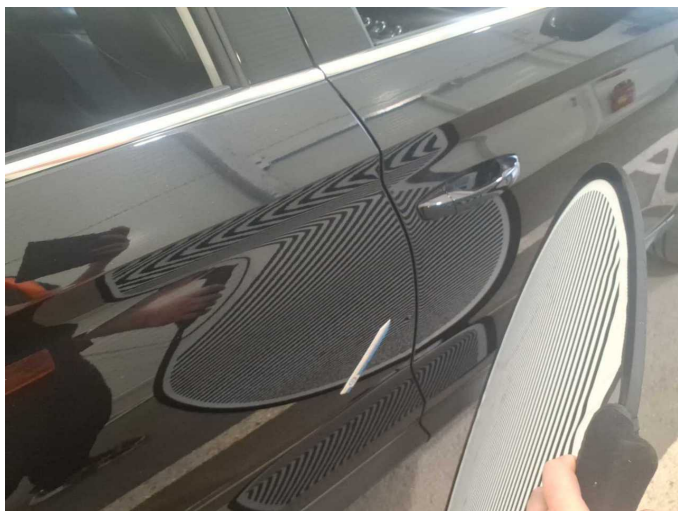
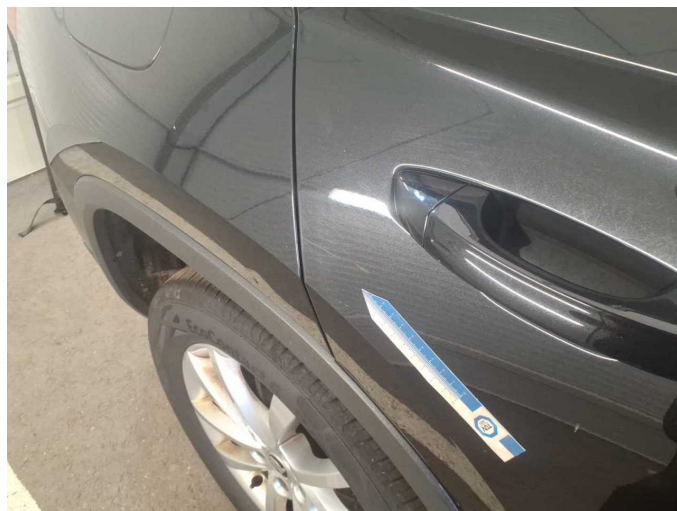
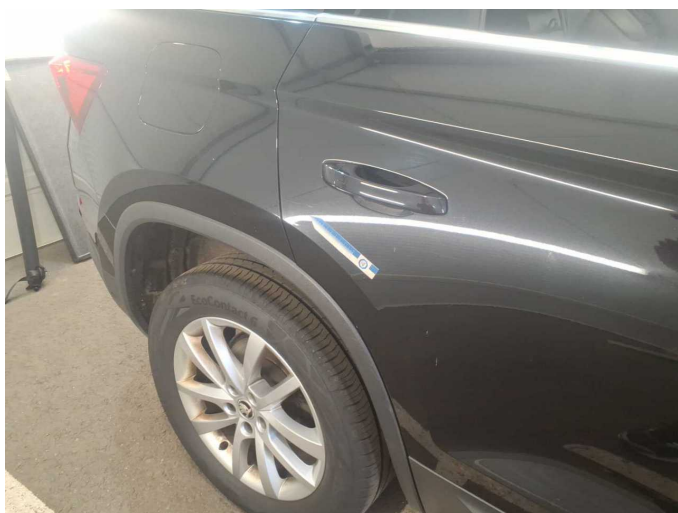
| No. | Component group | Description |
|---|---|---|
| 3 | Door - rear right side | Door - Scratch(es) - Paint |

**Damage 3:** Door - rear right side: Door - Scratch(es) - Paint

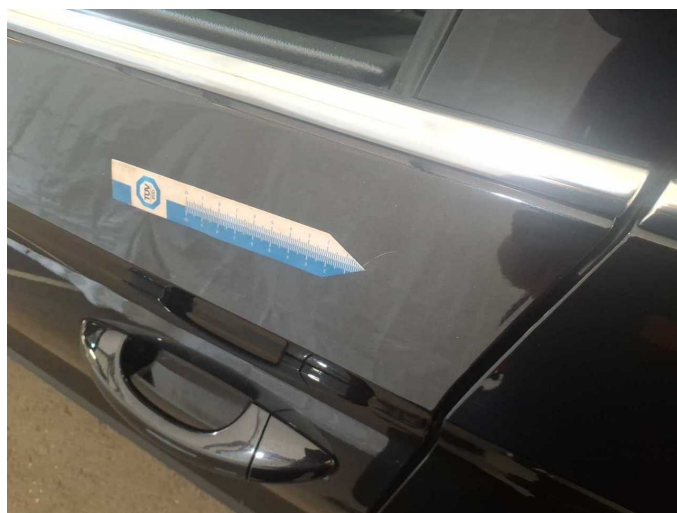
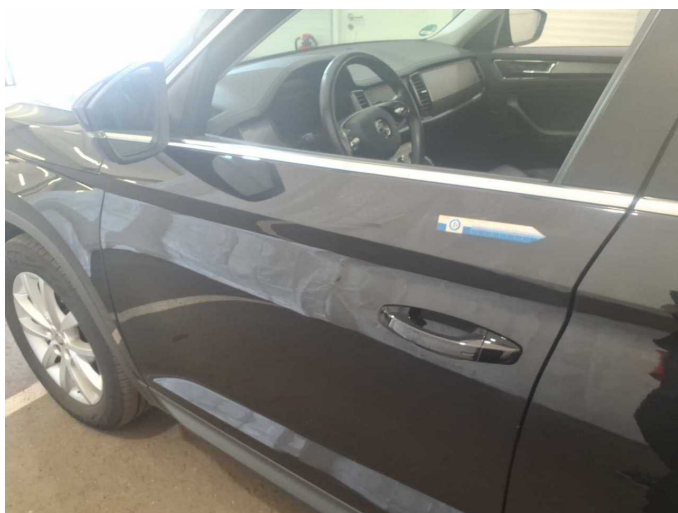
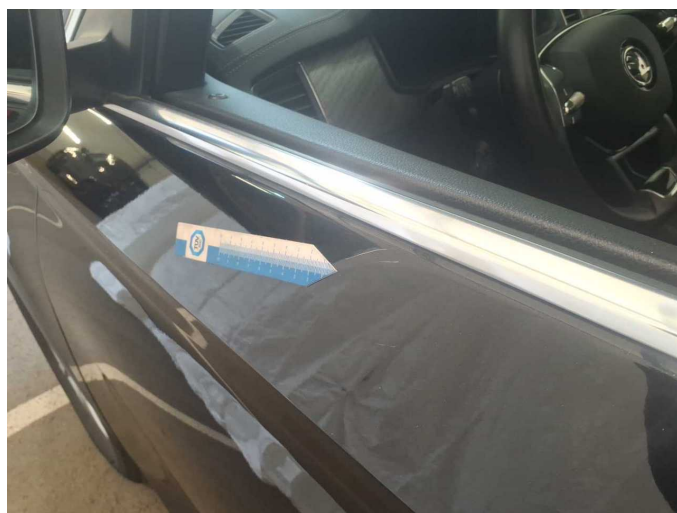
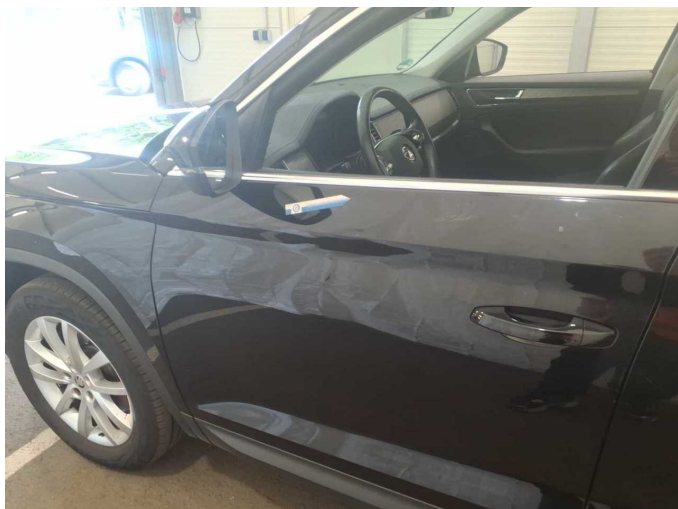
| No. | Component group | Description |
|---|---|---|
| 4 | Door - front left side | Door - Scratch(es) - Paint |

**Damage 4:** Door - front left side: Door - Scratch(es) - Paint

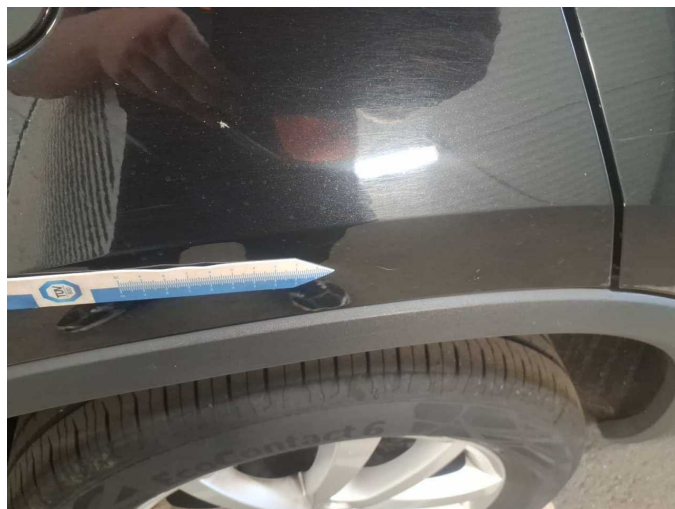
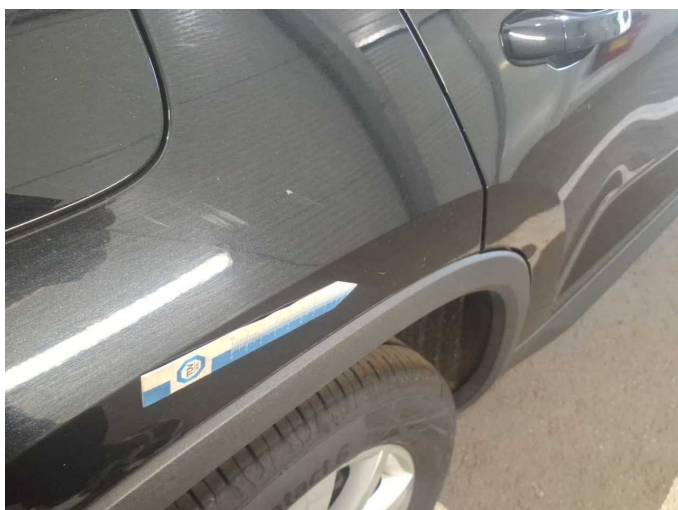
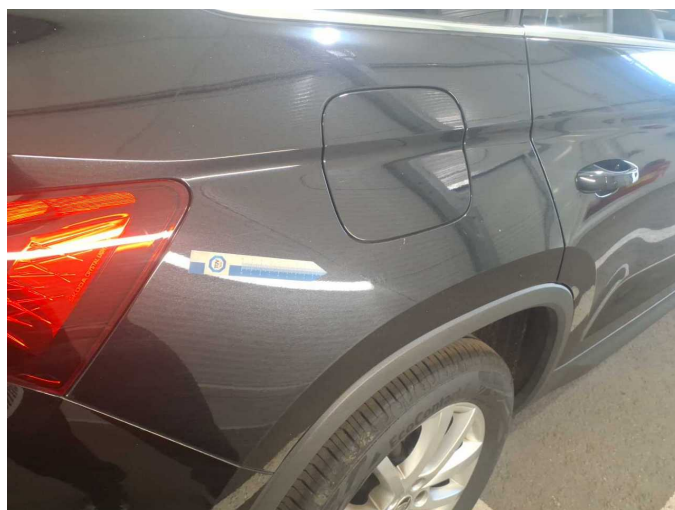
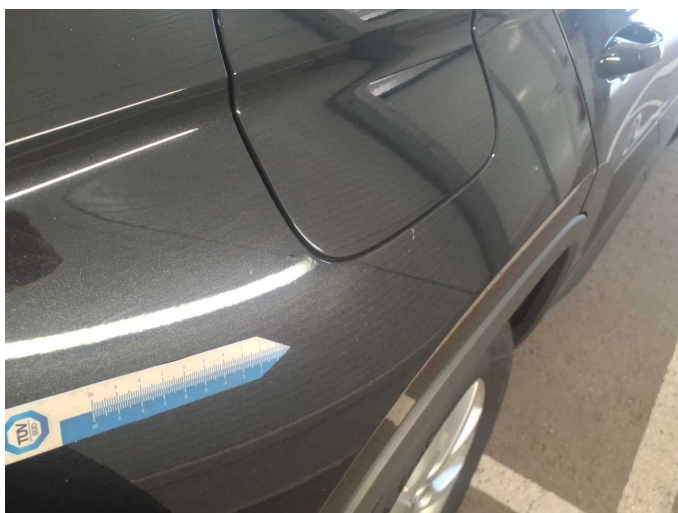
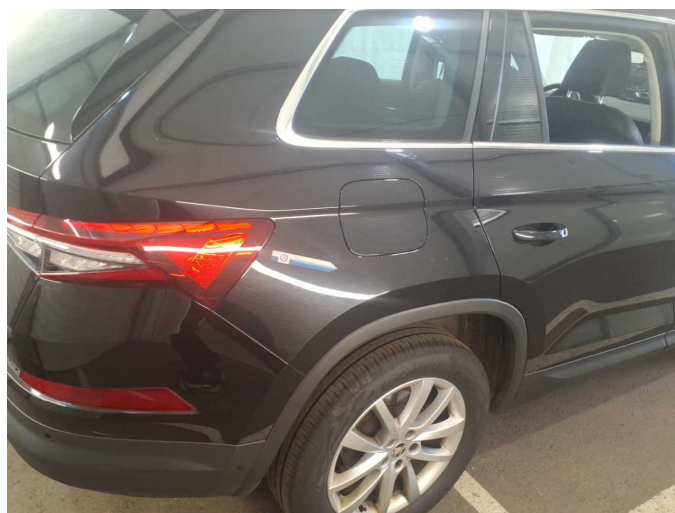
| No. | Component group | Description |
|---|---|---|
| 5 | Side panel - rear right side | Side panel - Scratch(es) - Paint |

**Damage 5:** Side panel - rear right side: Side panel - Scratch(es) - Paint

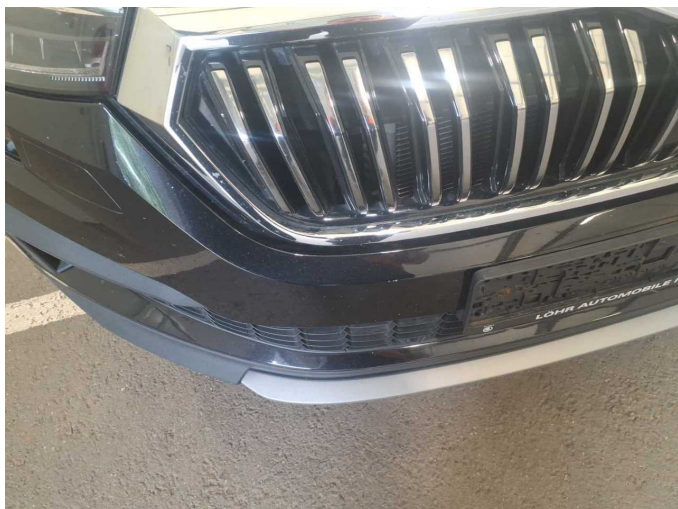
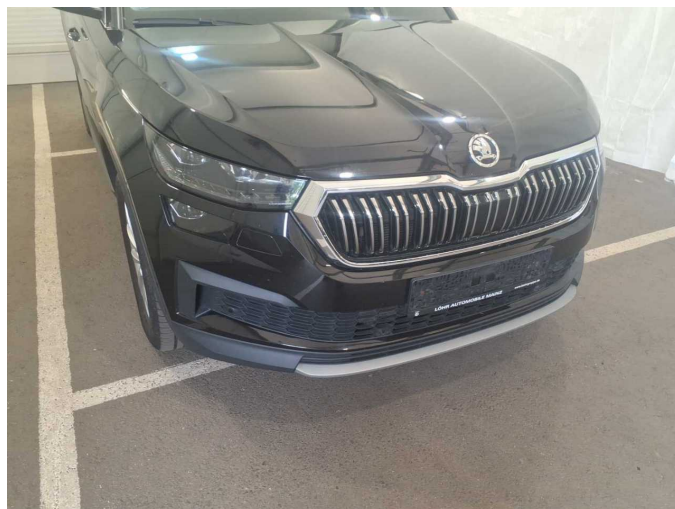
| No. | Component group | Description |
|---|---|---|
| 2 | Front bumper | Front bumper - Stone chips - No deduction |

**Wear and tear 2:** Front bumper: Front bumper - Stone chips - No deduction

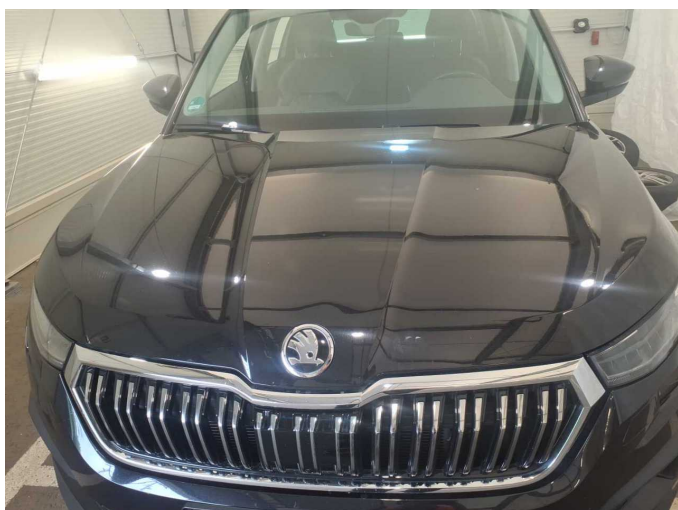
| No. | Component group | Description |
|---|---|---|
| 3 | Bonnet | Bonnet - Stone chips - No deduction |

**Wear and tear 3:** Bonnet: Bonnet - Stone chips - No deduction

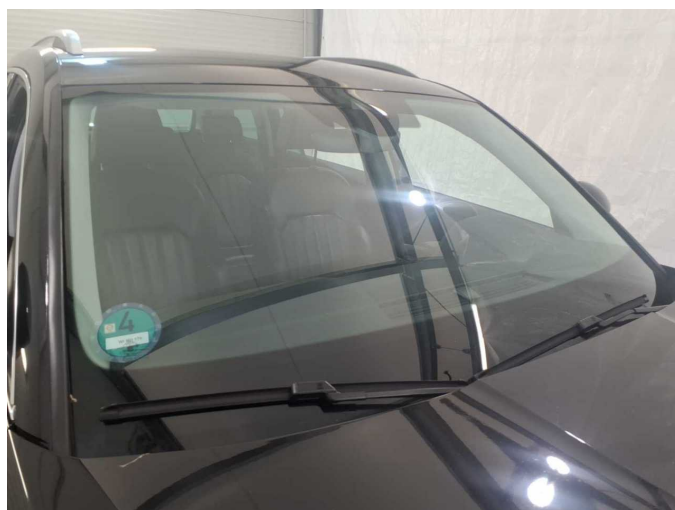
| No. | Component group | Description |
|---|---|---|
| 4 | Vehicle glazing | Windscreen - Stone chips - No deduction |

**Wear and tear 4:** Vehicle glazing: Windscreen - Stone chips - No deduction

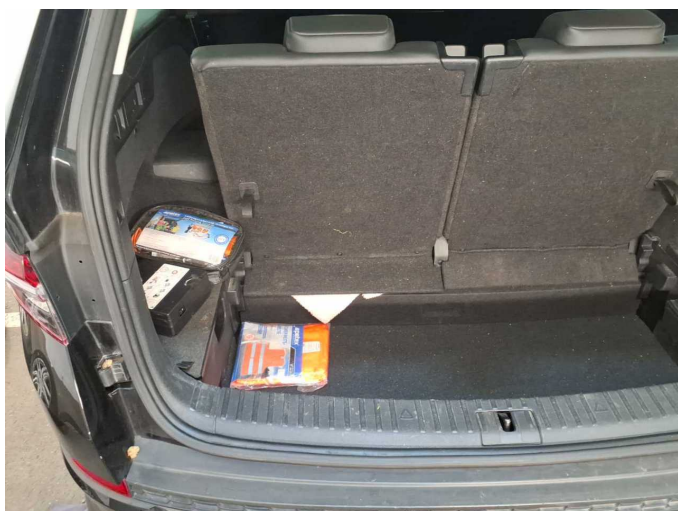
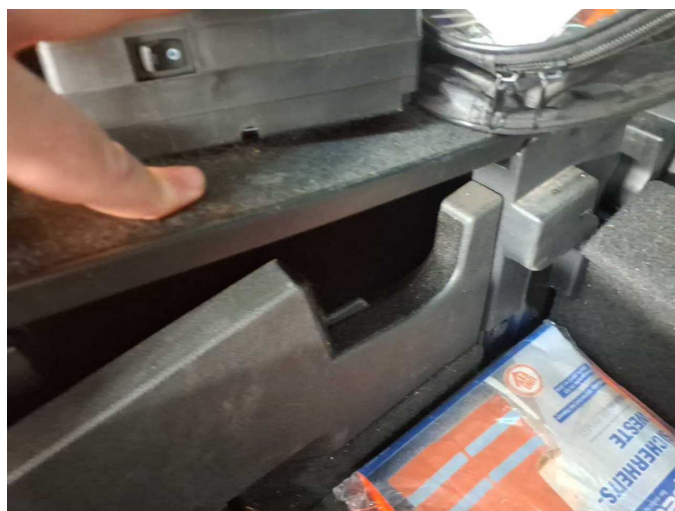
**Missing part 1:** Equipment: Tirefit filler - Missing - Replace

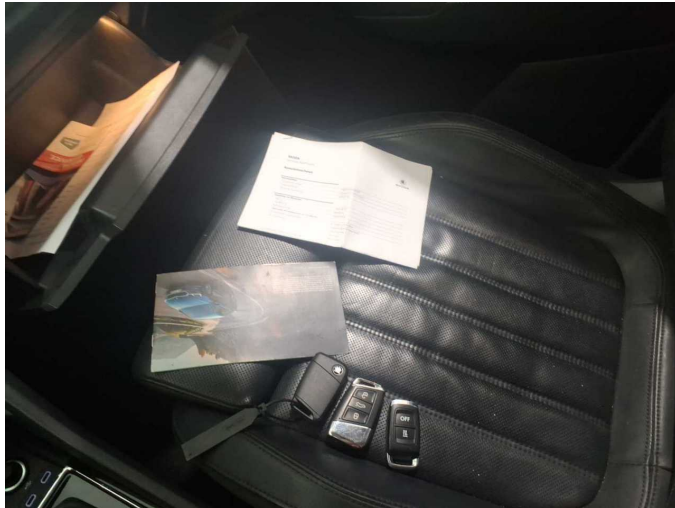
**Missing part 2:** Documents: Log book - Missing - Replace

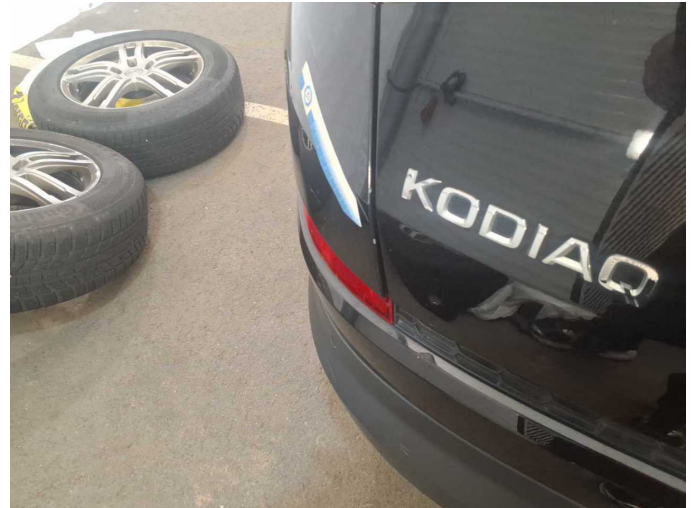
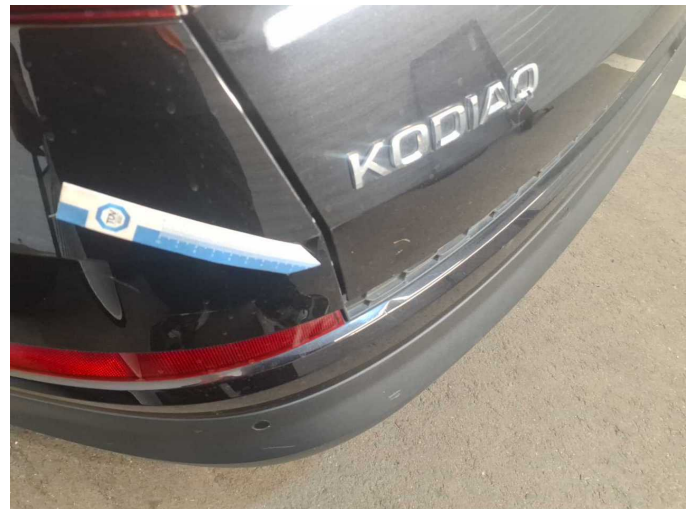
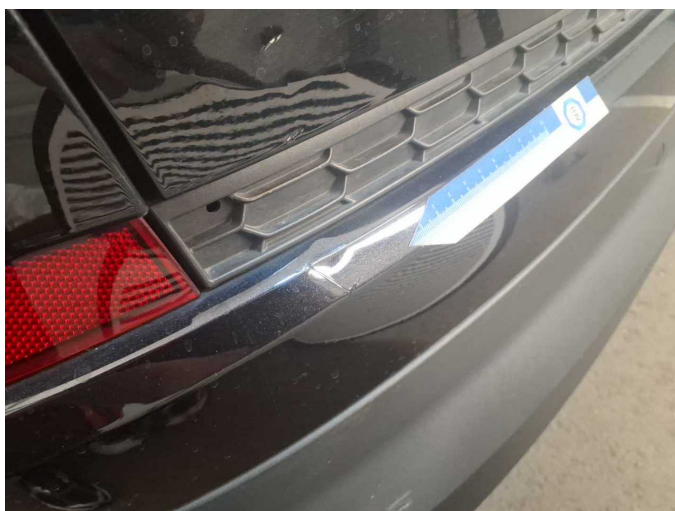
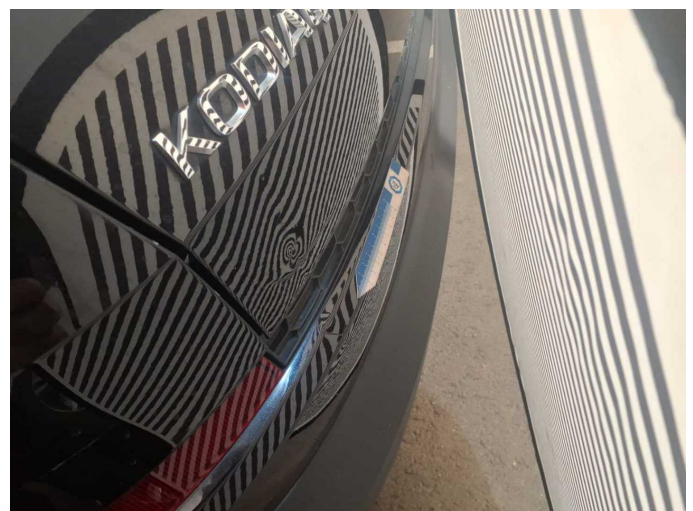
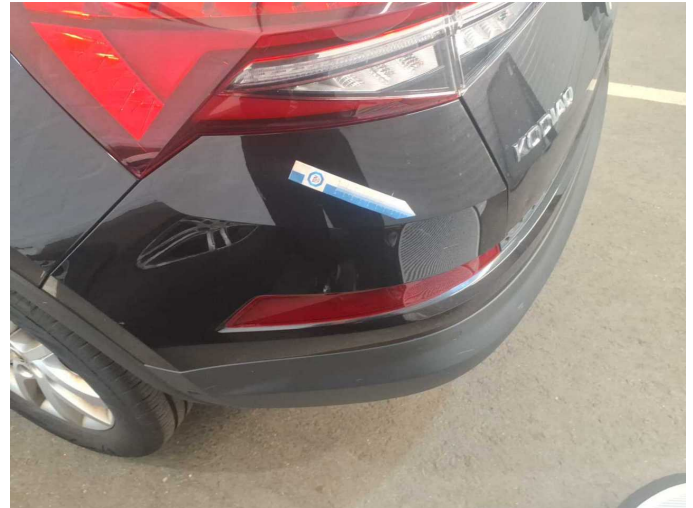
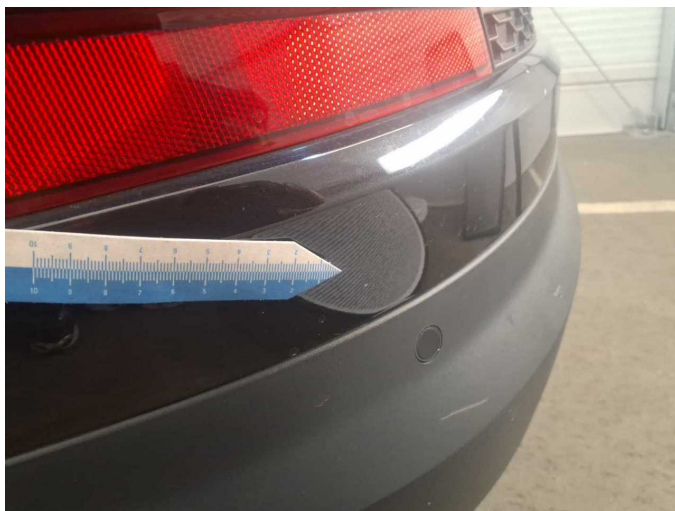
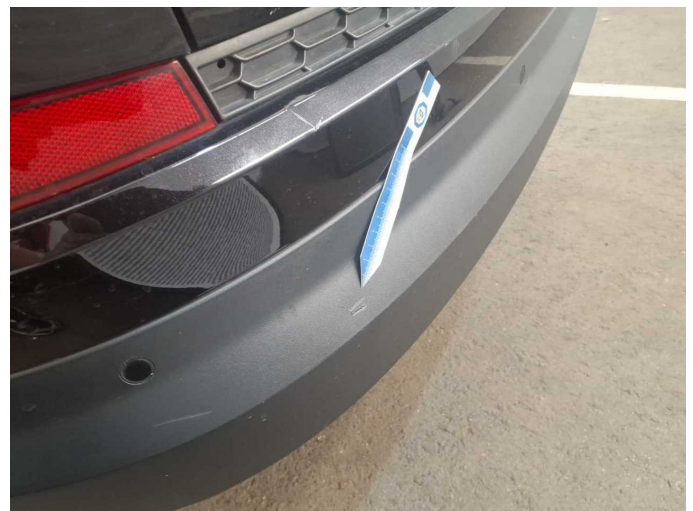
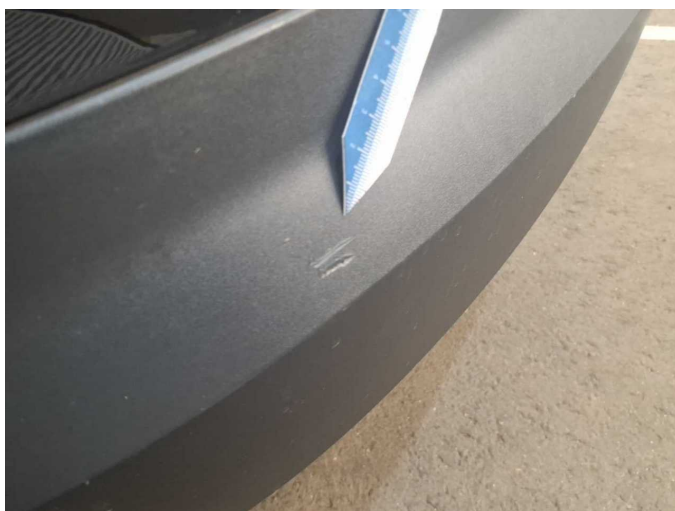
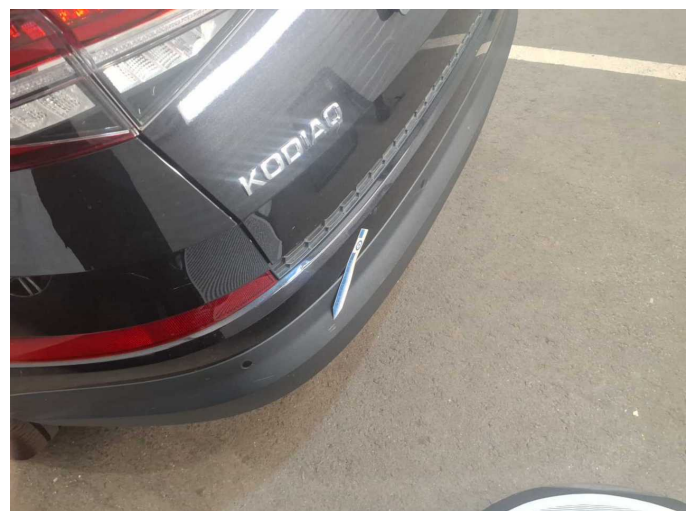
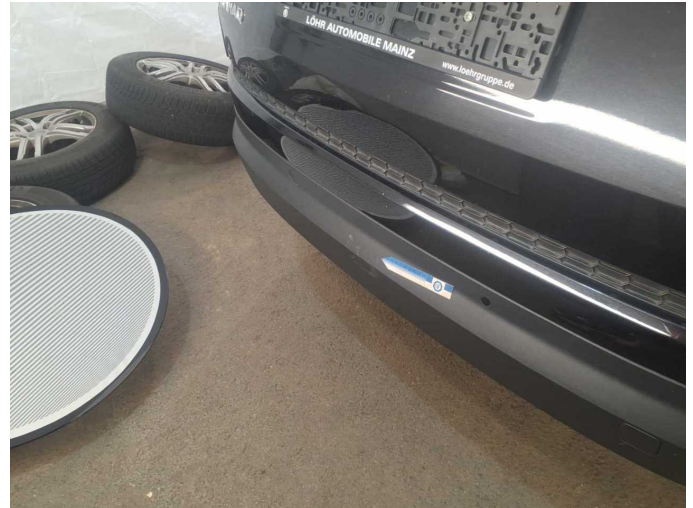
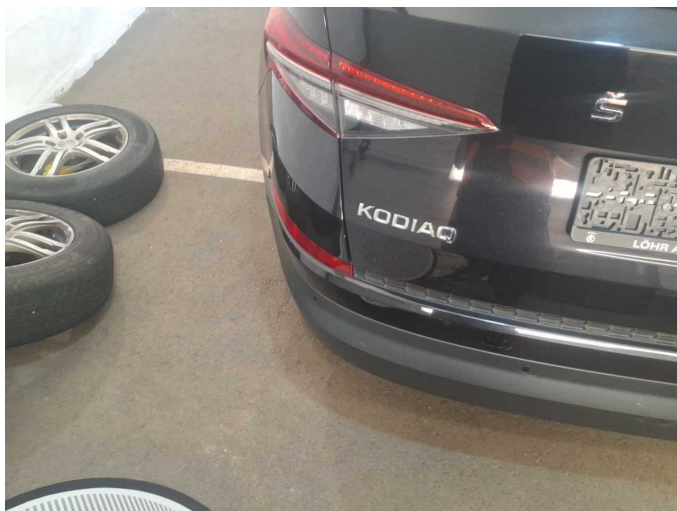
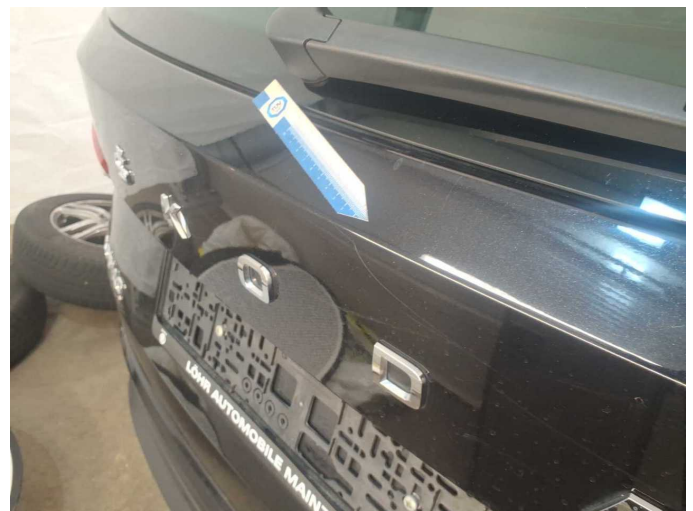
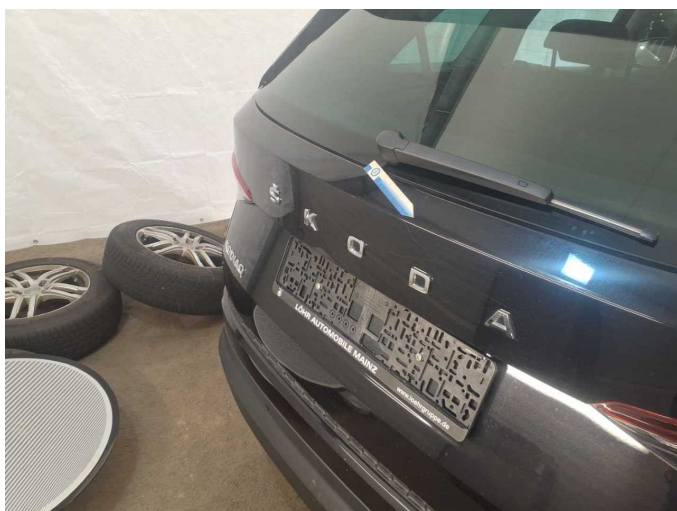
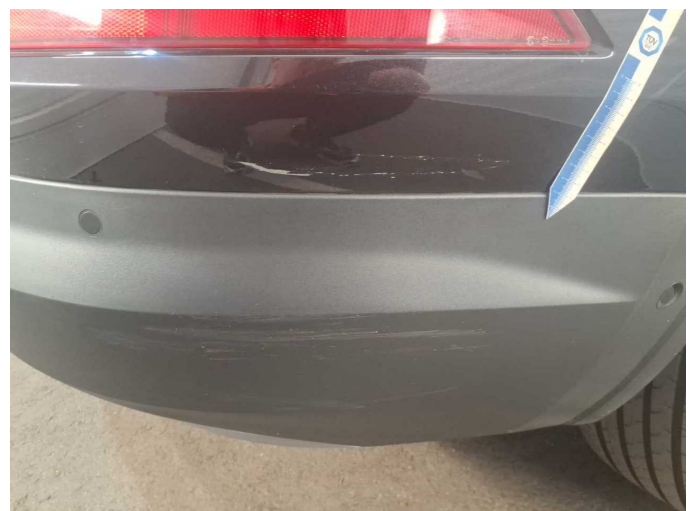
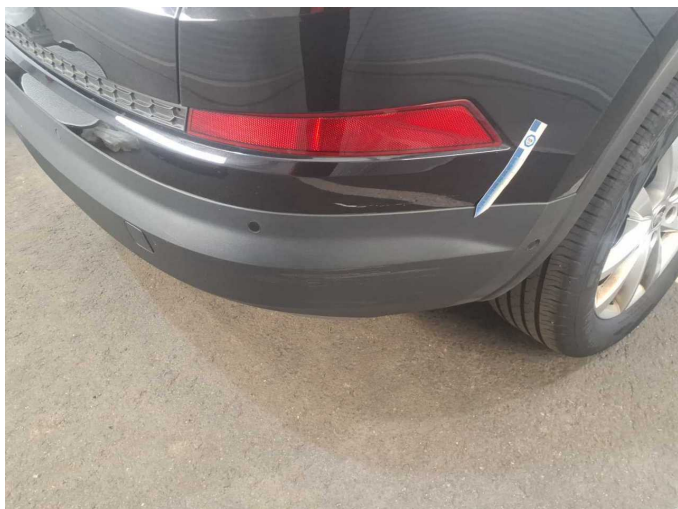
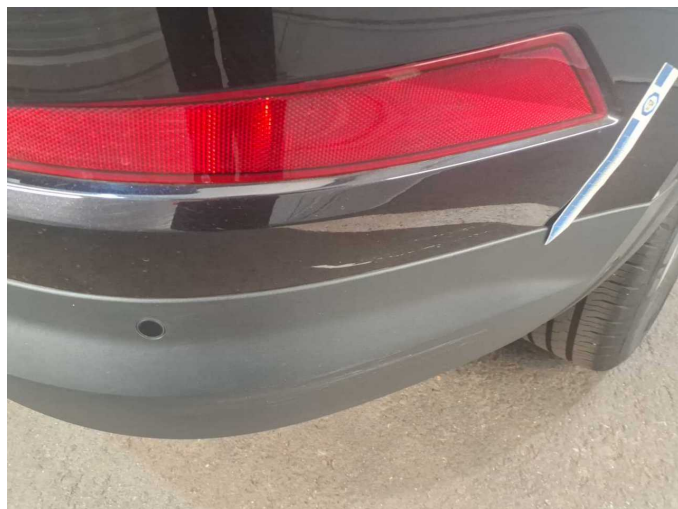
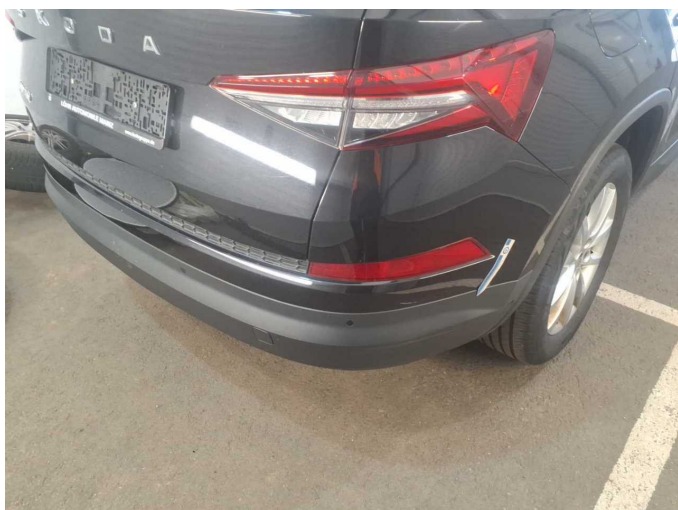
1 Rear

Non-repaired previous damages were found at the vehicle. The necessary repair costs are listed in the expert report or if necessary, are listed in detail in a separately enclosed repair cost calculation.

**Accident 1:** Rear
