Expertise

Protocol number: 46530986  
Order No. / Reference: 26497473  
Inspection date: 15 Jul 2026

Manufacturer: Skoda  
VIN: TMBJC7NY1PF040100

Model: Enyaq iV 80

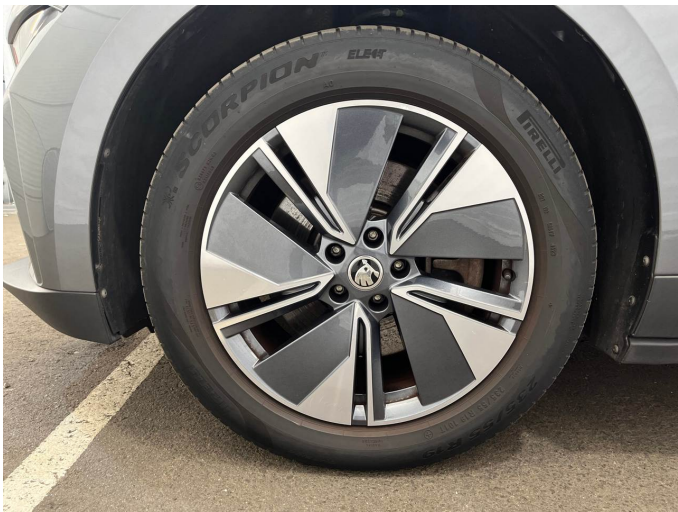
| # | Tyre size | Type of tyre | Manufacturer | Tread depth |
|---|---|---|---|---|
| 1) | 235/55 R19 101T | Summer tyres on Light alloy | Pirelli | 5mm / 5mm |
| 2) | 255/50 R19 103T | Summer tyres on Light alloy | Pirelli | 4mm / 4mm |

Figure 12: Mounted tyres

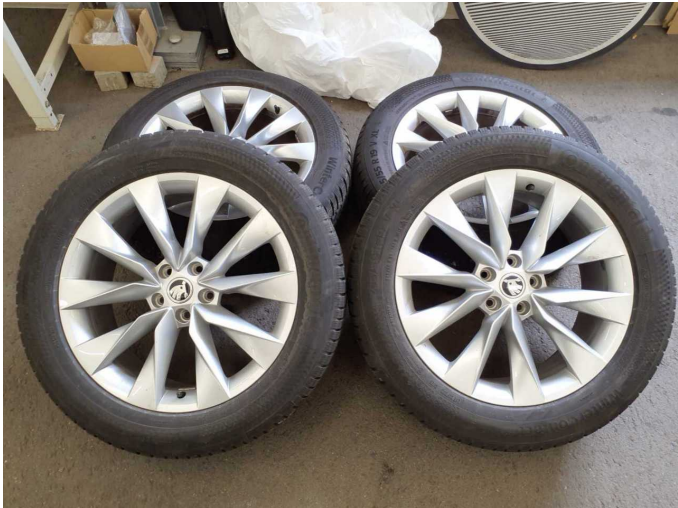
| # | Tyre size | Type of tyre | Manufacturer | Tread depth |
|---|---|---|---|---|
| 1) | 235/55 R19 105V | Winter tyres on Light alloy | Continental | 8mm / 8mm |
| 2) | 255/50 R19 107V | Winter tyres on Light alloy | Continental | 8mm / 8mm |

Figure 16: Additional tyres

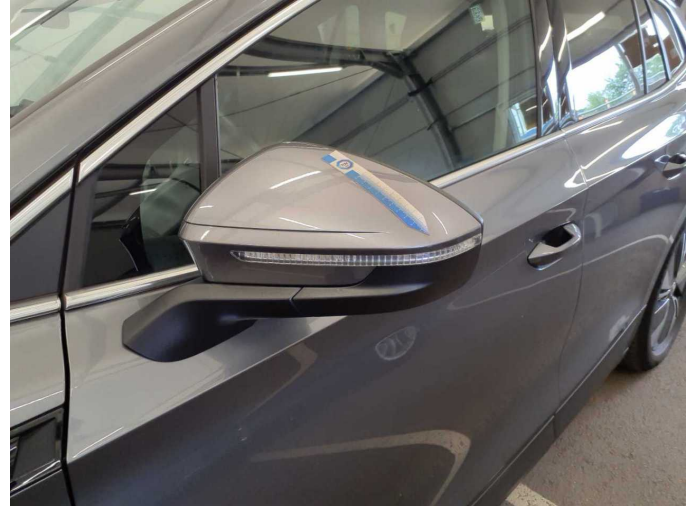
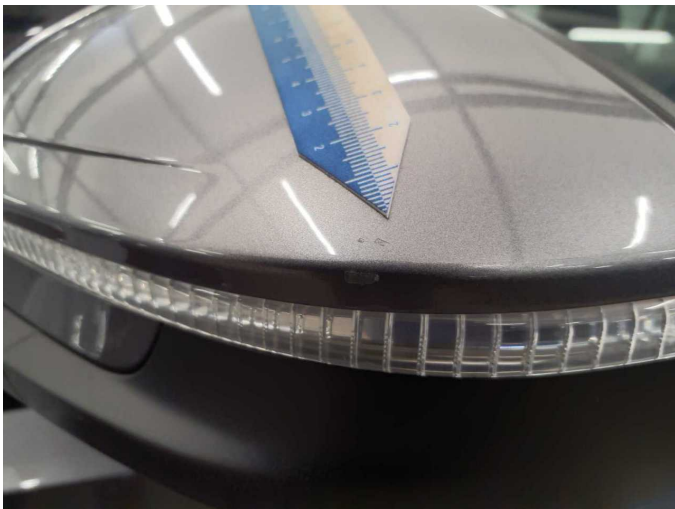
| No. | Component group | Description |
|---|---|---|
| 1 | Wing mirror - left side | Cap - Scratch(es) - Smart repair |

**Damage 1:** Wing mirror - left side: Cap - Scratch(es) - Smart repair

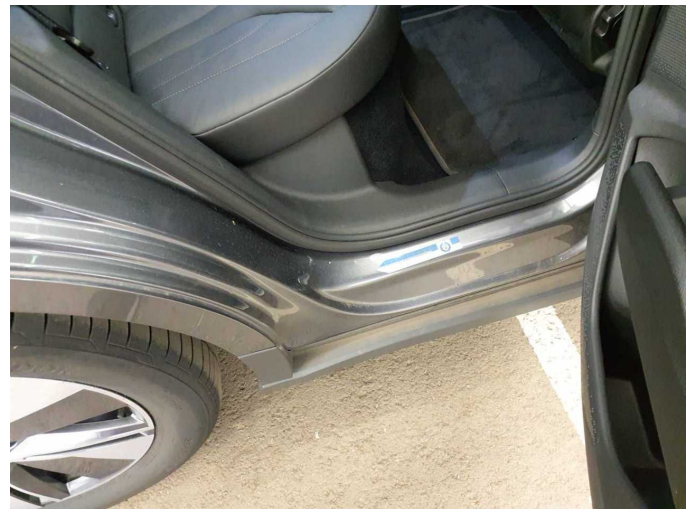
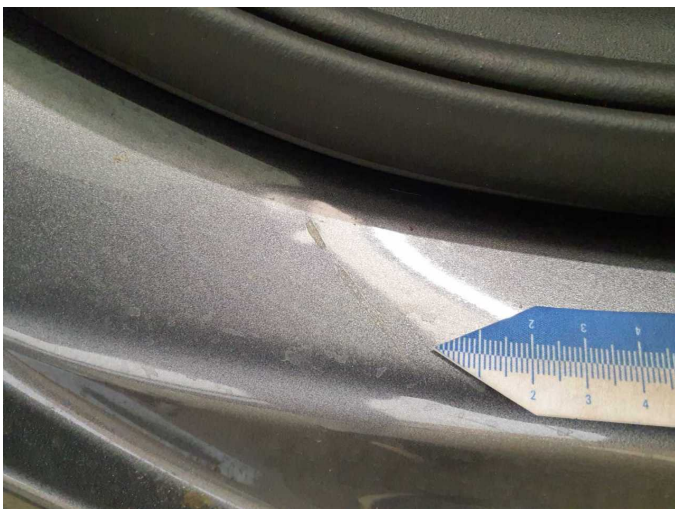
| No. | Component group | Description |
|---|---|---|
| 2 | Side panel - rear right side | Sill - Scratch(es) - Smart repair |

**Damage 2:** Side panel - rear right side: Sill - Scratch(es) - Smart repair

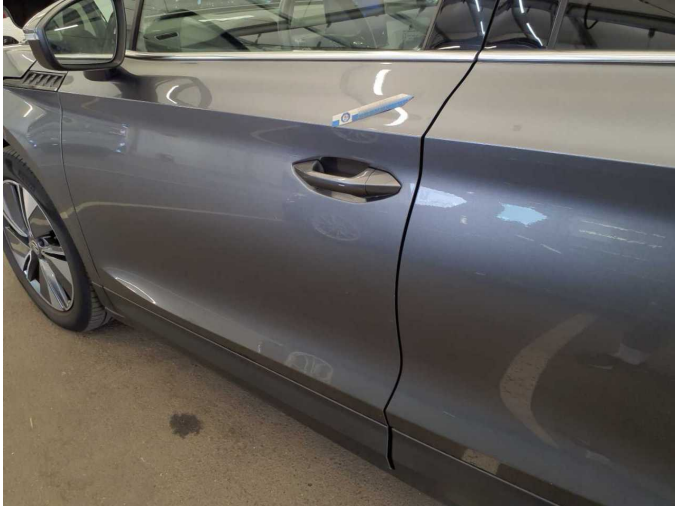
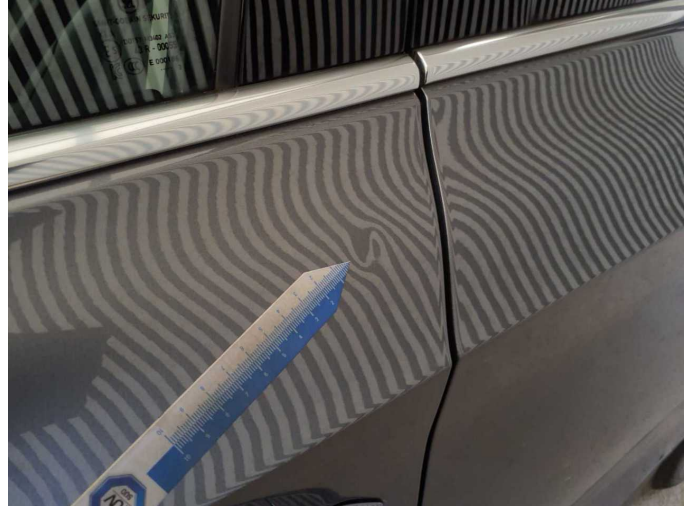
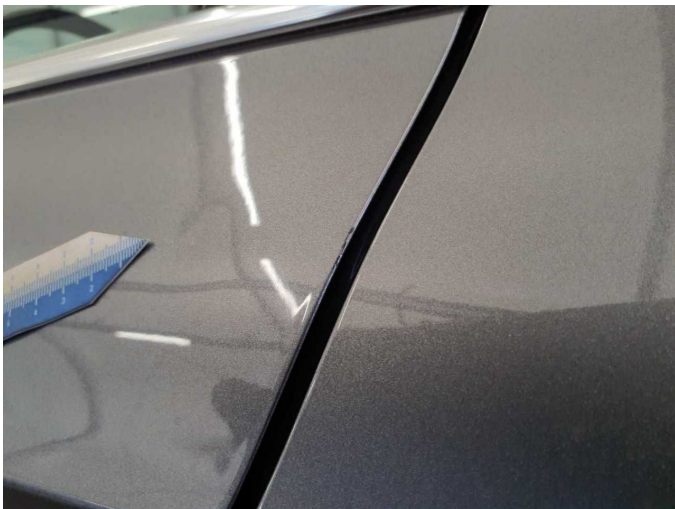
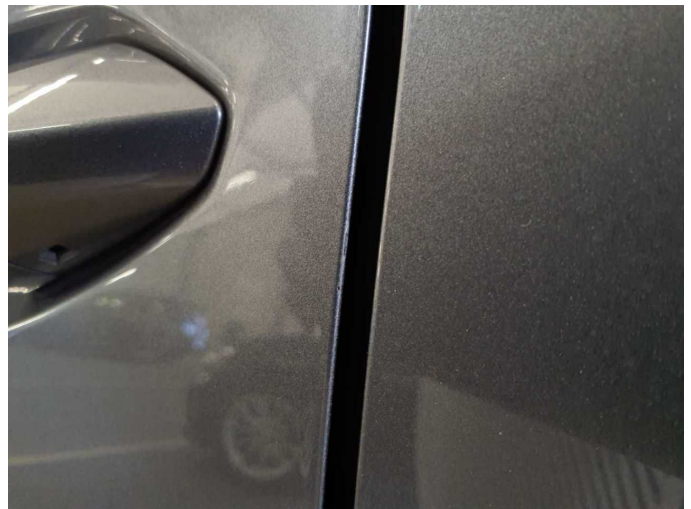
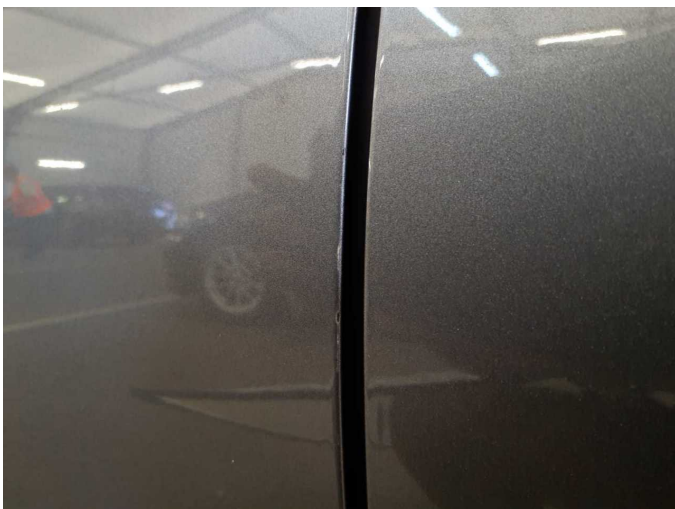
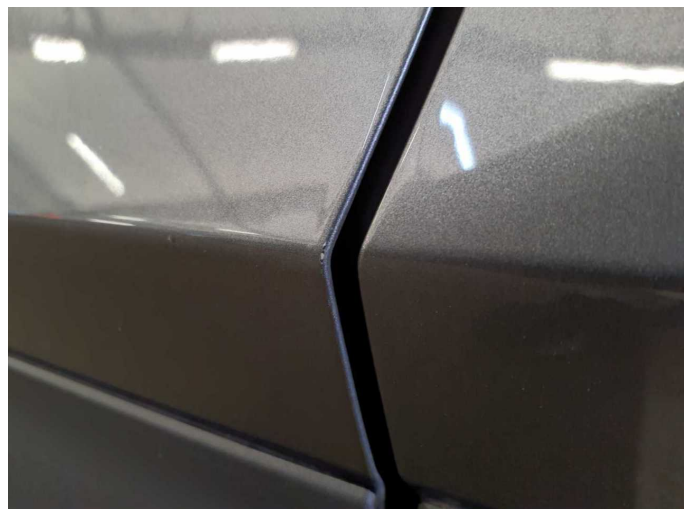
| No. | Component group | Description |
|---|---|---|
| 4 | Door - front left side | Door - Dent / paintcoat damage - Paint |

**Damage 4:** Door - front left side: Door - Dent / paintcoat damage - Paint
