Expertise

Protocol number: 46135399
Order No. / Reference: 26426718
Inspection date: 19 Jun 2026

Model: Q5 50 TFSIe quattro S tronic S line

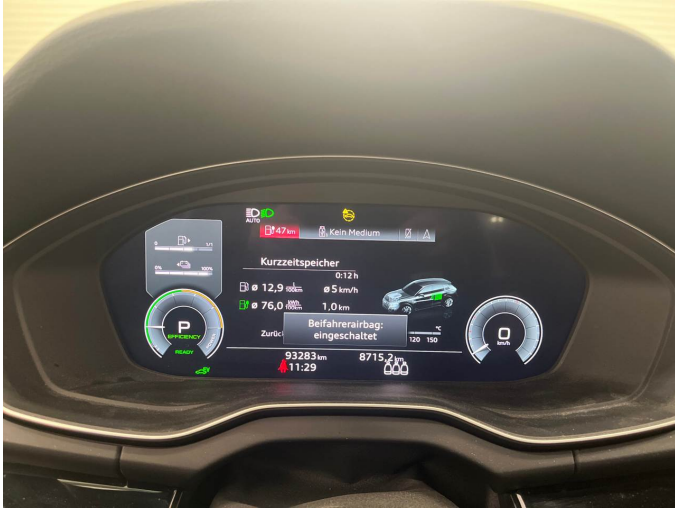
Figure 7: Instrument cluster

Mileage (Read) 93,283 km

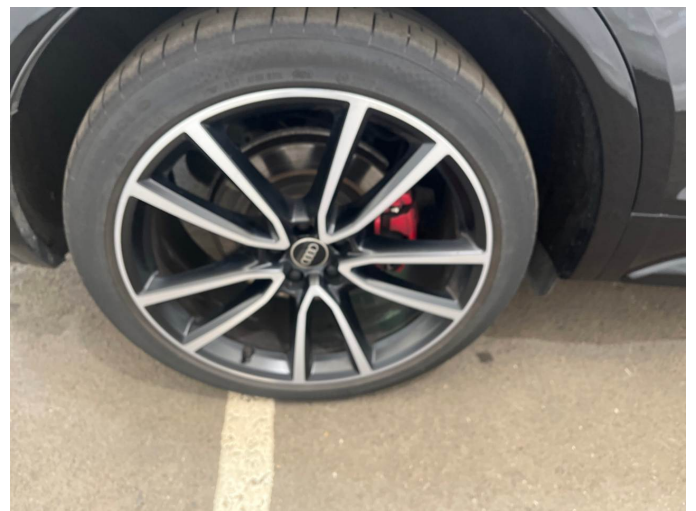
Figure 12: Mounted tyres

#	Tyre size	Type of tyre	Manufacturer	Tread depth
1)	255/40 R21 102Y	Summer tyres on Light alloy	Continental	6mm / 6mm
2)	255/40 R21 102Y	Summer tyres on Light alloy	Continental	6mm / 6mm

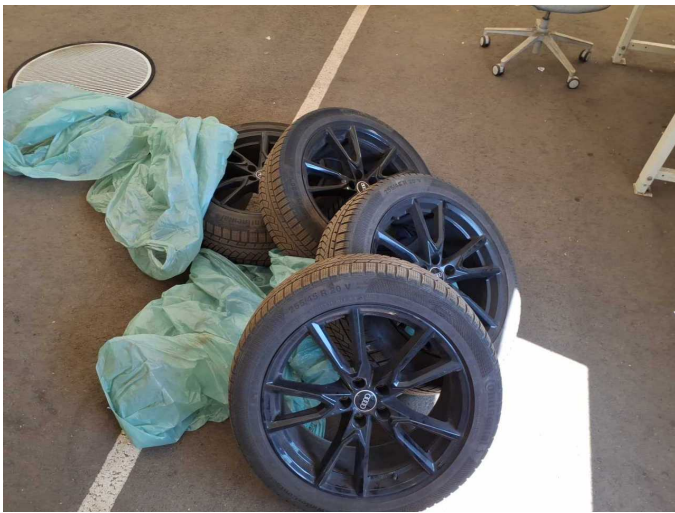
Figure 15: Additional tyres

#	Tyre size	Type of tyre	Manufacturer	Tread depth
1)	255/45 R20 101V	Winter tyres on Light alloy	Continental	5mm / 5mm
2)	255/45 R20 101V	Winter tyres on Light alloy	Continental	5mm / 5mm

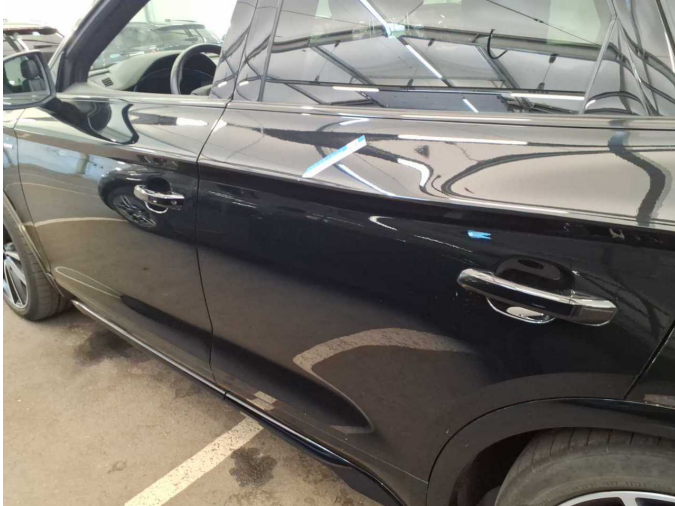
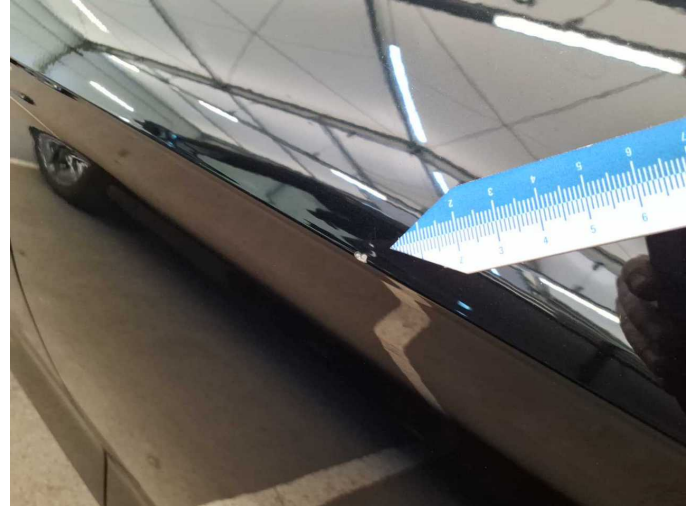
Damage 1: Door - rear left side: Door - Scratched - Smart repair

No.	Component group	Description
1	Door - rear left side	Door - Scratched - Smart repair
2	Rear bumper	Spoiler (& Lackschaden) - Deformed - Replace
3	Rear bumper	Rear bumper - Scratched - Repair and paint
4	Wheel / tyres	Alloy rim - front right side (Mit Materialabtrag) - Scratched - Replace

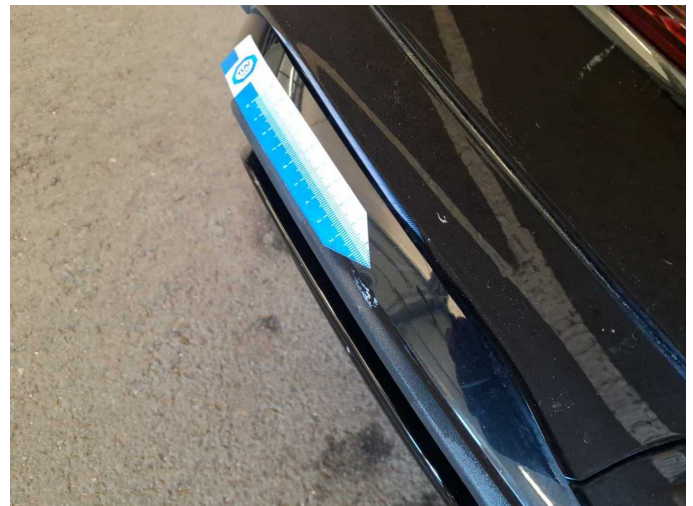
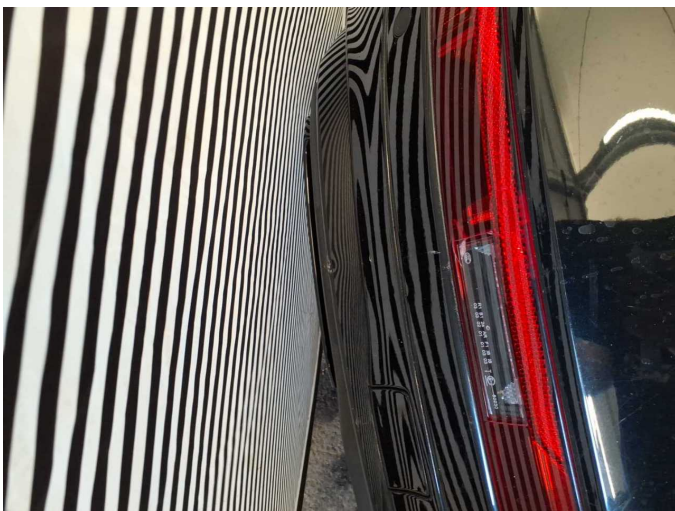
Damage 2: Rear bumper: Spoiler (& Lackschaden) - Deformed - Replace

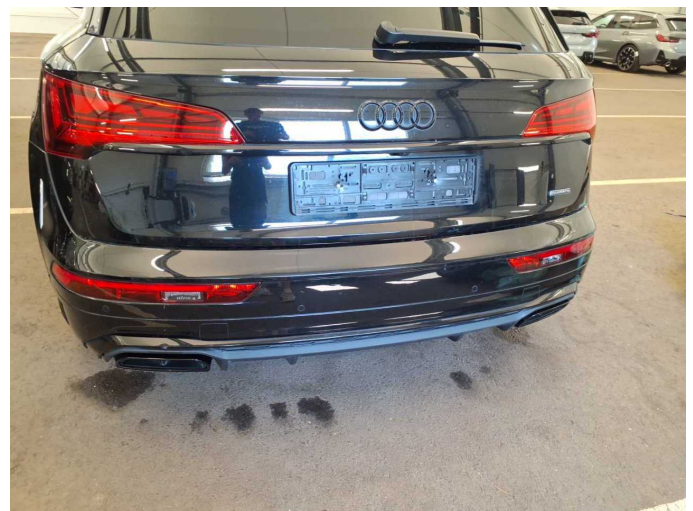
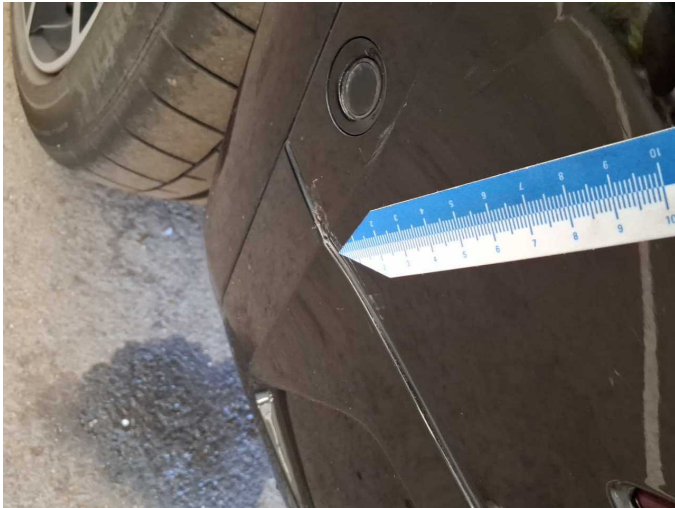
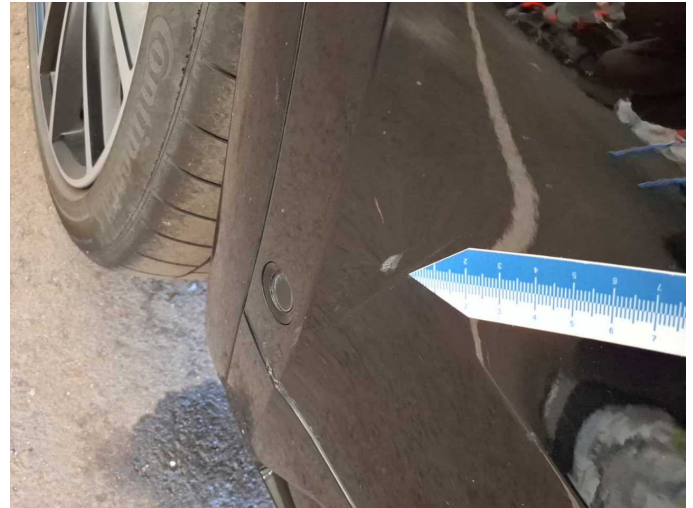
Damage 3: Rear bumper: Rear bumper - Scratched - Repair and paint

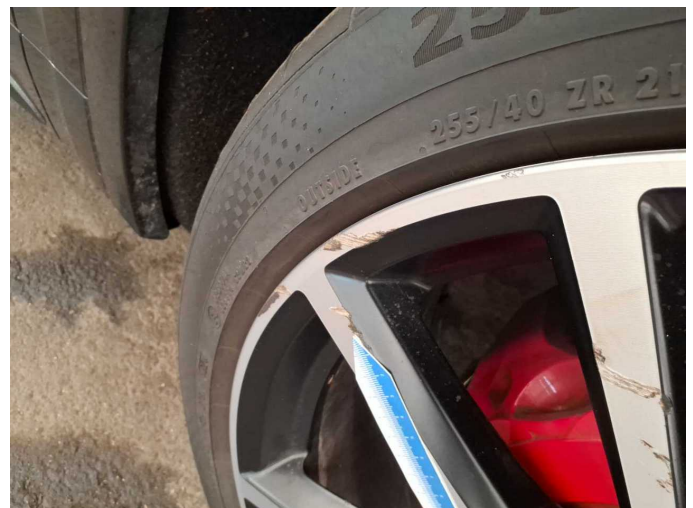
Damage 4: Wheel / tyres: Alloy rim - front right side (Mit Materialabtrag) - Scratched - Replace

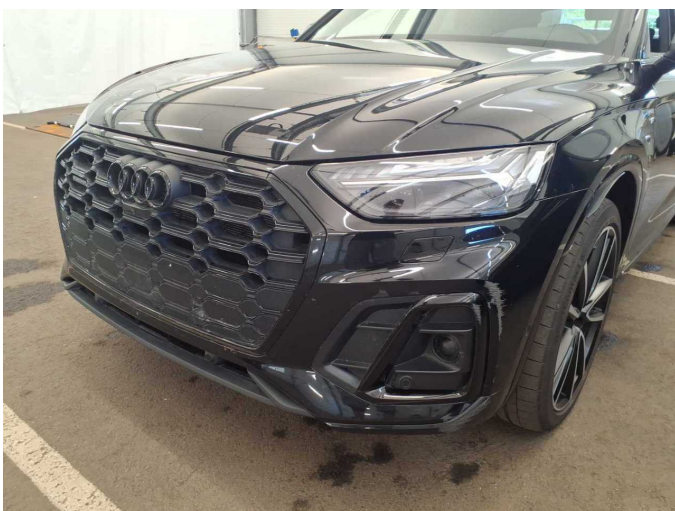
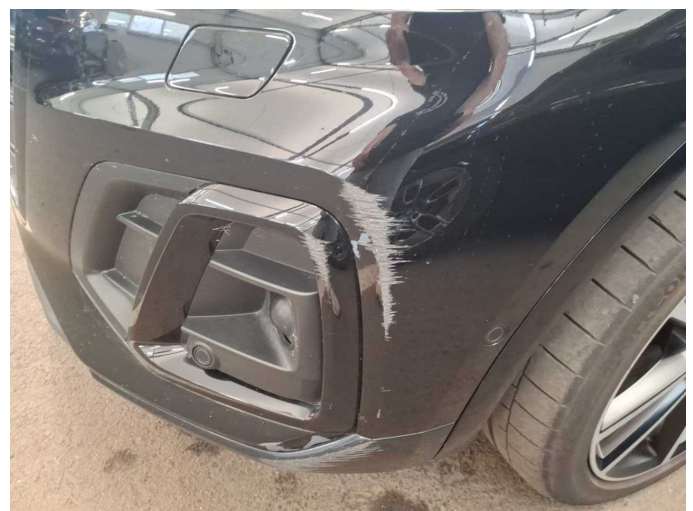
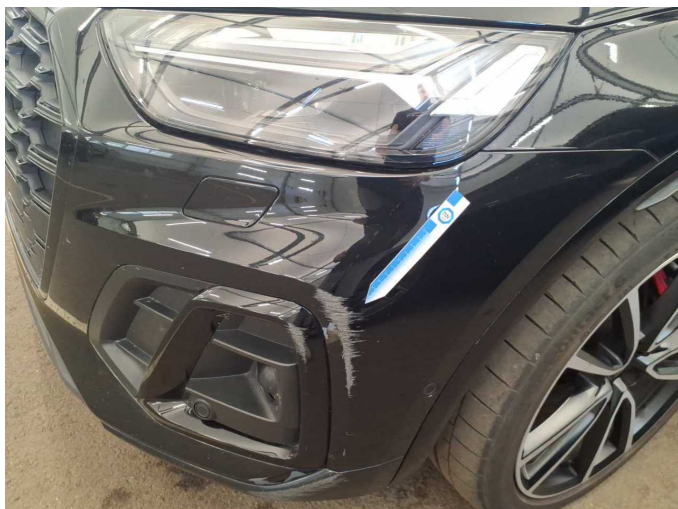
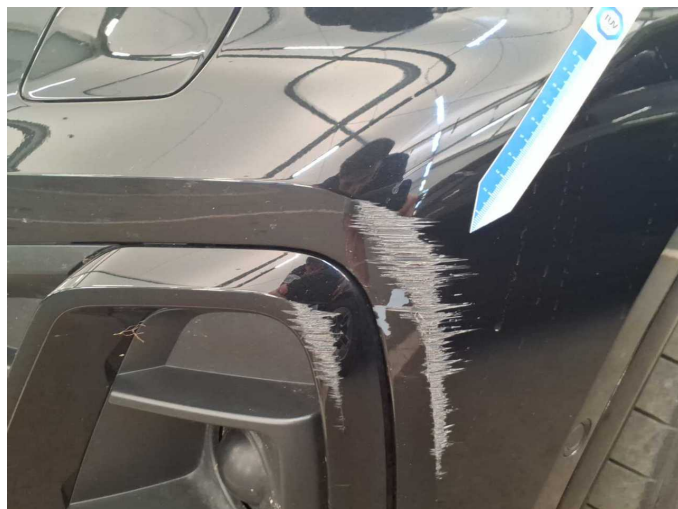
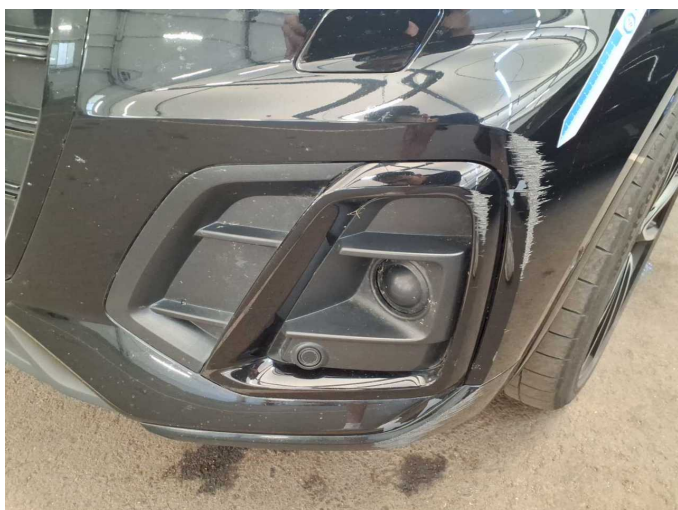
Non-repaired previous damages were found at the vehicle. The necessary repair costs are listed in the expert report or if necessary, are listed in detail in a separately enclosed repair cost calculation.

Accident 1: Front
