Expertise

Protocol number: 46474392  
Order No. / Reference: 26637945  
Inspection date: 13 Jul 2026

Manufacturer: Ford

Model: Focus Turnier 1.5 EcoBlue Start-Stopp-System Aut. TITANIUM

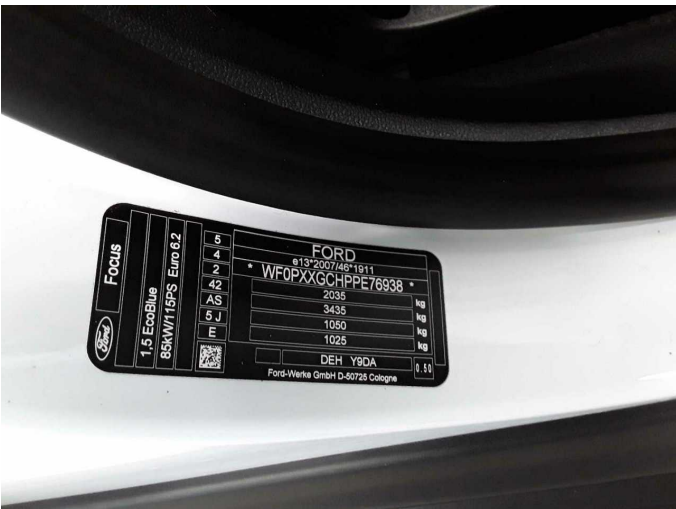
Figure 11: VIN

| VIN comparison | The vehicle identification number (VIN) was read from the vehicle and its conformity with the submitted documents was confirmed by the undersigned during the inspection. |

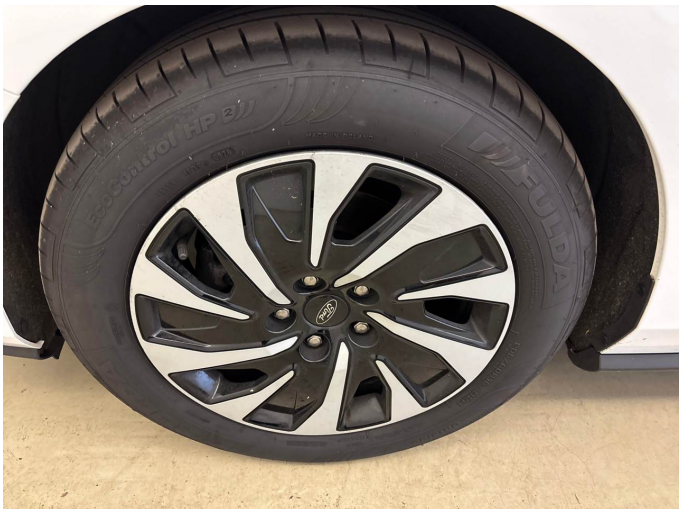
Figure 12: Mounted tyres

| # | Tyre size | Type of tyre | Manufacturer | Tread depth |
|---|---|---|---|---|
| 1) | 205/60 R16 92H | Summer tyres on Steel rim with wheel cover | Fulda | 3mm / 3mm |
| 2) | 205/60 R16 92H | Summer tyres on Steel rim with wheel cover | Fulda | 4mm / 4mm |

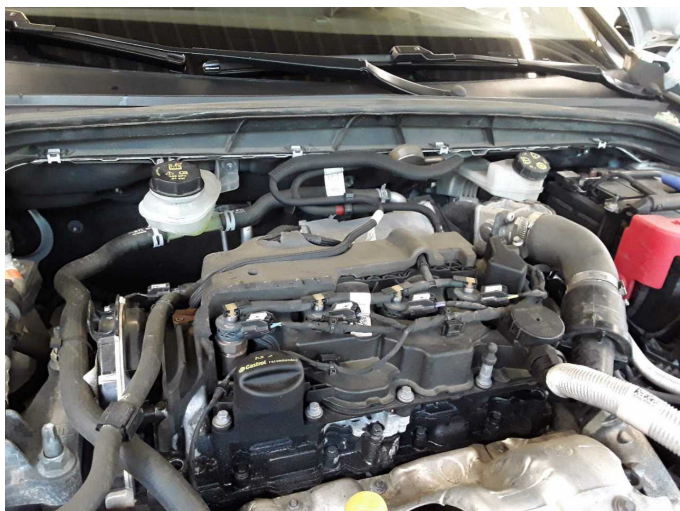
**Damage 1:** Engine: Engine cover - Damaged - Replace

| No. | Component group | Description |
|---|---|---|
| 1 | Engine | Engine cover - Damaged - Replace |

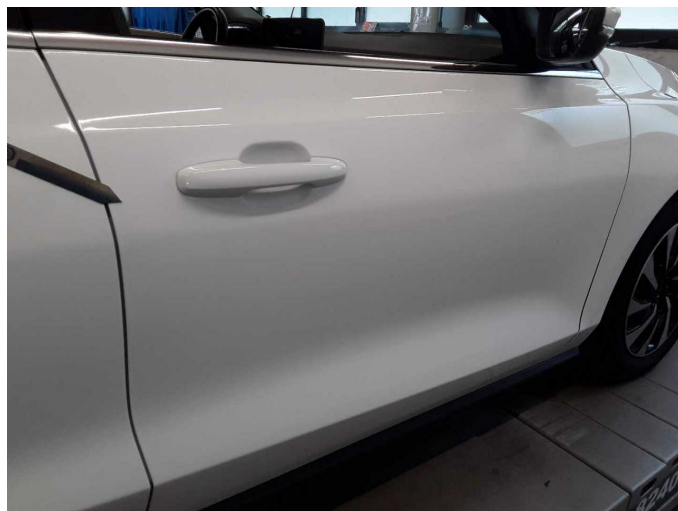
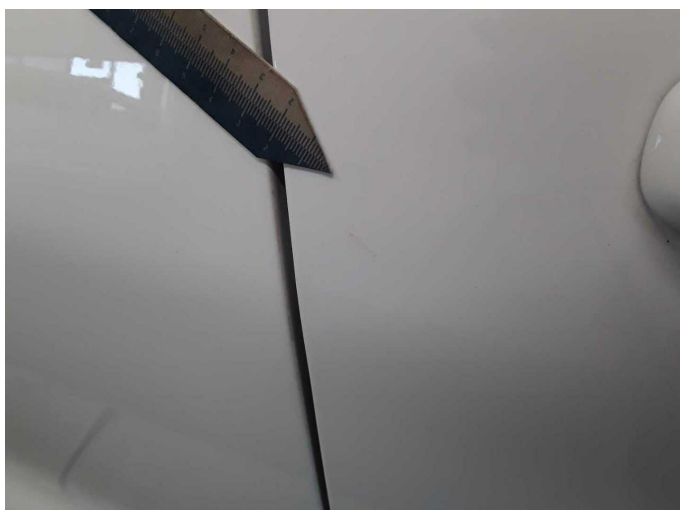
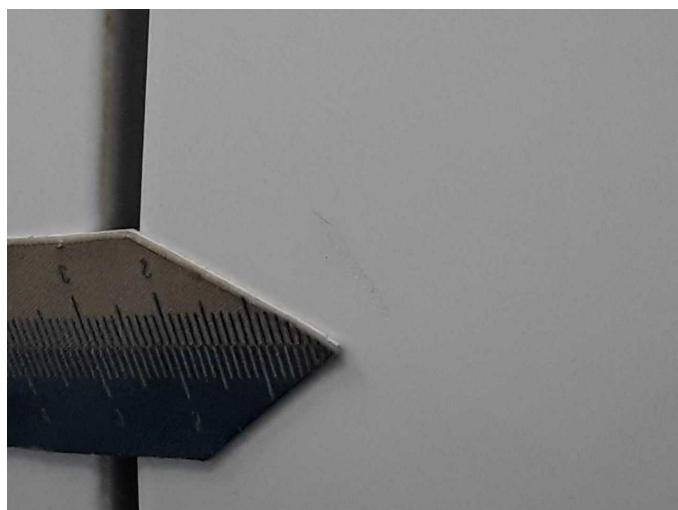
**Damage 2:** Door - front right side: Door - Scratch(es) - Smart repair

| No. | Component group | Description |
|---|---|---|
| 2 | Door - front right side | Door - Scratch(es) - Smart repair |

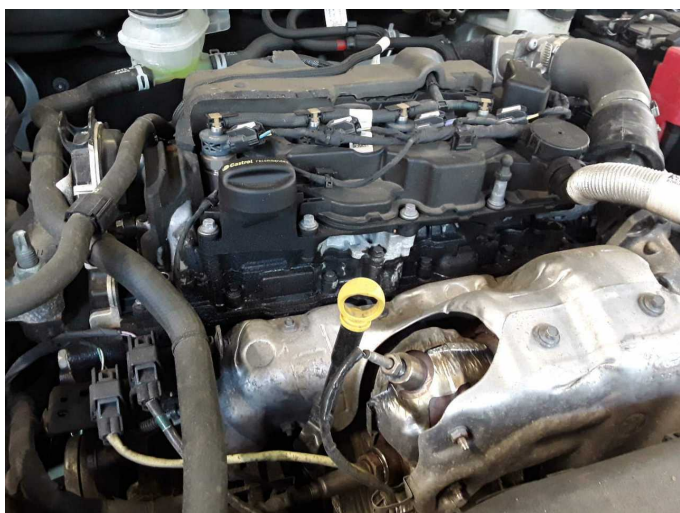
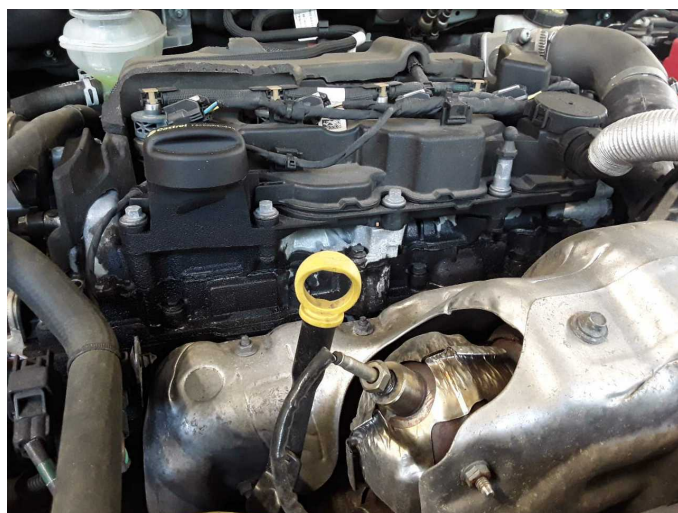
**Damage 3:** Engine: Engine - Leaking - Diagnosed and repair if necessary

| No. | Component group | Description |
|---|---|---|
| 3 | Engine | Engine - Leaking - Diagnosed and repair if necessary |
